Rough Roads, Increasing Speed and Change in Test Vehicle Motion - Data Separation Into 3 Road Segments

Posting Date: 9-April 2015

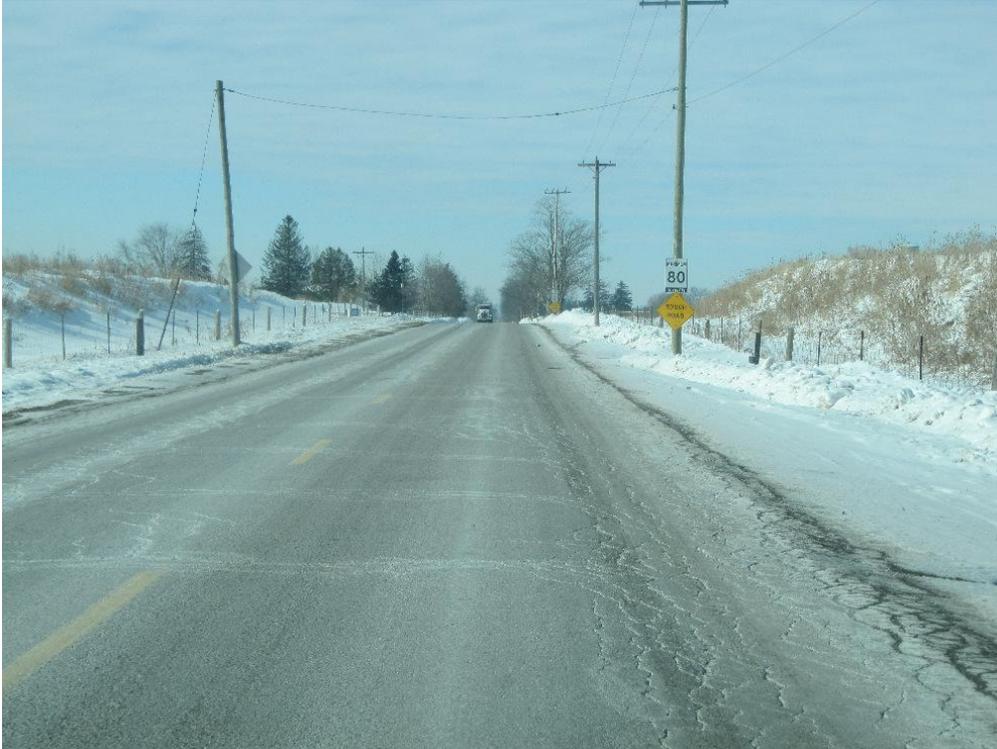
Figure 2: View looking westward along Sunningdale Road from just west of the intersection at Clarke Road. The utility pole on the right side of this view containing the "80 km/h" maximum speed sign, is the precise starting point where the captured data was analyzed.

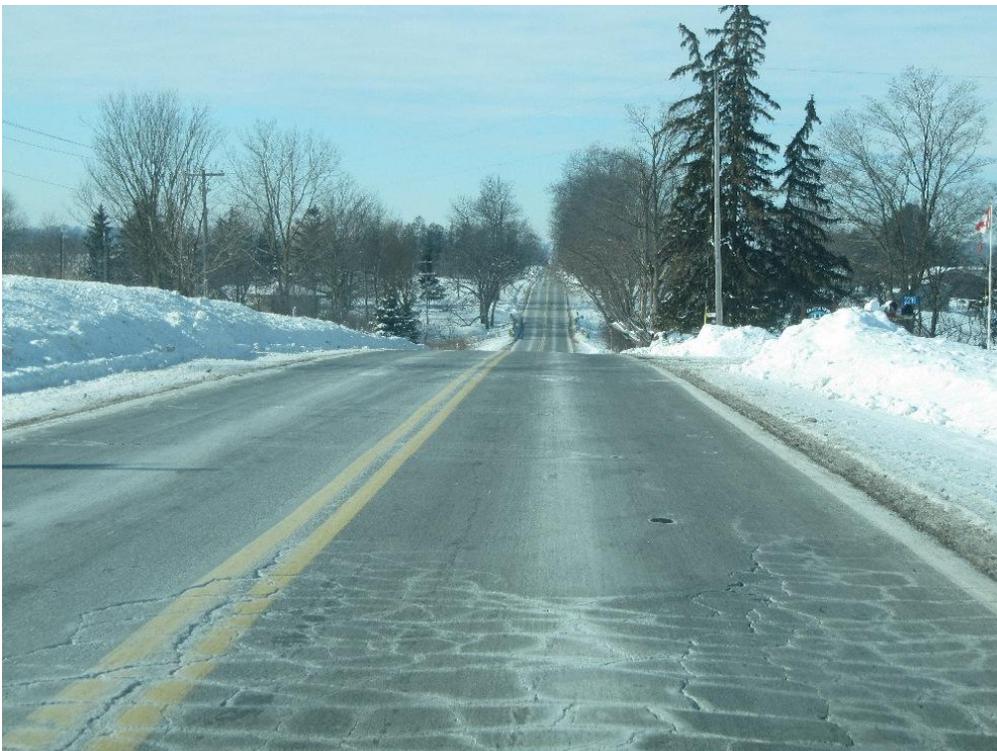
Figure 3: View, looking west along Sunningdale Road. Shortly after commencing the data collection a sag is encountered as shown in this view. Commencing at the location of a small bridge the rough road surface was repaved thus a smoother section of pavement was encountered.

Sunningdale Road was generally straight and level except for a small sag located near its east end. There was a small bridge at the bottom of this sag as shown in the westward views of Figures 3 and 4.

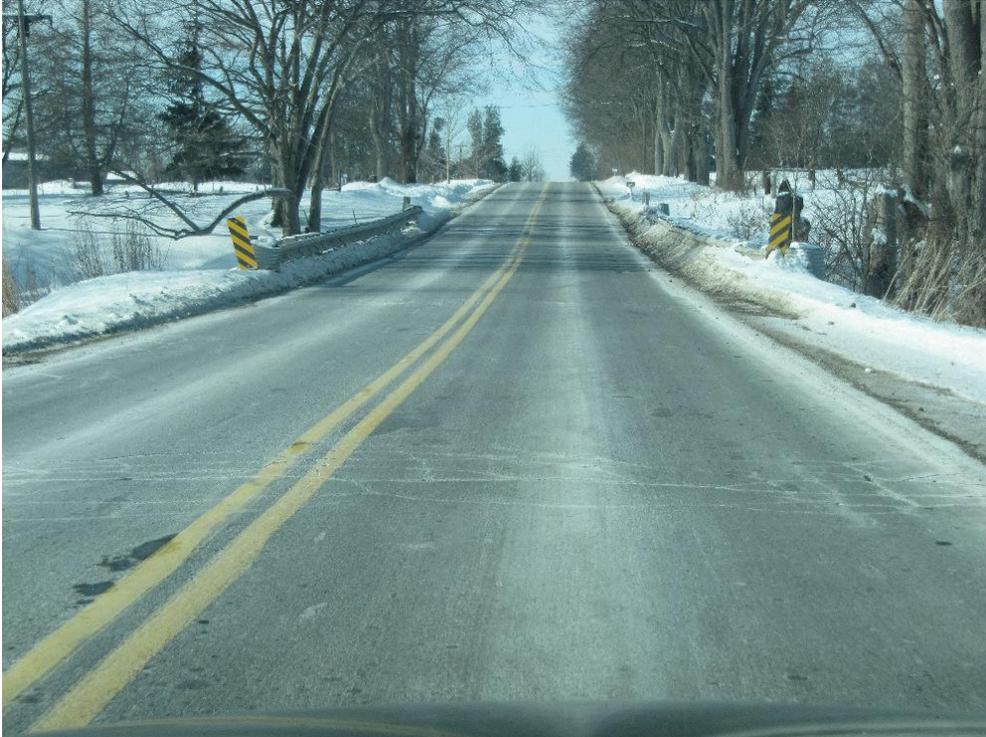
Figure 4: View, looking west along Sunningdale Road. The newer (smoother) section of pavement commenced at the west (far) side of this small bridge.

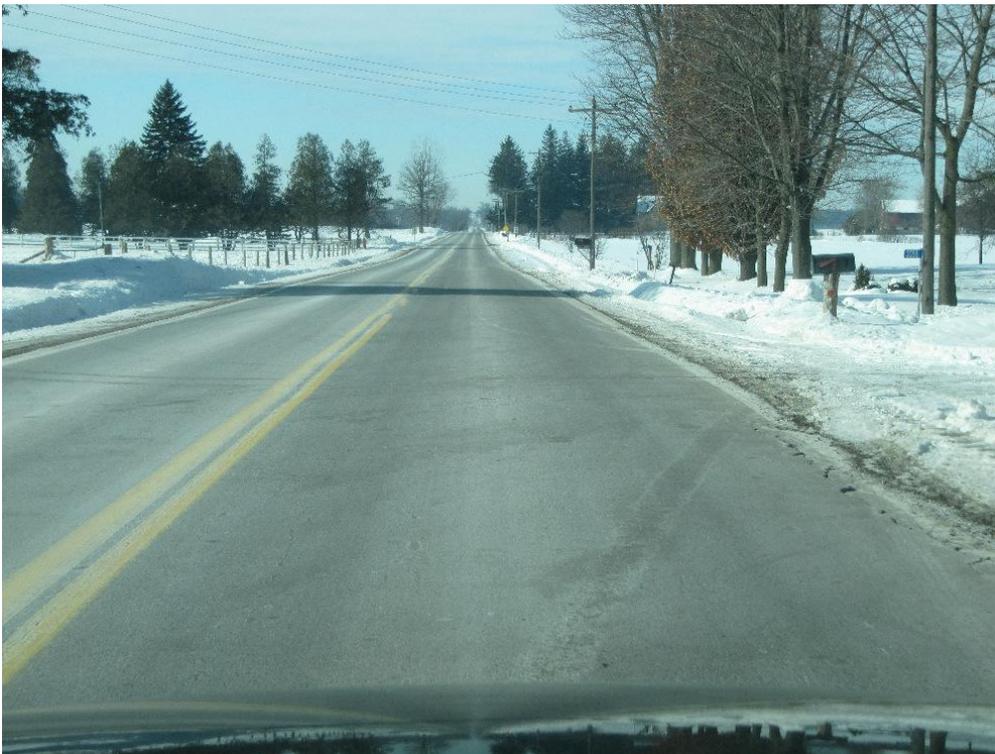
Figure 5: Upon mounting the upslope of the sag (at small bridge) the roadway entered a long section that was straight and level, as shown in this westward view. The pavement in this area was new and smooth.

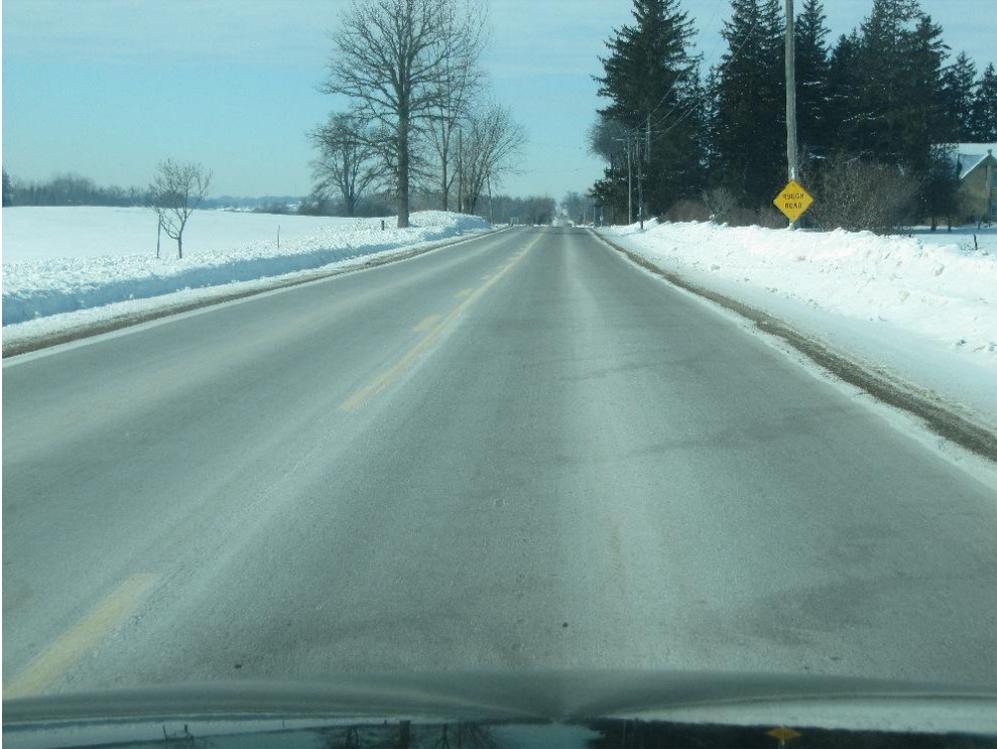
Figure 6: Near the end of the smooth section of pavement there was a warning sign posted on the right roadside indicating the return of the older and rougher section of road.

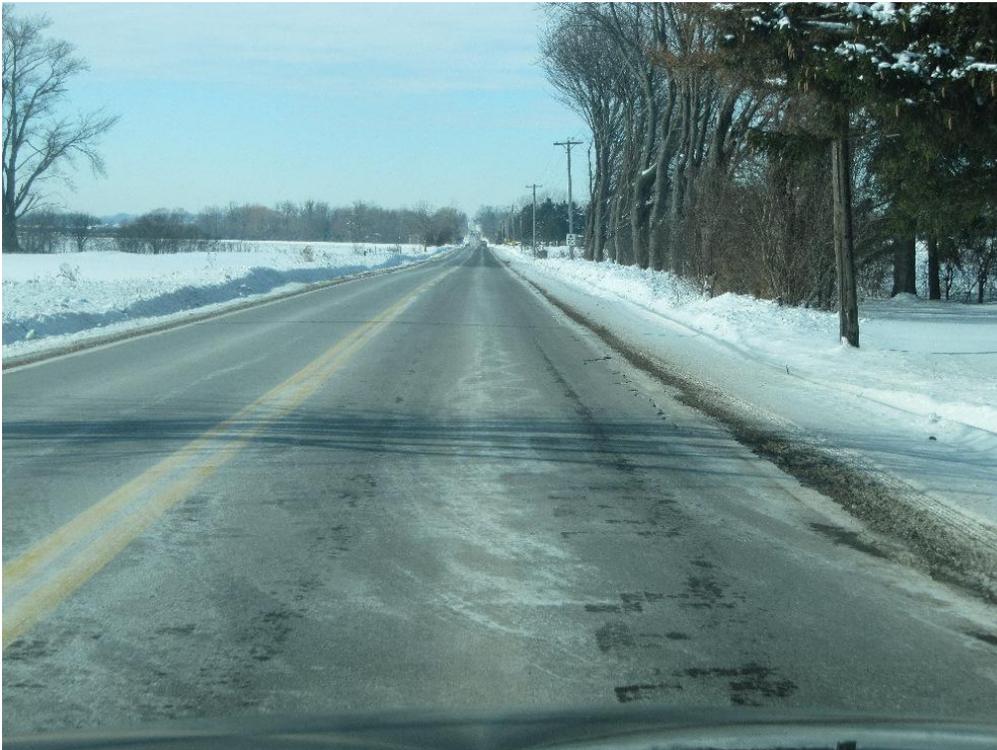
Figure 7: Continuing further westward the end of the newer pavement can be seen in the distant background of this westward view along Sunningdale Road.

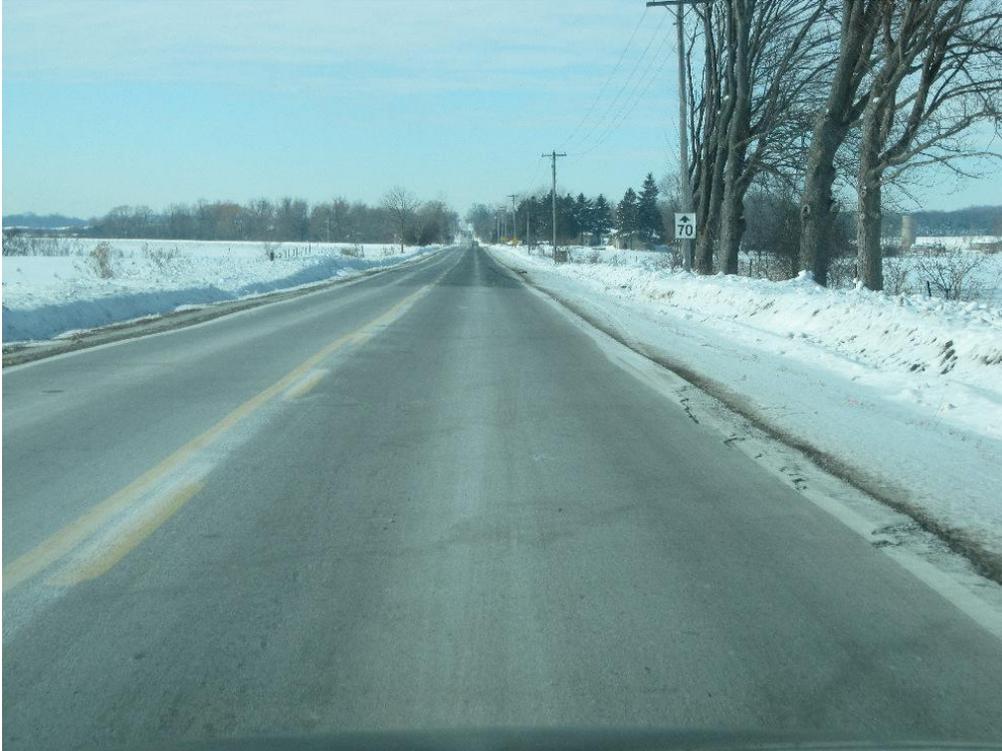
Figure 8: View, looking west along Sunningdale Road. The end of the newer section of pavement can be seen in the background.

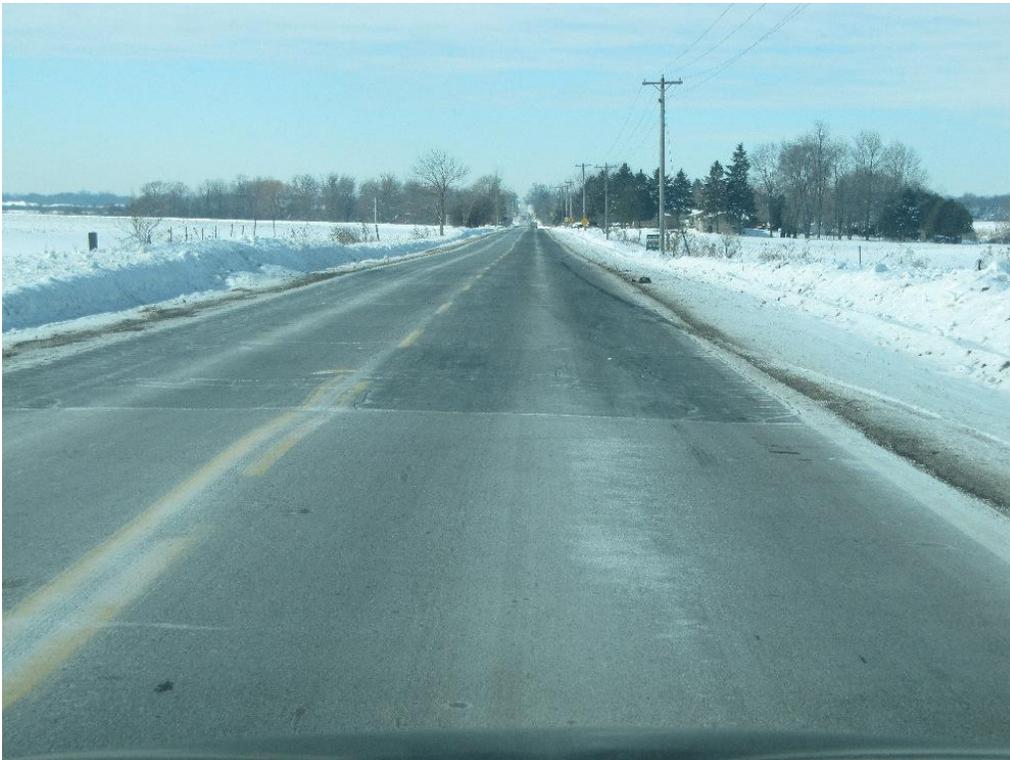
Figure 9: View, looking west along Sunningdale Road at the point where the newer section of pavement ends and the rougher section of surface returns.

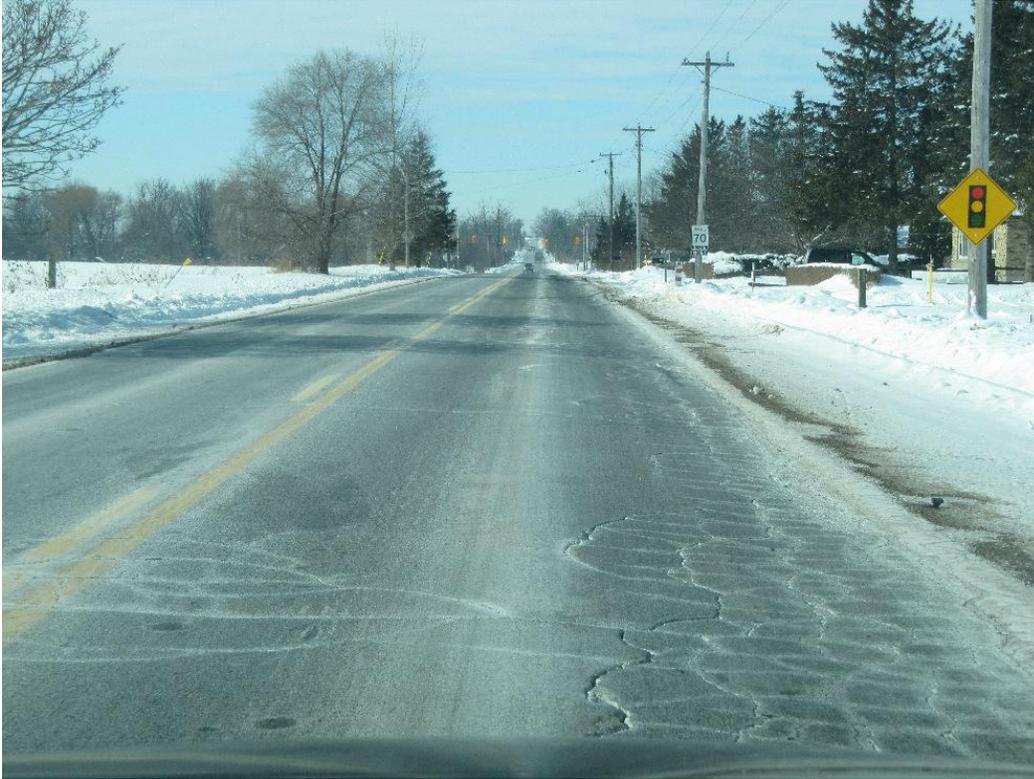
Figure 10: View, looking west along Sunningdale Road, along the rough portion of pavement on approach to the intersection with Highbury Avenue.

The point where the rough surface transitioned back into the newer section of pavement (Figure 10) is where the analysis of the gathered data was terminated. Thus each run contained a road segment of rough surface, followed by the smooth surface and then finished off with a segment of rough surface.

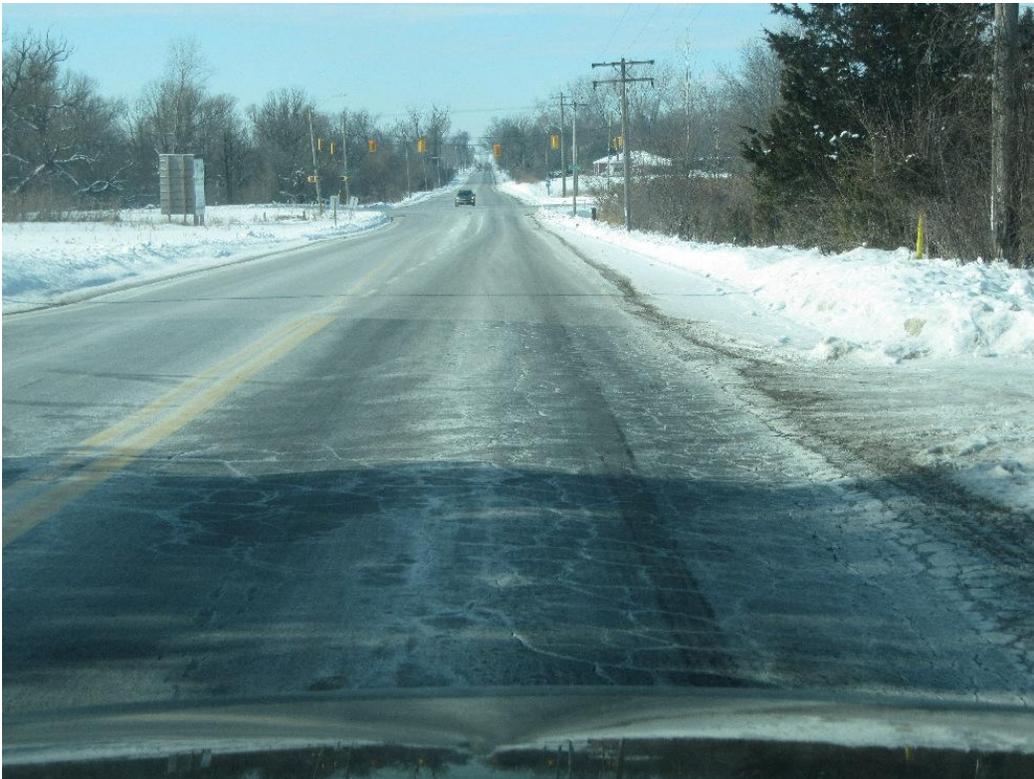
Figure 11: View, looking west along Sunningdale Road just east of the intersection with Highbury Avenue. This view shows that the rough segment of pavement ends on the approach to the Highbury intersection.
