Speed of Recreational Cyclists on Down-grade of Trafalgar Bike Path in London, Ontario

Zygmunt M. Gorski, Gorski Consulting, London, Ontario, Canada

June 19, 2020

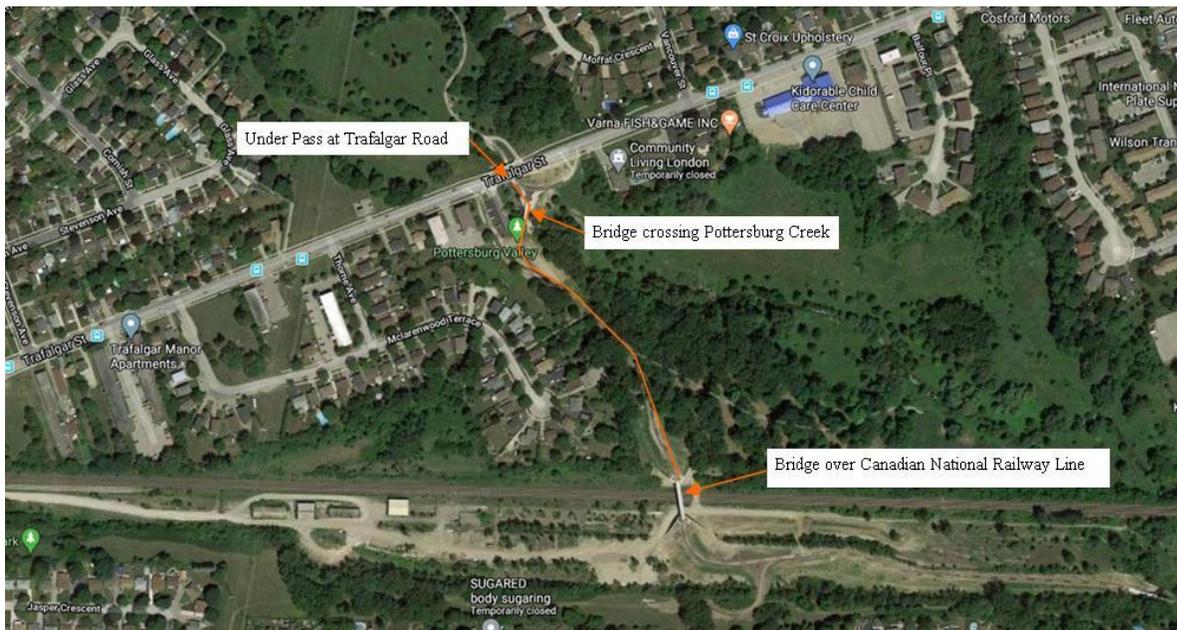
Figure 1 below shows a general view of the Trafalgar bike path from the new bridge over the Canadian National Railway (CNR) line through to the underpass at Trafalgar Road. The total distance between these references is approximately 350 metres.

Figure 1: Overall view of the City of London multi-sue path south of Trafalgar Road.

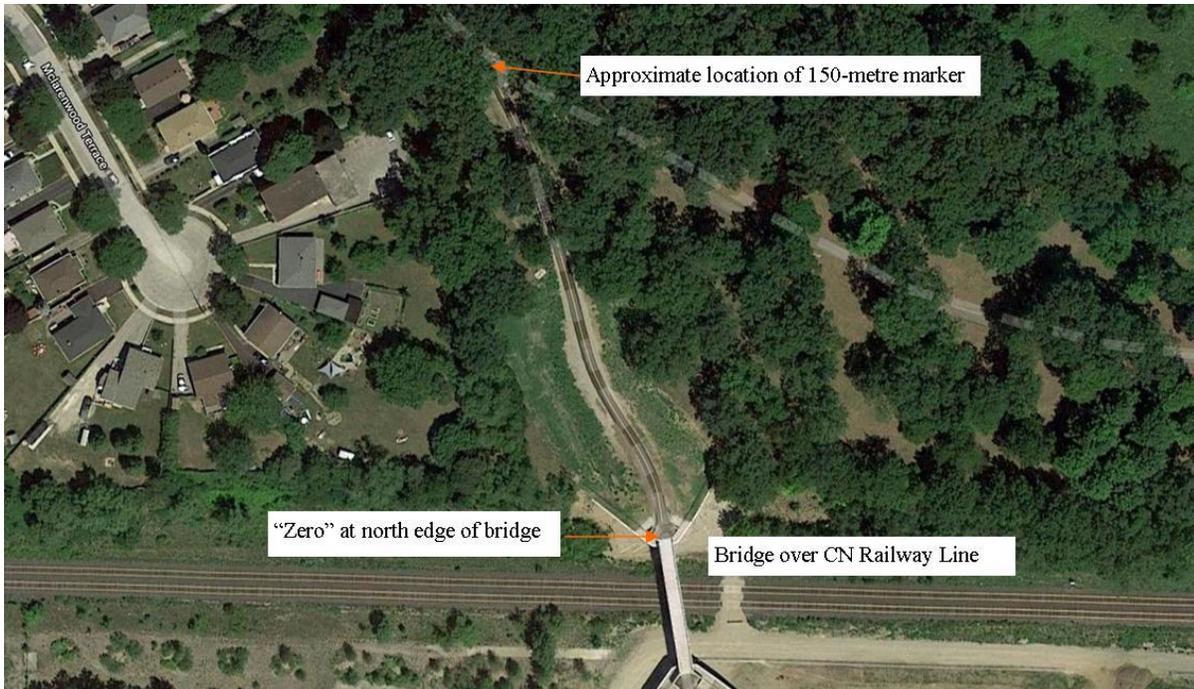
Figure 2 below shows the southern portion of the trail from the CNR bridge to a point approximately 150 metres to the north. In August of 2018 testing was performed over this segment of the path and the results were reported in an article posted to the Gorski Consulting website.

Figure 2: View of Trafalgar bike path near the CNR bridge.

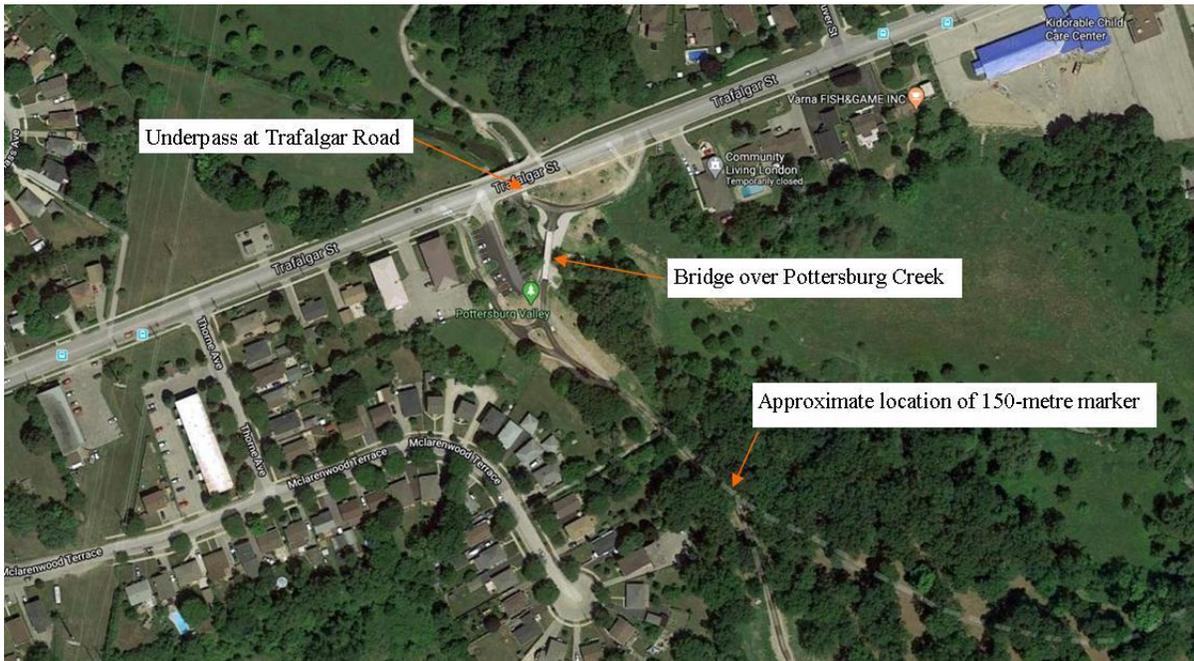
Figure 3 below shows the northern portion of the trail from the 150-metre marker through to the underpass of Trafalgar Road at the 345-metre marker. This is the portion of the trail where additional testing was performed on June 2, 2020 and the results of that testing will be reported in the present article.

Figure 3: View of Trafalgar Road path approaching the Trafalgar Road underpass.

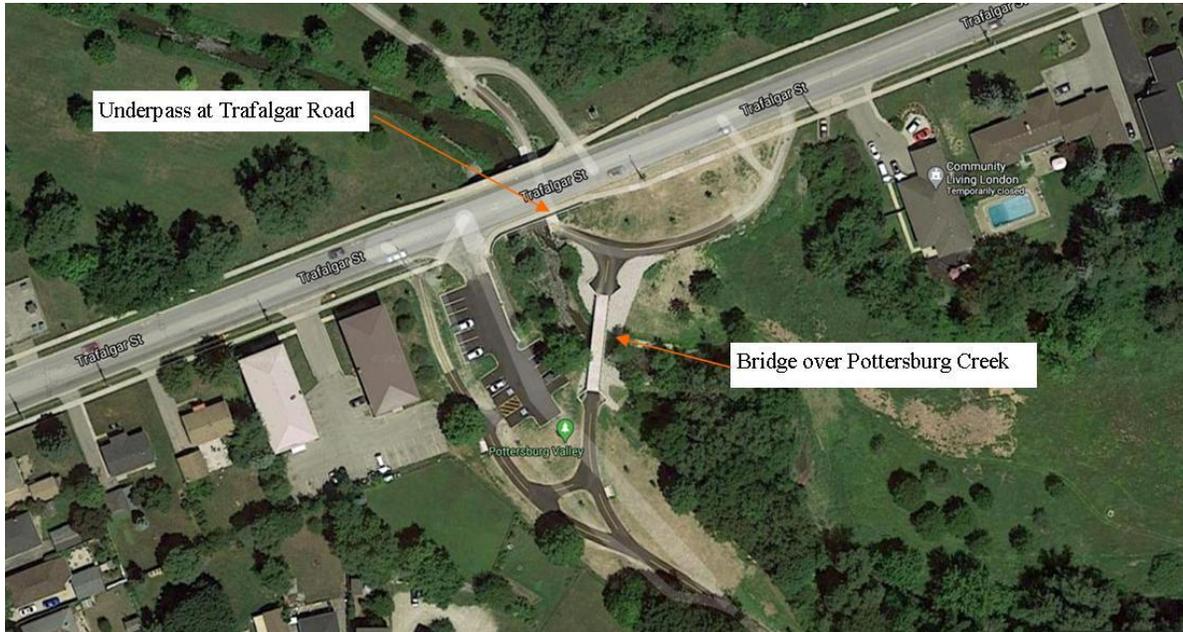
Figure 4 below shows a closer view of the trail on the approach to the Trafalgar Road underpass. It can be seen that, once cyclists cross the bridge over the Pottersburg Creek, they must make a sharp left turn and then an immediate right turn, while also travelling down a down-slope in order to enter the underpass.

Figure 4: Closer view of bridge over Pottersburg Creek and the Trafalgar Road underpass.

It needs to be questioned how the design was developed that connected the new section of the Trafalgar path to the underpass at Trafalgar Road. As cyclists travel northbound they approach a "T" intersection at Trafalgar Road which requires riders to either turn right or left. If they turn left then they are directed into the underpass. A possible reason for the "T" intersection is that the designers may have felt that this would cause cyclists to slow down before executing the left turn. Thus the slower speed may have been considered as a desirable outcome. Yet, by creating the "T" intersection they also created a situation where cyclists would have to make a sharp left turn and then an immediate, sharp, right turn to enter the underpass. These turns occur as there is a substantial down-slope and there is also very limited visibility caused by the south edge of the wall of the underpass.

The alternative could have involved construction of a longer bridge over Pottersburg Creek such that the bridge lined up more closely with the angle of the underpass and therefore the visibility obstruction of the bridge wall would be eliminated. While this alteration may result in higher cyclist speed it would also improve the visibility and allow cyclists an opportunity to slow down if they detect a problem ahead. This alternative may not have been economically feasible or the engineering may have been difficult. But whatever the reasons the status of the present design makes for an unsafe condition.

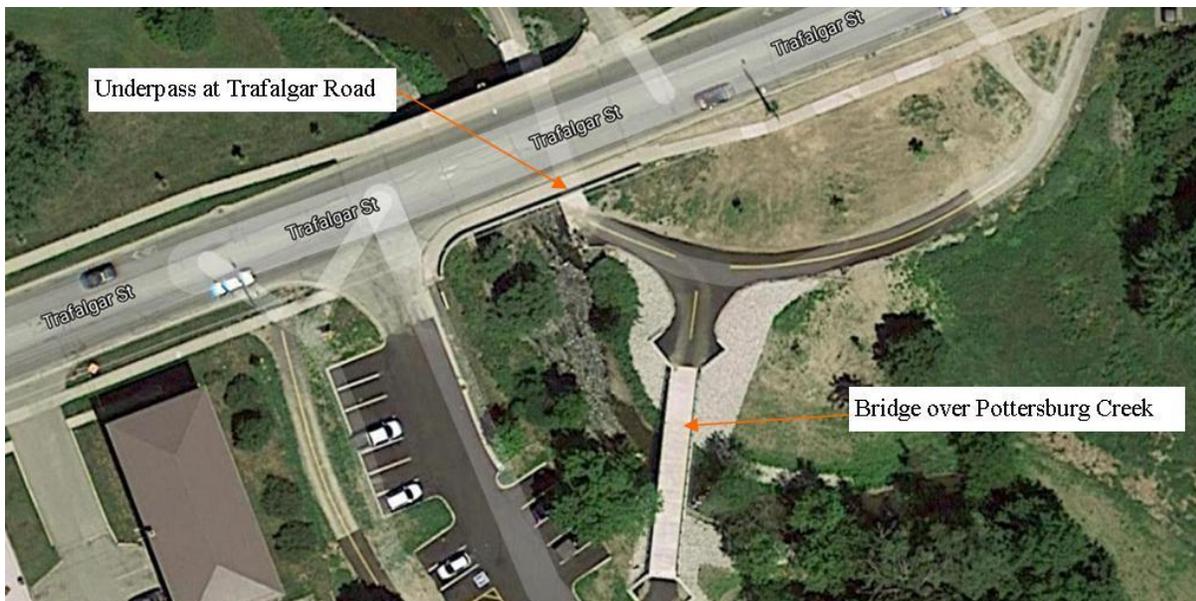
Figure 5 below provides a close-up view of the changes in direction of the path at the Trafalgar Road underpass.

Figure 5: Close-up view of the Pottersburg Creek bridge and the Trafalgar Road underpass.

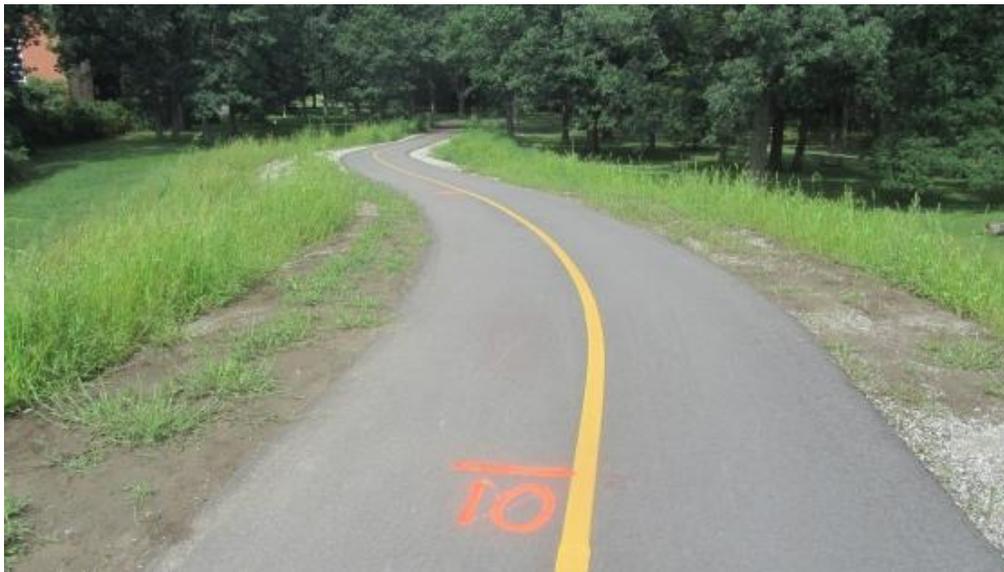
Figure 6 below shows a view looking north from about 10 metres north of the CNR bridge and this shows the characteristics of the Trafalgar path in the zone where the observations were performed in August of 2018.

Figure 6: View looking north from approximately 10 metres north of the CNR bridge.

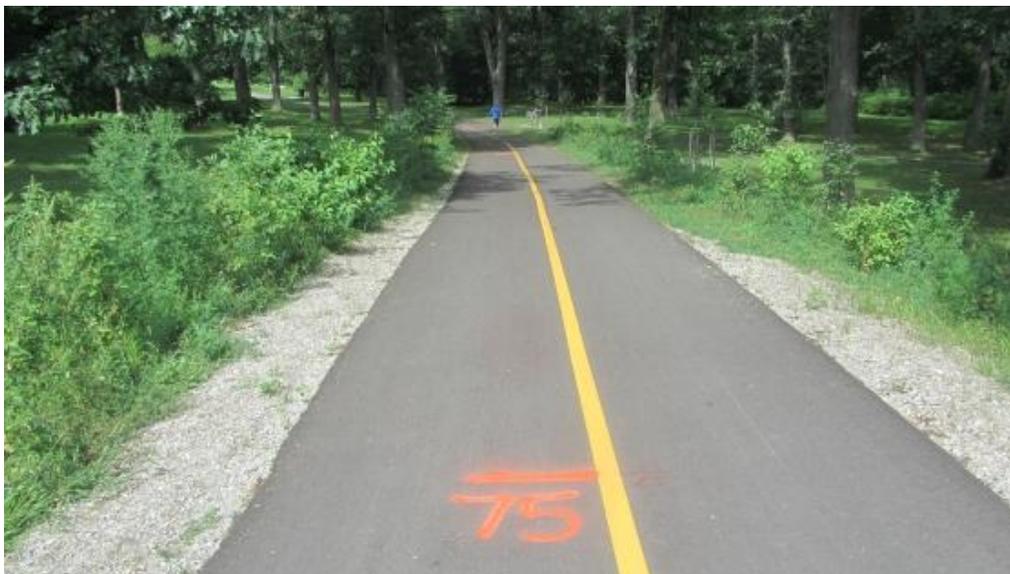
Figure 7 shows a view looking north from about 75 metres north of the CNR bridge. There is a steep down-slope in this portion of the path.

Figure 7: View looking north from approximately 75 metres north of the CNR bridge.

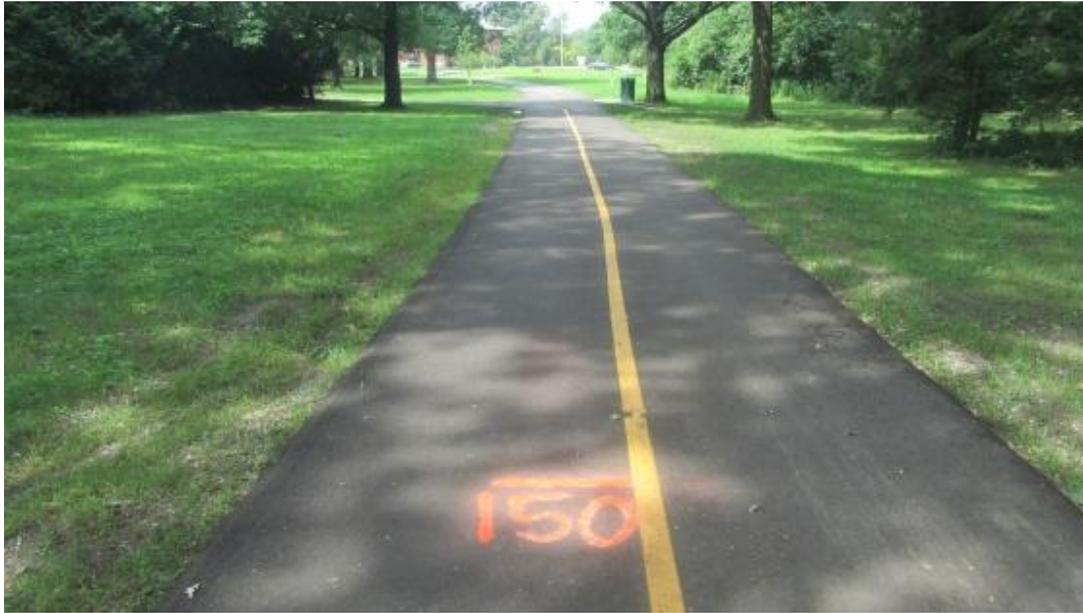
Figure 8 shows a view looking north from about 150 metres north of the CNR bridge. This is near the bottom of the down-slope where cyclists reach their highest speeds.

Figure 8: View looking north from approximately 150 metres north of the CNR bridge.

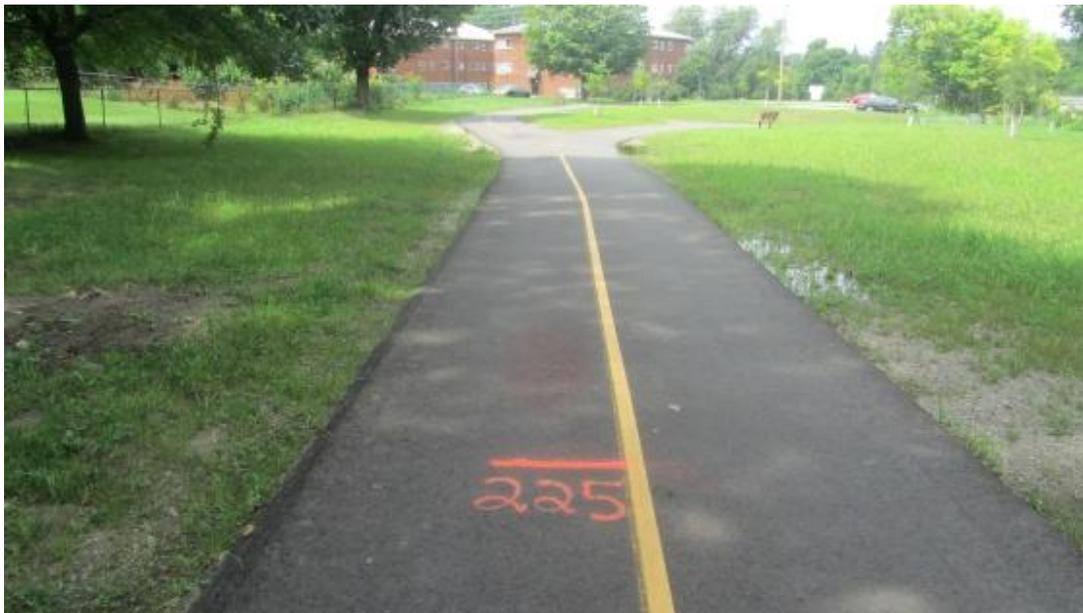
Figure 9 shows a view looking north at about 225 metres north of the CNR bridge. Here the path levels out until it curves to the right upon approach to the bridge at Pottersburg Creek.

Figure 9: View looking north from approximately 225 metres north of the CNR bridge.

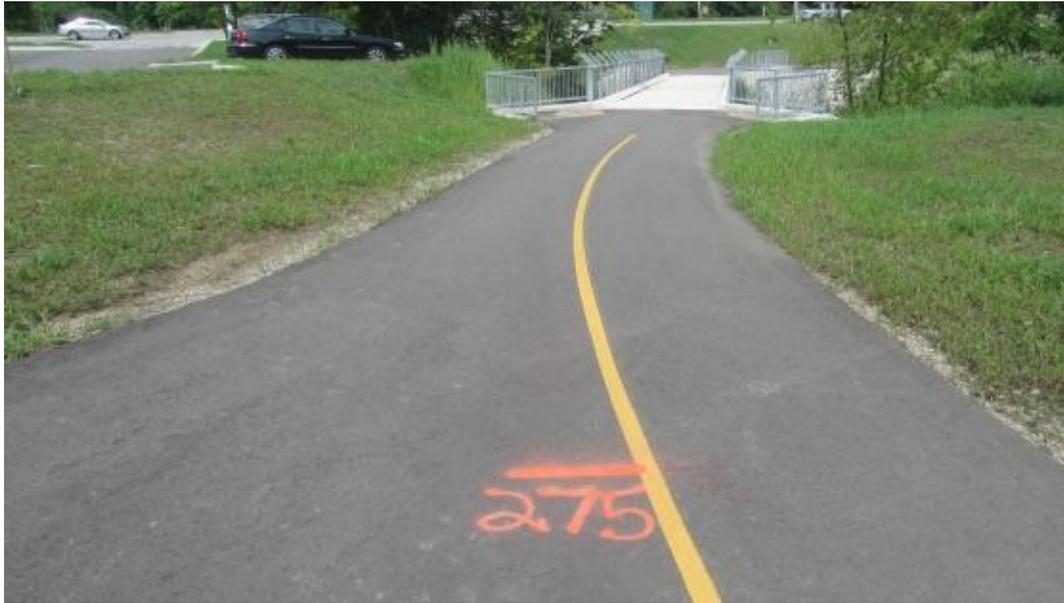
Figure 10 shows a view looking north from 275 metres north of the CNR bridge and we see how the path curves to the right to approach the bridge at Pottersburg Creek.

Figure 10: View looking north from approximately 275 metres north of the CNR bridge.

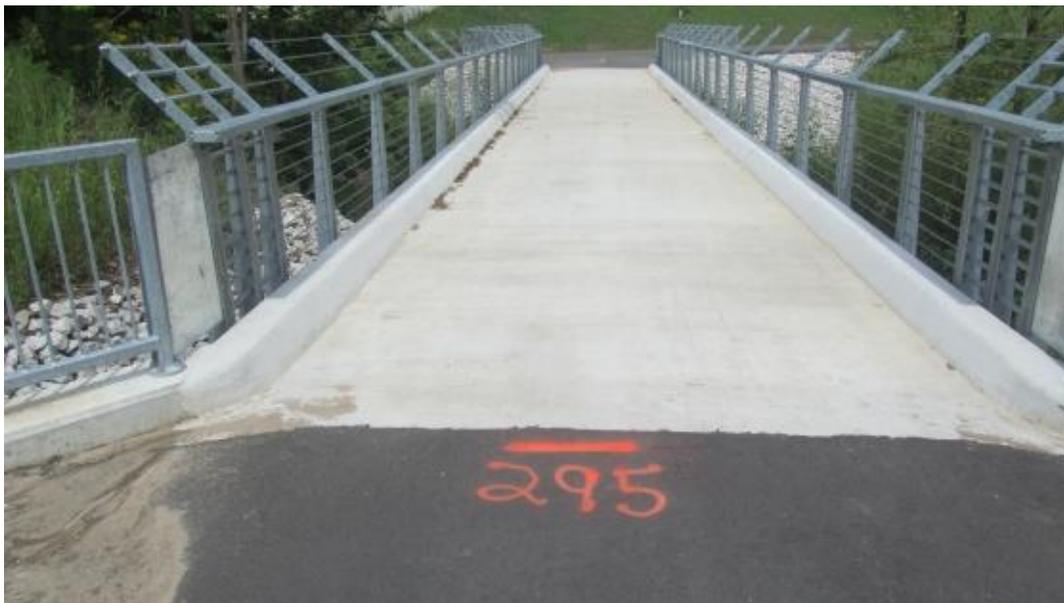
Figure 11 is a view looking north as one begins to cross the Potterburg Creek. Immediately after crossing the creek cyclists must make a sharp left turn followed by a right turn in order to enter the underpass of Trafalgar Road.

Figure 11: View looking north upon crossing the Pottersburg Creek bridge.

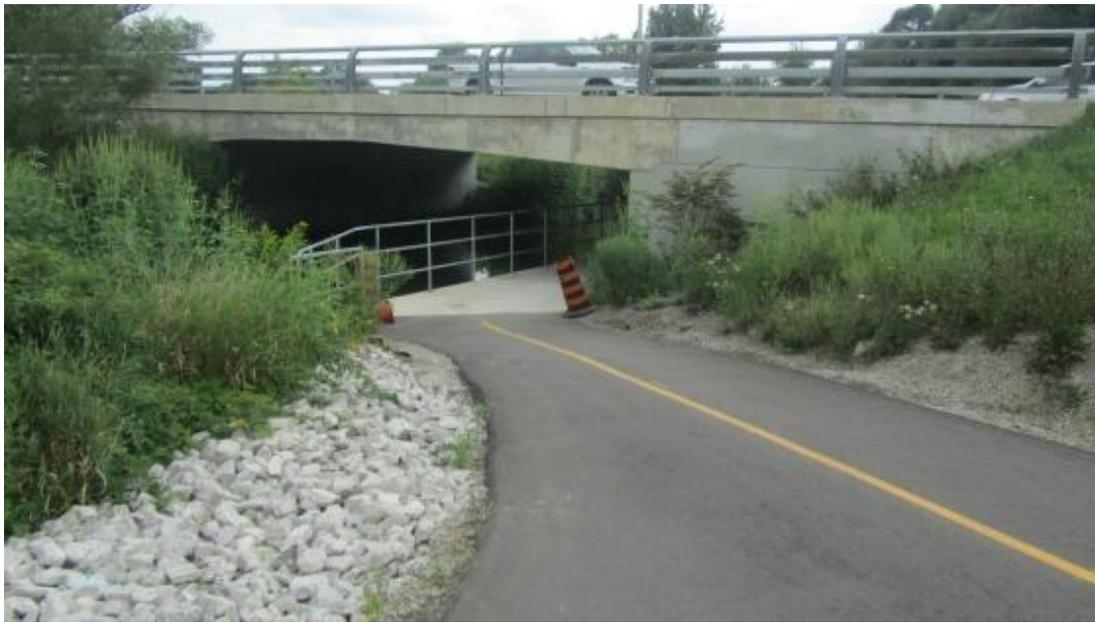
Figure 12 shows a view looking north at approximately 325 metres north of the CNR bridge. This is the view just as cyclists are making a sharp left turn and are preparing to counter-steer to the right in order to enter the underpass.

Figure 12: View looking north upon approach to the Trafalgar Road underpass.

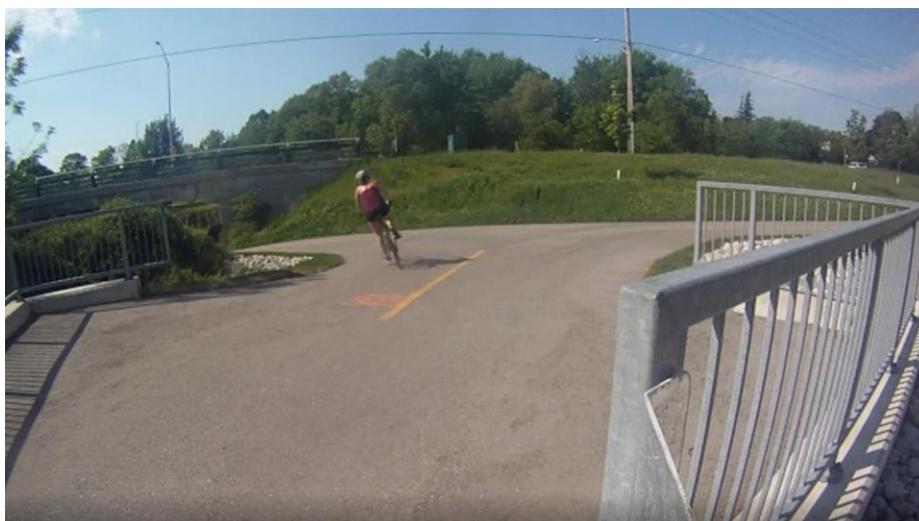
Observation #1: Young Female on Hybrid Bike

Further details of the motions of the northbound cyclists as they approach the underpass are demonstrated in the figures below. These figures are frames taken from the video cameras. These frames show how, in the very large majority of speeding cycles, they travel over the painted, yellow, centre-line of the path as they make their left turn. Thus they are on the wrong side of the path at a point when they approach the limited line of sight caused by the bridge wall.

The findings from the above photos indicate that cyclists do not follow painted lines of pathways simply because that is the way designers would wish them to travel. They travel along directions that are most suitable to their passage through a site. Thus the “T” intersection on the approach to the underpass was only partially effective in slowing the cyclists.

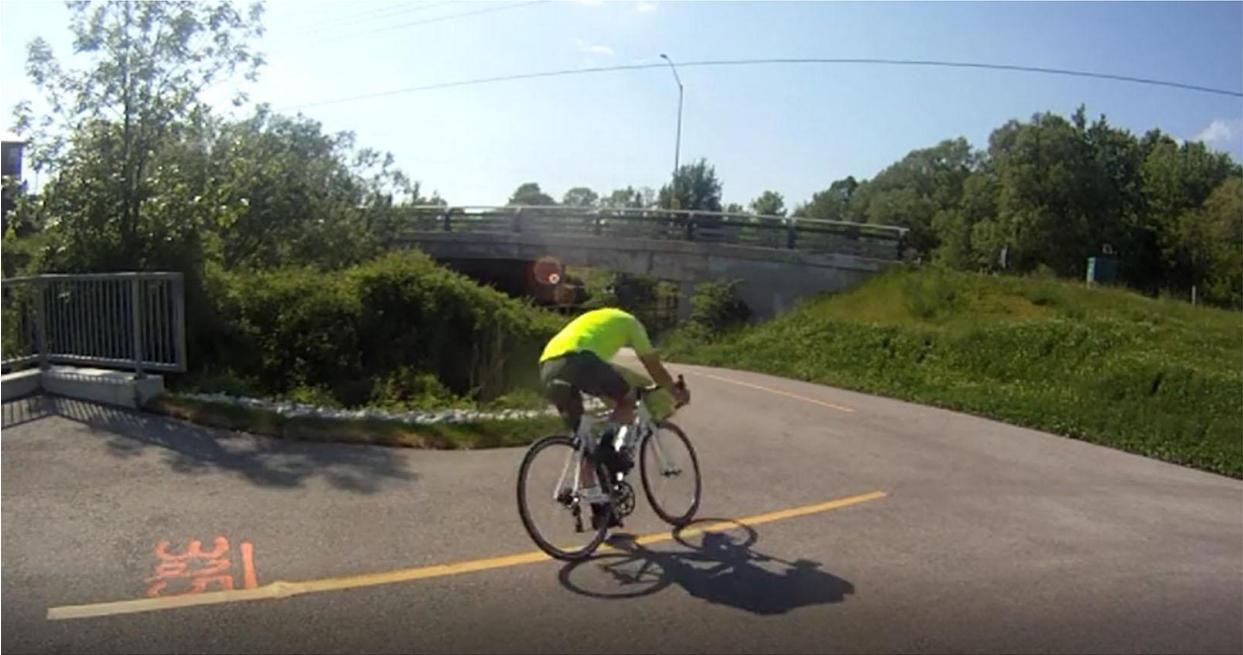
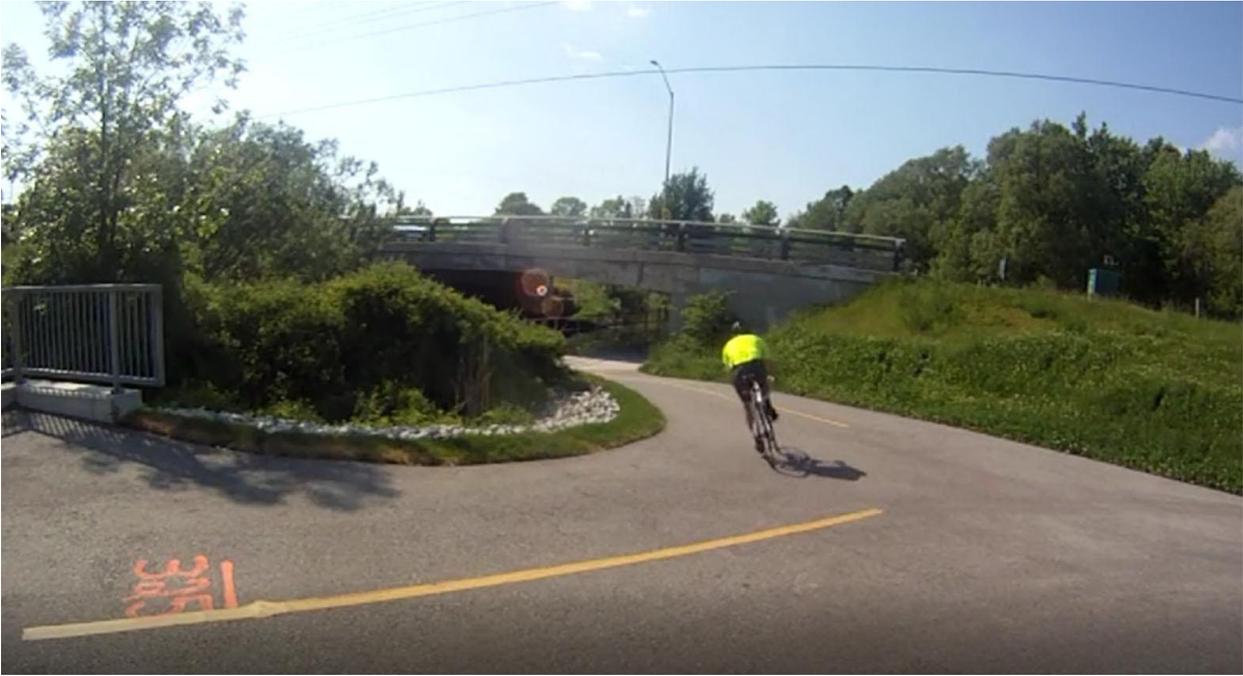
Observation #7: Male Cyclist With Yellow Shirt

The fastest speed of a cyclist was achieved by a male rider who was travelling at over 46 km/h at the beginning of the observation zone (between the 150 and 175-metre markers). As he travelled toward the underpass he reduced his speed to about 27 km/h yet, in our view, this was well above a safe speed given the limited line of sight within the underpass. Yet this was not the fastest approach speed at the underpass.

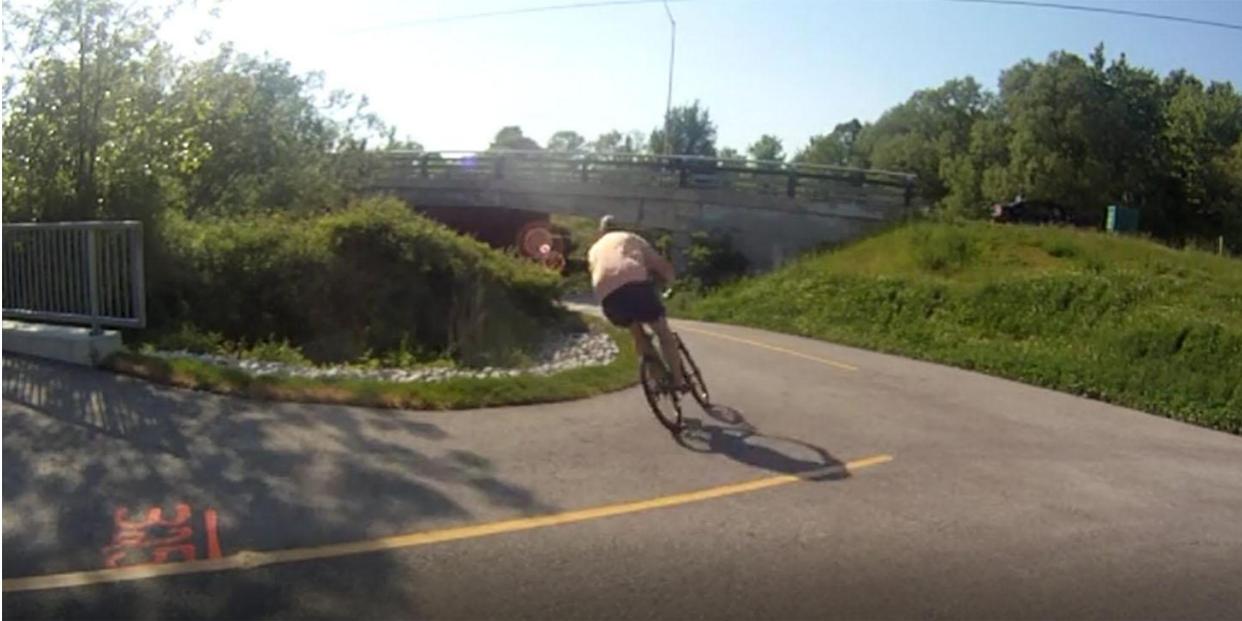
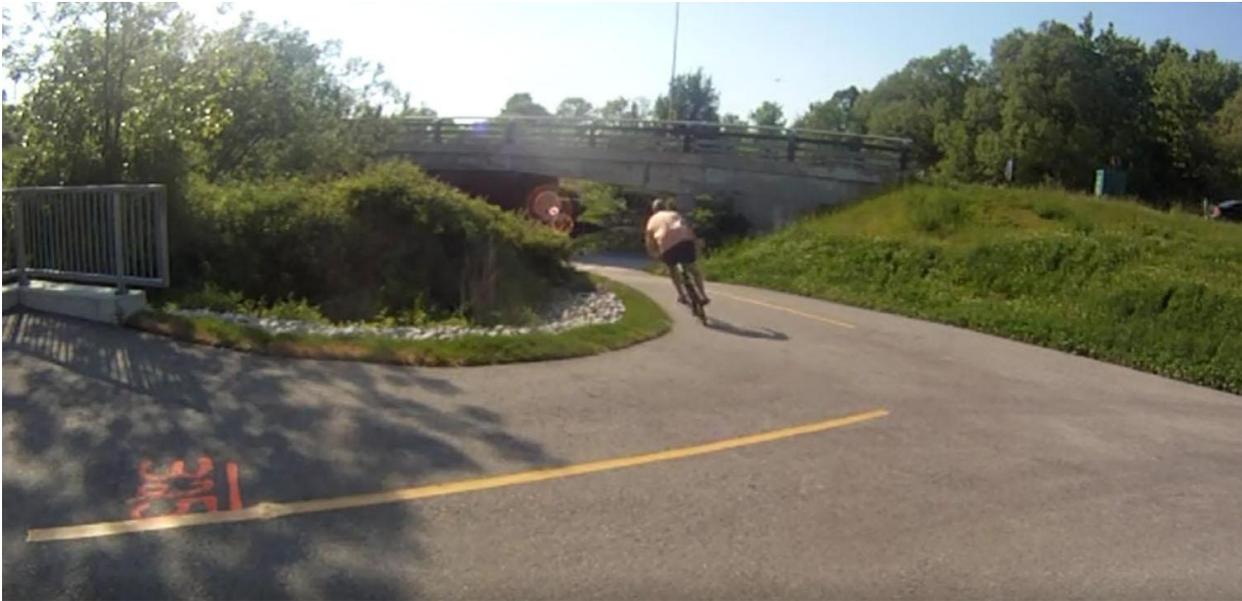
Observation #20: Male Cyclist in Orange Shirt

The fastest approach speed at the underpass was that of Observation 20, another young male whose speed was 41.5 km/h as he entered the observation zone and 33.8 km/h as he approached the underpass.

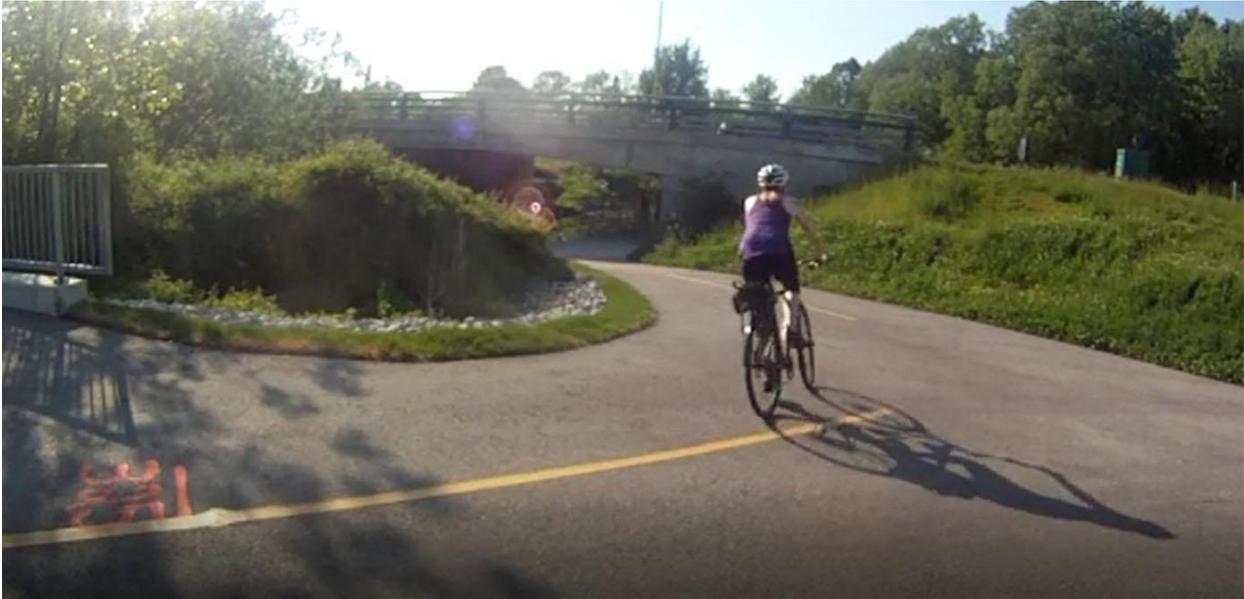
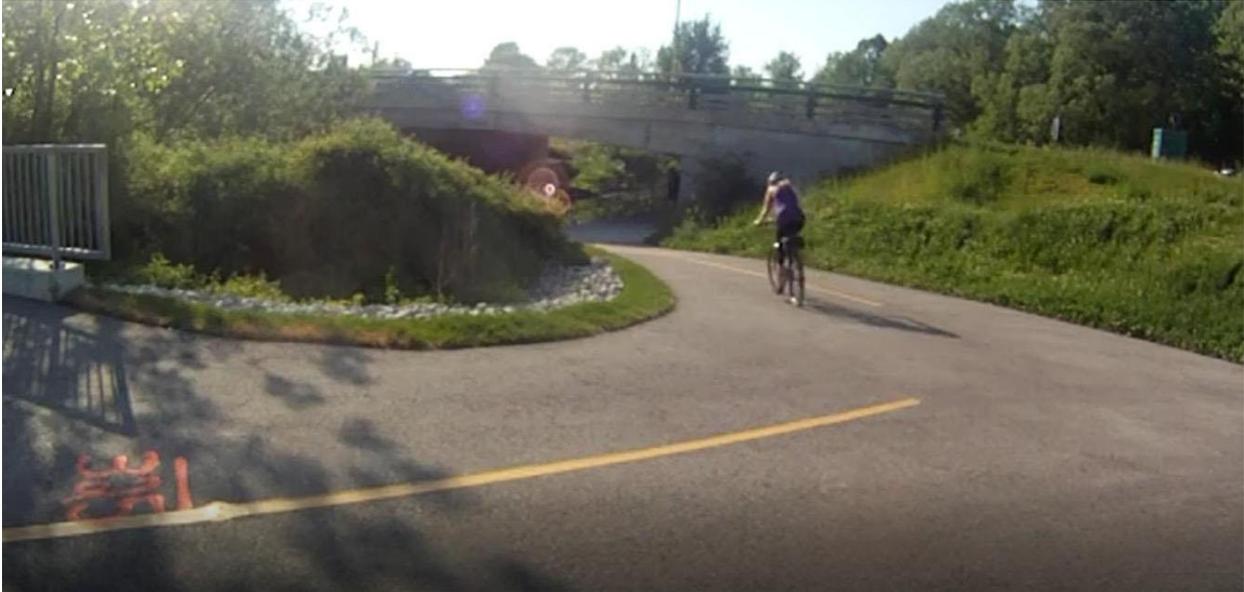
Observation #28: Female Cyclist With White Helmet and Dark Clothing

Some of the observations were affected by the presence of pedestrians. For example at Observation 28 the young female rider was partially obstructed by two pedestrians, one on each side of the path, near the 295-metre marker who were carrying on a conversation. As seen in the above table she reduced her speed to just 15 km/h as she approached the 295-metre marker. And as the female rider was approaching the underpass a male and female were walking their dog northbound and she had to slow down to about 13.8 km/h.

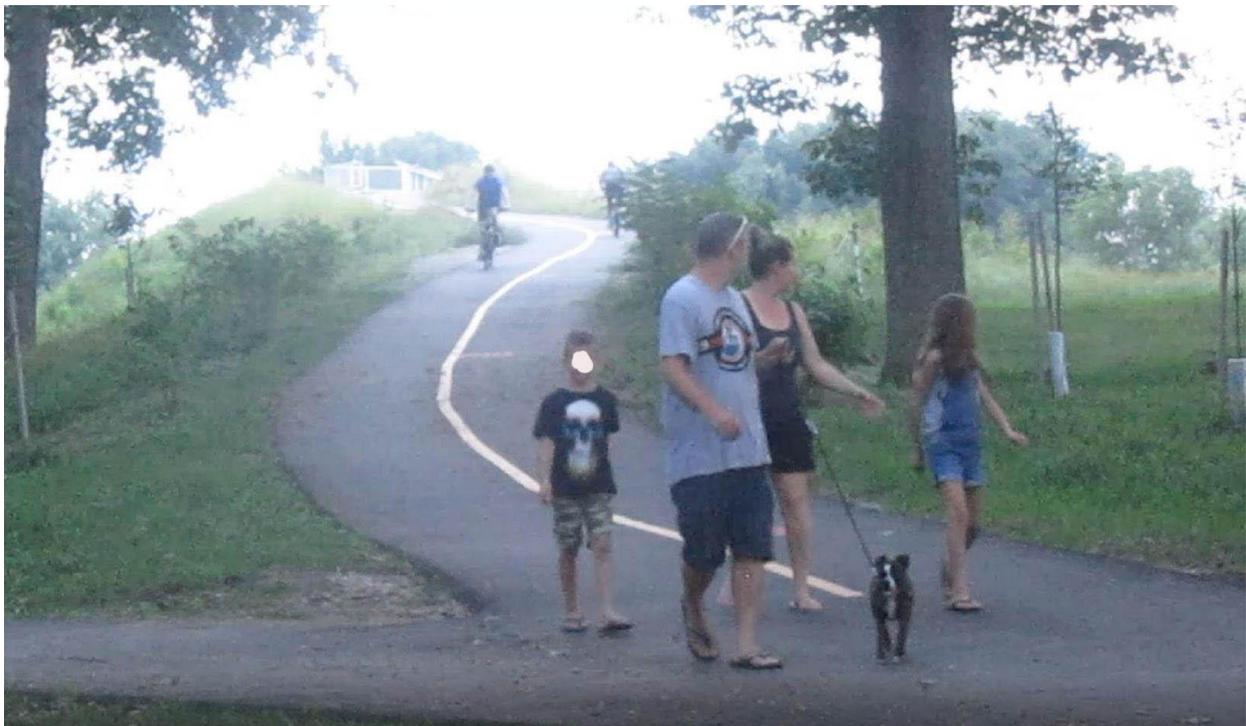
Figure 19 below shows an example of a cyclist travelling along the down-grade of the Trafalgar path with the CNR bridge in the background. It demonstrates the problem when pedestrians are approached from behind by a cyclist that is travelling at high speed.

Figure 19: In this typical view a cyclist is northbound on the down-slope of the Trafalgar bike path and approaches a family that is taking up most of the path width.

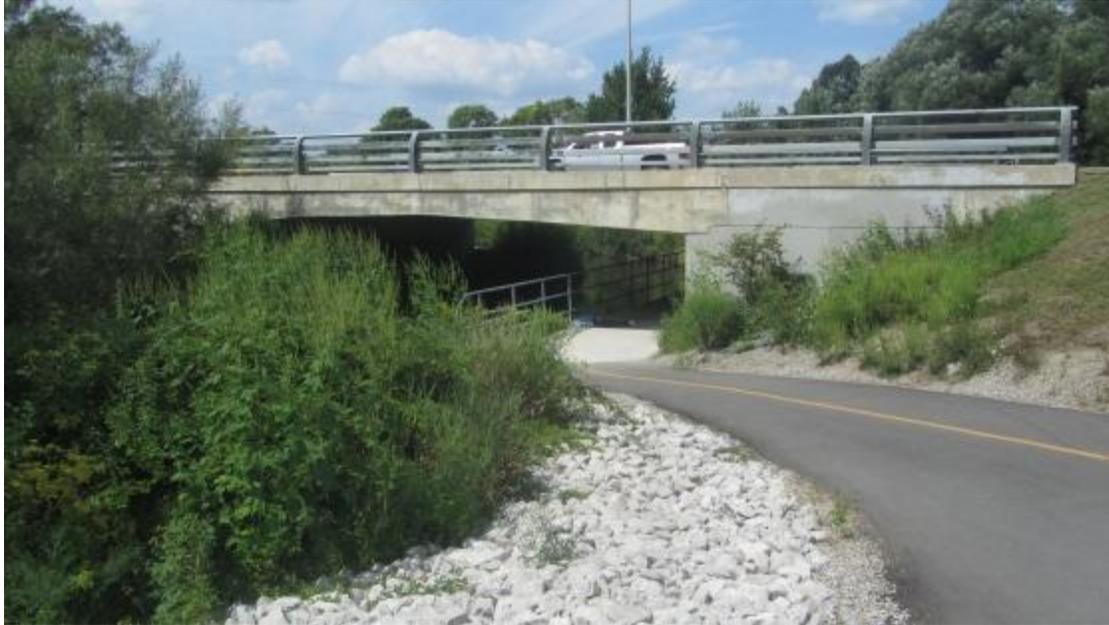
In another instance, Figure 20 below shows a view looking north toward the underpass. It is difficult to detect that there is a pedestrian lying on the pavement in the shadow of the underpass.

Figure 20: View of young female lying across the underpass within its dark shadow.

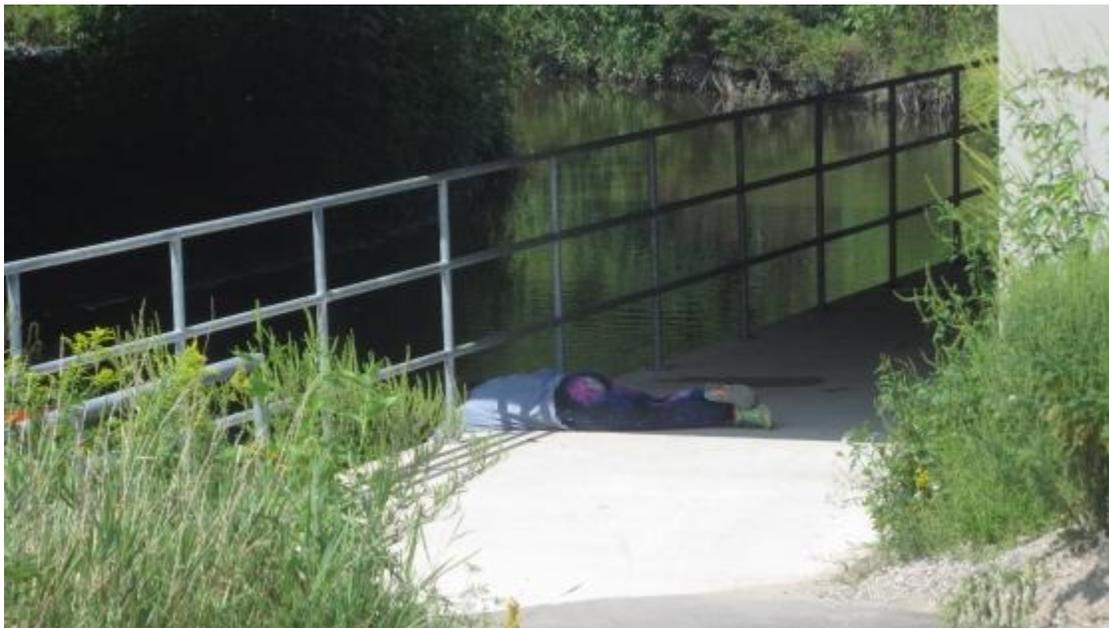
Figure 21 below shows a closer view of the young female who became interested in the fish that were passing through Pottersburg Creek. This interest made her fail to appreciate that her body was blocking the bike path at a location where she would not be seen. The high speed of northbound bicyclists and the lack of visibility formed by the curves of the path made it highly possible that a serious collision might have taken place.

Figure 21: Close-up view of young female lying across the underpass and distracted by the fish in the water of Pottersburg Creek.

While the solid railing shown at the edge of the creek may be of minimal concern when struck by motor vehicles, a cyclist who strikes such a railing will come to a sudden stop, while impact forces could be applied narrowly to vulnerable portions of the rider's body.
