Test Data to Document Road Surface Conditions On Wonderland Road South of Highway 401, London, Ontario

Posting Date: 17-Nov-2016

2. 0 Testing On Wonderland Road, London, Ontario

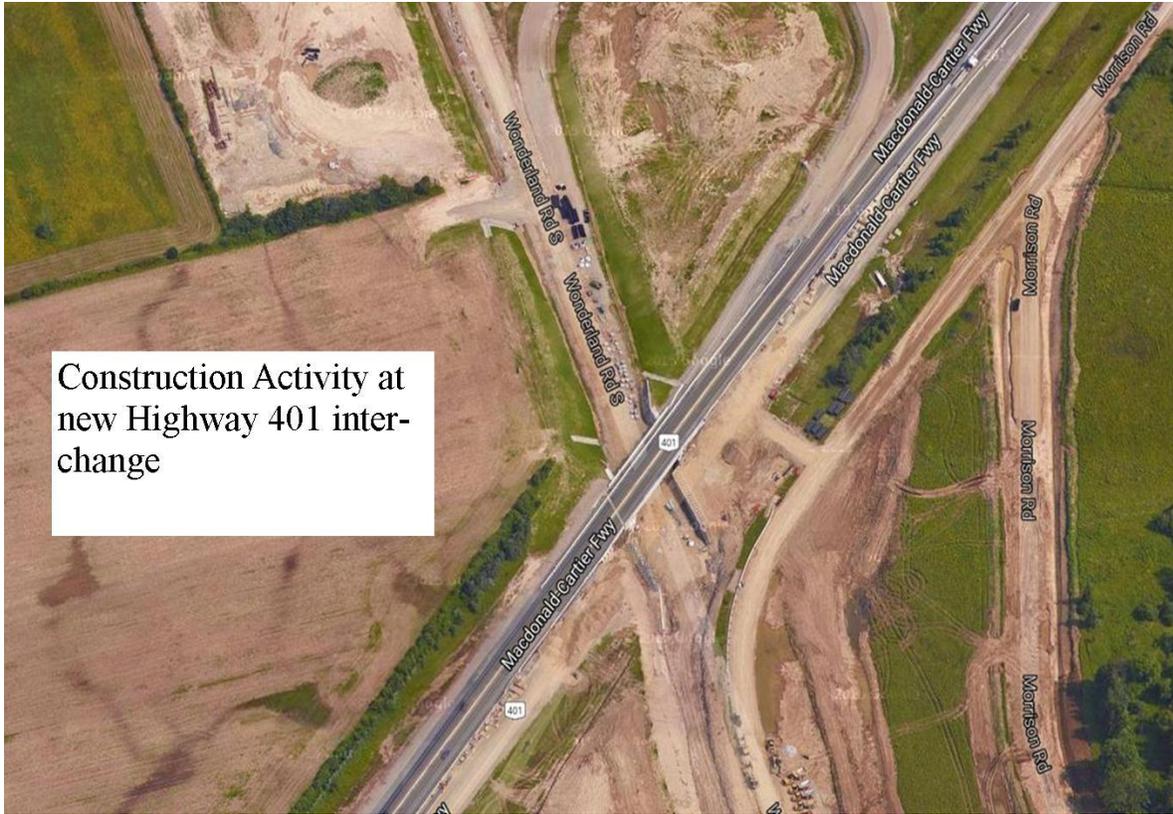
Figure 4: View of the new interchange being built at the junction of Wonderland Road and Highway 401.

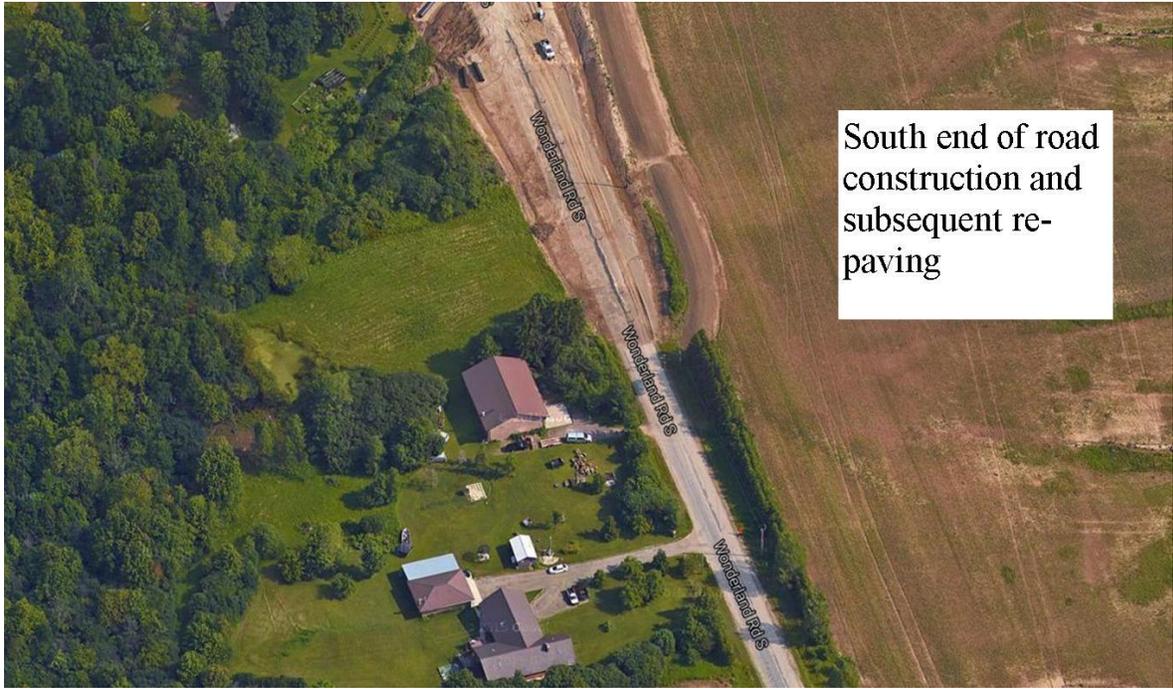
Figure 5: View of the south end of the construction zone on Wonderland Road, south of Highway 401 where the new construction terminated and the aged road surface remained further to the south.

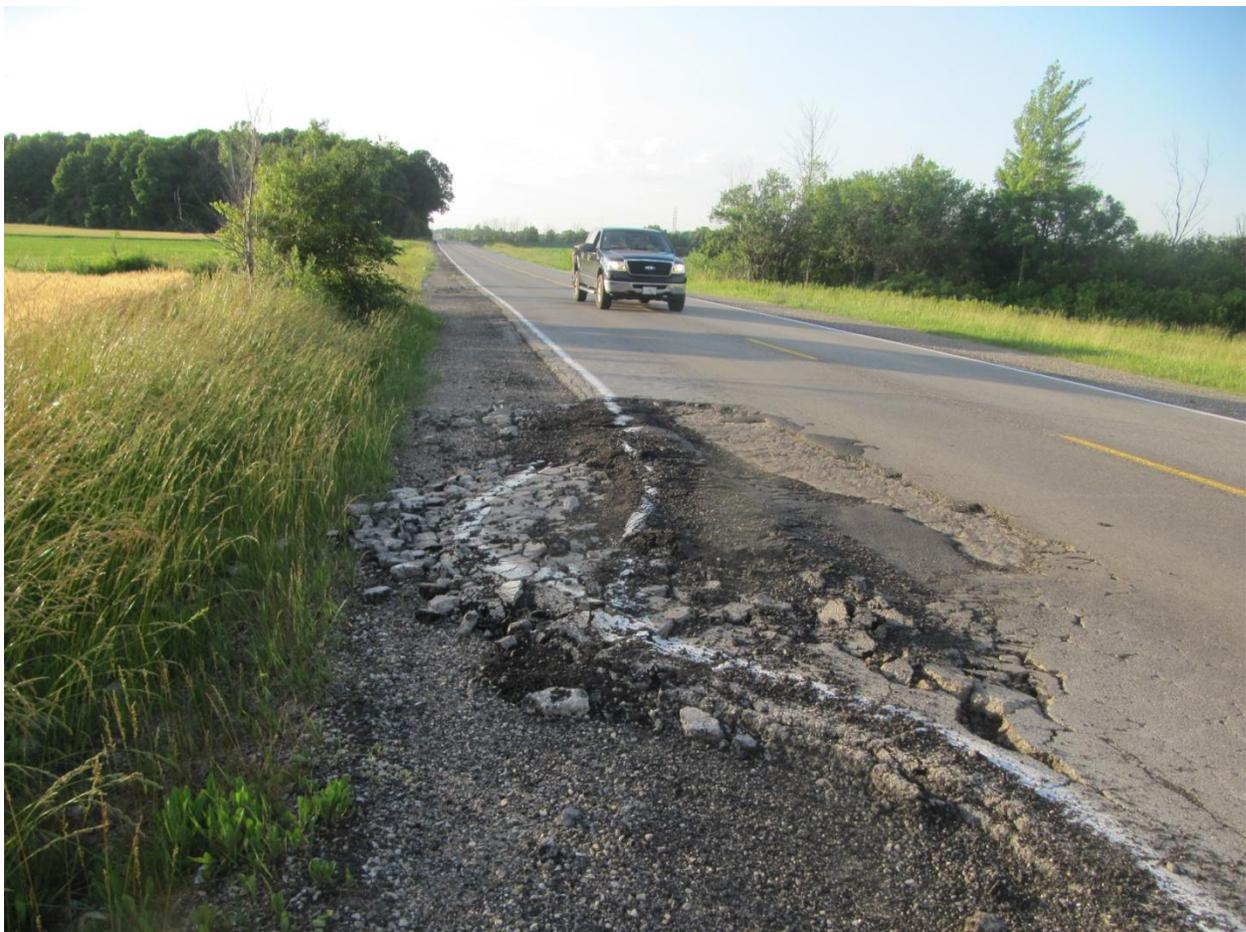
While the remaining aged portions of Wonderland were in poor condition the problem became much more intense when, on a day in June of 2016, we came across a major road surface failure as shown in Figures 6 and 7.

Figure 6: View, looking north on Wonderland Road and showing a major collapse of the surface of the southbound lane.

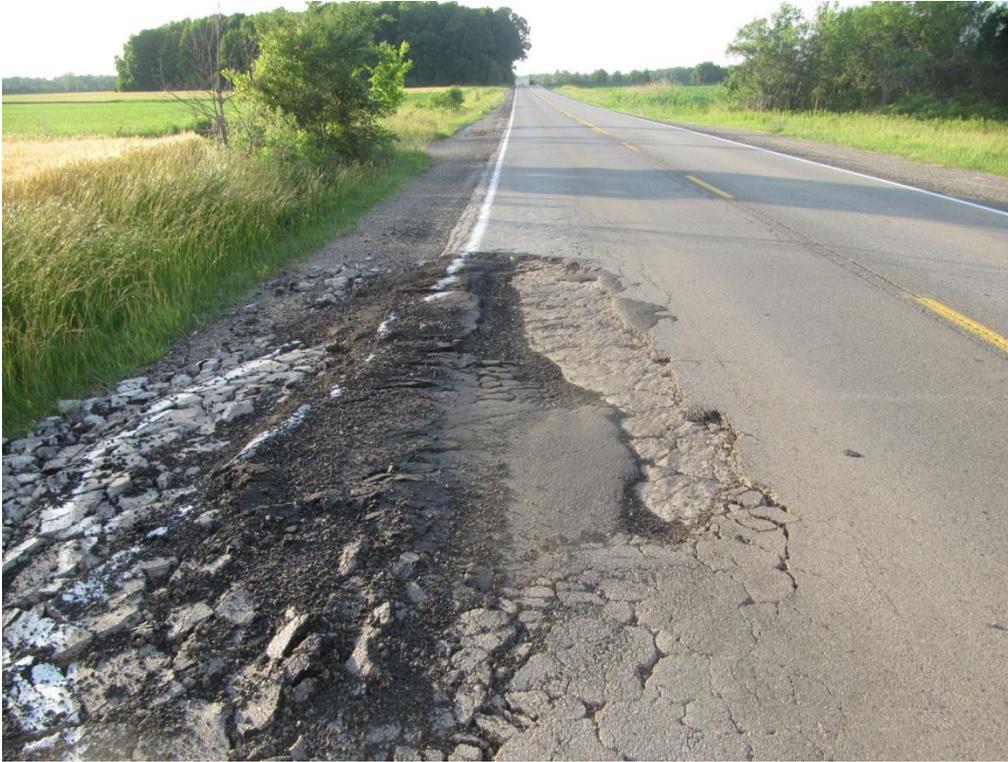
Figure 7: View of an asphalt patch in the failure indicating that roads personnel had tried to make a repair but this was unsuccessful.

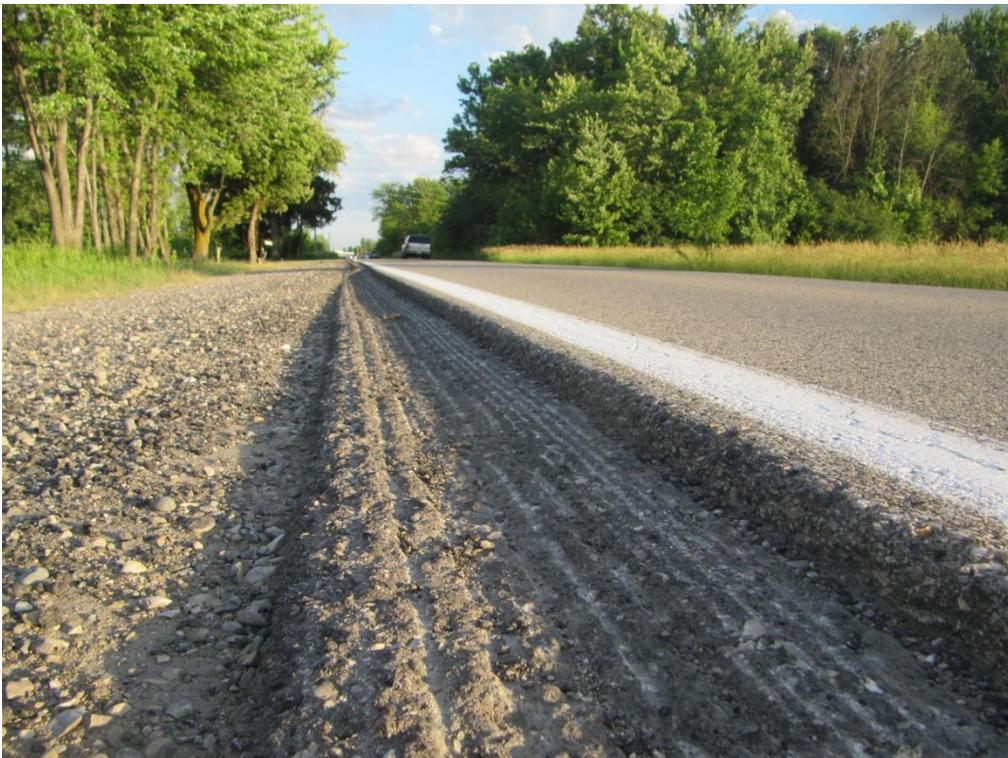
Figure 8: An edge of Wonderland Road that has been milled out resulting in a steep edge drop off.

In another portion of Wonderland Road it was apparent that the road edge had been milled out thus exposing the public to a deep edge drop off as shown in Figure 8. In other areas the road exhibited major depressions and undulations causing our vehicle to be displaced in random directions.

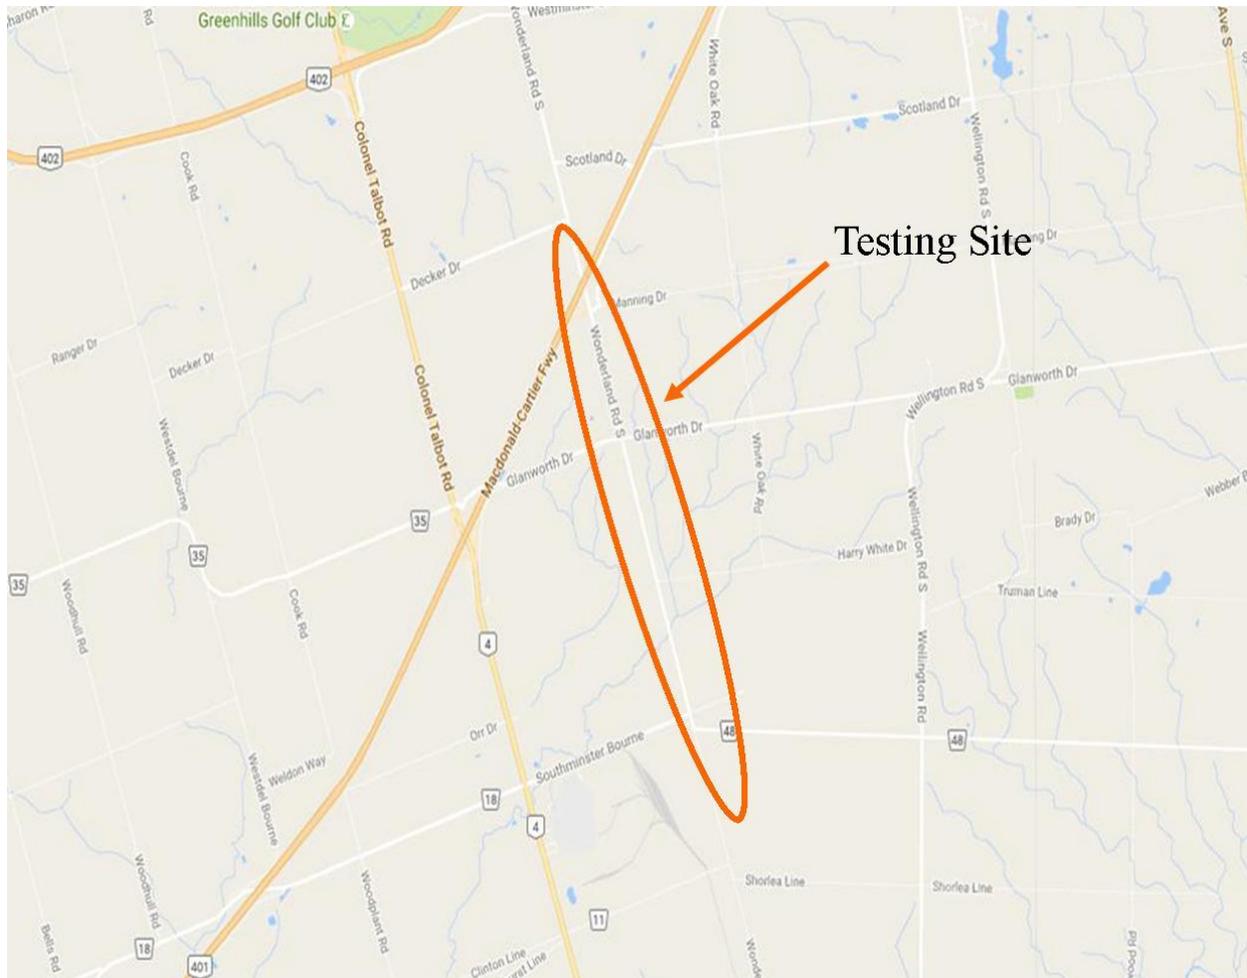
Figure 9: An oblong circle shows the general area along Wonderland road where the testing was conducted.

As a result of these observations Gorski Consulting decided to conduct testing along Wonderland Road to provide some objective data on the extent of its defects. Figure 9 shows the general area along Wonderland where the testing was conducted.

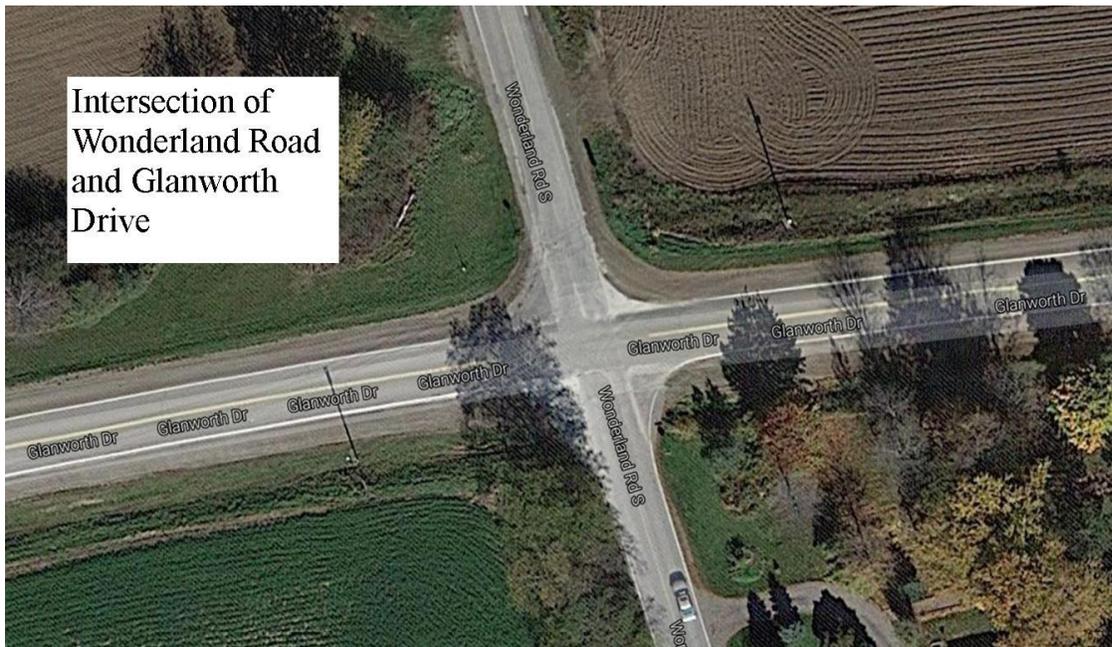
Figure 11: View of the intersection of Wonderland Road with Glanworth Drive. At the time of the testing traffic on Wonderland was still required to stop at a stop sign before proceeding through the intersection.

As can be seen in Figure 10 the testing began at a driveway just north of Highway 401. The test vehicle was driven southward where a stop had to be made at the intersection with Glanworth Drive (Figure 11). The vehicle then continued further south where it crossed a small bridge as shown in Figure 12. As the vehicle reached the intersection with Ferguson Line (See Figure 13) the driver made a U-turn and the testing continued in a northward direction, retracing the southbound path, back to the driveway. Upon reaching the driveway the vehicle was stopped and the driver accessed the iPhone to send the data to an e-mail address for eventual export an Excel spreadsheet at the

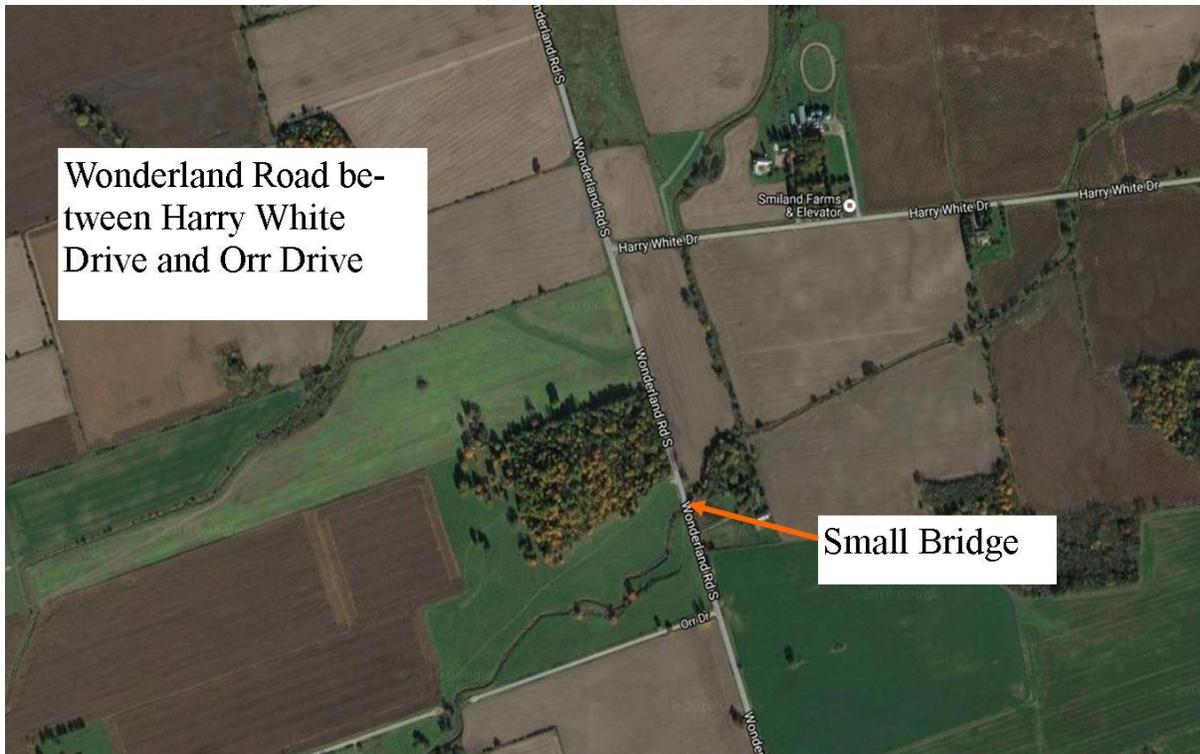
Figure 12: Travelling further south the test vehicle had to cross a small bridge over a creek as seen in this figure.

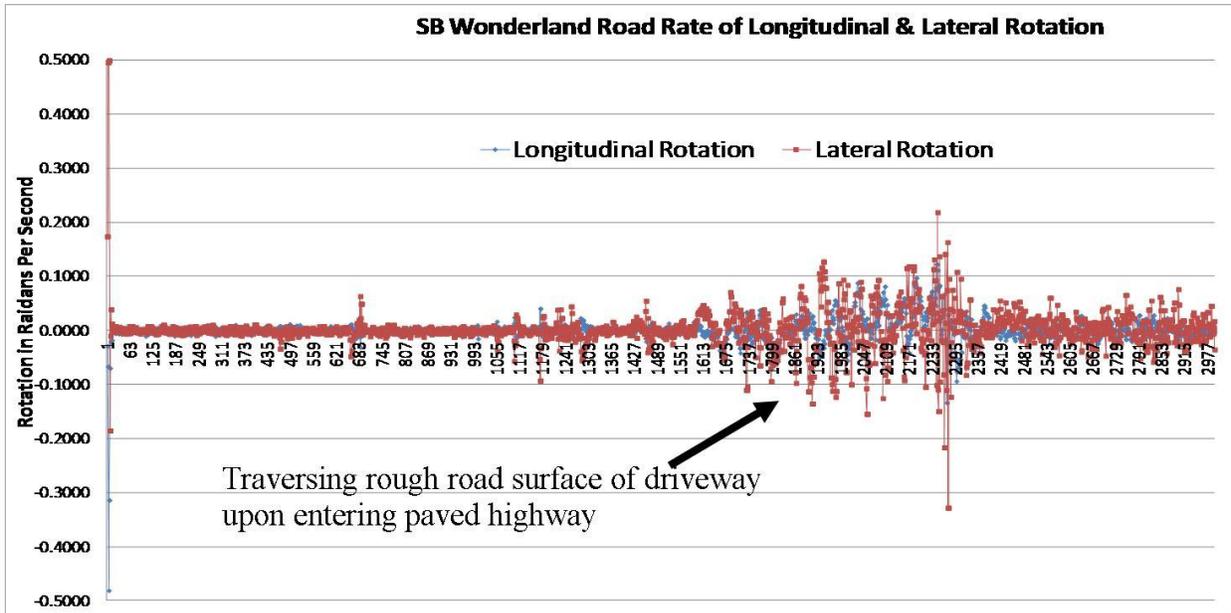
Figure 18: Chart between 0 and 3000 samples.

Figure 18 shows the first 3000 samples or the first 33 seconds of data as the test vehicle is stopped through the first part of the chart and then pulls out of the driveway and begins to travel southbound on Wonderland Road. The rough surface of the unfinished driveway causes high rotations of the vehicle. Once the vehicle enters onto the newly paved surface of Wonderland the rotations diminish near the end of the chart.

Referring back to Figure 14 we note that the lateral rotation of the test vehicle was 0.0408 radians per second over these first 33 seconds of motion. We can see in the charted details that this value was higher because of the motions caused while exiting the driveway. Conversely the chart shows that once the vehicle entered onto the newly paved surface the rotations dropped dramatically. Also one can see the very small rotations in the first portion of the chart where the vehicle is stopped. Thus these results illustrate that the sensed rotations are consistent with what one would expect.

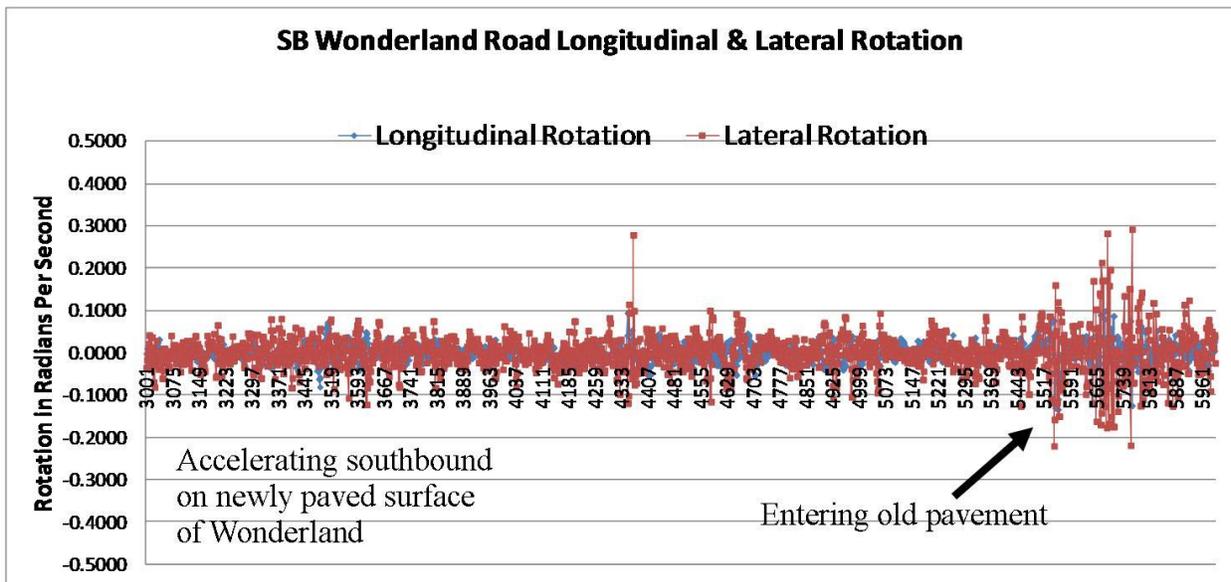
Figure 19: Chart between 3001 and 6000 samples.

In Figure 19 we see the charted rotations, between 3001 and 6000 samples, as the test vehicle continues southbound on the newly paved portion of Wonderland Road and then rotations become more prominent near the end of the chart where the test vehicle crosses onto the older portion of pavement south of Highway 401. Referring back to Figure 14 we see that the average lateral rotations over this road segment is 0.0424 radians per second, or not much different than the average in the first 3000 samples. Yet

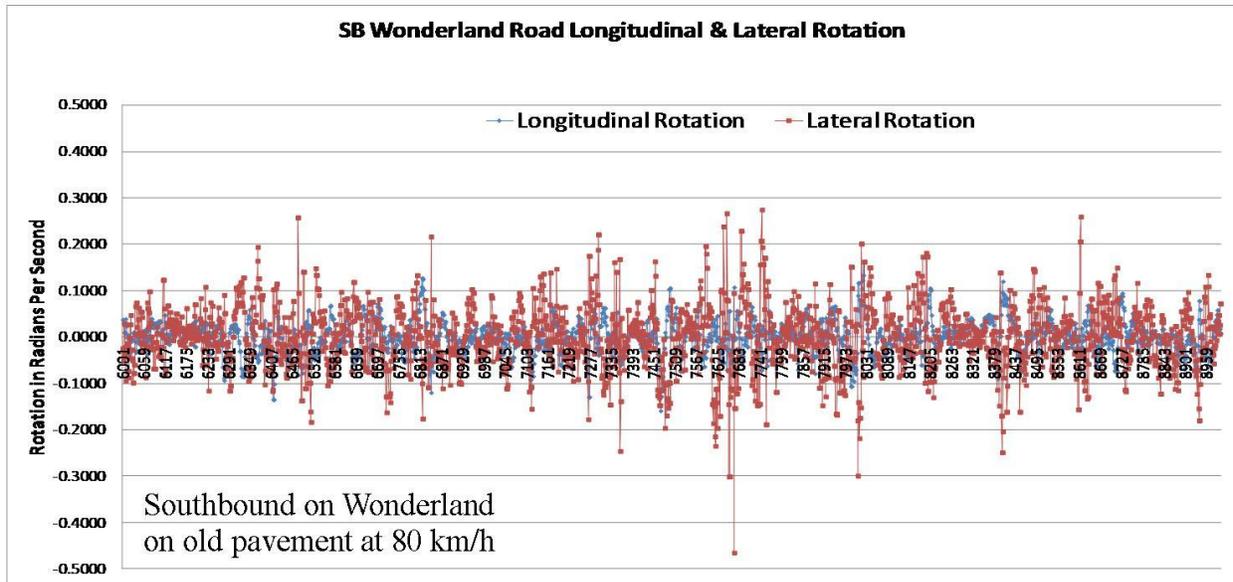
Figure 20: Chart between 6001 and 9000 samples.

In Figure 20 we see the road segment between 6001 and 9000 samples. Figure 14 indicates that this is where the test vehicle reached the cruising speed of 80 and was moving at this constant speed southbound over the old pavement while travelling toward the intersection with Glanworth Drive. Figure 14 indicates that the average lateral rotation is 0.0680 radians per second, or substantially higher than the previous averages. The chart of Figure 20 shows that there is not a single portion of the road that stands out as the prominent factor in causing this high rotation, although there is one value near sample 7680 that caused a rotation rate between 4000 and 5000 radians per second.

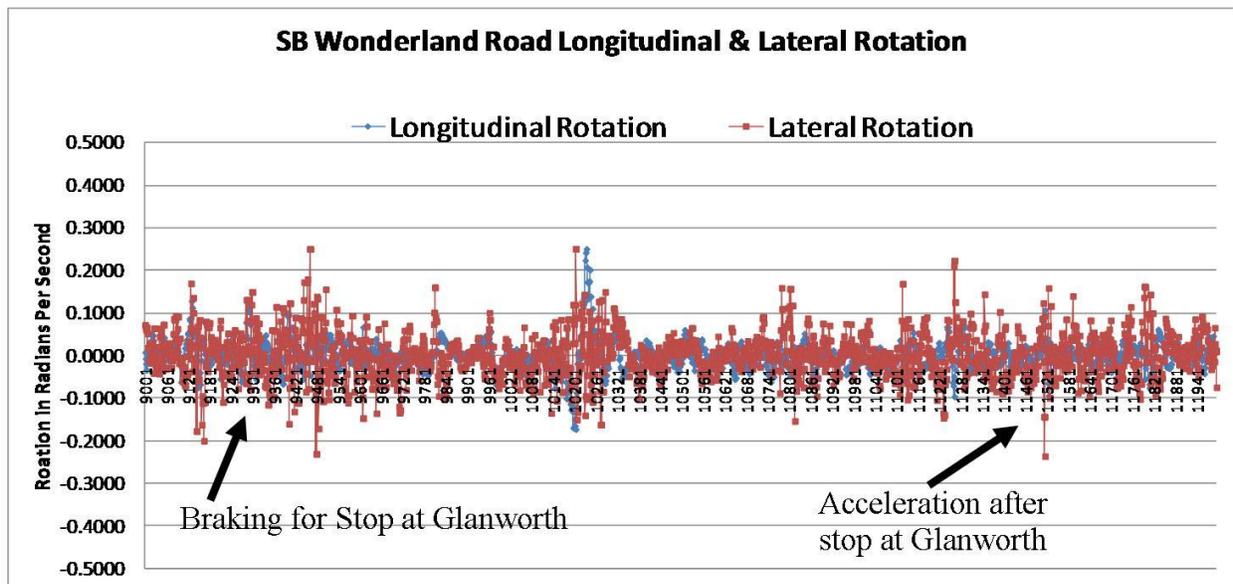
Figure 21: Chart between 9001 and 12000 samples.

Figure 21 shows the data as the test vehicle is braked and comes to a brief stop at the Glanworth Drive intersection. One would expect that the rotations would be reduced as the vehicle slows down and that is what occurs.

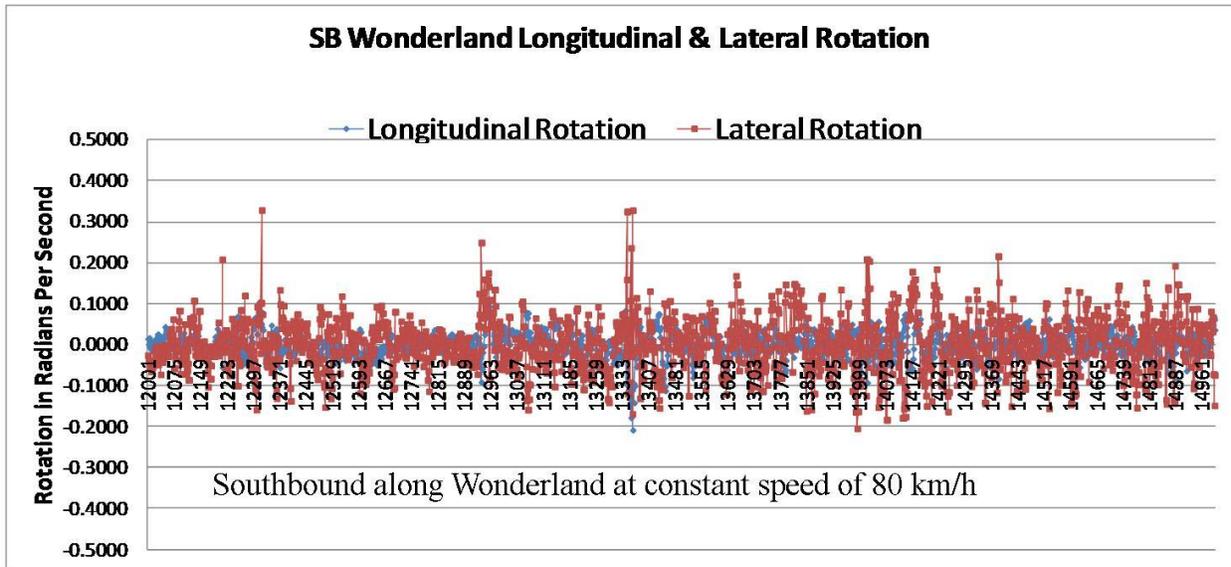
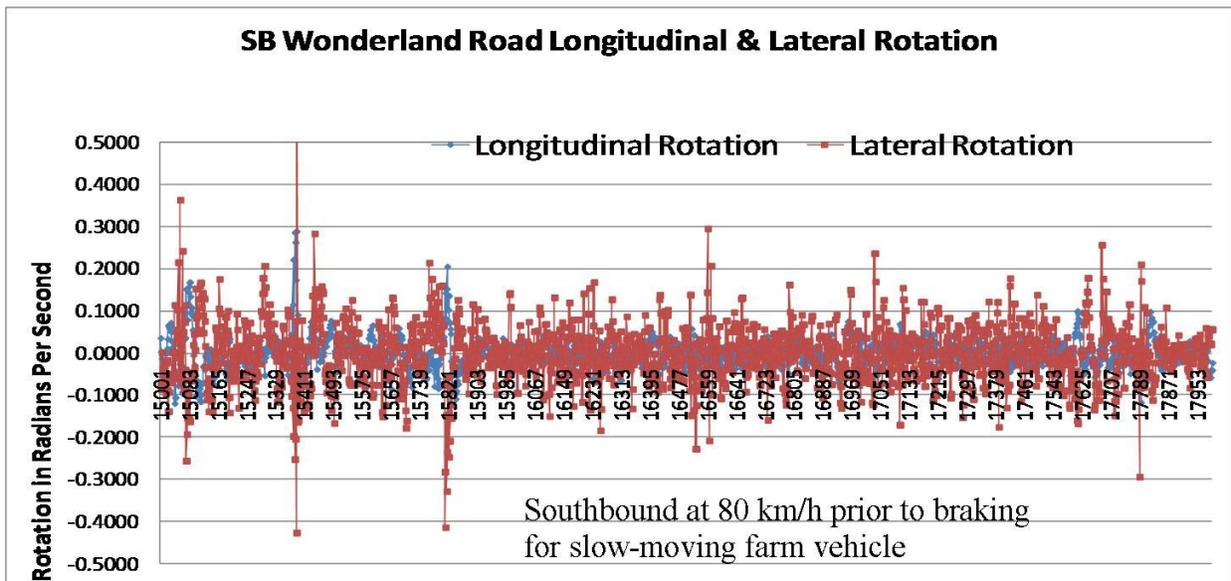
Figures 22 and 23 show what happens as the test vehicle continues southward past the Glanworth intersection. At the constant speed of 80 km/h we see that the average lateral rotations rise to 0.0632 and 0.0731 respectively. Those are very high values. That can be appreciated by examining any of the data previous obtained on other roads and highways in the Road Data page of the Gorski Consulting website.

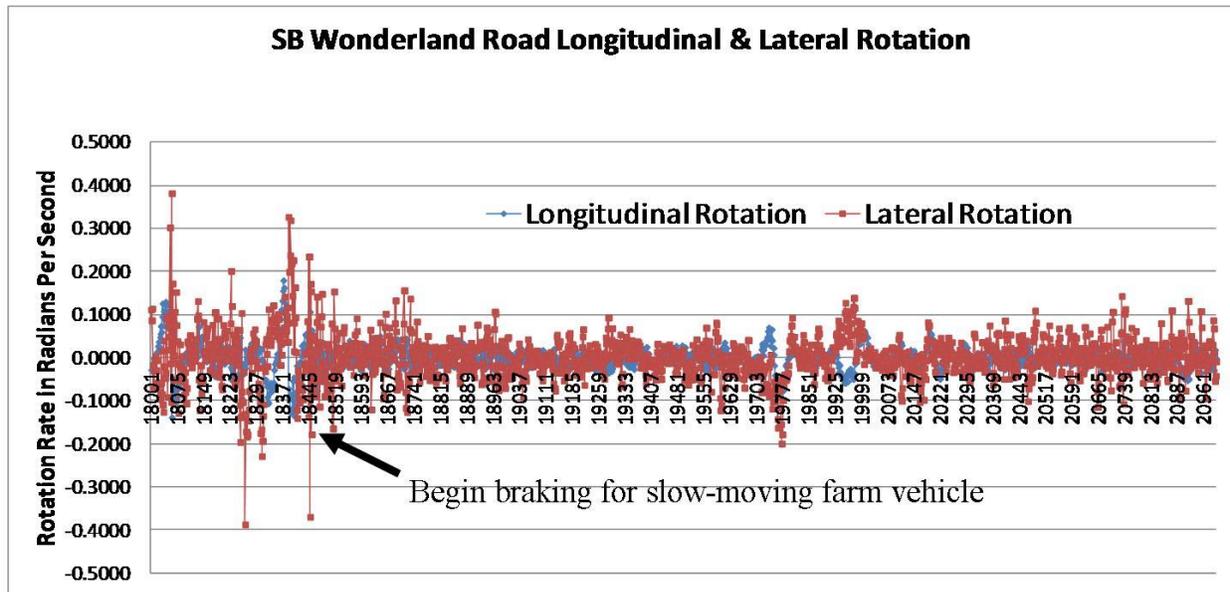
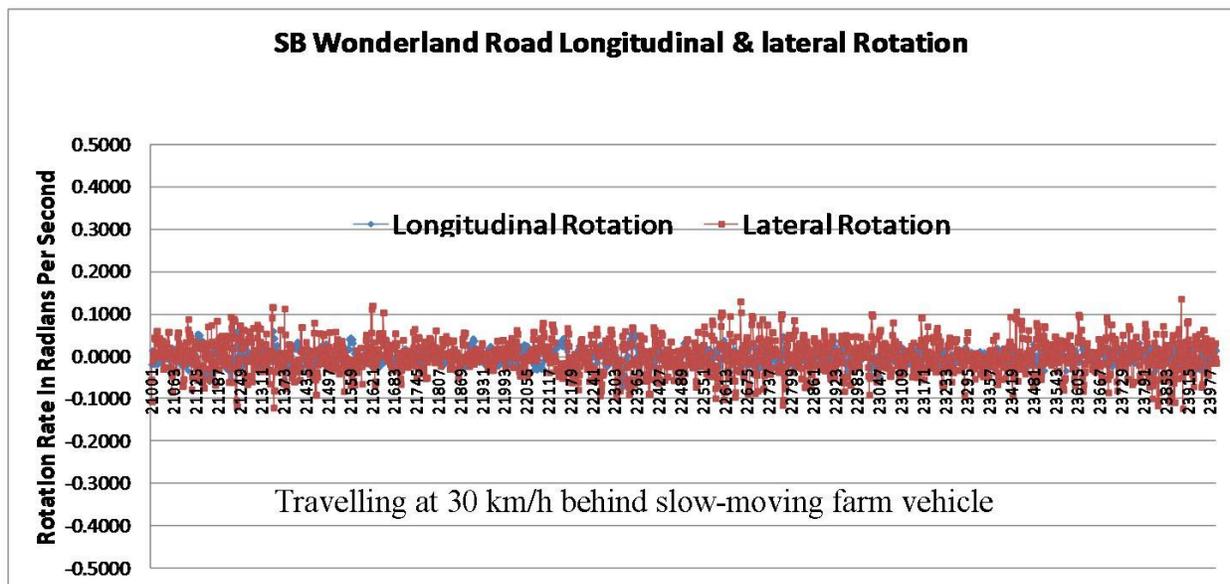
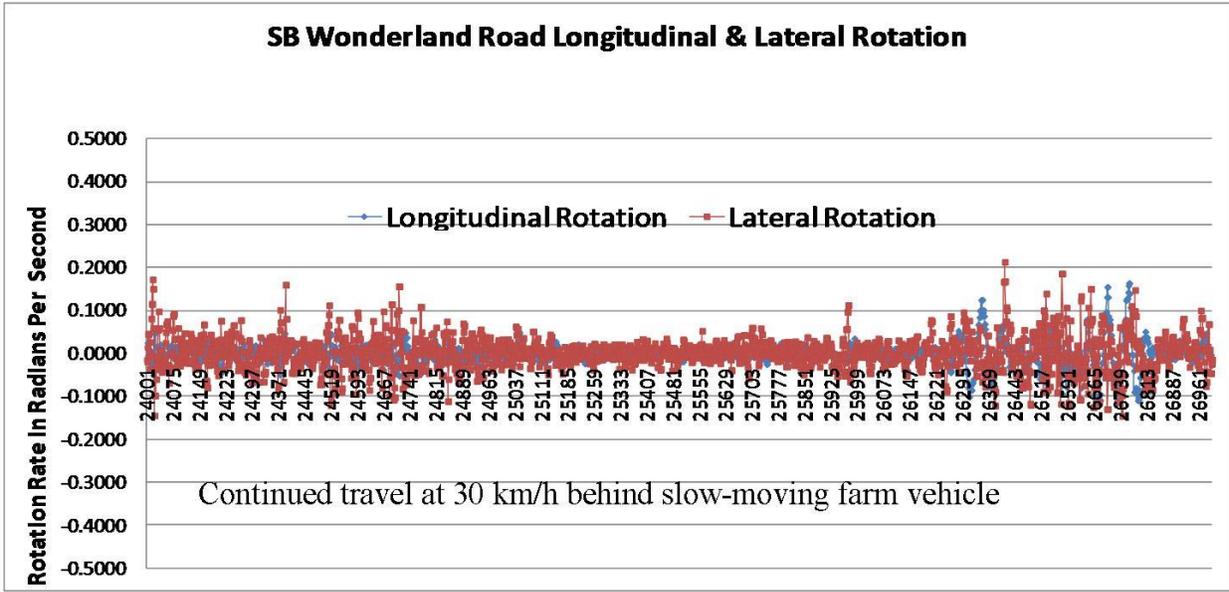
In Figures 24, 25 and 26 we see the reduction in rotations as the test vehicle is slowed to a speed of 30 km/h because of a slow-moving farm vehicle. Again, these results illustrate that the sensed data is consistent with what would be expected.

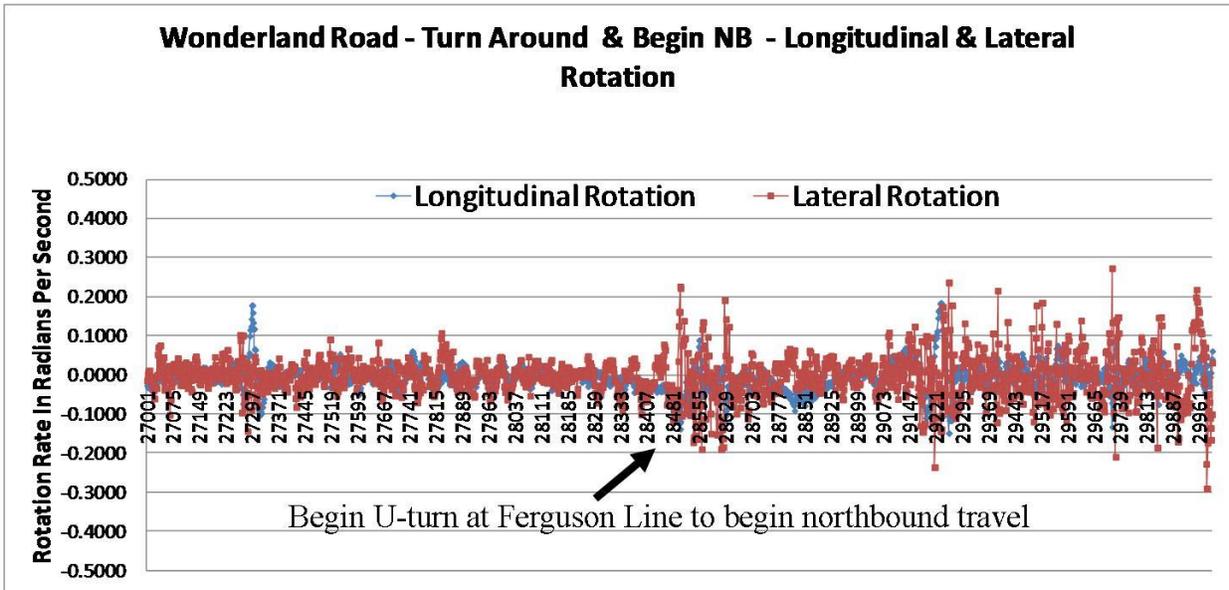
Figure 27: Chart between 27001 and 30000 samples.

In Figure 27 we see the data as the test vehicle reaches Ferguson Line and a U-turn is made to continue the testing northbound on Wonderland. During the U-turn there is an increase in the rotation of the vehicle even through its speed has been reduced to 15-20 km/h, and this would be expected. By the end of this chart the test vehicle has already increased its speed to 70 km/h and is travelling on the return route northbound on Wonderland. As expected, as the vehicle's speed increases the rotation rate also increases.

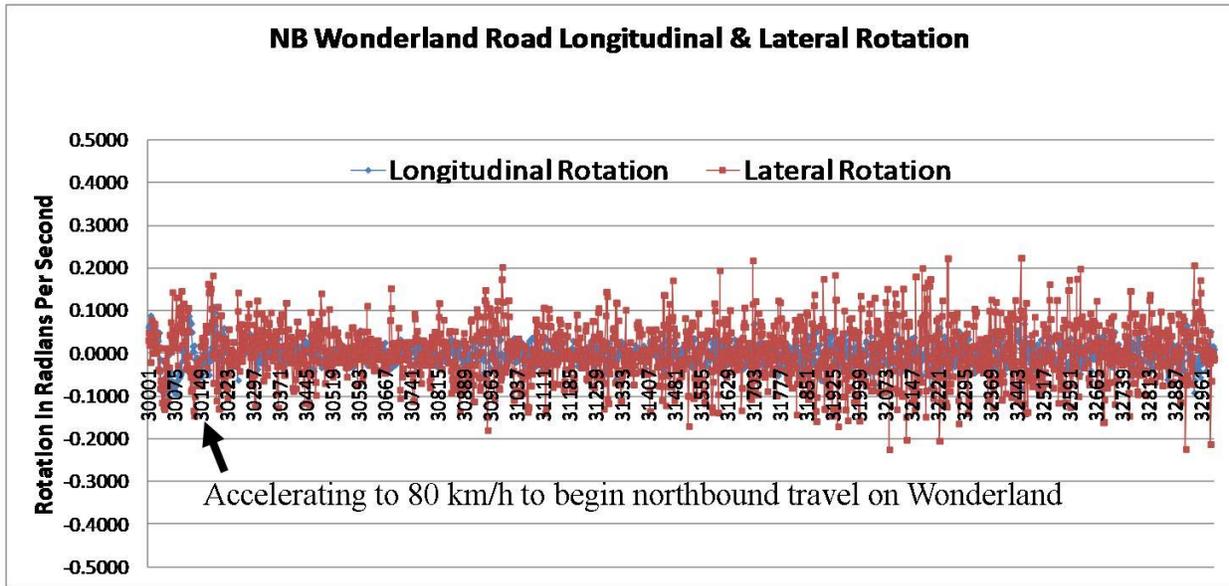
Figure 28: Chart between 30001 and 33000 samples.

In Figure 28 we see the test vehicle accelerating for an additional 4 seconds until it reaches its cruise speed of 80 km/h. Figure 16 indicates that the average lateral rotation within these 33 seconds of data is 0.0641 radians per second. That is not as high as the highest value that occurred between 15000 and 18000 samples when the test vehicle was southbound near Harry White Drive. Yet it is still very high.

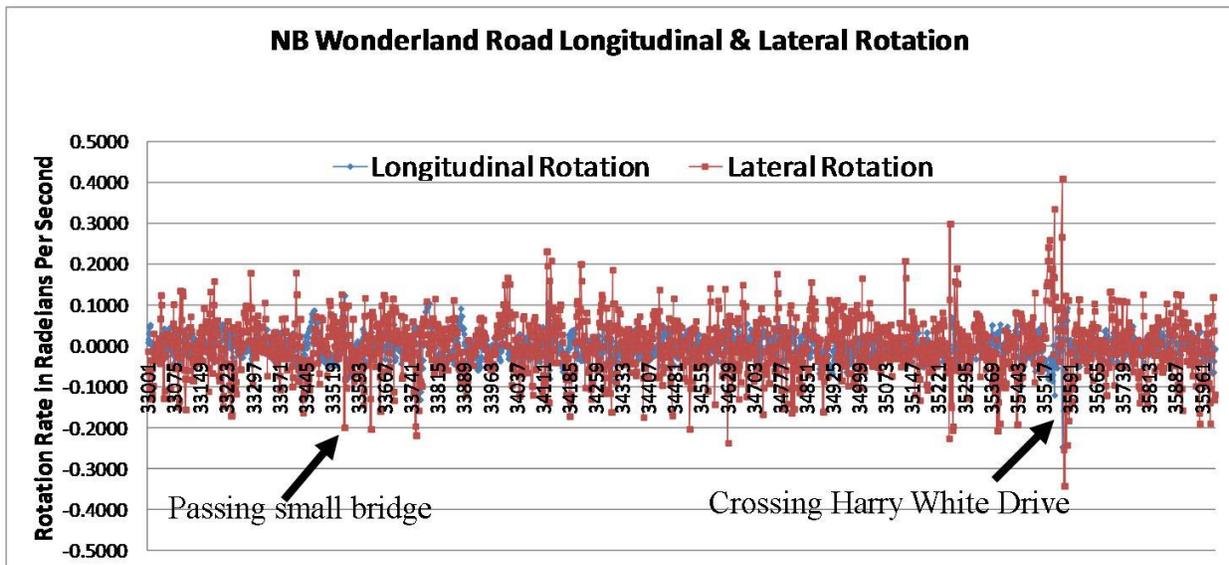
Figure 29: Chart between 33001 and 36000 samples.

Figure 16 indicates that the data in Figure 29 produced an average lateral rotation of 0.0699 thus the rotation has increased. In particular we see a large spike in the rotation just as the test vehicle in near Harry White Drive.

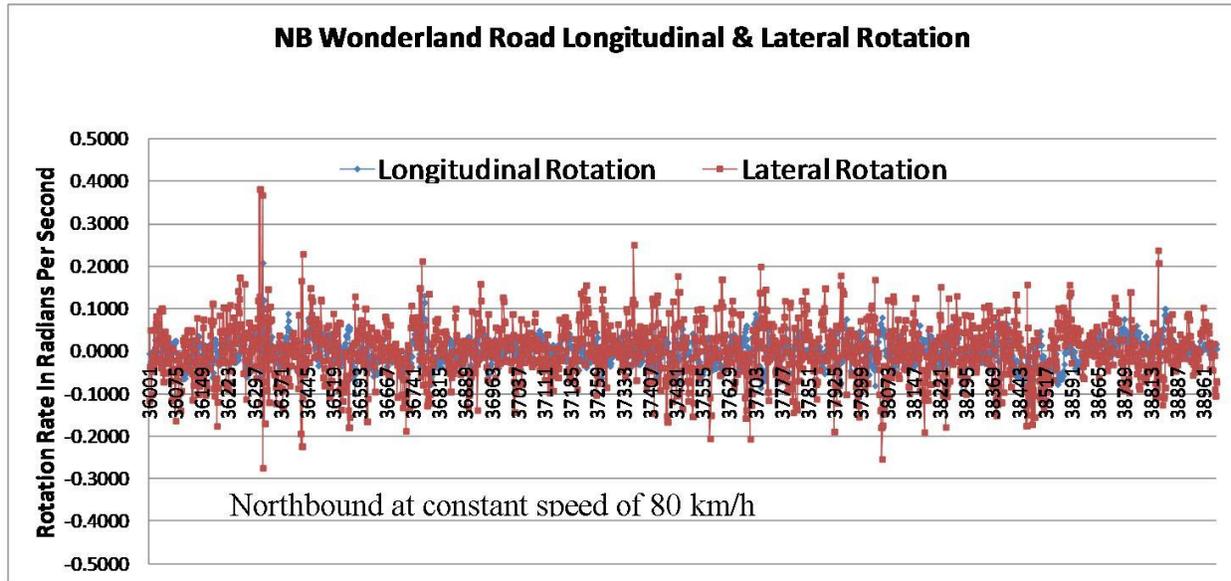
Figure 30: Chart between 36001 and 39000 samples.

Figure 16 indicates that the data in Figure 30 also shows a high lateral rotation rate of 0.0660 radians per second.

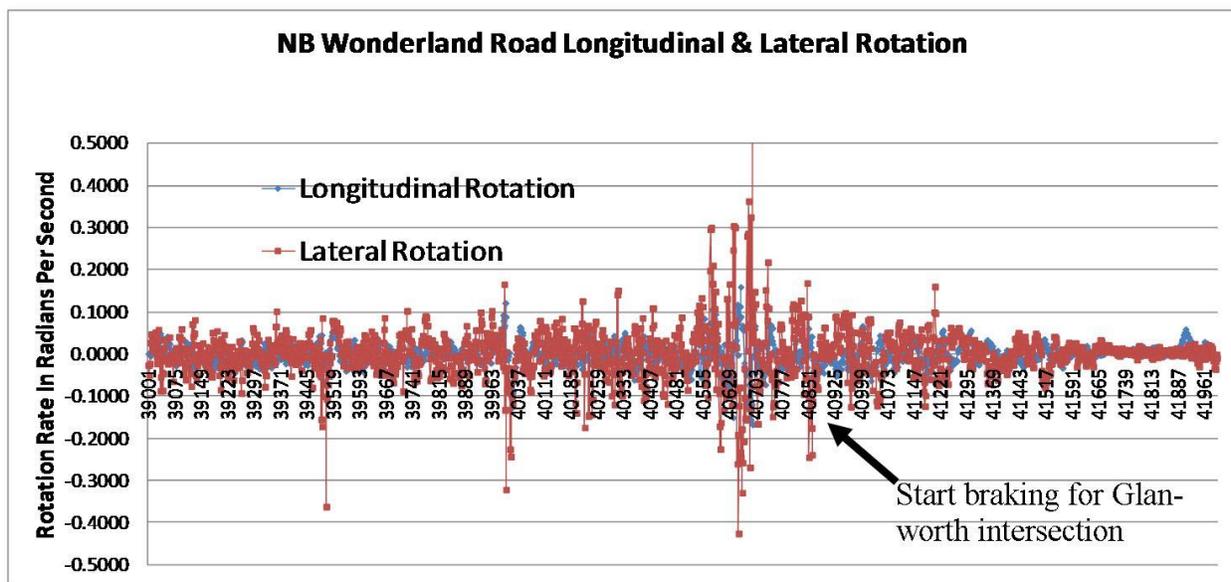
Figure 31: Chart between 39001 and 42000 samples.

Figure 31 shows an interesting set of data in that the average lateral rotation is reduced to 0.0598 because of the braking that has commenced for the stop at Glanworth Drive. Yet we see a very large spike in the lateral rotation just before the braking occurred. The spike is so high that the red line is drawn extending beyond the range of the chart. Thus this would be an area of the road that would be worthwhile exploring.

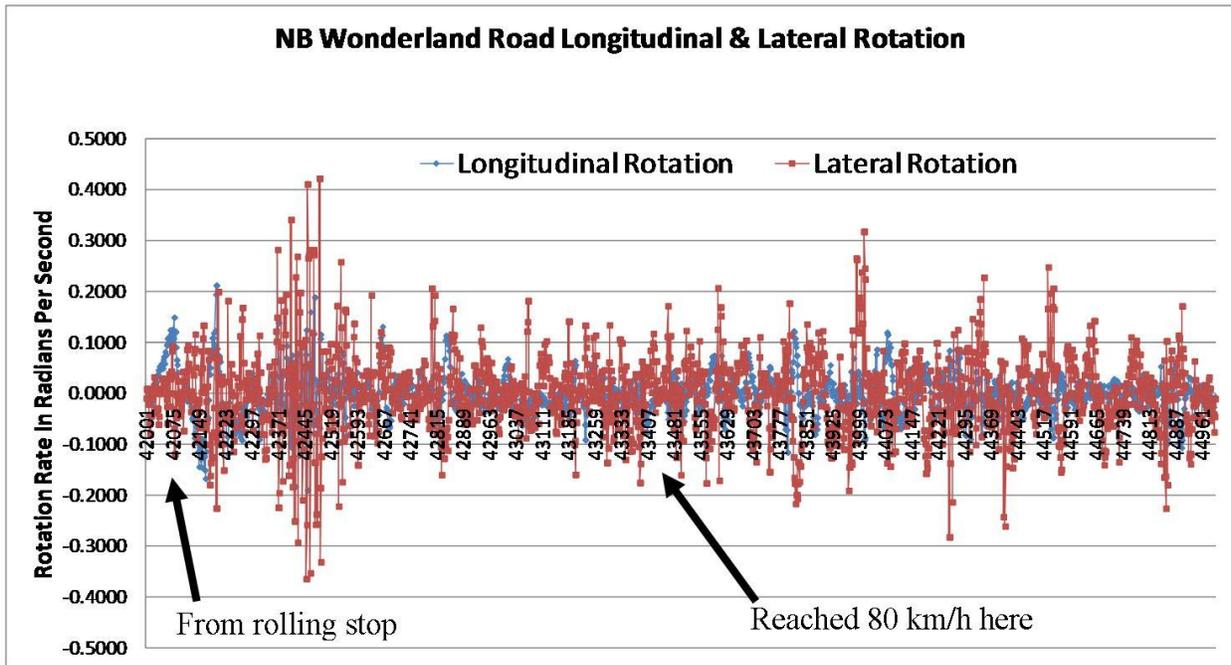
Figure 32: Chart between 42001 and 45000 samples.

Similarly, Figure 32 shows another area of high rotation as the test vehicle was accelerating for about 3 seconds from its rolling stop at the Glanworth intersection. Figure 17 indicates that this road segment produced the highest, average, lateral rotation of 0.0767 radians per second. Beyond the above-mentioned area of high rotation during the acceleration there are also several spikes of rotation after the vehicle has reached its cruise speed of 80 km/h.

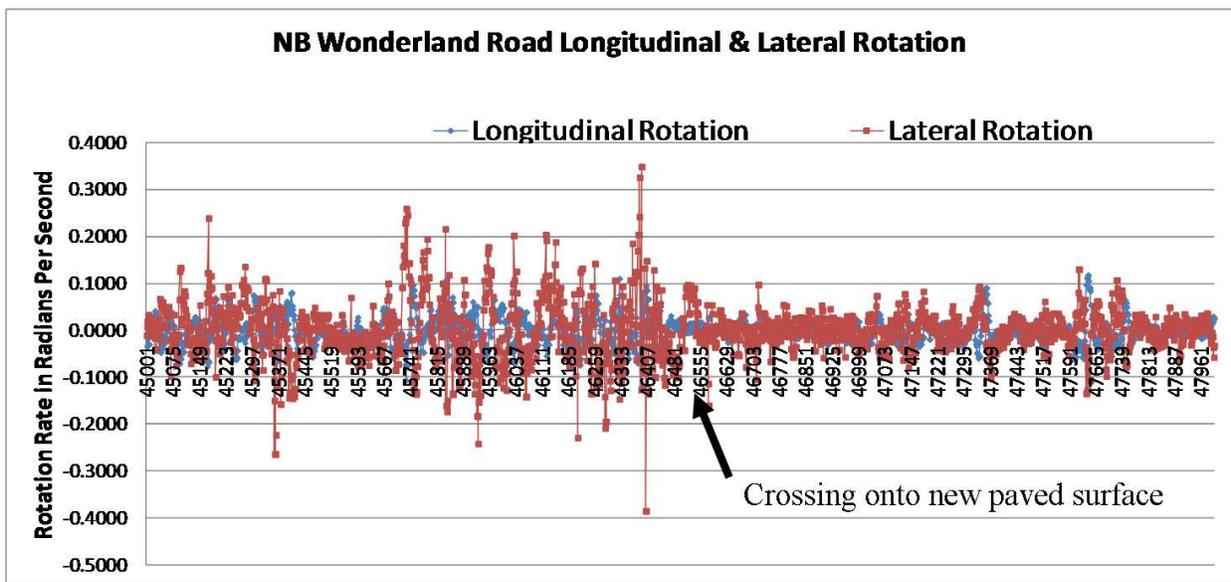
Figure 33: Chart between 45001 and 48000 samples.

These high rotations persist into Figure 33 until the test vehicle reaches the area of the newly paved asphalt and then we see an obvious decrease in lateral motion. Even though in Figure 33 the test vehicle continues travelling at highway speed the lateral motion continues to be low, again as expected, until the vehicle makes its left turn into the driveway north of Highway 401.

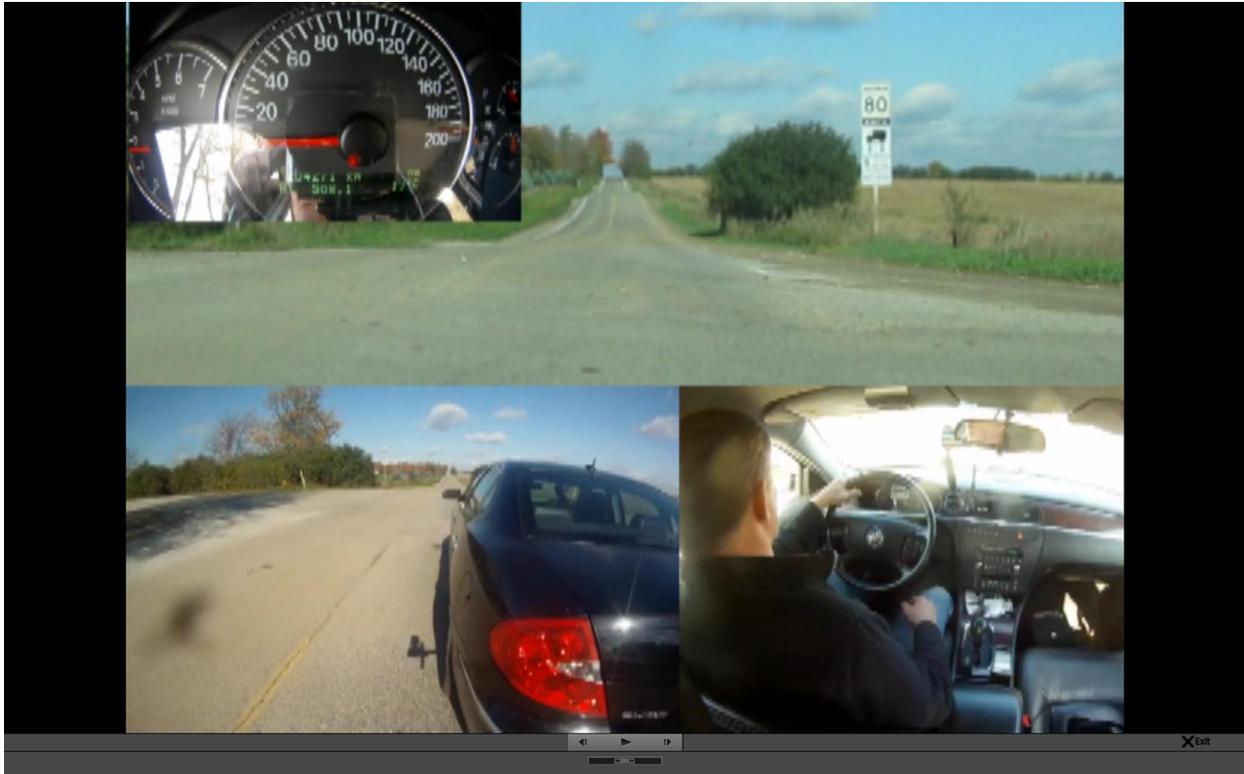
Of greater utility is that the road data is matched to the output of the multiple video cameras attached to the test vehicle. Thus we can know precisely what portion of the road caused the data. As an example, we can explore what caused the large motions in the test vehicle at the beginning of Figure 32 as the test vehicle was being accelerated forward after it had stopped for the Glanworth intersection. Figure 35 is a screenshot taken from the Premiere video project showing the views of four video cameras at the point where the test vehicle was beginning to accelerate forward from its stop. One can see the speedometer/tachometer in the upper left corner. The speedometer is at “zero” and the tachometer is at about 1800 rpm. So this is where the acceleration began.

We can also see, in the upper right, a “zoomed in” from the camera looking forward through the vehicle’s windshield. This view helps to show what features of the road the vehicle will be approaching.

At the bottom left is a view from a camera mounted on a lateral pole that is anchored to a bike rack behind the test vehicle. Thus this view shows the portion of the road to the left of the vehicle and we can see the vehicle’s left rear tire. Thus we know precisely where the vehicle is on the road when these views are shown.

Figure 35: Screenshot from Premiere video project showing the northbound test vehicle stopped at the intersection of Glanworth Drive and beginning to accelerate forward.

Finally, in the bottom right, is a view looking forward toward the driver's seat from a camera mounted behind the two front seats. A view like this provides information about the driver's actions.

When these views are seen in video it is possible to see the "bounce" of the vehicle and cameras when there is a large disturbance caused by the road. And this is precisely what was observed in the video project as the frames were viewed. Thus we could establish that the test vehicle was being disturbed just as it was passing over the intersection.
