## The Seven S-Curves of Adelaide - Part 4

Further to our continuing efforts to examine the differences in seven S-Curves on Adelaide Street north of London, Ontario, this latest article provides results of our additional testing with a vehicle instrumented with multiple video cameras and an accelerometer. In addition, a large protector was attached to the vehicle's steering hub and data of steering wheel rotations will also be presented.

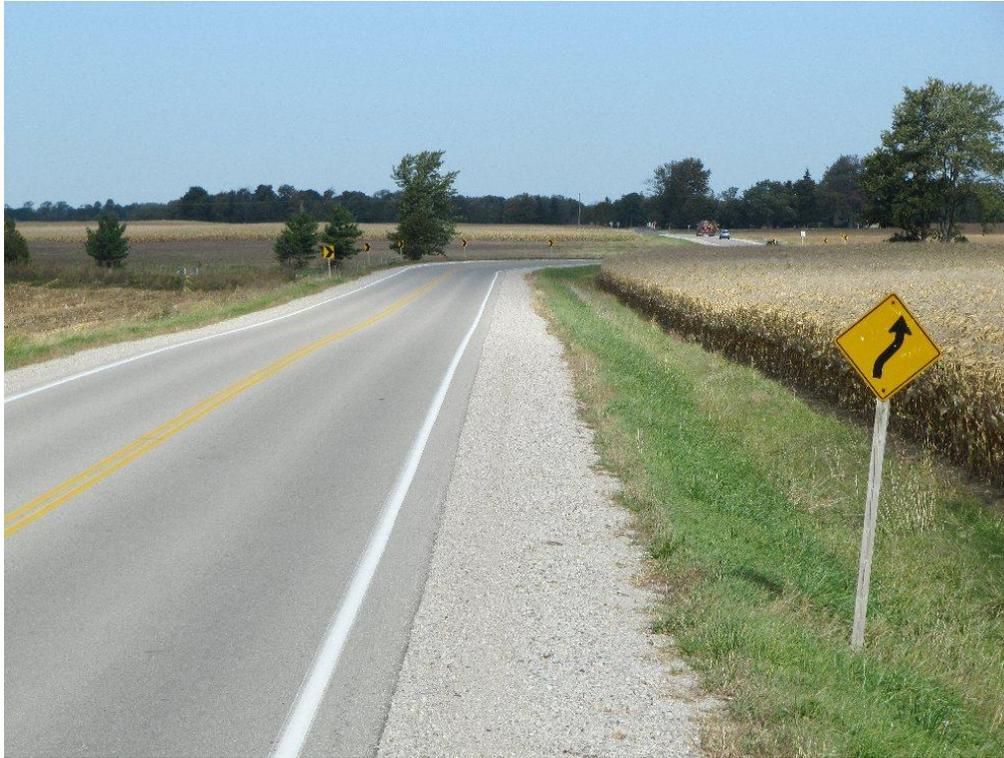
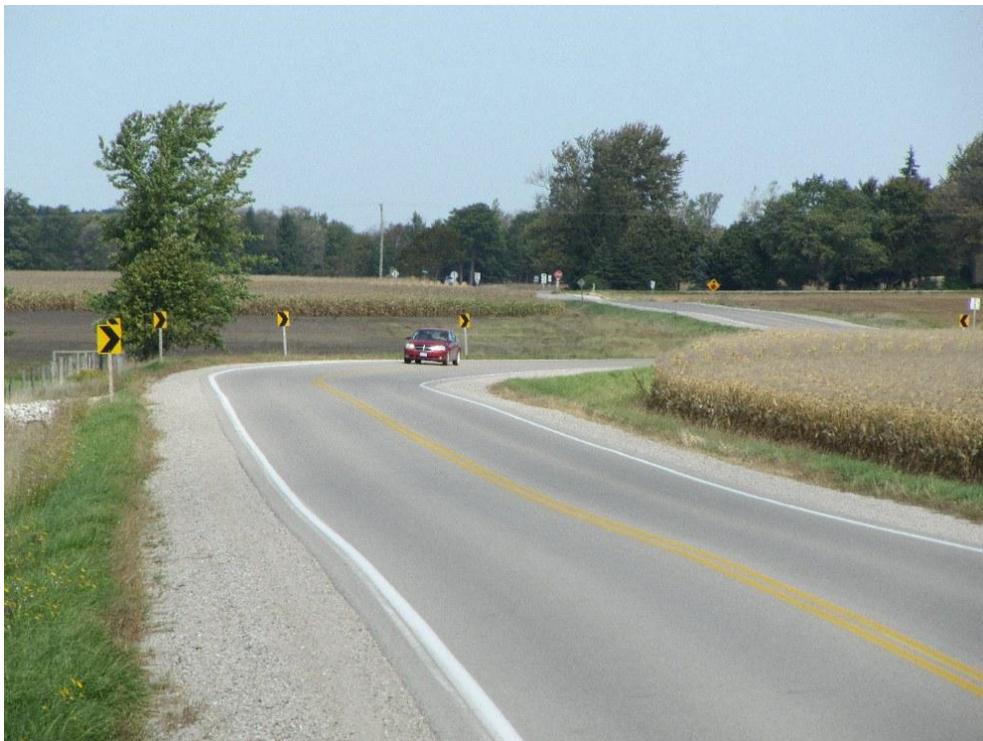
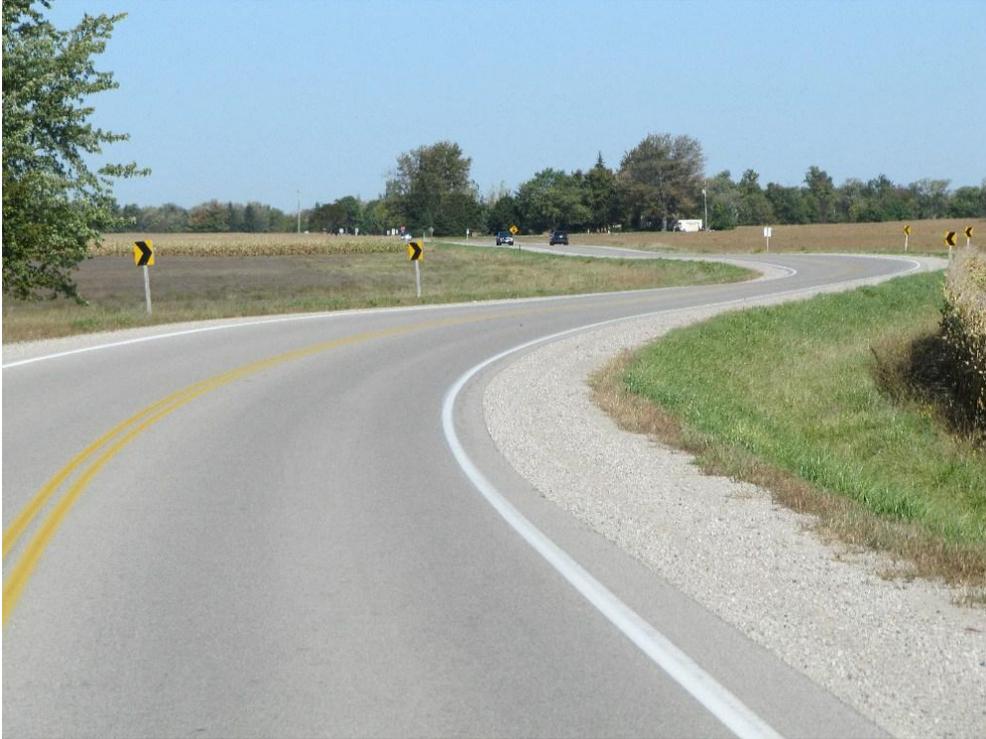
Figure 1: Curve 3

Figure 2: Curve 3

Figure 3: Curve 3

The following three photos on Pages 2 and 3 show the views of Curve 3. These are followed by four photos on Pages 3 and 4 showing Curve 4.

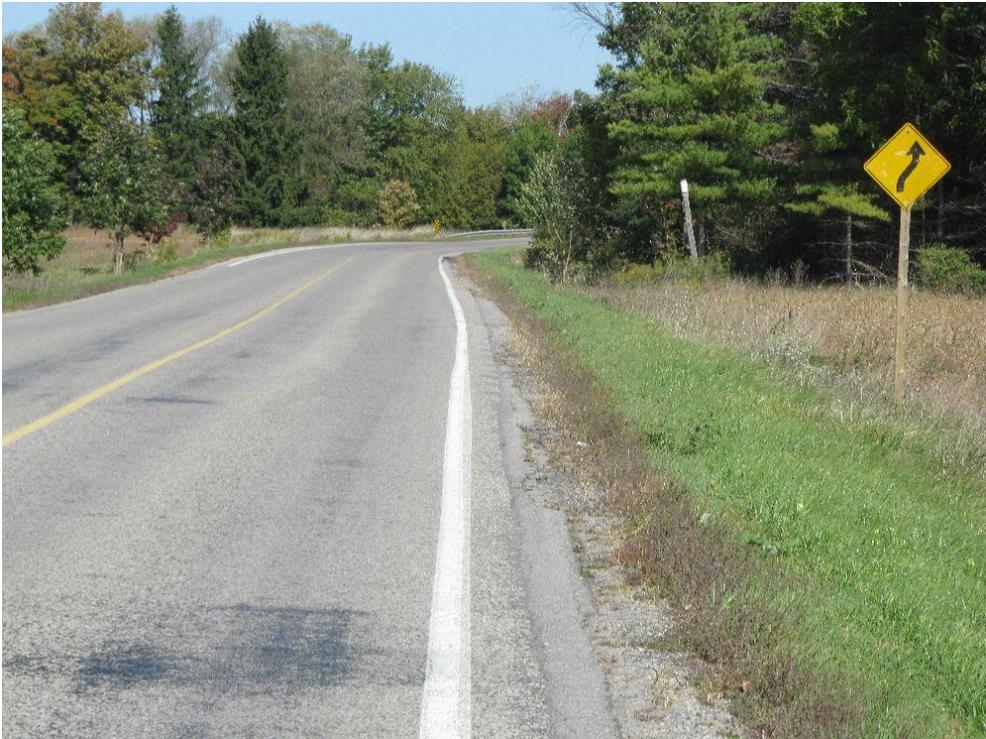
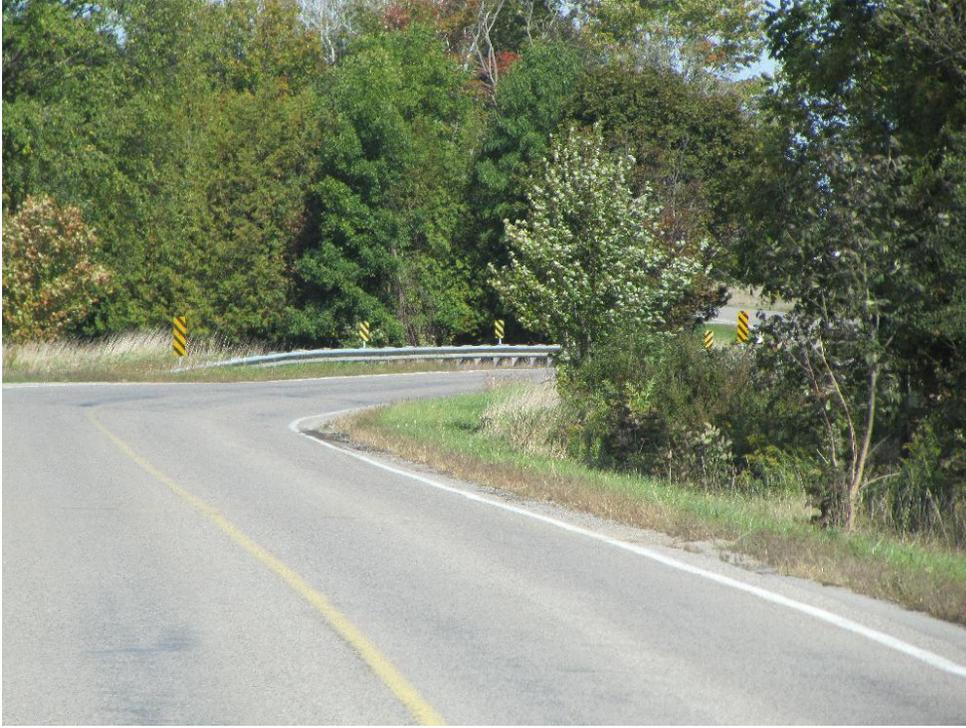
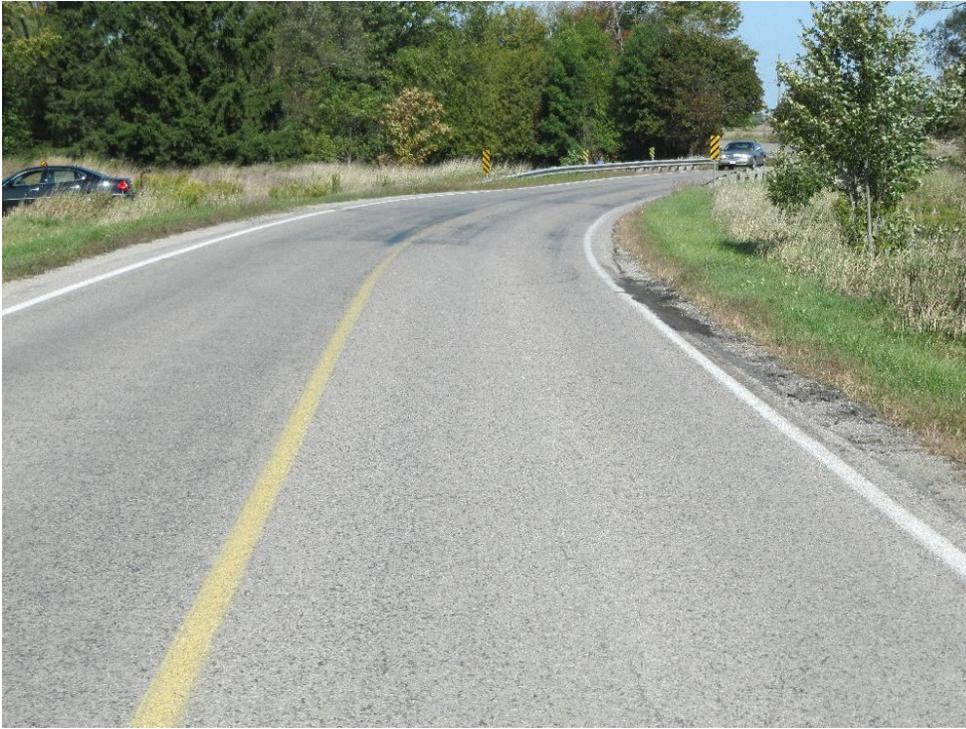
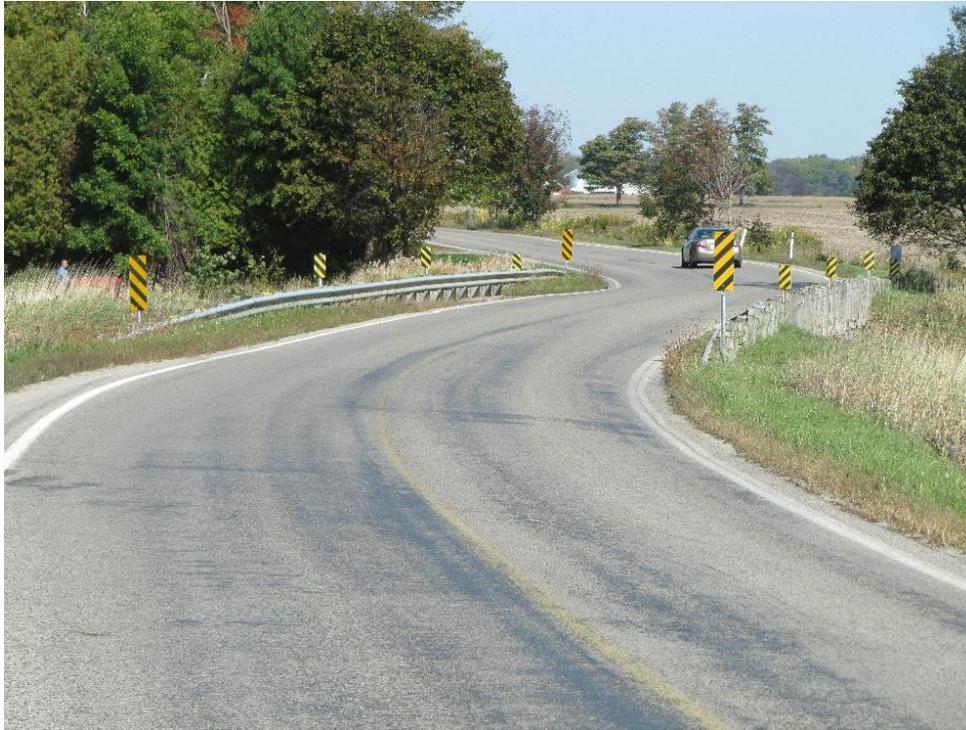
Figure 4: Curve 4

Figure 5: Curve 4

Figure 6: Curve 4

Figure 7: Curve 4

The curve warning sign at Curve 4 is located only a very short distance prior to the commencement of the curve. There are trees and bushes close to the road that make it difficult to see the layout of the curve. As the driver starts into the first curve to the right there is a sudden increase in the lateral acceleration to a peak of about -0.25 g. Then there is a rapid change in the lateral acceleration to a peak of over 0.30 g in the second portion of the S-curve to the left. Drivers who become familiar with the road can make better adjustments for these differences. But drivers who are new to the area could be surprised by these differences. Even drivers who have passed through Curve #4 on a number of occasions could be caught unprepared if certain changes, such as poor weather conditions, cause a difference in the speed at which a driver can travel through the curve.

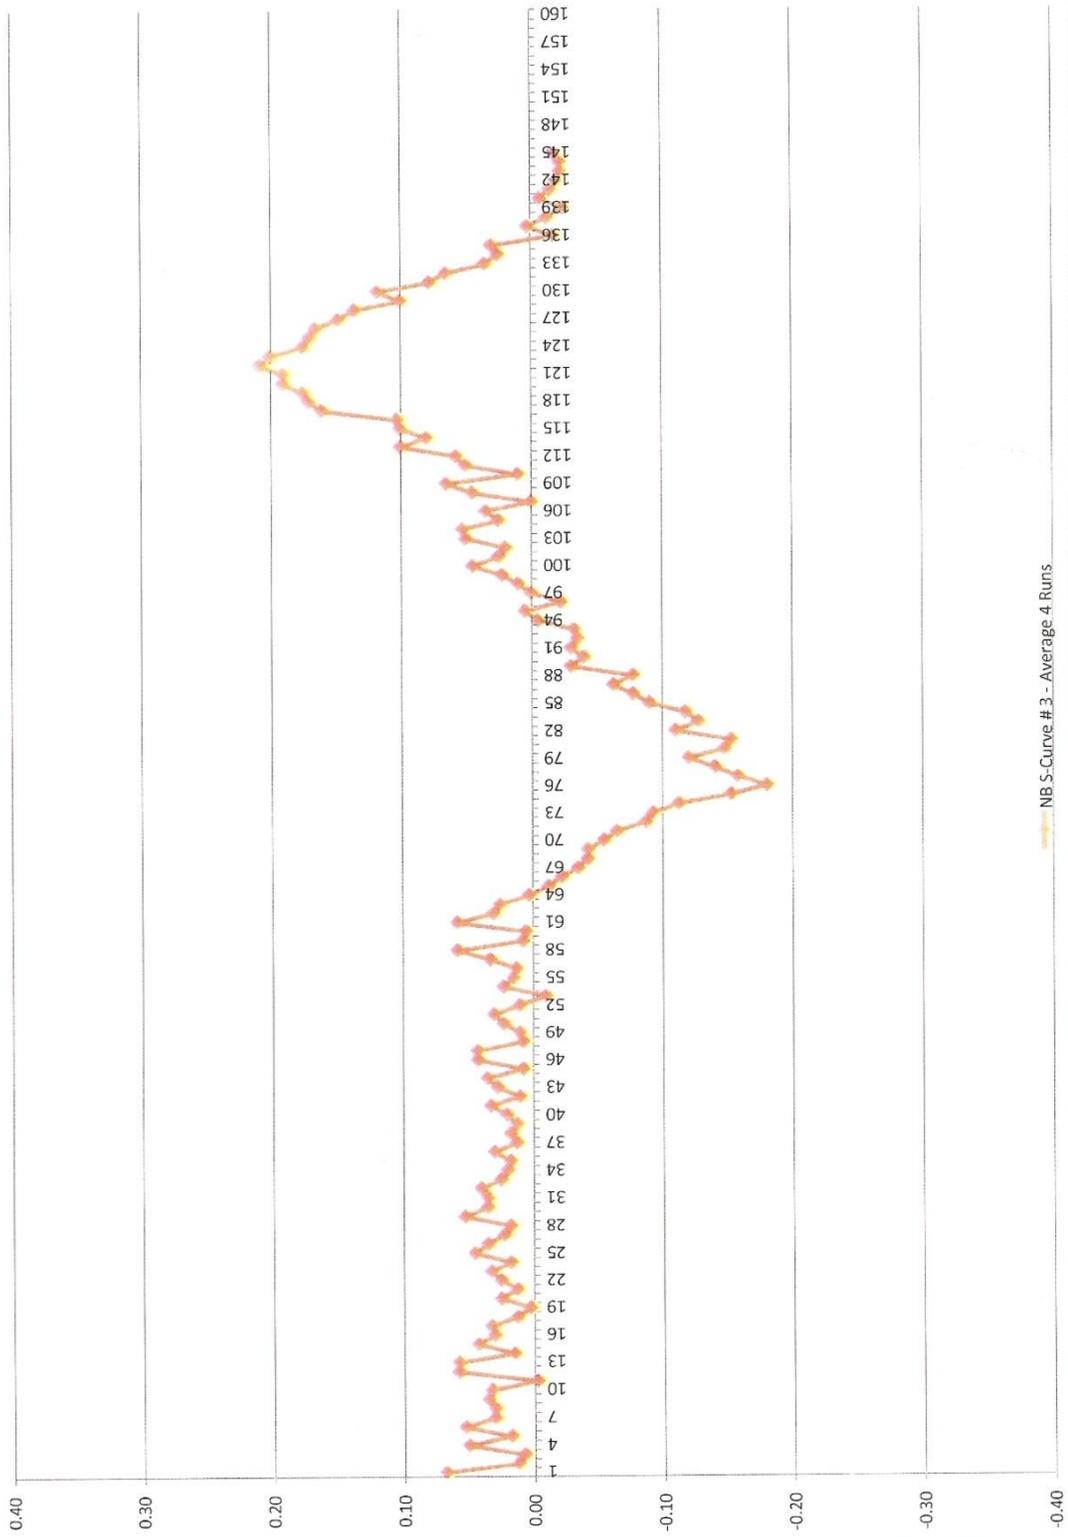
NB S-Curve #3 - Average 4 Runs

The chart from Curve 3 shows a fairly steady acceleration at the beginning of the data collection as the lateral acceleration pulses between 0.0 g and 0.5 g. We stated earlier that this slightly positive value may be due to the cross fall in the lane which is normally about 2 percent. As the data passes observation 60 we see the change to a negative acceleration as the vehicle begins to travel into the right curve. We can also see a relatively mild change from a -0.19 g to a 0.20 g peak from observation 75 through to observation 122, or about 47 observations. Recall that our video was shot at 30 frames per second and we documented the lateral acceleration every 5 frames, so there were 6 observations taken every second. So the 47 observations encompasses a time of about 7.8 seconds during which the acceleration changes from the negative peak to the positive peak. At 90 km/h, or 25 metres per second, this change would take place in about 196 metres. So these values demonstrate some fairly mild conditions that a driver should experience without much of a challenge.

# Northbound S-Curve #3 With Cruise Activated - Average 4 Runs

Thus the absolute value of the lateral acceleration in Curve #4 changes by about 0.58 g in about 20 observations, or 3.3 seconds, or a distance of about 83 metres. In contrast, in Curve # 3 the absolute value of the lateral acceleration changed by about 0.39 g in about 47 observations, or 7.8 seconds or 196 metres. These are substantial differences between the two curves.

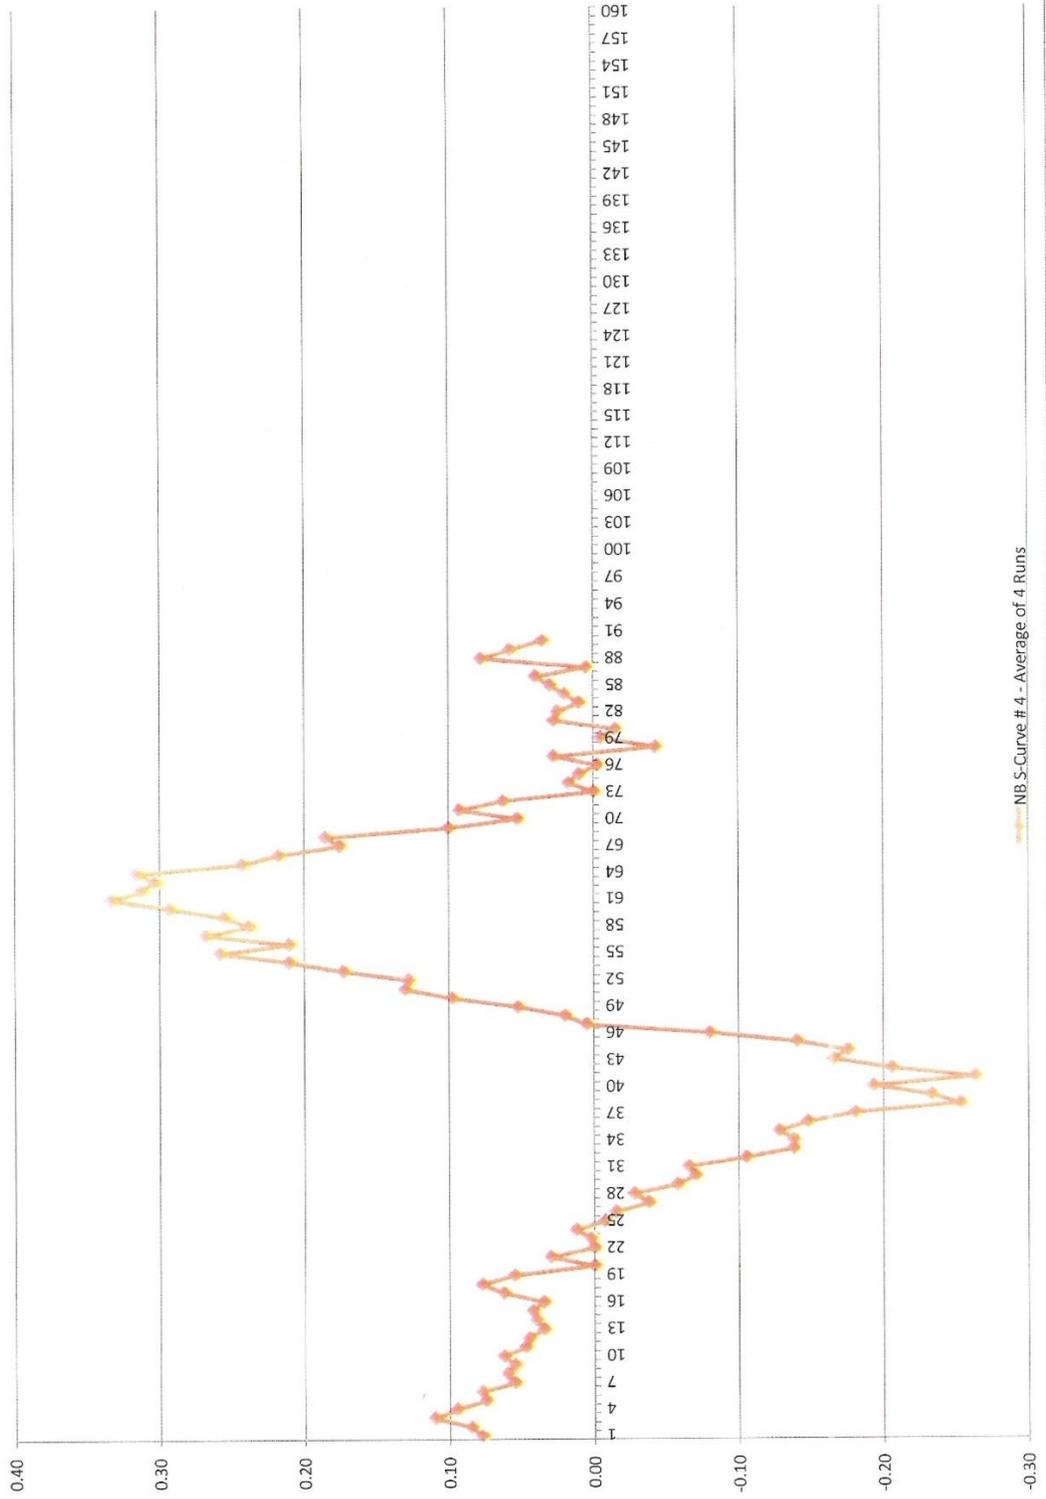
Conversely, the chart from Curve 4 shows that the curve warning sign is very close to the start of the curve because we see the change in the data occurring toward negative acceleration only about 18 observations into the chart. The negative acceleration reaches its peak at about observation 40 and this peak is about -0.26 g. Then we see a very sudden transition from this negative peak to the positive peak of about 0.32 g at about observation 60.

Northbound S-Curve #4 With Cruise Activated - Average 4 Runs

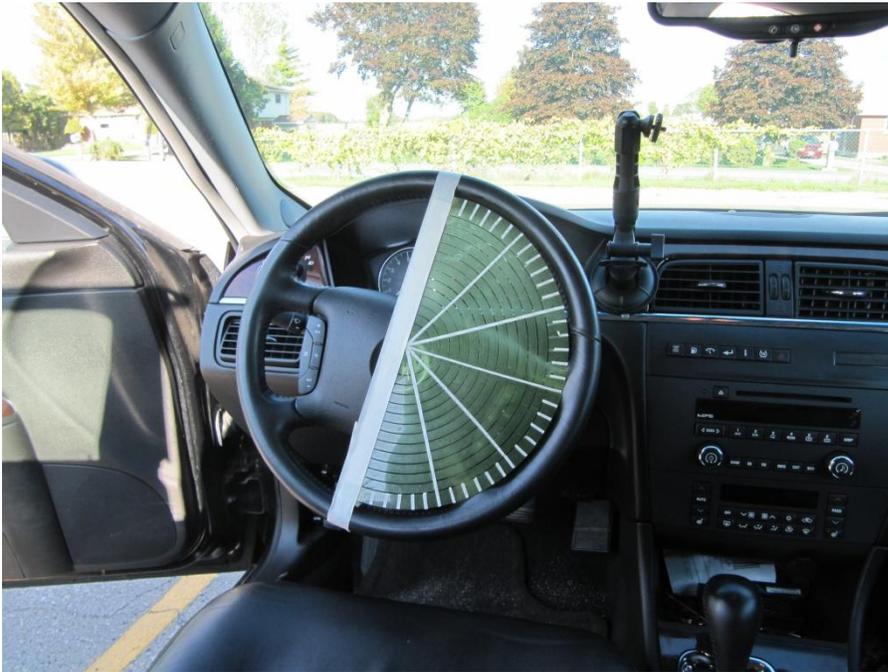
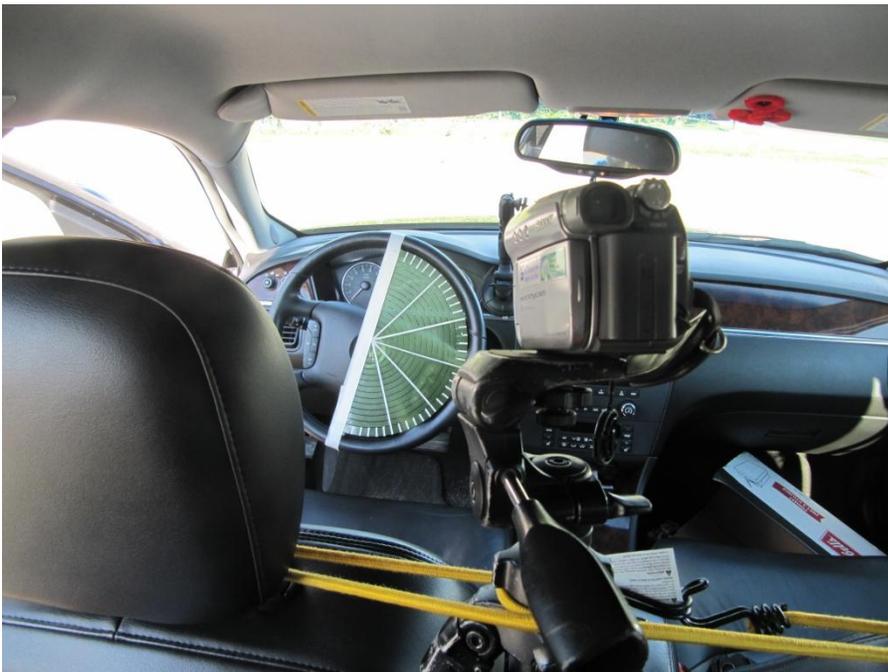
We have previously explored steering wheel motions by attaching a large protractor to the steering hub of our test vehicle , as shown in the two photos below.

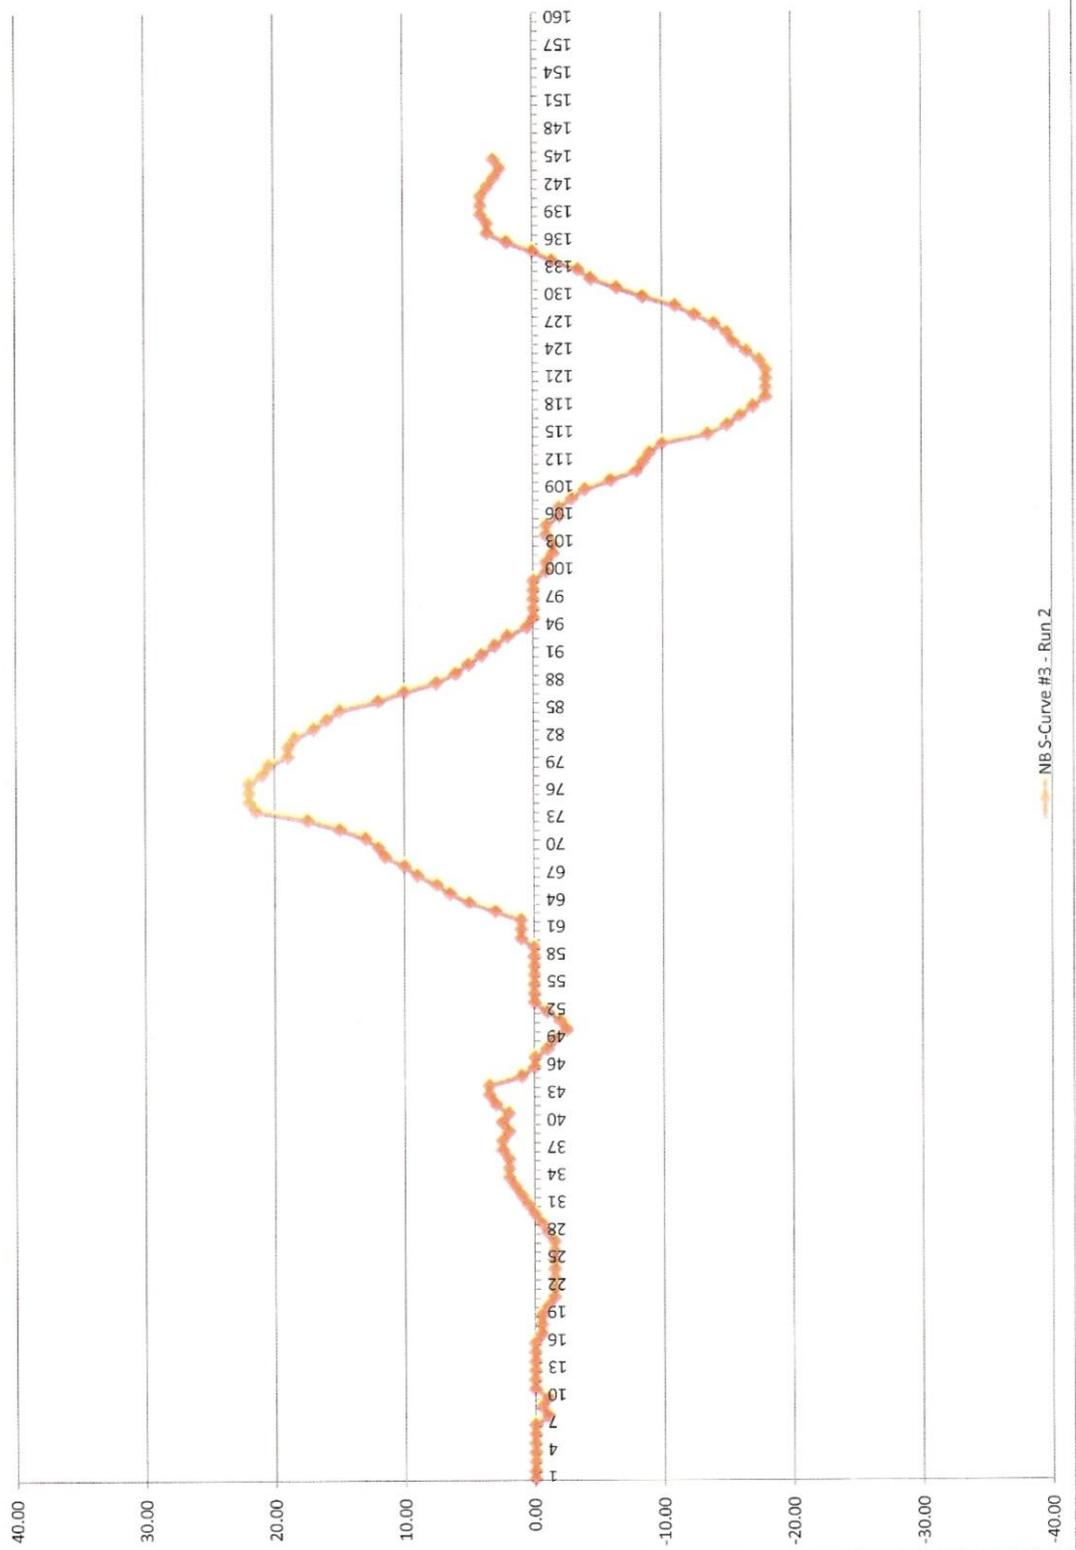
# Northbound S-Curve #3 - Steering Wheel Rotation With Cruise Activated - Run #2

As can be seen in the charts, the steering wheel rotations mimic the lateral acceleration values obtained from our accelerometer. Curve #3 required less steering input and the transition was more gradual between the right and left curves of the S-Curve. In contrast the data from Curve #4 shows more dramatic steering inputs that transitioned over a shorter time and distance. These results are not unexpected. There should be an obvious relationship between steering wheel inputs and the lateral accelerations that would be experienced by a test vehicle.

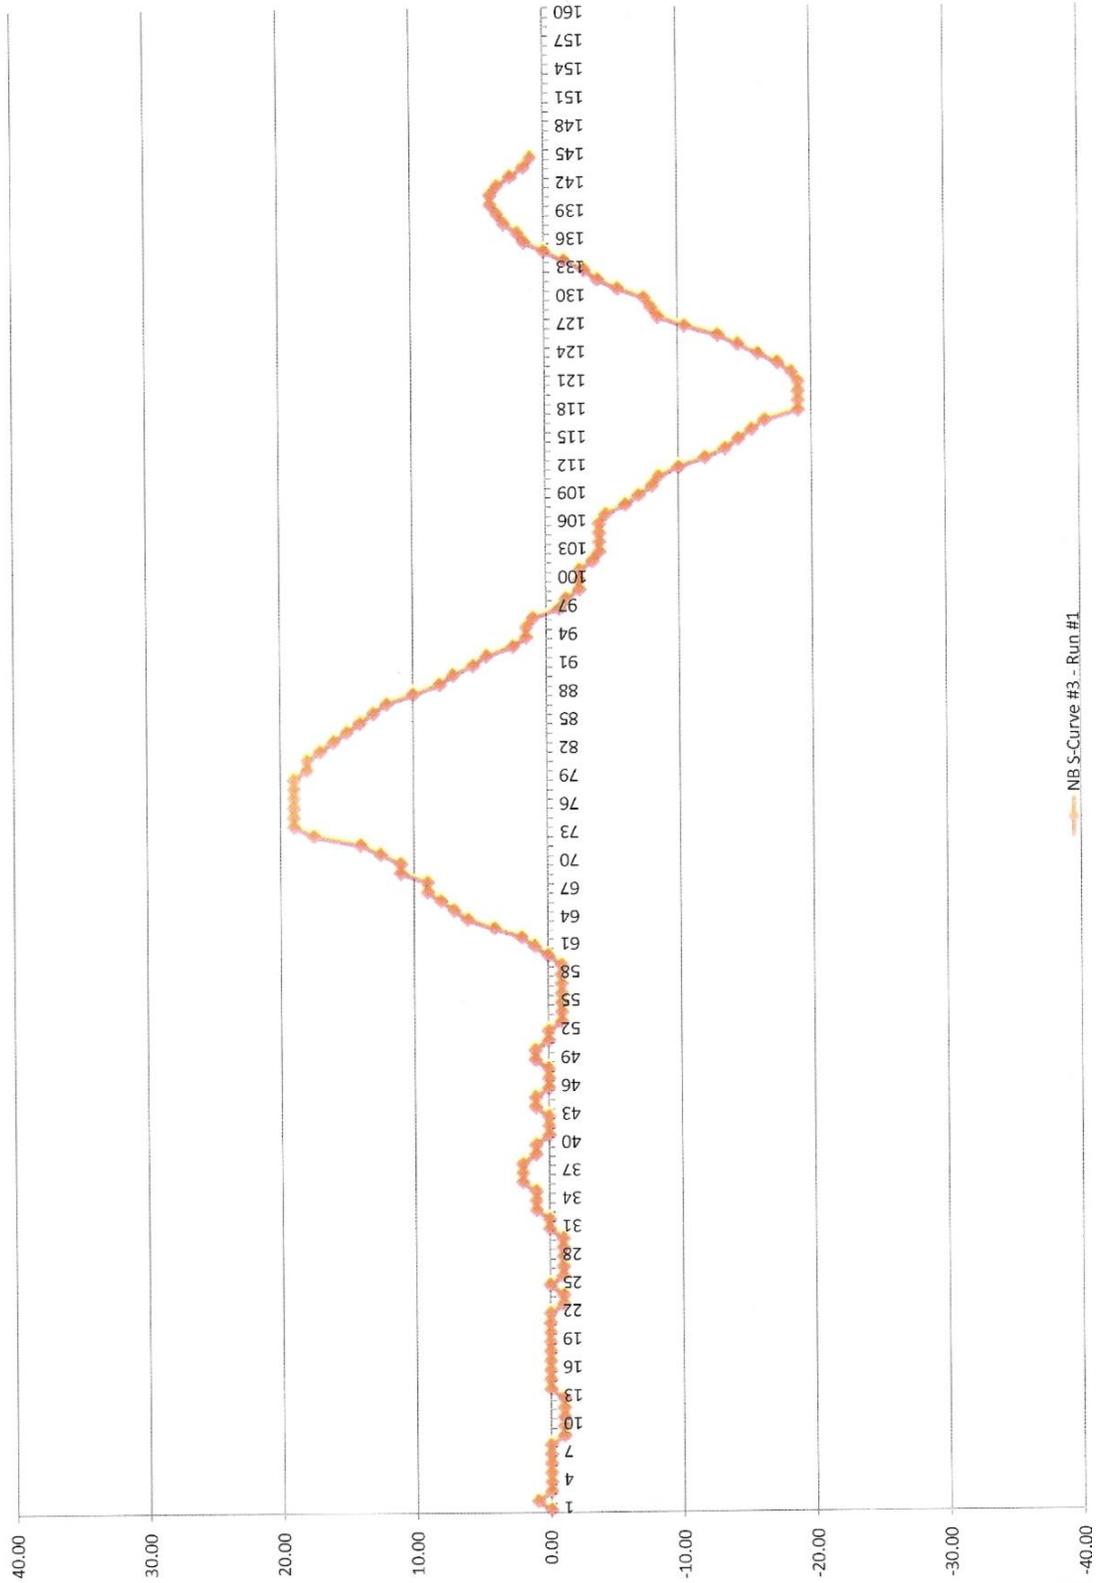
# Northbound S-Curve #3 - Steering Wheel Rotation With Cruise Activated - Run #1

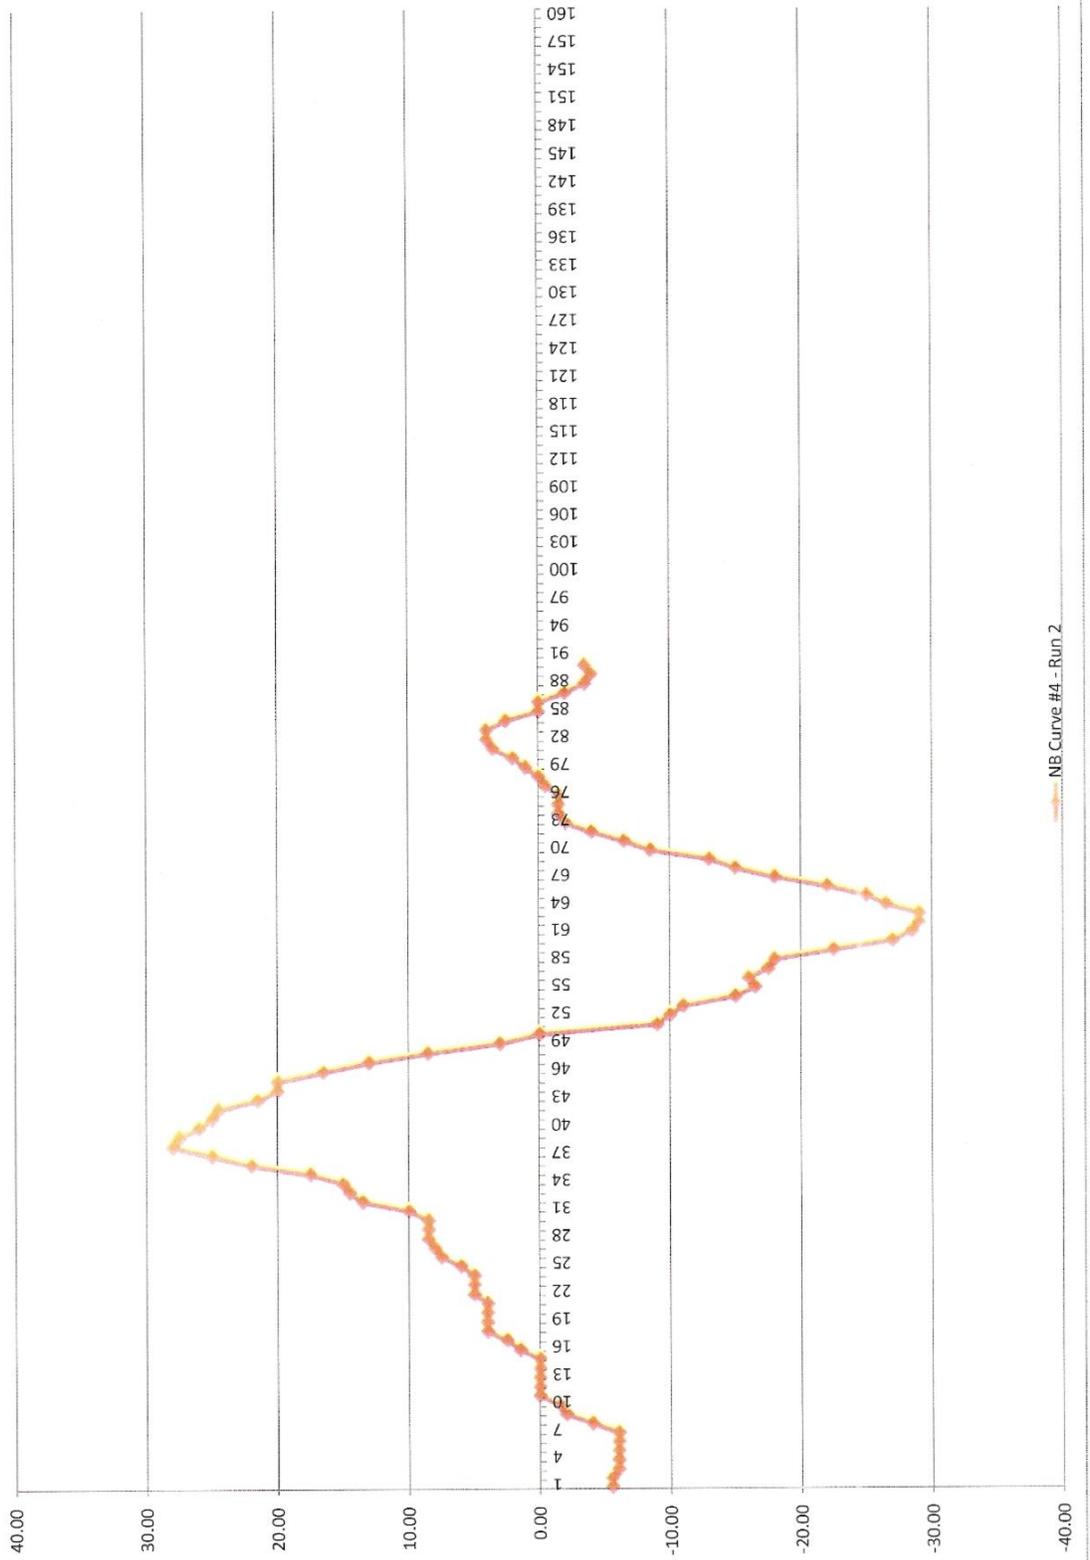
Northbound S-Curve #4 - Steering Wheel Rotation With Cruise Activated - Run #2

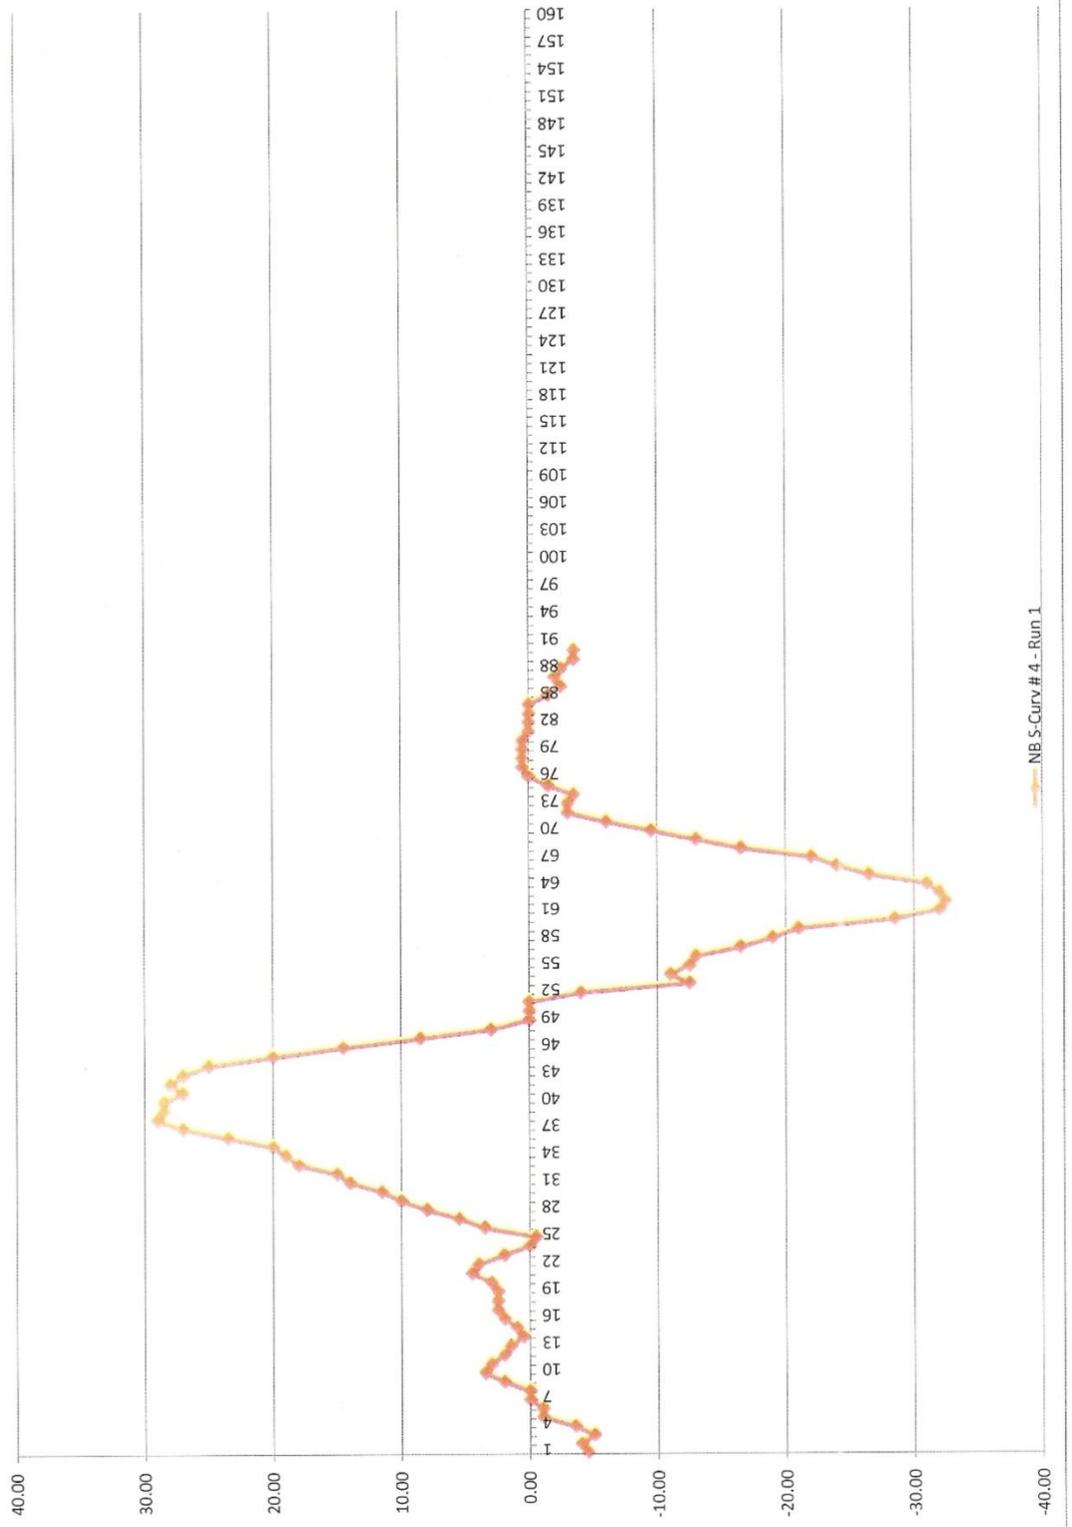
NB S-Curv# 4 - Run 1

# Northbound S-Curve #4 - Steering Wheel Rotation With Cruise Activated - Run #1
