Tire Marks from Reversing on a Loose-Gravel Shoulder

Posting Date: 11-Aug 2014

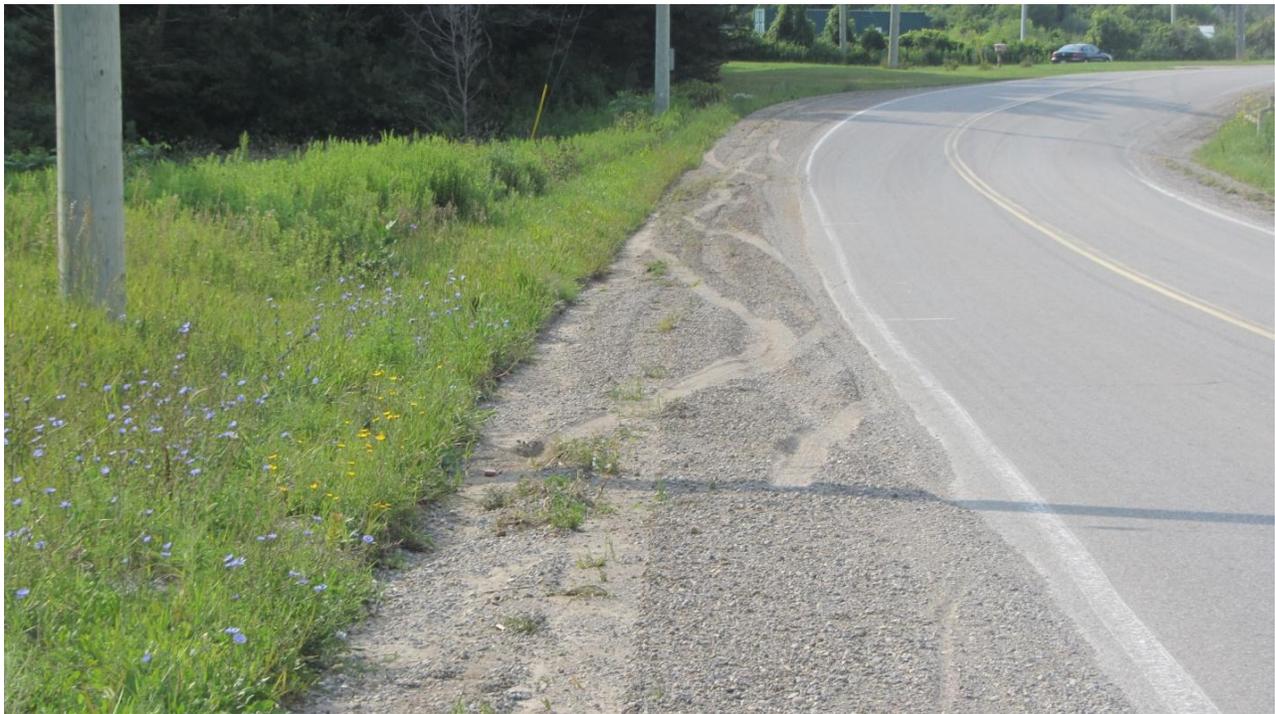
Figure 1: View, looking southbound along the S-curve of Clarke Road, north of Fanshawe Park Road in London, Ontario. Tire marks on the east shoulder indicate a reversing motion of a vehicle on the loose gravel.

Figure 1 shows an overall view of the tire marks produced by this vehicle as it passed through the S-curve on Clarke Road, in north-eastern London, Ontario, Canada, shortly before August 8, 2014.

This is the same location where, only a few days previous, we reported on another set of tire marks on this shoulder, where a northbound vehicle rotated out of control and came to rest on the opposite (west) shoulder. The discussion of those tire marks is found in the article "Review of Loss-of-Control Tire Marks on a Gravel Shoulder" which was posted onto the Gorski Consulting website on August 5, 2014. In fact, if one were to look closely into the gravel shoulder of Figure 1 one might still be able to detect the curving yaw mark from that previous episode.

If the reader has examined our previous articles discussing the re-grading of this shoulder then it should also be possible to detect the straight and broad tire mark of the right wheels of the northbound road grader that passed by the site on July 31, 2014, or approximately one week before these photos were taken. It is because the road grader loosened up the gravel that made the various tire marks so visible.

Looking at the meandering tire marks one might judge that there was something peculiar taking place and that it might be difficult to uncover the vehicle's motions. However that is not the case. One merely needs to look at the north (closer) end of the tire marks to detect that they seem to "end" as if the vehicle has just lifted off the planet, and this is a telltale sign that the vehicle has stopped and begun to move backwards, generally along the same path as where it entered the shoulder.

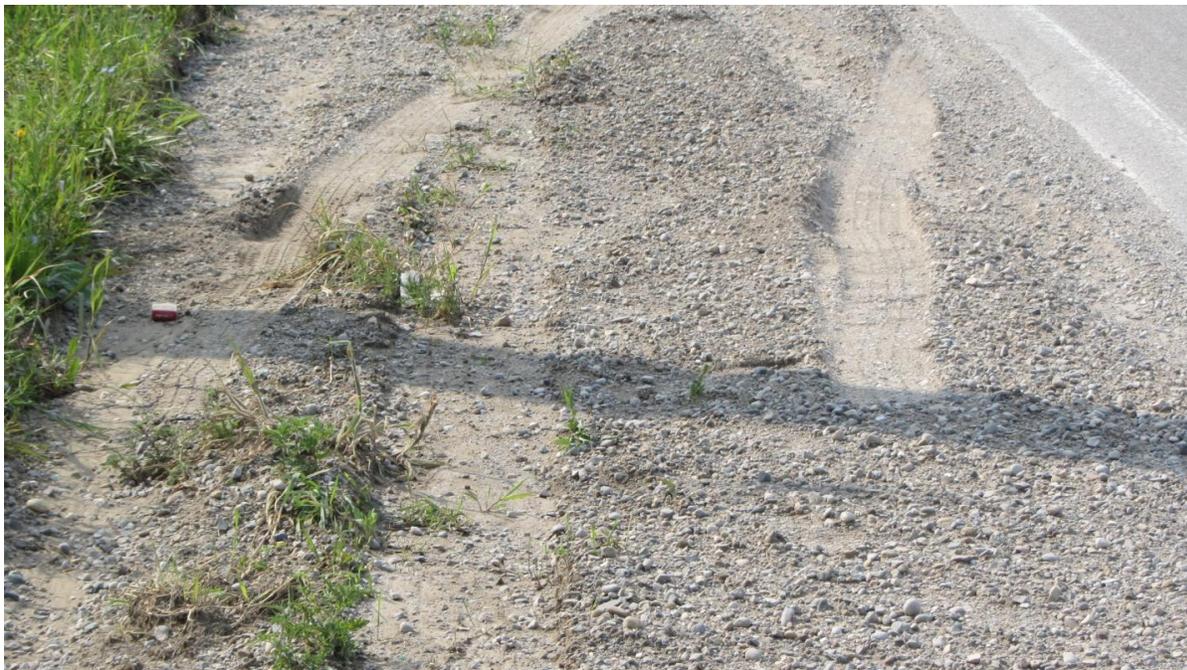
Figure 2: Closer view of the north end of the tire marks that indicate the vehicle has stopped and begun to reverse backwards along the shoulder.

Figure 2 shows a closer view of the north end of the tire marks and we can clearly see the loose gravel in the vicinity and therefore the characteristics of the tire marks are well-defined.

Again we see the broad and straight tire mark of the road grader. We also might begin to appreciate the wavy character of the reversing tire marks as the driver adjusts his/her steering input at low speed. Such adjustments are not typical of a vehicle travelling forward to a stopped position so, again, it confirms that the vehicle is reversing.

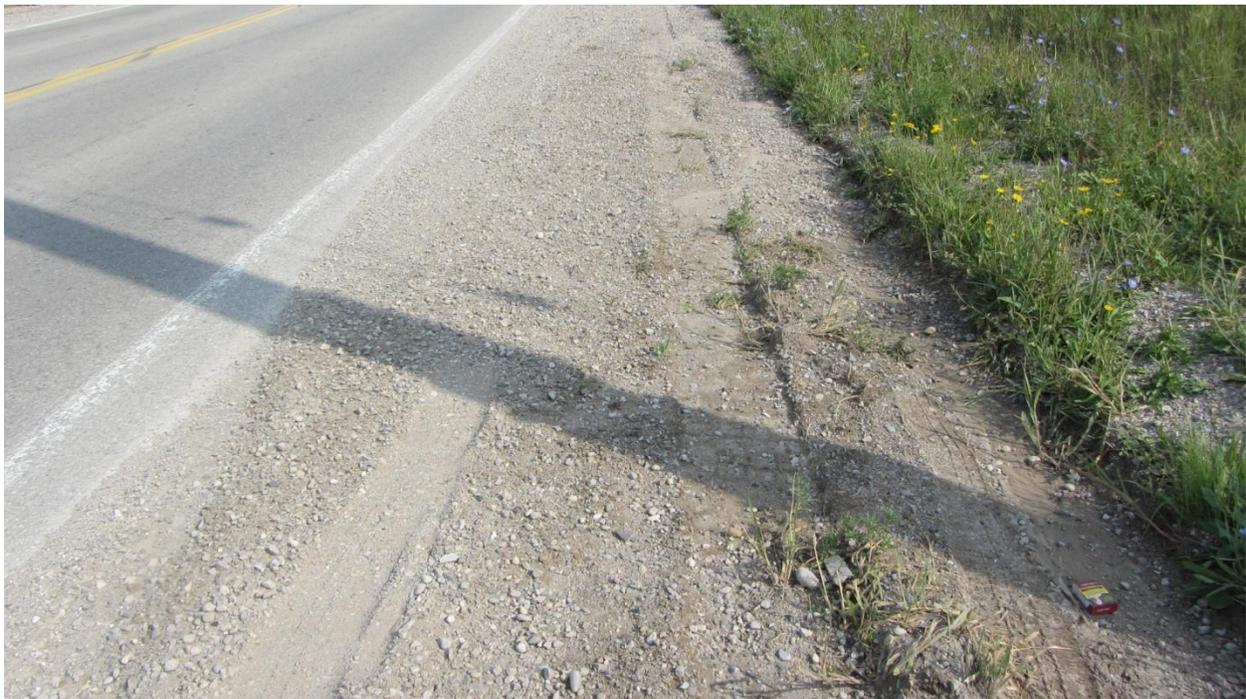
Figure 3: View, looking north, along the north end of the tire marks. The marks are not as easily visible from this viewing direction.

In Figure 3 we change our viewing direction to look south at that north end of the tire marks. We point out that the characteristics of the tire marks are not as clearly visible from this direction because of the position of the sun which is somewhat behind the camera. It is often the case that the visibility of tire marks and other roadway evidence is often dictated by the observer's position with respect to the sun and that, in many instances, an investigator should return to an accident site at dawn or dusk if those observations were being made in mid-day. Similarly, if the investigation was being conducted in sunny conditions then the investigator should return to the site on the earliest cloudy day. These changes in the sun's position and cloud cover will often expose additional evidence that was masked by the bright sun.

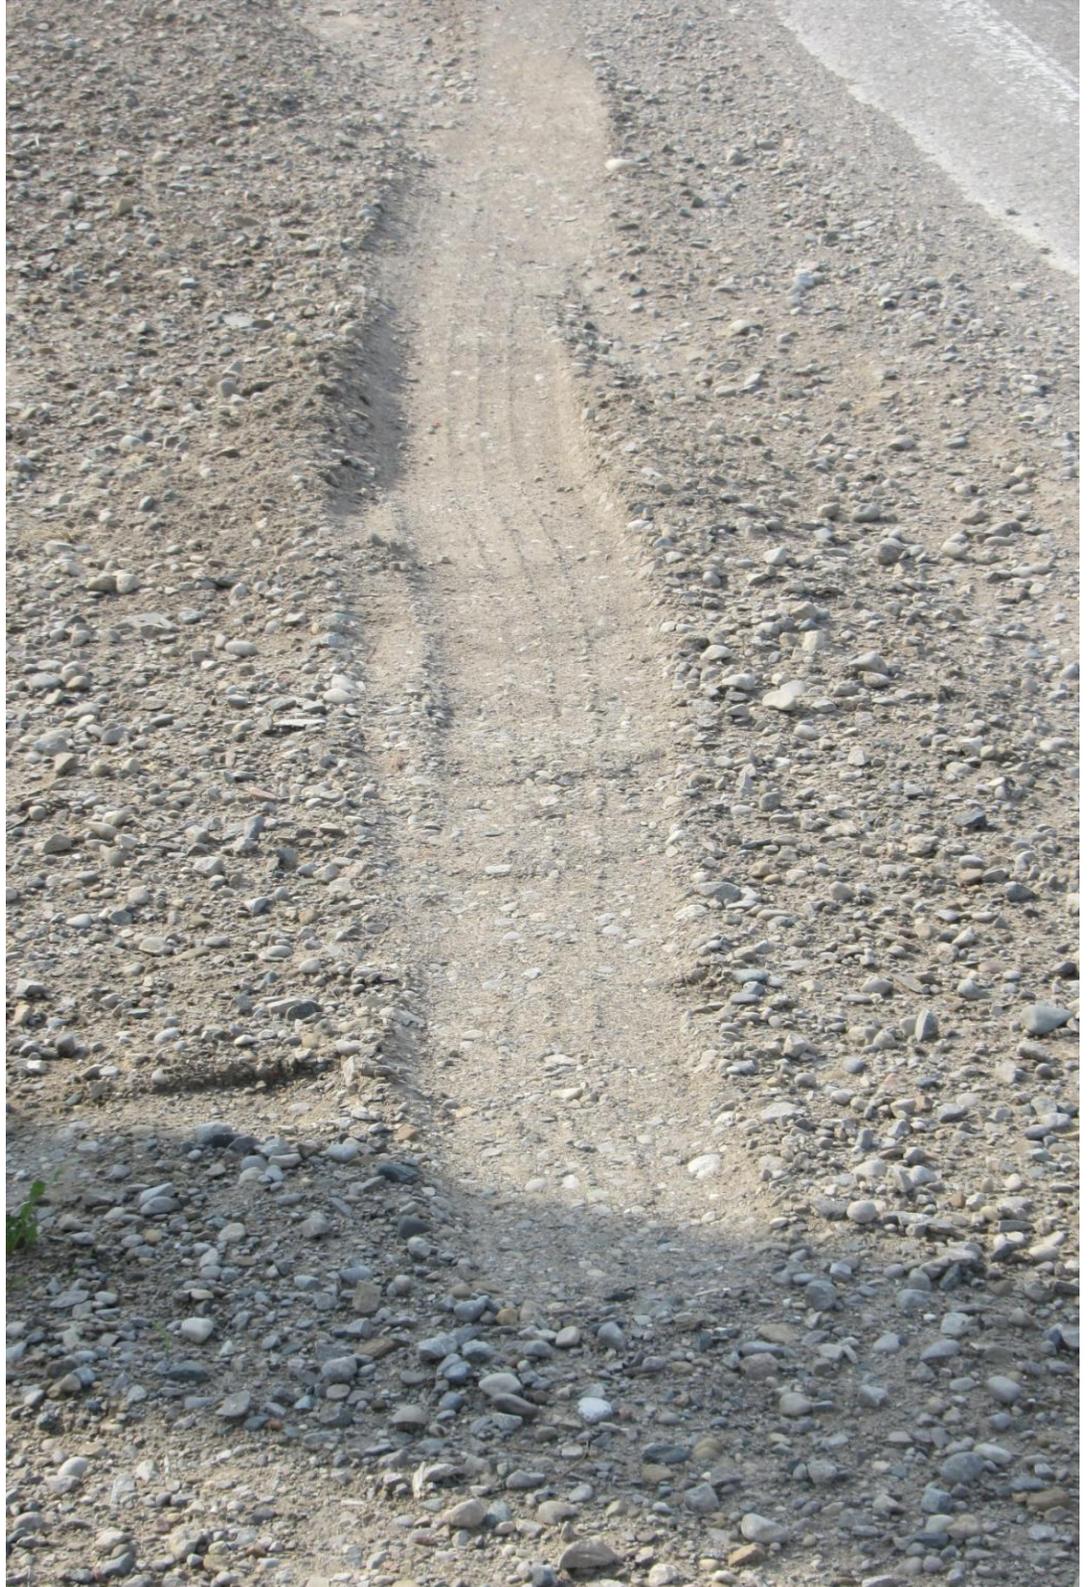
Figure 4: Southward view of tire mark caused by the left side tires of the vehicle.

Figure 4 returns us to a southward view along the north end of the west tire mark that was caused by the left side tires of the vehicle. We can see the meandering character of the mark. We can also see the imprint of the tread of the tire. If we look more closely we might also be able to detect the edges of the tire mark and note that the reversing tire mark overlaps the mark that was made when the vehicle was travelling forward and exiting the road surface. Figure 5 shows the tire mark caused by the right side tires.

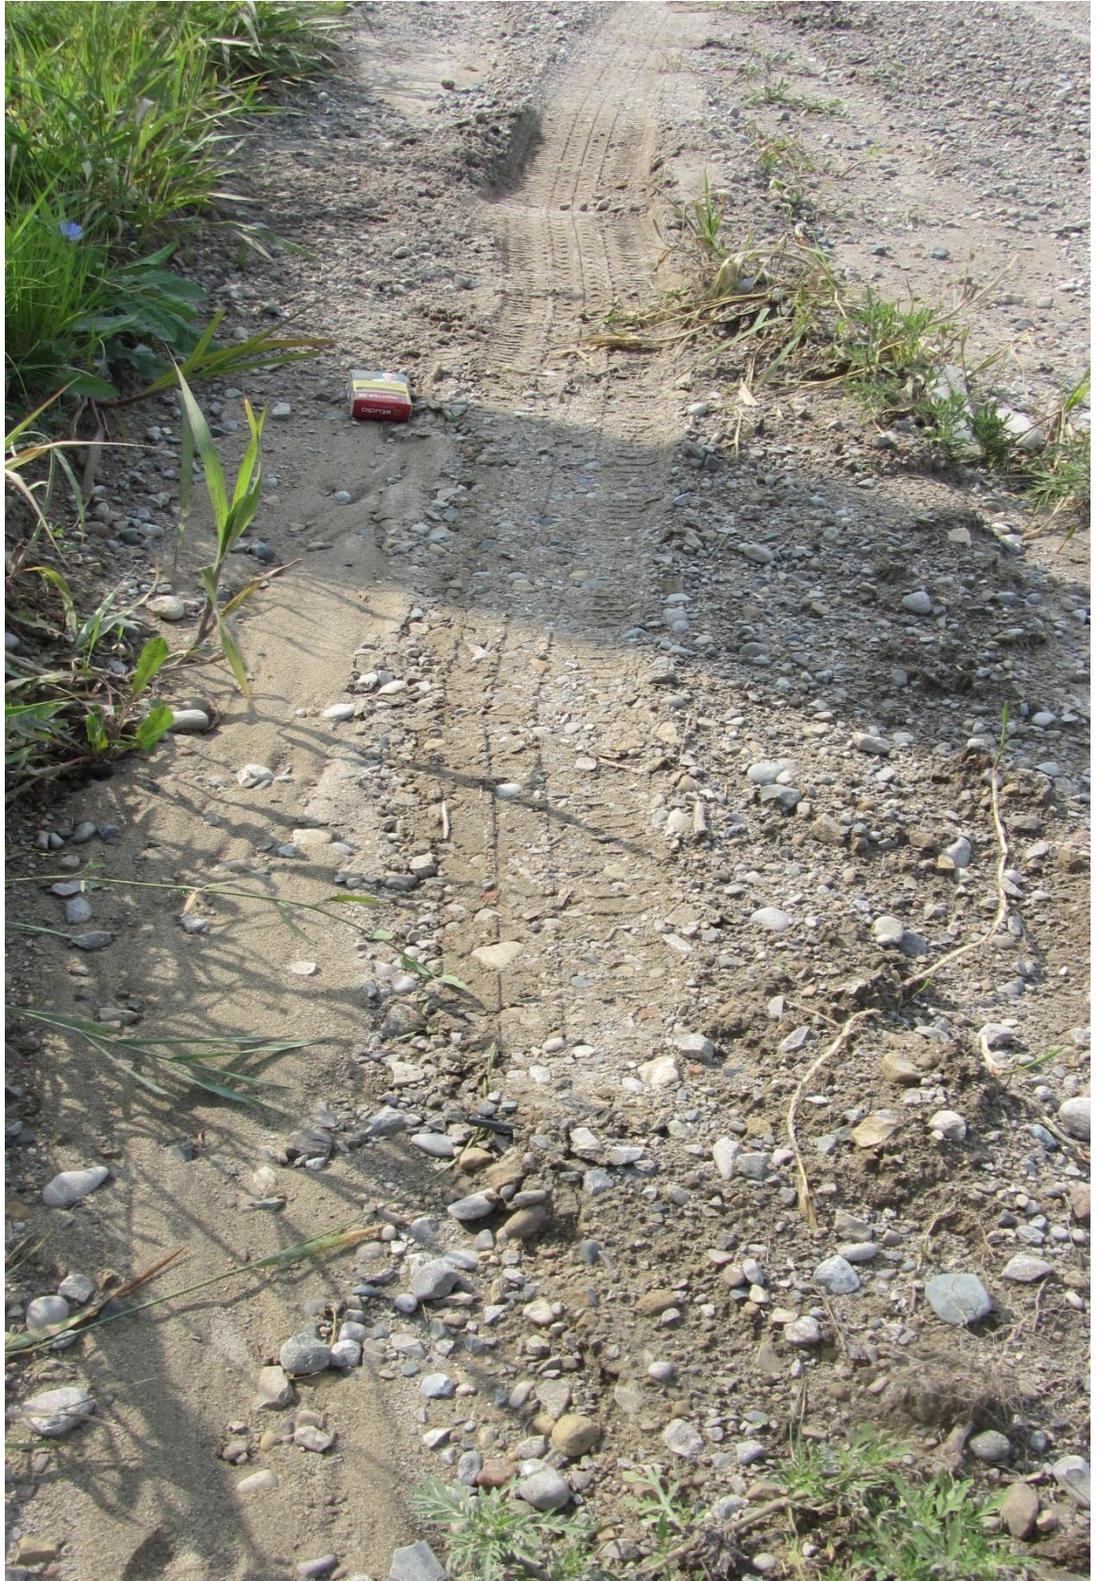
Figure 5: Southward view showing the tire mark caused by the right side tires of the vehicle.

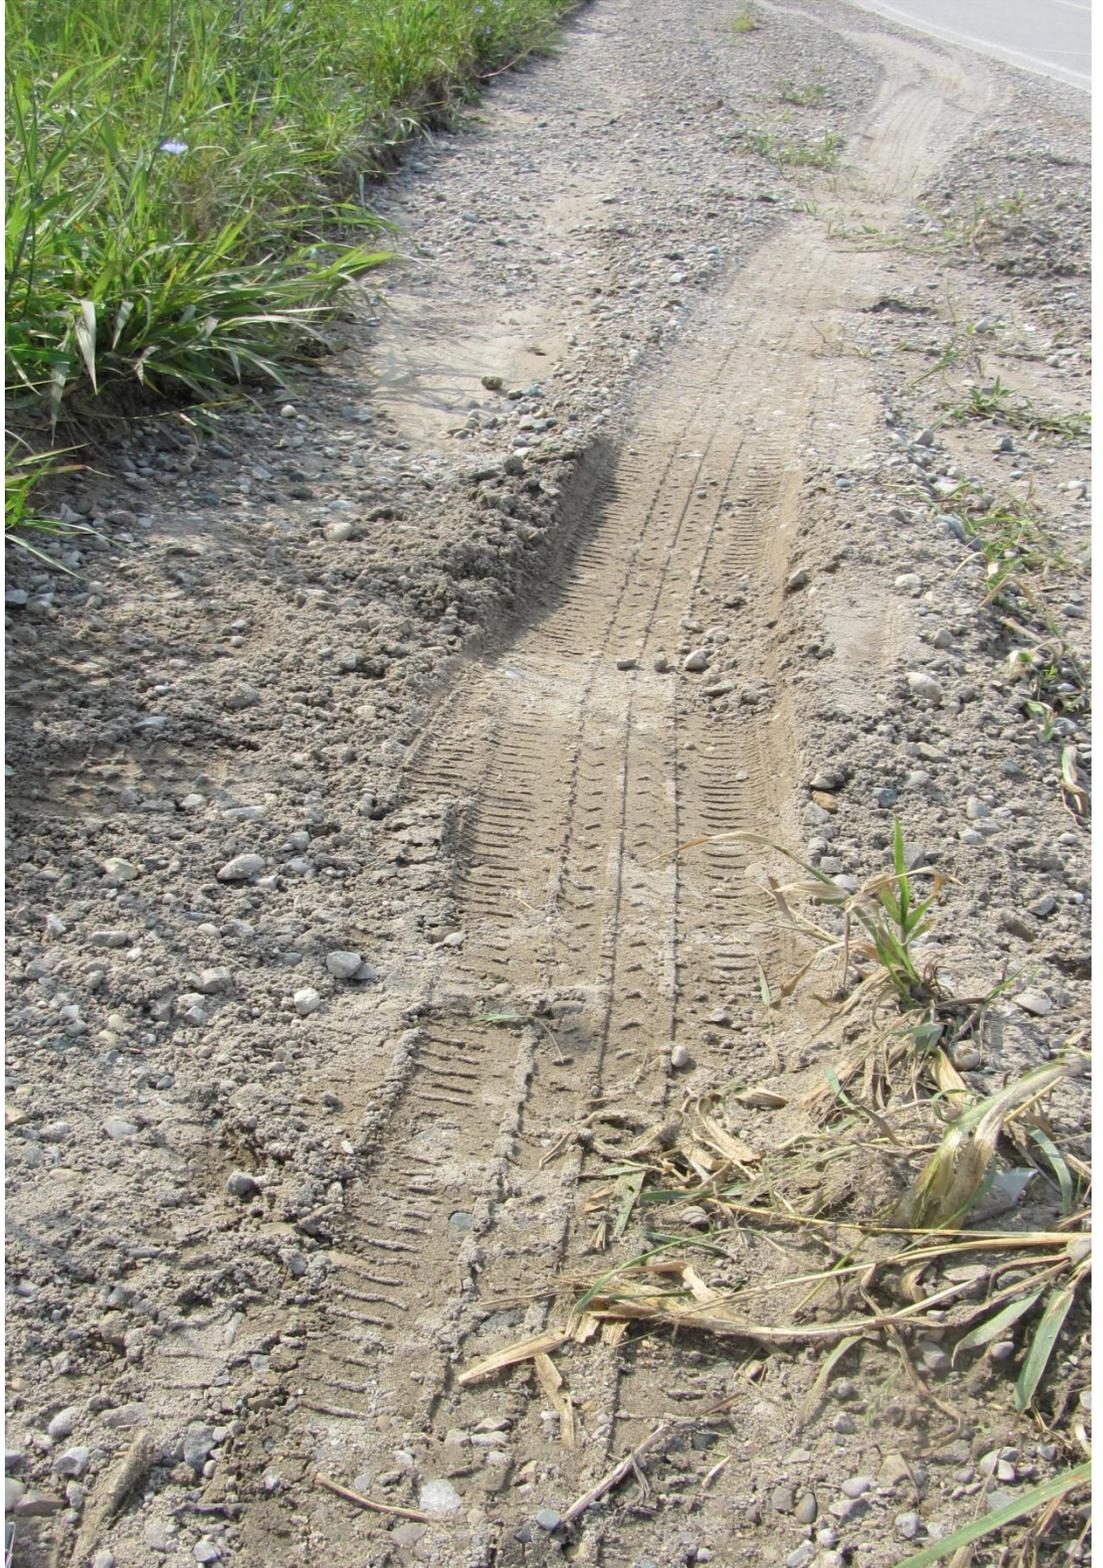
Figure 6: Southward view of right-side tire mark showing the area where the right tire came to a halt before reversing.

Figure 6 shows a southward view of the right-side tire mark near the point where the right rear tire came to a stop before the vehicle began to reverse its motion. Figure 7 shows a view further southward along that tire mark.

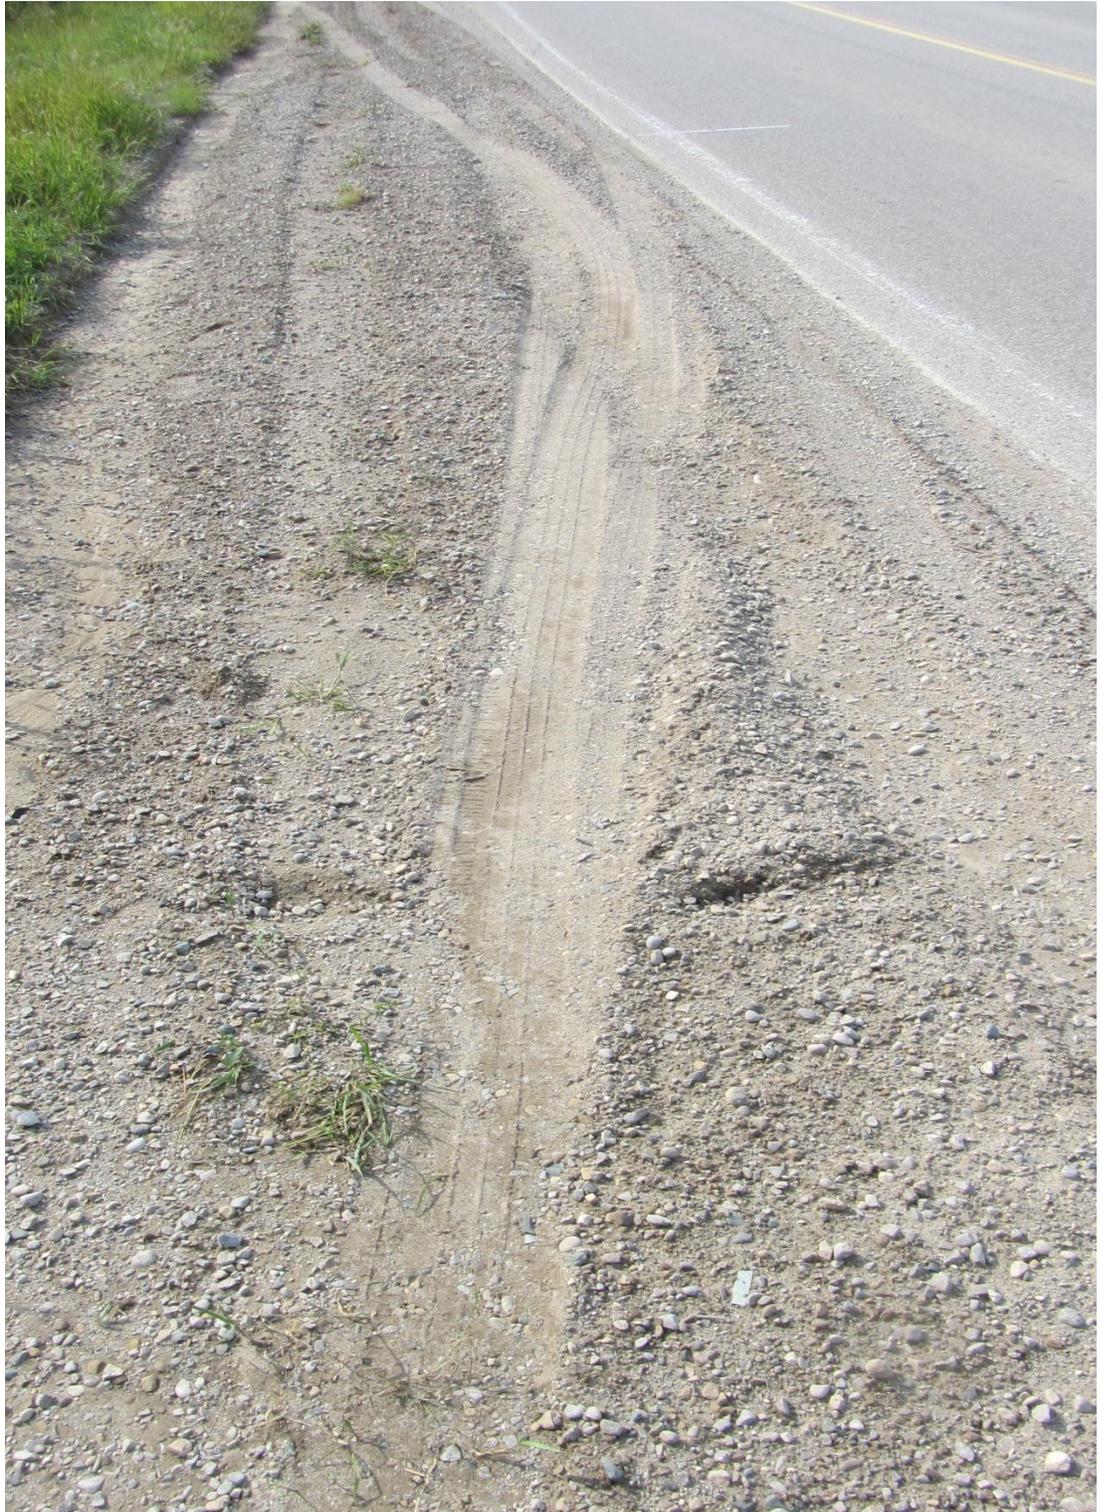
Figure 7: View of right tire mark as the vehicle reverses.

In Figure 7 it should be possible to detect four tire marks side-by-side. First it should be possible to detect the two tire marks of the vehicle as it exits from the road surface and travels toward the camera, then one should be able to detect the two tire marks as the vehicle reverses and erases the original marks as it moves away from the camera. In the process of reversing the vehicle follows a similar path to its motion when it exited the road. So, while reversing, the left side tires of the vehicle actually re-enter onto the pavement for a short distance before returning back onto the shoulder in the distant background. The various tire marks may be differentiated further in Figure 8.

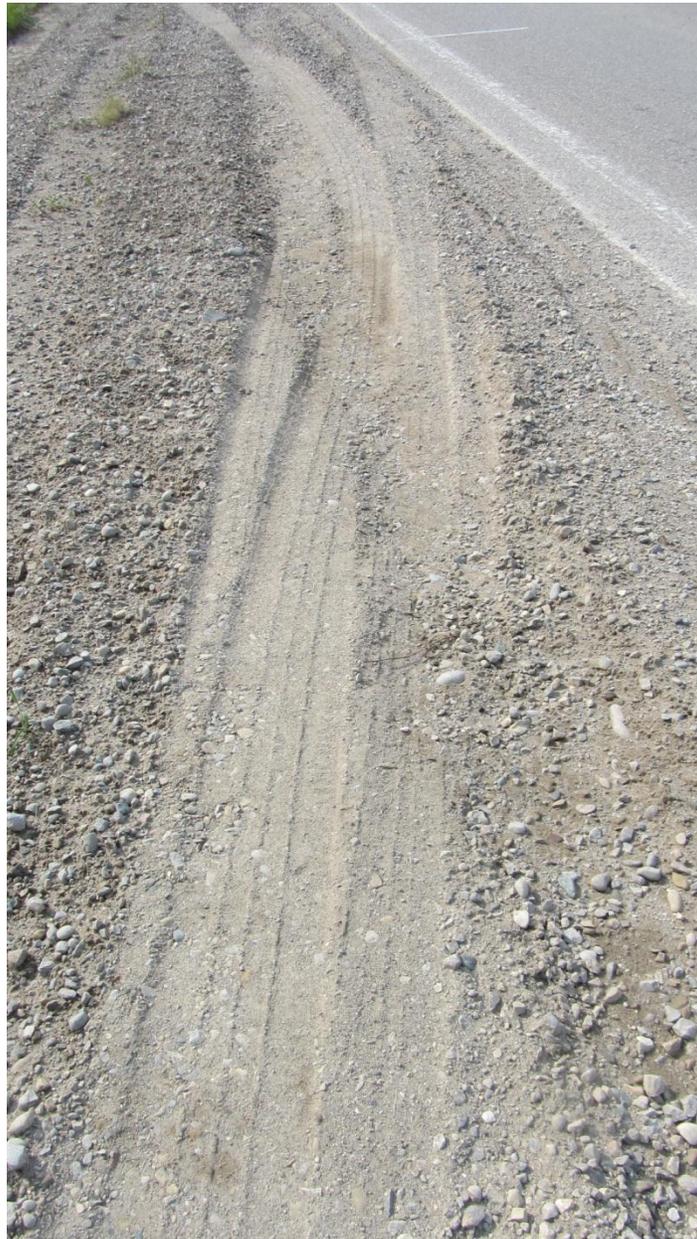
Figure 8: Southward view of tire marks caused by the right tires of the vehicle.

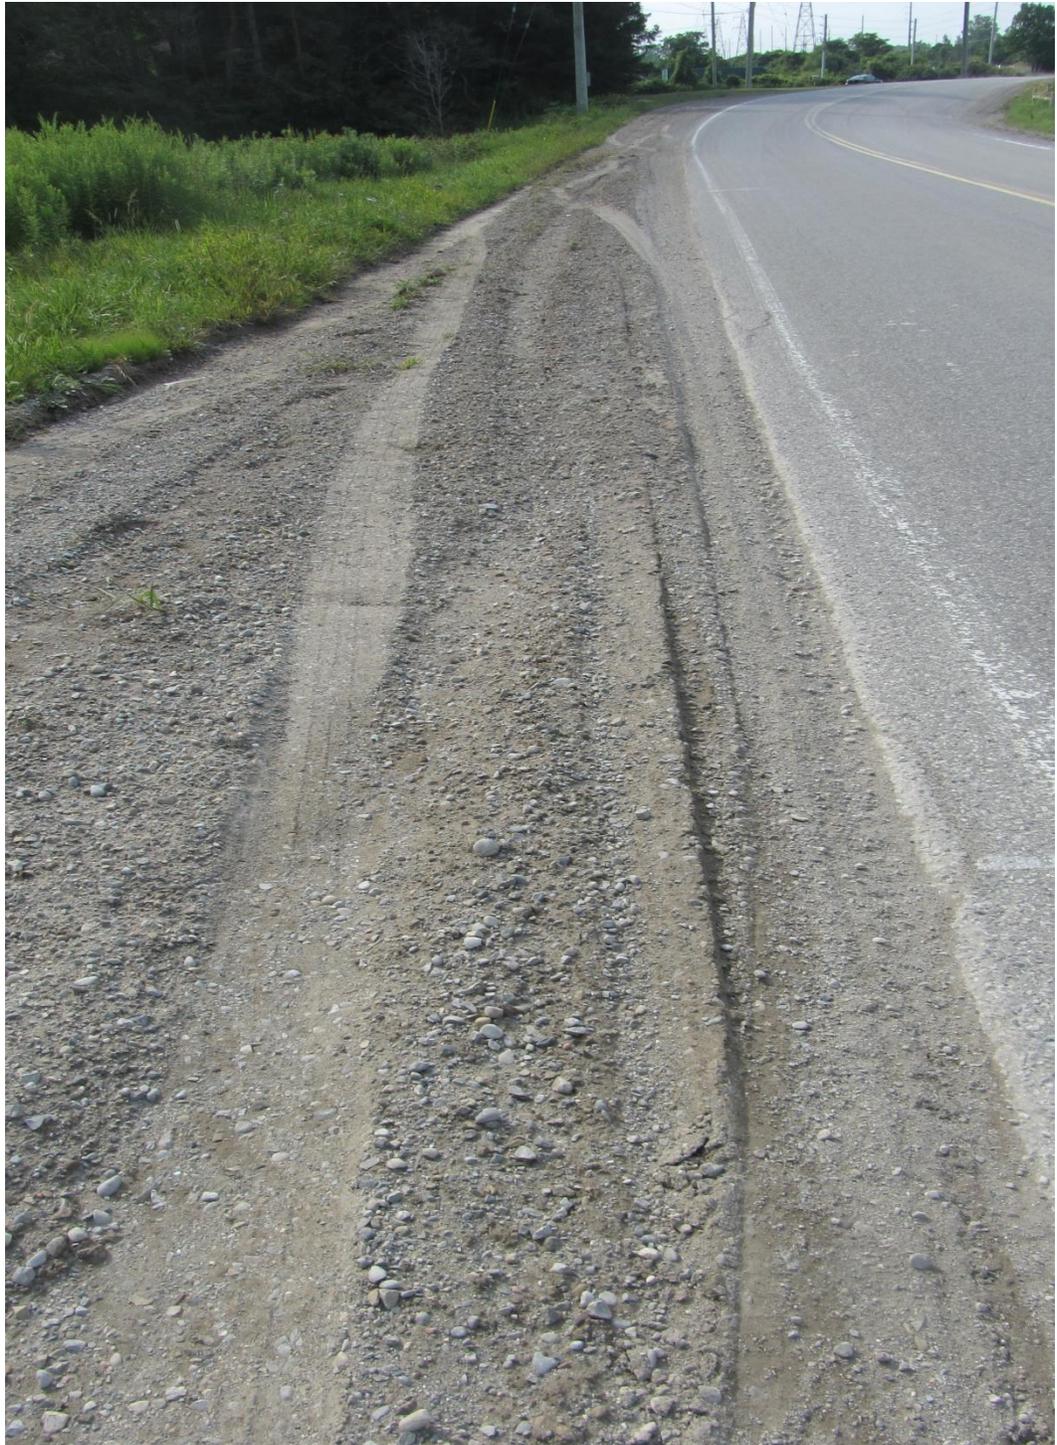
Figure 9: Southward view showing the right side tire marks of the reversing vehicle.

As we progress further southward Figure 9 shows the tire marks of the right side tires of the vehicle in the foreground while the left side tires are travelling on the pavement. In the distance it may be possible to detect where the left side tires return to the shoulder as the vehicle continues its reversing motion.

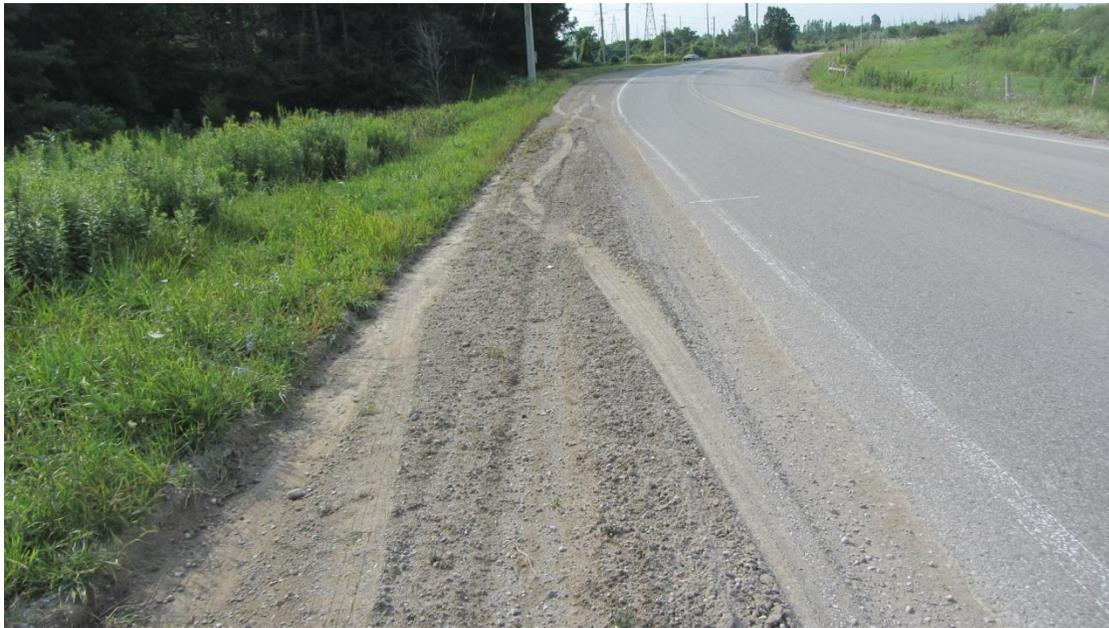
Figure 10: Location where left side tires return to the gravel shoulder.

As the vehicle continues its reversing motion Figure 10 shows how the left side tires return to the gravel shoulder. The vehicle then moves so far away from the pavement that the right side tires travel onto the grass roadside in the background.

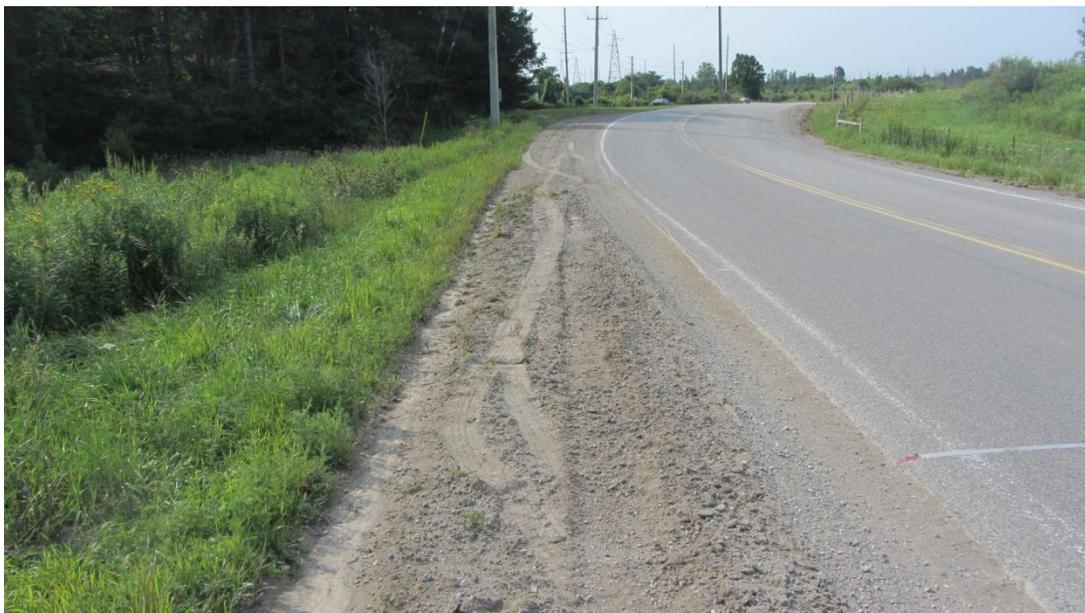
Figure 11: The driver makes a steering correction as evidenced by the separation in the travel path between the front and rear tires.

The driver then makes a correction in the vehicle's path from continuing into the grass as evidenced by the front tires following a different path than the rear tires, as shown in Figure 11.

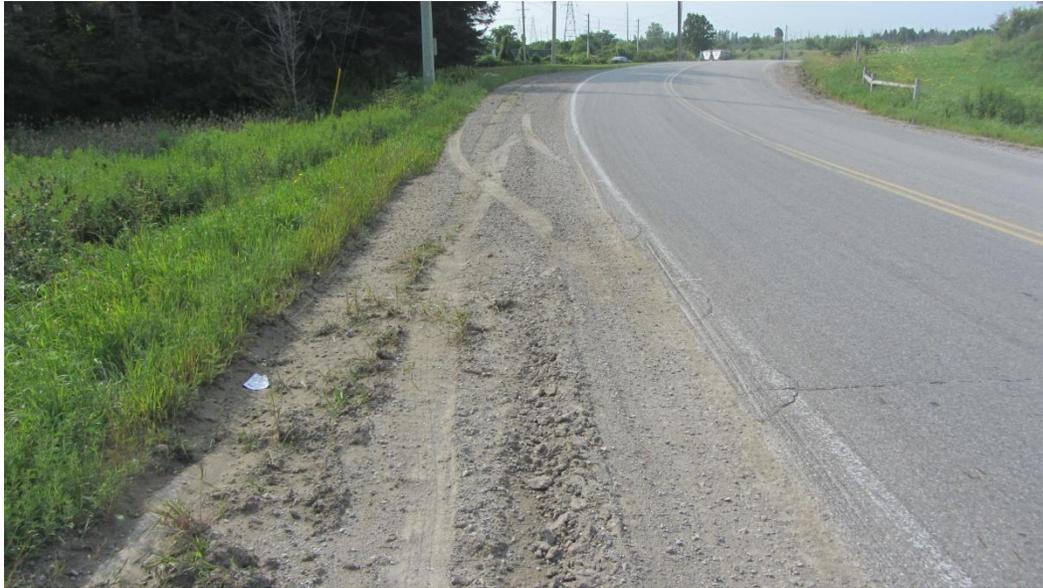
Figure 12: View of left side tires travelling in the middle of the shoulder while the right side tires are travelling in the grass roadside as the vehicle continues reversing.

After this correction the vehicle continues reversing with the right side tires travelling on the grass while the left side tires travel roughly in the middle of the shoulder, as shown in Figure 12.

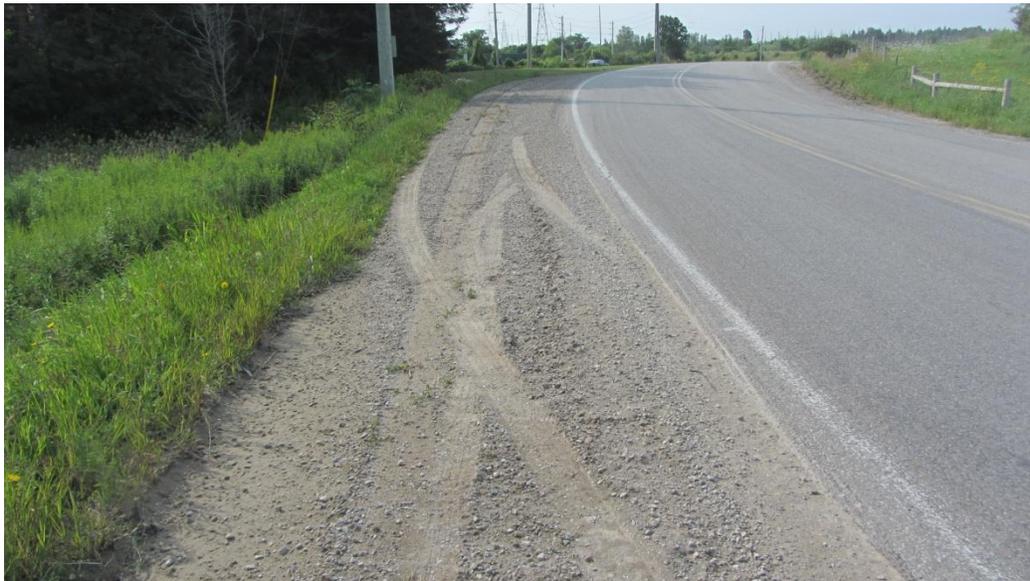
Figure 13: The tire marks terminate in the background where the vehicle stops its reversing and then accelerates forward toward the camera and back onto the road.

After reversing for a further, short distance the vehicle comes to a halt and then accelerates forward, toward the camera, and onto the pavement for the final time, as shown in Figure 13.

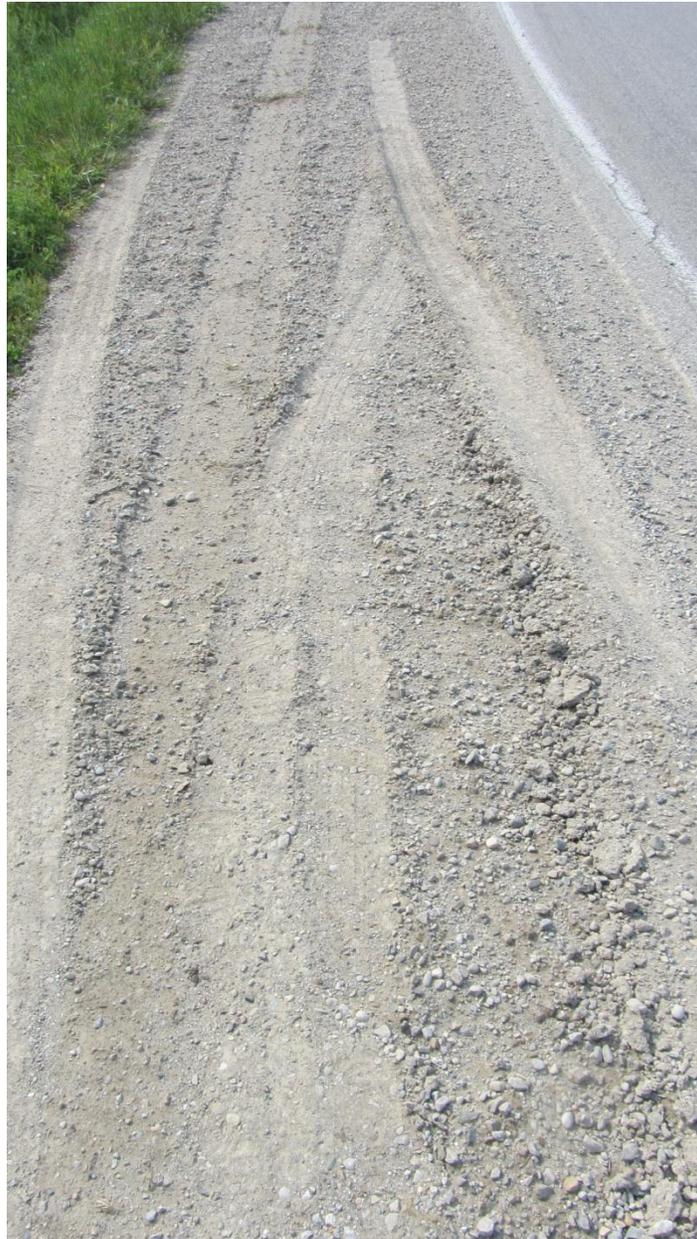
Figure 14: View of location where the vehicle stops its reversing motion and accelerates forward toward the camera.

The location where the vehicle stops its reversing and accelerates forward is more visible in Figure 14 although the presence of the older tire mark from the road grader might complicate that visualization.
