iPhone Accelerometer Results From 45 Emergency Braking Tests on Snow-Covered Roads

Posting Date: 04-April 2013

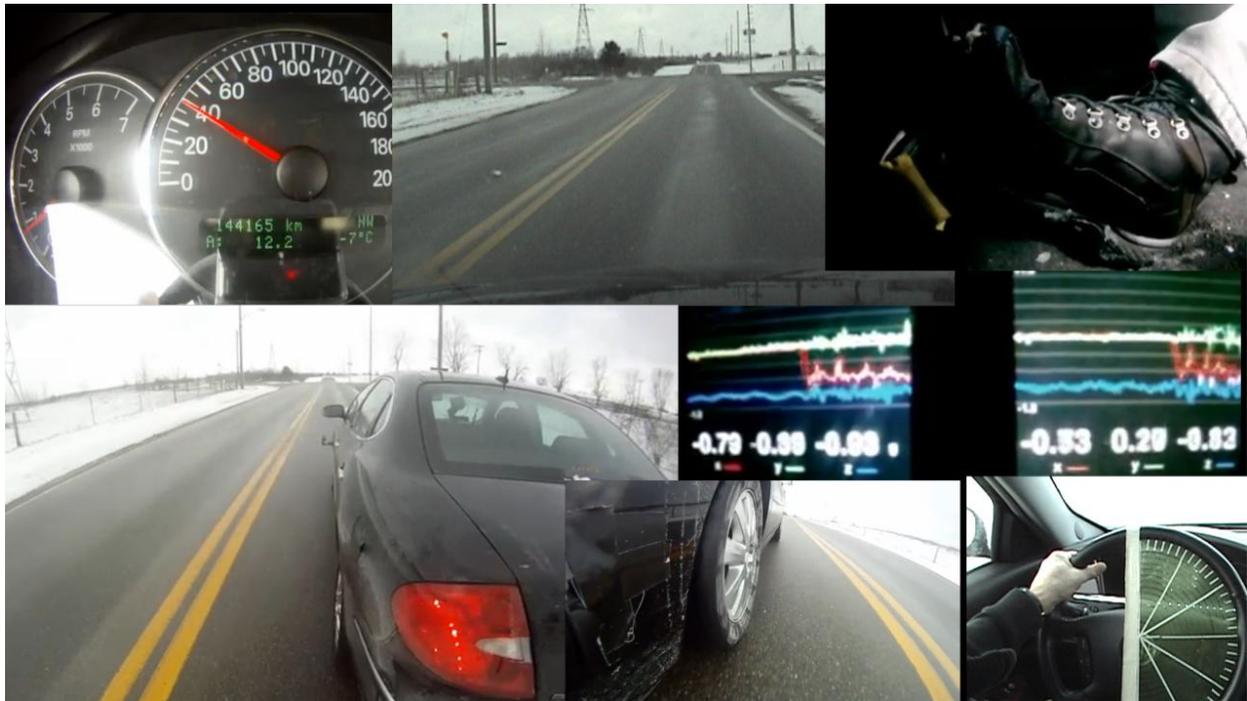
Figure 1: Example of a set of synchronized videos used in previous testing, similar to the present set-up.

A video camera pointed at the brake pedal of the test vehicle meant that we could detect, within a 30th of a second, when the brake pedal was first contacted in the braking test. Another video camera placed underneath the vehicle's front bumper provided a very close-up view of the road surface and therefore we obtained a reasonably precise (within a 30th of a second) record of when the vehicle came to rest. This combination provided a reasonably precise recording of the total time of deceleration and thus an average g value for the test could be obtained. By comparing

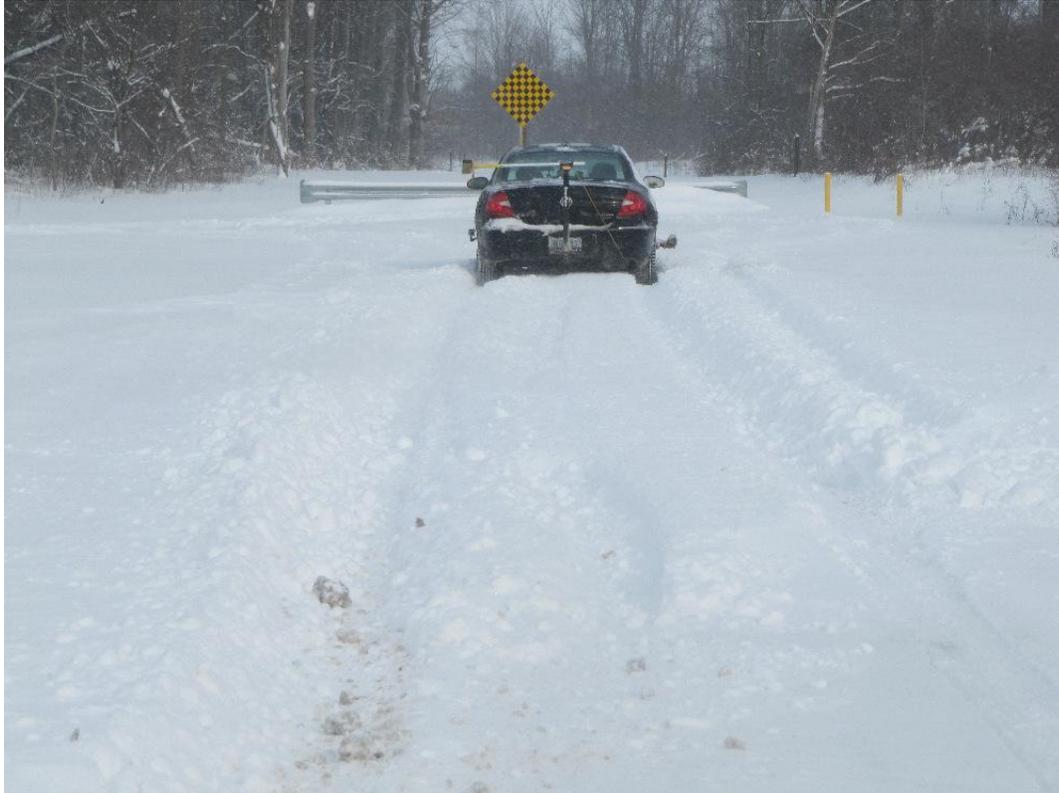
Figure 2: Resultant snow disbursement following braking Test #8 in deep snow.
