# Maximum Acceleration in Reverse Gear to Simulate Unintended Acceleration Scenario

*Posting Date: June 6-2015*

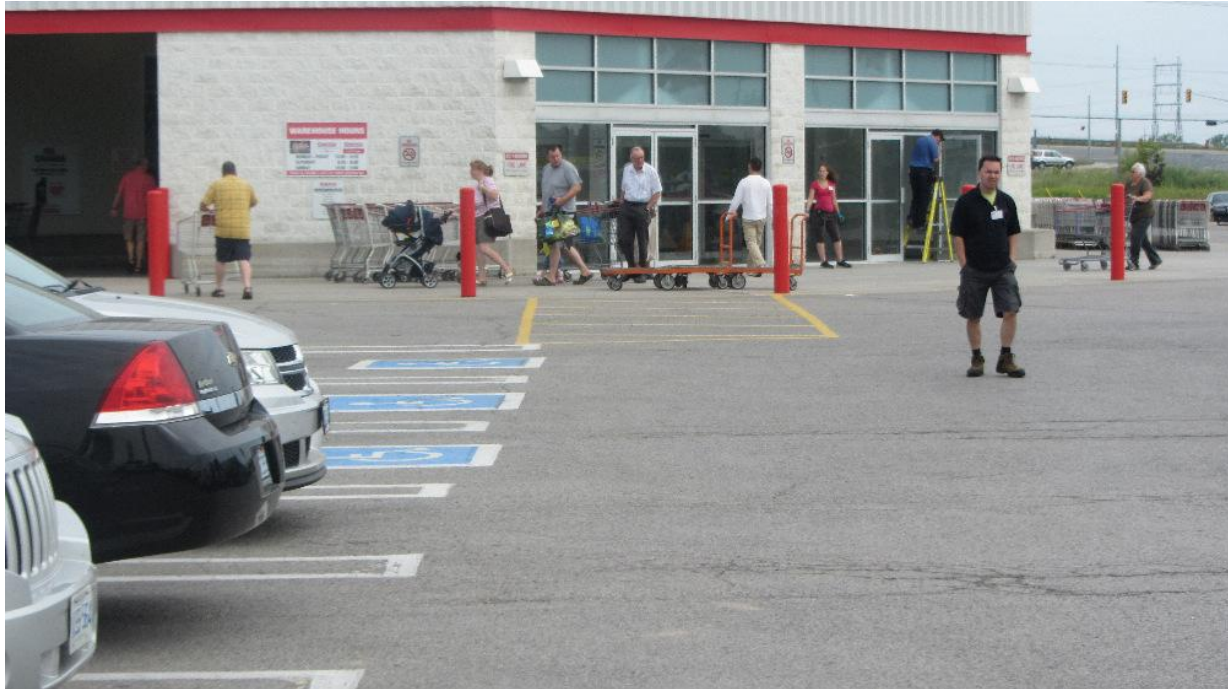
Figure 2: View showing the direction from which the Monte Carlo reversed on its way toward the Costco front doors in the background. This photo was taken a few days after the incident.

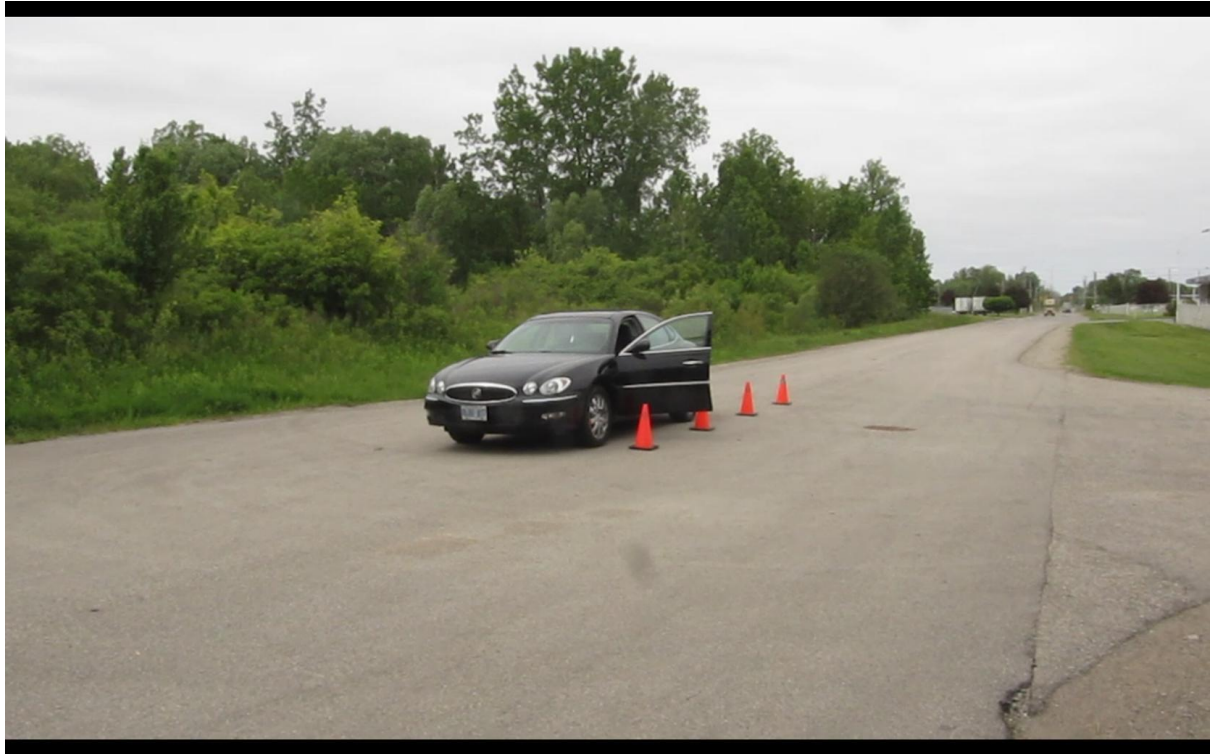
Figure 3: View of 2007 Buick Allure test vehicle at its position before the acceleration test.

Figures 1 through 5 show the test vehicle, a 2007 Buick Allure, positioned on the test site, as well as during the maximum acceleration test. Four traffic cones were placed along the left side of the test vehicle at 2-metre gaps. The first cone was placed next to the centre of the left front wheel. After accelerating through the position of the cones the vehicle was braked, hard, until it came to a stop. During this test the accelerometer and gyros of an iPhone 4S documented the vehicle's acceleration and motion. This data was sent via e-mail to a host computer and transferred to an Excel spreadsheet where it was analysed.

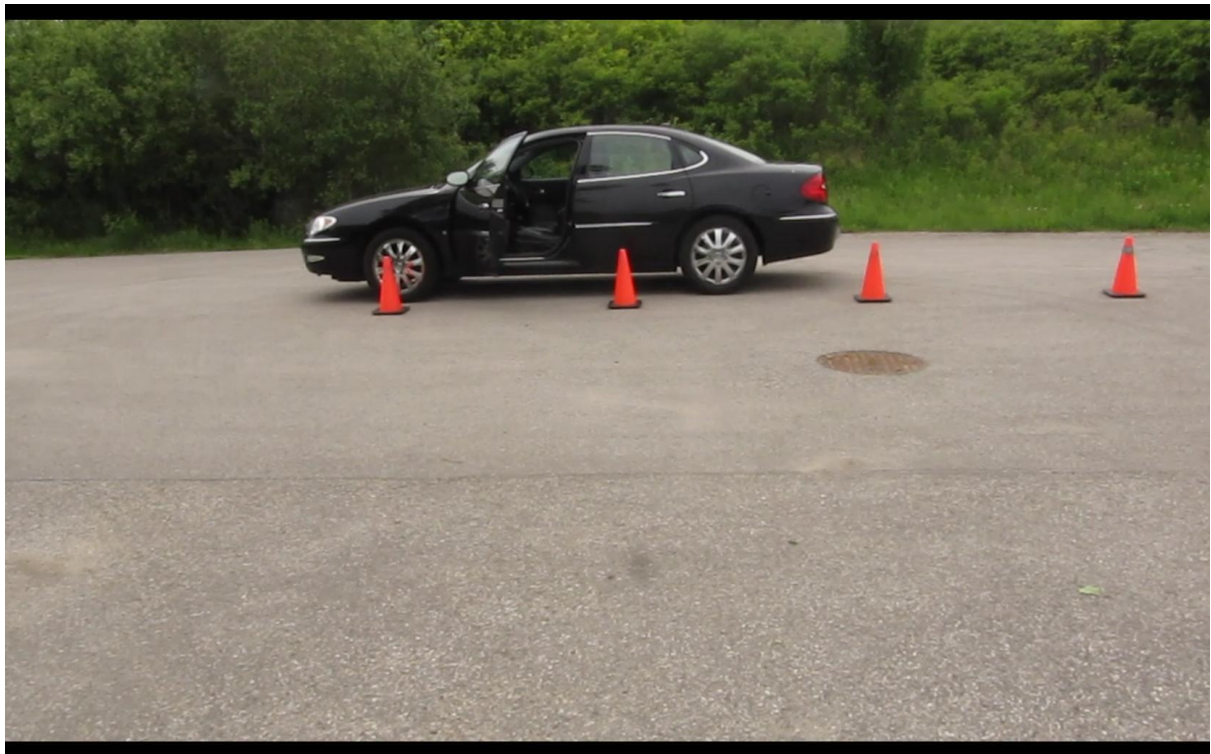
Figure 4: Left-side view of the test vehicle at its position before the acceleration test.

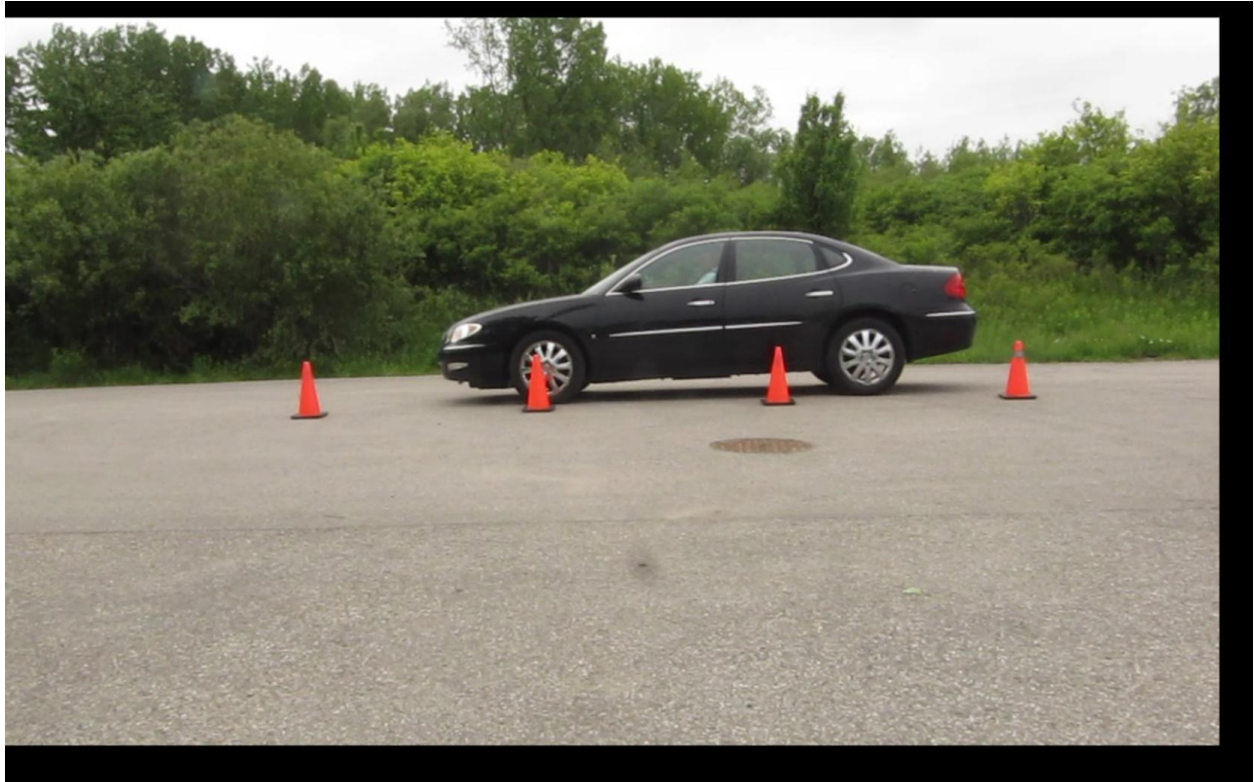
Figure 5: View after the test vehicle has reversed 2 metres during the test.

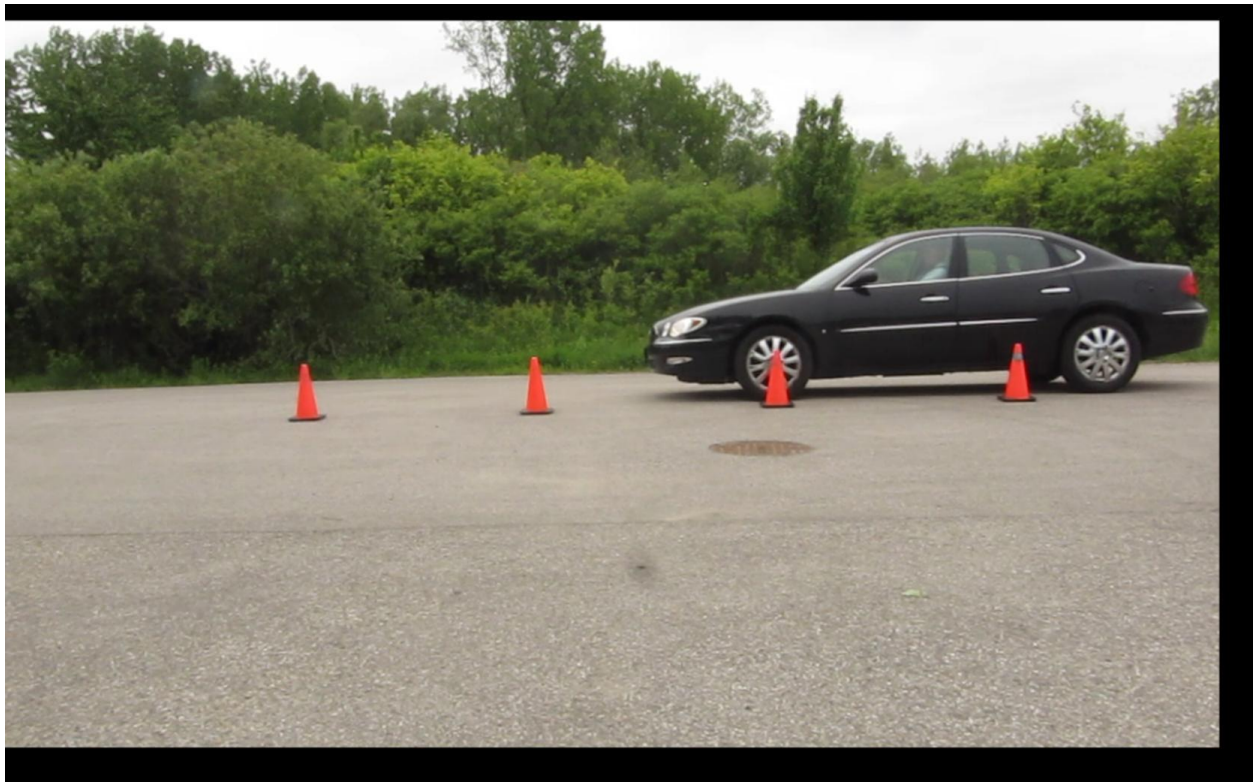
Figure 6: View after the test vehicle has reversed 4 metres during the test.

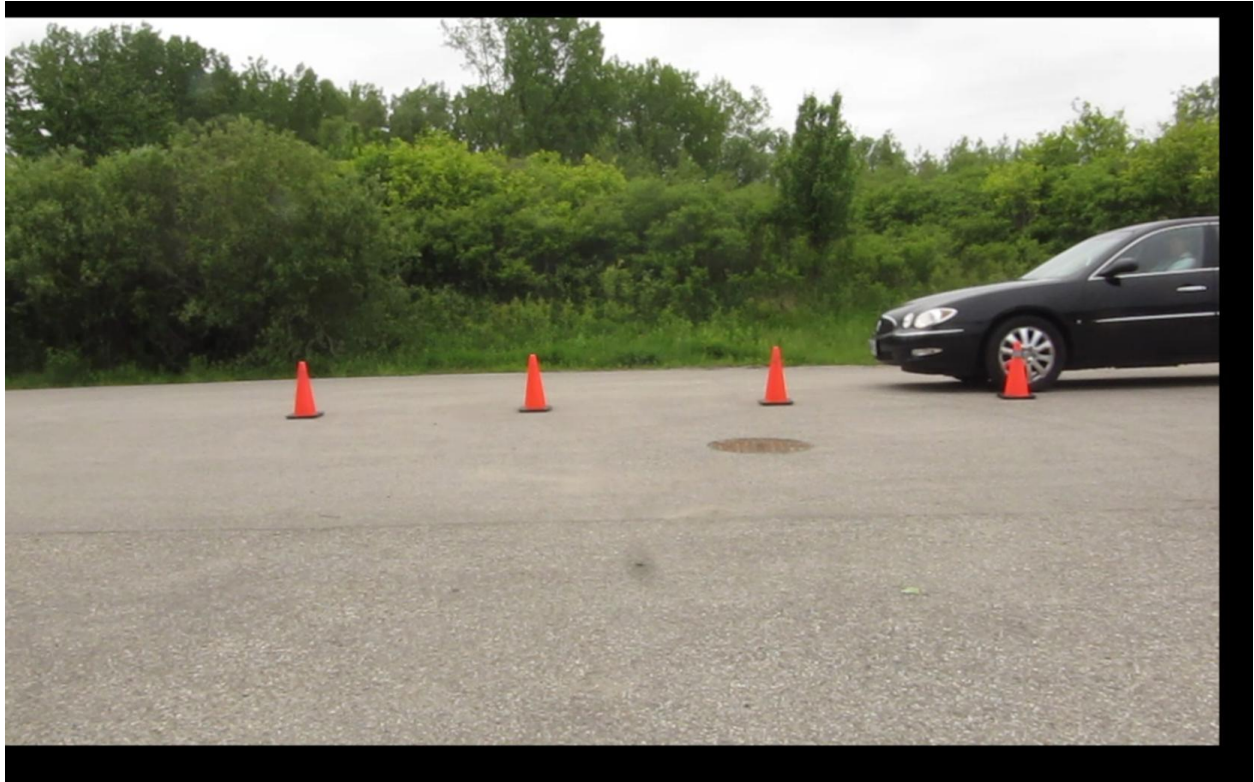
Figure 7: View after the test vehicle has reversed 6 metres during the test.

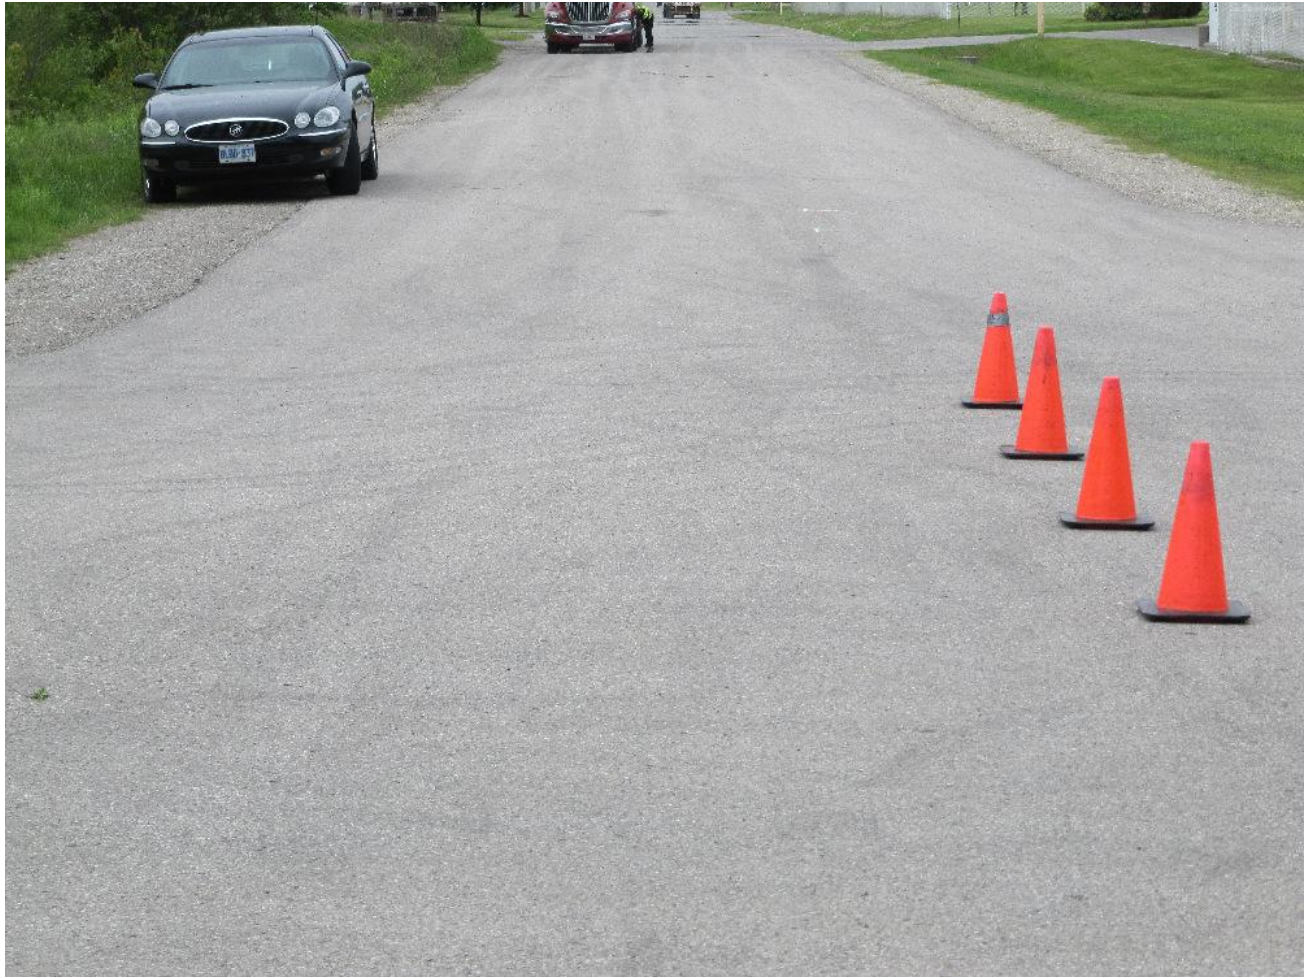
Figure 8: View of the road surface in the area where the test was conducted.

Video and still photos were taken of the road surface in the area where the vehicle was accelerated and braked. Close examination of the road surface made it possible to detect faint acceleration marks as well as more prominent ABS braking marks on the surface. Figures 6 through 9 show this area shortly after the test was completed. No attempt was made to select an area of the road where the tire marks might be more visible and this provides an opportunity to consider the real life situation where an acceleration might occur in less than ideal locations, where the presence of other tire marks, debris or other unrelated markings might mask the presence of the relevant evidence.

The first visible indication of a tire "patch" indicating that the ABS system was engaged was at 16 metres from the starting location of the acceleration. In reality there was evidence of a tire mark prior to that location however it would be unclear whether that mark was from acceleration or braking due to the lack of any detail in the faint mark. The vehicle came to a halt 19.5 metres from its starting location.

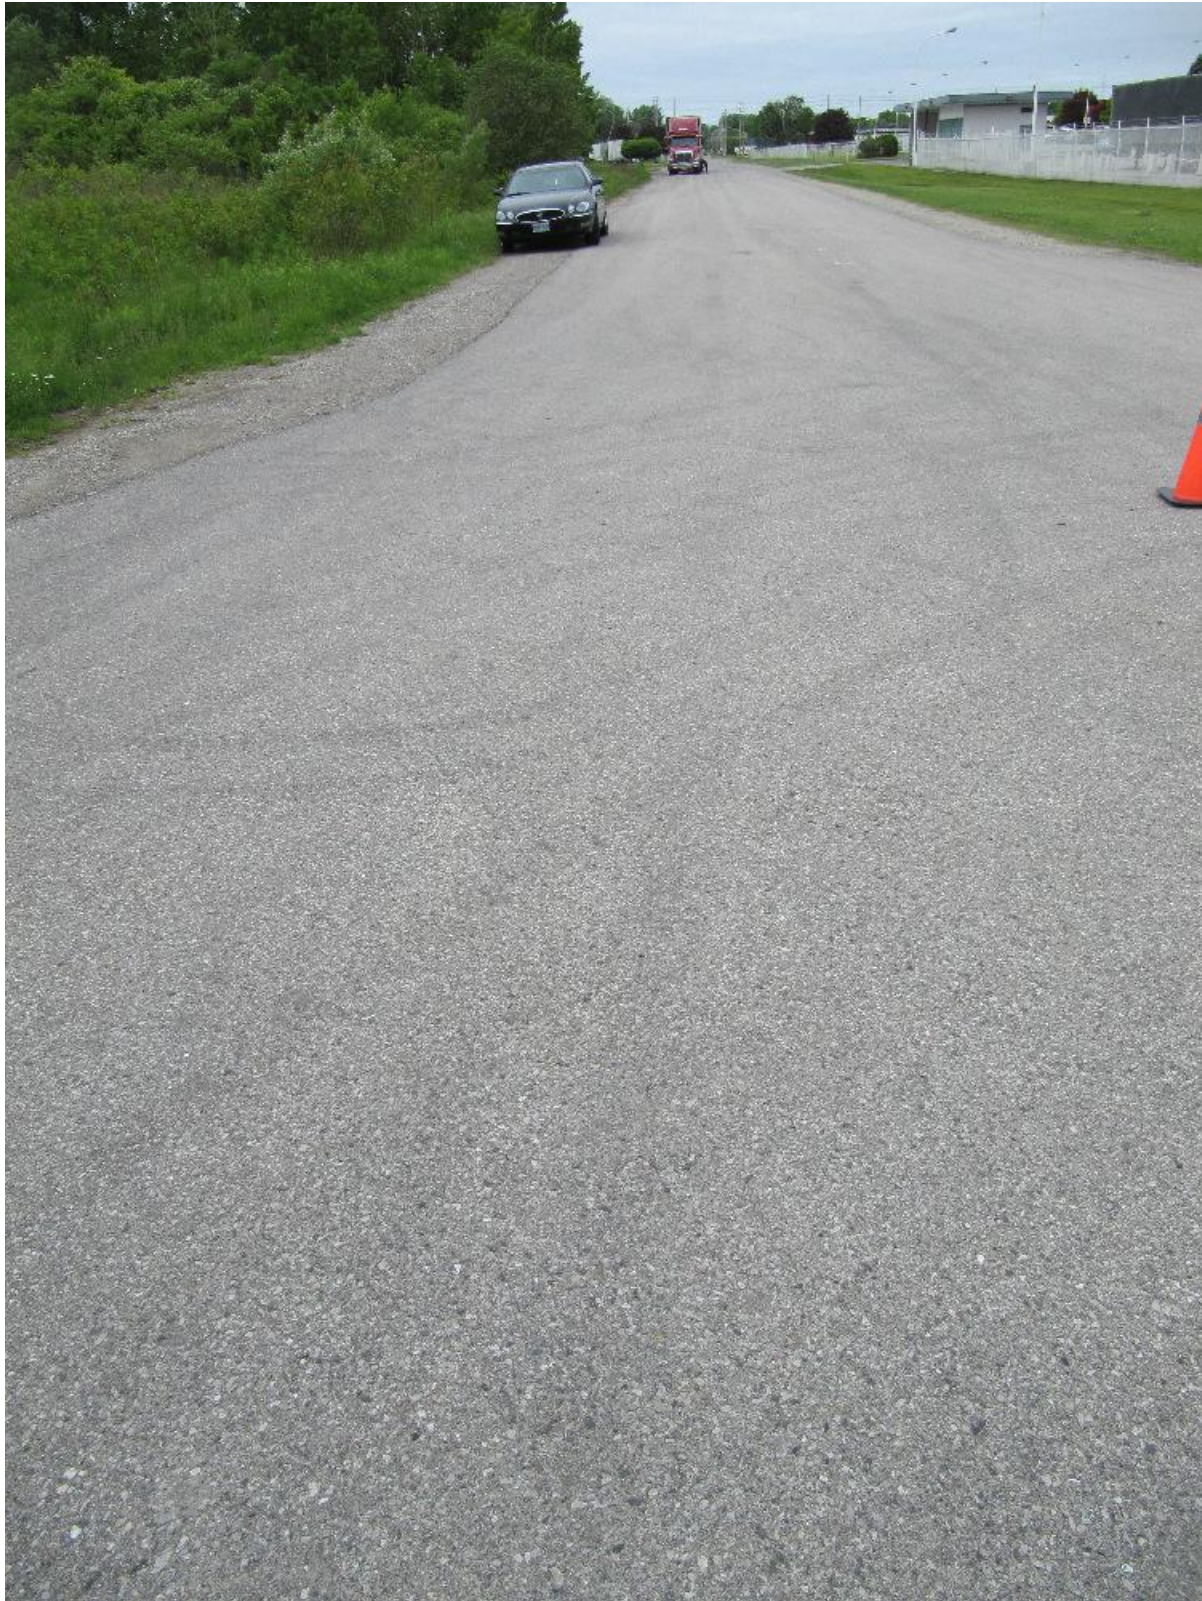
Figure 9: View of the road surface where the test was conducted.

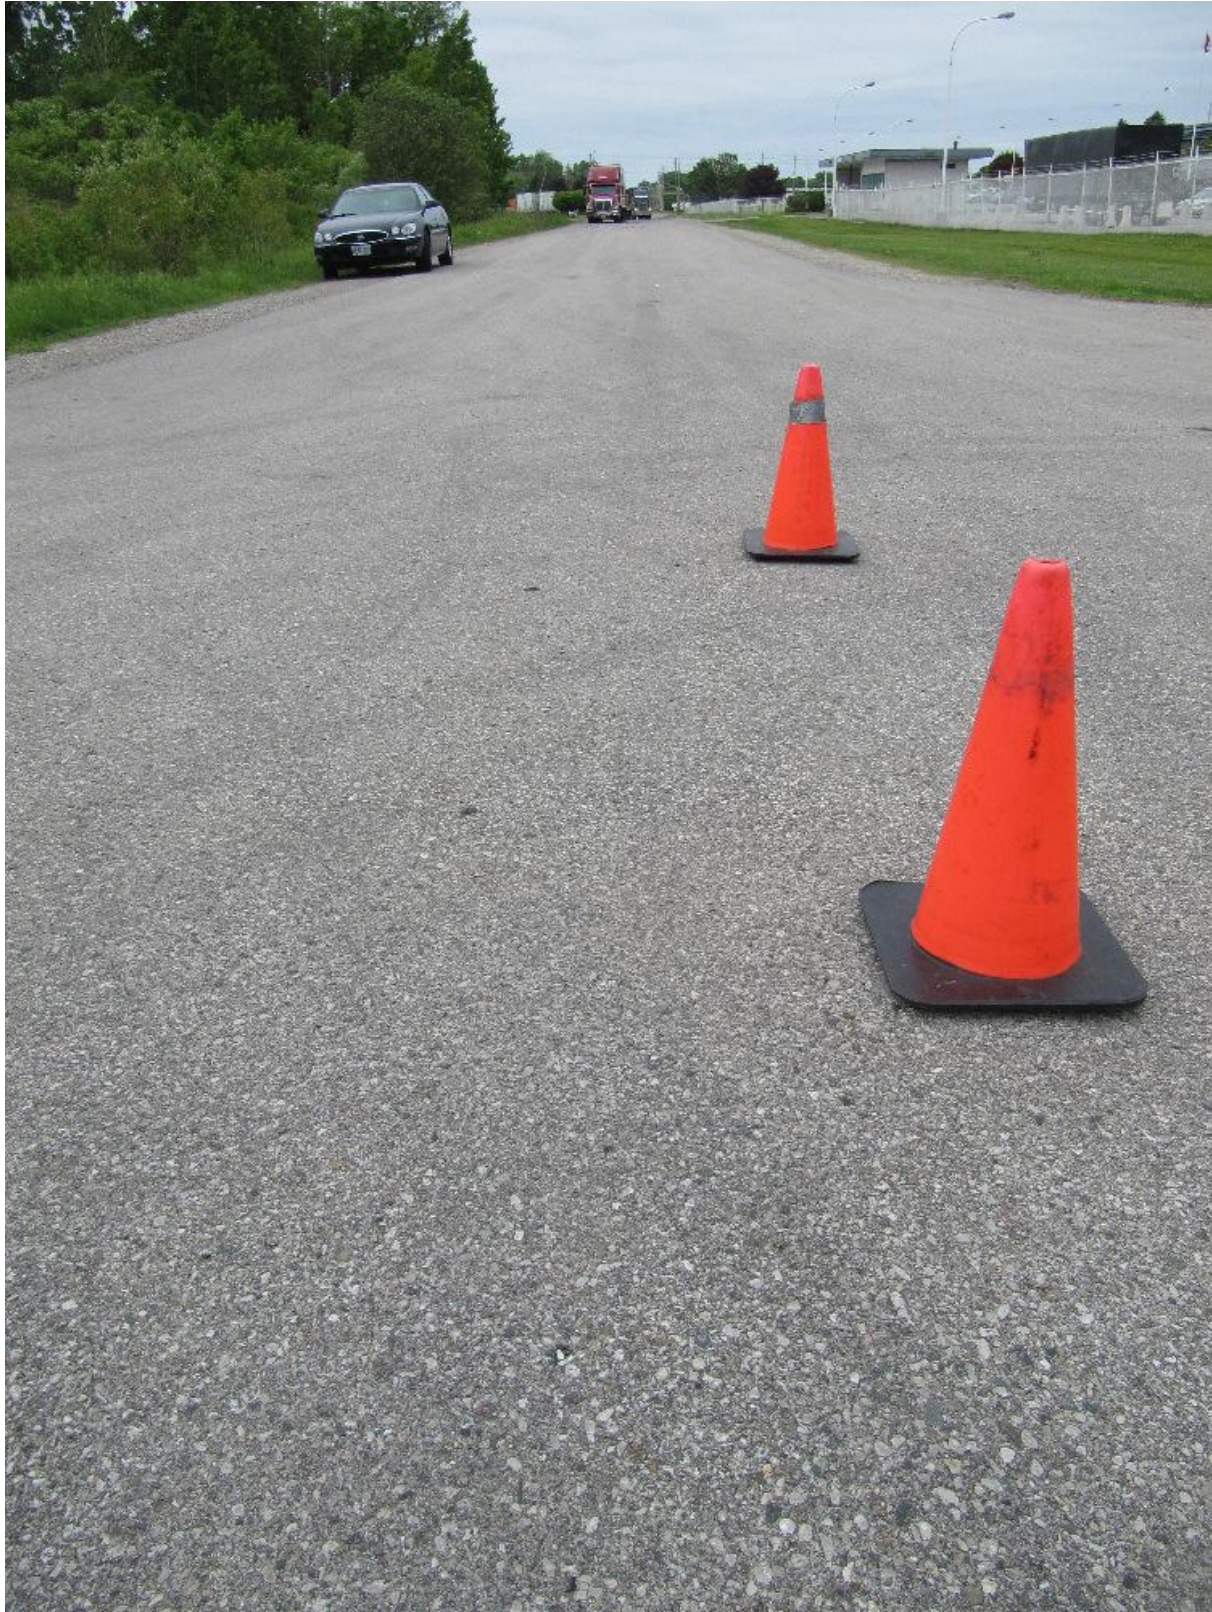
Figure 10: View of the road surface where the test was conducted.

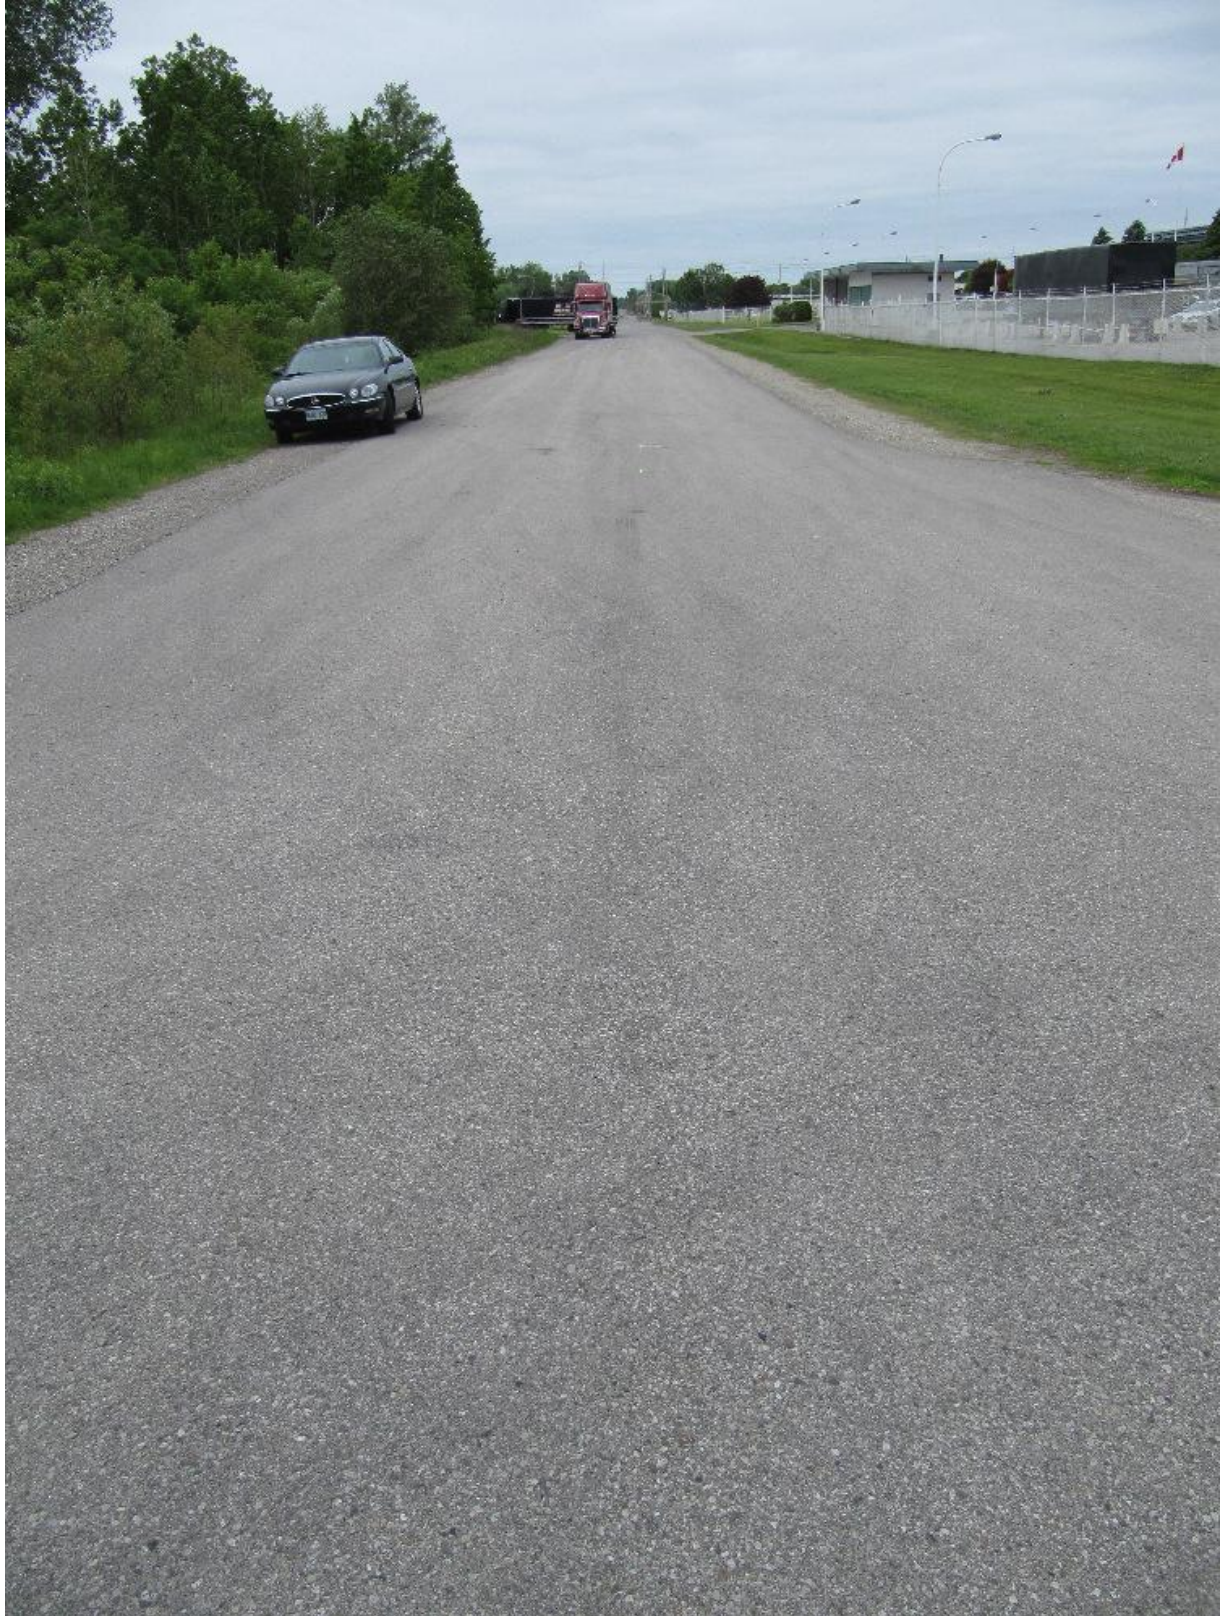
Figure 11: View of the road surface where the test was conducted.
