# Maximum Accelerations in Reverse and Forward Gear to Simulate Unintended Acceleration Scenario

*Posting Date: July 27-2015*

Gorski Consulting  
London, Ontario, Canada

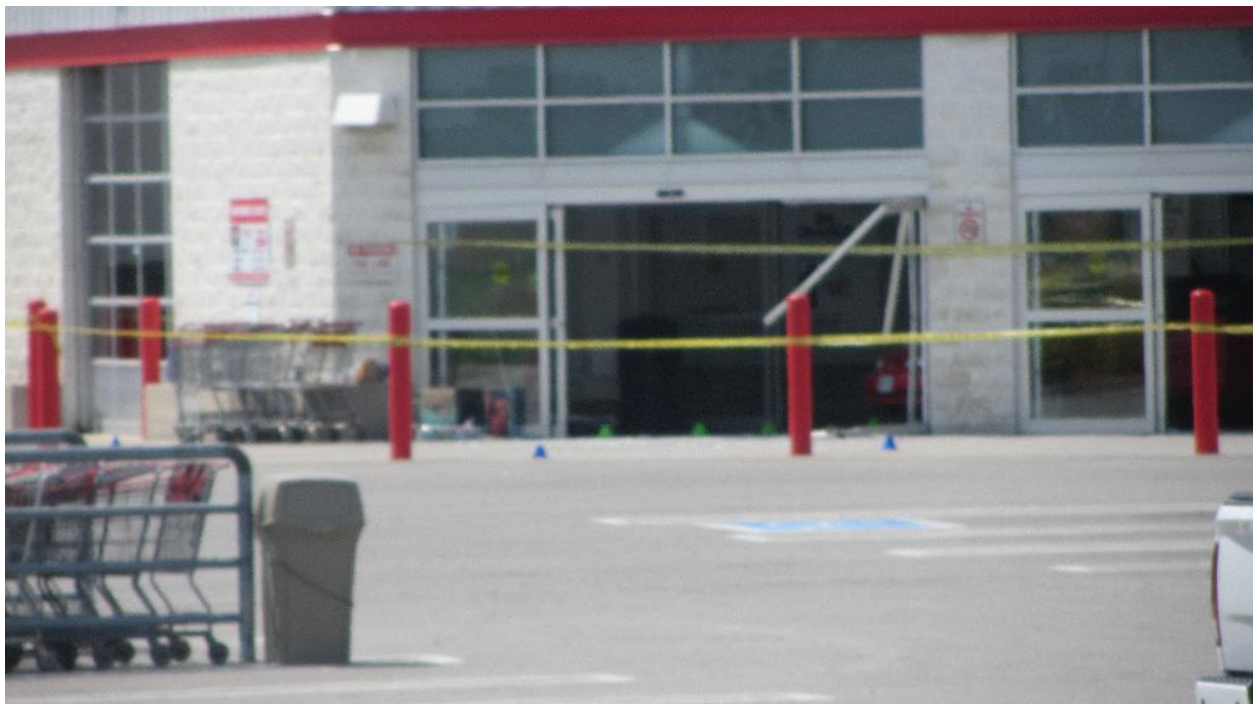
Figure 1: View of the entrance to the Costco retail store on Wellington Road in London, Ontario on July 24, 2014. Police tape surround the front doors where a red, 2004 Chevrolet Monte Carlo reversed at high speed killing two family members.

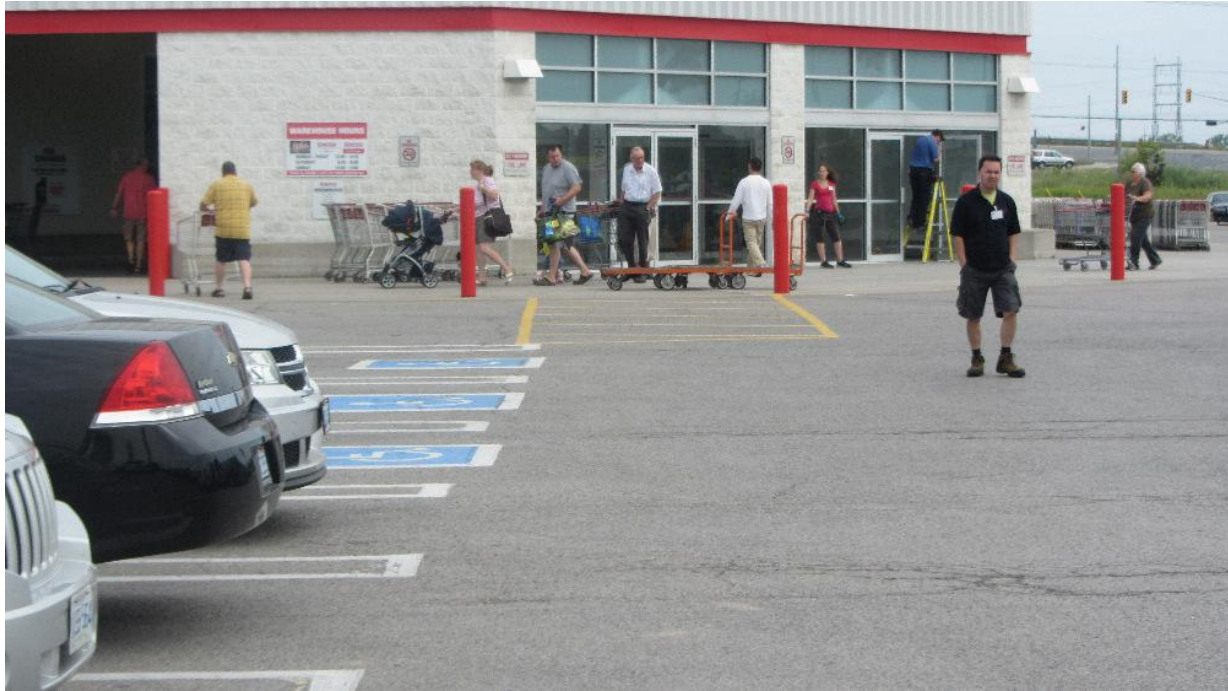
Figure 2: View showing the direction from which the Monte Carlo reversed on its way toward the Costco front doors in the background. This photo was taken a few days after the incident.

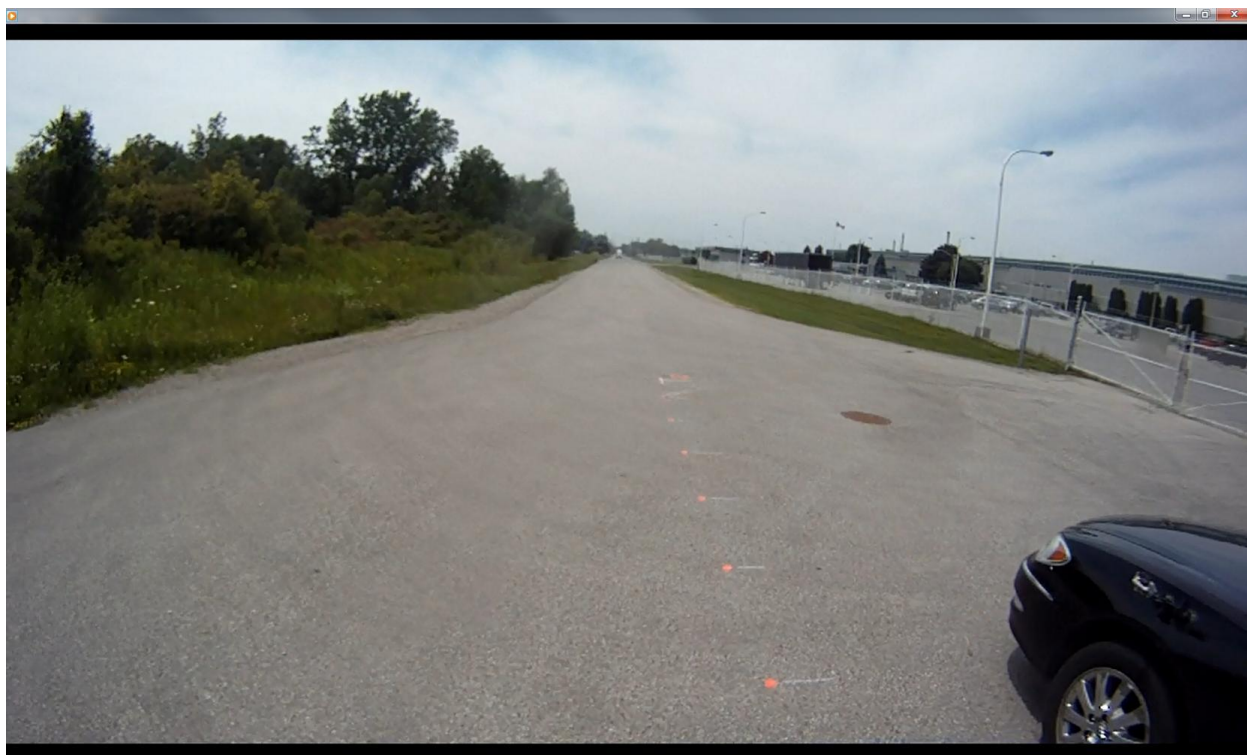
Figure 3: View looking west along the test site. Markers can be seen on the pavement at one-metre intervals. The left-front of the test vehicle can be seen at the lower right of the view.

The test area was marked at one-metre intervals over a distance of 50 metres. At ten metre intervals the distance was marked in large numerals (i.e. 10, 20, 30 etc.) so that they would be in clear view of the cameras. A video camera was placed adjacent to the brake and accelerator pedals so that the motions of the driver's foot could be determined during the acceleration and subsequent braking. The following figures provide some details of the preparations and running of the tests.

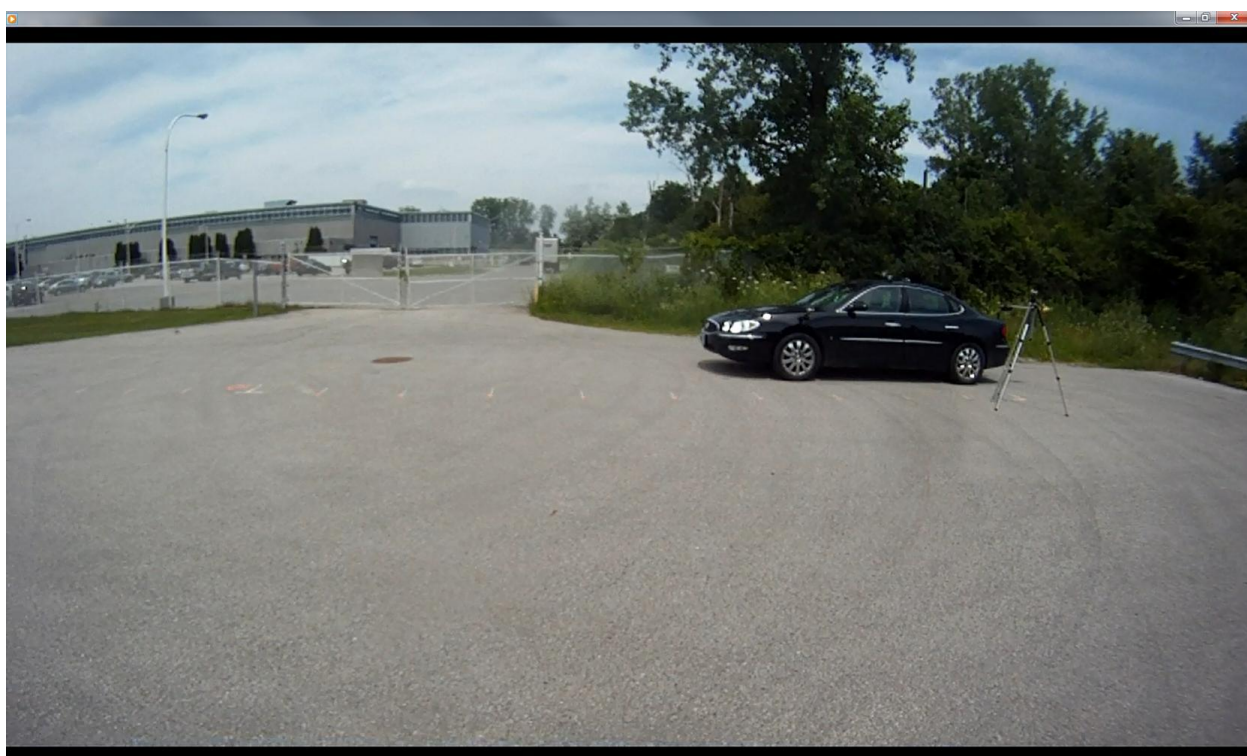
Figure 4: View looking north at the start position of the test vehicle.

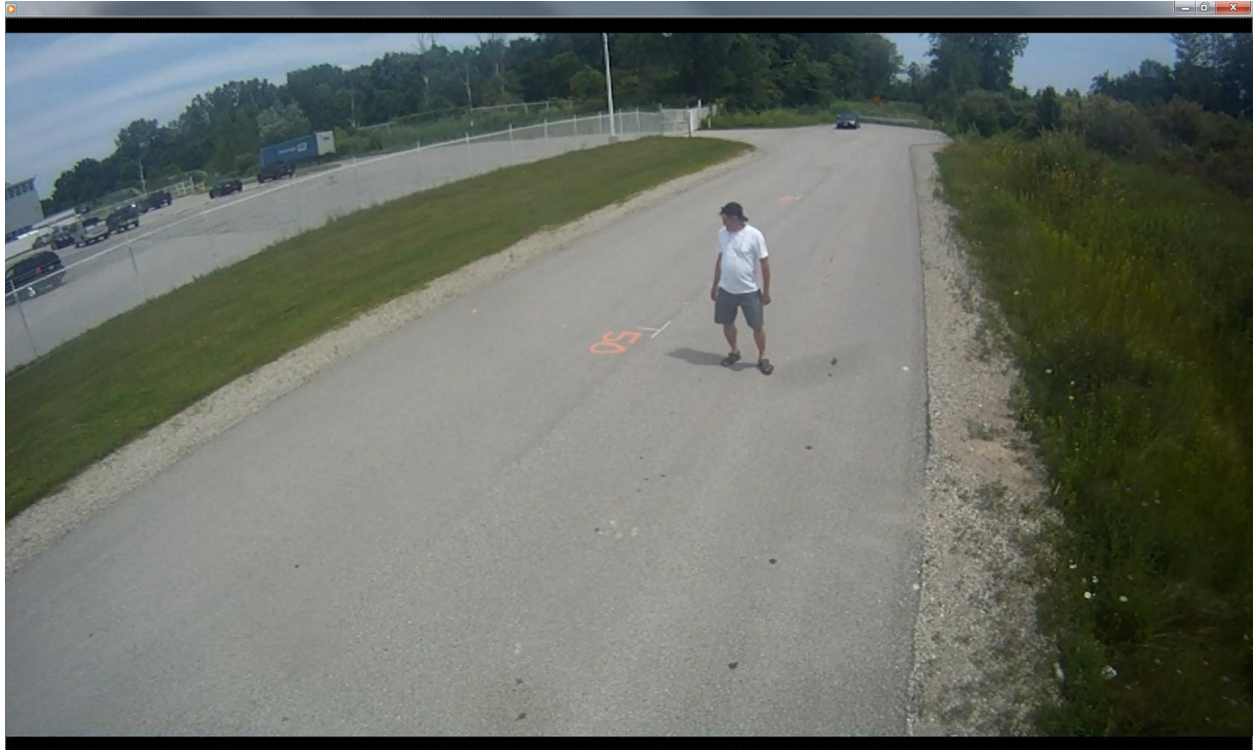
Figure 5: View looking east at an investigator standing next to the 50-metre marker of the test site with the test vehicle in the background prior to the testing.

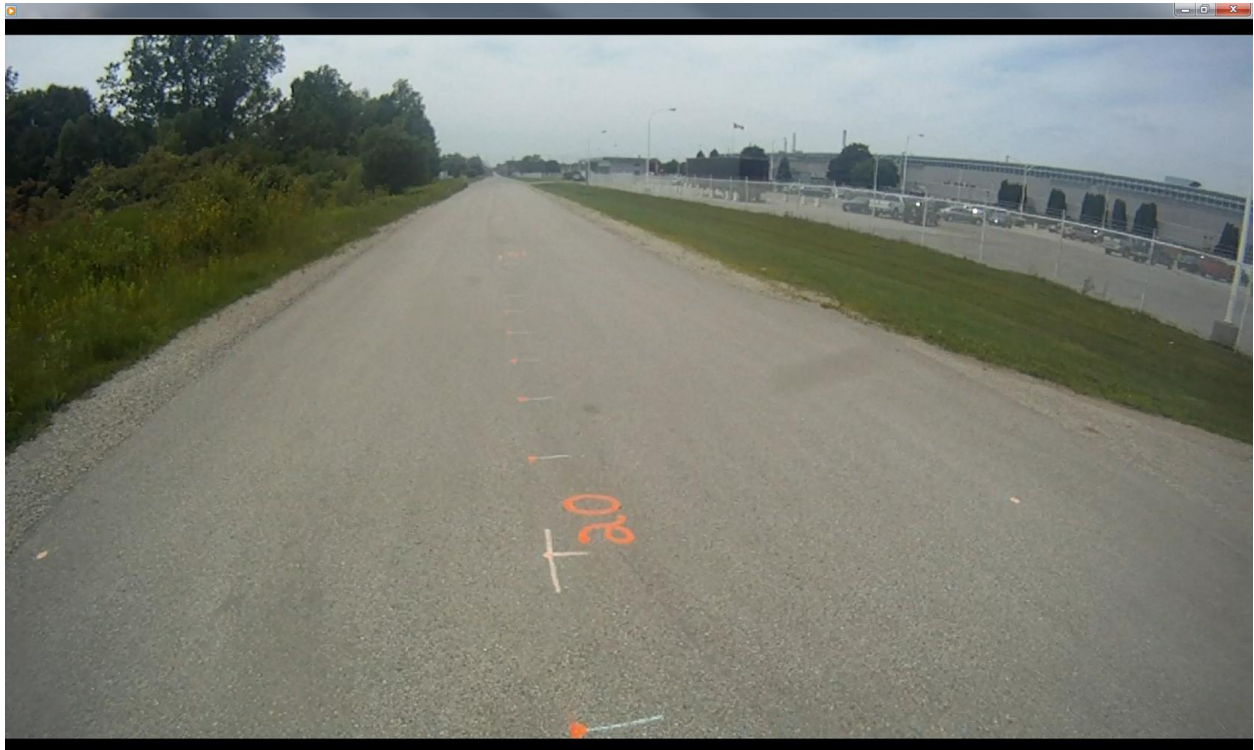
Figure 6: View looking west along the markers of the testing area.

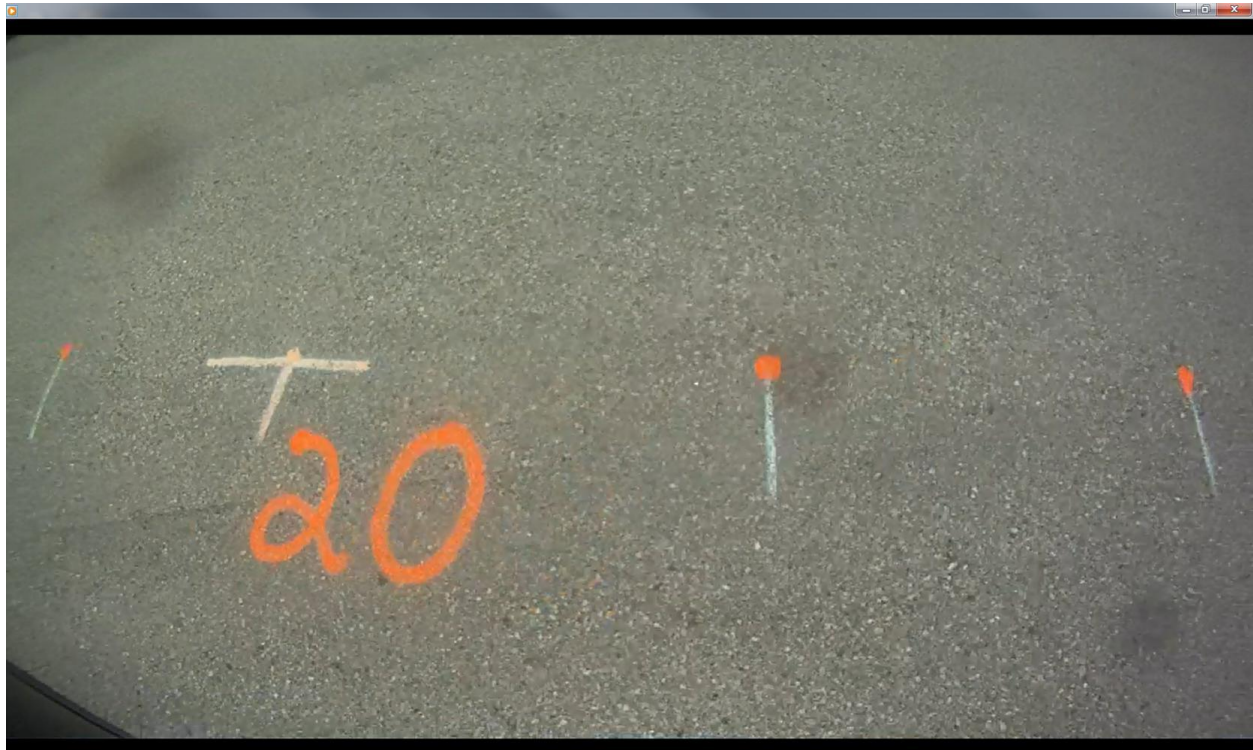
Figure 8: Example of the view from the camera mounted on the left front fender of the vehicle as it was accelerated through the test site. The vehicle's position could be determined by studying this video of the markers.

A total of seven video cameras were used. These views were incorporated into an Adobe Premiere video-editing program where the views were synchronized and displayed together on the computer screen. Analysis of these tests led to the selection of only 4 cameras views that we used to create the figures shown below. A view of the speedometer was determined to be useful to demonstrate the speed and status of the tachometer. A view showing the brake/accelerator pedals along with the driver's foot was deemed useful as it would show the position of the foot and depression/release of each pedal as the acceleration and braking took place. A third view from the 50 metre marker was deemed useful as it would show most of the vehicle's path along the test site but more importantly, near the end of the test as the vehicle reached its maximum acceleration and then commenced its deceleration to a stop. Finally the view of a camera mounted behind the left rear corner of the vehicle was useful in displaying the status of the brake lights as well as the position of the vehicle along its path.

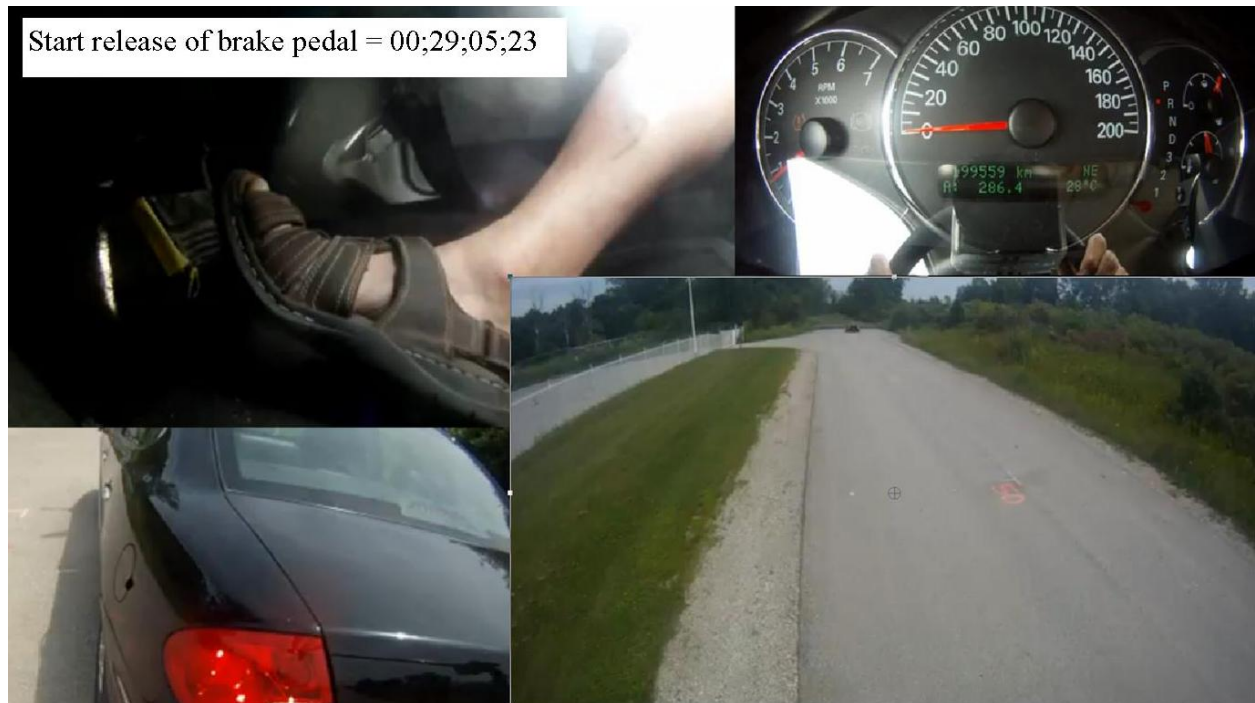
Figure 9: Views from four video cameras at the start of Test #1. In the upper left is a view of the driver's foot at the time that it began to release the brake pedal. The status of the speedometer and tachometer can be seen in the upper right. The view from a camera positioned near the 50-metre marker is shown in the bottom right. The view of the exterior braking lights of the test vehicle is shown in the bottom left.

Figure 9 (below) shows a screenshot taken from the computer screen with the four views combined in the Premiere project. This view was taken precisely at the start of Test #1 when the driver's foot was starting to release the brake pedal on its way to depressing the accelerator pedal. The driver attempted to complete this motion as quickly as possible.

The numerical value of "00;29;05;23" is the timecode in the Premiere project. Thus the time being indicated is 00 hours, 29 minutes, 5 seconds and 23 frames of the 30-frames-per-second format of the video. We can examine the remaining figures and compare the change in the timecode to understand when each action has taken place during the test. In Figure 9 a piece of yellow tape has been placed to the left side of the brake pedal so that its position can be more easily detected in the video.

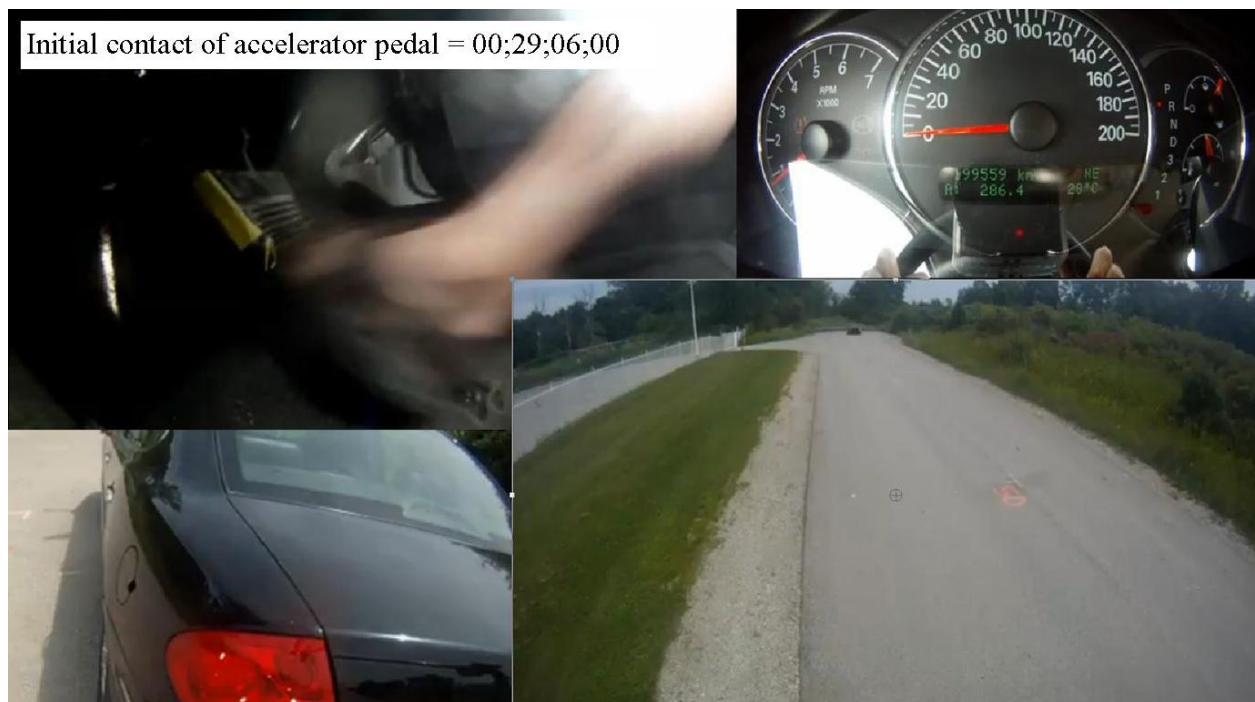
Figure 10: Status when the driver's foot makes initial contact with the accelerator pedal.

Figure 10 (below) shows the status of the test as the driver's foot makes contact with the accelerator pedal. Note that essentially nothing has changed in the four views except that the driver's foot has moved and that the timecode has now changed to read "00;29;06;00". Thus comparing the timecode in Figure 9 we know that a time of 7 frames has elapsed between the time that the driver began to release the brake pedal and the time that contact was made with the accelerator pedal. Seven frames amounts to about 0.23 seconds, therefore we know that it took this much time for the driver to move his foot from the brake pedal to the accelerator pedal - a fairly quick action.

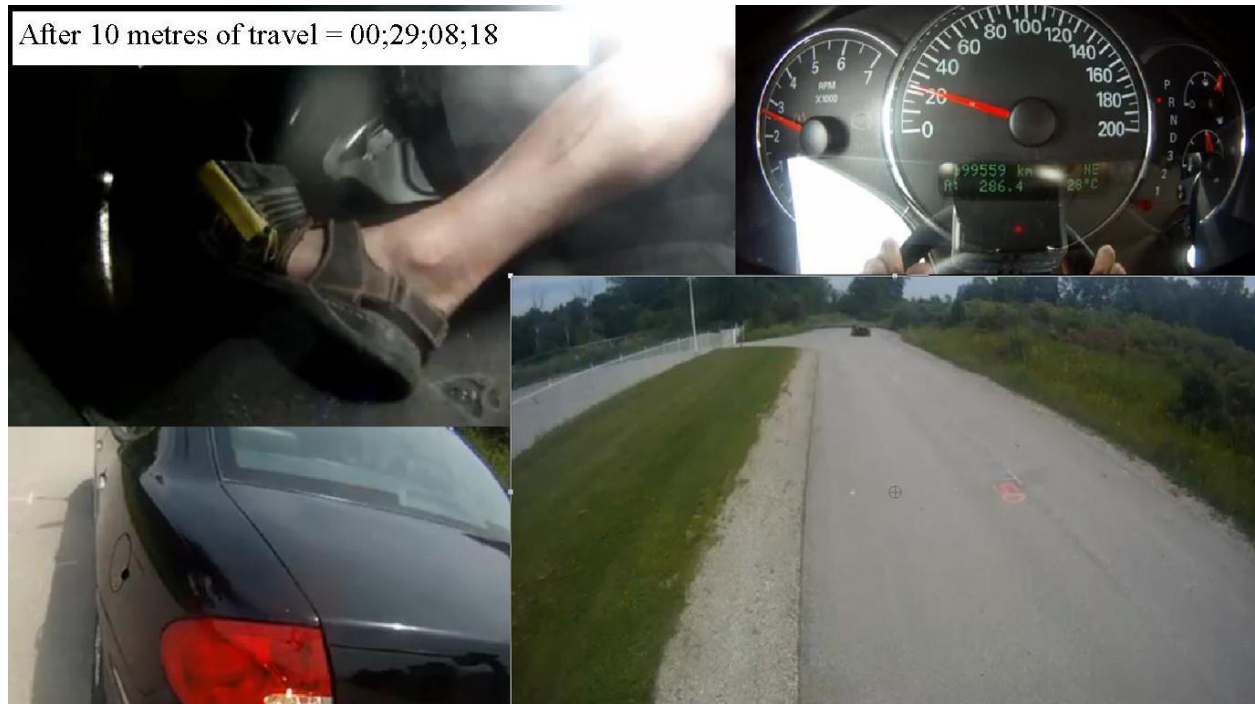
Figure 11: View from Test #1 after the vehicle has accelerated for 10 metres.

Figure 11 shows the status of the views after the vehicle has accelerated rearward for 10 metres. The vehicle's speed has reached 22 km/h and the tachometer reads 2700 rpm. The timecode reads "00;29;08;18" thus a time of 2.83 seconds has elapsed since the driver began to release the brake pedal. Similarly, the elapsed time from when the driver touched the accelerator pedal was 2.60 seconds.

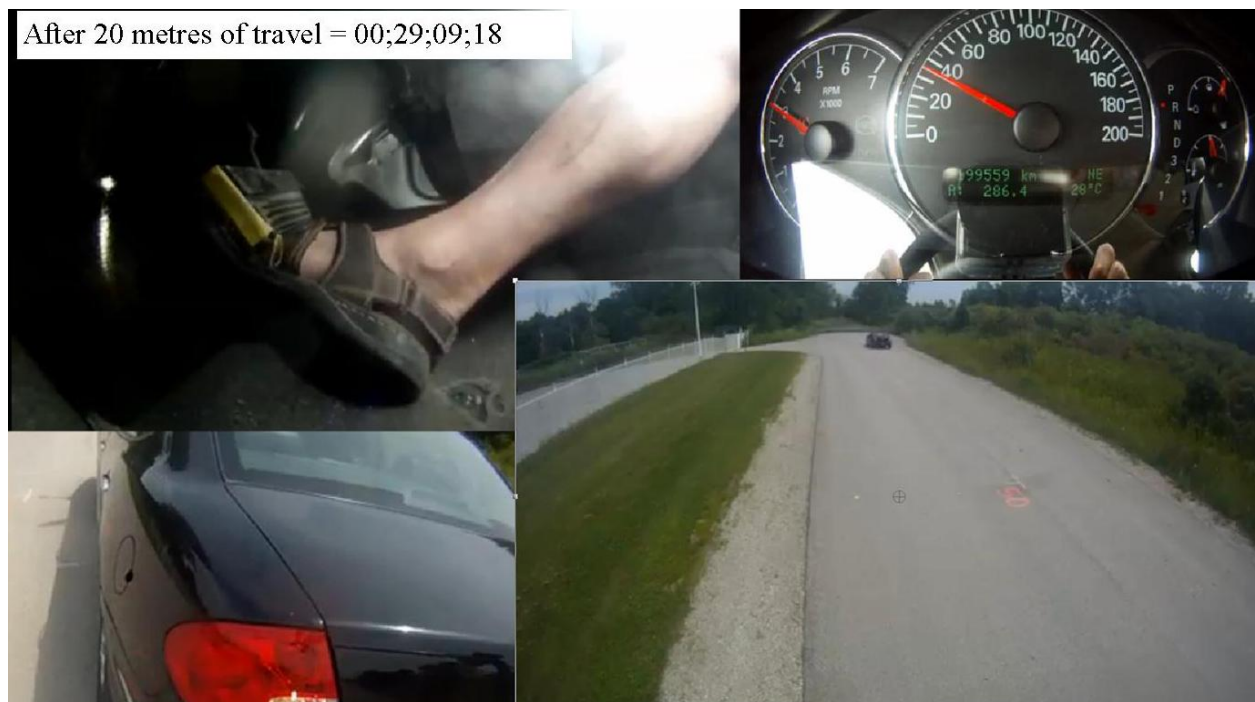
Figure 12: View from Test #1 after the vehicle has accelerated for 20 metres.

Figure 12 shows the status of the views after the vehicle has accelerated rearward for 20 metres. The vehicle's speed has reached 35 km/h and the tachometer reads 3000 rpm. The timecode reads "00;29;09;19" thus a time of 3.83 seconds has elapsed since the driver began to release the brake pedal. Similarly, the elapsed time from when the

driver touched the accelerator pedal was 3.60 seconds and the elapsed time from passing the 10 metre marker was 1.00 seconds.

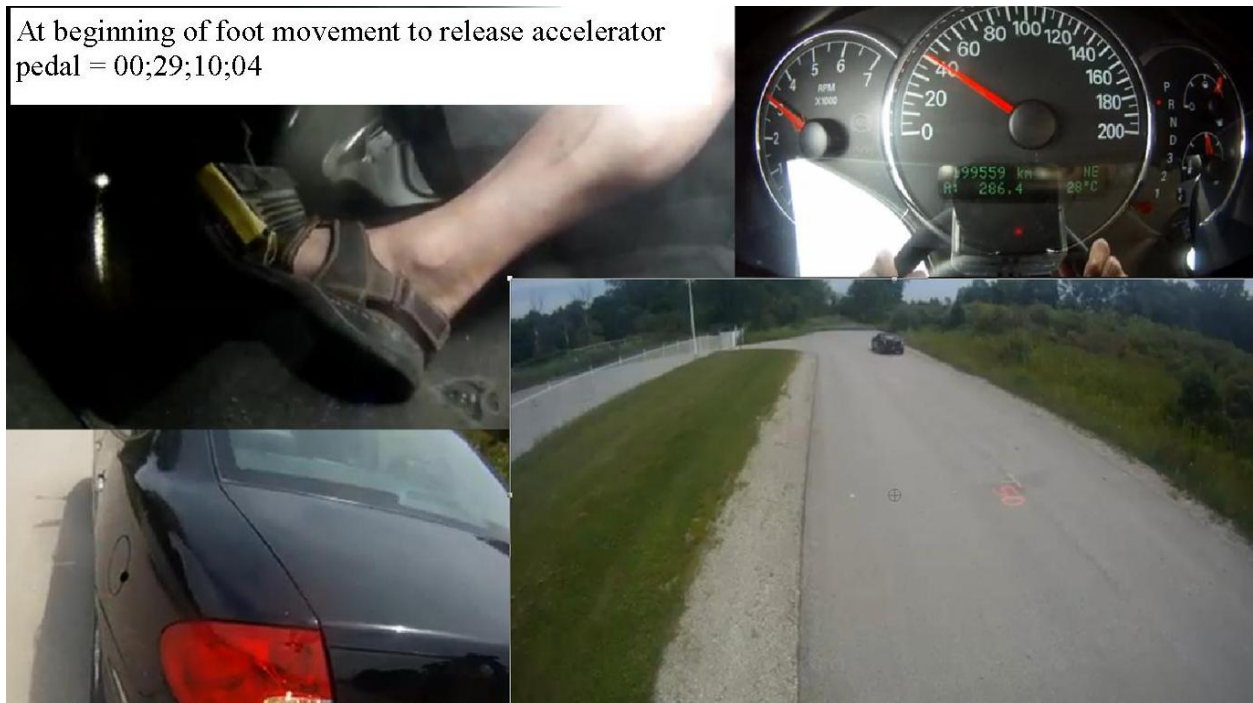
Figure 13: Status of views when the driver's foot begins to release the accelerator pedal.

Figure 13 shows the status just as the driver's foot begins to release from the accelerator pedal so as to commence braking. This occurs when the vehicle's speed has reached about 41 km/h and the tachometer reads about 3200 rpm. At this time the vehicle has travelled 27 metres. The timecode reads "00;29;10;04" therefore a time of 4.37 seconds has elapsed since the driver released the brake pedal or 4.13 seconds since the driver's foot made initial contact with the accelerator pedal.

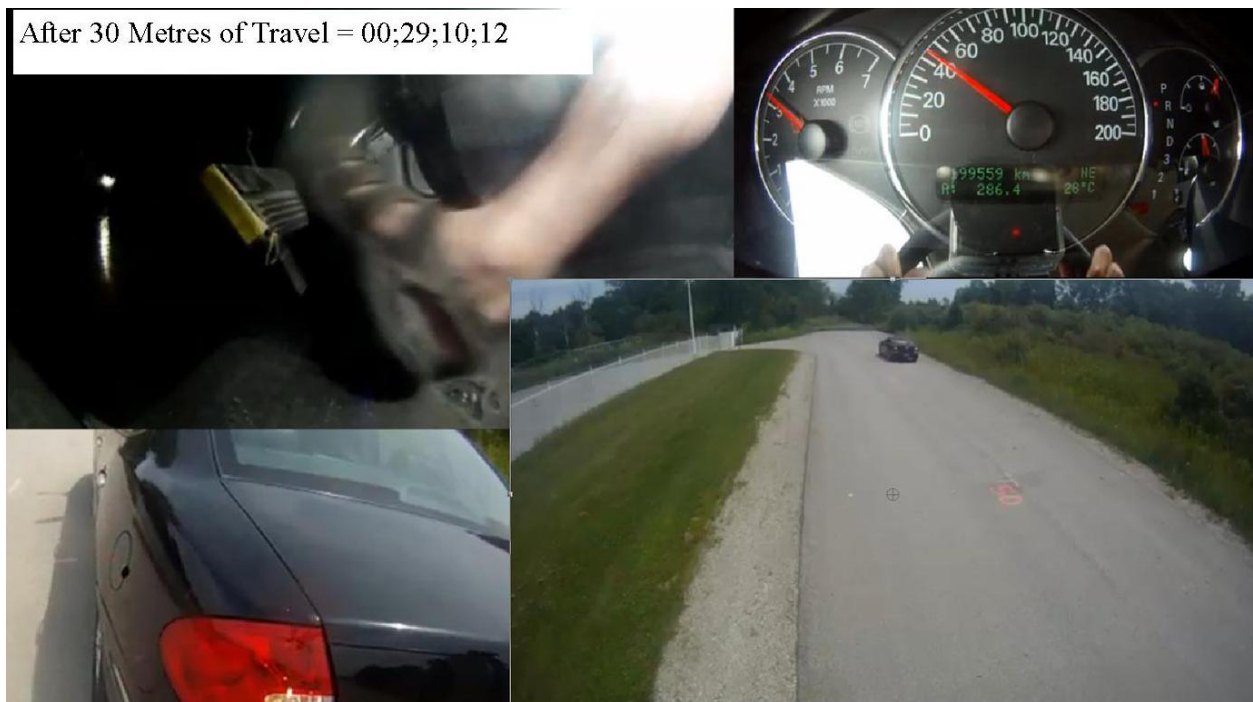
Figure 14: View from Test #1 after the vehicle has accelerated 30 metres.

Figure 14 shows the status as the vehicle passes the 30 metre marker at a timecode of "00;29;10;12". Here the vehicle has accelerated to a speed of about 44 km/h and the tachometer reads about 3200 rpm. The elapsed time from initial release of the brake pedal is 4.63 seconds or 4.40 seconds since initial contact of the accelerator pedal.

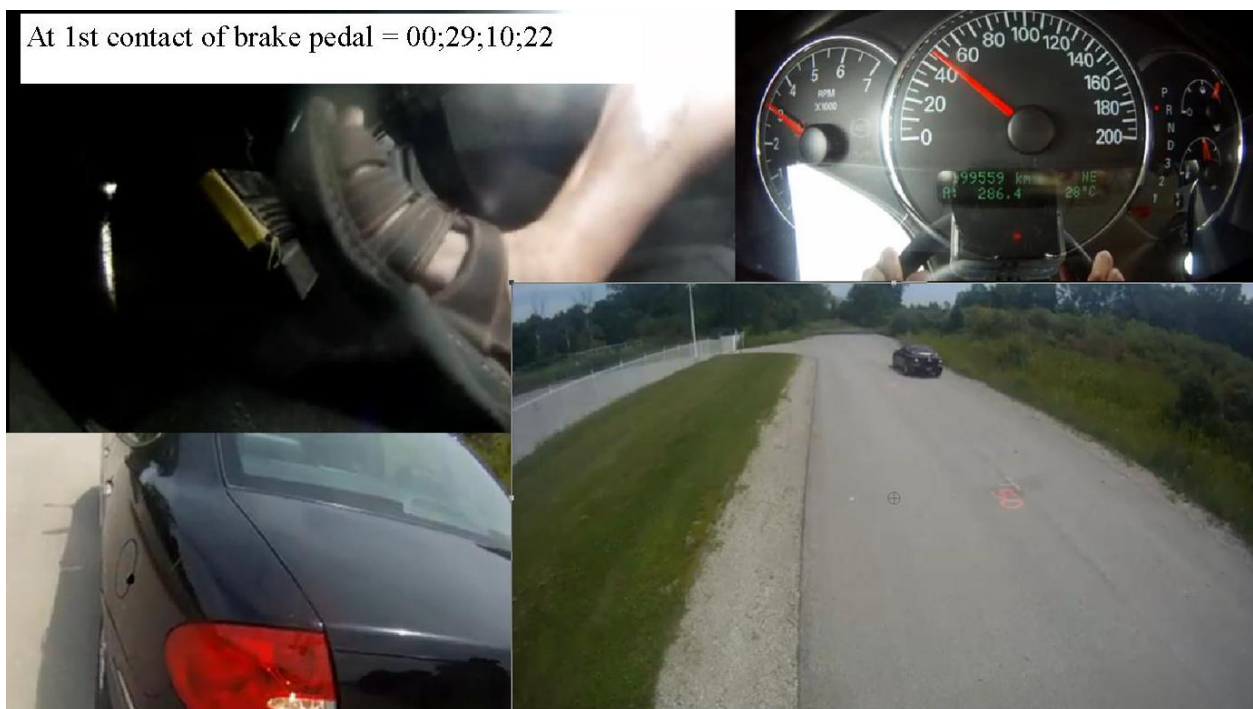
Figure 15: Status at first contact of the brake pedal.

Figure 15 shows the status as the driver's foot makes first contact with the brake pedal. The vehicle has reached a speed of about 47 km/h and the tachometer reads 3100 rpm. The timecode reads "00;29;10;22" thus a time of 4.97 seconds has elapsed since the driver initially leased the brake pedal or 4.73 seconds since the accelerator pedal was first contacted. At this time the vehicle has travelled 35 metres.

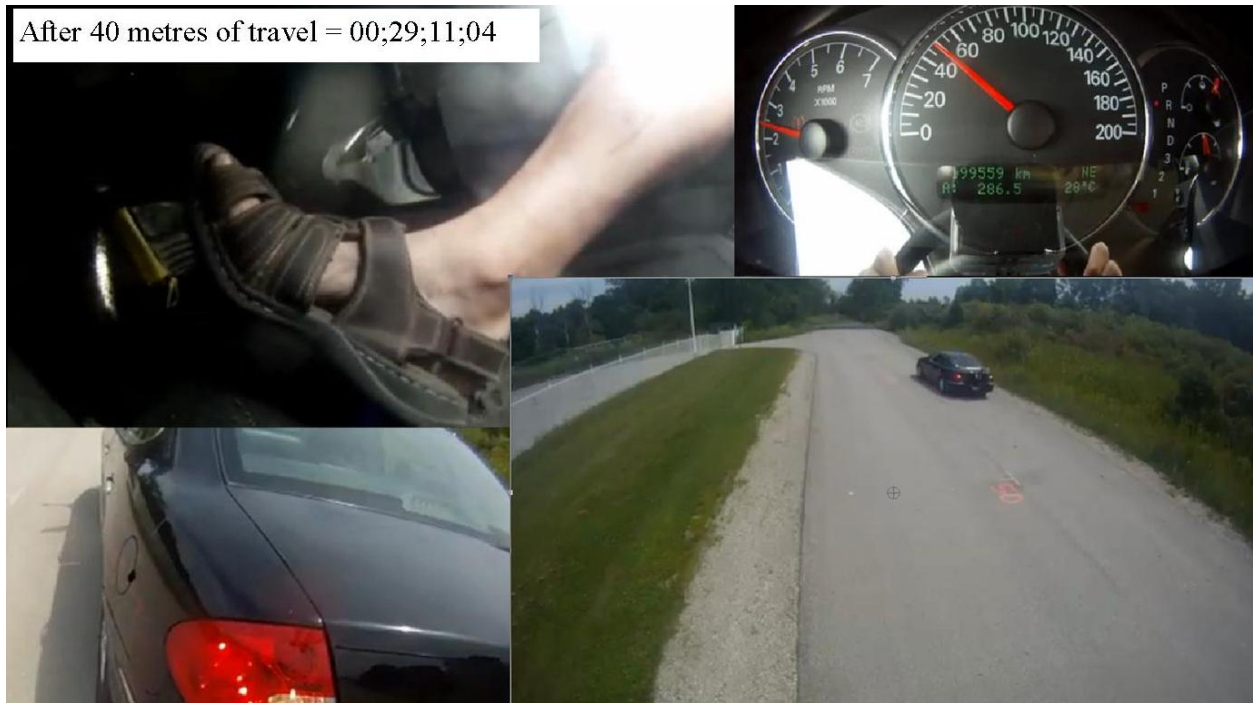
Figure 16: Status of Test #1 after the vehicle has travelled 40 metres.

Figure 16 shows the status as the vehicle reaches the 40 metre marker. At this time the driver's foot is still compressing the brake pedal. The vehicle's speed has fallen to 44.5 km/h and the tachometer reads 2400 rpm. The timecode reads "00;29;11;04" thus a time of 5.37 seconds has elapsed since initial brake pedal contact or 5.13 seconds since initial contact of the accelerator pedal.

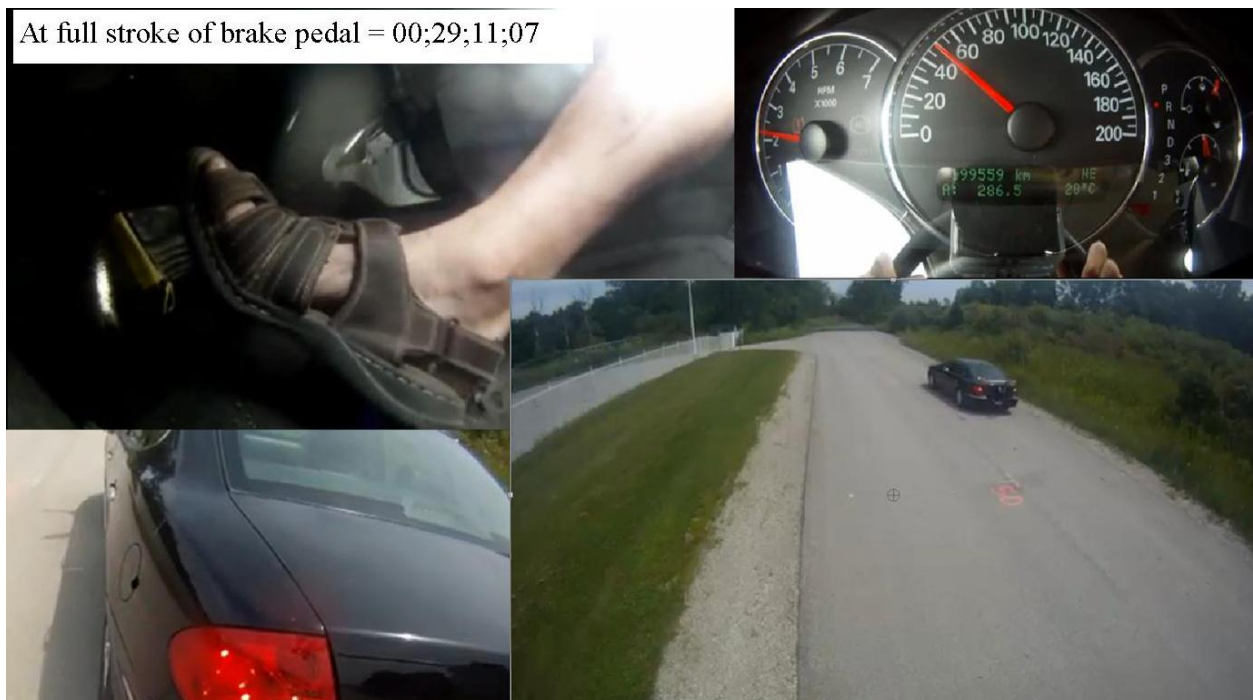
Figure 17: Status of the views at full compression of the brake pedal which occurred just after the vehicle crossed the 40 metre marker.

At full compression of the brake pedal the vehicle is travelling about 44.5 km/h and the tachometer reads about 2250 rpm.

Figure 17 indicates that shortly after the vehicle passes the 40 metre marker the brake pedal has been depressed to its maximum. This occurs at timecode "00;29;11;07" or about 5.47 seconds after the brake pedal was initially released at the start of the test.

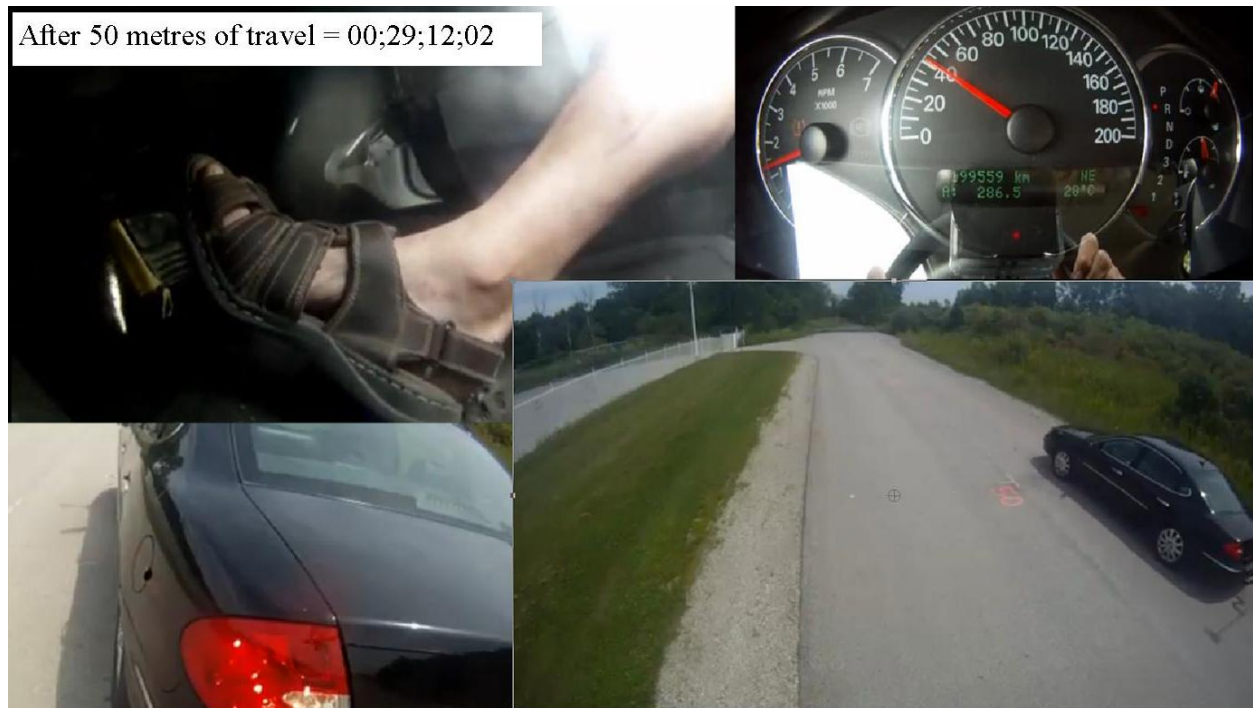
Figure 18: Status as the vehicle passes the 50 metre marker.

Figure 18 shows the status as the vehicle crosses the 50 metre marker. The brake pedal has been fully depressed. The vehicle is travelling at 42 km/h and the tachometer reads 1300 rpm. The timecode indicates "00;29;12;02" or an elapsed time of 6.3 seconds since the brake pedal was initially released or 6.07 seconds since first contact of the accelerator pedal.

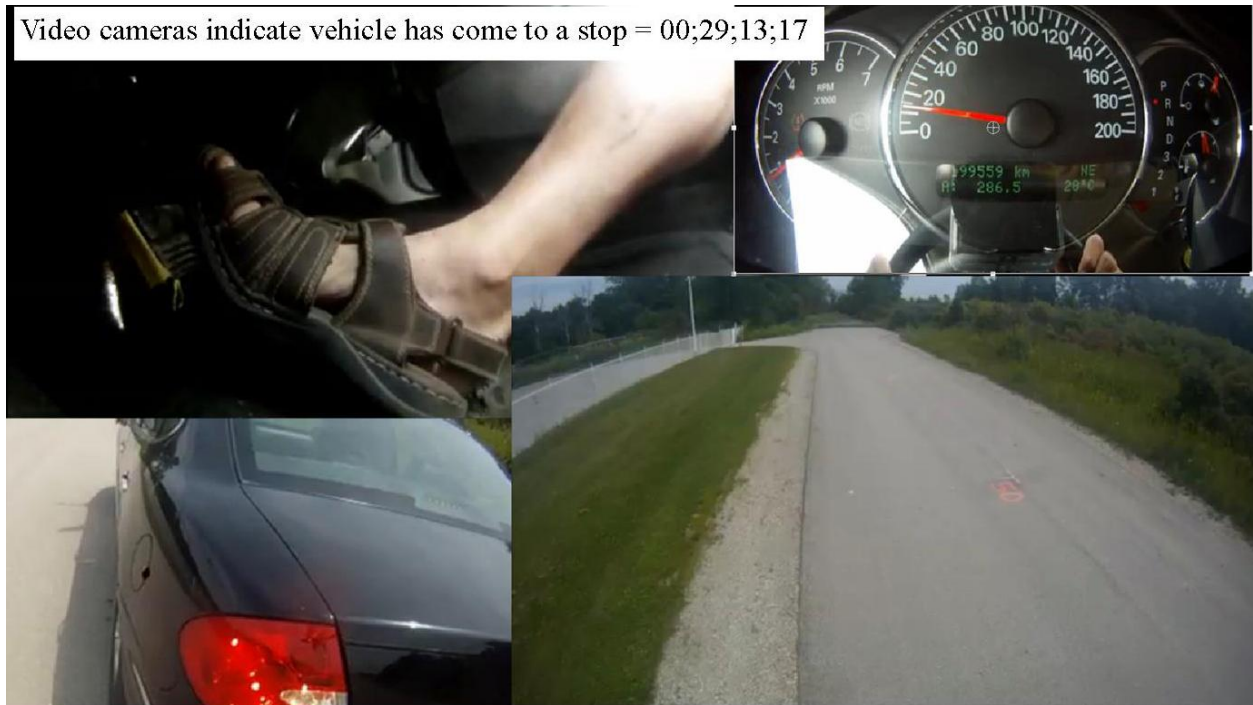
Figure 19: Status when the video cameras indicate that the test vehicle has come to a stop.

Figure 19 shows the status when the video cameras indicate that the test vehicle has come to a stop. At this time the speedometer still indicates a speed of 14 km/h and the tachometer reads about 850 rpm. The timecode indicates "00;29;13;17" or an elapsed time of 7.80 seconds from the initial release of the brake pedal or about 7.57 seconds since initial contact of the accelerator pedal.

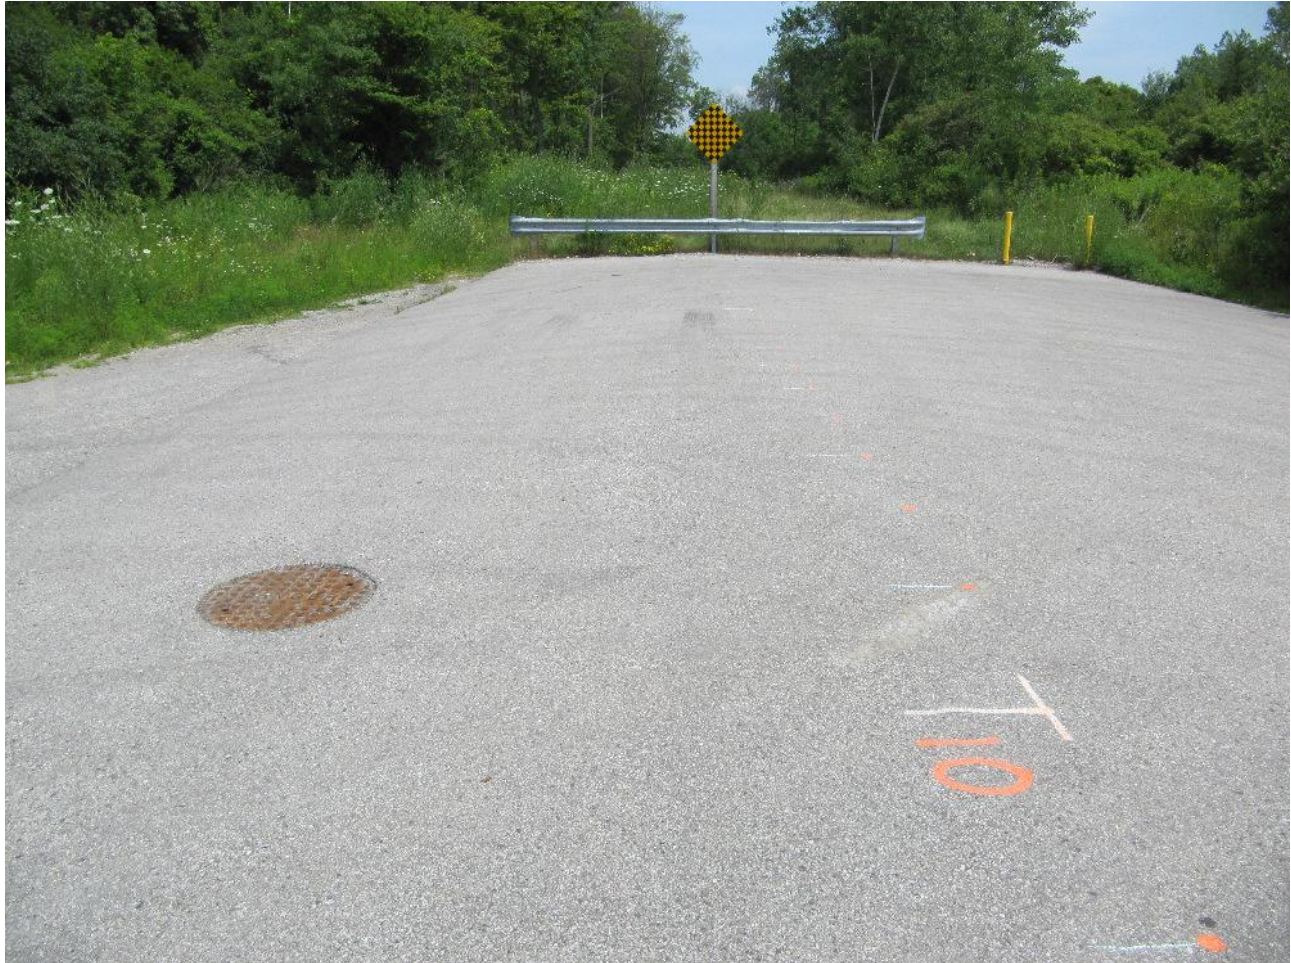
Figure 25: View looking east toward the start location of the four tests. The two forward accelerations were performed to the left (north) of the line of markers while the two rearward accelerations were performed to the right.

Tire marks were generated during the four tests. The marks produced during the two forward accelerations were readily visible for approximately 2 metres followed by very faint marks for a longer distance. Tire marks were also produced during the initial portion of rearward accelerations although they were faint and difficult to detect. Tire marks were also visible during the braking portion of all four tests. The following figures provide a visual record of the tire marks.

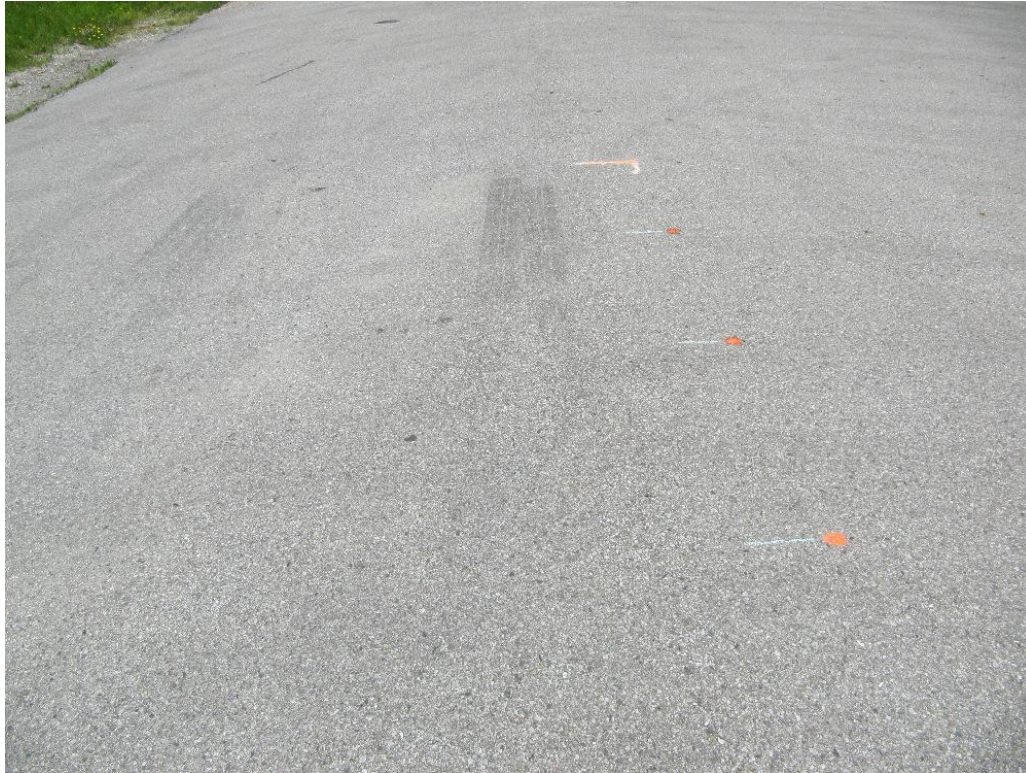
Figure 26: View, looking east, at the two sets of tire marks produced during the two forward accelerations.

It must be appreciated that the visibility of these marks varies depending on the direction from which they are viewed and the environmental conditions at the time of viewing. The photos in these figures were taken on a sunny day and this makes the tire marks less visible. On a cloudy day the marks would likely be more visible than what is shown.

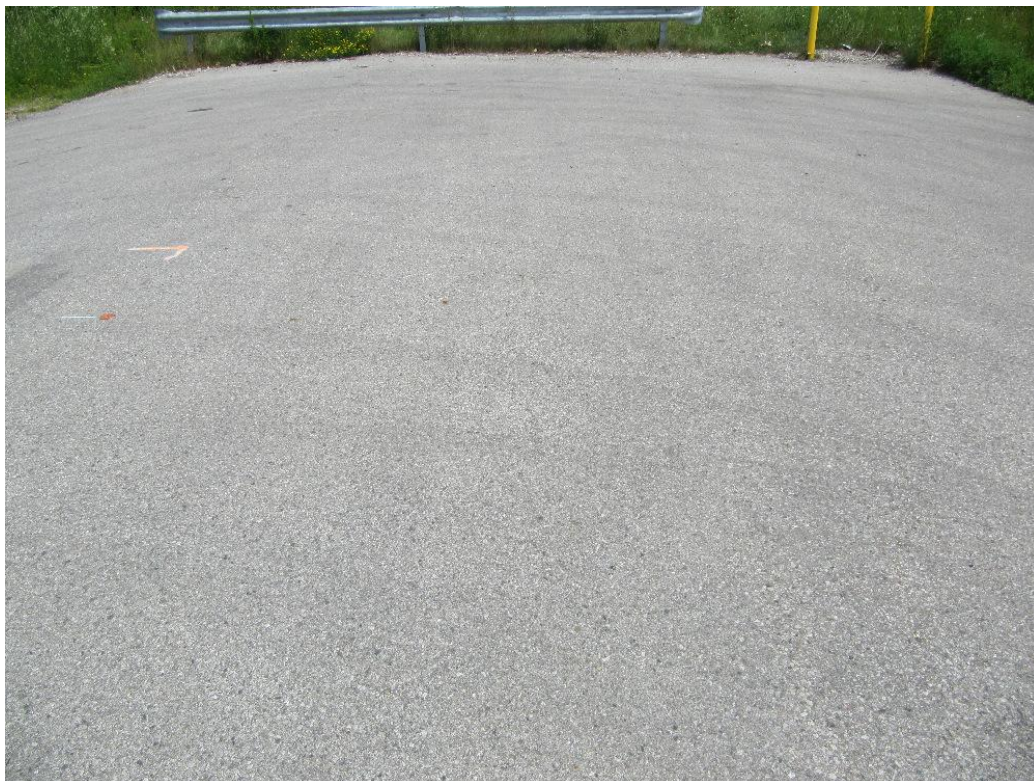
Figure 27: View, looking east, at the area where the two rearward accelerations were commenced. Although difficult to detect, faint tire marks were produced.

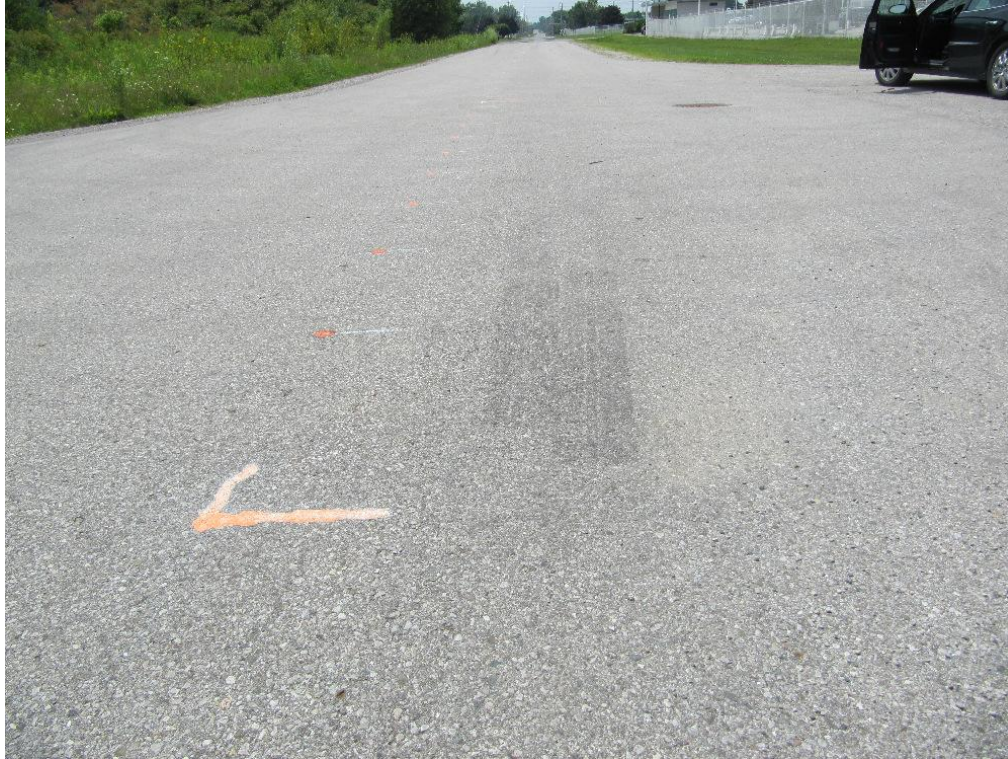
Figure 28: View, looking west, at the tire marks produced by the left front tire of the test vehicle during the two forward accelerations.
