# Maximum Accelerations in Reverse and Forward Gear to Simulate Unintended Acceleration Scenario

*Posting Date: July 27-2015*

Gorski Consulting  
London, Ontario, Canada

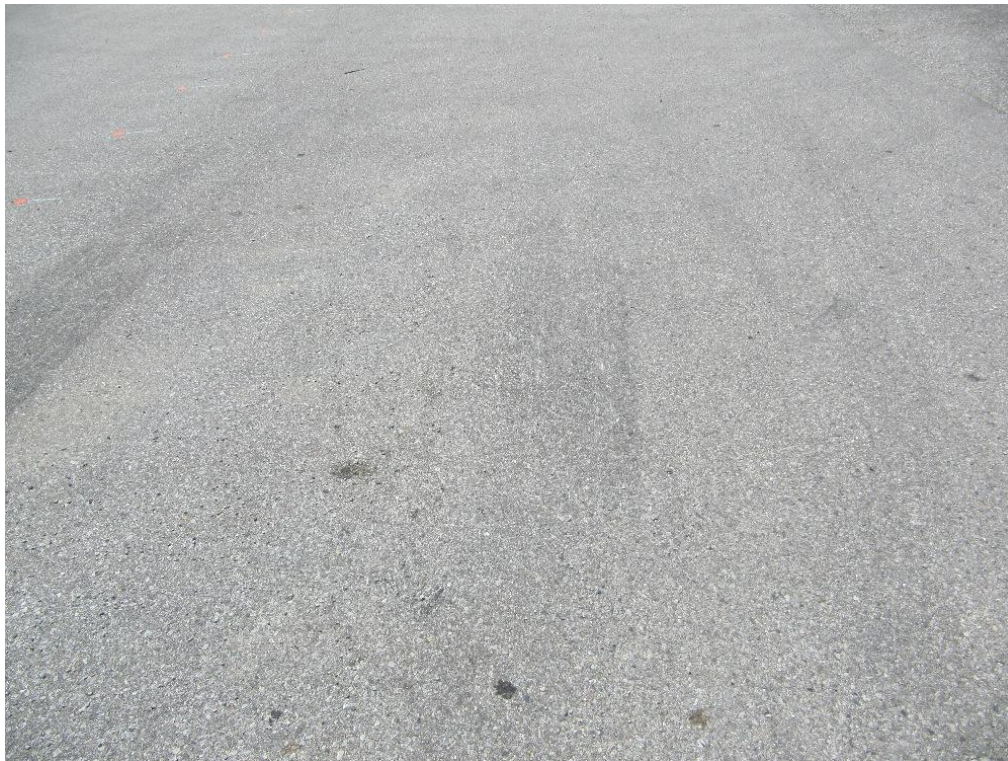
Figure 29: View, looking west, at the tire marks produced by the right front tire of the test vehicle during the two forward accelerations.

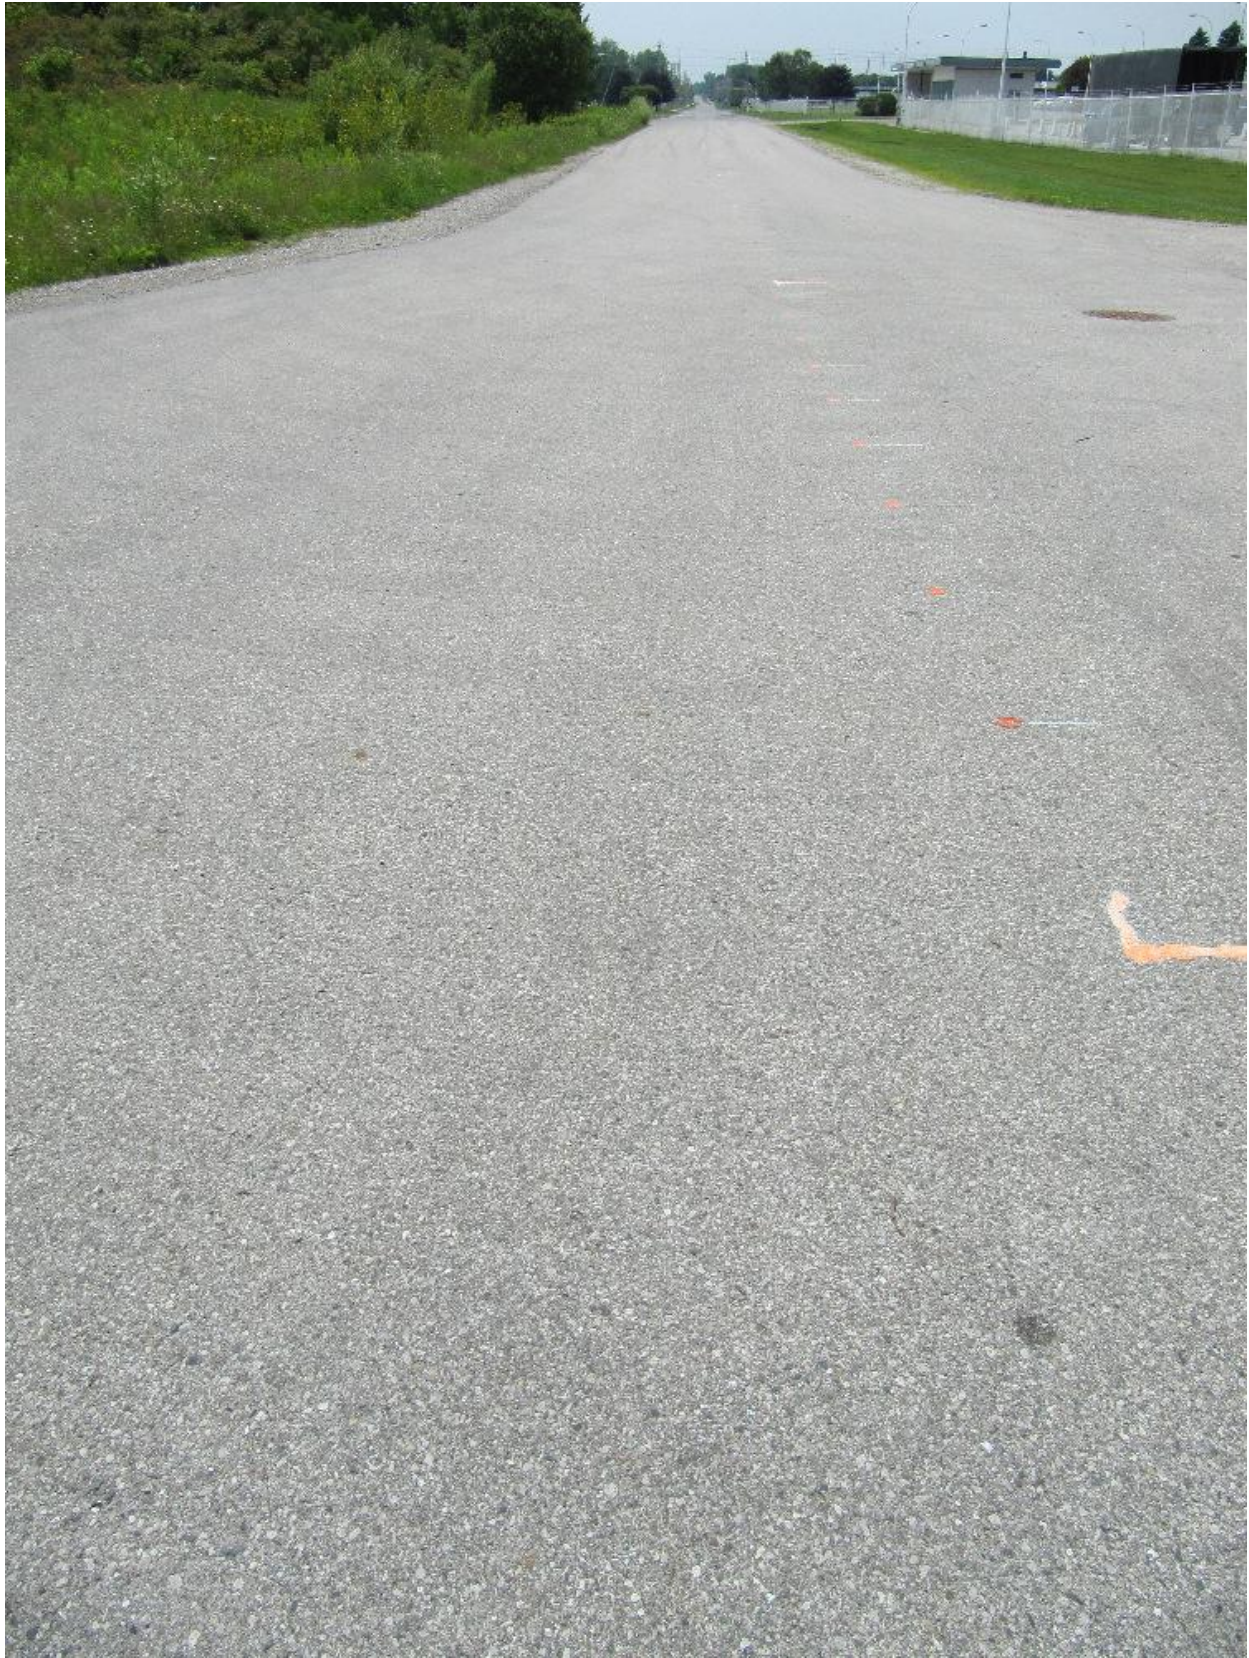
Figure 30: View, looking west, at the location of the two rearward acceleration marks.

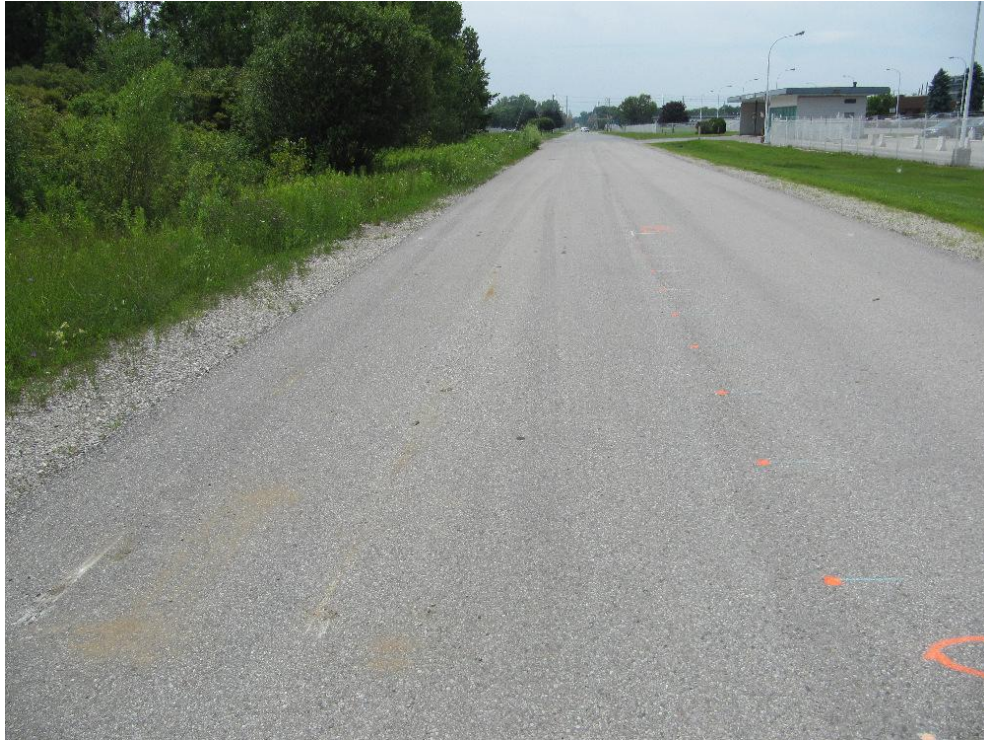
Figure 31: View, looking west along the braking tire marks produced during the latter portion of the rearward acceleration tests.

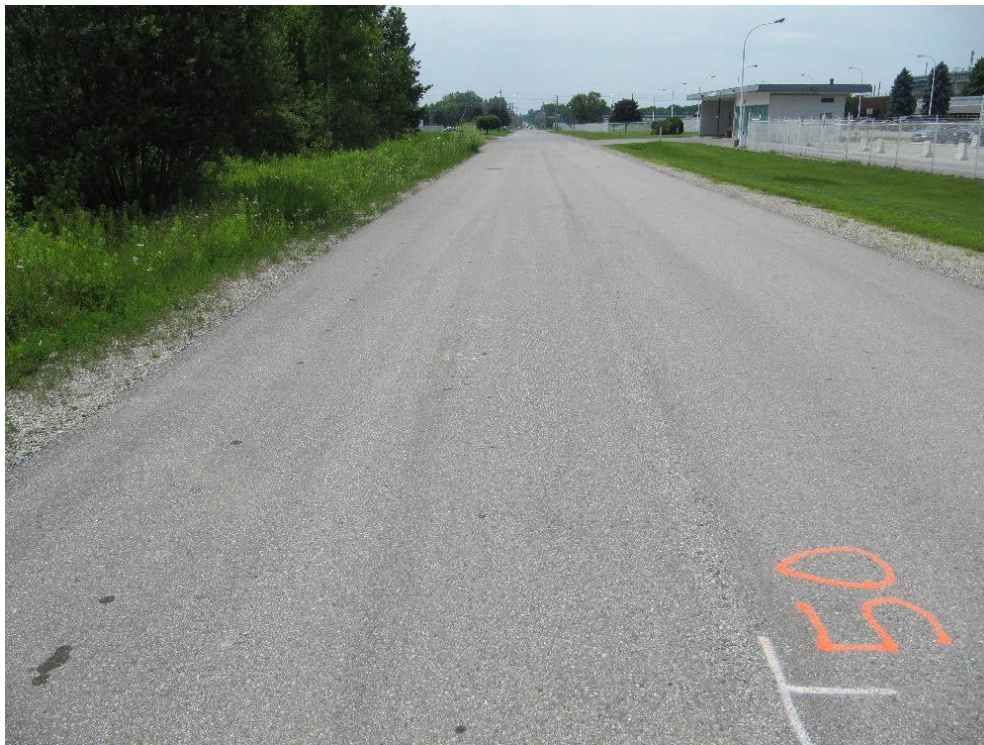
Figure 32: View of tire marks produced during braking. The tire marks to the left of the line of markers are those from the rearward accelerations while those to the right are from the forward accelerations.
