Warning Signs That Give The Wrong Warning

Posting Date: 29-Aug 2014

Gorski Consulting
London, Ontario, Canada

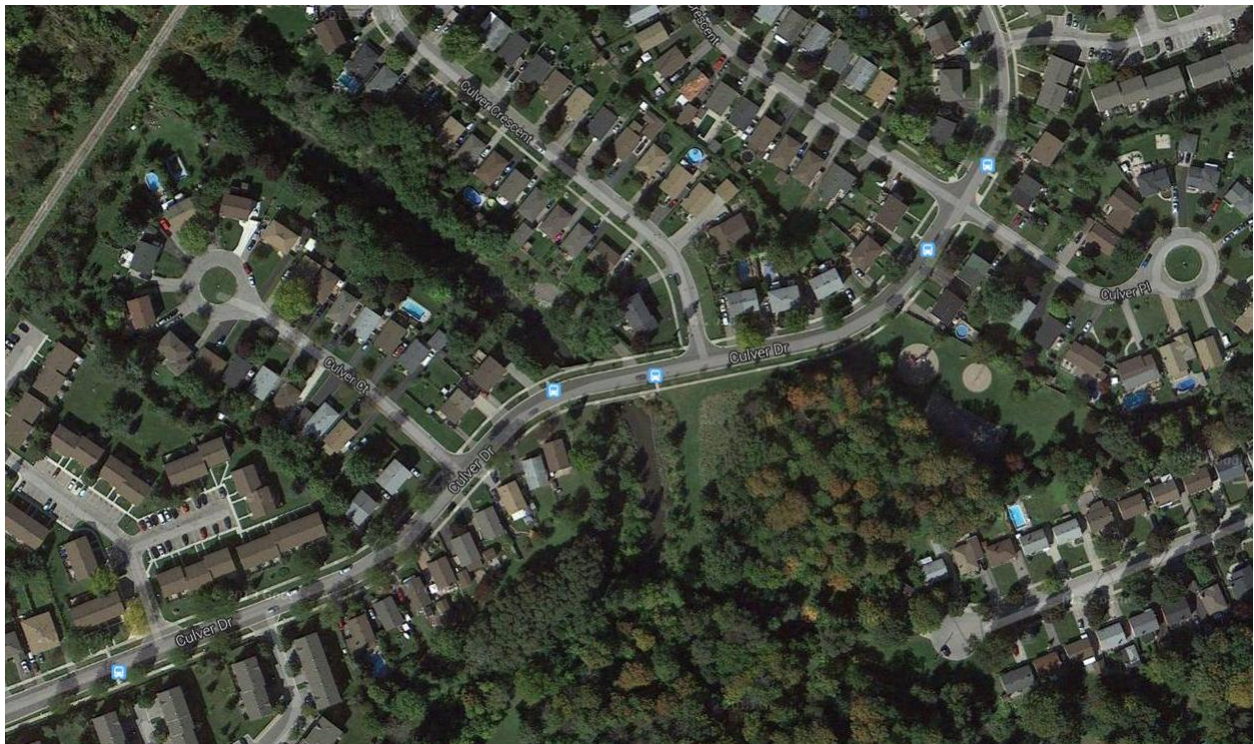
Figure 1 shows Culver Drive in the north-eastern area of the City of London, Ontario. Culver Drive is not unusual in that it snakes through a typical subdivision via some tight curves.

Figure 1: Overhead view of Culver Drive in London, Ontario.

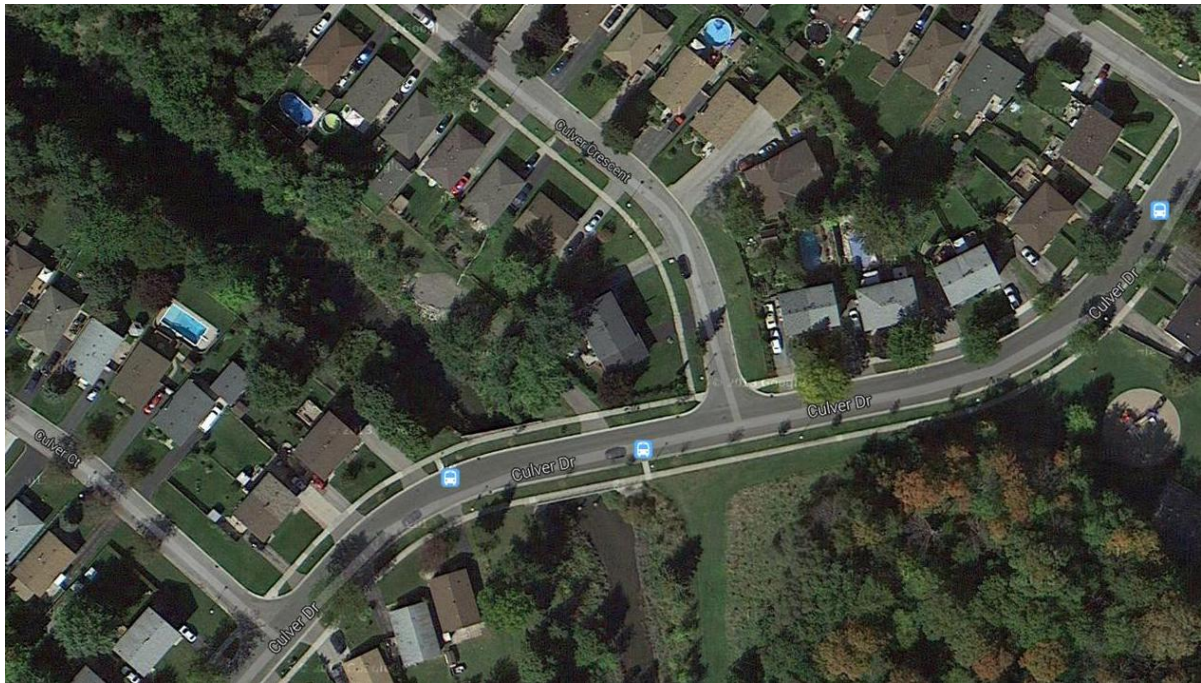
The present scenario that we will be examining is the very short straight section of Culver Drive located between two fairly sharp curves, as shown in Figure 2.

Figure 2: View of a short, straight section of Culver Drive accompanied by sharp curves to its east and west.

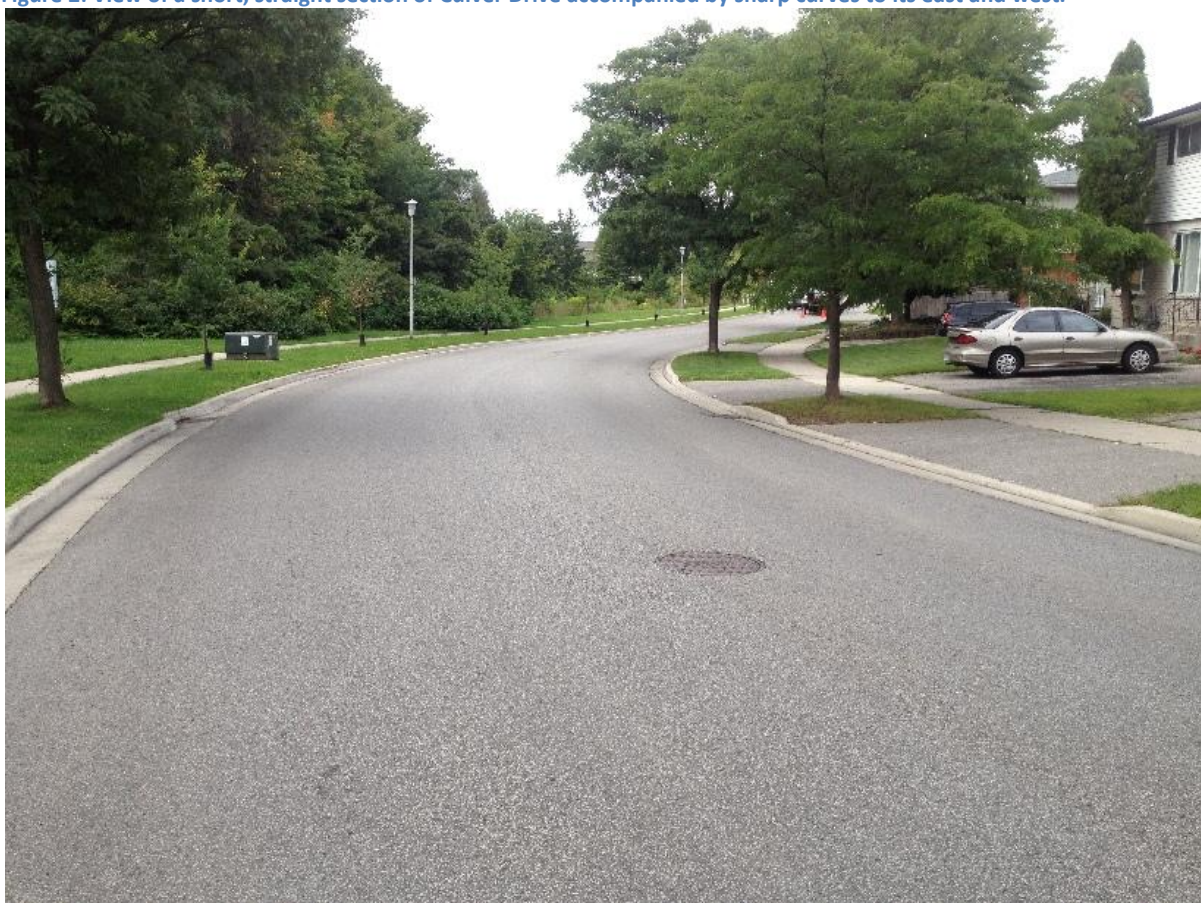
Figure 3: View looking west along Culver Drive from the curve just east of the short, straight road segment.

Figure 3 shows a view looking west from the curve just east of the short, straight, road segment, on a mid-week day in August, 2014. It may not be apparent however, if one looks very closely along the road in the distance, there appears to be something visible between the tree branches. In Figure 4 we zoom in on that area and we can see that there are two workers on the road, with some traffic cones and a large truck.

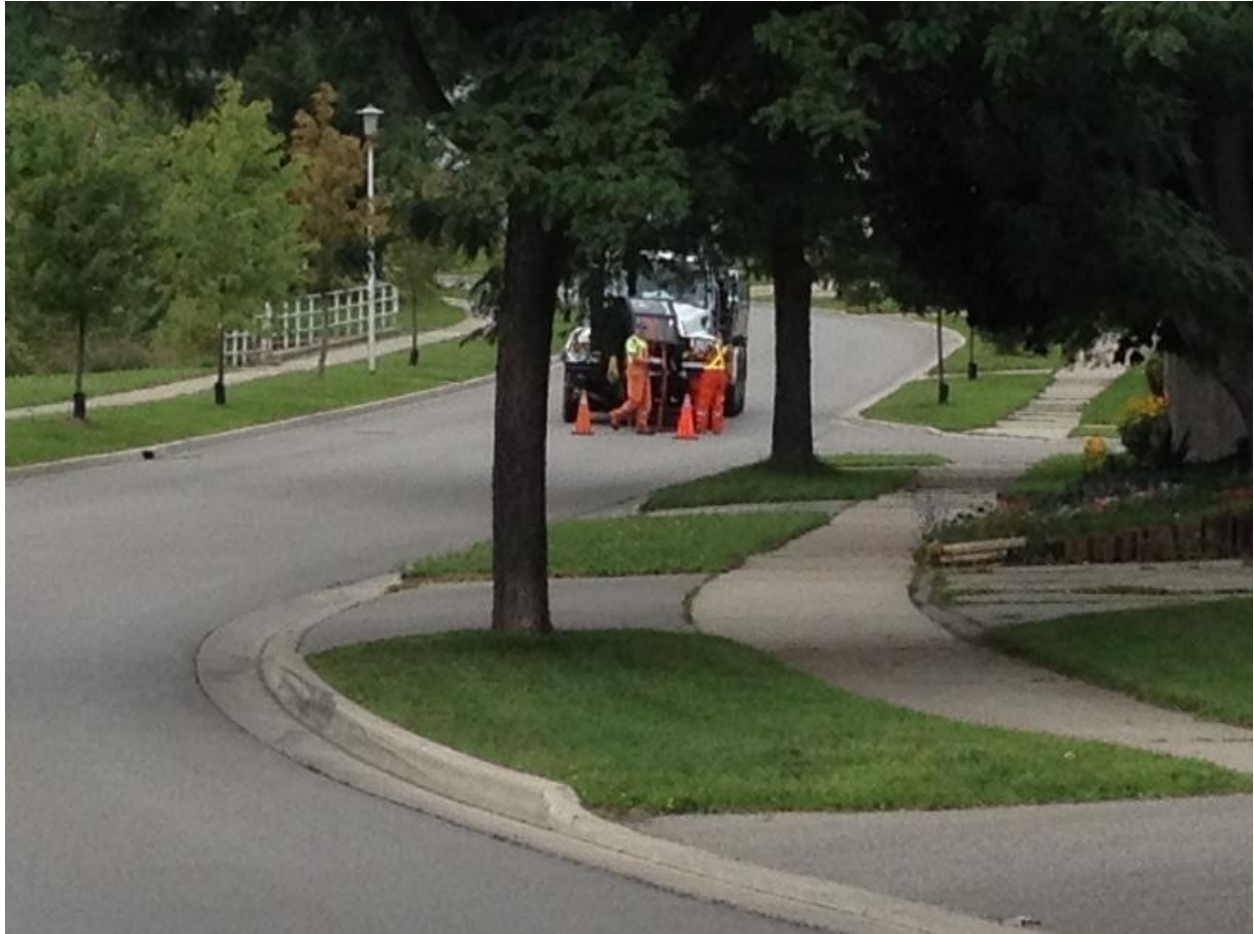
Figure 4: View, looking west, zoomed in on a work site with workers and a large truck.

However, from this viewing location around the sharp curve there is very little prior warning to indicate their presence.

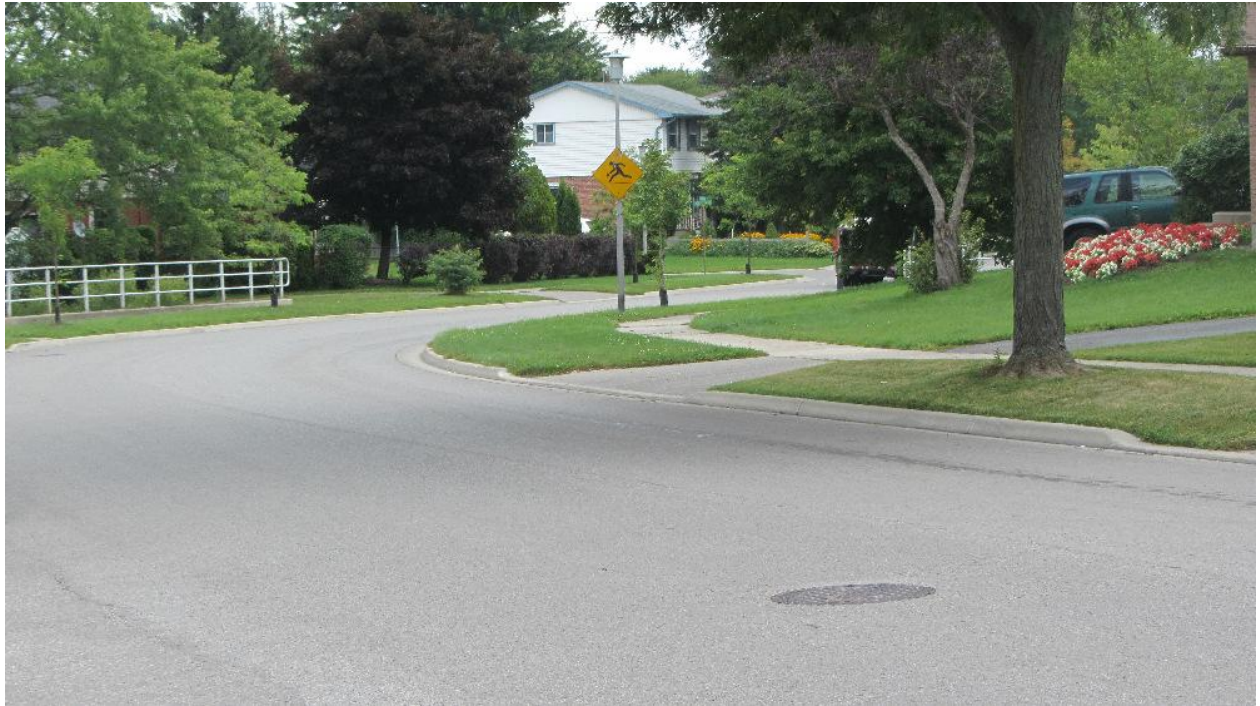
Similarly, when we travel to the west side of the straight section of road and look eastward, we see the view that is shown in Figure 5. Again we see that the presence of the truck and workers is blocked by the trees around the curve. In Figure 6 we zoom in on their location.

Figure 5: View, from the west side of the straight road segment showing that the truck and workers are blocked from view.

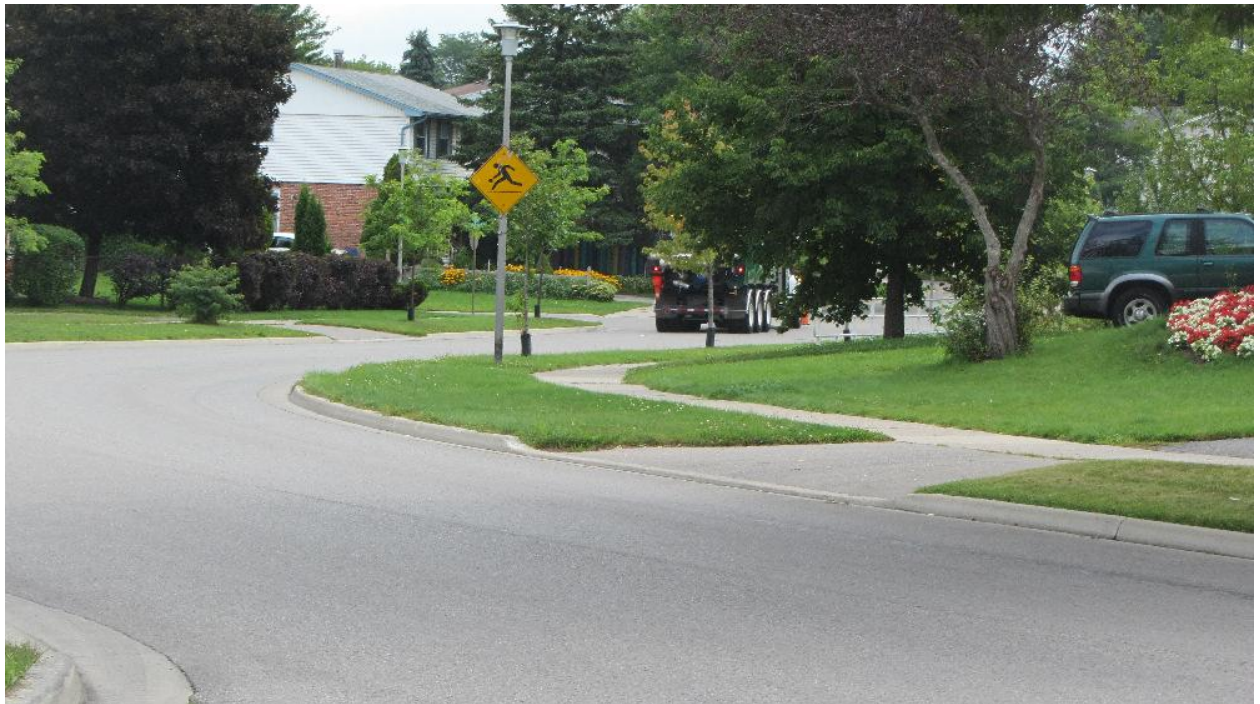
Figure 6: View, from west of the straight road segment, zoomed in on the partially obscured truck stopped in the middle of the road.

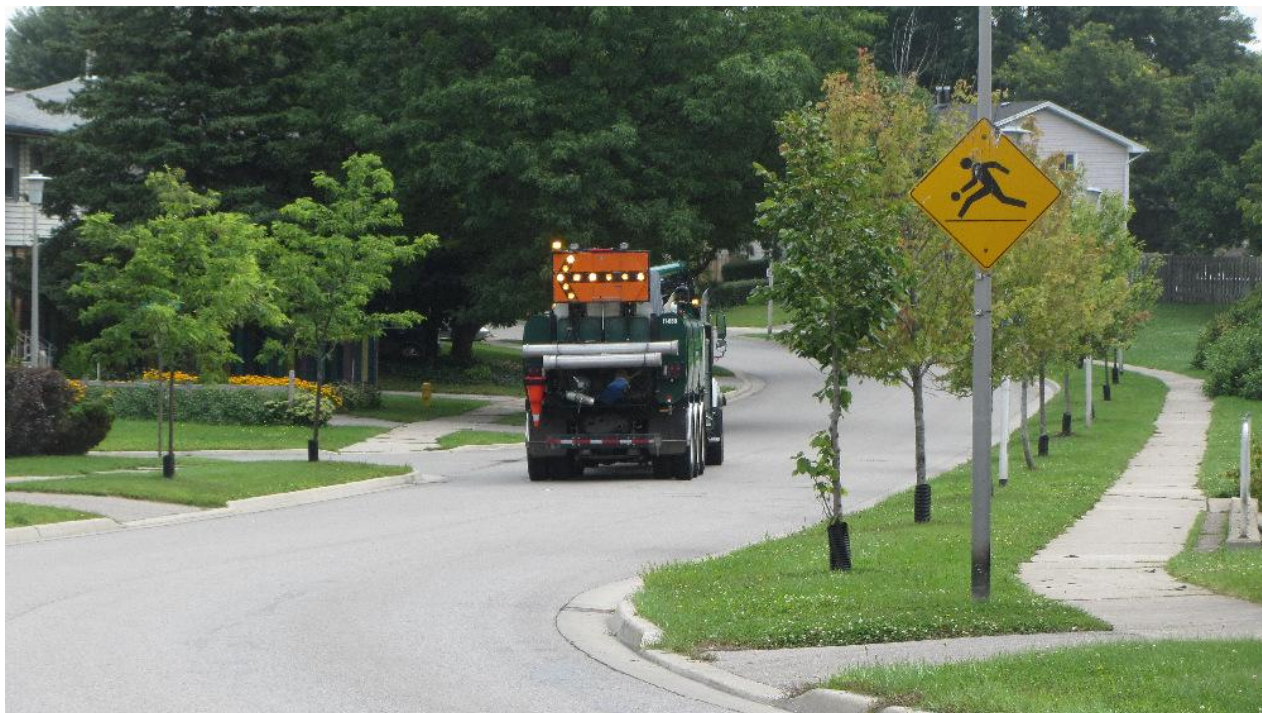
If we progress further eastward into the curve we begin to see the full rear of the truck, as shown in Figure 7, and now we see the standard TC-12 warning sign that is required to be placed on the back of a work truck whenever there is "Very Short Duration" (VSD) work being carried out on a road. That warning sign is a flashing arrow pointing to the

left, supposedly to inform drivers that they should pass the truck by travelling around it to the left. But does that make any sense?

Figure 7: View of rear of truck with a TC-12 warning sign, with a arrow signally that approaching traffic should pass the truck on the left.

We ask the reader to take a good look at the position of the stopped truck on the road in Figure 7. Clearly this truck is not in the eastbound lane, it is primarily in the westbound lane. There is no possibility for approaching vehicles to pass the truck by travelling to the left of it.

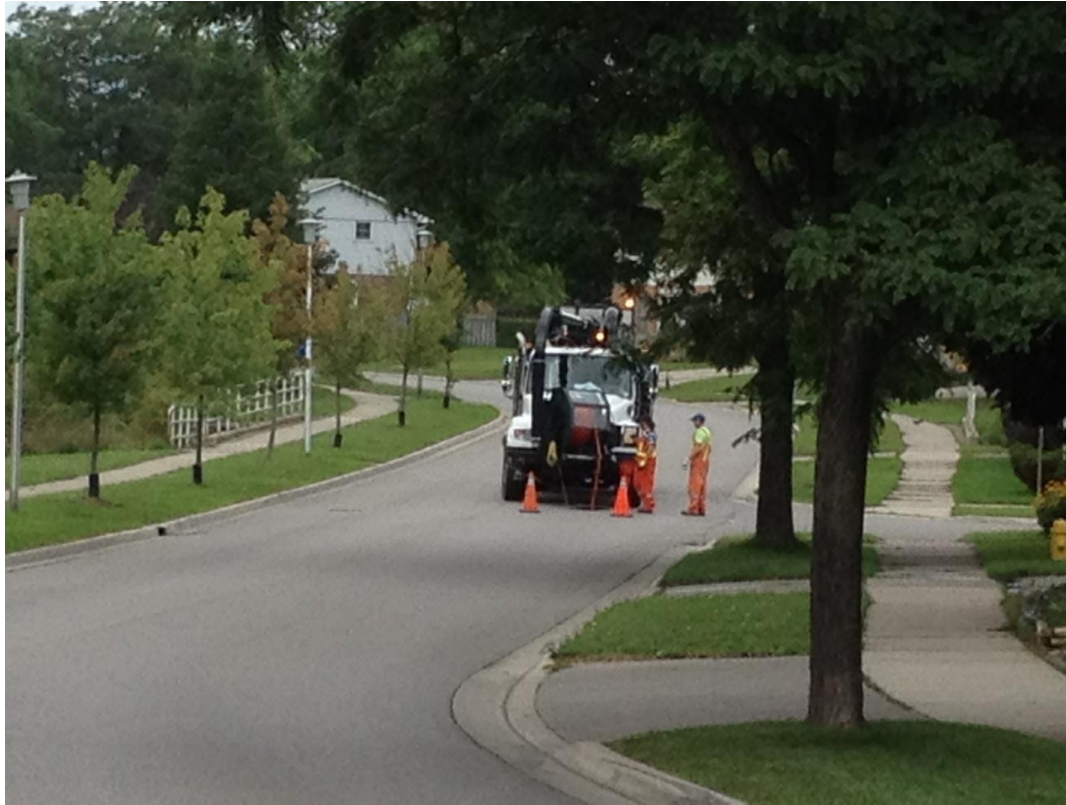
More so, when we approach the truck from the east we see the view shown in Figure 8. Clearly the truck is blocking the westbound lane. But there is no signage whatsoever to inform drivers of this fact. Meanwhile the workers are working in front of the truck and would have no protection if a westbound vehicle collided with them.

The limited visibility created by the sharp curves and very short segment of straight road means that drivers using the eastbound lane to pass the truck would have a very short time and distance to see each other.

Figure 8: View, looking west, showing the work truck has blocked the westbound lane and there are no warning signs anywhere to warn drivers of its presence.

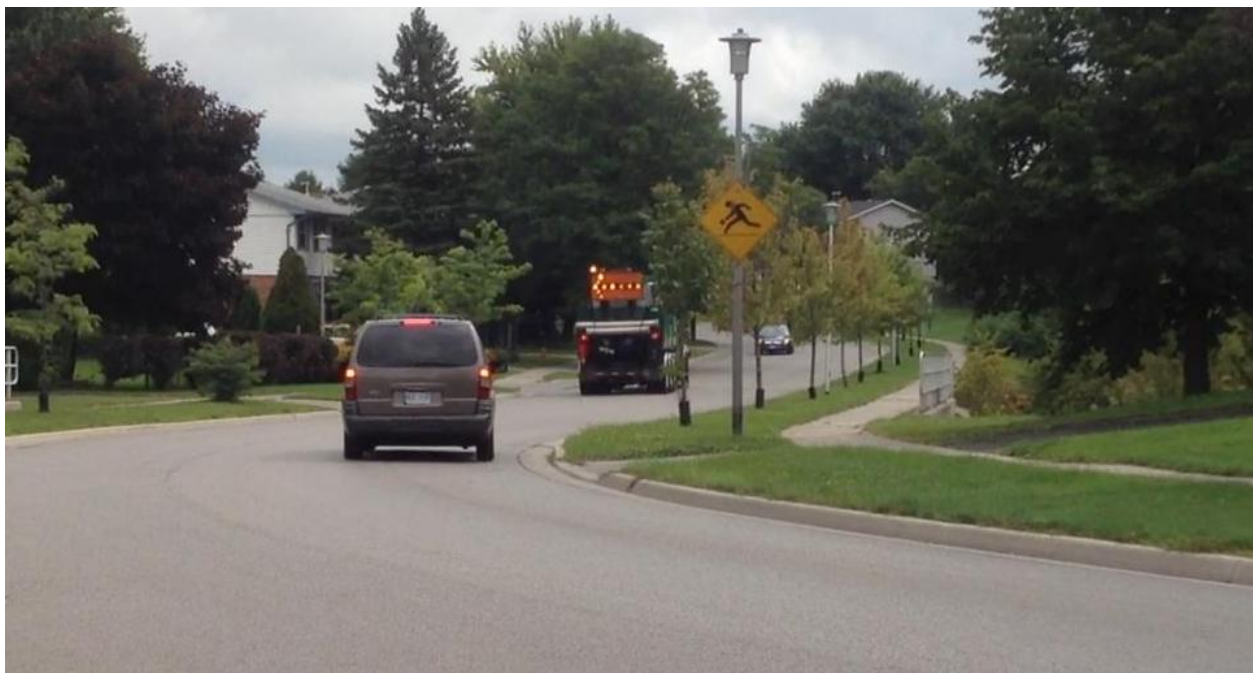
The following are a couple of examples of potential collisions that were frames taken from our videos. In Figures 9 through 16 we see a conflict between a westbound passenger car that, initially, has to come to halt to allow an eastbound van to pass by the stopped truck. As the westbound car then accelerates into the eastbound lane an eastbound London Transit bus comes into view and a collision is closely averted. The potential collision was likely avoided because the London Transit bus was already intending to stop at a bus stop that happened to be located just before the stopped truck. This allowed the westbound car to pass by the slowing bus without incident. However this was more likely a case of lucky circumstance that could easily have been a major collision if the bus was actually intending to drive straight ahead.

Figure 9: View of eastbound van and westbound car that must use the eastbound lane to pass the stopped work truck. Note that the van driver will ignore the warning sign indicating that he should pass the truck by steering around it to the left.

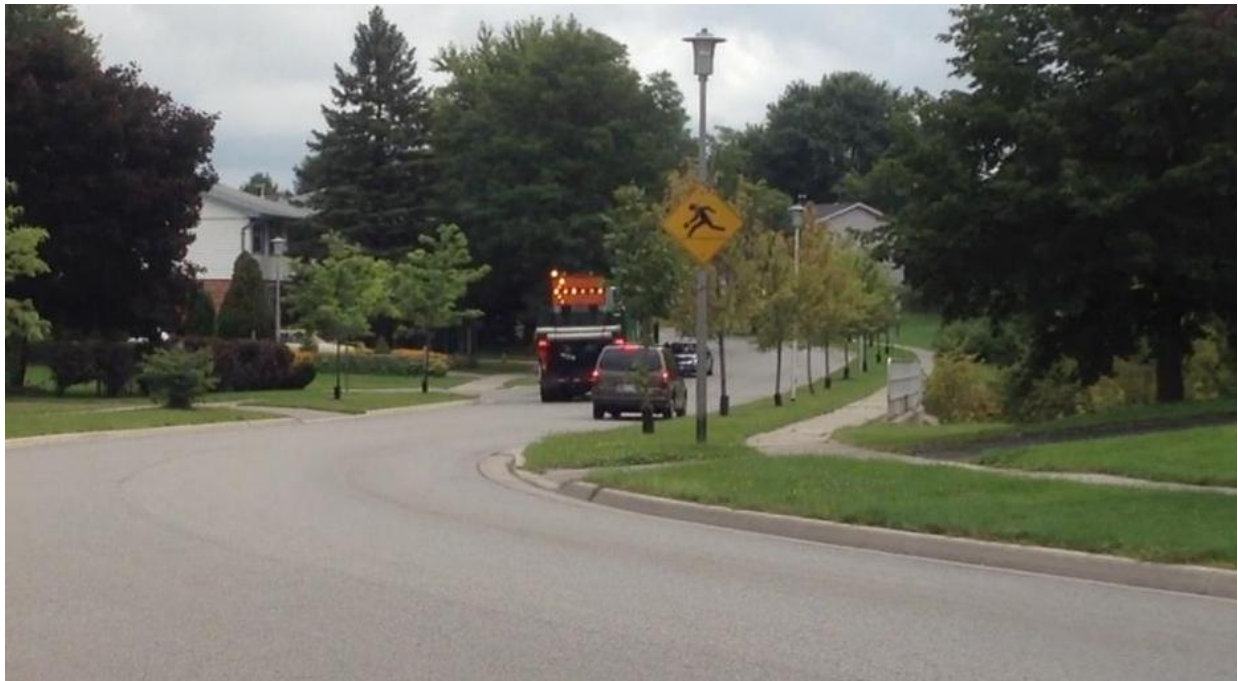
Figure 10: View of eastbound van passing the stopped truck while the westbound car stops and waits.

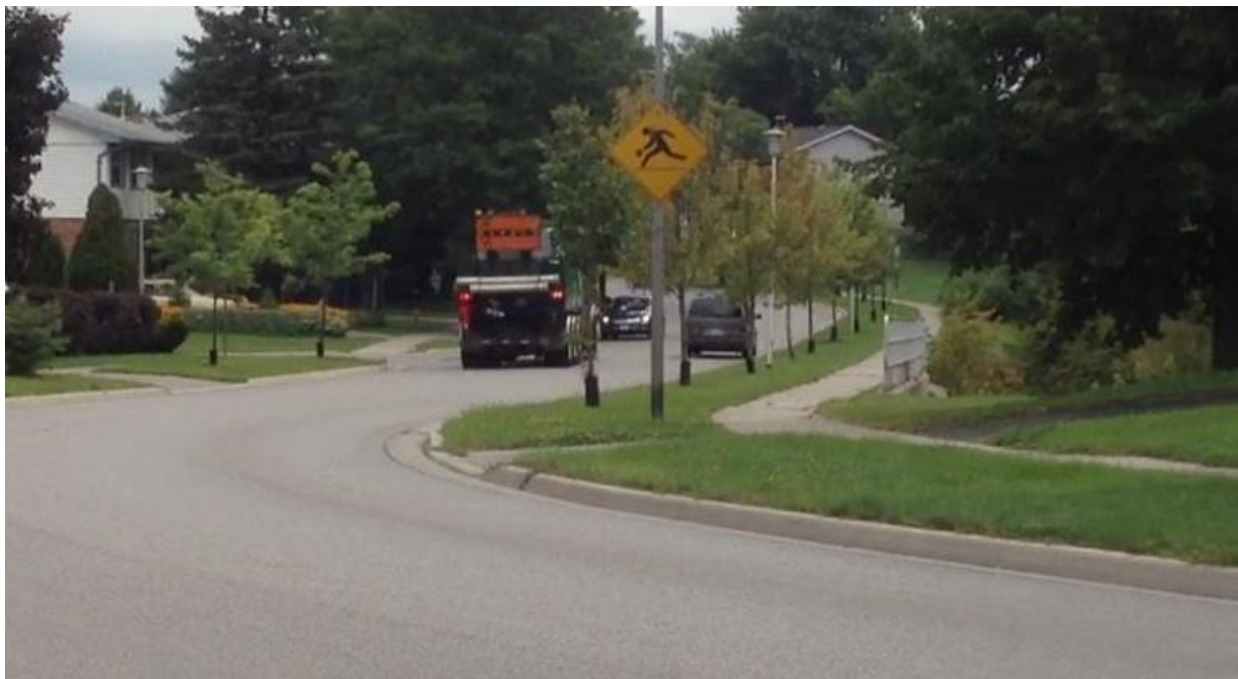
Figure 11: View of eastbound van passing the stopped truck while the westbound car stops and waits.

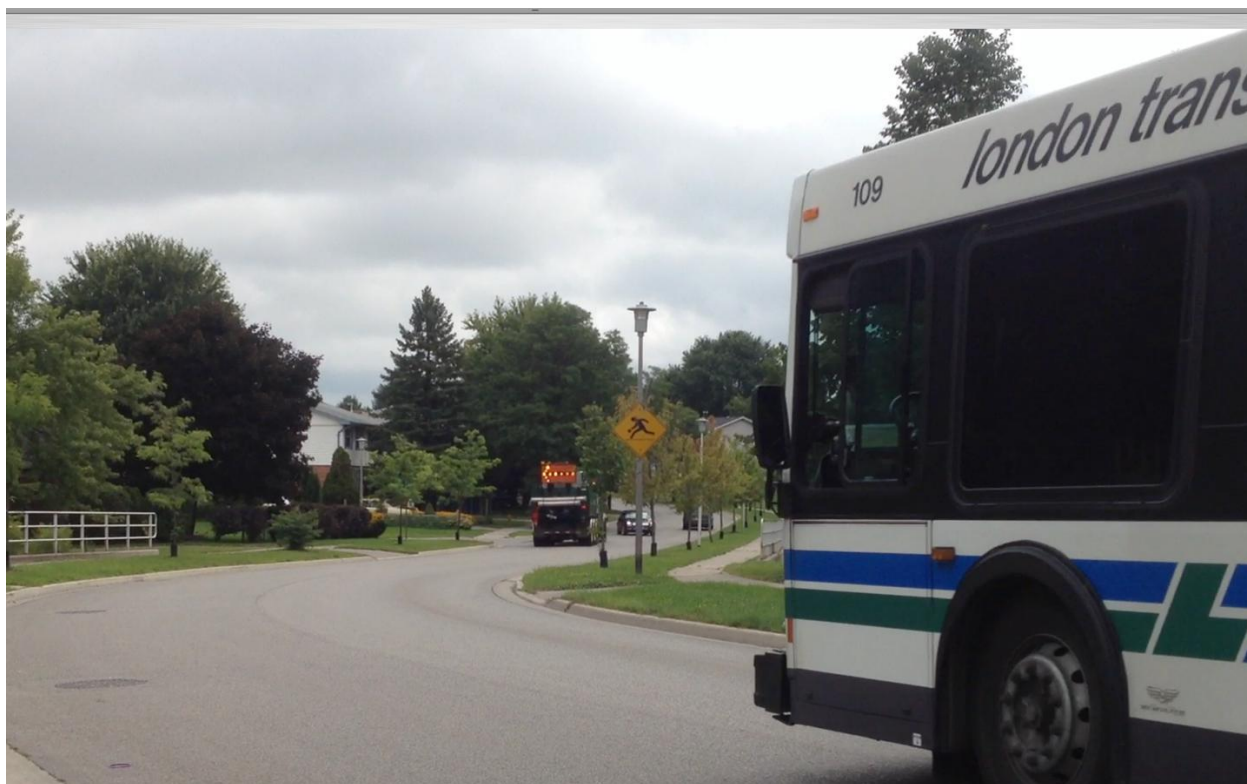
Figure 12: View of eastbound London Transit bus approaching just as the westbound car accelerates into eastbound lane to pass the stopped truck.

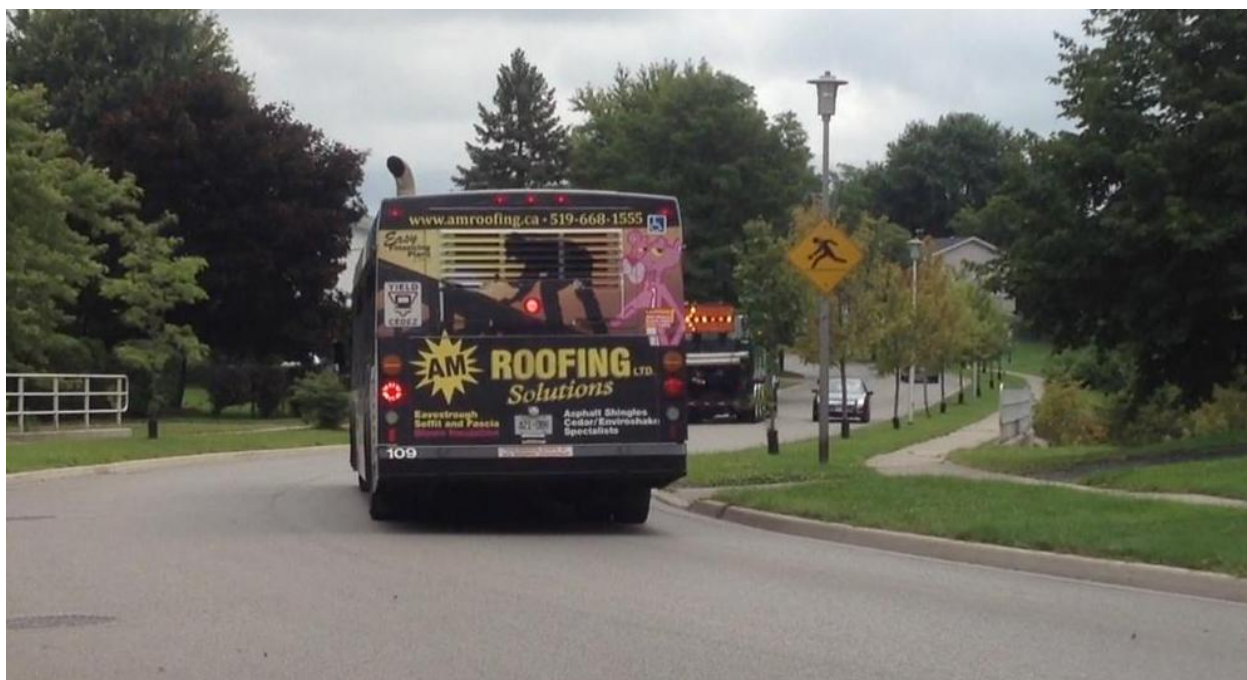
Figure 13: Transit bus driver applies braking as westbound car veers into the bus's lane.

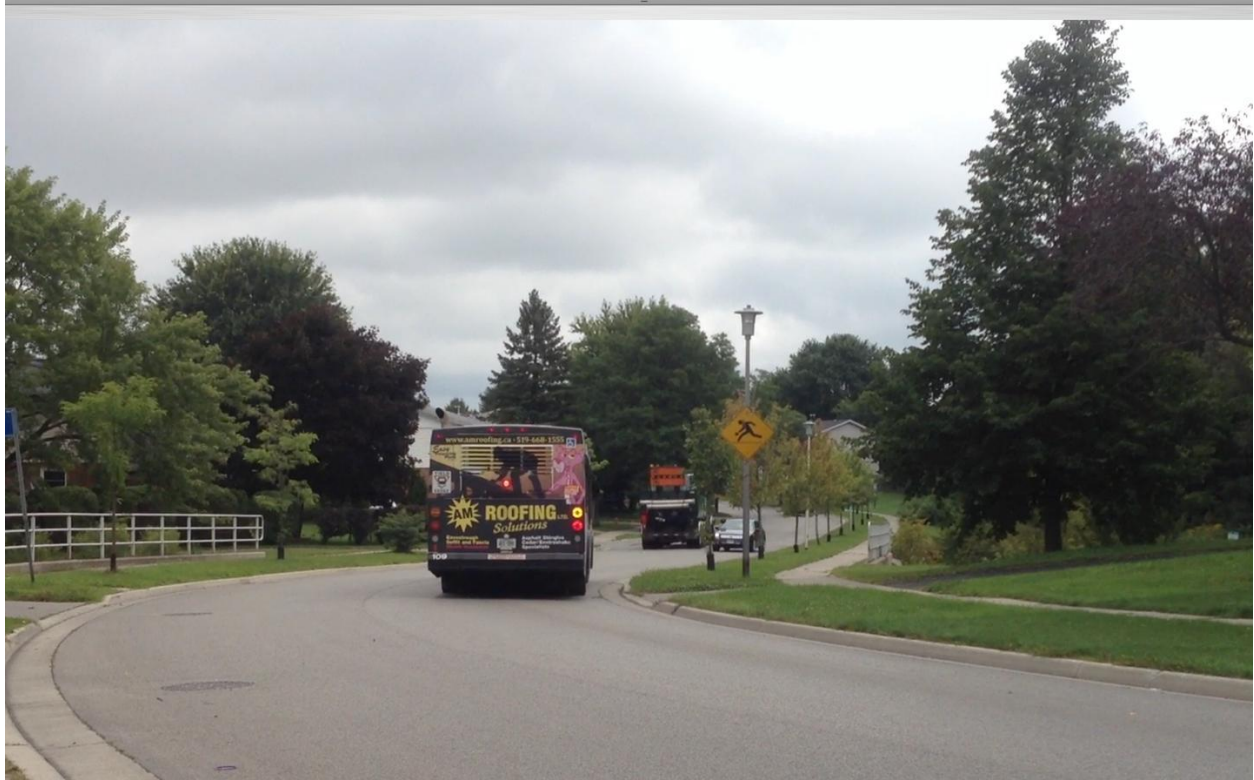
Figure 14: Bus driver applied right turn signal as an indication that the bus is stopping at the bus stop.

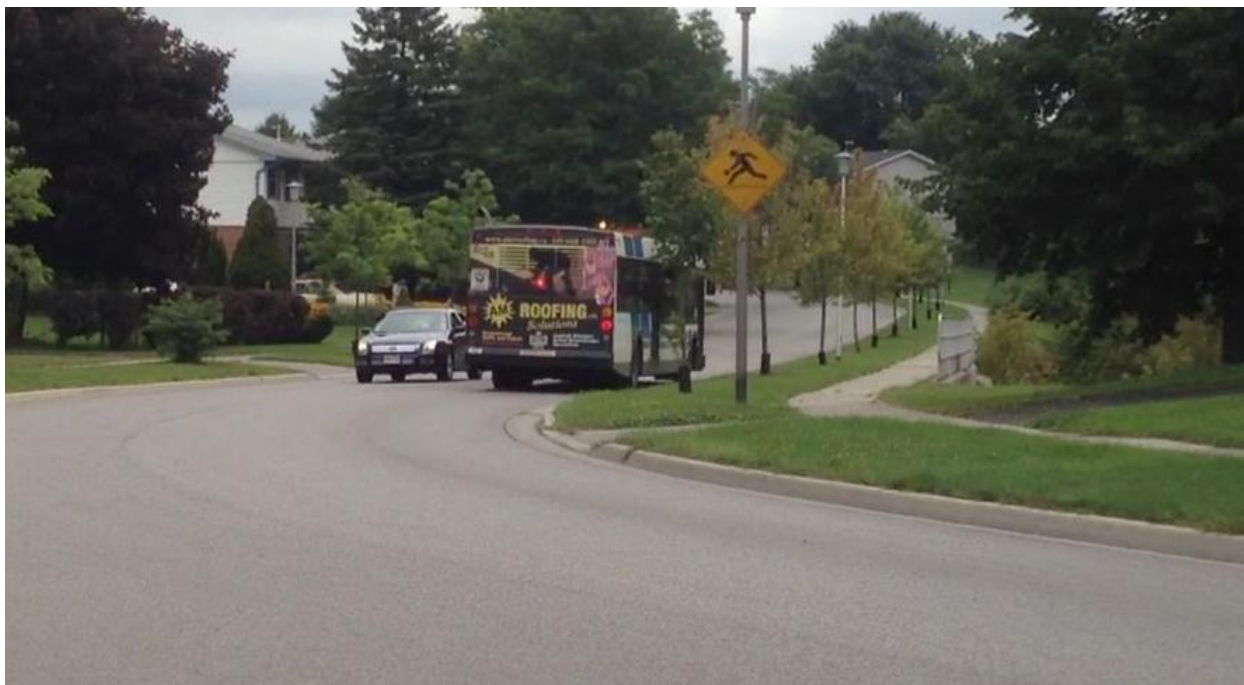
Figure 15: View of westbound car passing the bus which is stopping at a bus stop.

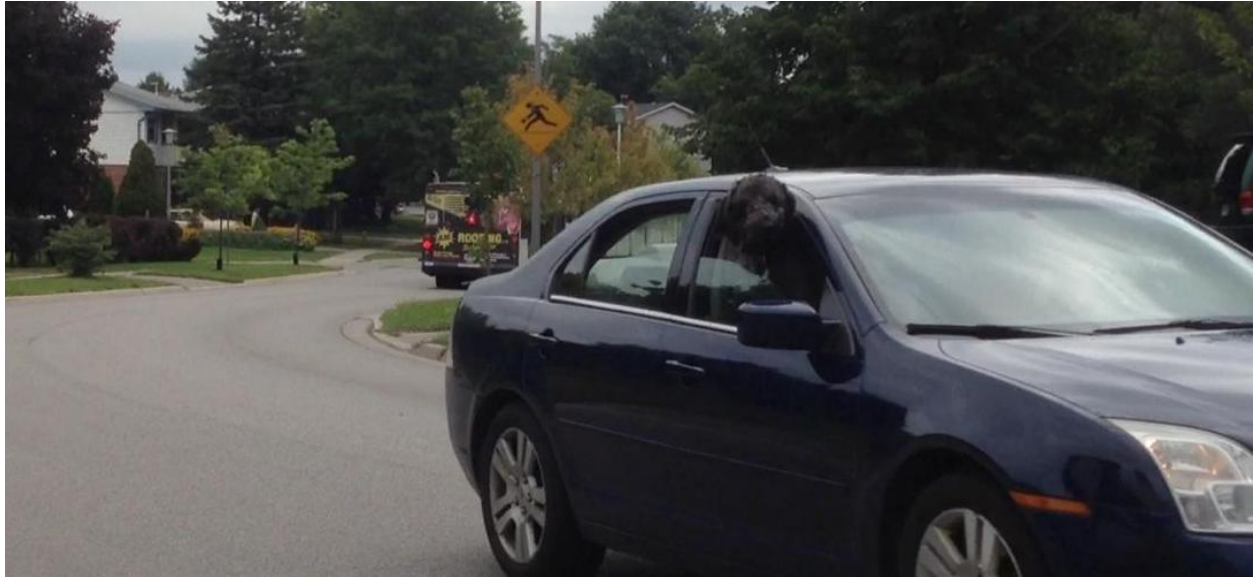
Figure 16: View of interesting passenger (or perhaps an English driver?) of westbound car, while bus has come to a halt at the bus stop. A collision is fortuitously avoided.

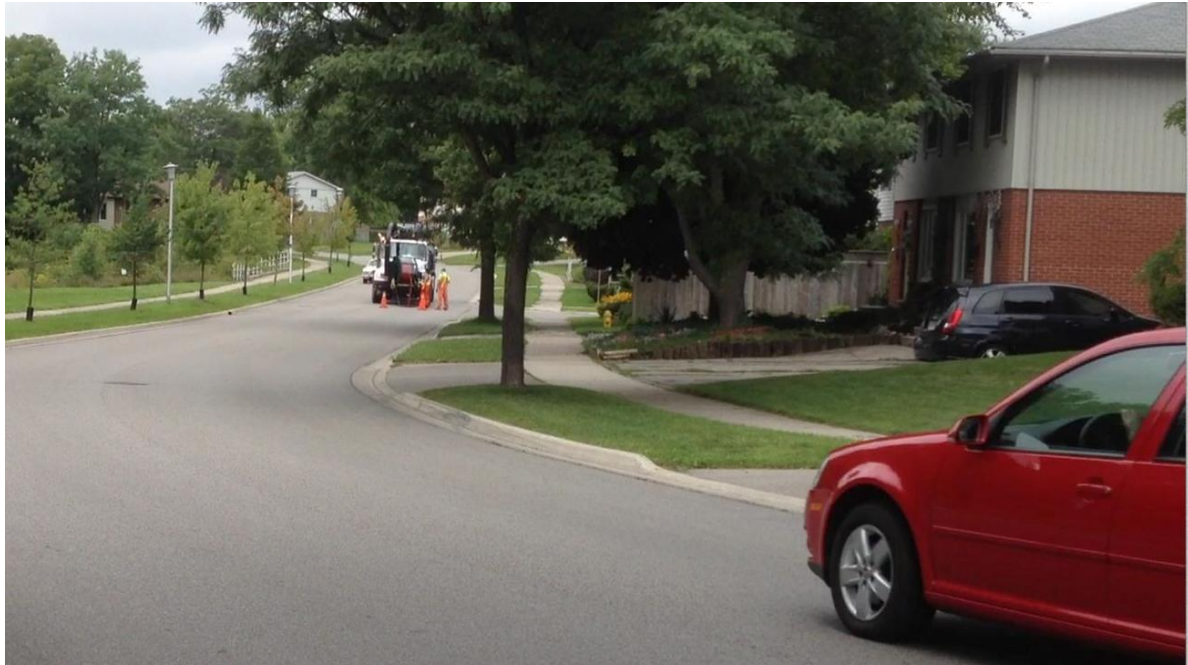
In Figure 17 we observe a westbound red car entering the view as it travels around the right curve while the City of London truck is stopped ahead and blocking the westbound lane. Note that there are no warning signs placed either on the road, on the roadside or on the stopped truck to notify the oncoming driver of the situation. It would be expected that the driver of the red car would steer into the opposing, eastbound lane to pass the stopped truck. However, if we look closely we can see that there is an eastbound car that is just entering into the view from behind the truck.

Figure 17: View, showing a westbound red car whose driver is not in a position to see that an eastbound car is approaching from behind the City of London truck which is stopped and blocking the westbound lane.

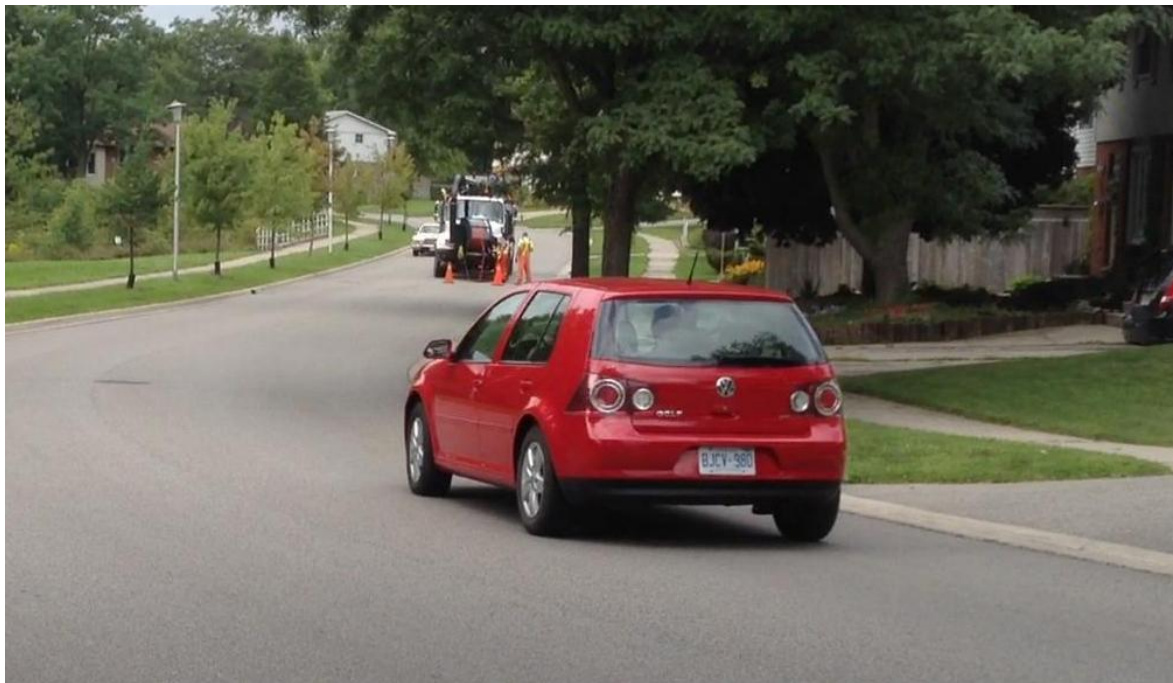
In Figure 18 we can see that the driver of the westbound red car is in a position to begin to see the eastbound car which has just emerged from behind the stopped truck. However the time to detect, identify and determine a course of action takes a finite time and therefore the driver of the red car has not yet initiated any braking.

If the driver of the red car was travelling at a reasonable speed then a collision could be avoided if moderate to hard braking was applied. However, that is not always the case. What if the driver of the red car was actually speeding? The possibility is that hard braking might not prevent a collision and therefore the driver might attempt to steer hard to the right and attempt to travel to the right of the stopped truck. In such a scenario the driver of the red car may be unsuccessful and the car would collide into the front end of the parked truck. However, we can see that there are two workers standing in front of that parked truck and there is a reasonable likelihood that the red car could strike one or both of the workers and perhaps even pin them between the car and truck. Such a scenario could easily prove to be fatal.

Figure 18: At the location shown in this figure the driver of the red car should begin to detect the presence of the eastbound car yet a reaction of braking or steering would begin no earlier than 0.50 seconds later but more likely 1.0 to 1.5 seconds later.

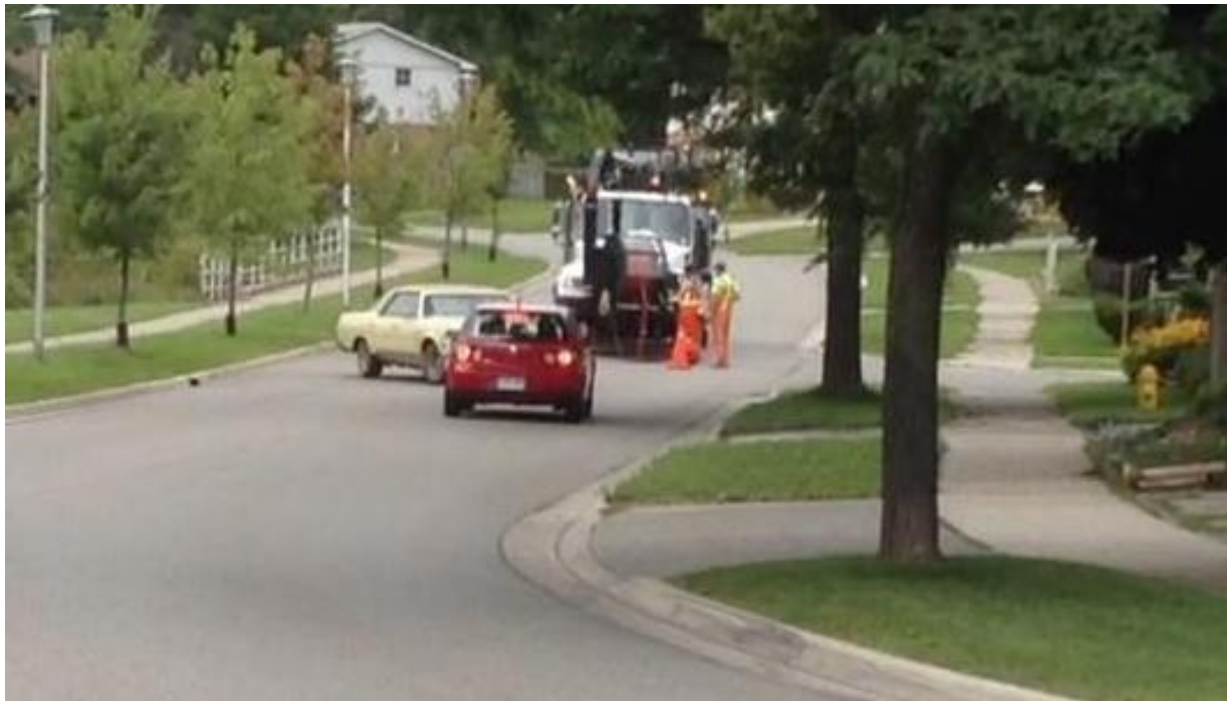
There is an additional possibility that the driver of the eastbound car could attempt to steer to the left to avoid the red car entering into the eastbound lane. Such a reaction could cause a scenario similar to what is shown in Figures 19 and 20.

Figure 19: If the driver of the cream-coloured eastbound car attempted to avoid the red car by steering hard to the left then a collision scenario such as the one shown in this figure could occur.

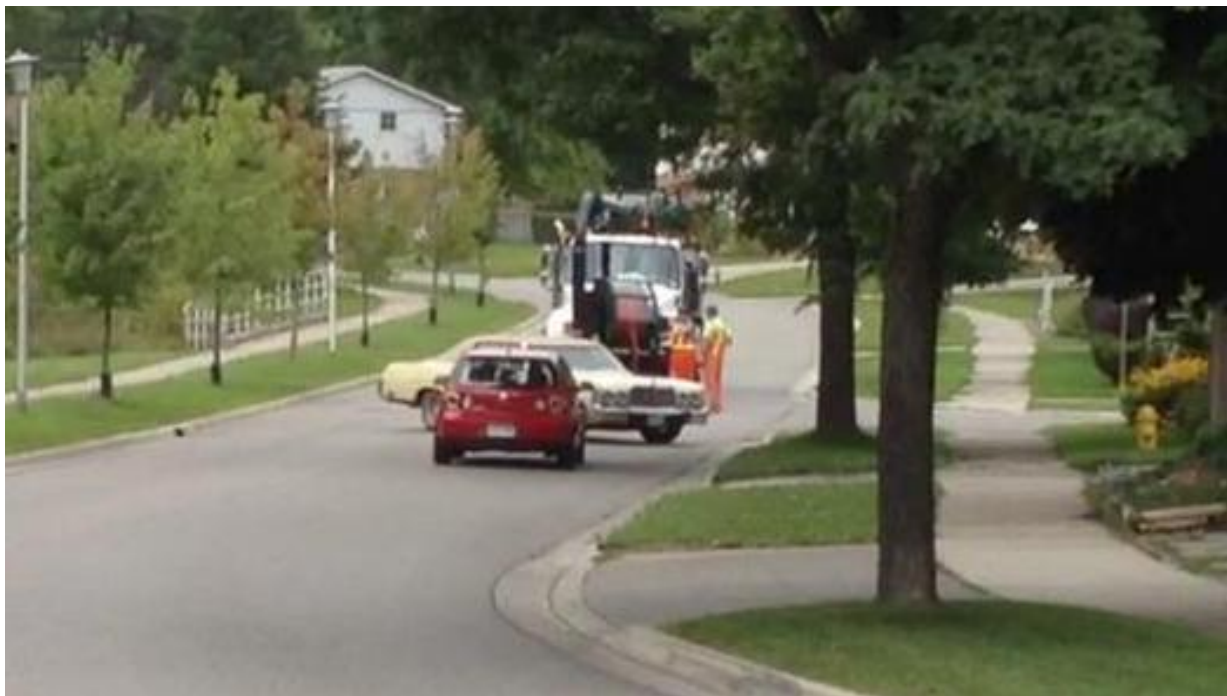
Figure 20: Here the cream-coloured vehicle might be rotating counter-clockwise, out-of-control, and at a slower speed than the red car such that both vehicles could be propelled westward into the front end of the stopped truck, possibly striking the workers.

If the red car was travelling quickly and the cream-coloured car was travelling slowly then both vehicles could be propelled into the front end of the stopped truck. Once

again, we could see the potential for serious or even fatal injuries to one or both of the workers who are standing, unprotected, in front of the truck.
