Archived News - 2016 - July

Fatal Head-On Collision on Glendon Road, West of London, Ontario

Fatal Rear-End Collision At Highway 23 Construction Site Near Woodham, Ontario

Fatal Rollover on Highbury Ave North of Commissioners Road in London, Ontario - What is Known From the Site Evidence

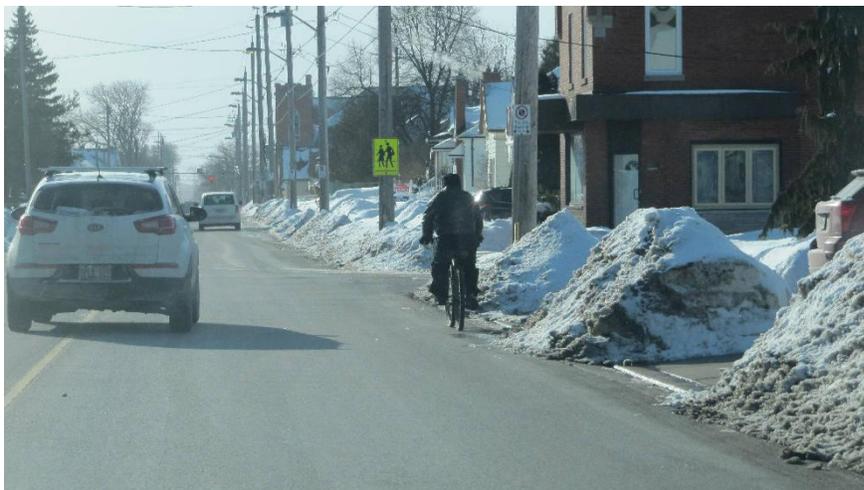
While in the past bicycles were used for recreation in mild conditions, lately they are used for essential transportation in less than ideal conditions as shown in the above example.

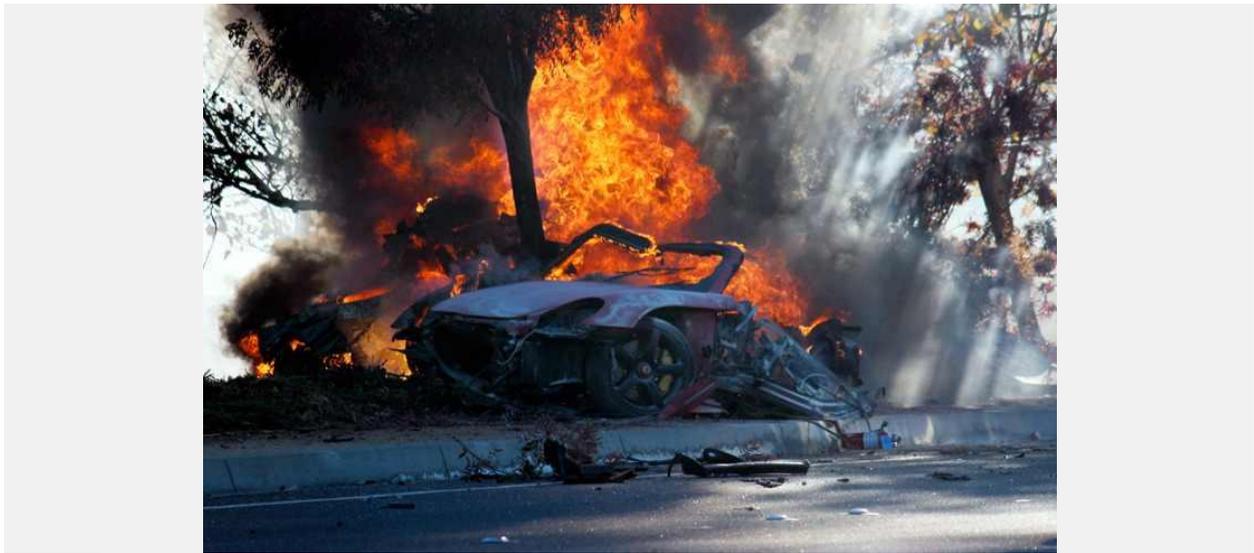
The well-known star of the Fast & Furious movie series, Paul Walker, died in this fiery crash of a Porsche on November 30, 2013.
