Calvin William Gogo Charged: Double Fatal On Pressey Line, Malahide, March 26th, 2011

It has been reported that at approximately 10:35 P.M. on Saturday, March 26, 2011, an eastbound GMC Pick-up truck, carrying a driver and four passengers collided with the south concrete bridge abutment on Pressey Line just west of Carter Road, just north-east of Aylmer, Ontario. I was out at the accident site this afternoon and have the following to report.

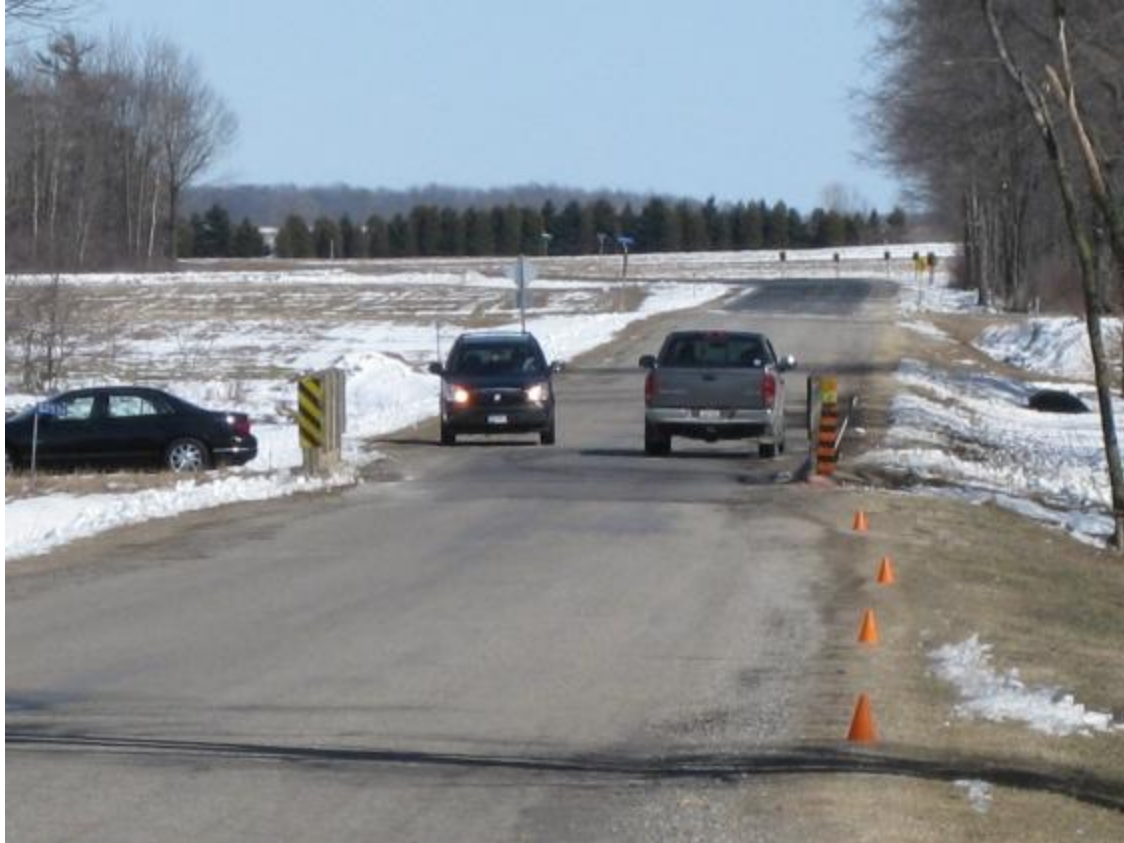
If you look at this photo and the one previous it should become apparent that the bridge is quite narrow and that traffic approaching it has a good likelihood of getting close to the concrete abutments because the width between the abutments is only 6.2 metres. No wonder there was the sign indicating this was a "Single Lane Bridge". For example below is a photo, zoomed in from 150 metres west where we see two vehicles passing each other near the bridge. Yes, two vehicles could make it through but just barely.
