# Characteristics of Tire Marks During Braking and Acceleration During a U-turn on Gravel Shoulders - Part 3

*Posting Date: 29 Feb-2016*

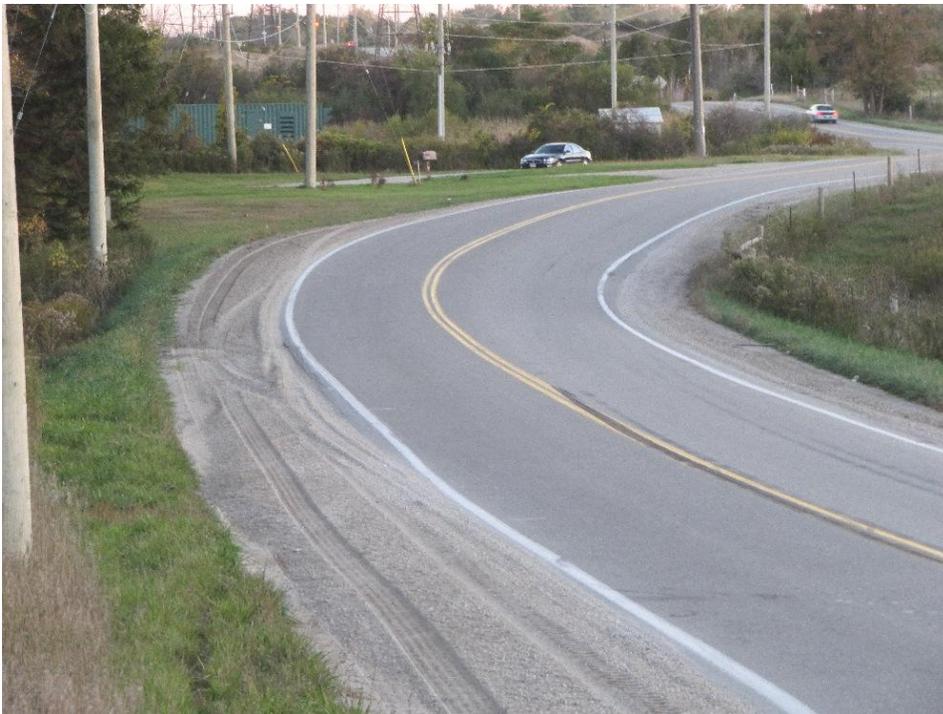
**Figure 1: View looking south at the S-curve of Clarke Road north of Fanshawe Park Road in London, Ontario on October 11, 2013. This is the "Laboratory" where a number research studies have been conducted at Gorski Consulting.**

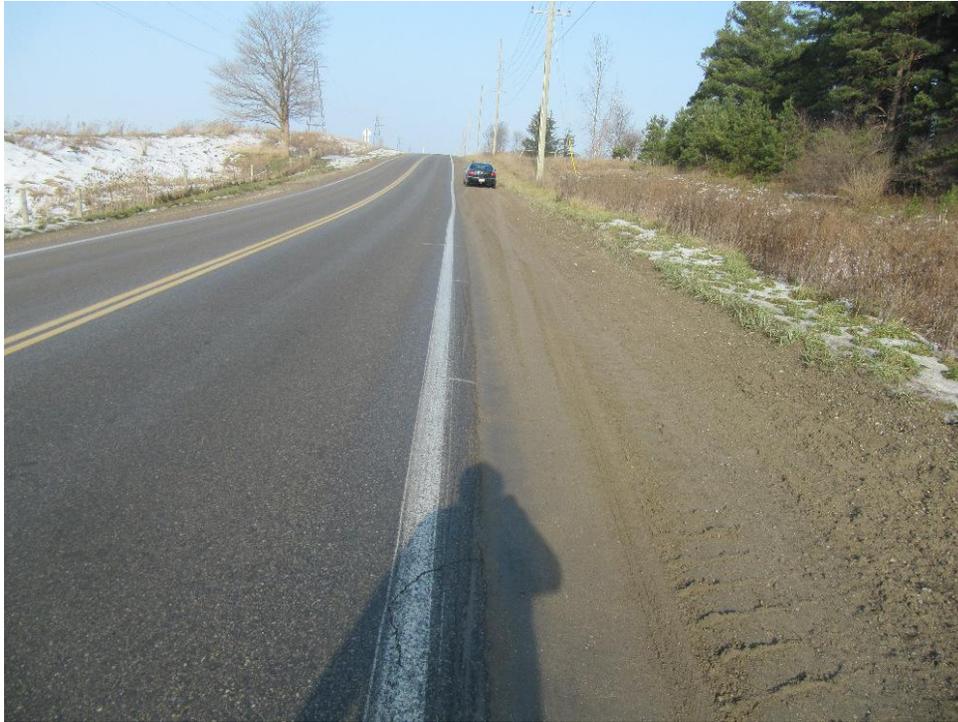
Figure 7: View, looking north, along the east shoulder of Clarke Road toward the stopped position of the test vehicle after it entered the shoulder at a speed of 60 km/h and then was braked to a stop.

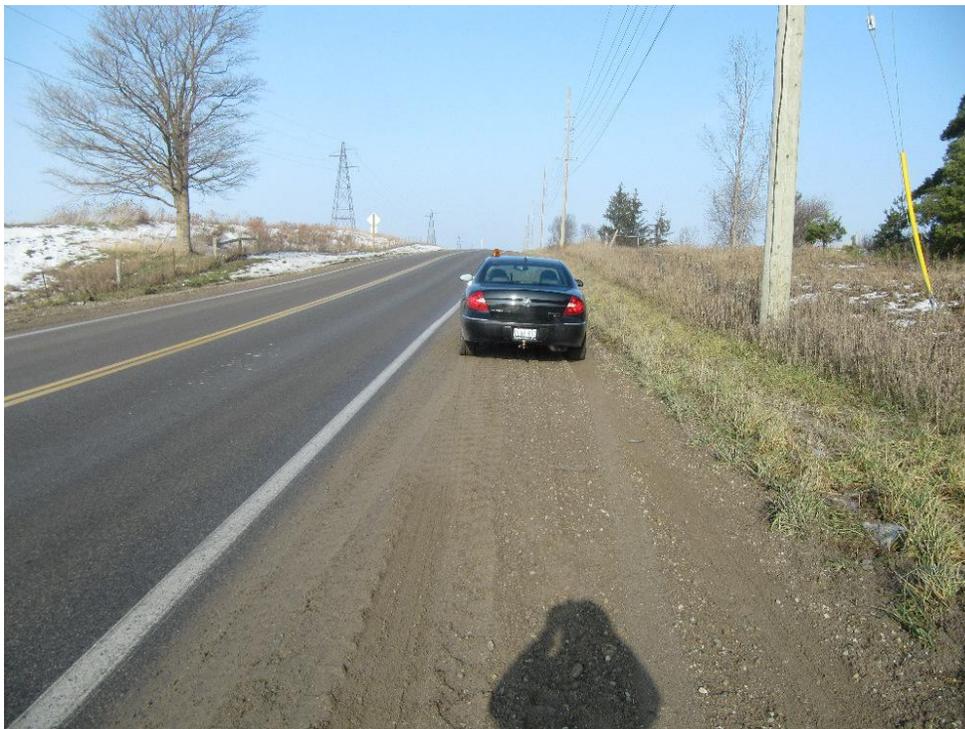
Figure 8: View, looking north, along the east shoulder of the Clarke Road at the stopped position of the test vehicle.

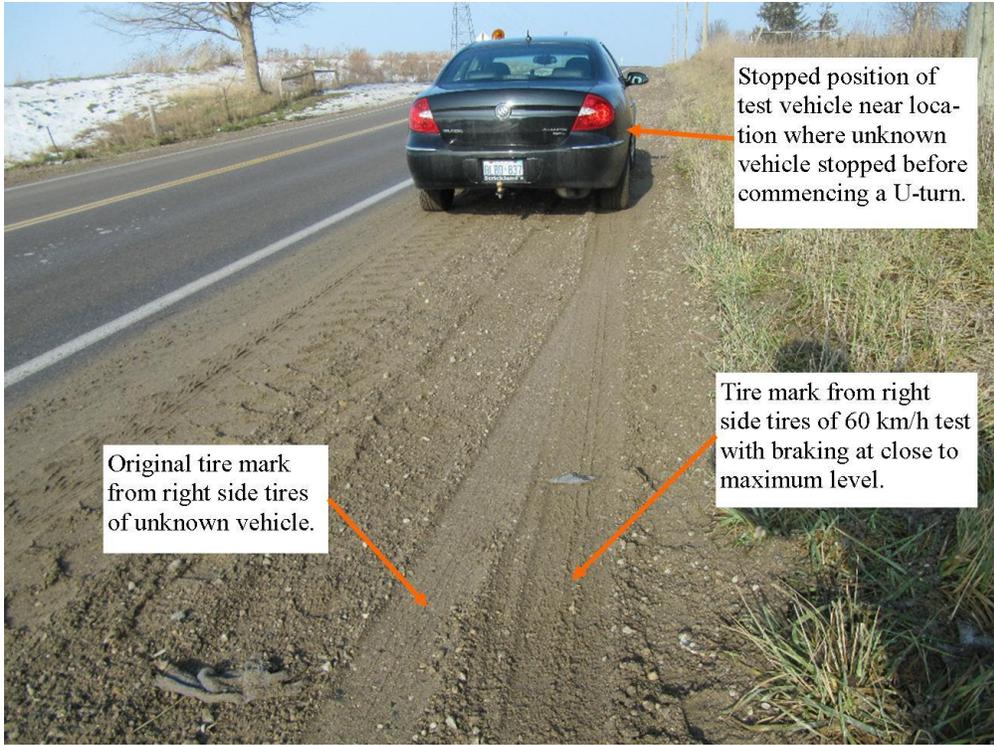
Figure 9: View of test vehicle and tire marks behind it.
