Fatal School Bus Collision North of London Ontario

Posting Date: 11-Oct-2016

Gorski Consulting
London, Ontario, Canada

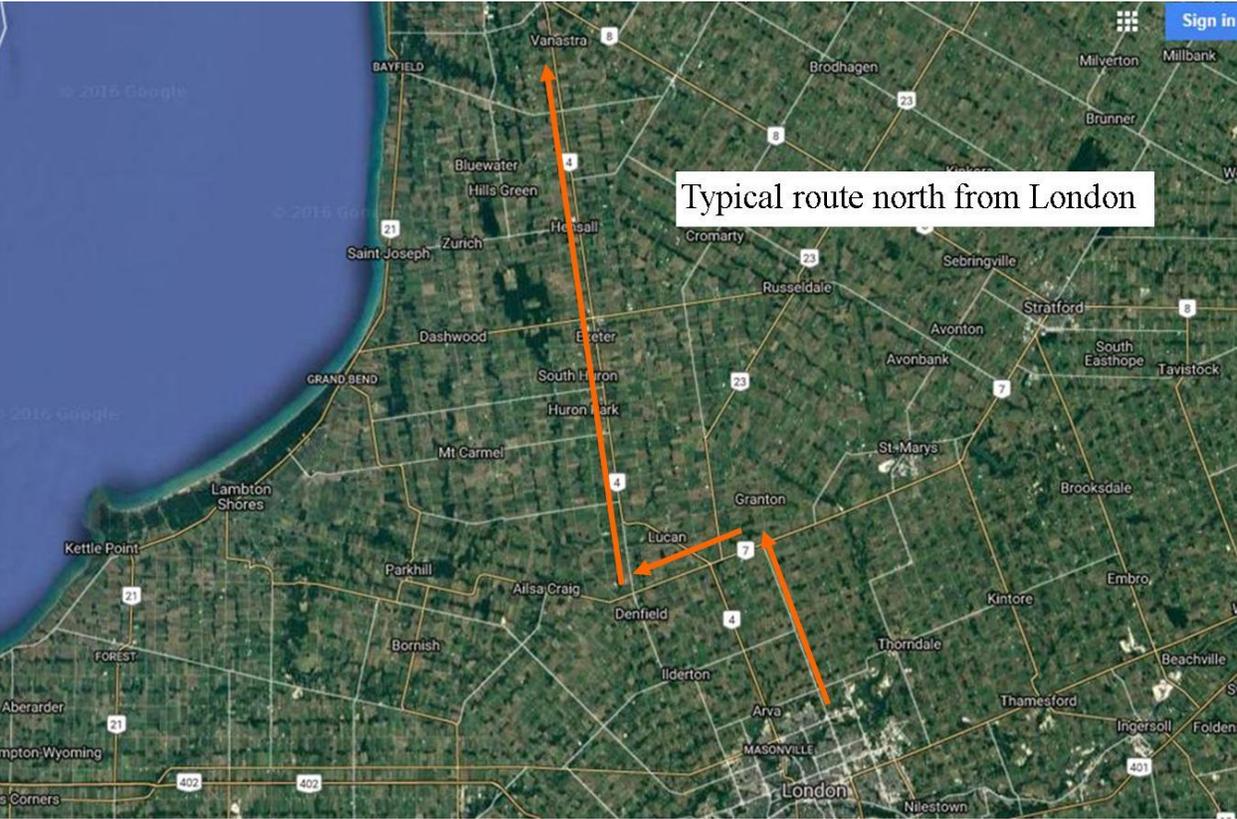
The collision was being investigated by the Ontario Provincial Police (OPP) who released the photo of the crash site seen in Figure 1. In the photo it can be seen that the bus is lying on its passenger side and the struck tree is located in the background. The curiosity about this view is that the road surface is gravel. One would wonder why a full size school would be travelling along this gravel road when the driver's destination was still about an hour away. Travel on gravel roads might seem reasonable if the bus was picking up students at their rural residences which might often be located on local, gravel roads. But at the time of the collision the bus was empty and it would not be picking up students. Furthermore, travelling between London and Clinton would be expected to take certain well-established routes, over paved highways. Twelve Mile Road would not be a primary choice for long distance travel because not paved but contains a gravel surface.

Figure 1: Photo of the collision site released by the OPP.

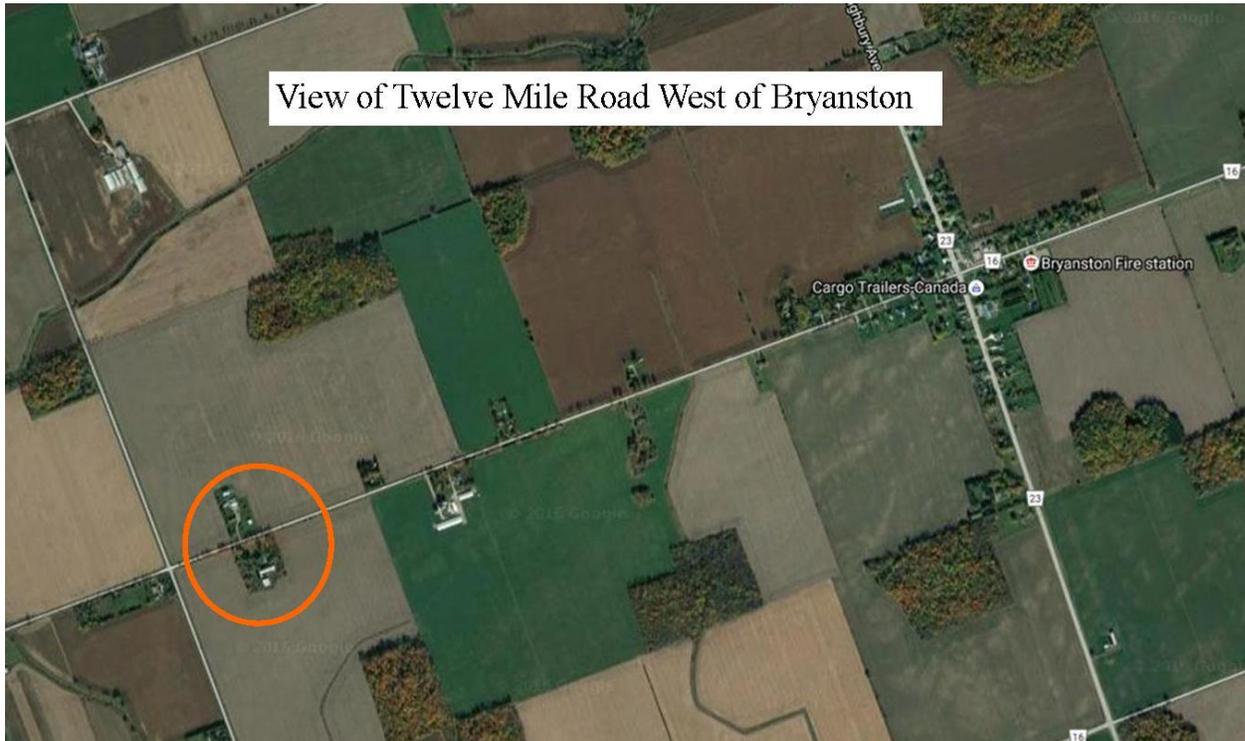
Figure 5 provides a closer view of the accident site, circled in orange, with respect to the intersection at Middlesex County Road 23 at Bryanston.

Figure 5: View of the accident site with respect to the intersection with Middlesex County Road 23 at Bryanston.

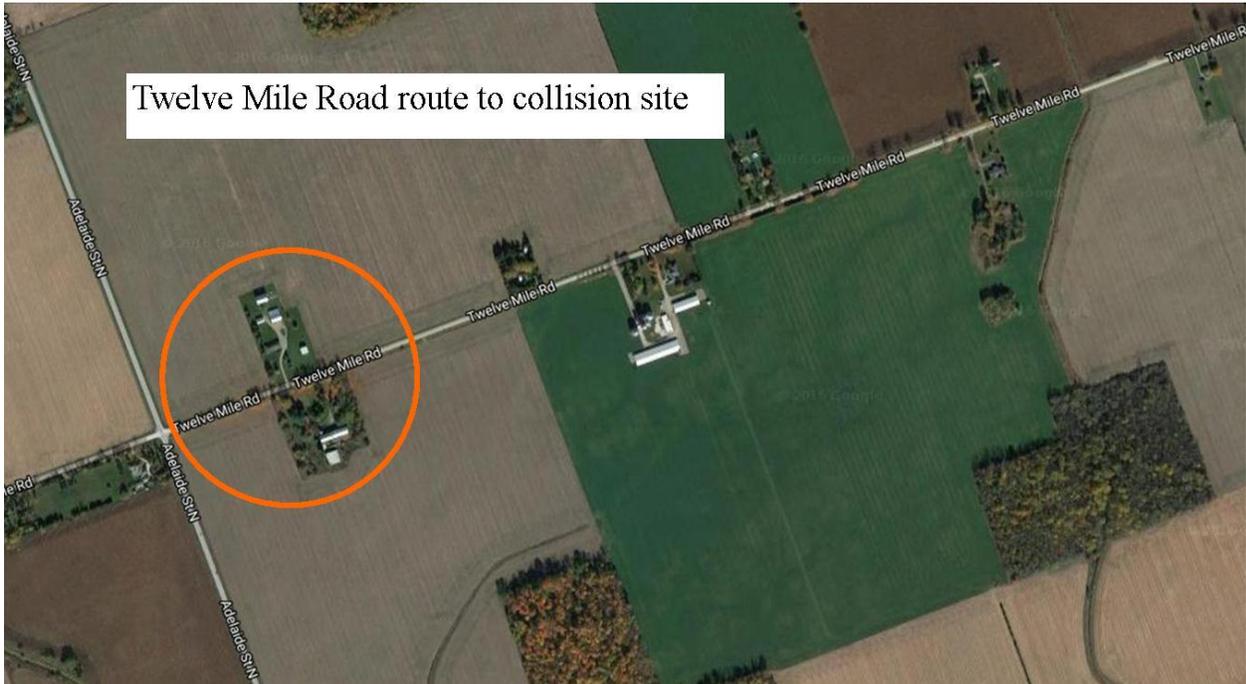
Twelve Mile Road route to collision site

One can observe that Twelve Mile Road is essentially agricultural with farmsteads and farm fields on both sides of the road. Figure 6 brings us closer to the farmstead located on the north side of the area of impact while Figure 7 pinpoints location of the tree on the south side of the road where the impact occurred.

Figure 6: View of farmstead in vicinity of the collision site on Twelve Mile Road.

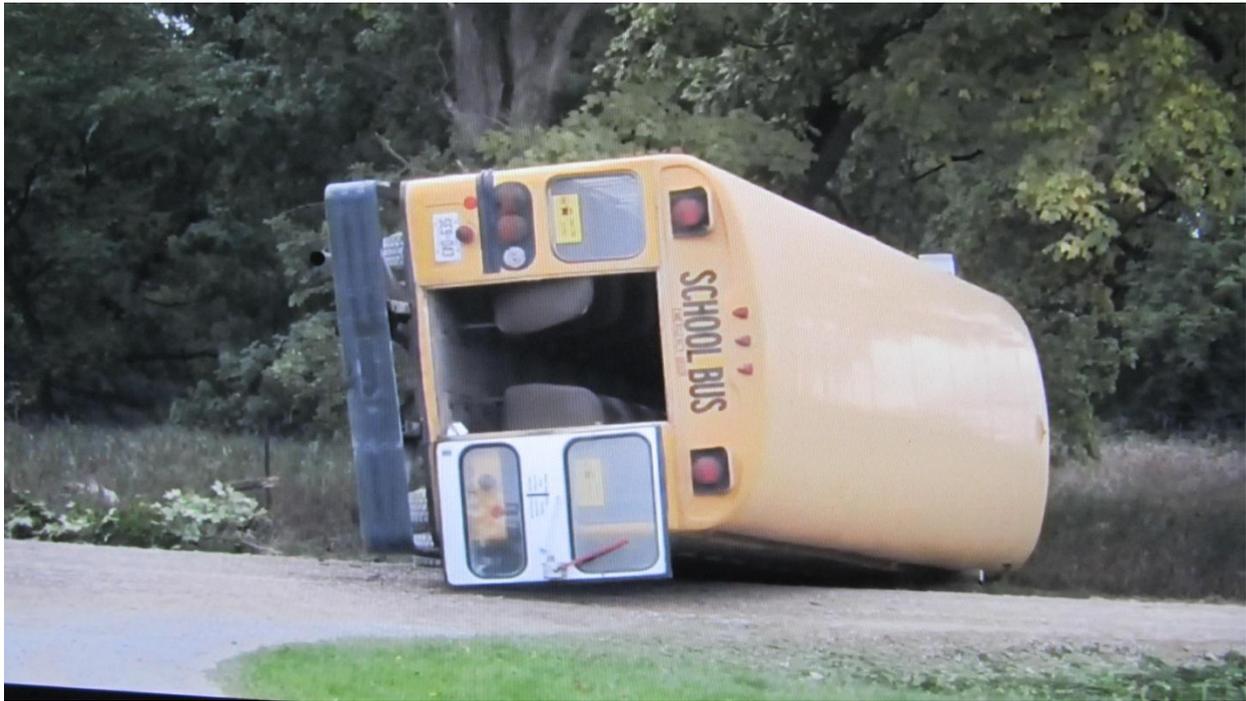
Figure 8 shows another view of the school bus at its final rest position and one can see the edge of the private driveway in the bottom left corner of the view, thus one can orient the position of the school with respect to the aerial photo in Figure 7. Figure 9 provides another view, looking east, of the vehicle's rest position. Figure 10 provides an indication of the extent of frontal crush to the bus as a result of the tree impact.

Figure 8: A view of the private driveway in the bottom left of this photo allows for an estimation of the bus position along the roadway.

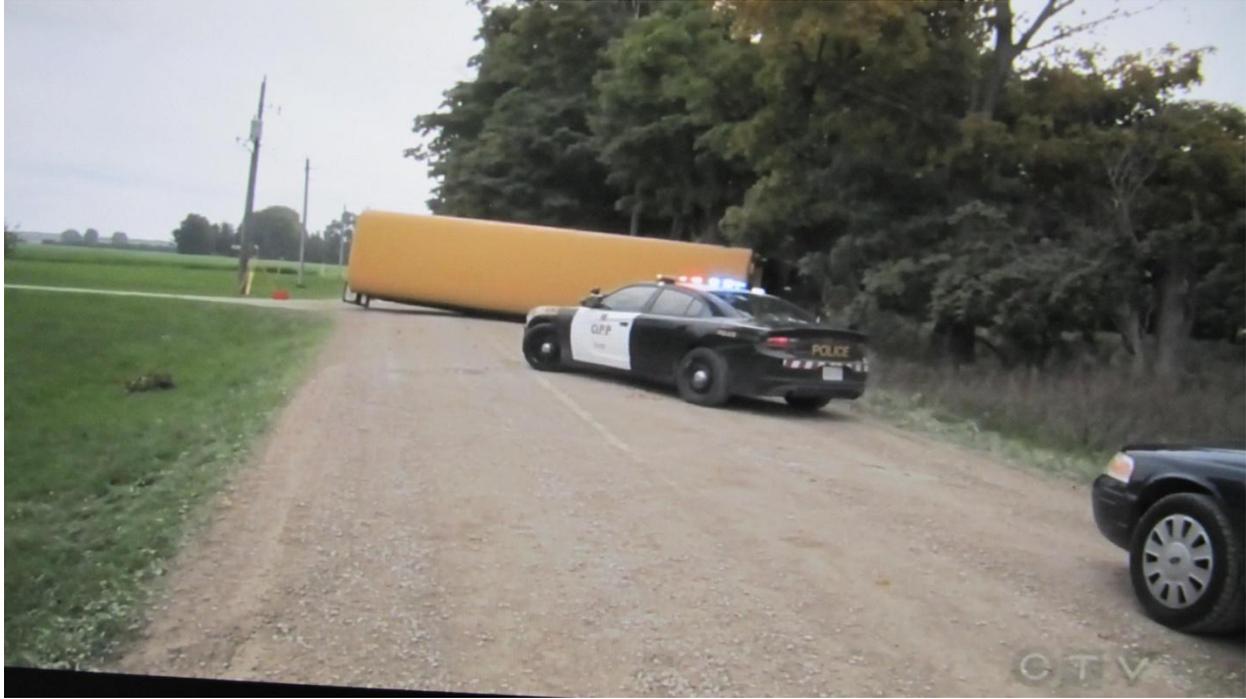
Figure 9: View looking east along Twelve Mile Road with the school bus at its final rest position.

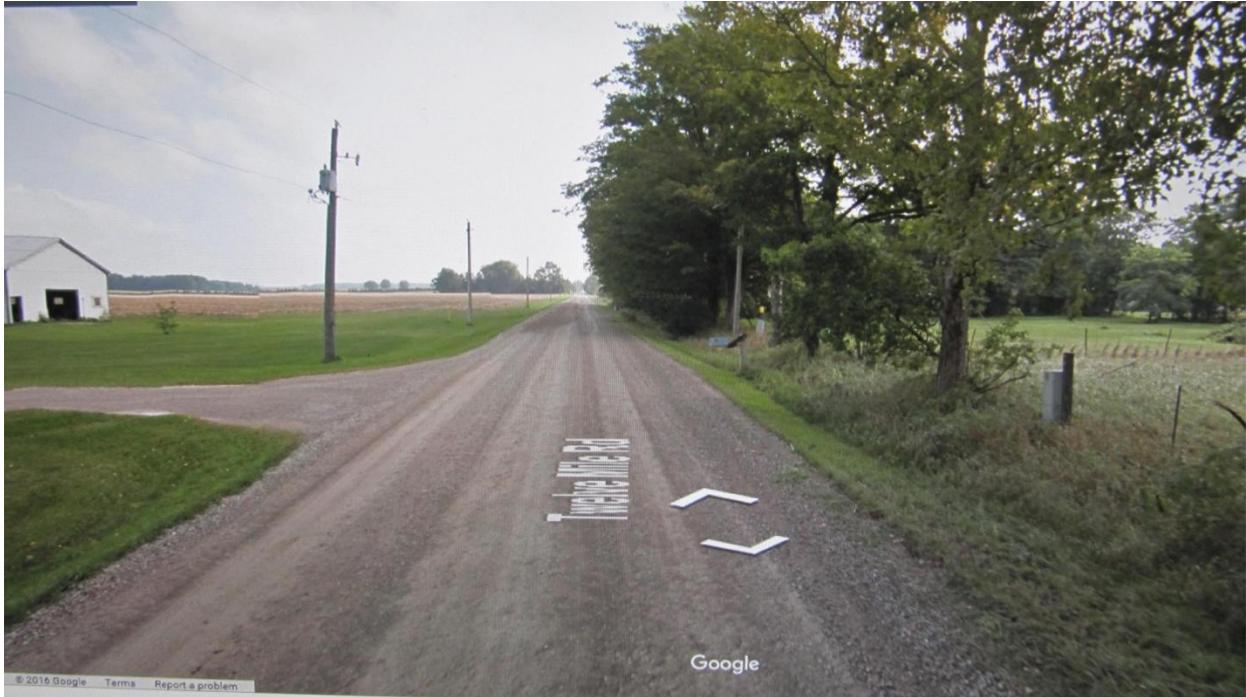
Prior to attending the collision site Gorski Consulting conducted an examination of the collision area via Google Maps. Figure 11 shows a view looking east along Twelve Mile Road toward the collision site. As we look into the background one can detect a difference in the shade of the gravel surface. This difference is more visible as we move further westward in Figures 12 and 13.

Figure 11: A Google Maps view of the collision site looking east. The private driveway at the final rest position of the bus can be seen on the left of this view while the struck tree can be seen on the right.

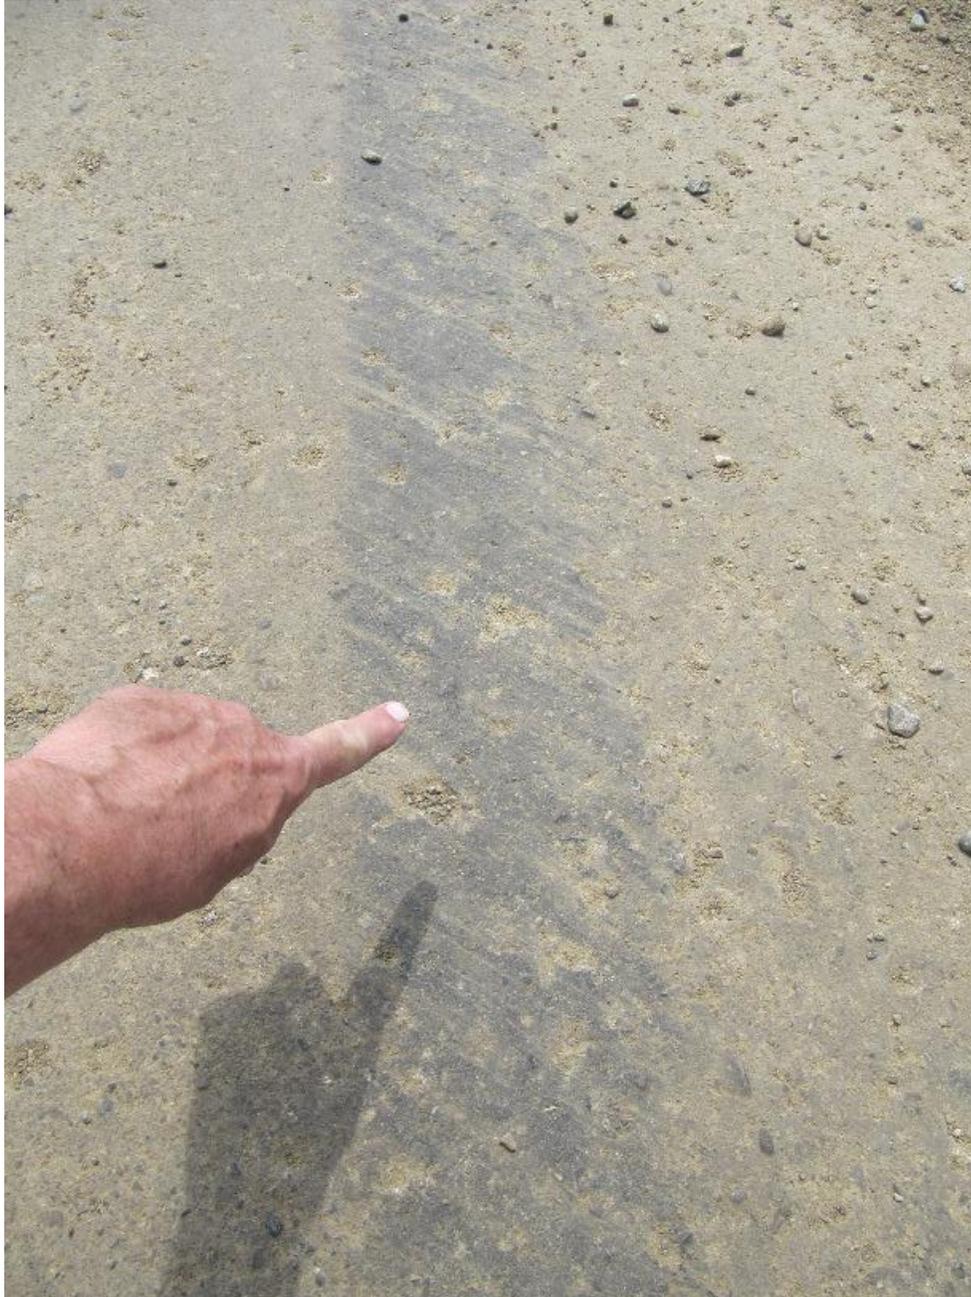
An answer is forthcoming shortly. In the meantime it can be highlighted that the loss of control of a vehicle on a packed, gravel surface can be identified by yaw marks that will be visible as shown in Figure 17. The angle of the striations within the mark will indicate whether any braking or acceleration occurred when the mark was produced. With respect to the site on Twelve Mile Road no such yaw marks were found.

Figure 17: Yaw marks indicative of a vehicle's loss-of-control rotation can be detected on the packed portion of the surface. As typical, the angle of the striations within the mark will reveal any indication of braking or acceleration.
