Further Interpretations of Loss-of-Control Tire Marks on a Gravel Shoulder

Posting Date: 14-Oct 2013

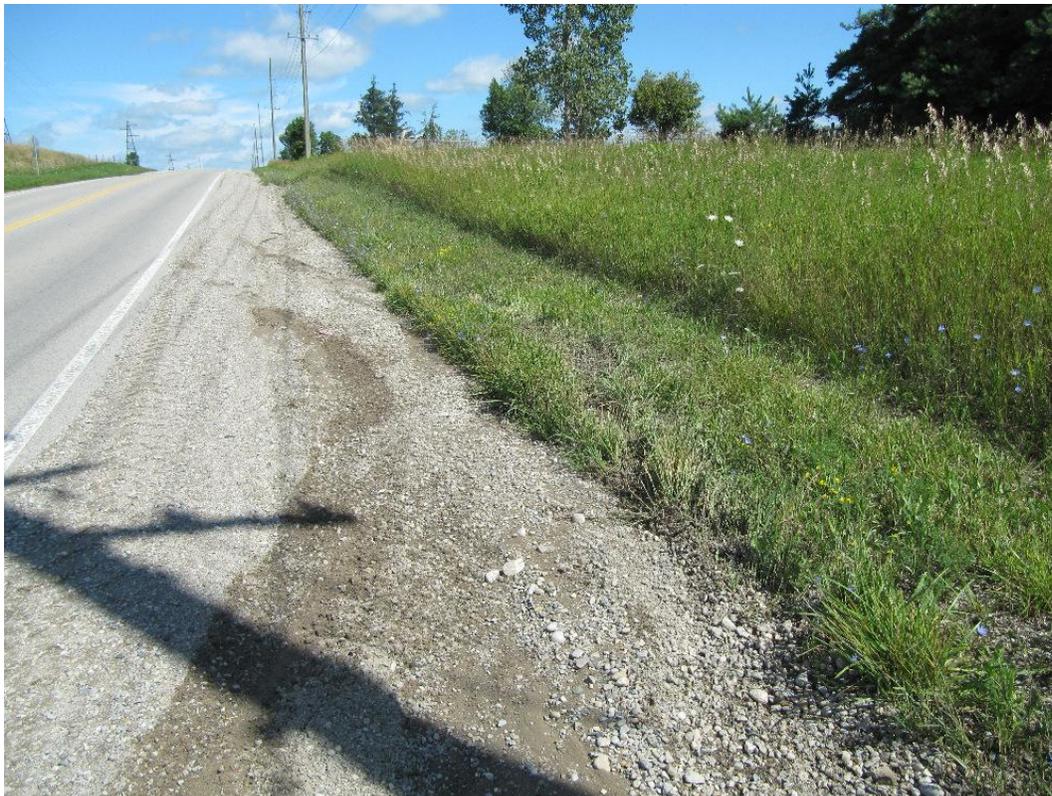
Figure 20: A copy of Figure 11 from the August, 2013 article showing a northerly view of the tire marks entering partly onto the east grassy roadside.

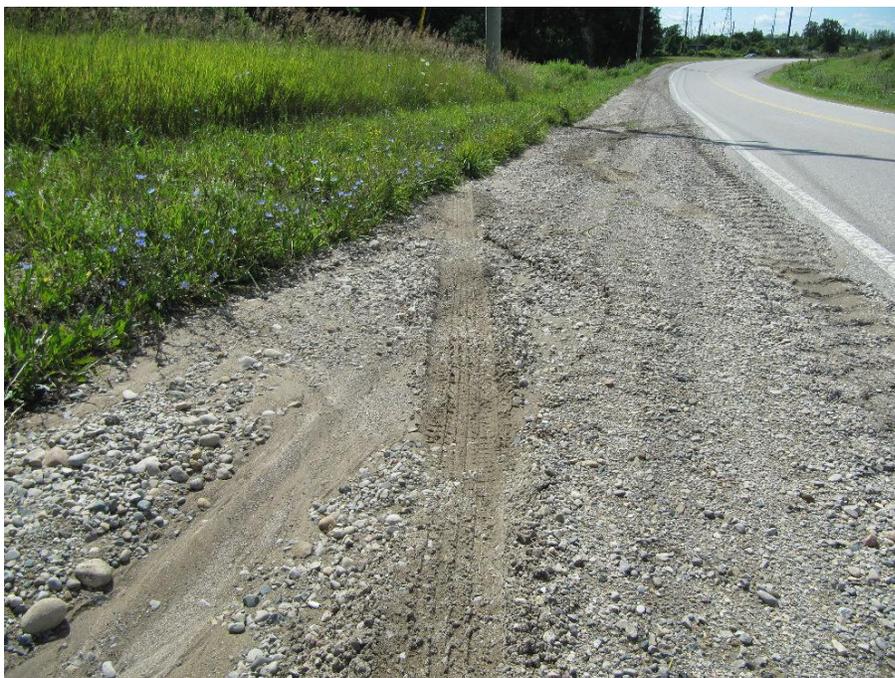
Figures 6, 7 and 21 have already provided some general, southward views of the tire marks in the vicinity where they exit the grassy roadside, so now we will look at some details of those marks.

Figure 21: A copy of Figure 16 from the August, 2013 article showing a southerly view of the tire marks as they exit from the east grassy roadside.
