# Irony of Selective Road Safety Enforcement

*Posting Date: 28-Apr 2013*

Gorski Consulting  
London, Ontario, Canada

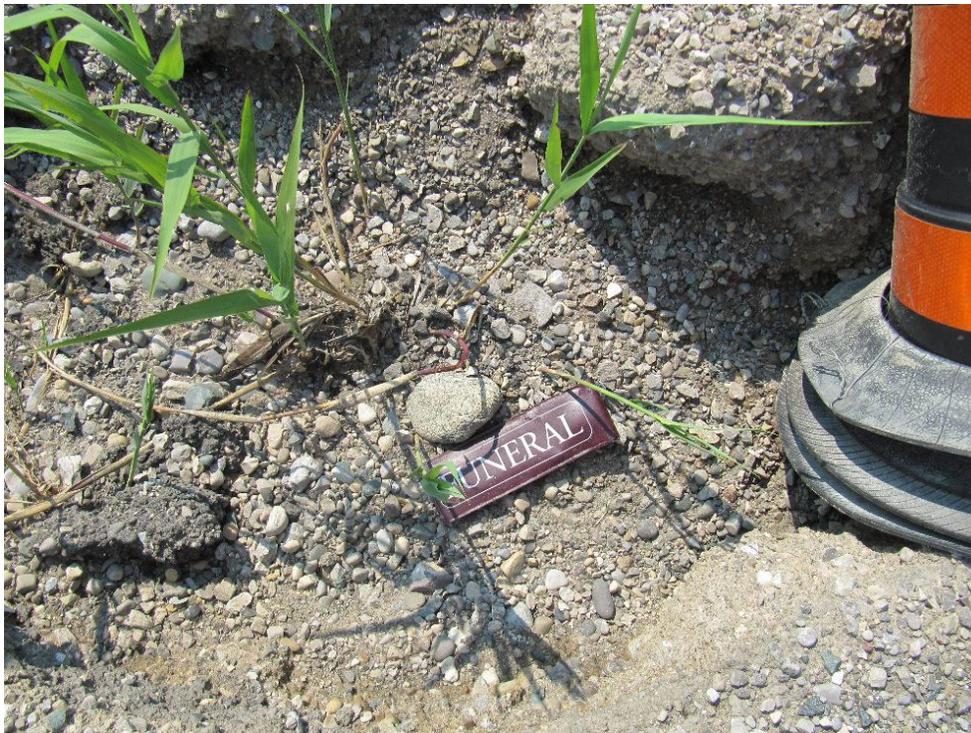
Figure 7: "Funeral" badge found lying in crevice of gravel shoulder on September 2, 2011.

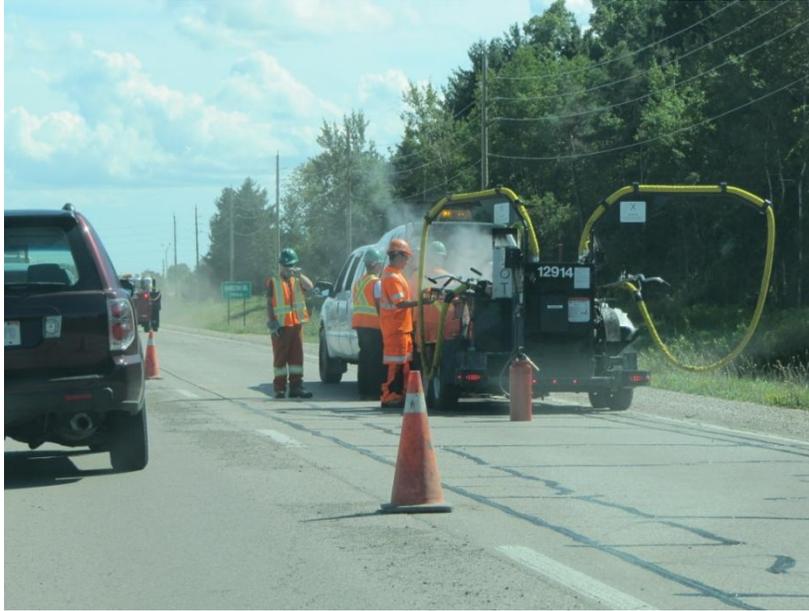
We also recalled what diligence was taken by repair crews when we observed them on August 20, 2012, as shown in Figures 9 and 10 below. The deterioration of the pavement was prevented by cutting into it and applying a rubberized asphalt sealer to fill in any possible cracks.

Figure 9: View of work crew operating in the southbound lanes of the Veterans Memorial Parkway.

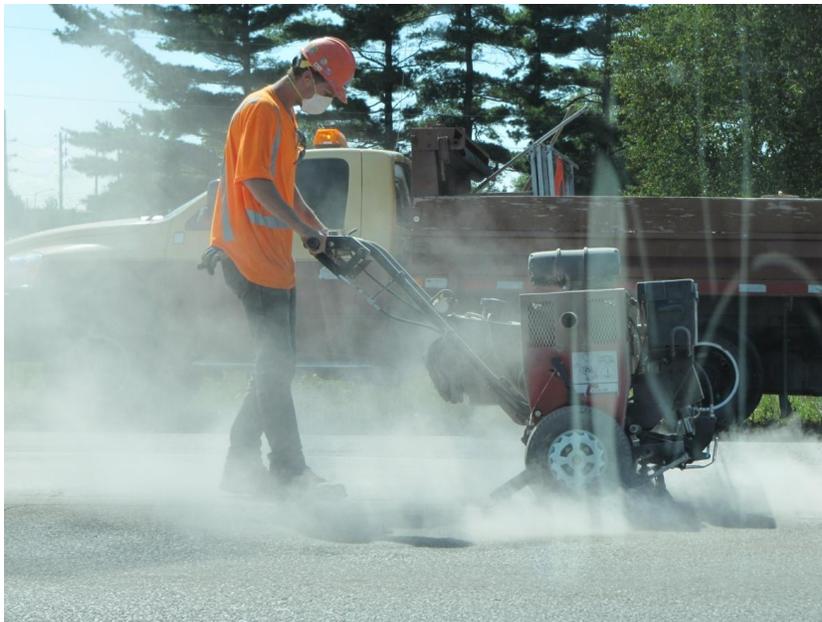
Figure 10: View of worker cutting into the pavement of the southbound lanes of Veterans Memorial Parkway on August 20, 2012.

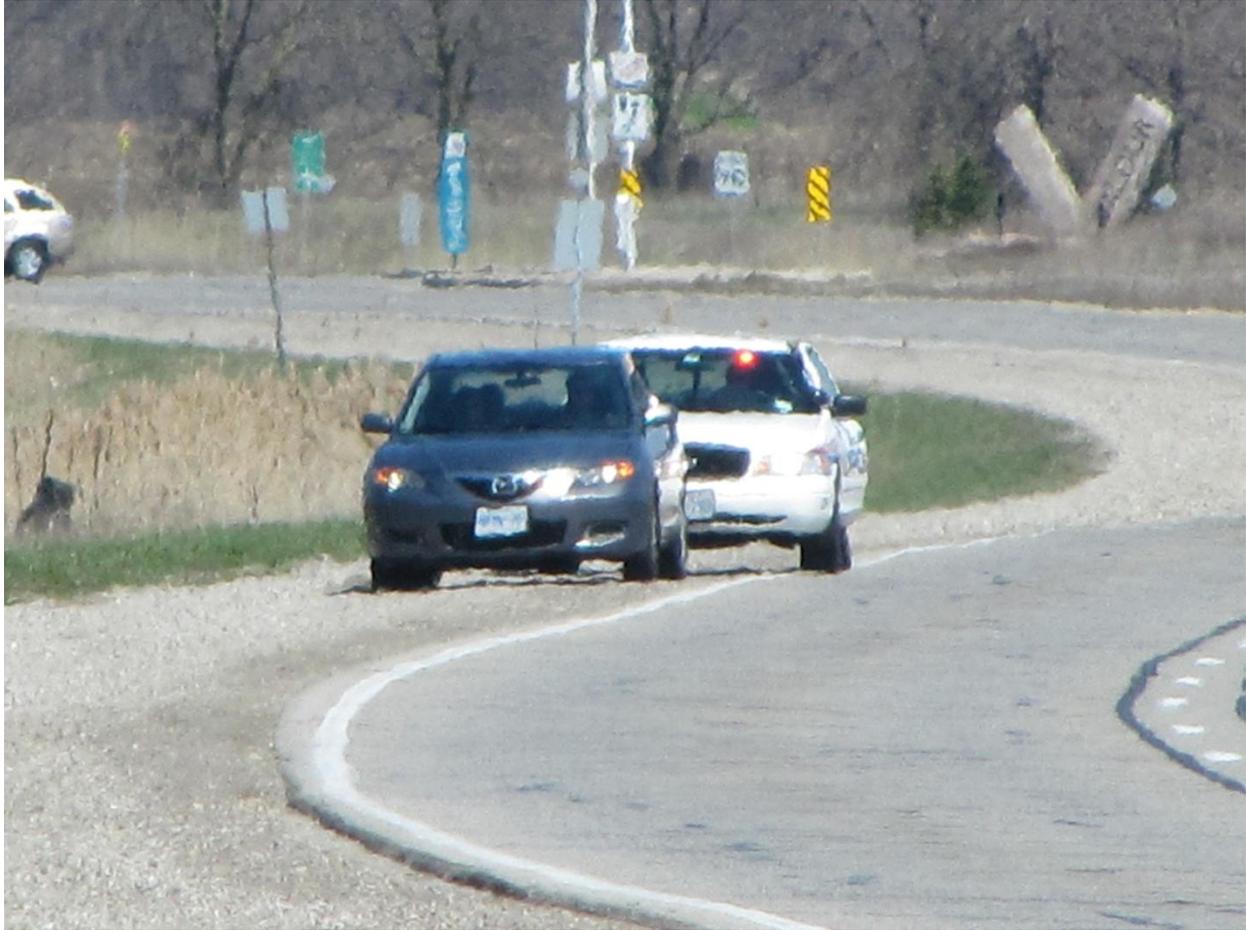
Figure 12: Zoomed in view of London Police cruiser making a traffic stop on the shoulder of the southbound lanes of the Veterans Memorial Parkway on April 26, 2013.

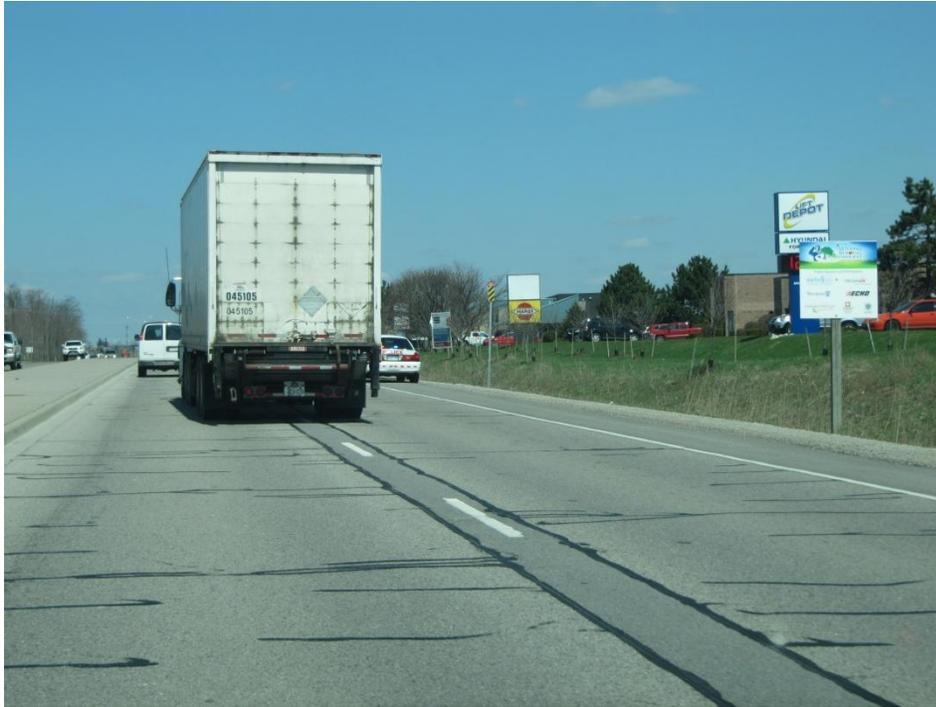
Figure 13: View of large truck moving over to the clear lane while passing the police cruiser making a traffic stop on the northbound lanes of the Veterans Memorial Parkway on April 26, 2013.

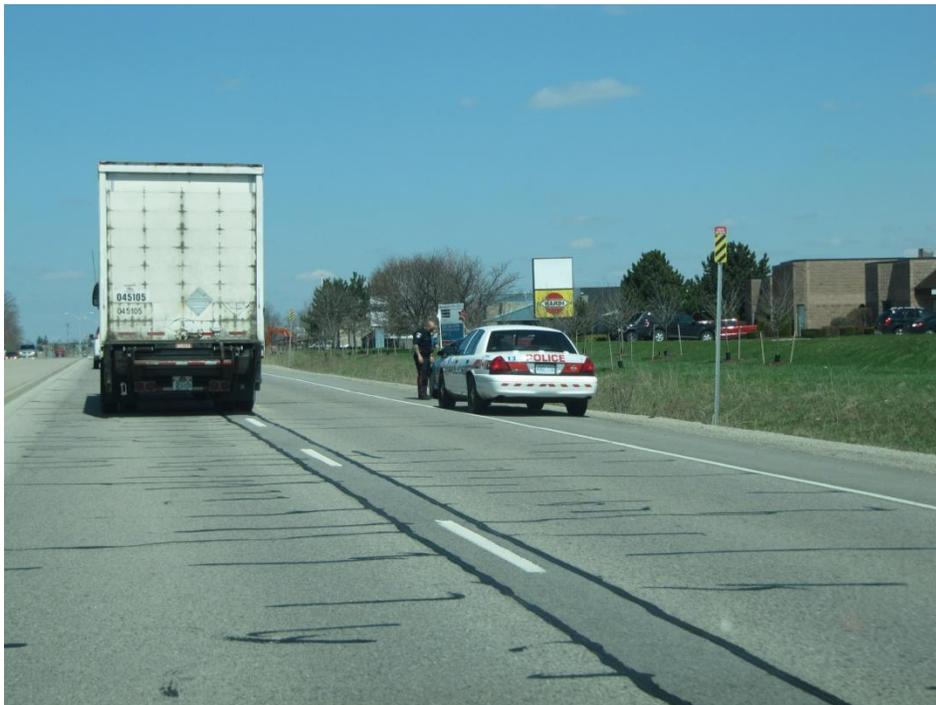
Figure 14: View of courageous police officer, standing outside of his cruiser near the northbound lanes of the Veterans Memorial Parkway on April 26, 2013.

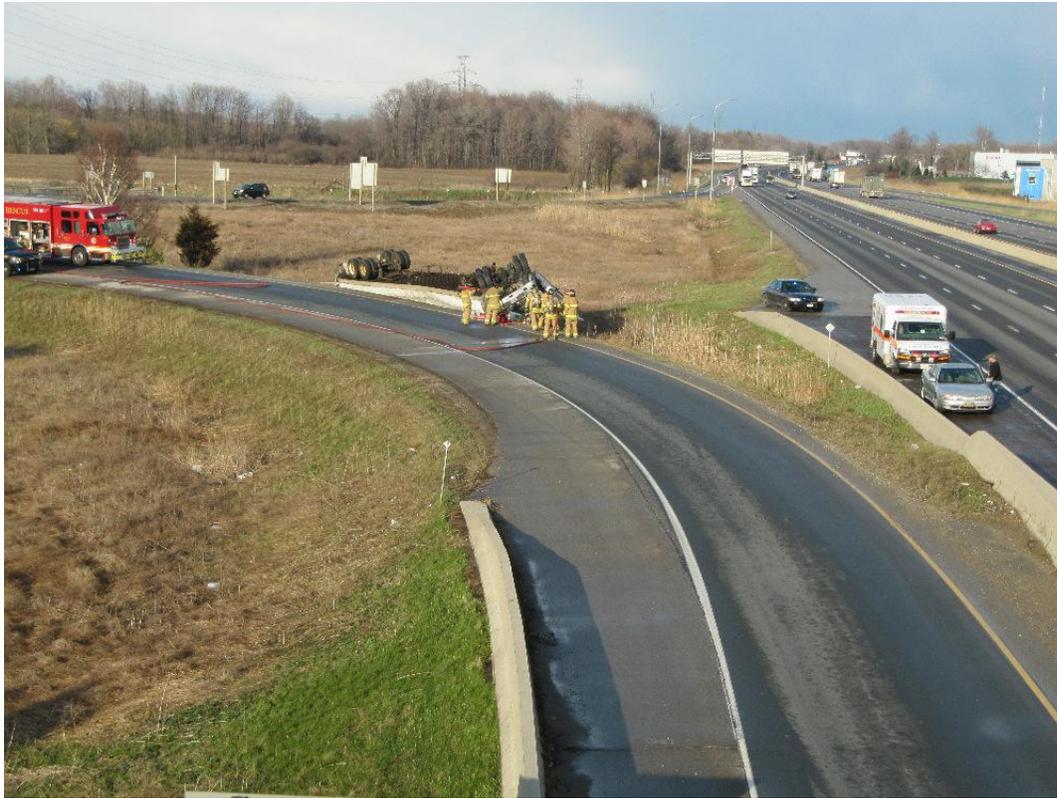
Figure 17: View, looking east toward the westbound entrance ramp to Hwy 401 from Highbury Ave where a Tractor trailer rolled over at approximately 1830 hours on April 25, 2013.

The driver of this transport truck reportedly sustained injuries but these were not serious. But the scenario could have been much worse. The truck cab was crushed above the driver and these drivers are more likely to be unrestrained in the mistaken belief that the mass of their trucks would prevent the large velocity changes that are experienced by smaller vehicles. Without wearing a seatbelt this driver could have been in a precarious situation, and even if he was restrained the collapse of the cab roof could have made the consequences unpredictable.

The typical scenario in such cases is that the driver of the rig travels too fast for "the" road conditions. But the road conditions changed rapidly as we know that a sudden downpour passed through the site at the time of the crash. So as we have said so many times before, there is no such thing as "the" road conditions, but that the road conditions often change and violate a driver's expectations.

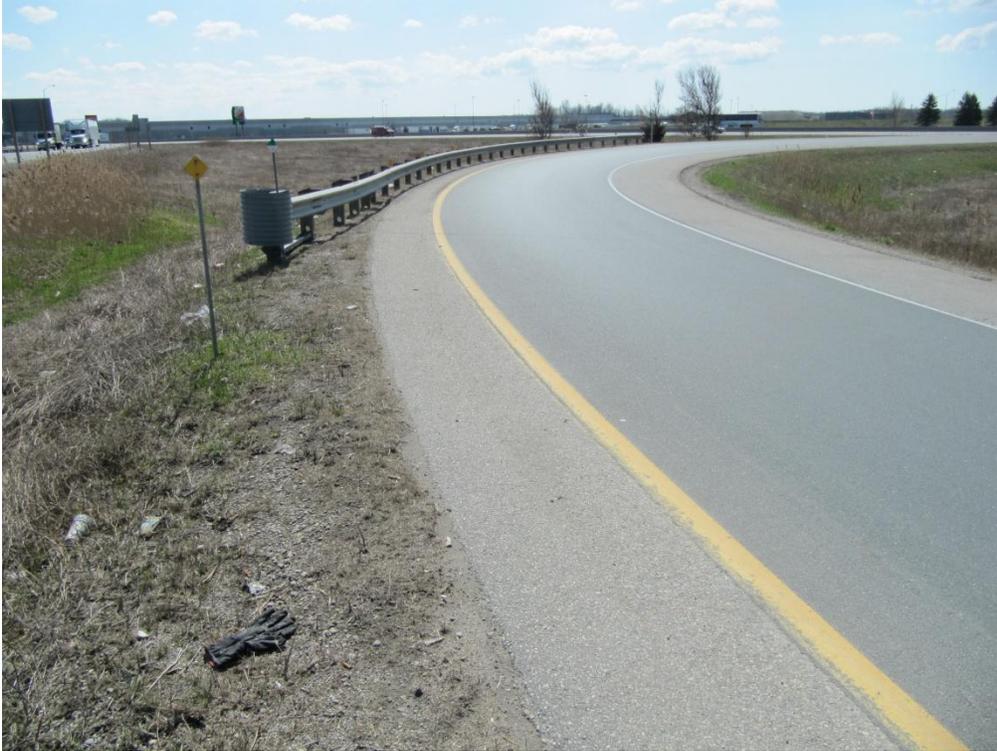
Even on the evening of April 25th we observed that there was a guardrail on the outside of that ramp but it ended prior to the point of where the tractor trailer rolled over. Yet, from our vantage point, we could see that there was a drop from the outside of the ramp, along a steep slope, down to the roadside and any vehicle travelling off that road surface would be in danger of rolling over. In fact, the evidence indicated that the truck had barely managed to tip over as its final rest position was not very far from the initiation of the roll. The minimal extent of the roll was evident in that, even though it travelled over a steep bank, the truck only managed two, quarter rolls.

Figure 19: View of beginning of guardrail on entrance ramp to Westbound Hwy 401.

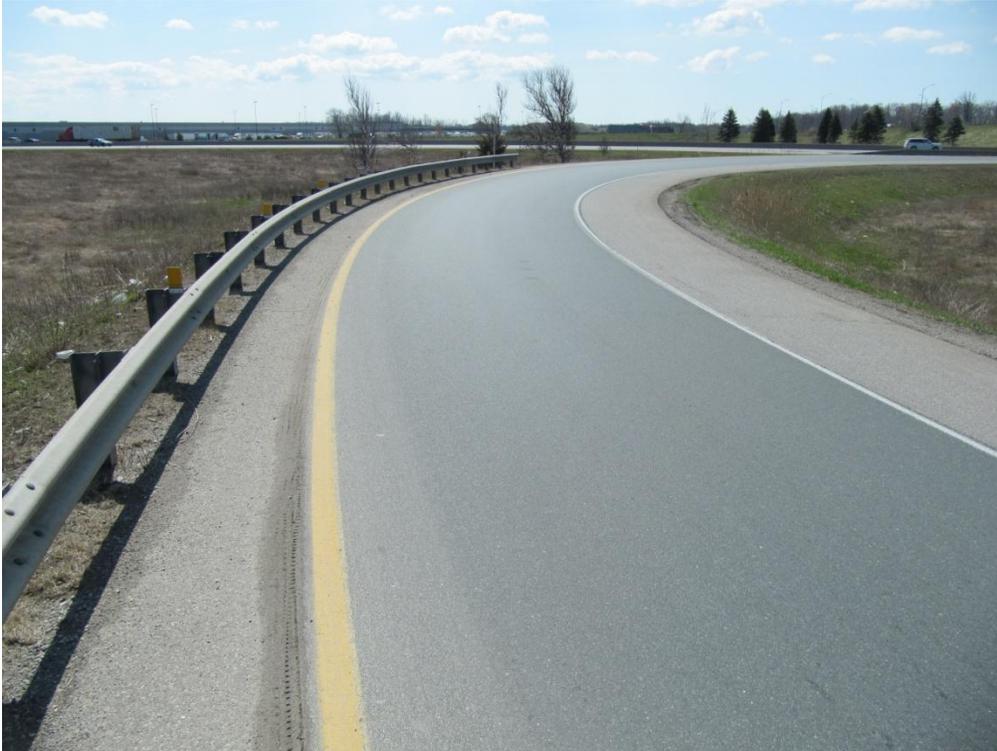
Figure 20: View looking further along outside guardrail of entrance ramp to westbound Hwy 401.

What we observed from examining the guardrail is what good condition it was in. No evidence of any previous impacts, not even any minor dents. That could be a good thing and it could also be bad. As we came to the end of the guardrail, as shown in Figure 21, we observed that the transport truck had not made any contact to it. In fact, several of the fragile, diamond shaped, curve-delineation, marker posts marking the outside of the ramp were still standing erect at the end of the rail as shown in Figures 22 and 23.
