# Speed Advisory Sign - A Source of Potential Municipal Liability

*Posting Date: 11-Nov 2014*

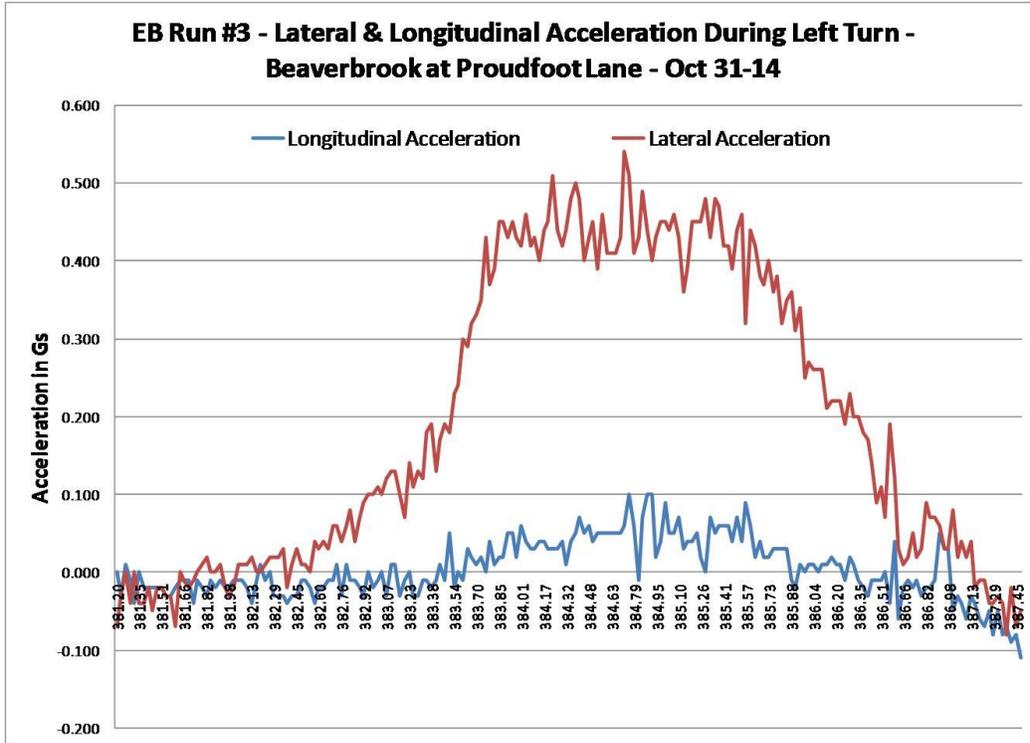
Figure 16: Test #3, eastbound on Beaverbrook.

As can be seen in our data, in all nine eastbound tests the lateral acceleration was well beyond the 0.21g that is the standard value that should exist when the Speed Advisory is set for 30 km/h. This means that vehicles passing through the curve at the Advised speed use up a precariously large amount of the available tire force. This means that small changes in the centrifugal or centripetal force could result in a destabilizing condition and a resultant loss-of-vehicular control by the driver.

The installation of the 30 km/h Speed Advisory tab below the Turn sign is a standard procedure to inform drivers of the safe speed at which they can travel through the curve. Yet during our 9 eastbound runs the speed of our vehicle was below 30 km/h in the middle of each turn. Only one test (#6) was performed 30 km/h while the remaining tests were run between 26 and 28 km/h. Yet, in all of these tests the lateral acceleration was well beyond the recommended 0.21g. In all the tests the lateral acceleration approached or exceeded 0.50g. That is a large difference compared to the recommendations.
