# Speed Advisory Sign - Additional Testing

*Posting Date: 16-Nov 2014*

This article deals with a specific Speed Advisory tab that exists on the very sharp "curve" of Beaverbrook Road where it intersects with Proudfoot Lane in London, Ontario, as shown in Figure 1.

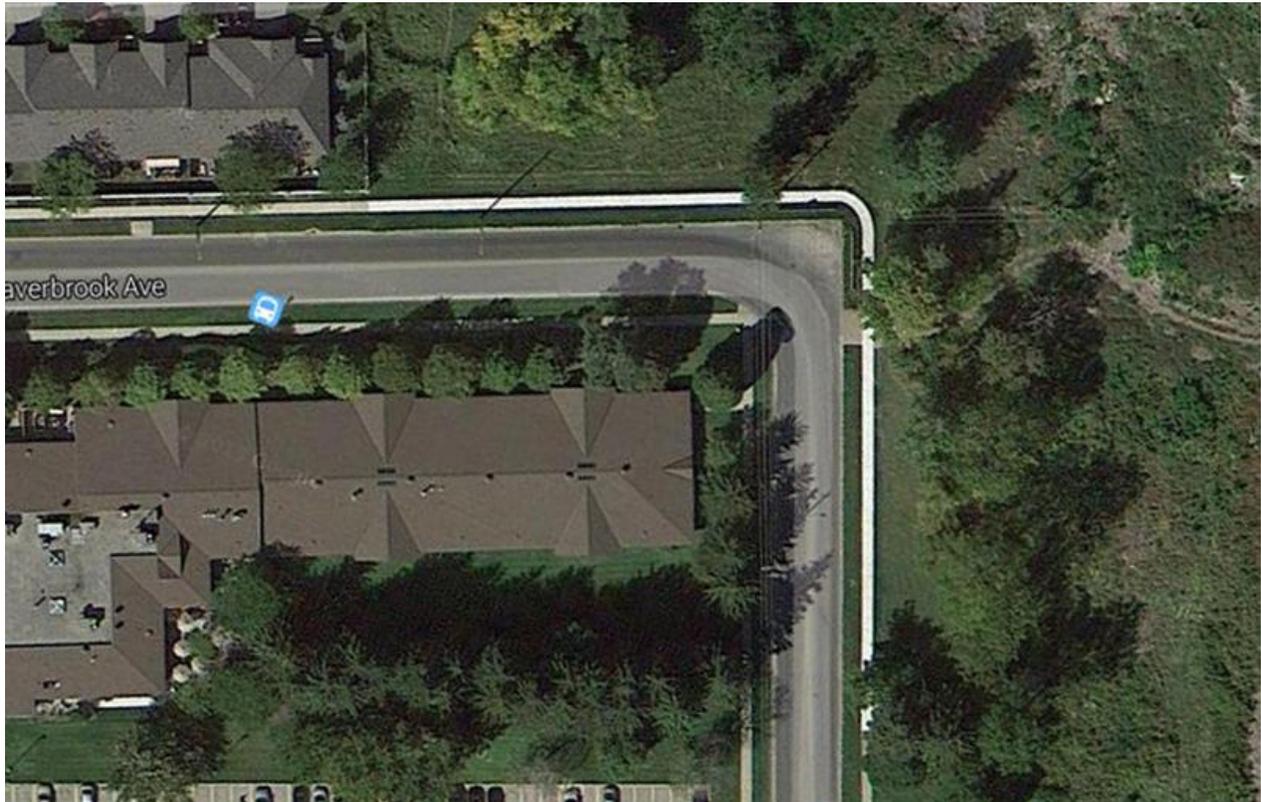
Figure 3: View of 90 degree "Curve".

The ball-bank indicator is a simple tool that identifies the lateral force being experienced by a test vehicle that is driven around a particular curve, as demonstrated in Figures 3 and 4. As a test vehicle's speed increases the ball in the indicator will begin to be displaced to markings such as 10 degrees. When the ball in the ball bank indicator reaches a desired angle then the speed of the test vehicle is used as the Advisory Speed and his posted on the approach to the curve. The ball bank indicator's design is able to take into account the effects of super-elevation (banking of a surface) and road cross-slope. Historically, for highway conditions, the value indicated on a Speed Advisory tab has been that achieved by a test vehicle when the ball-bank indicator reaches an angle of 10 degrees.

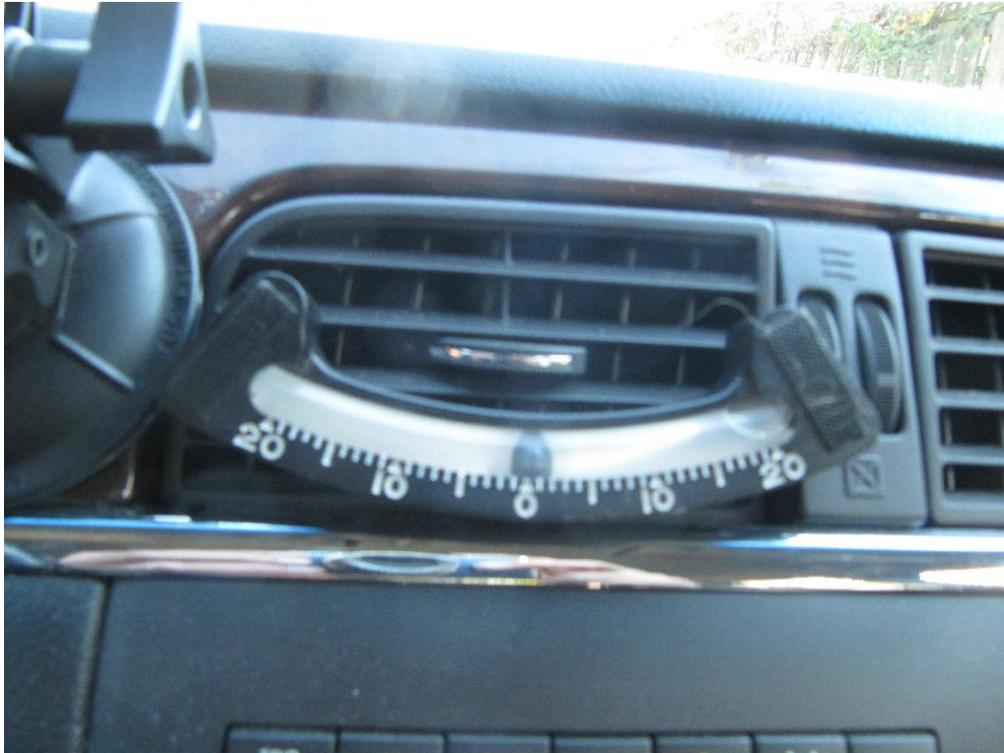
Figure 4: Example of a ball-bank indicator whose ball is sitting at rest ("0") indicating no lateral force is being experienced.

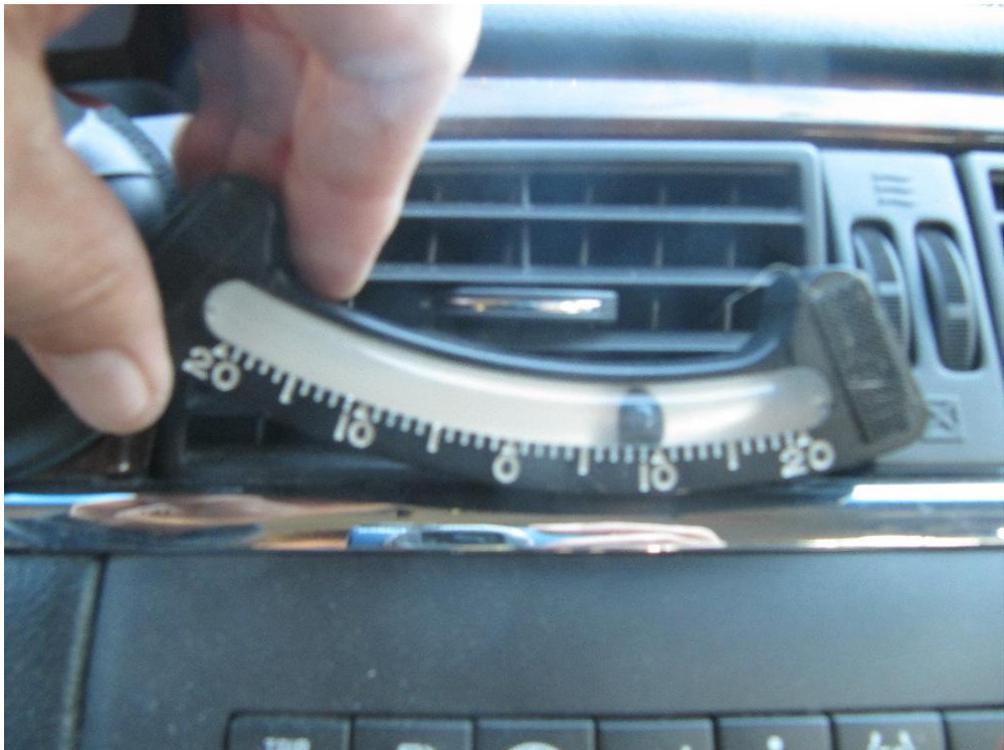
Figure 5: Advisory Speed on a highway is determined when the speed of the test vehicle causes the ball in the ball-bank indicator to move to the 10 degree position.

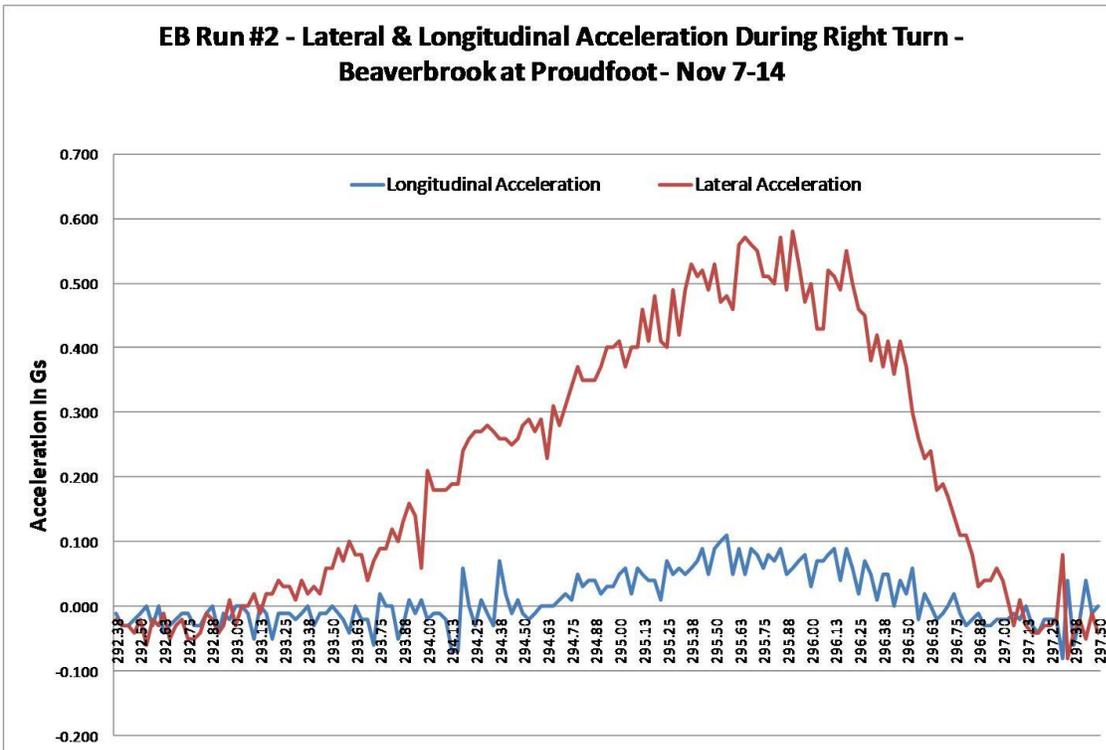
Figure 7: Eastbound Run #2

Figures 6 through 9 display the graphs from the acceleration data that was sensed during these additional tests.

Because of the orientation of the accelerometer in the vehicle the longitudinal acceleration (blue line) had positive values whenever the vehicle slowed down and negative values whenever it sped up.

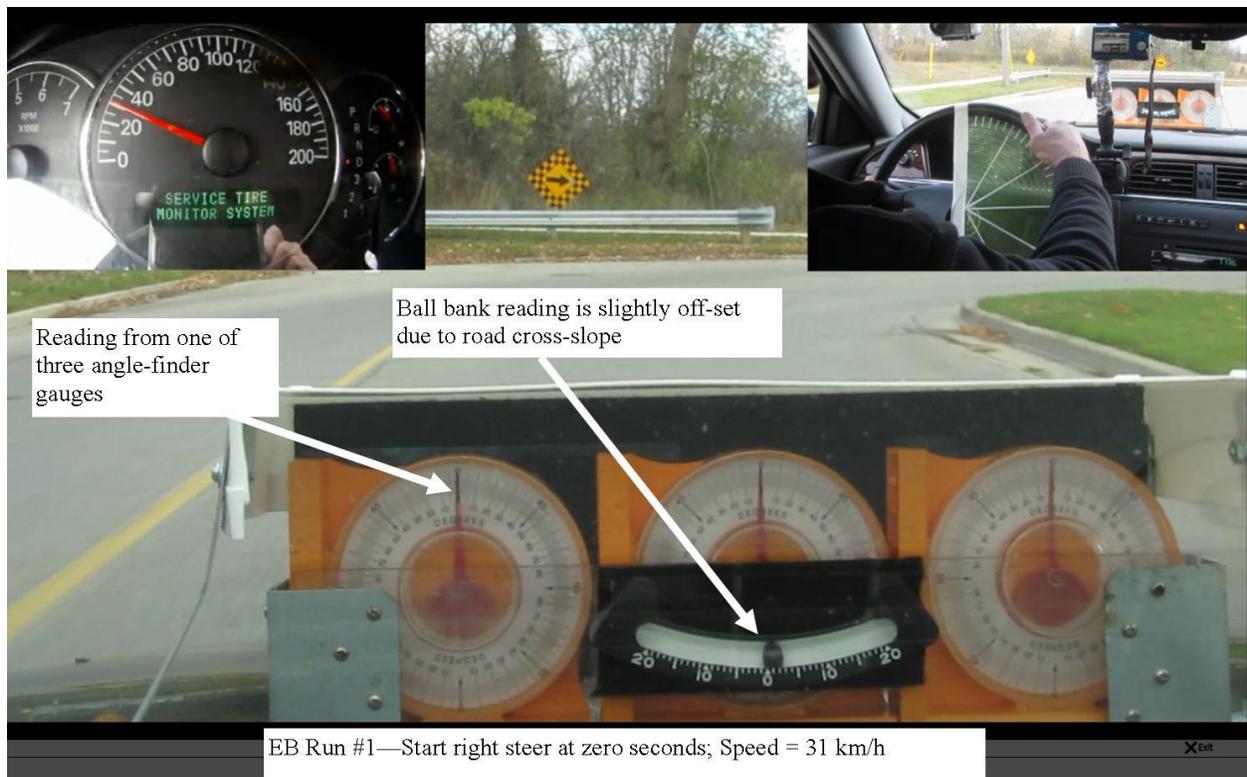
Figure 10 shows the display from three of the video cameras used in our testing in Run #1. The large view in the centre of the figure was obtained from a camera pointing through the test vehicle's windshield at a housing which contained a set of gauges, which included the ball bank indicator, attached to the hood of the test vehicle.

The other three, yellow gauges in Figure 10 are simple angle-finding instruments that one would buy at a home renovation store. The reason why these other three gauges exist is because their display is not as damped as the one from the ball bank indicator and they can also display a wider angle than the maximum 20 degrees shown on the ball bank display.

At the upper left of Figure 10 we see the view from a video camera that is pointed at the speedometer of the test vehicle. Thus we are able to document the speed of the test vehicle at the time that the angles are displayed in the gauges.

At the upper right of Figure 10 is a view from a video camera pointing toward a large protractor that is mounted to the steering wheel of the test vehicle. Thus we are also able to examine when the steering commences into the turn, how much steering is induced and how fast the steering wheel is turned.

Figure 10: View at beginning of steering into the right turn.

The view in Figure 10 is taken precisely when we began to steer to the right during our first eastbound run. This is precisely at the beginning of the data displayed in the chart shown in Figure 6. One can see in Figure 6 that both the longitudinal and lateral accelerations are near "zero" at the start of the steering input.
