Tree Impact On Ferguson Line On April 3rd, 2011 Leads to Critical Injuries

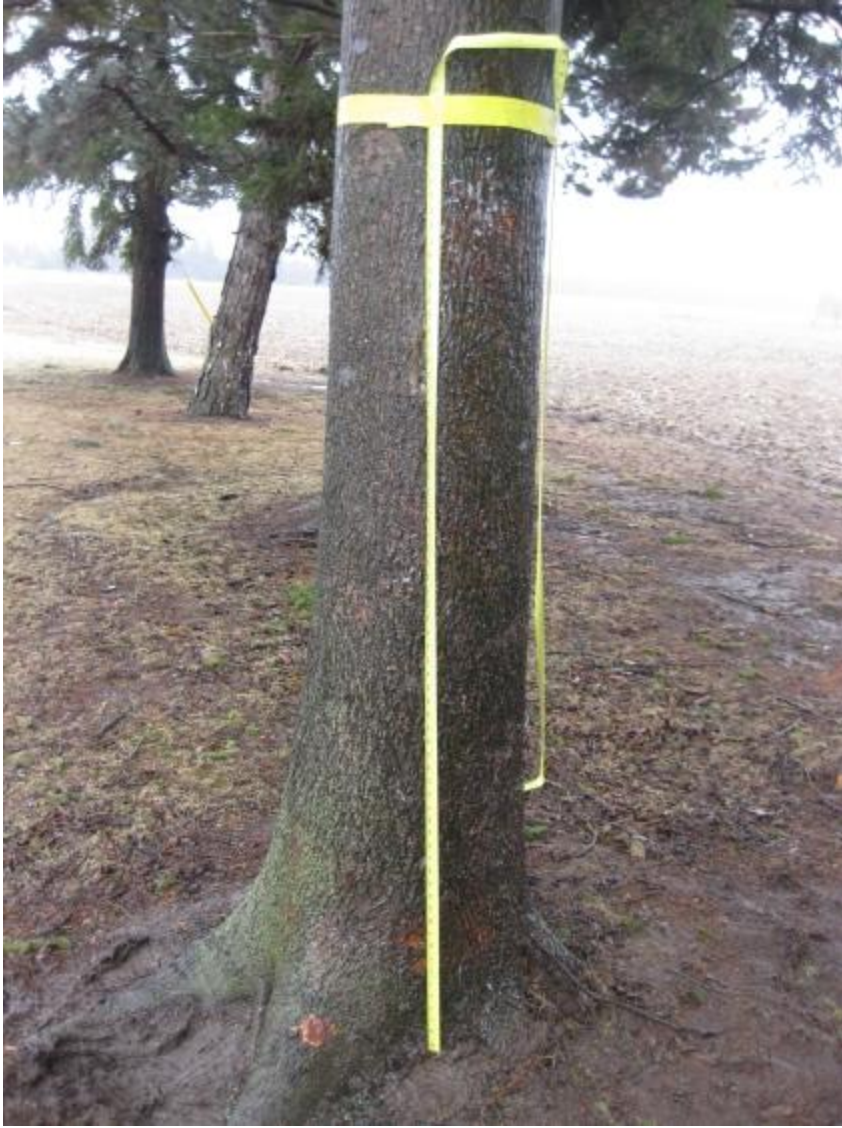
Now this north tree does not show much evidence of damage. It is likely to survive to be a danger to future drivers. You can see some bark is missing near the base but otherwise you might not notice the markings and transfers imbedded in its bark. One thing I like to do is to place a tape measure against a tree or pole so that I can document the height of any impact damage or transfers. So below is the same tree with a tape measure attached.
