Was Speed The Primary Factor That Led To The Fatal Injuries of Matthew Hartle?

Posting Date: 16 May 2012

Gorski Consulting
London, Ontario, Canada

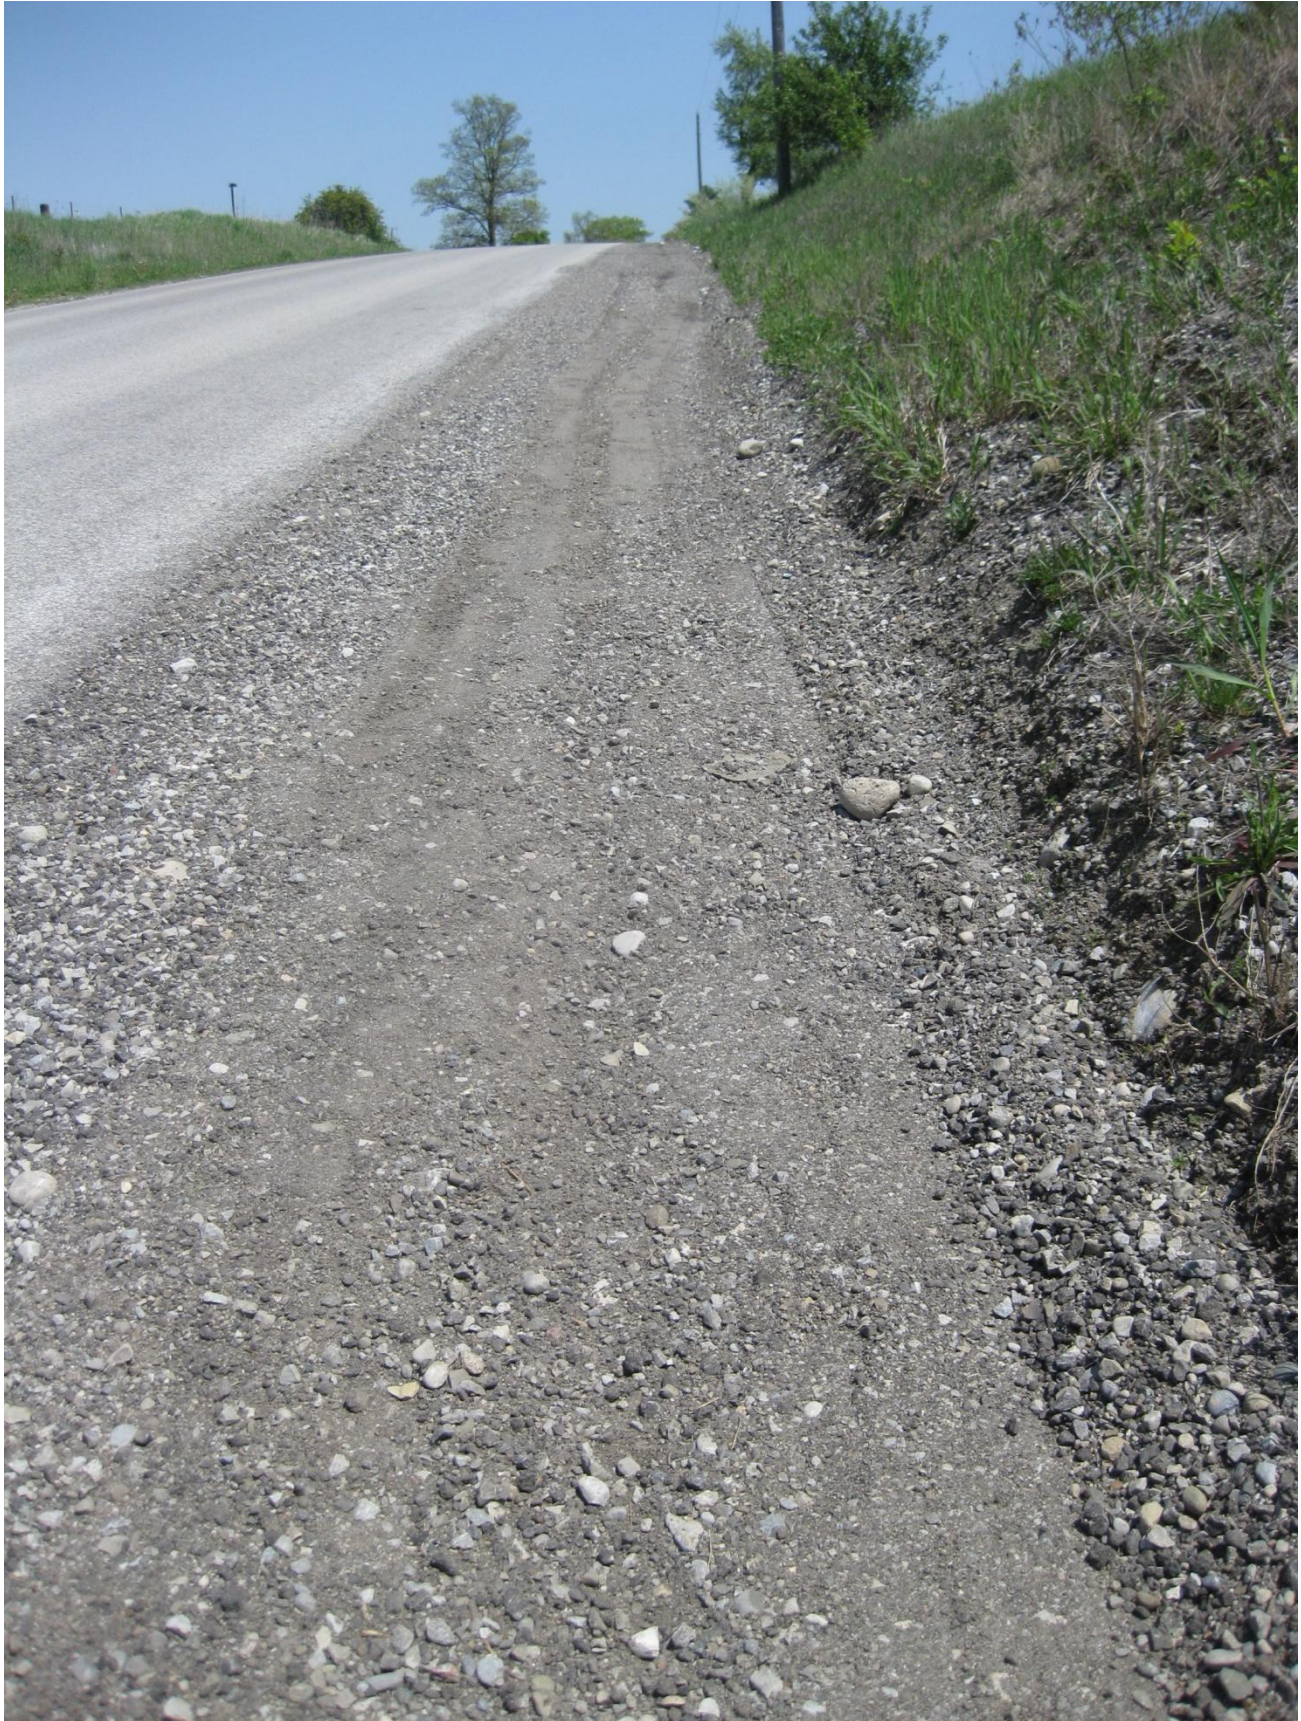
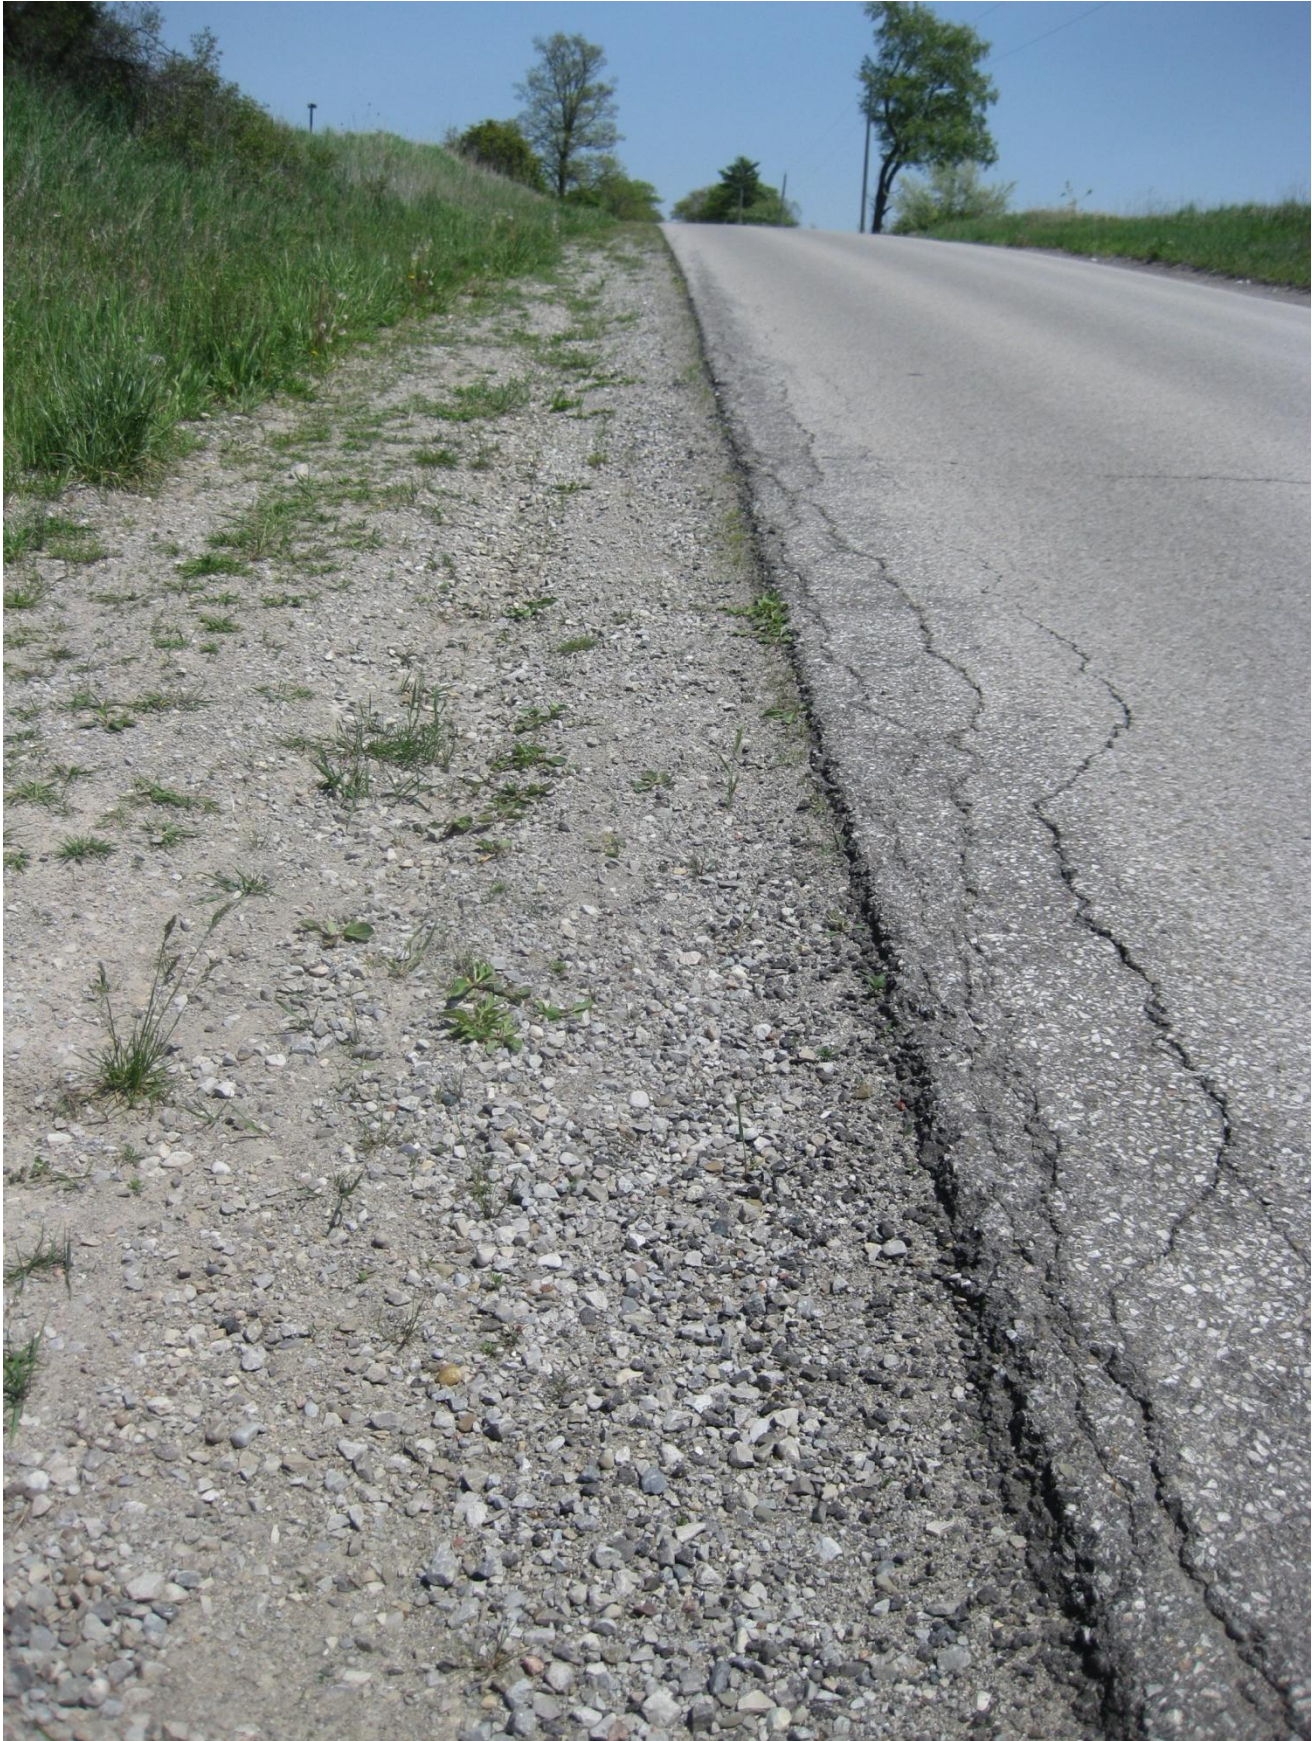
Interestingly, it would appear that road maintenance personnel were likely out at the site around the time of the crash because we could see the fresh grading of the south shoulder on the upgrade of the sag, on approach to the accident site, as shown in the photo on the following page. This photo shows the typical signs of fresh grading of the gravel of the shoulder and the tire marks from the grader in the freshly turned gravel. This south shoulder is the one of interest because, in a loss-of-control collision, it is this shoulder that a vehicle typically enters before a driver loses directional control of a vehicle. Furthermore, the north shoulder was not graded, as demonstrated in the photo on Page 9. So why would maintenance personnel be present at the site of this collision shortly before or after the collision, and grading this south shoulder? Interestingly, they did not re-grade the shoulder all the way up the slope. The regrading stopped just west of the hillcrest. But we will see shortly that there is other evidence on the south shoulder at the hillcrest that is of particular significance to the cause of this accident.

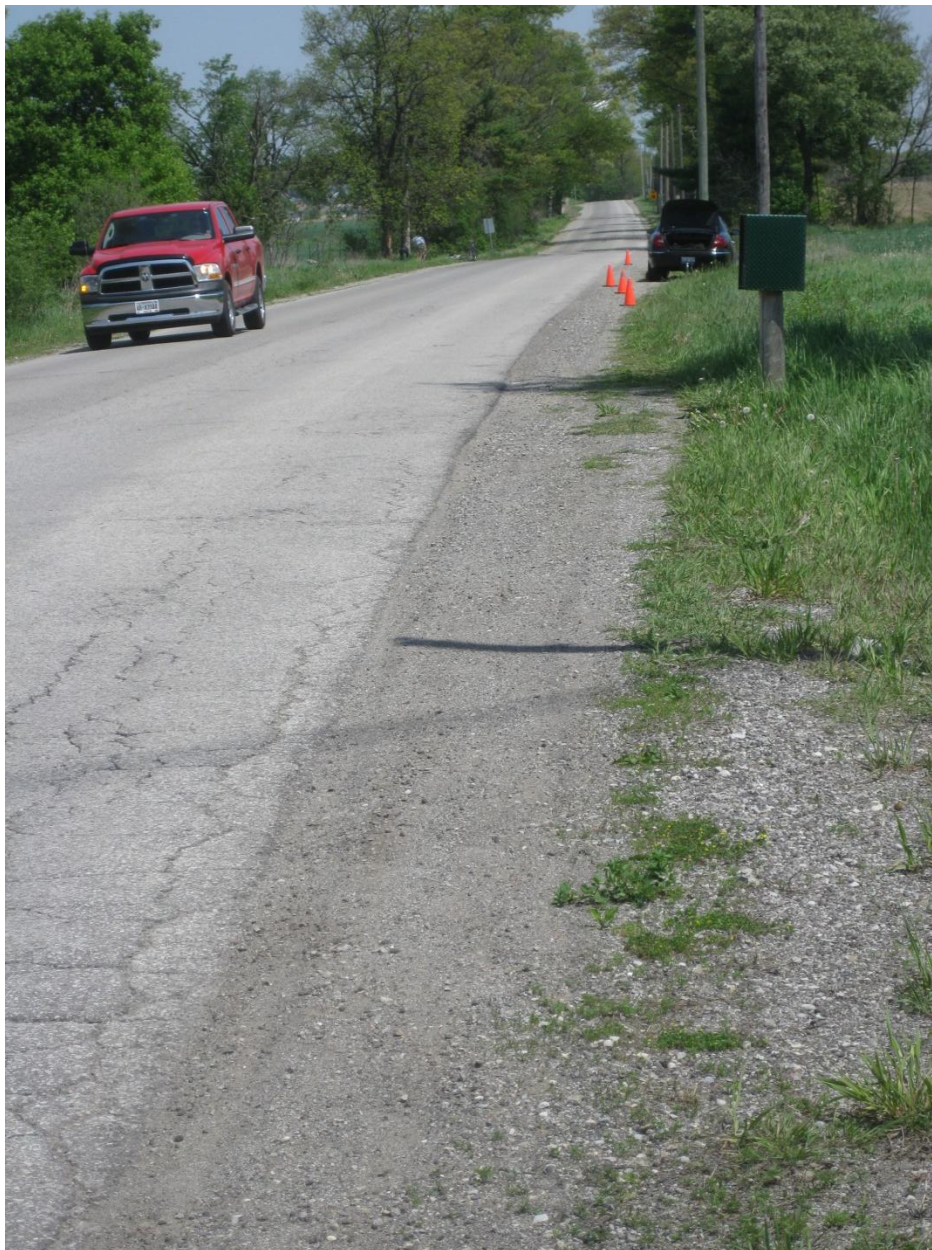
The view in the photo below is looking eastward from the south shoulder on Alps Road at the top of the hillcrest. So the sag is behind the camera. As per typical procedure you will note below that we parked our vehicle on the south shoulder with cones surrounding it to warn drivers of our presence. The impacted tree is located on the left (north) side of the road beyond our parked car in the distant background. If you look closely you may see some persons at the tree examining it.

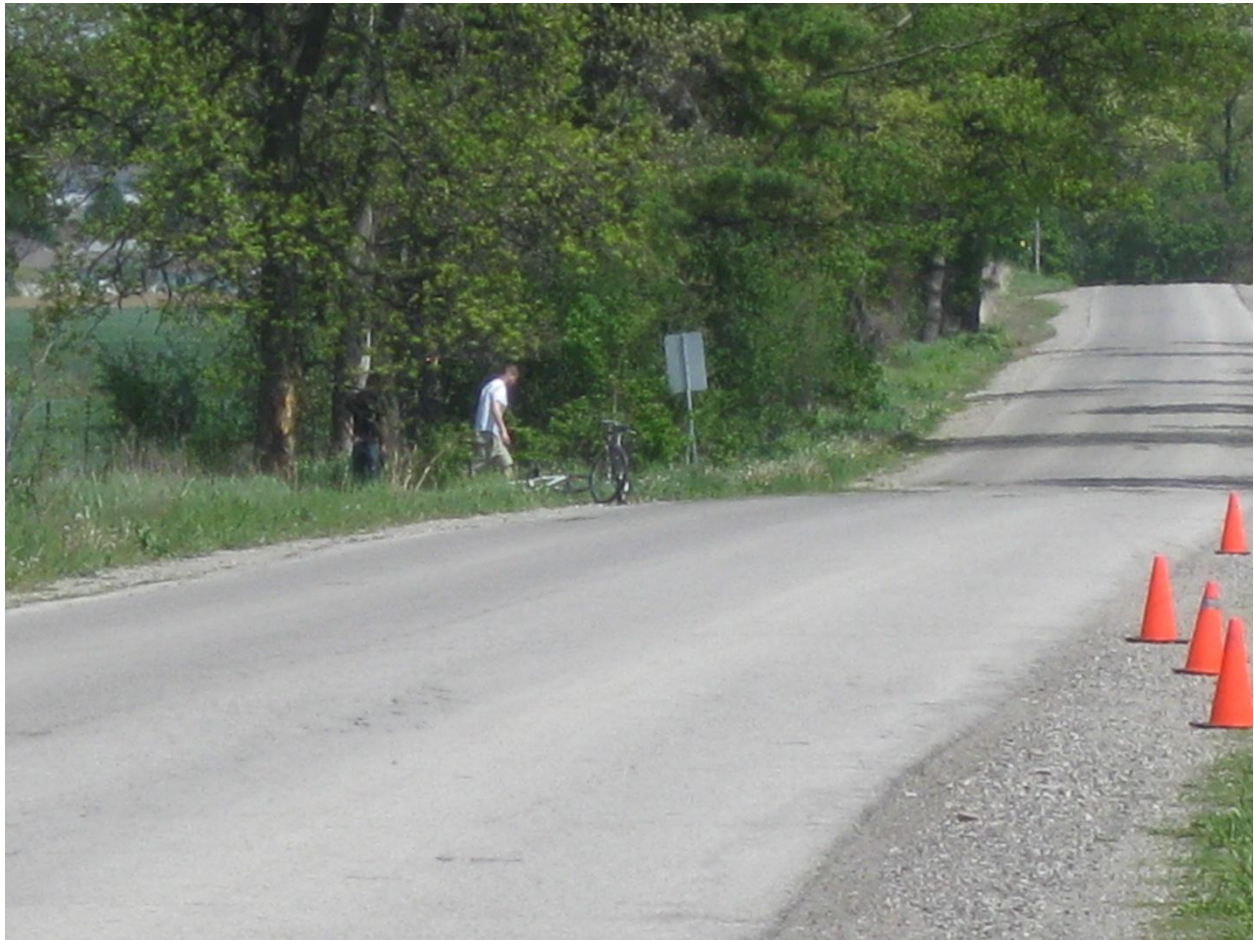
As we zoom in with our cameras lens we can see the view below which shows the persons (two cyclists) at the impacted tree while our row of cones is visible on the right edge of our photo. This is a very compressed and distorted view of the length of the road.
