ET-Plus Terminal Impacts – Further Evaluation of Their In-Service Performance

Posting Date: 1-May-2017

In a previous Gorski Consulting article (“ET-Plus Terminal Impacts – Evaluation of Their In-Service Performance”), dated March 12, 2106, six instances of impacts of ET-Plus terminals were reported. The present article is a report on an additional 4 instances.

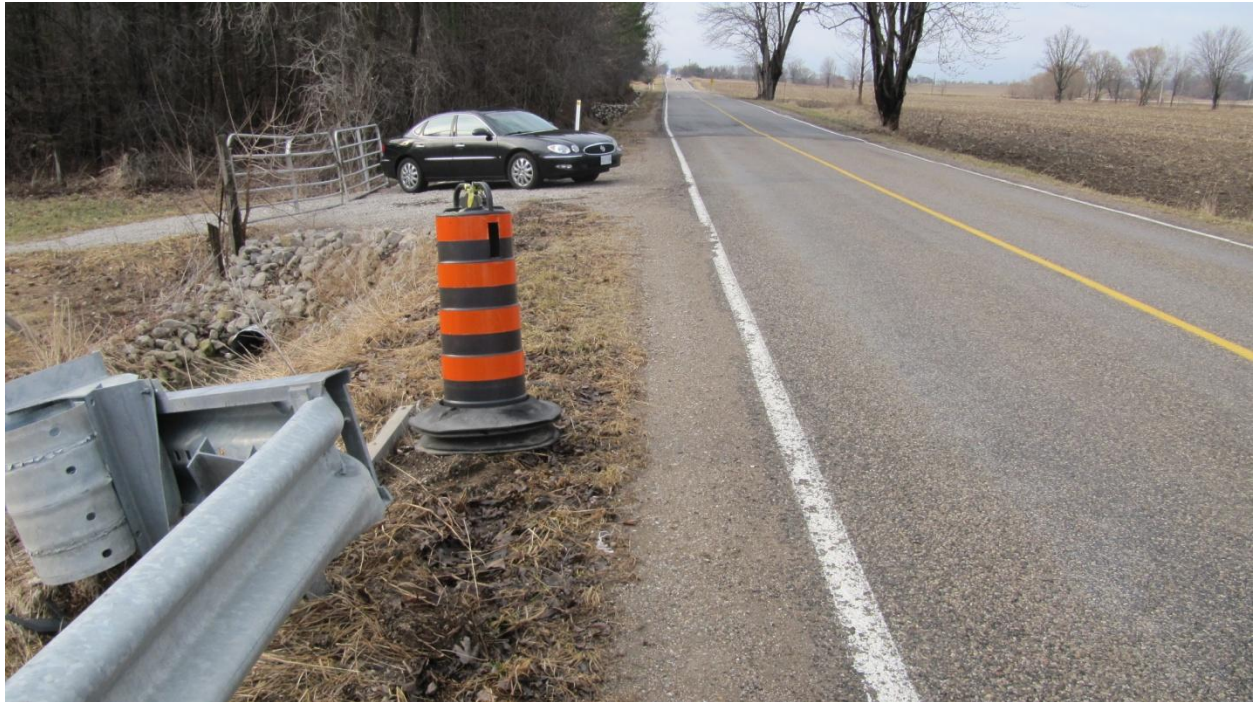
Figures 9 through 13 show how the ET-Plus terminal has been rotated to a position almost perpendicular to the length of the guardrail. The rail is buckled at the rear edge of the terminal such that no additional length of the rail is capable of passing through the terminal's throat. These Figures also show that there is almost no additional buckling of the guardrail in the distance south of the terminal thus this is not a high severity impact.

Figure 9: View looking south at the struck ET-Plus terminal on the west side of Wonderland Road.

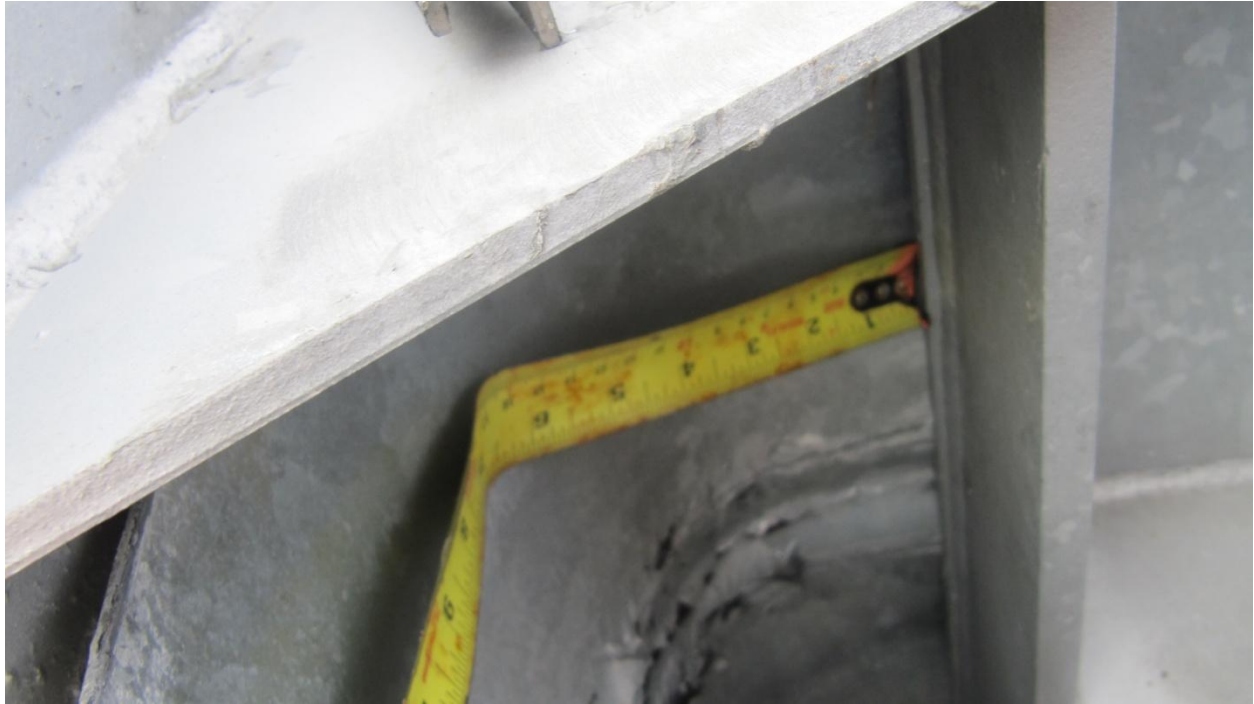
Figure 14 shows a view looking at the length of the rail that has been squeezed through the throat of the terminal. The measurement method shown in Figures 15, 16 and 17 indicates that only 114 centimetres of the rail has passed through the terminal yet we observe that the terminal is already in an extreme state of rotation.

Figure 14: View, looking down, at the short length of guardrail that has passed through the throat of the ET-Plus terminal.

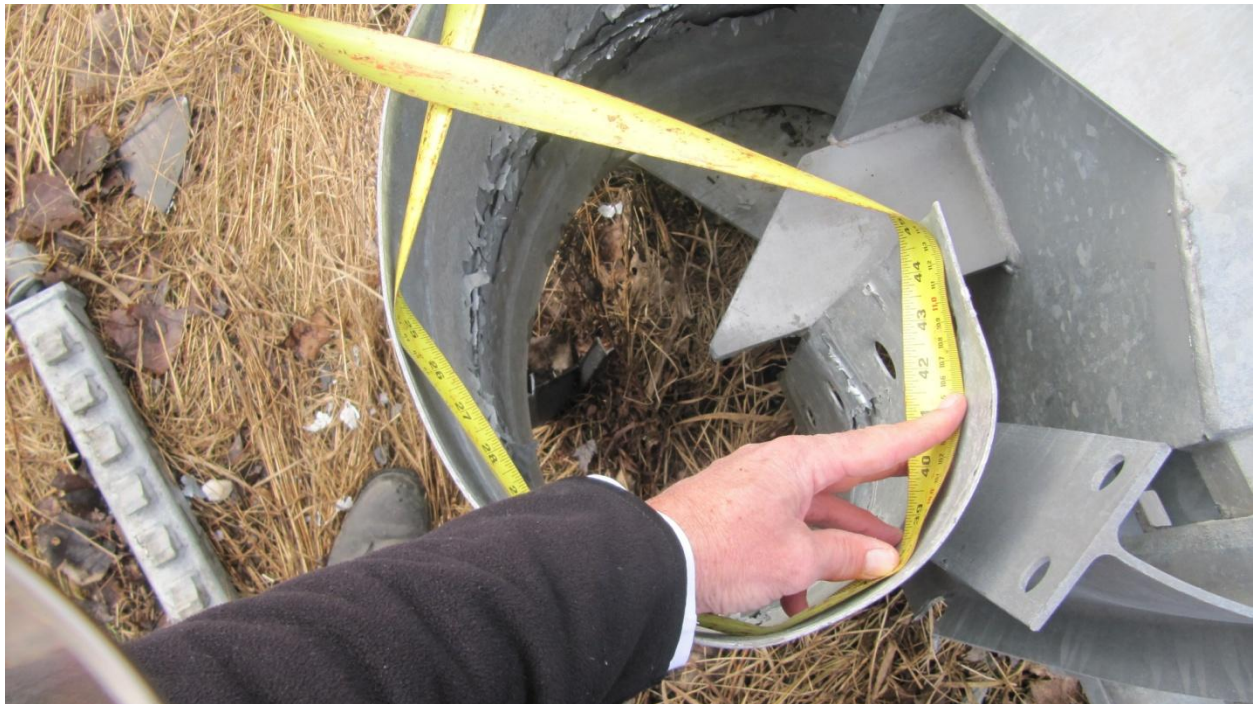
Figure 15: View showing the method used to measure the length fo the guardrail that has passed through the throat of the terminal. Here the zero end of a tape measure is placed at the throat and the tape is then wrapped around the coil of the deformed rail as shown in Figure 16.

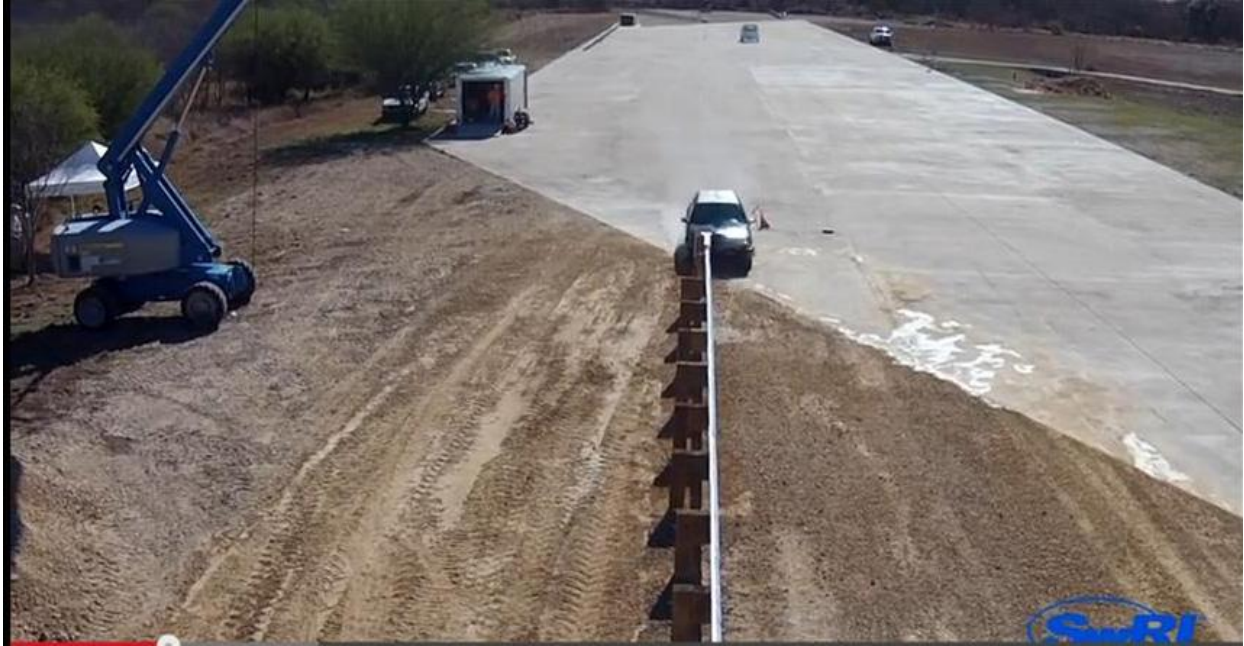
Figure 28: Example of the compliance test set-up taken from the South West Research Institute's (Texas) re-testing of the ET-Plus in early 2015.

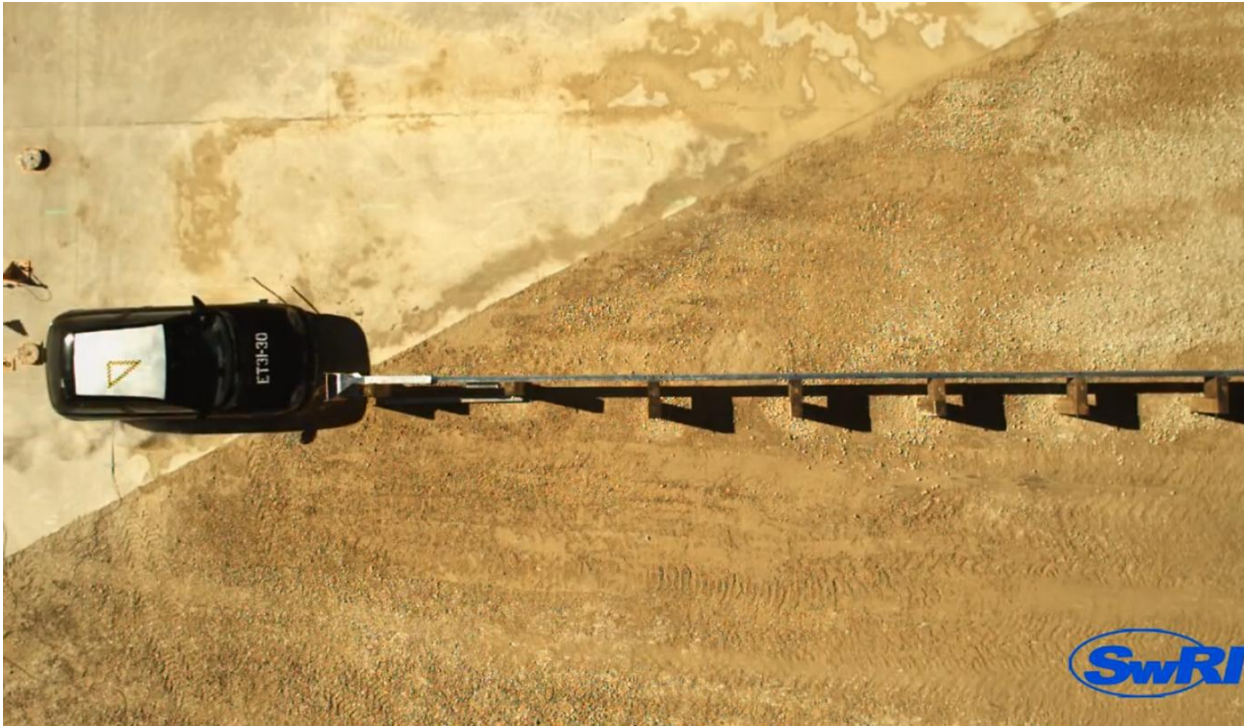
In Figures 28 and 29 we see a small Geo Metro making initial contact with the terminal and then in Figure 30 we see that, after a substantial distance of travel a considerable length of the rail has been extruded through the terminal in a curled state.

Figure 29: View of Geo Metro making initial contact with the ET-Plus head.

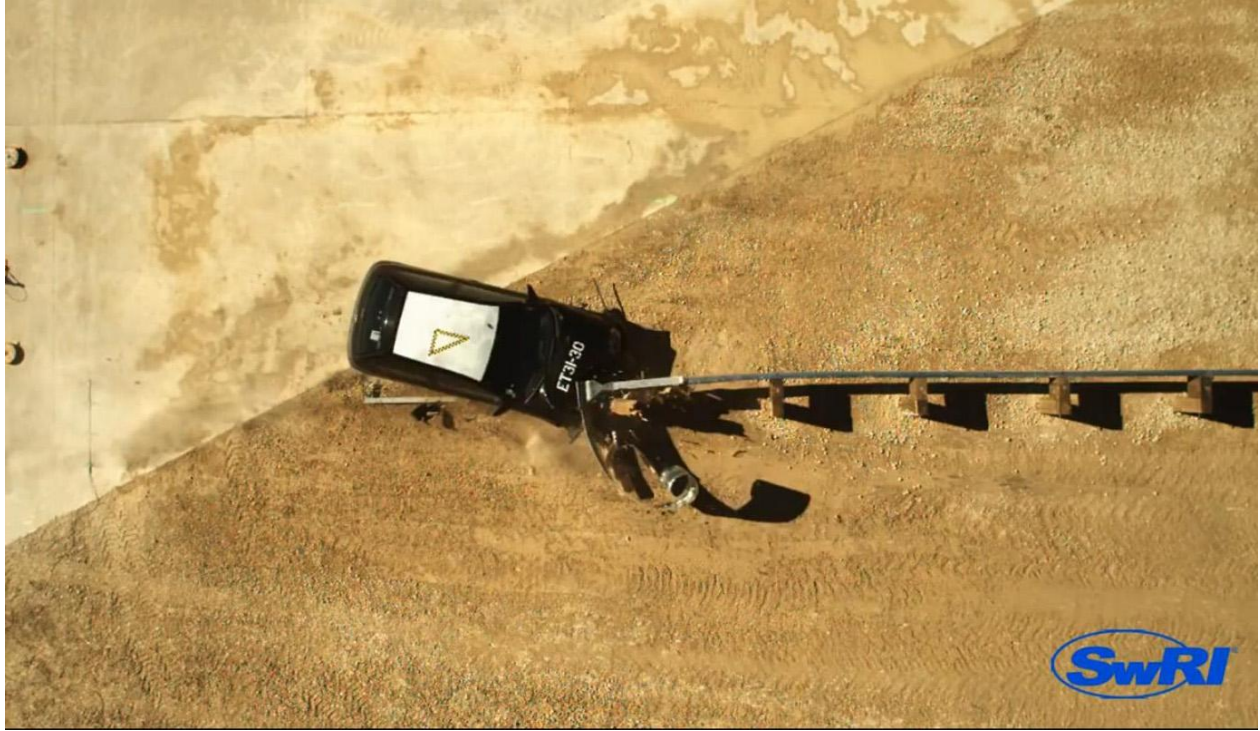
Figure 30: View of the Metro after it has travelled a considerable distance and has caused a considerable amount of rail to be extruded through the terminal head.

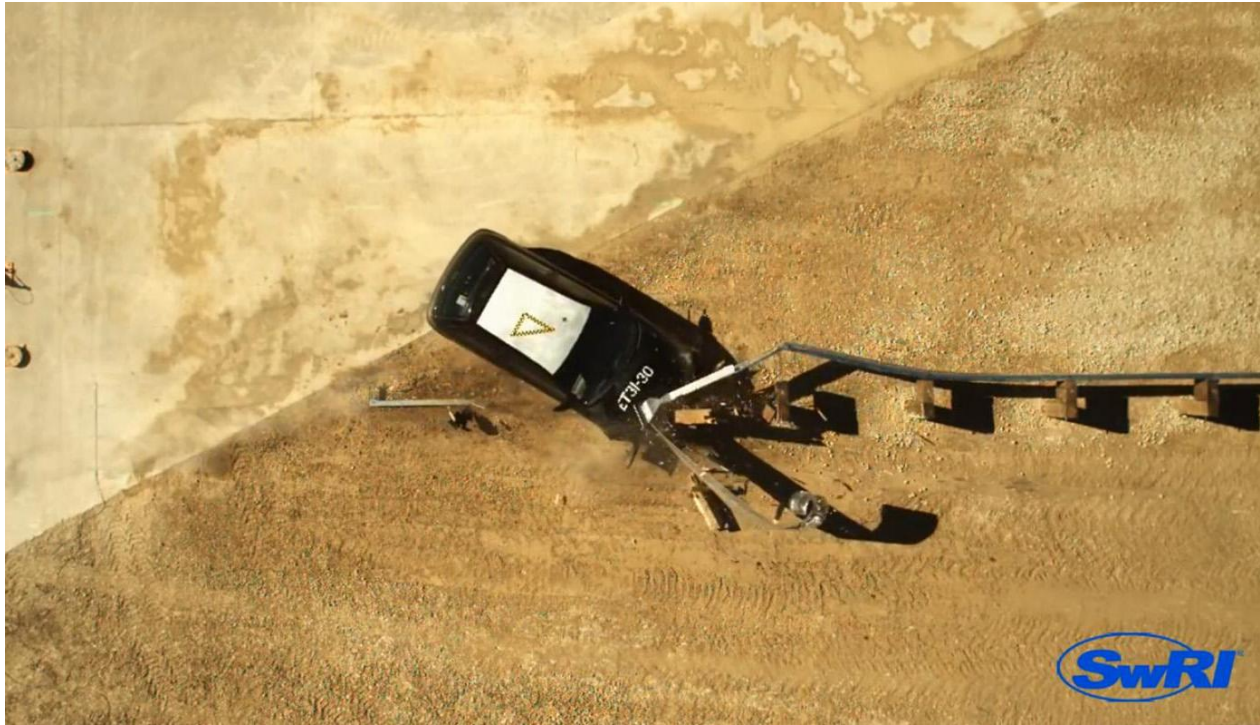
Figures 31 through 34 show the results of the compliance test as the Geo Metro rotates and the rail begins to buckle. Here we see that the rail forms a spear that penetrates the driver's side door and enters into the driver's seating space. This is an obvious injury producing consequence whose consequences to a live driver in a real-life collision could be potentially fatal if the wrong set of factors is assembled.

Figure 31: The rail begins to buckle the Metro rotates.

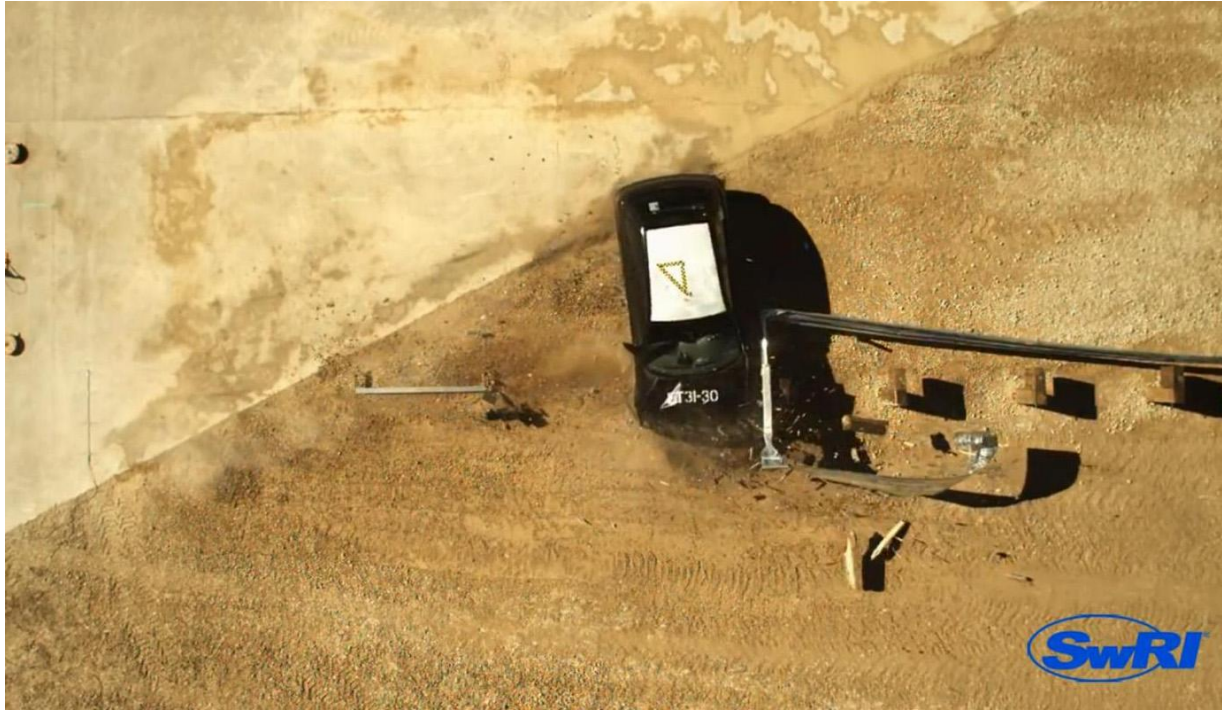
Figure 32: The rail continues to buckle as the Metro continues to rotate.
