Historical Patterns In Loss-of-Control Events At Specific Road Locations

Posting Date: April 2, 2018

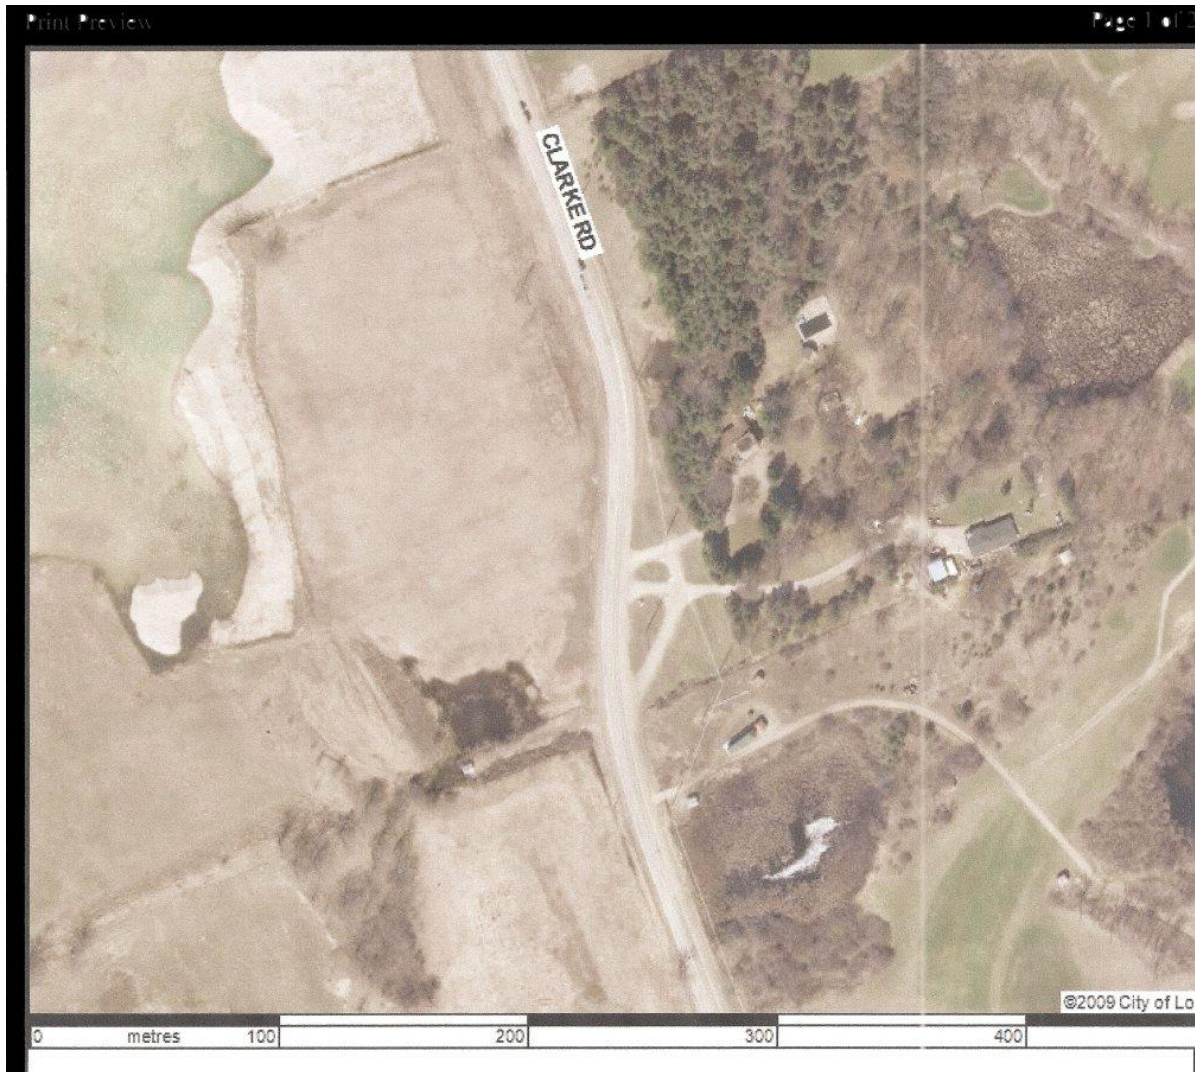
Figure 1 shows an aerial view of the site in April of 2008, taken from the City of London website. This shows the two curves of the S-curve such that a northbound driver would first experience a curve to the right, followed by a curve to the left. There is limited housing in the area although several driveways exist between the two curves on the east side of the road.

Figure 1: Aerial view of the research site on Clarke Road north of Fanshawe Park Road taken in April, 2008.

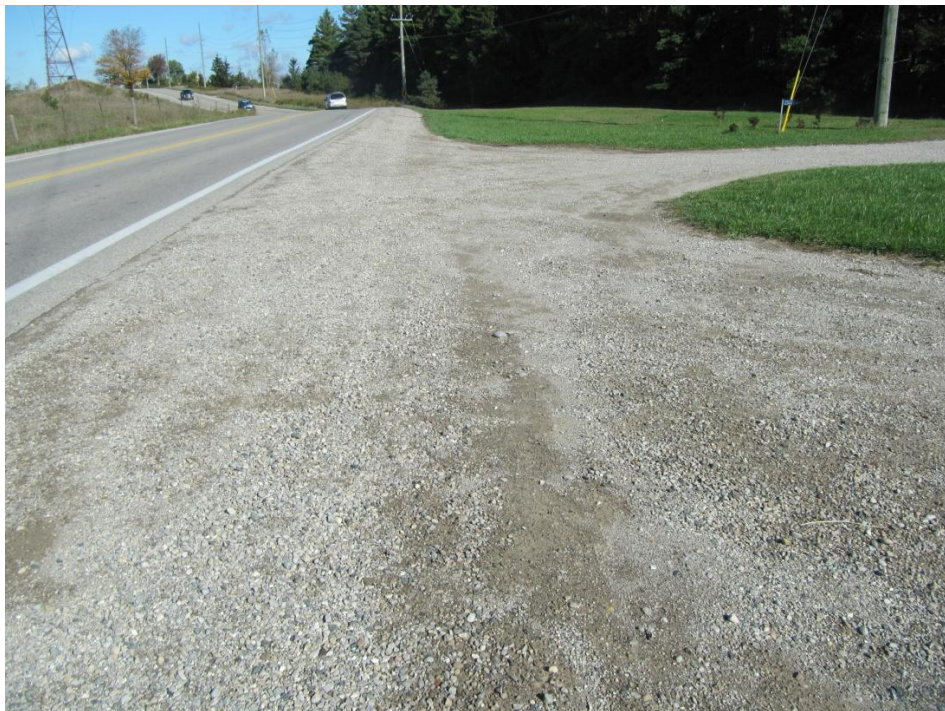
Figure 4 provides a view from the opposite direction, looking north, from the east roadside between the two curves. Thus southbound vehicles would be travelling toward the camera.

Figure 4: View, looking north at the east roadside between the two curves of the S-Curve.

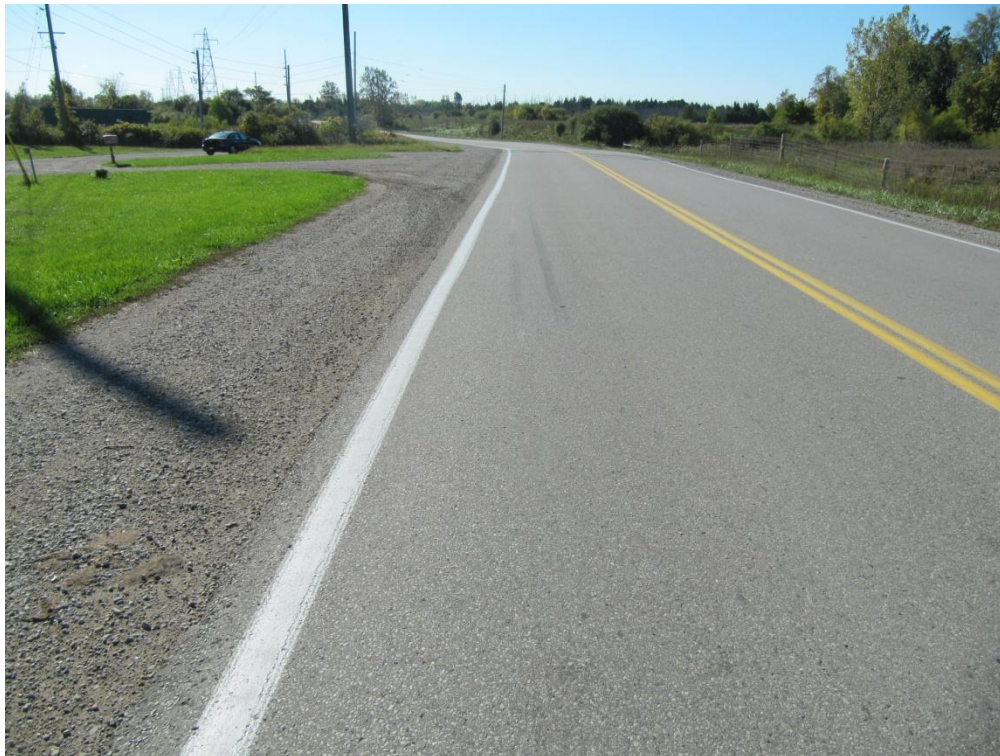
Finally, Figure 5 shows a view looking south at the east roadside between the two curves of the S-Curve.

Figure 5: View, looking south, toward the east roadside between the two curves.

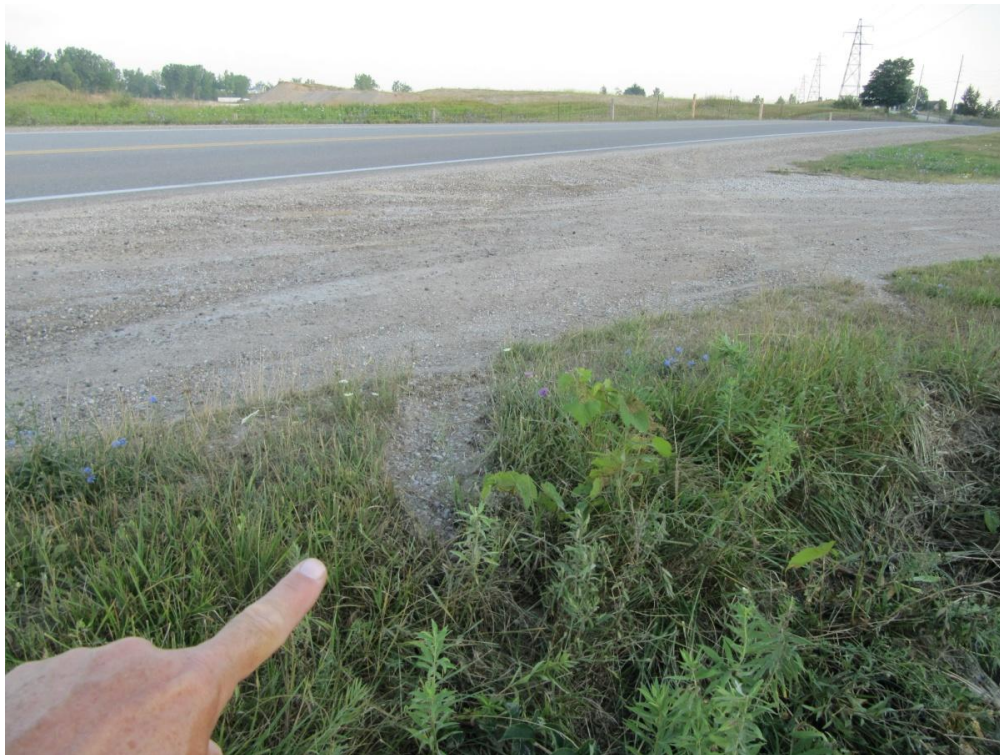
Figure 12 shows the tire marks in the grass as the vehicle approaches the bushes and fence. Figure 13 shows the wooden anchor posts of the fence that are knocked over and Figure 14 shows a close-up view of the fresh scrapes on one of the wooden posts indicating that contact was made. Figures 15 and 16 show northward views the tire marks leading back toward the road surface.

Figure 15: View, looking northward, toward the tire marks on the grass and gravel as we look back toward where the vehicle exited the road surface.

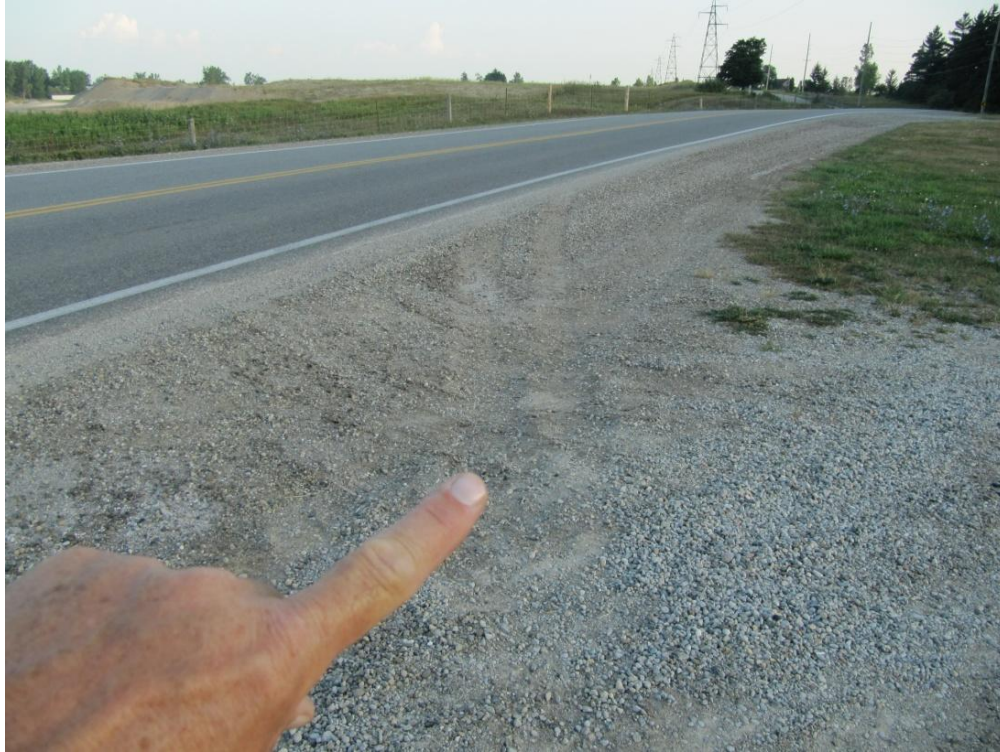
Figure 16: View, looking northward, showing the tire marks in the gravel as we look back to where the vehicle first exited the road surface.

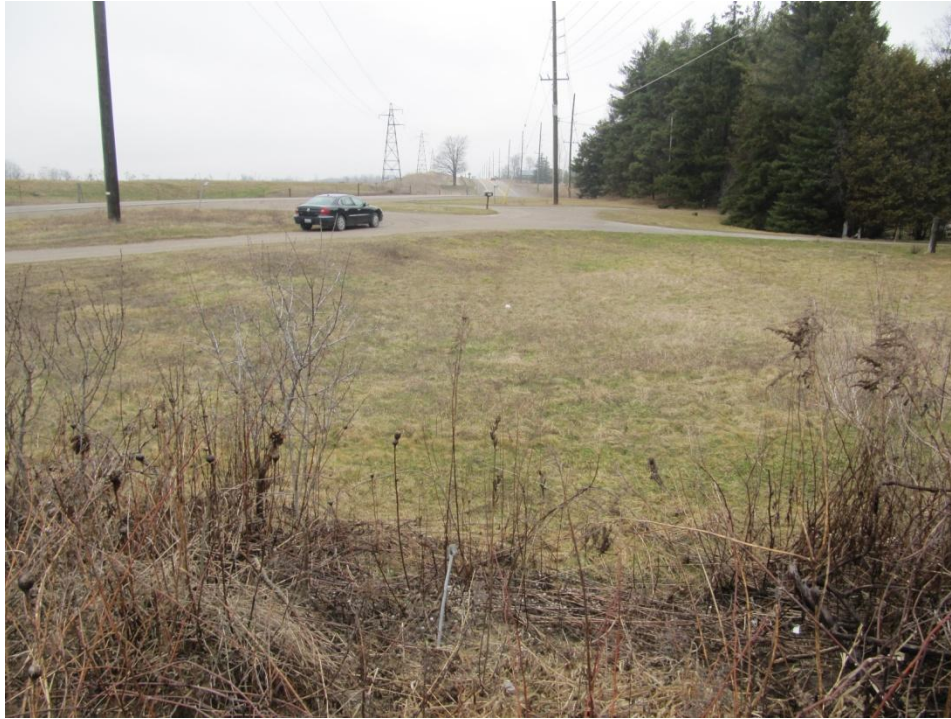
Figure 23: View looking north, from the struck fence and brush, matching the faint tire marks and the observing the north curve in the distant background.

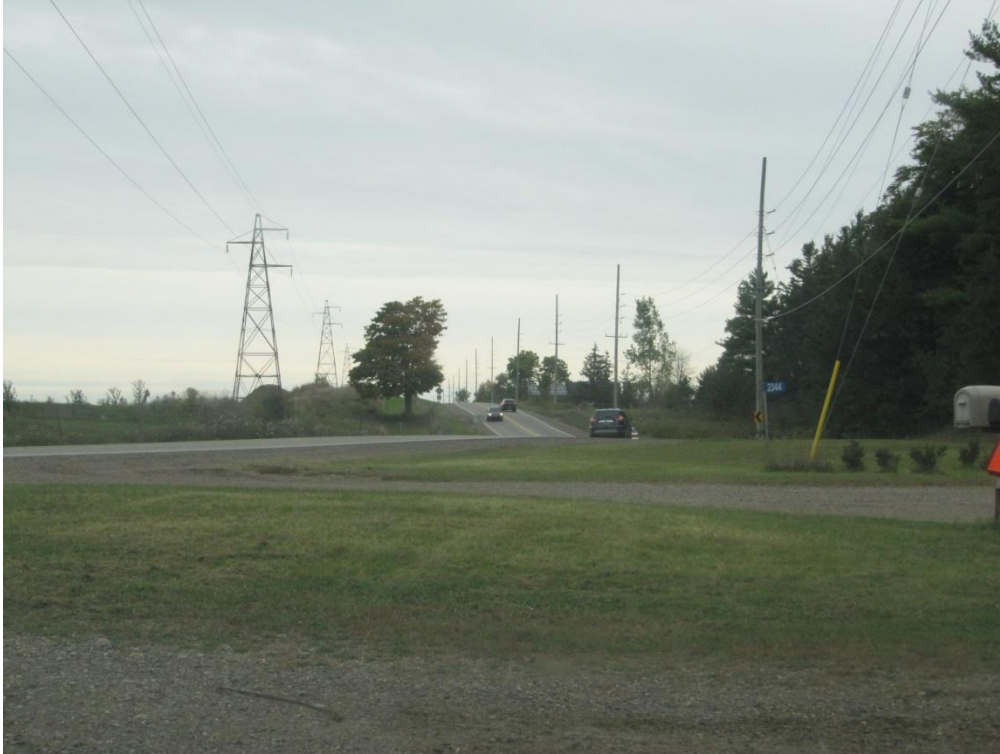
This next incident was similar to that of Event 3 in that tire marks were observed on the east roadside only a short distance south of the north curve, as noted in Figure 25. Fortunately, we had walked through the site on Tuesday, September 29th and a photo taken at that time (See Figure 26) confirmed that the tire marks were not present at that time. So, at most, these tire marks could only be about 3 days old. The freshness of the markings found on October 2nd allowed the ability to see the tire marks as they passed through the gravel driveways as demonstrated in Figures 27 and 28.

Figure 26: Photo taken on September 29th, 2015 confirming that the tire marks did not exist on that day of our road inspection.

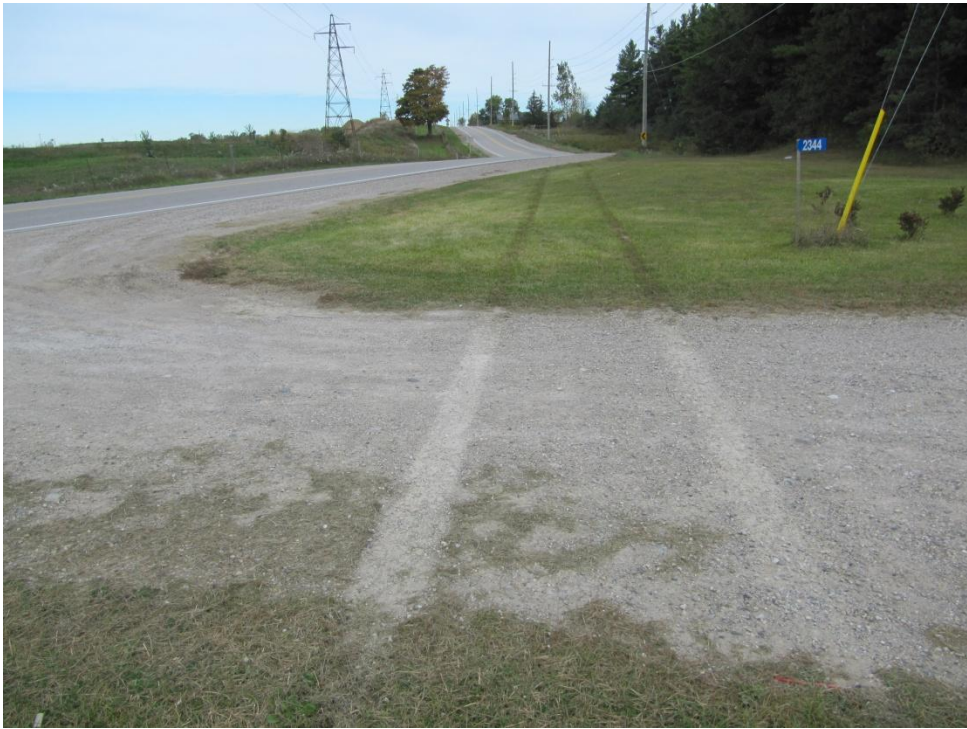
Figure 27: View, looking north, at the tire marks passing through the gravel of the driveway.

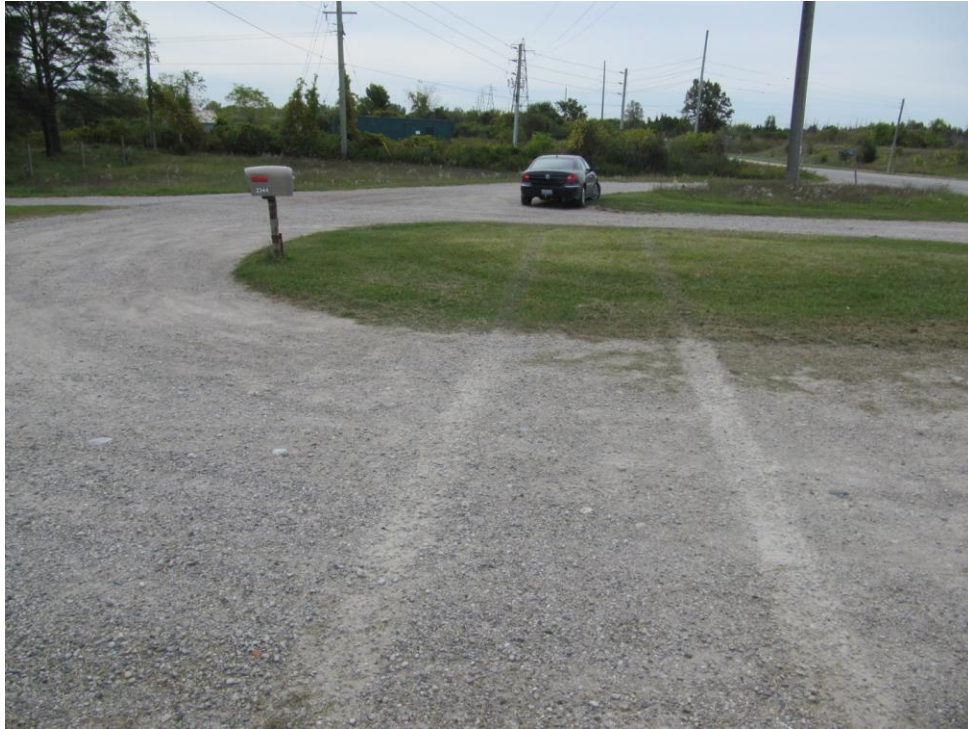
Figure 28: View, looking south, at the tire marks visible on the gravel driveway. The marks are no longer visible at the second driveway near the parked car in the background.

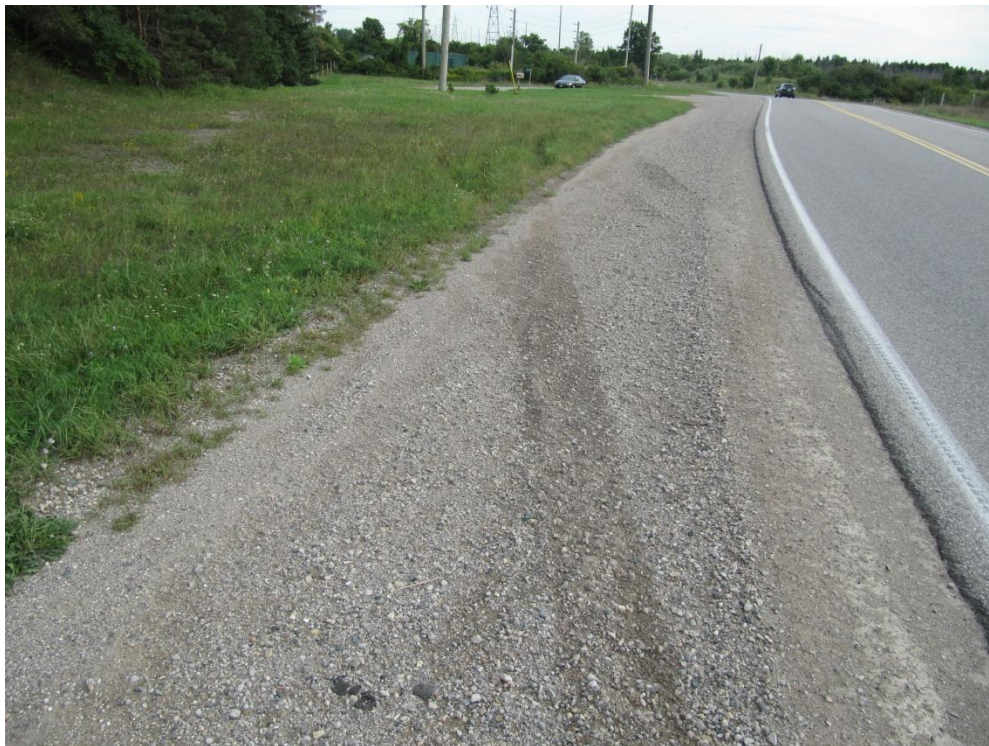
Figures 30 and 31 show views looking south at the tire marks as they exit onto the east roadside at the south end of the north curve. As the tire marks reach the grass it can be seen that the vehicle is in a clockwise rotation and the tire marks start to curve back toward the roadway.

Figure 30: View, looking south, at the tire marks exiting onto the east roadside and the vehicle begins to rotate back toward the road on the grass in the background.

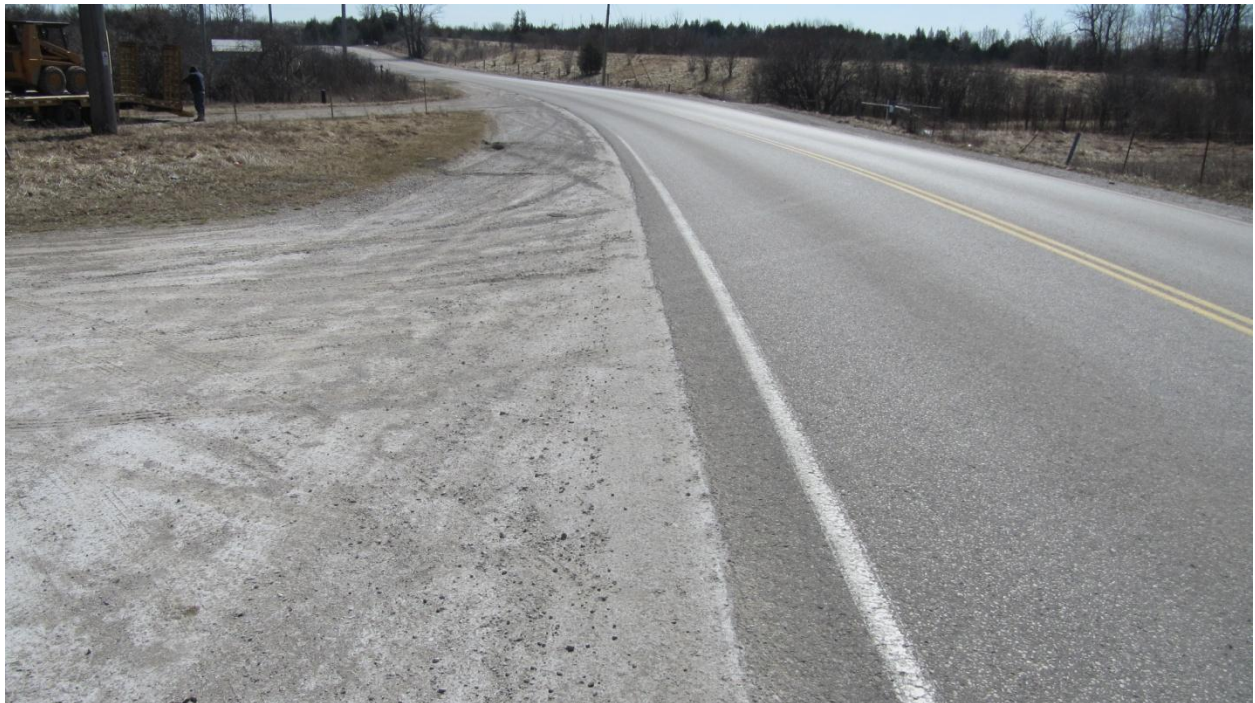
Figure 33 provides an overall, southward view of the area where the loss-of-control yaw marks exist in the background of the east shoulder. This indicates that the vehicle exited the road surface at a substantial distance south of the north curve similar to Events 1 and 2. Unlike Events 1 and 2 the vehicle was not travelling quickly enough to reach the fence and bushes further to the south but rather came to a stop on the east shoulder.

Figure 33: View, looking south, at some yaw marks in the background of the east shoulder. This view gives a general idea of their position with respect to the incidents discussed previously.

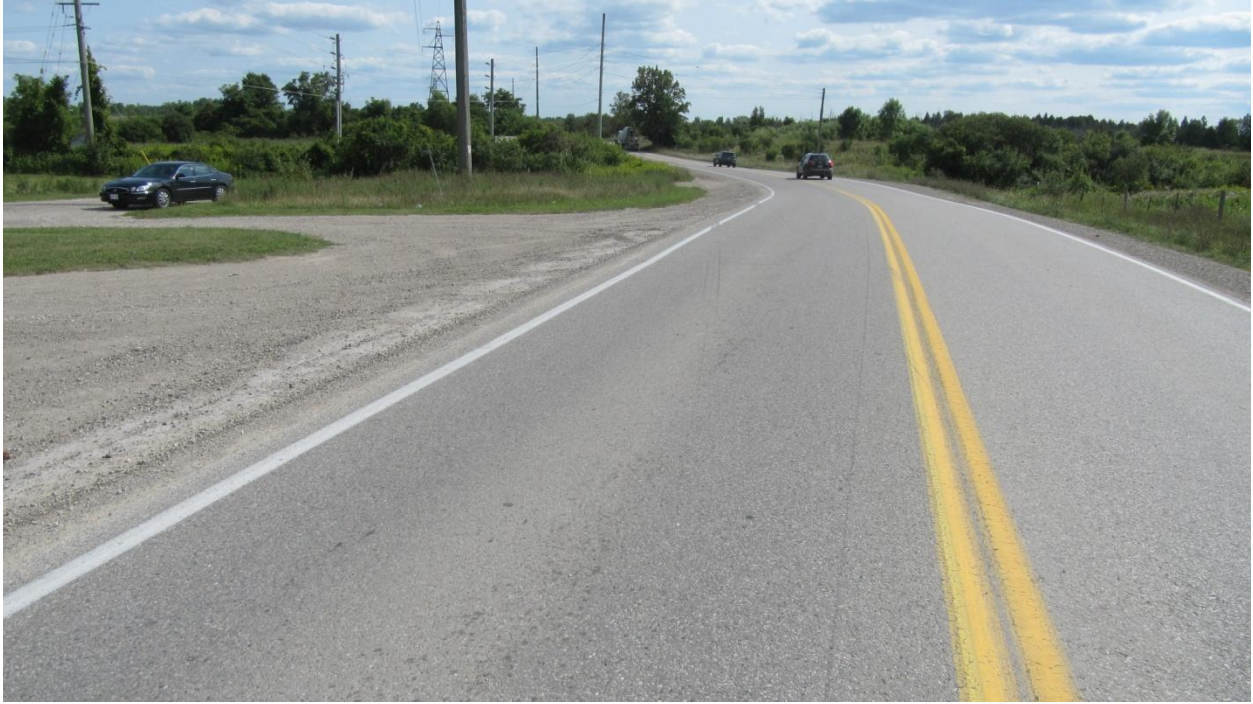
Figure 37 shows a general view, looking south, along the northbound lane where there are some faint yaw marks in the background. There is a linear black mark in the northbound lane that is close to and parallel to the centre-line but that is not related to the southbound vehicle's motion.

Figure 37: View, looking southbound in the northbound lane toward some yaw marks that exist in the background of the northbound lane.

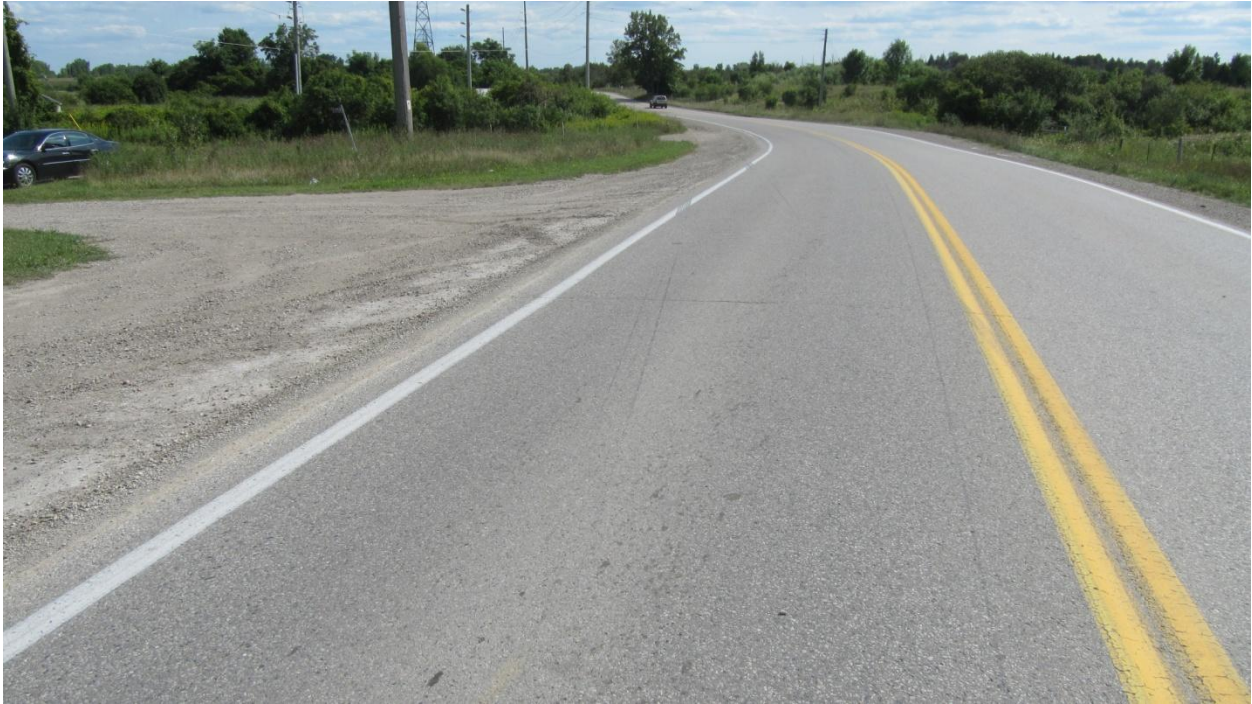
Figures 38 and 39 provide closer views of the yaw marks on the northbound lane as the southbound vehicle rotates onto the east shoulder and roadside in the background.

Figure 38: View, looking south, at the yaw marks in the northbound lane.

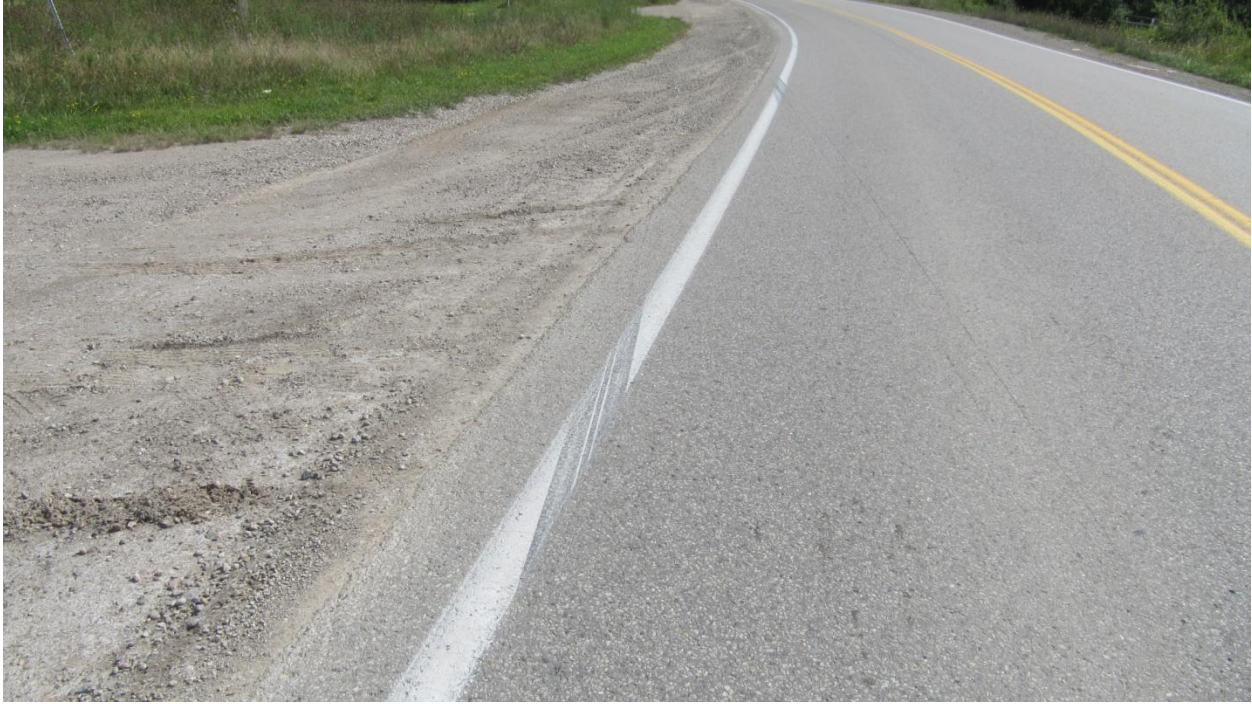
Figure 39: View, looking south, of the yaw marks in the northbound lane.

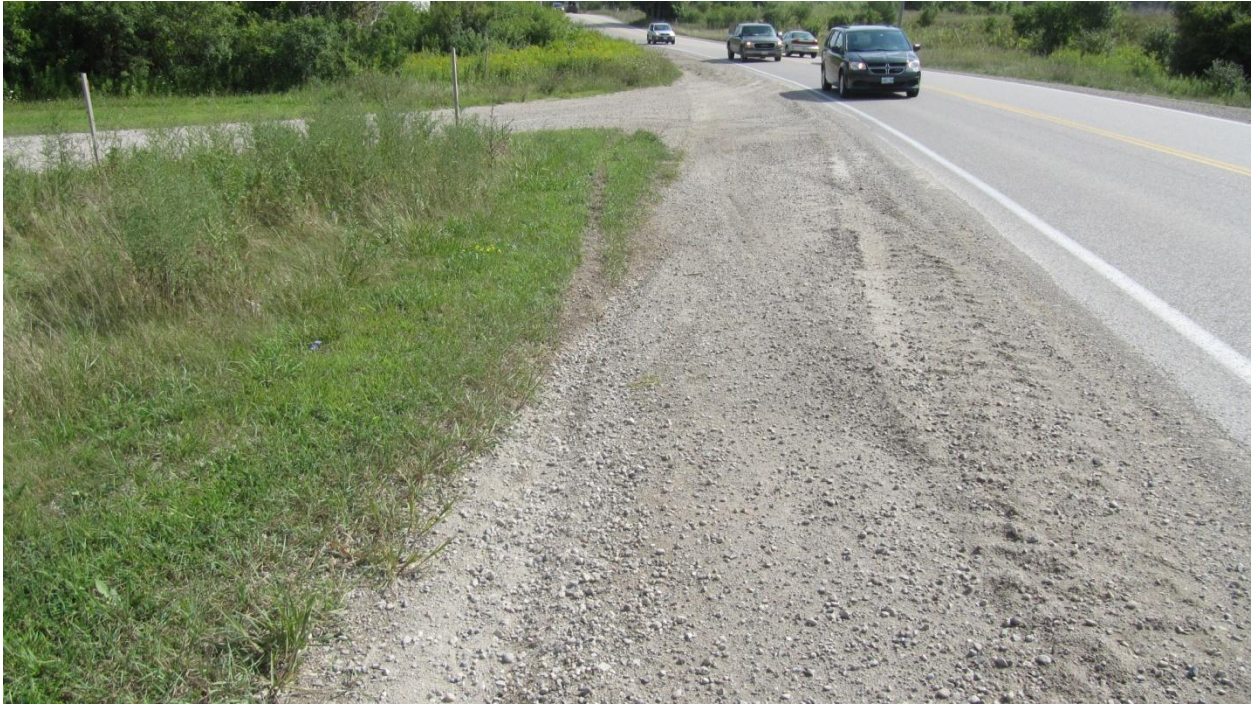
Figures 40 and 41 provide views of the tire marks on the shoulder and grass roadside.

Figure 40: View, looking south, at the yaw marks created on the east shoulder and roadside.

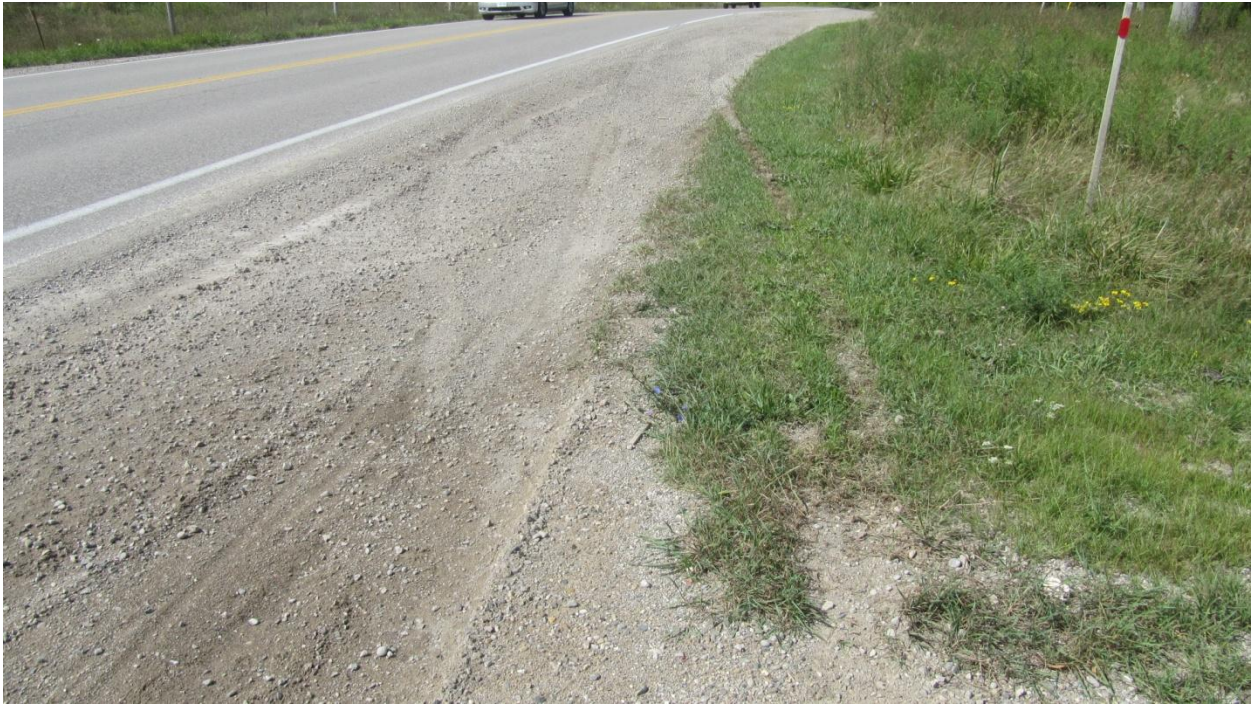
Figure 41: View, looking north, at the tire marks created on the east shoulder and roadside.

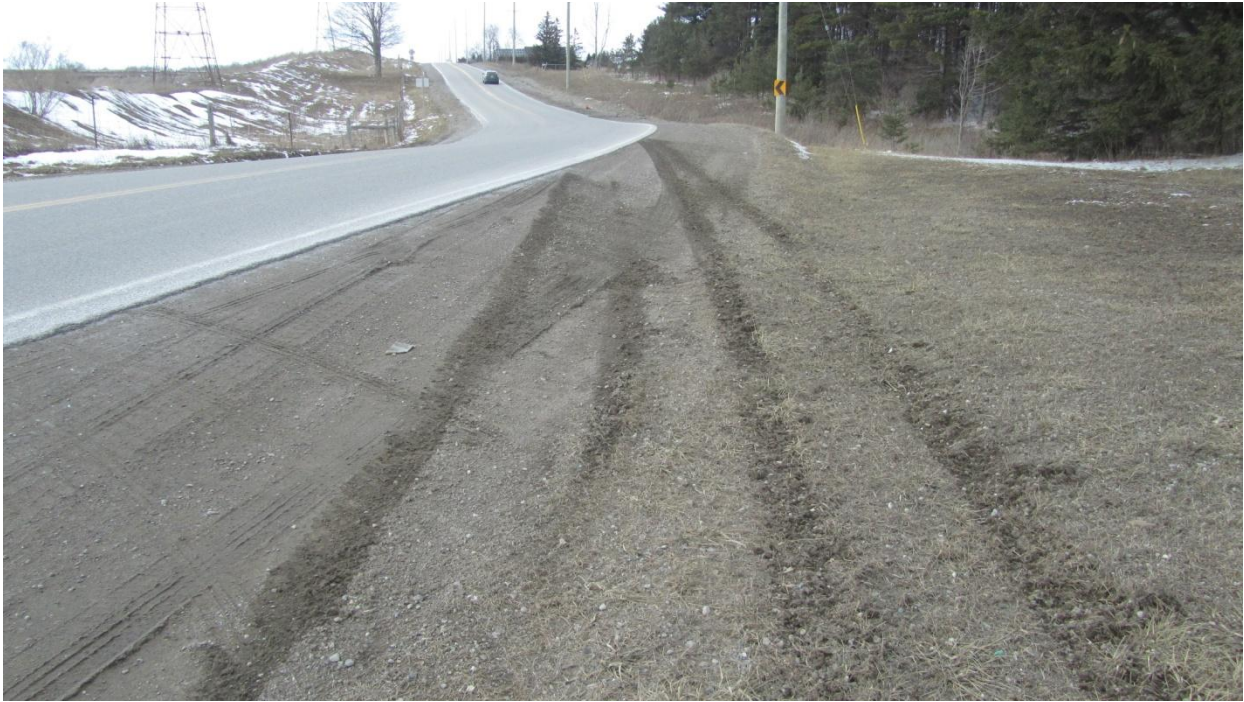
Figure 43: View, looking north, at the tire marks of the southbound vehicle as it enters the east shoulder.

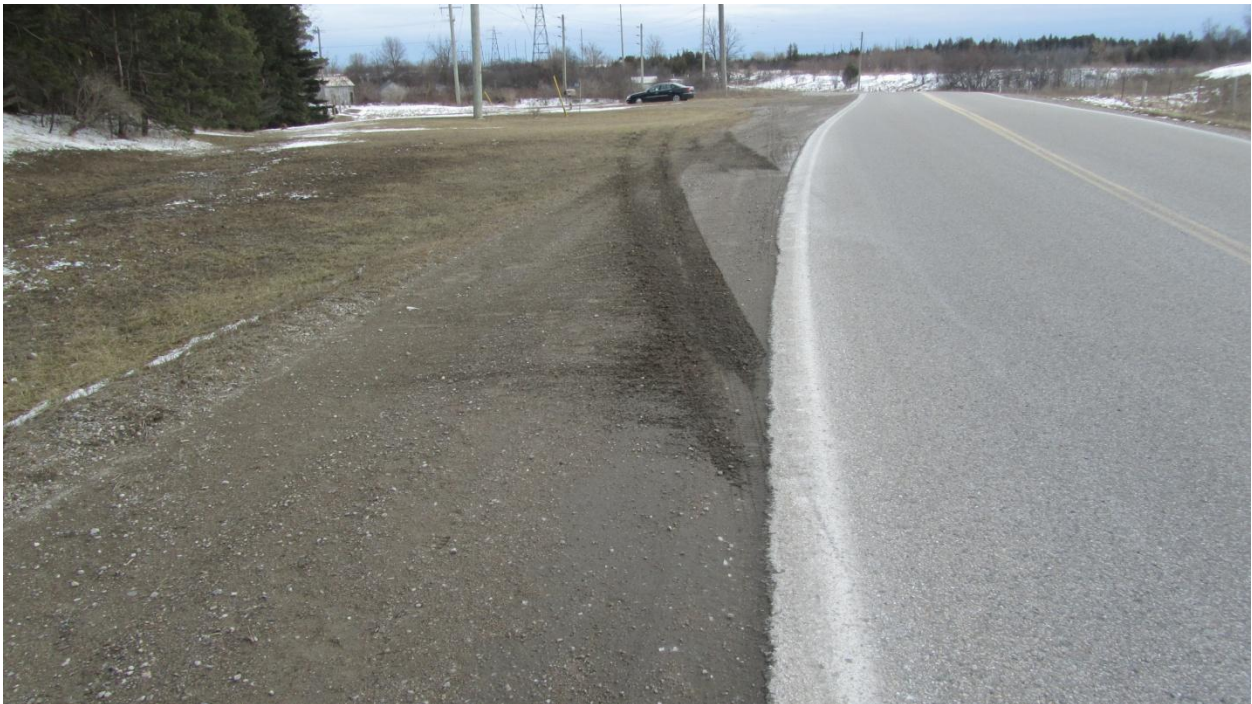
Figure 44: View, looking south, at the tire marks of the southbound vehicle as it enters the east shoulder and roadside.

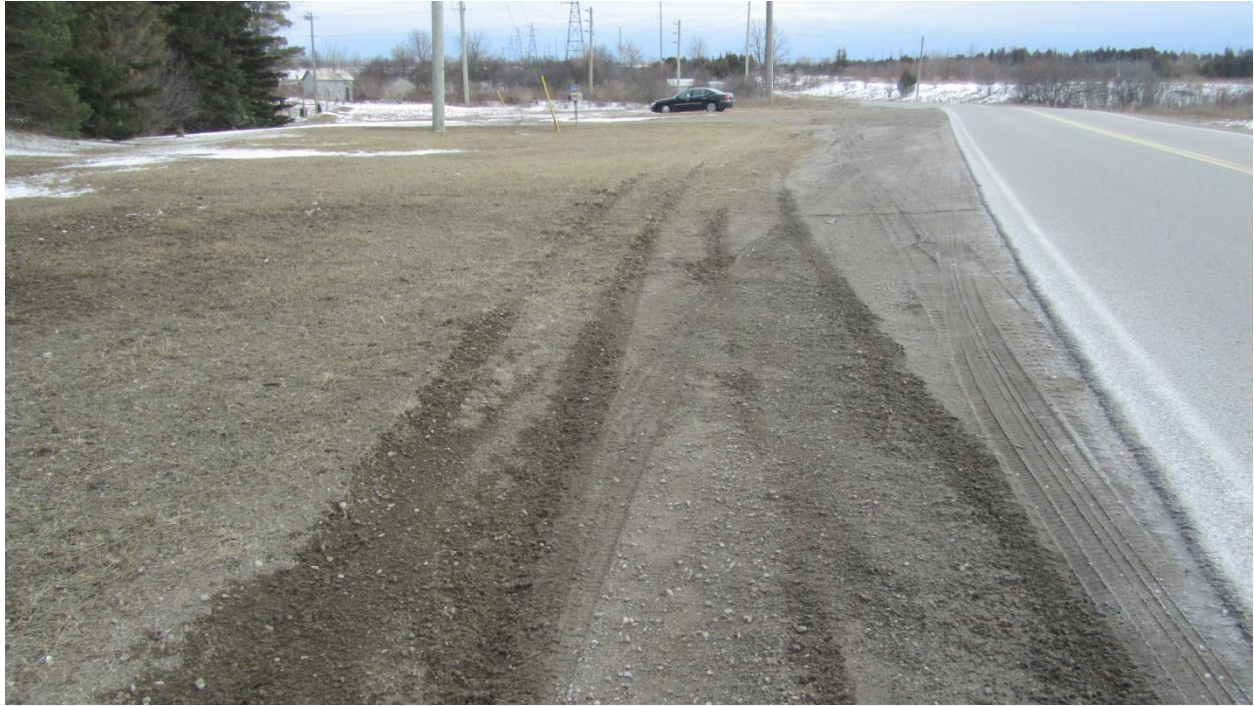
Figure 45: Southward view of the tire marks as they pass through the grass of the east roadside. The tire marks continue toward the parked car in the background.

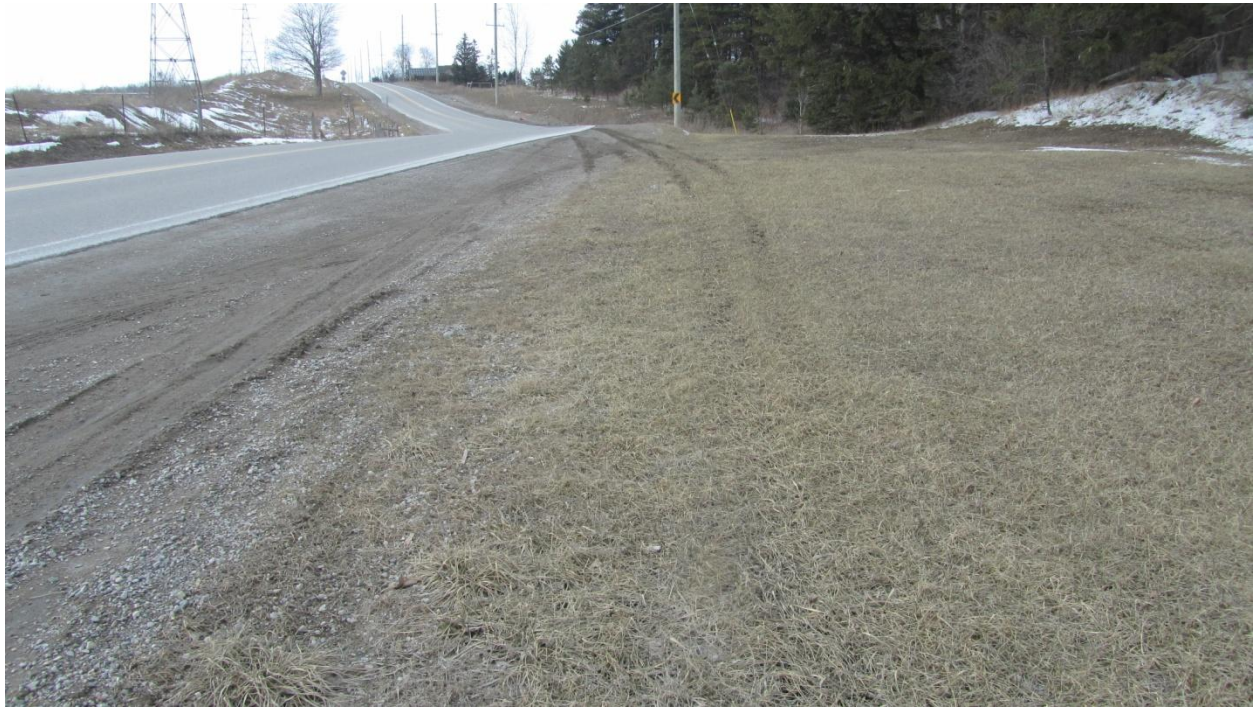
Figure 46: View, looking north, at the tire marks of the southbound vehicle approaching the camera.

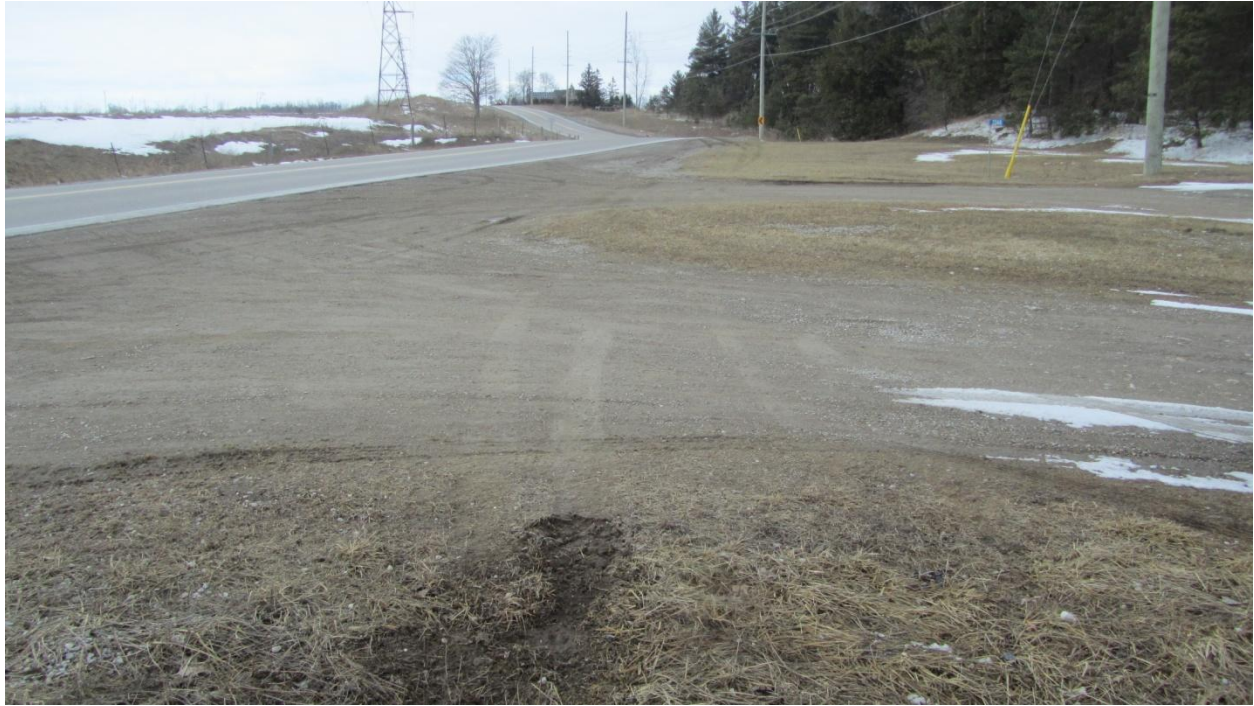
Figure 47: View, looking north, at the tire marks as they pass through a driveway at the east roadside.

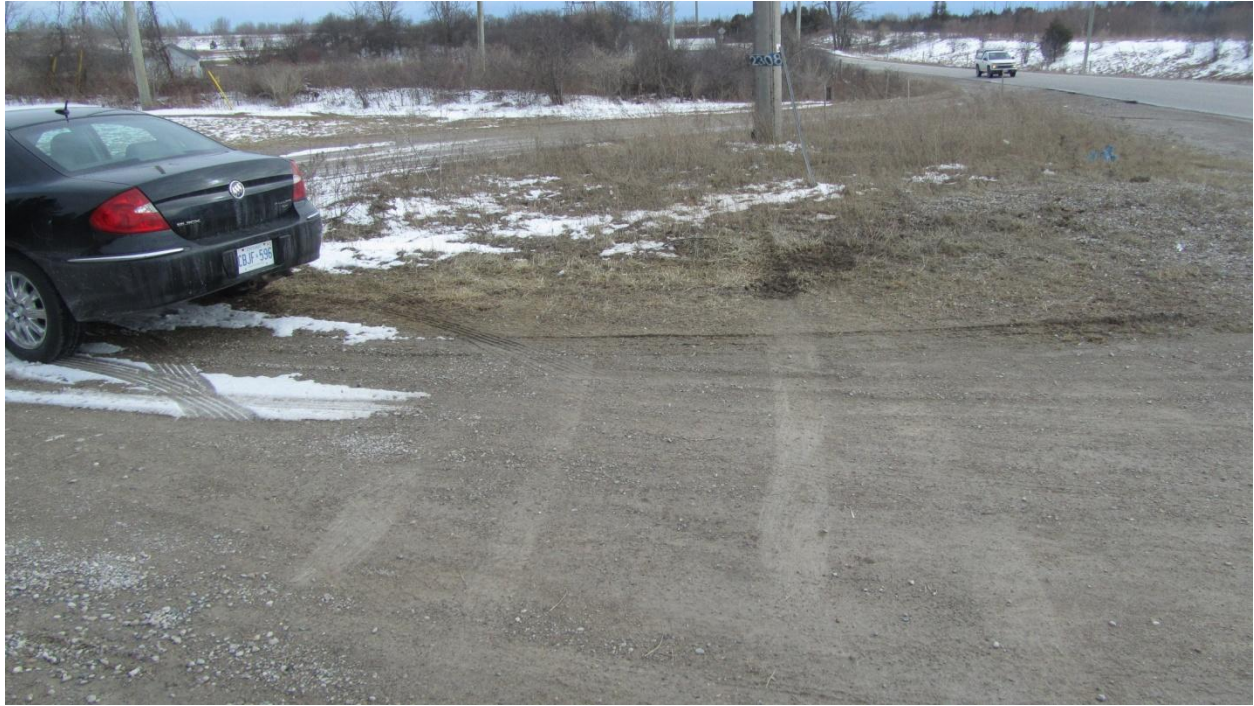
Figure 48: View, looking south, as the southbound vehicle passes through a driveway and passes to the left (east) of the large utility pole.

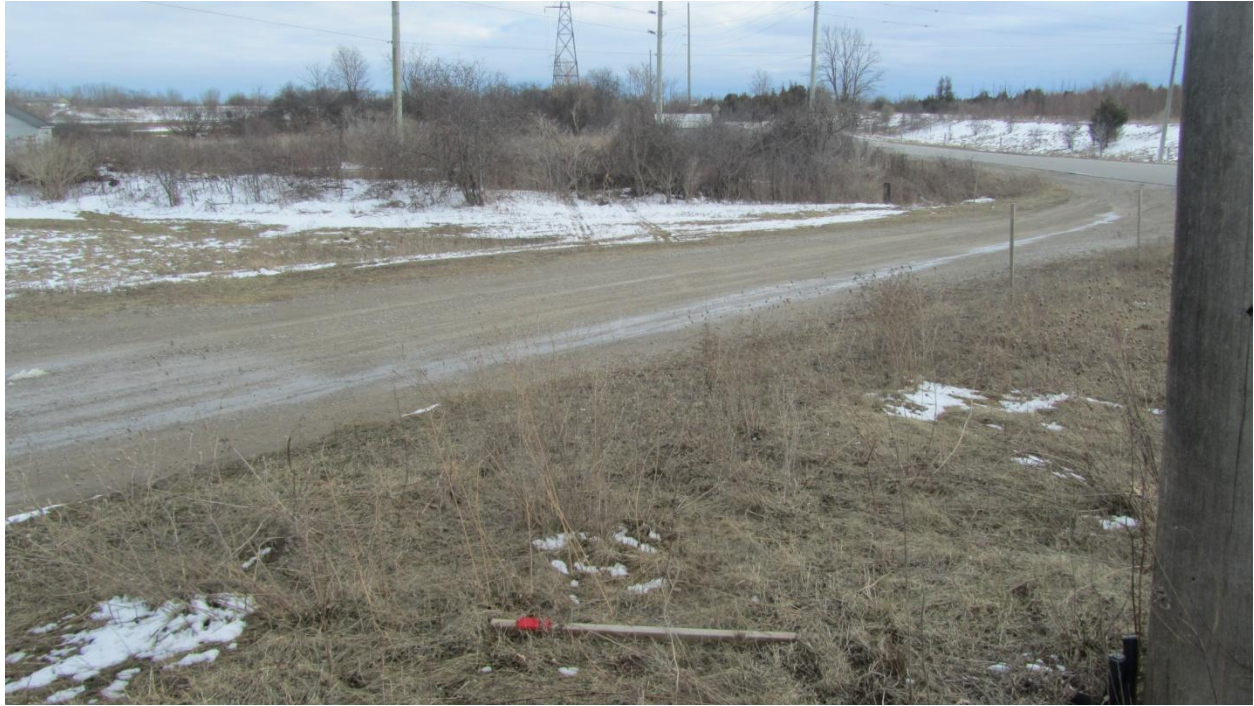
Figure 51: As the southbound vehicle passes by the utility pole additional tire marks are visible south of a driveway indicating that the vehicle travelled into the fence and bushes in the background.

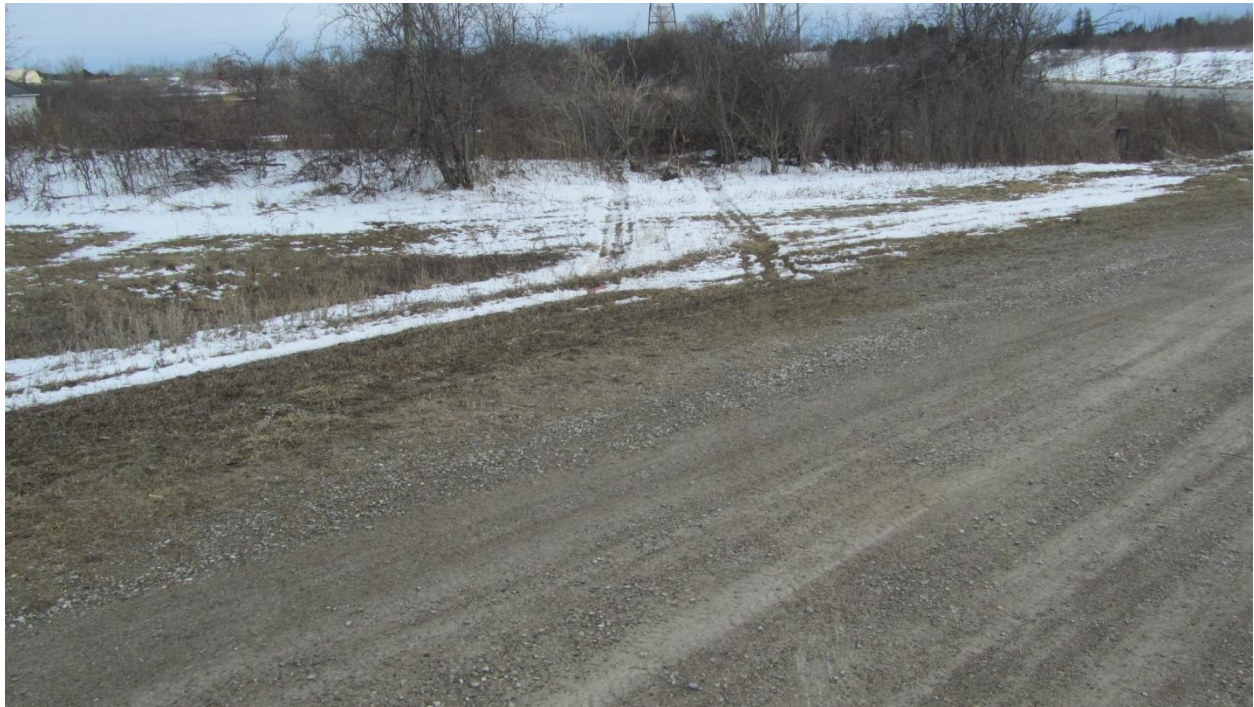
Figure 52: Closer view of the tire marks showing the vehicles path into the fence and bushes.

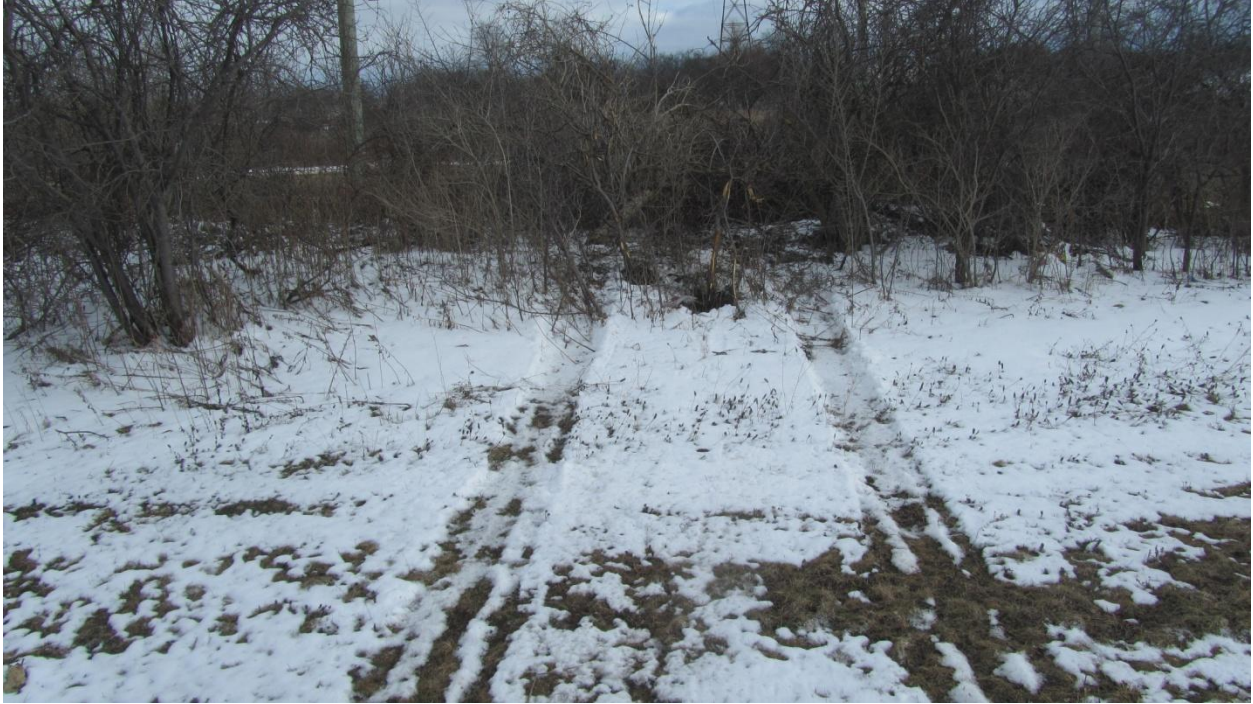
Figure 53: View, looking south, showing the tire marks indicating that the southbound vehicle passed through the fence and bushes and onto an adjoining property owned by the City of London.
