Historical Patterns In Loss-of-Control Events At Specific Road Locations

Posting Date: April 2, 2018

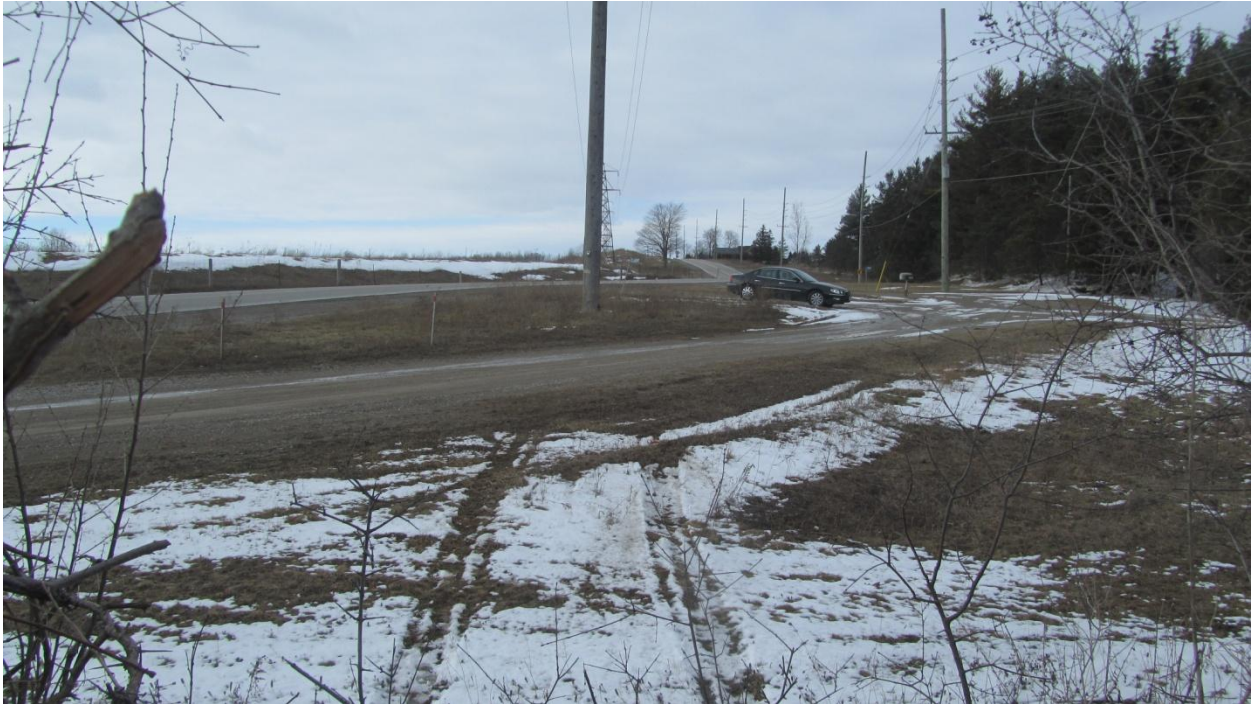
Figure 54: View, looking north from the location of the fence, showing the tire marks in the foreground and the path of the southbound vehicle coming toward the camera in the background.

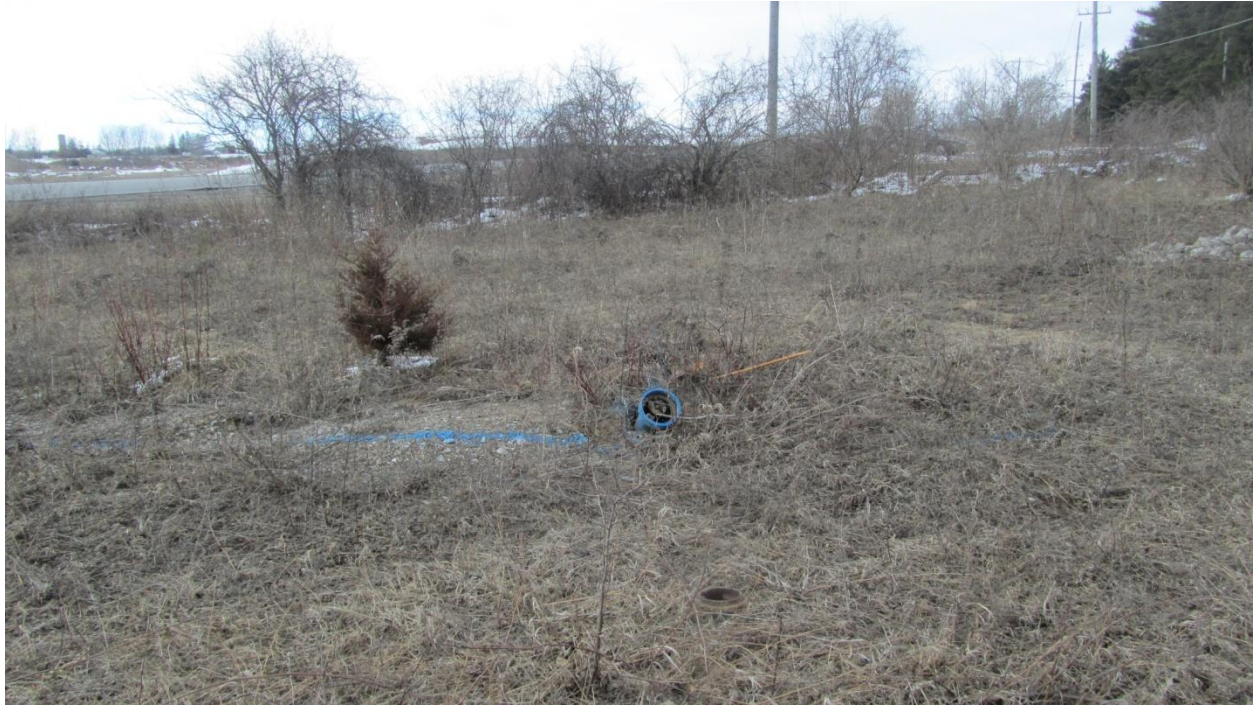
Figure 55: View, looking north, while standing on the City owned property and looking at the fence and bushes where the southbound vehicle vaulted toward the camera. In the foreground is blue-painted pipe and a yellow pole both of which were struck by the southbound vehicle after it vaulted through the fence.

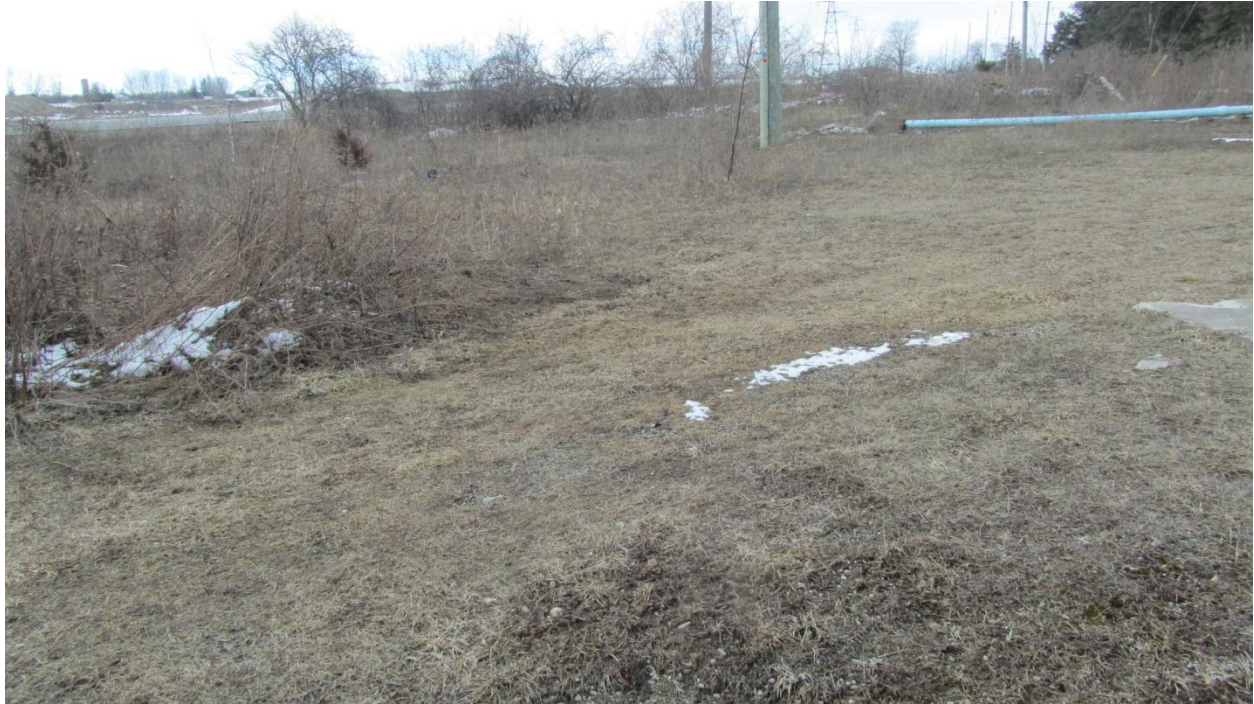
Figure 58: View, looking north, from south of the final rest position of the southbound vehicle. There is a driveway in the foreground where tire marks were found suggesting the at involved vehicle either exited under its own power or was assisted by another vehicle.

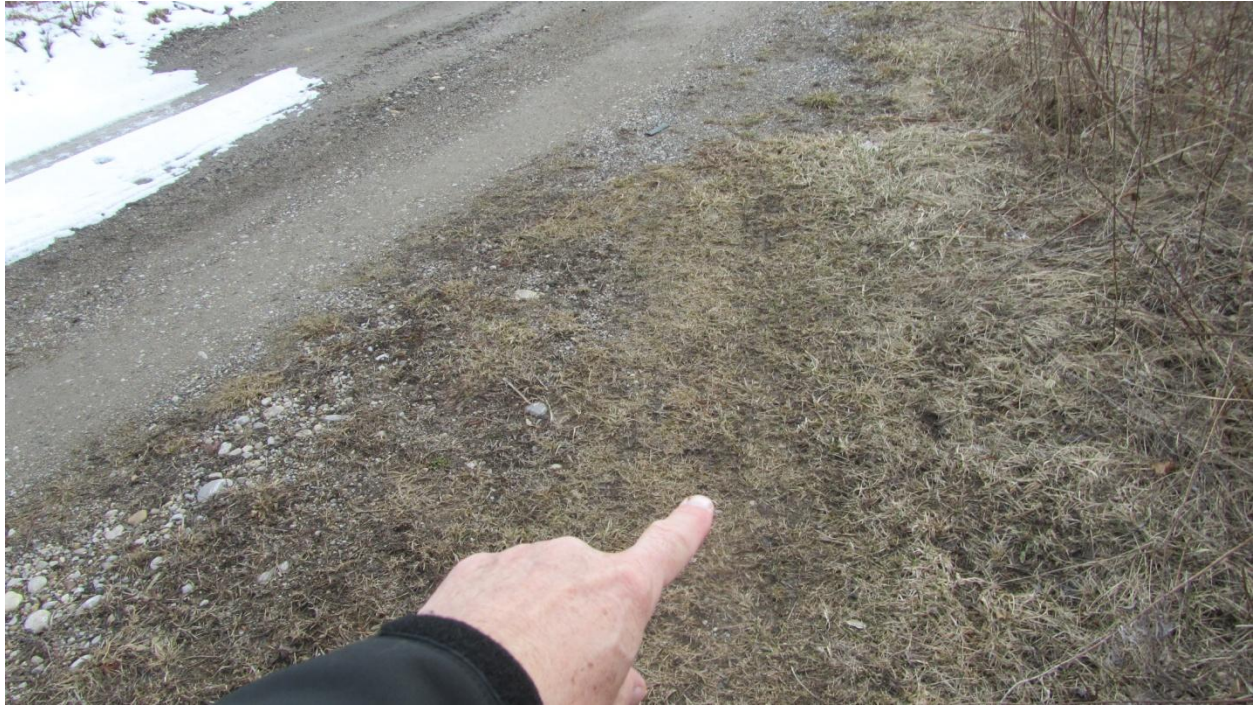
Figure 59: The investigator's finger is pointing to some tire marks near an exit driveway indicating the path of the involved vehicle which exited back onto the road via it own power was assisted by another vehicle.

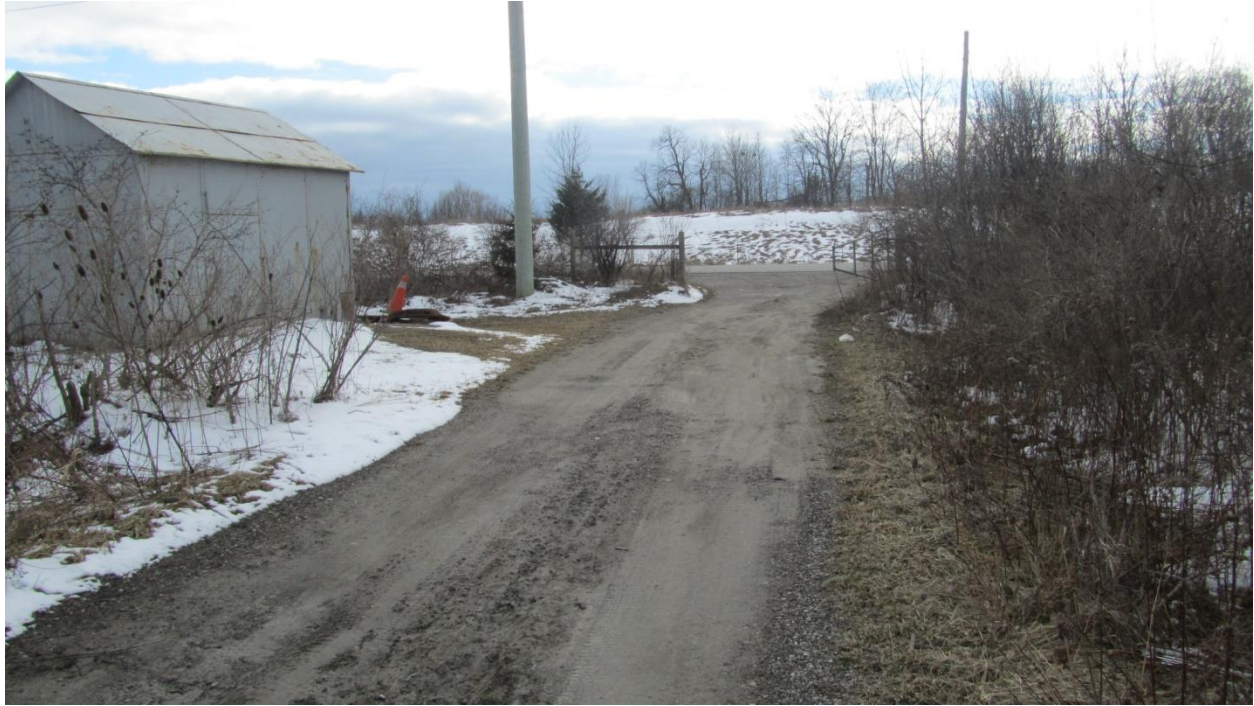
Figure 60: View of the driveway of the City-owned property where the southbound vehicle exited back onto the roadway.
