# Gorski Consulting Website

## Archived News - 2013 - March

### **Another Fatality of Young Teenager Trapped in Submerged Vehicle in Toronto**

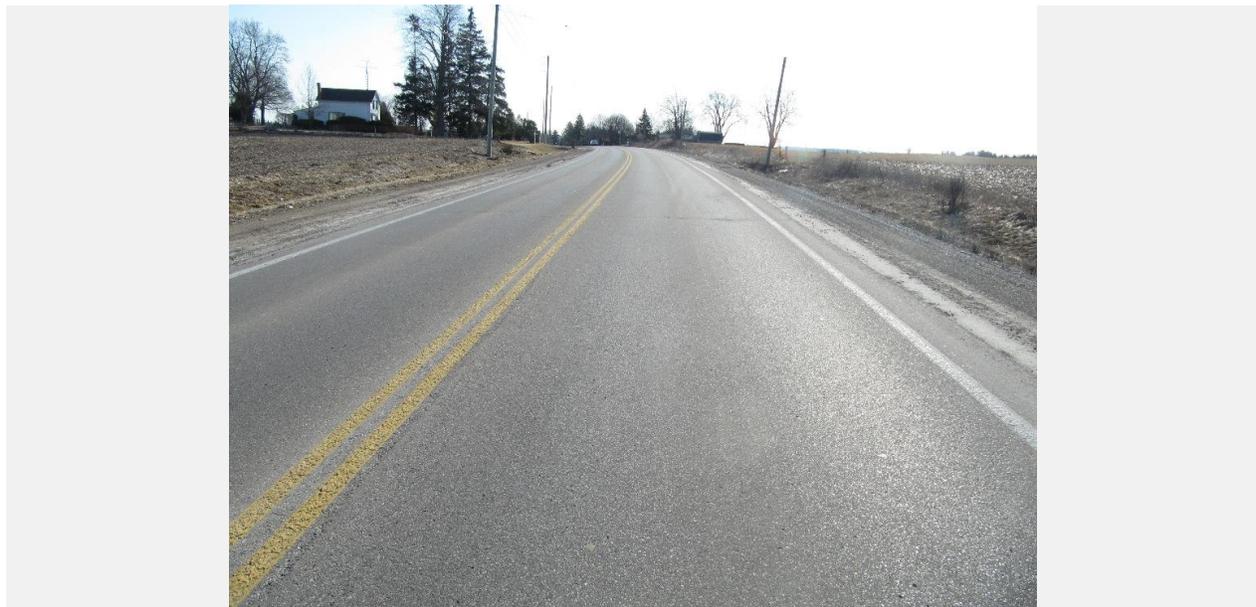
Gorski Consulting attended the site this morning, March 30, 2013 and it became apparent that the involved eastbound vehicle had to be travelling at a very fast speed when the driver lost control at the top of a hill which also contained a left curve. Below is a photo taken from several hundred metres west of the vehicle's final rest position, looking east, to the curve and downgrade where the driver lost control.

View, looking east on Commissioners Road to the left curve and downgrade where the Honda Accord driver lost control of his speeding vehicle.

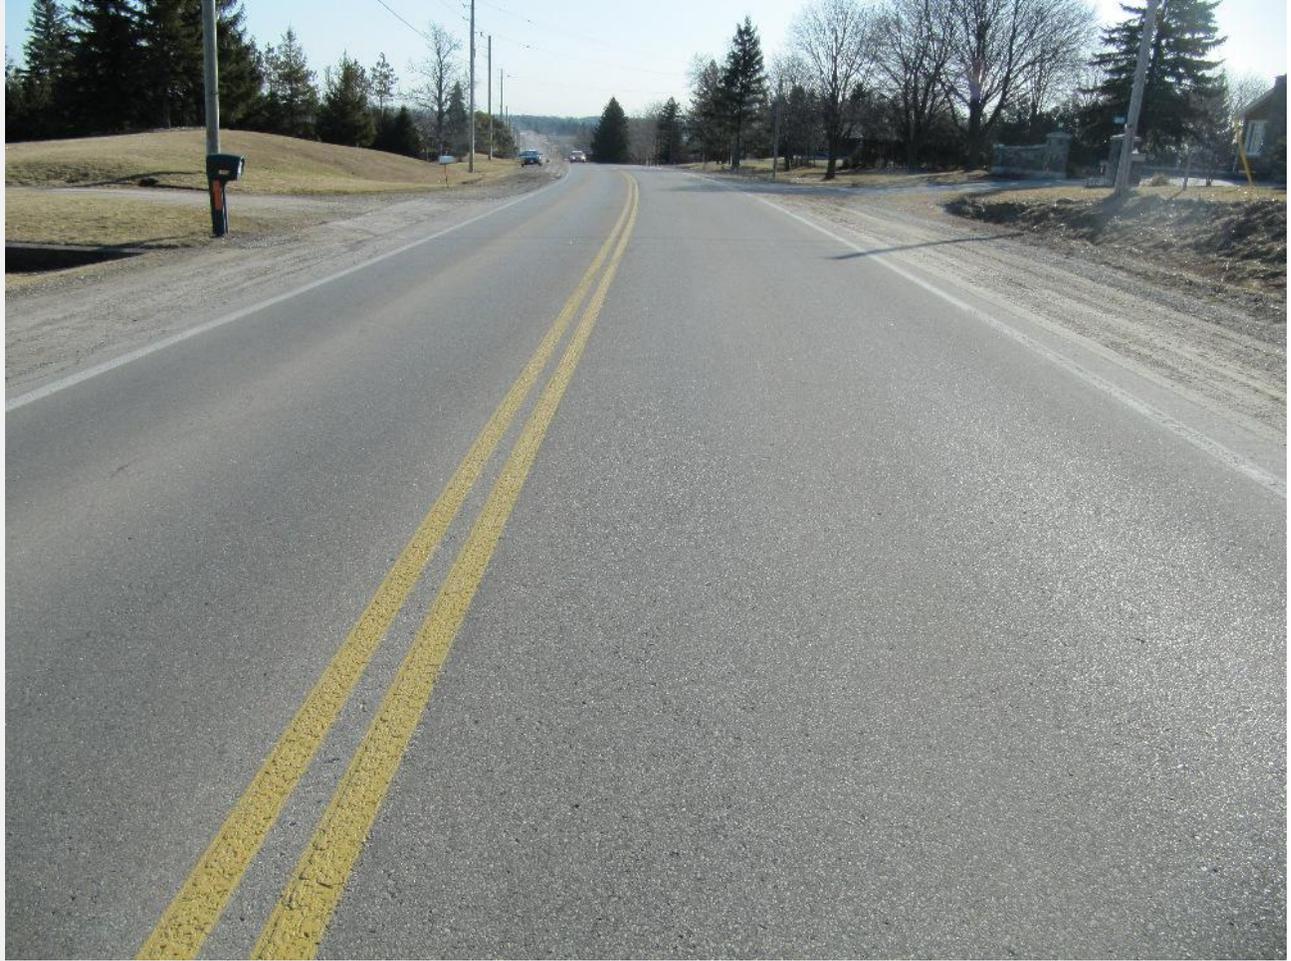
The photo below shows another eastward view partway through the left curve. The Accord eventually travelled onto the right (south) roadside in the background.

View, looking east, parkway through the left curve of Commissioners Road. The Accord left the roadway to the right (south) in the background.

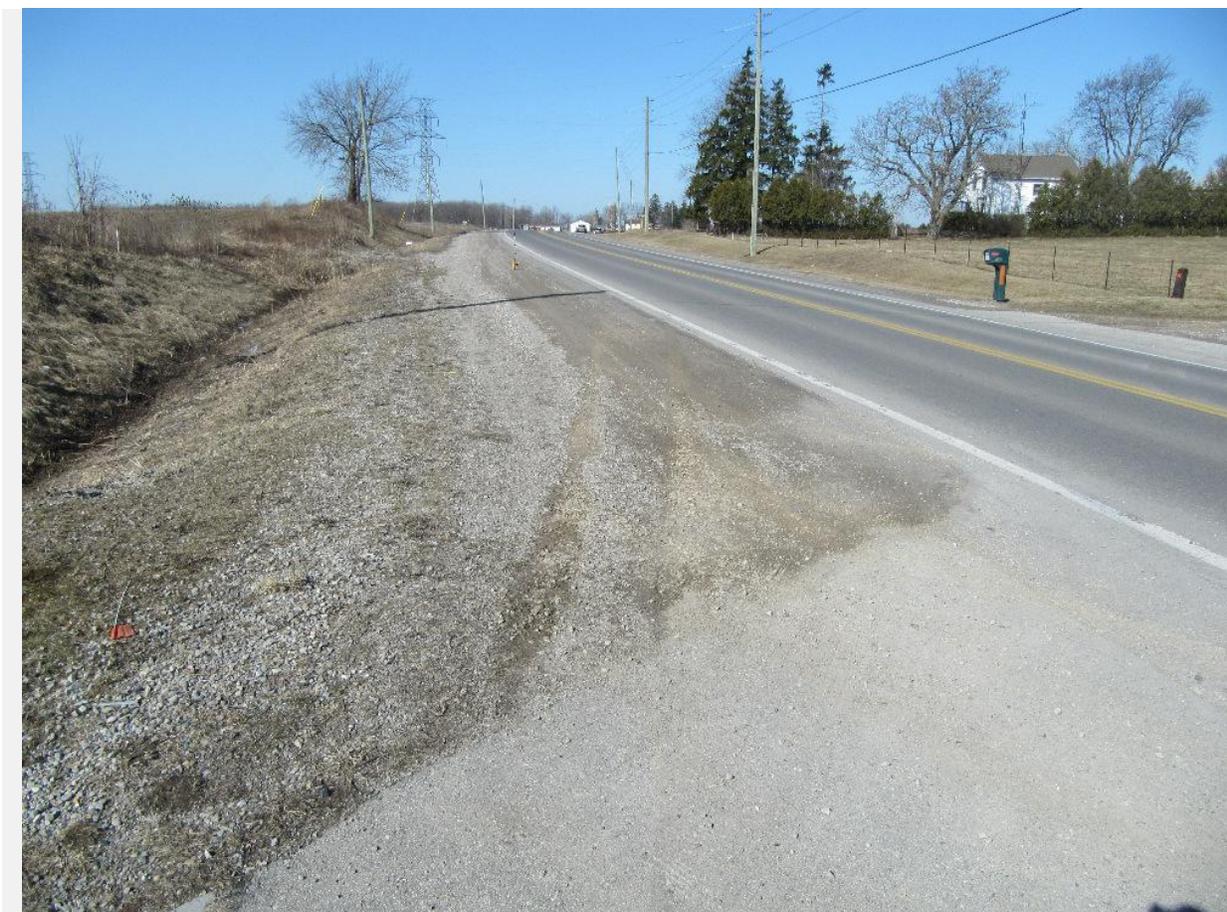
The first yaw tire marks were visible on the roadway centre-line at a location when the vehicle was already at an advanced stage of rotation. The photo below looks back westward along the curve from the location of a driveway in the foreground where the vehicle travelled off the road surface.

View, looking westward from a driveway where fresh yaw marks can be seen in the gravel shoulder in the foreground from the Accord as it approached the camera.

In the above photo we have placed a measurement wheel on the south (left) shoulder across from the point where the first visible yaw marks were observed at the roadway centreline. Using this location as a "Zero" reference we measured the Accord's path to its final rest position. As the vehicle was already at an advanced stage of rotation at this location it means that it had to be losing speed for a substantial distance before producing this first visible evidence. From this first visible yaw mark the Accord travelled about 83 metres through a lawn where it just grazed the stump of a large maple tree, as shown in the photo below.

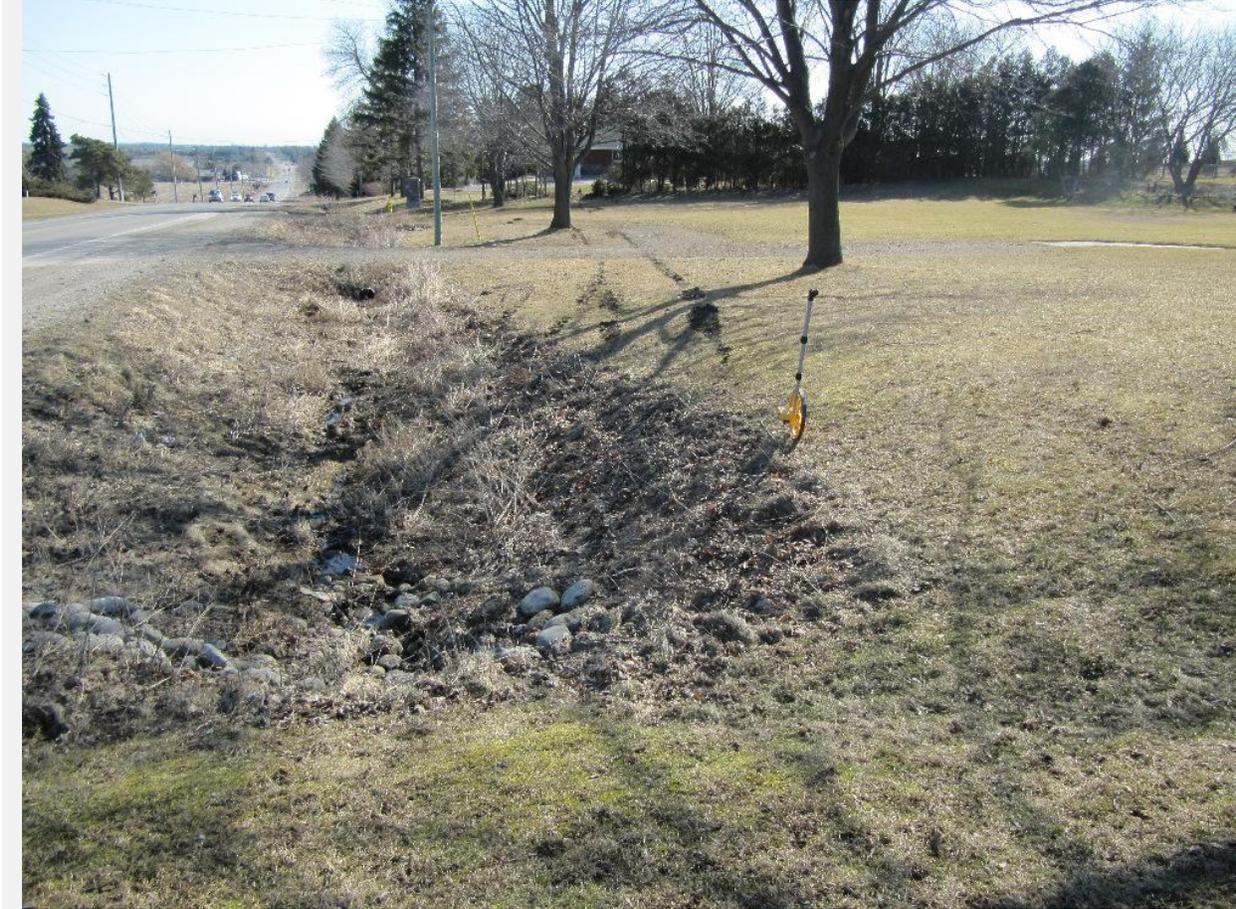
View, looking south-east from the driveway, toward the south roadside where the loss-of-control tire marks are visible on the lawn. Note how the tire marks just graze the stem of a large maple tree in the background.

The position of our measurement wheel in the above photo is 43 metres east of its original position across from the start of the yaw marks at the roadway centre-line. After grazing the noted maple tree the Accord travelled an additional 30 metres before striking a row of smaller cedar trees, as shown in the photo below.

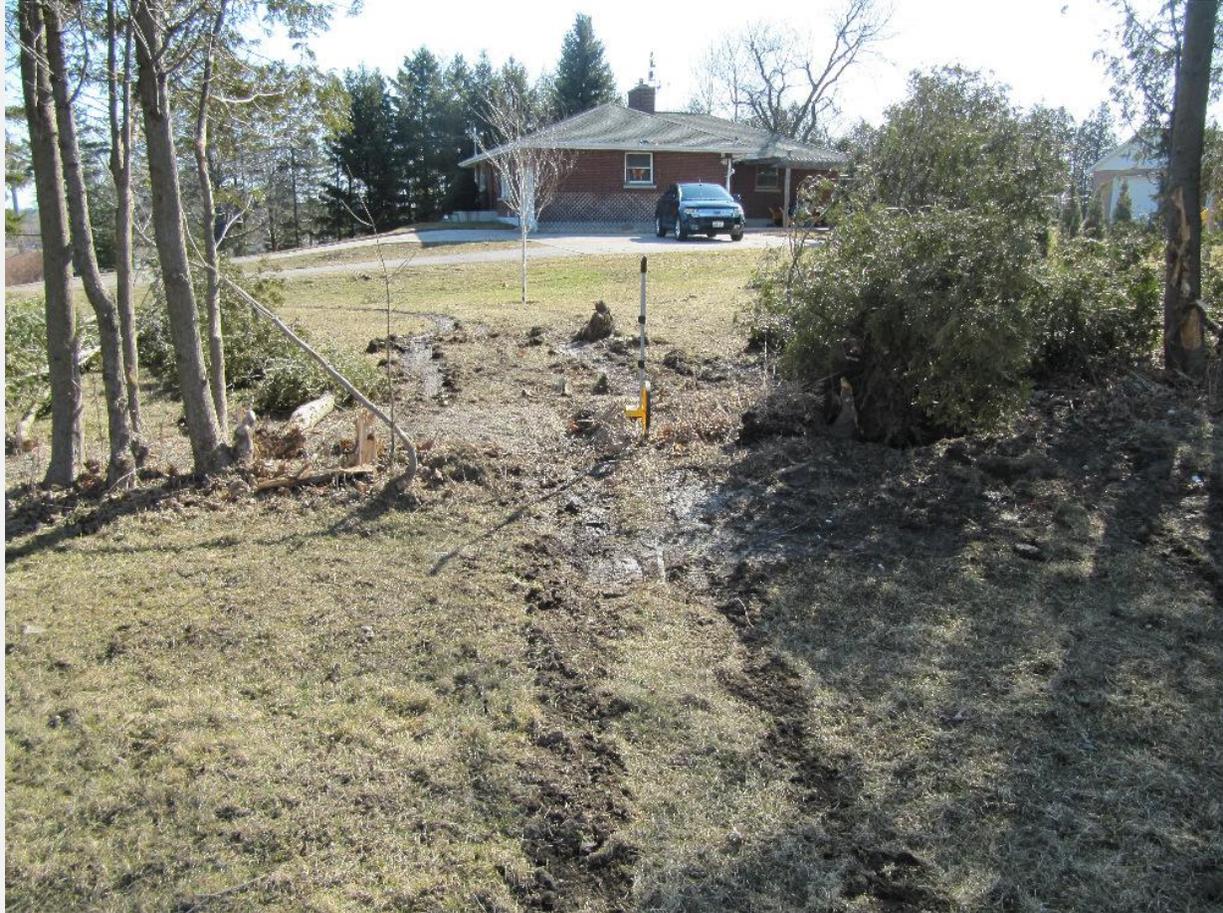
View, looking southeast, toward the final rest position of the Accord against a row of cedar trees. These cedars were located about 112 metres from the yaw marks that were first visible on the roadway centreline.

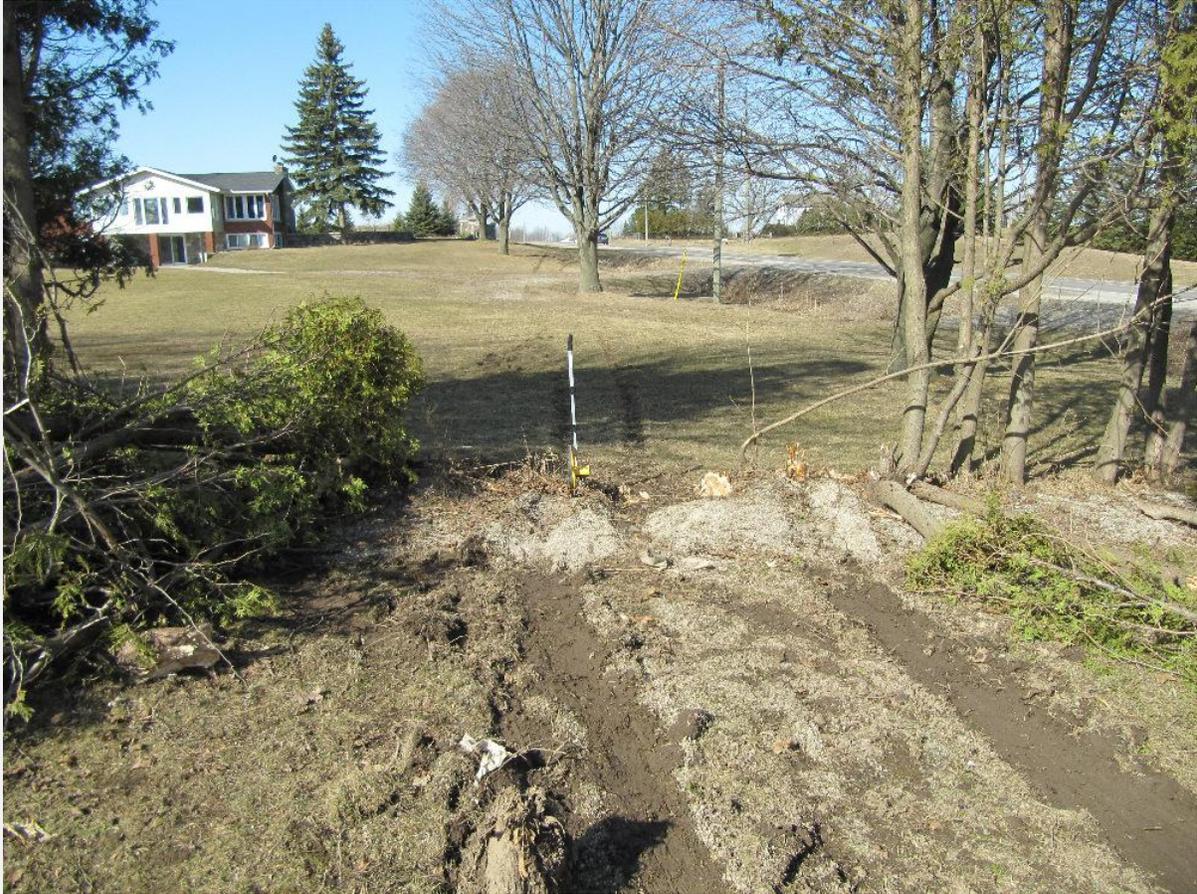
Several of these cedar trees were knocked over indicating that the vehicle had to be travelling at significant speed at that location even after decelerating over the previous 112 metres of visible evidence. The photo below shows a view looking back along the path of the Accord from its final rest position at the row of cedars.

View, looking north-west, from the final rest position of the Accord, along its travel path from the roadway in the background. The markings in foreground are from repair work undertaken after the crash.

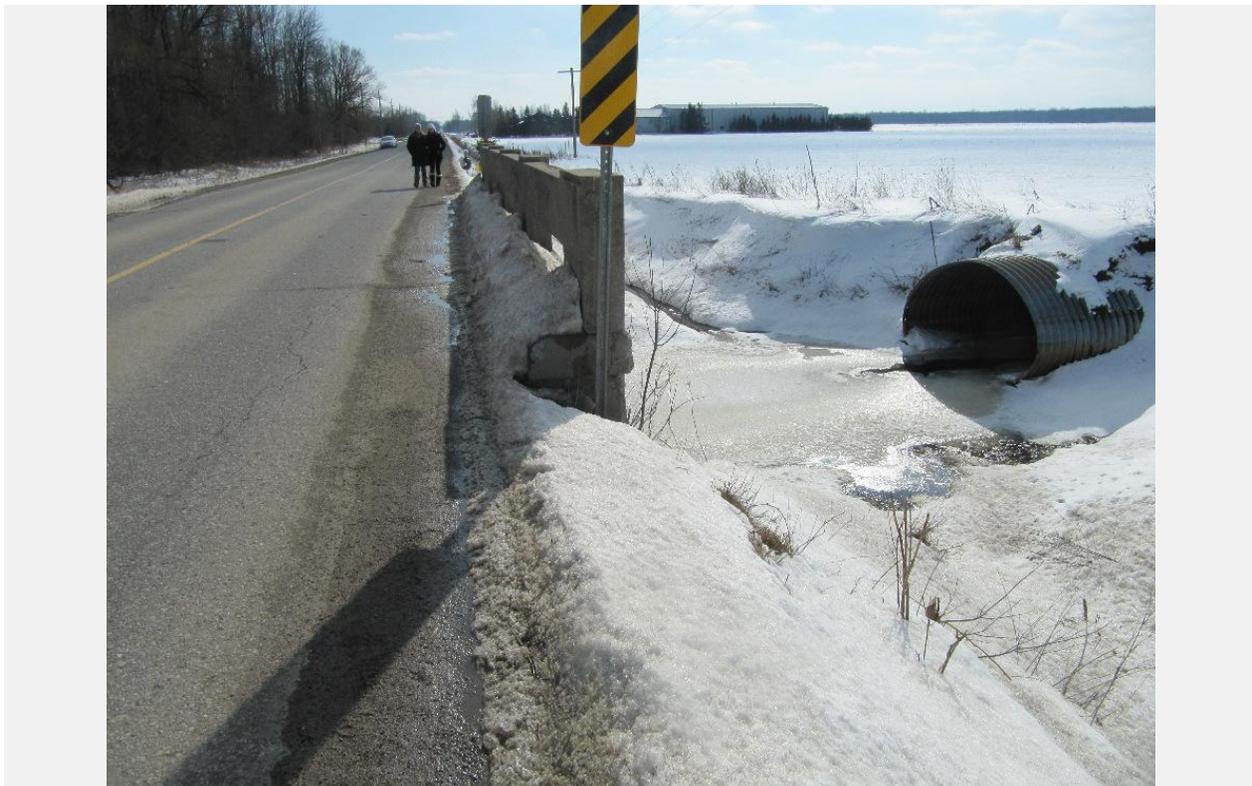
View of lack of guardrail and water-filled ditch where three persons died when their vehicle came to rest upside down in the ditch.

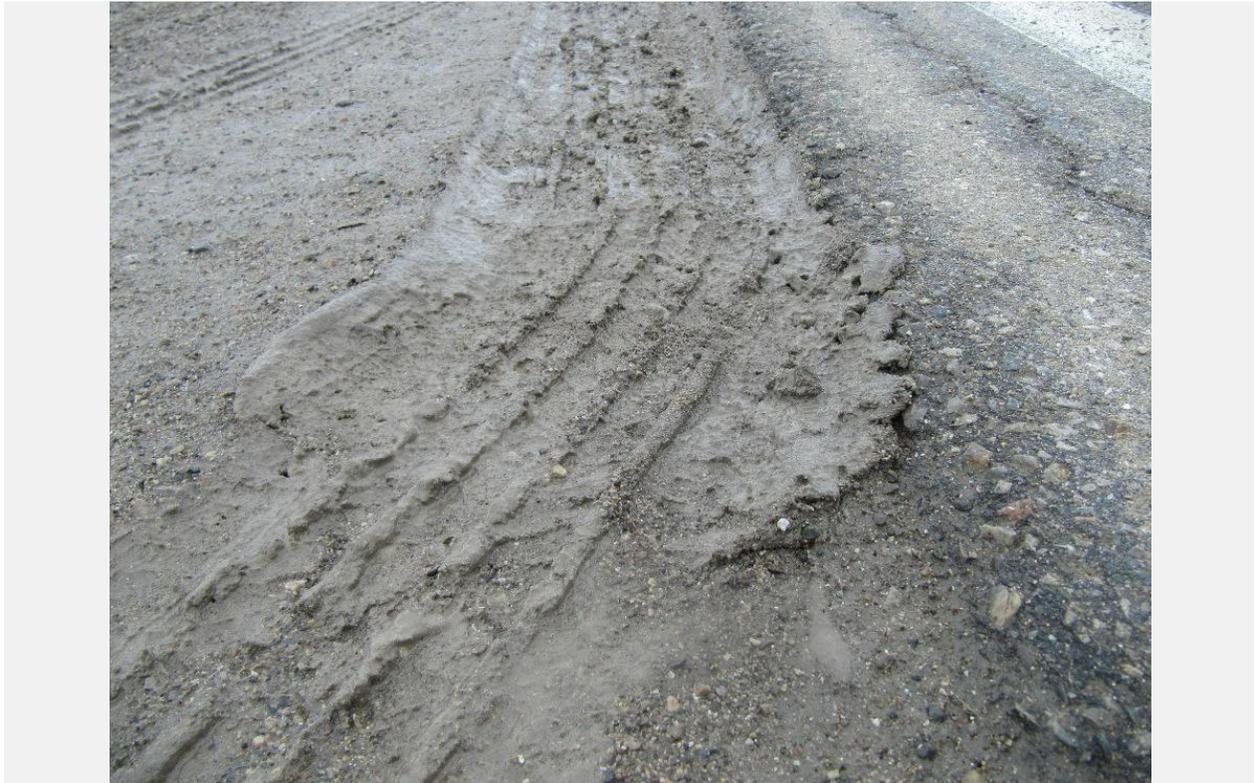
Tire mark at end of emergency braking test on gravel shoulder using a 2012 Ford Fusion.

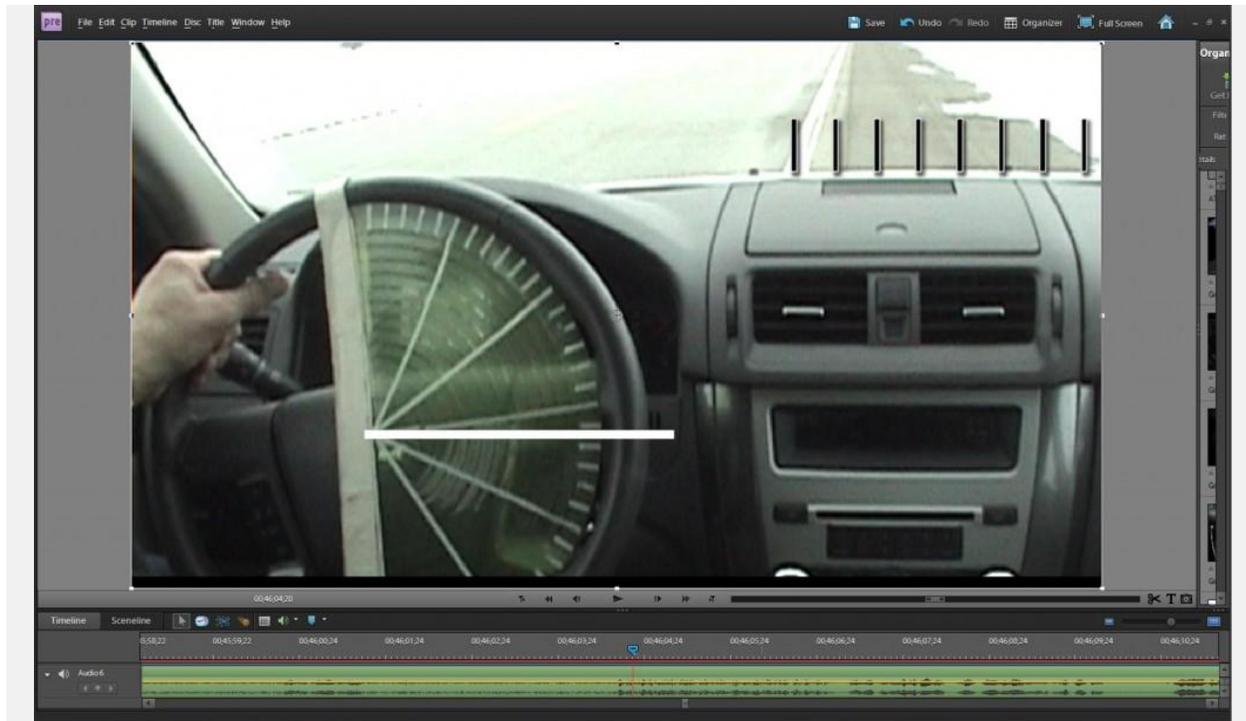
One of the more interesting analysis techniques involves using the "Text Insert" function to produce various markers in our video so that we can follow the rotation of the steering wheel and the vehicle during our braking tests. An example of such insertion is shown in the photo below where we insert a row vertical lines along the dash to observe how the white roadway edge line migrates in the view and therefore indicates vehicle rotation. Another example shows a horizontal white line which is produced at the protractor of the steering wheel hub to explore the magnitude and quickness of steering inputs.

"Text Insert" function allows markers to be placed in video to observe steer and vehicle rotation.

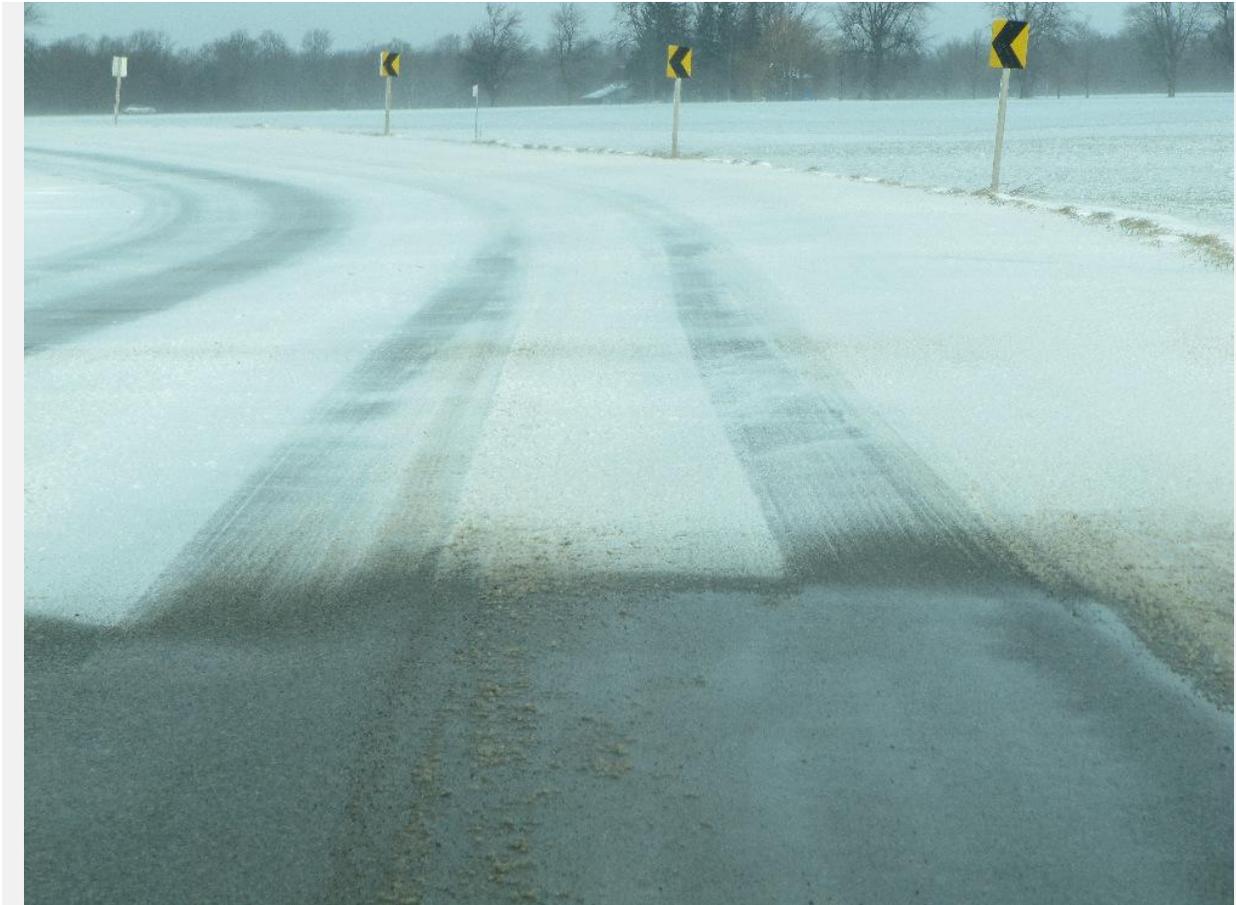
Road conditions are more susceptible to change at a curve because the wind direction will change with respect to the road so that a bare and wet road may suddenly develop a layer of blown snow on the surface that was not present on the approach to the curve.

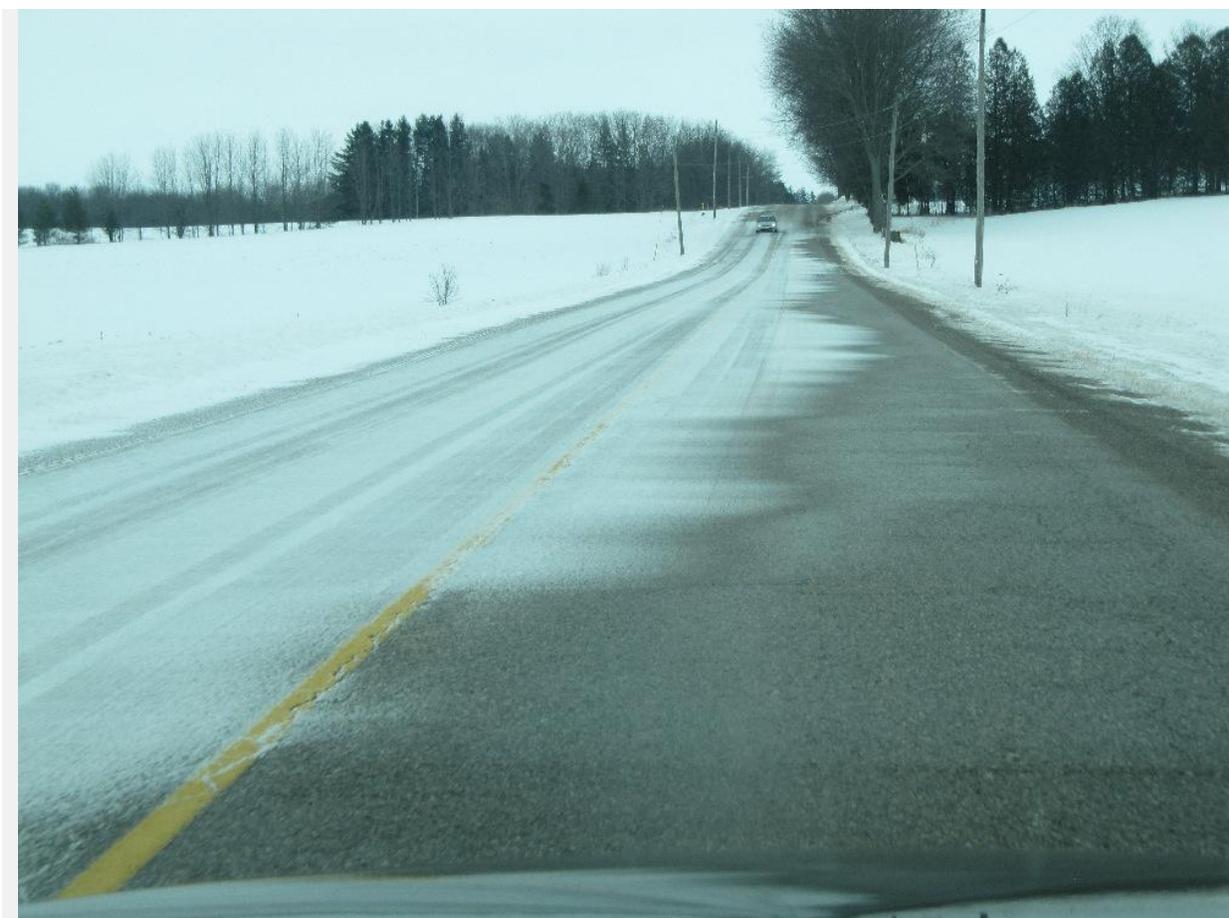
Which side of this road represents "The" road condition? Would the condition change depending on which direction a vehicle is travelling? We indicate that road conditions are often variable.

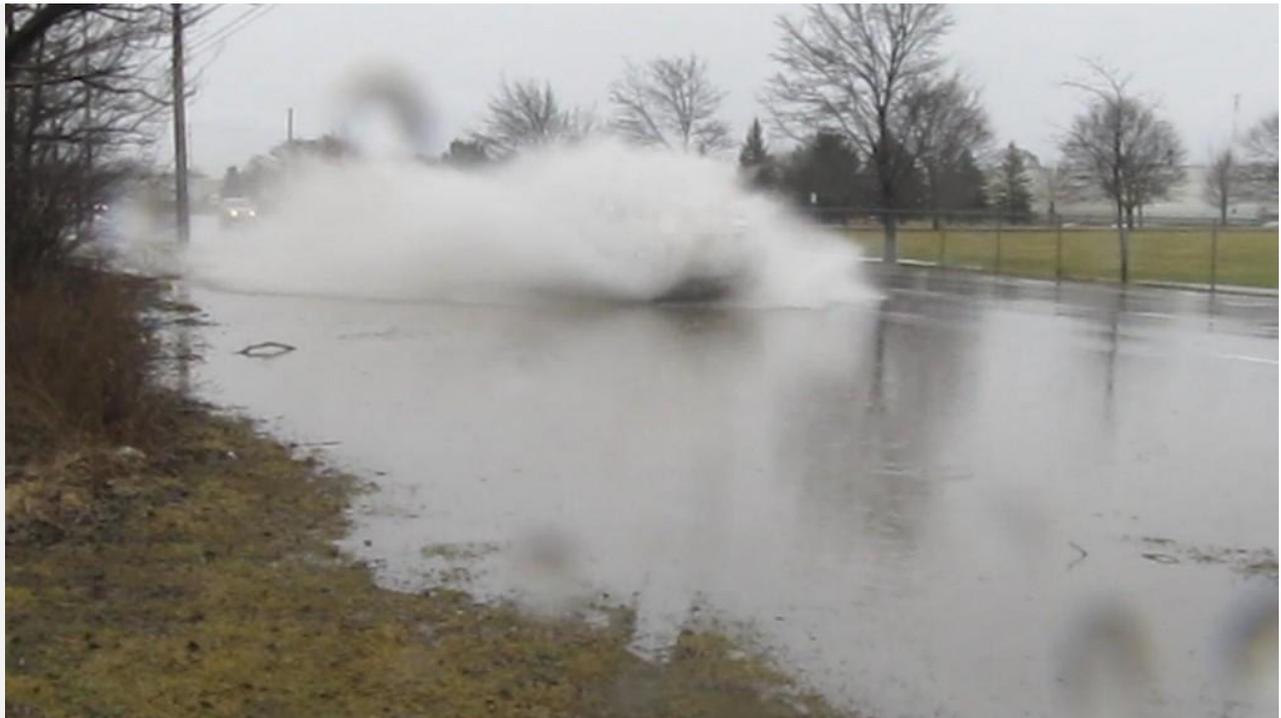
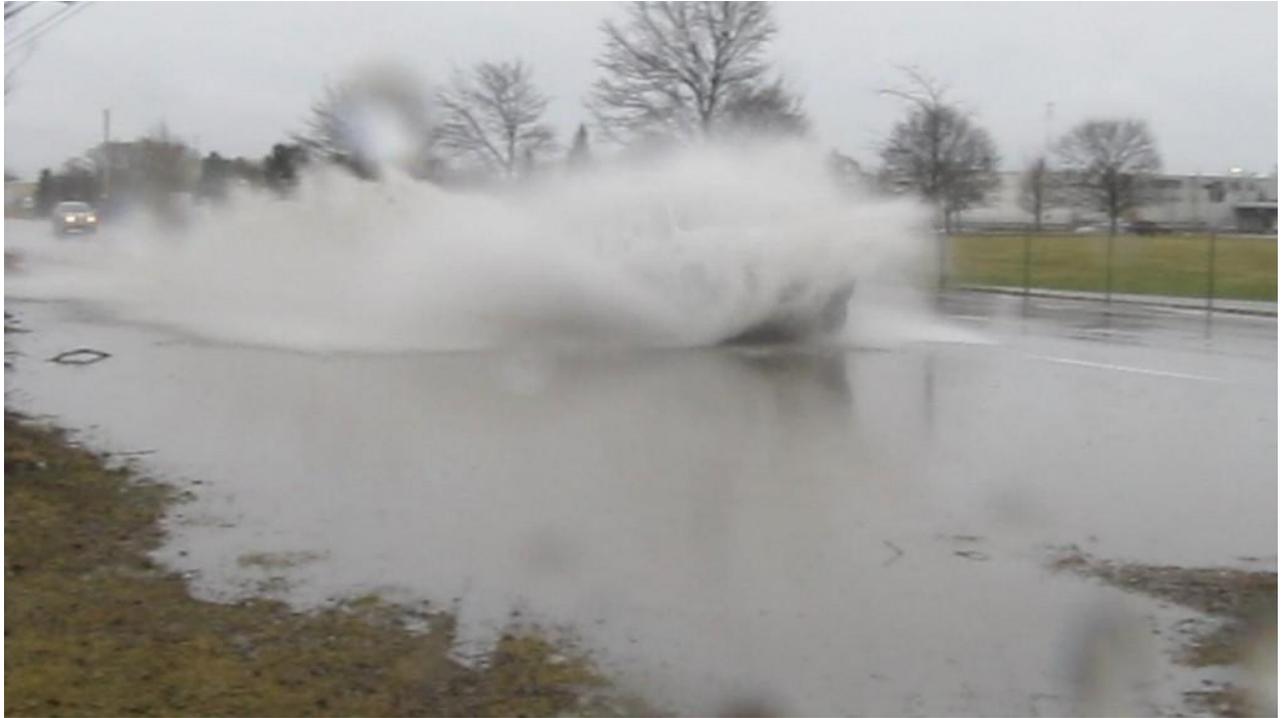
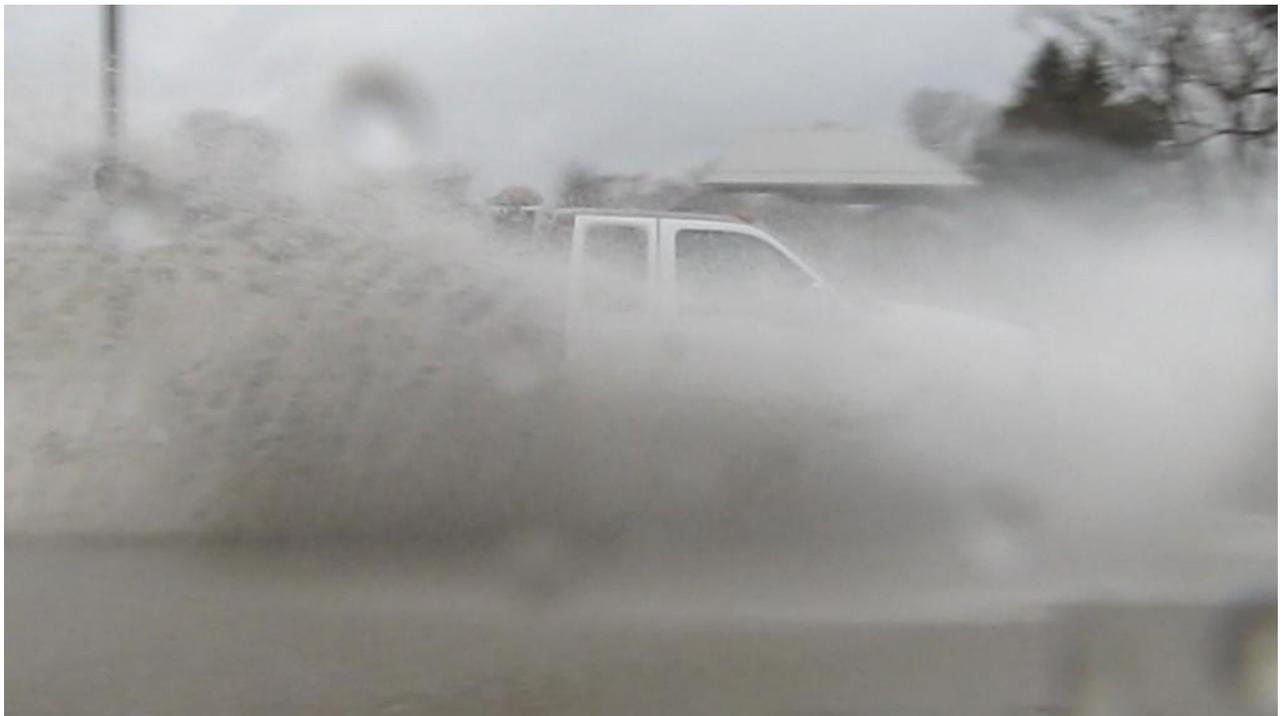
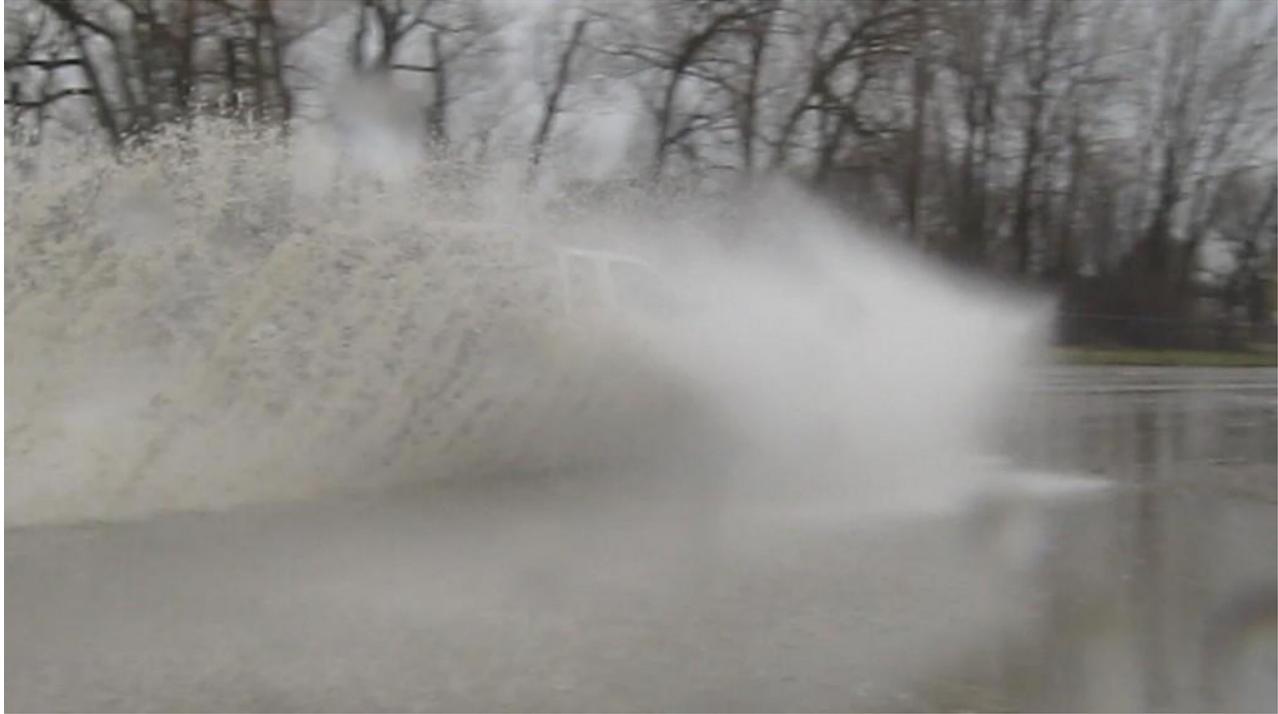
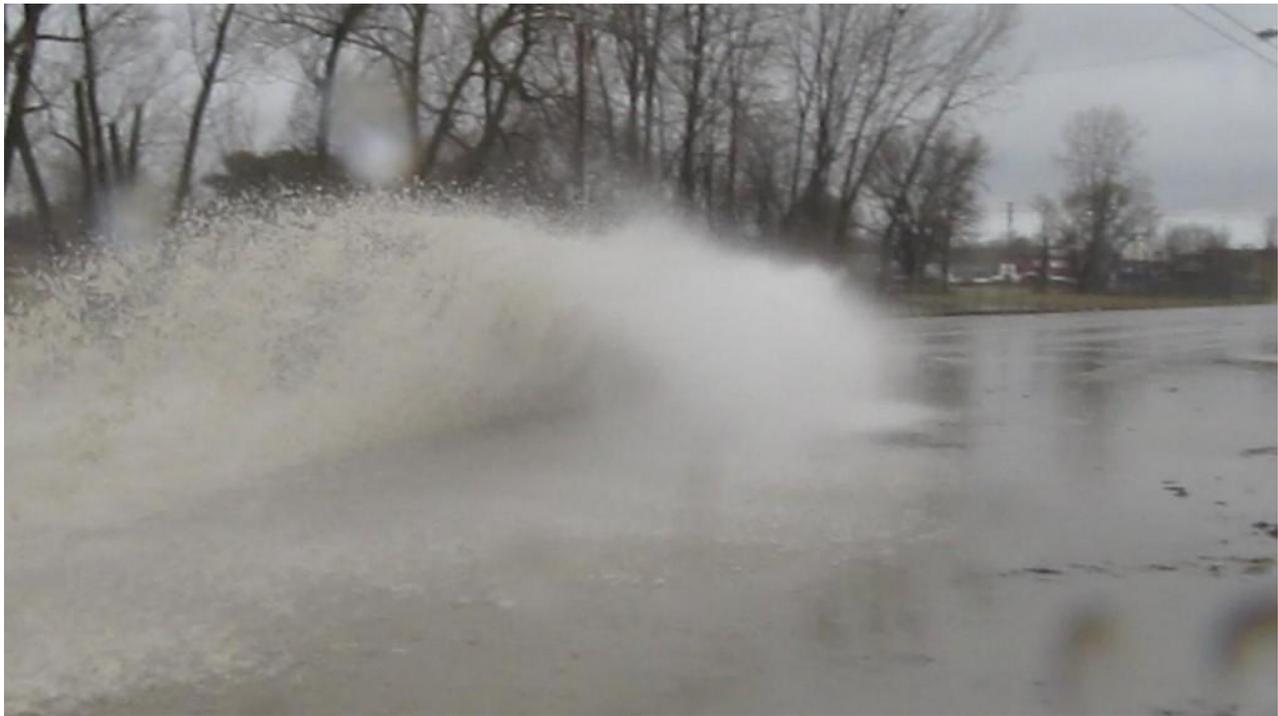
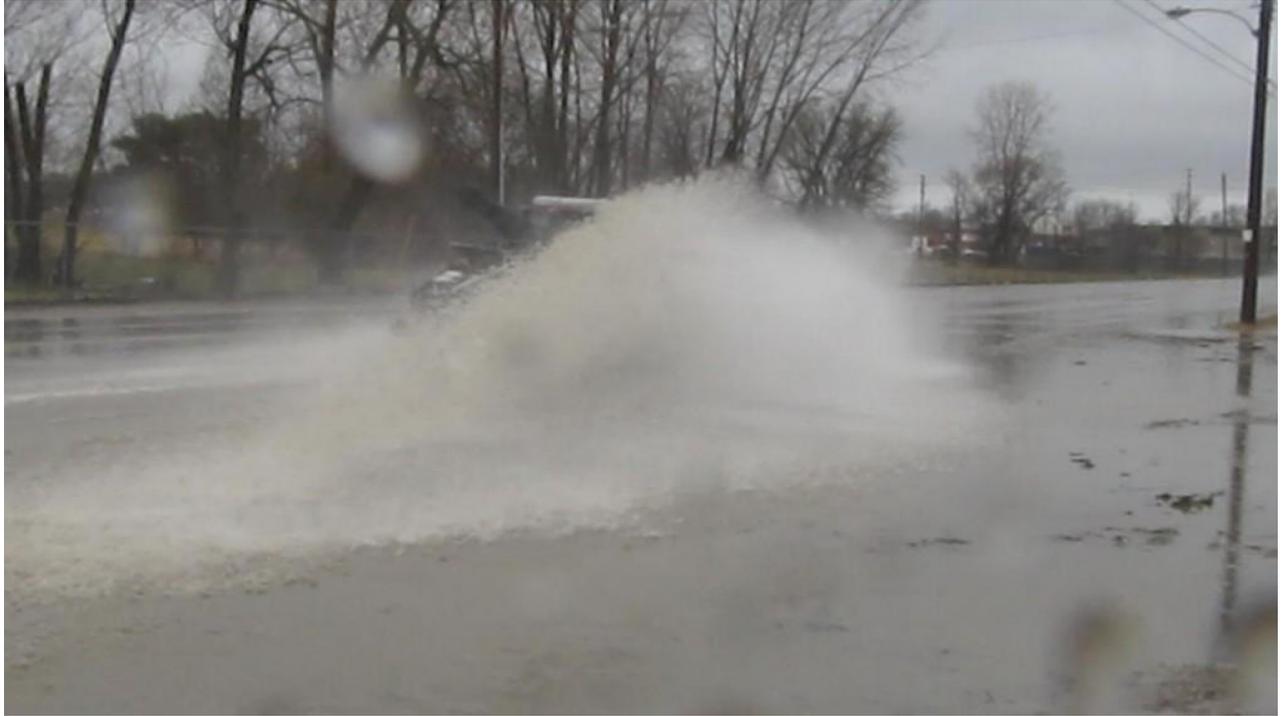
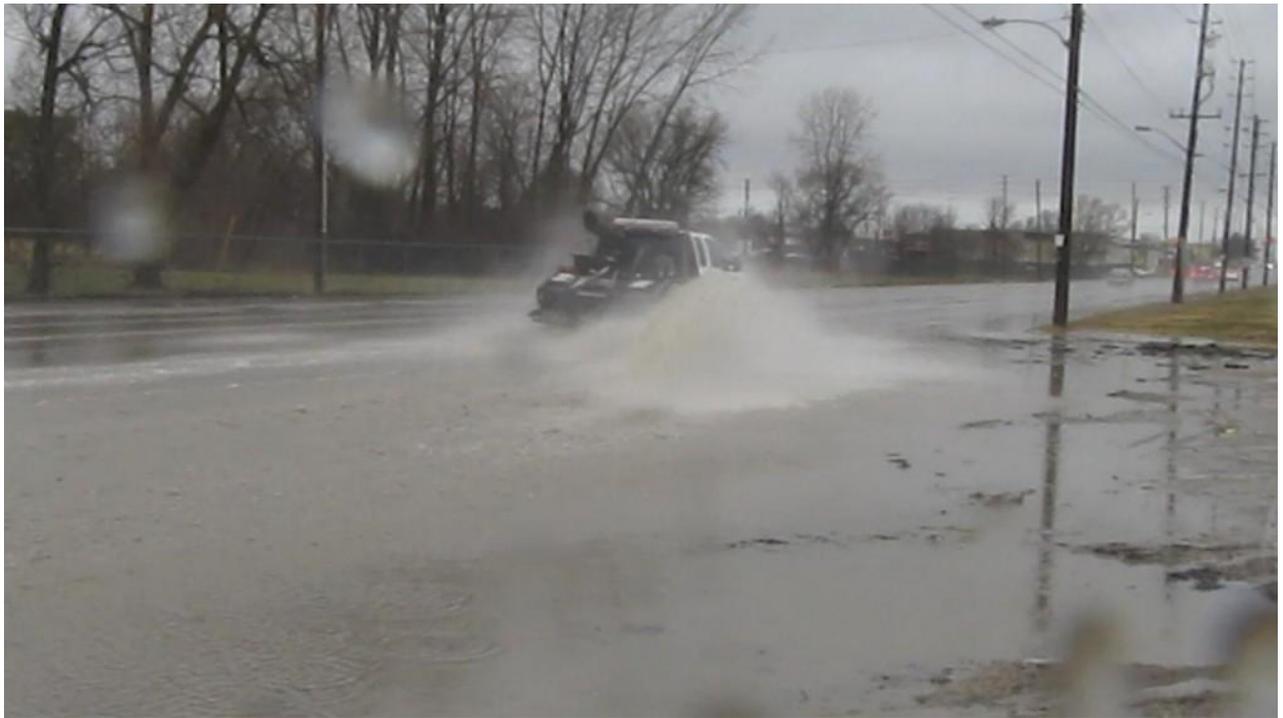
Flooding on Clarke Road just north of Oxford Street in London Ontario Canada is common and therefore when it occurs the City maintenance personnel block off the northbound curb lane with traffic cones to keep vehicles from "drowning" in the shallow lake. Only on the morning of March 11, 2013 someone forgot to block off the lane

resulting in some tremendous spray and possible surprise to some motorists who entered the area at speed without recognizing the depth of the water as shown in some of the following photos.

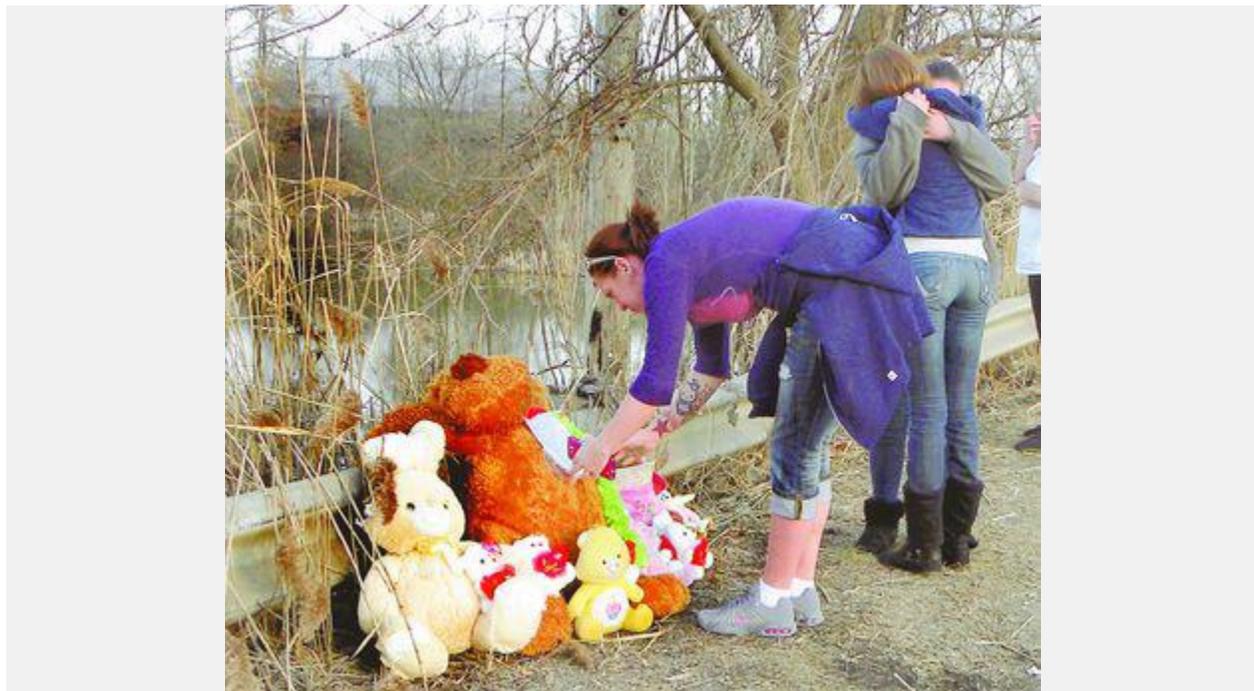
Teddy bears laid against the low guardrail by well-wishers who are unaware of the defectively low rail that likely contributed to the deaths of the six teenagers.

In the Warren Ohio multiple fatal crash the guardrail clearly looks to be too low. Anyone with any experience with roadway design and maintenance would know that. We are certain that numerous persons with experience with roadway design and maintenance are shuttering in silence as they look at this guardrail. We write "in silence" because ethically, as persons who should be concerned about the public's safety, they should be shouting loudly to anyone who will hear that this low guardrail is a death trap and similar installations should be repaired. Instead many persons with experience in roadway design and maintenance are also those who are employed by the various roadway maintenance organizations, whether they be paid by a municipality, state, province or other official organization that could be sued if a roadway is not maintained properly.

The photo below demonstrates the sad irony of this tragedy as friends and relatives of the six deceased teenagers lay teddy bears and other mementoes directly against the very low guardrail that they do not recognize as the factor that might have contributed to the deaths.

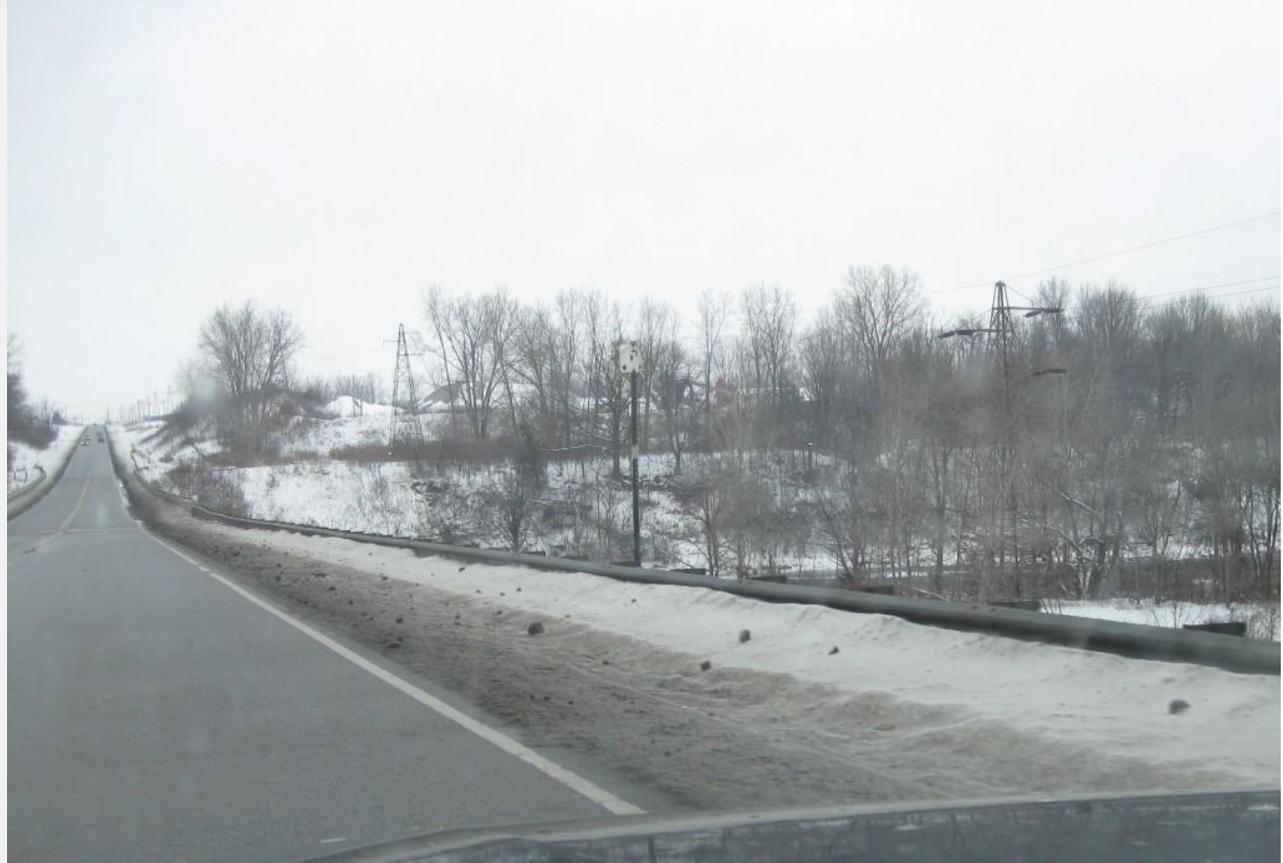
Snow thrown against guardrail next to the north Thames River bridge on Highbury Avenue in London, Ontario from January 13, 2010.

The obvious issue is that guardrails and other roadside barriers cost considerable money to install and maintain. However if they do not protect the public from the dangers that lie beyond them then why are the barriers in existence? If tall snow banks are allowed to be created in front of these barriers the snow will compress and harden creating an solid, icy structure that is able to support considerable weight. These hardened snow banks act as ramps in preventing proper interaction between a loss-of-control vehicle and the barrier. The effectiveness of a guardrail is that a vehicle's centre-of-gravity is supposed to be captured within the barrier's deforming and deflecting structure thus redirecting the vehicle from the harmful condition that lies on the other side of the barrier. When a hard and tall snow bank lies in front of the guardrail the approaching vehicle is lifted up enough to change the manner of contact with the barrier causing barrier over-ride. Furthermore, when a large percentage of vehicles on the highway are large trucks and buses then a large percentage of vehicles on the road have a much higher centre-of-gravity than that of a typical passenger car or light truck. Thus the barrier that is designed to deflect the centre-of-gravity of a lower passenger car will not perform adequately when being struck by a higher-centre-of-gravity vehicle such as a large truck or bus.
