# Gorski Consulting Website

## Archived News - 2013 - March

### **Another Fatality of Young Teenager Trapped in Submerged Vehicle in Toronto**

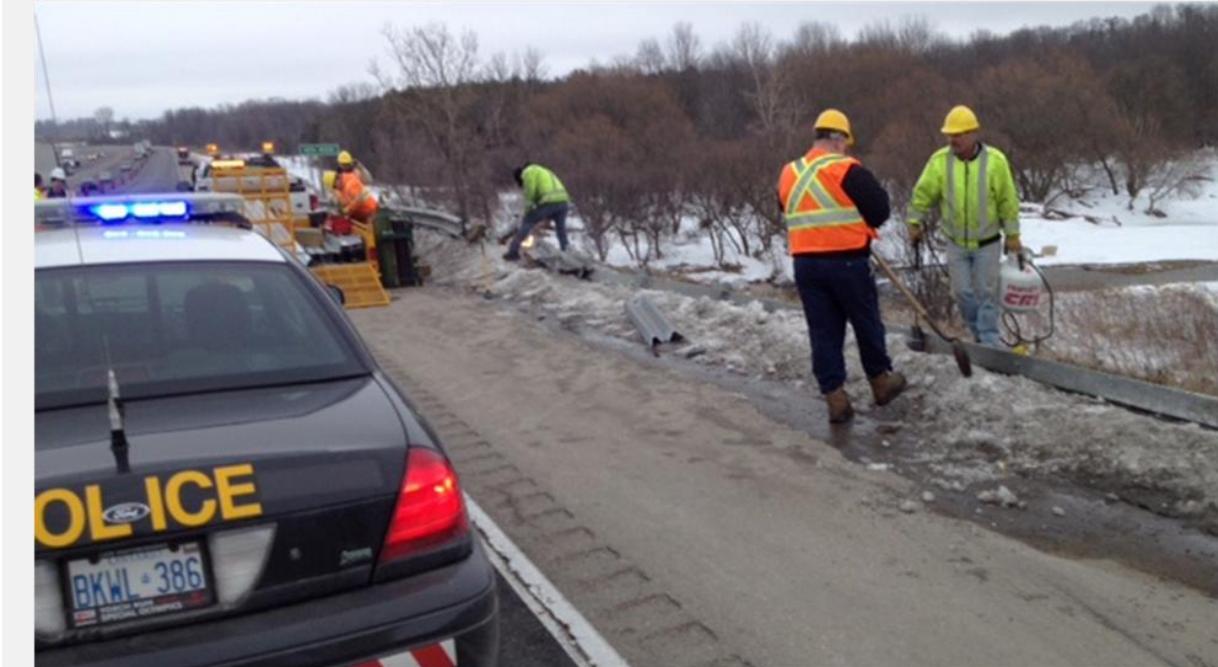
CTV News photo of remains being made to damaged guard rail where transport truck broke through and plunged into the Nith River

Although there was extensive media coverage of the event on the day of it occurred there were no photos or video taken of the guardrail and road where the transport truck exited the road. Now, as of March 6th, there are a number of photos of that guardrail but only after alterations have been made and at a time when repair crews are already destroying the evidence that the emergency personnel have not previously destroyed.

So what was the condition of the guardrail when the collision occurred? Maybe the public will never know. But the above photo provides some possibilities even though the evidence is much destroyed. Look at the bank of snow against the guardrail. Although much of the snow has melted it is clear that the snow is piled against the guardrail. When a snow has been plowed into such a bank and it rests there for several days the partial melting transforms the bank into something that is very solid which can support a large weight. This is not a snow bank of fresh snow. It is an aged bank that is likely condensed into a solid icy structure. When a vehicle approaches such an aged snow bank it can act like a ramp and make the guardrail height irrelevant. Although a typical guardrail is often little match for a tractor-trailer that approaches it at a significant angle the point is that we have no information about that at this time. And we will likely have none of that information provided to the public. All we know is that the functioning of a guardrail like this can be compromised when snow is placed against it in this fashion.
