# Gorski Consulting Website

## Archived News - 2013 - October

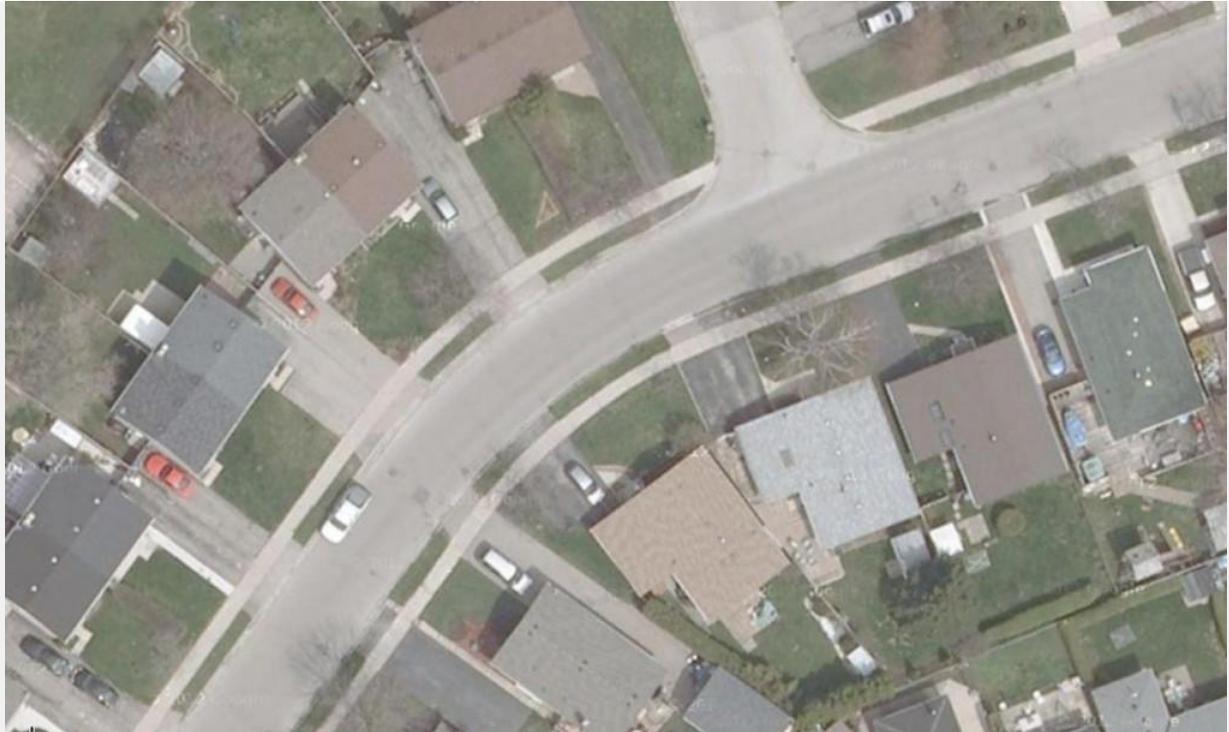
Google Maps view of site showing a white car parked just beyond the curve. At night-time and with no artificial illumination the headlights of a vehicle would be the only illumination that could help the driver detect the parked vehicle.

Residents are canvassing persons in the area to sign a petition calling for speed bumps and artificial illumination on the road which is presently non-existent. The lighting is particularly important because it was reported that a car was parked on the outside of the curve and just beyond its terminus. Therefore a vehicle travelling in night-time conditions would not illuminate the location of the parked car until a very short distance ahead. It is apparent from the tire marks left on the road that the driver of the car veered sharply to the left, likely to avoid the parked car and entered into a yawing motion before exiting the road and striking the 10-year-old boy.

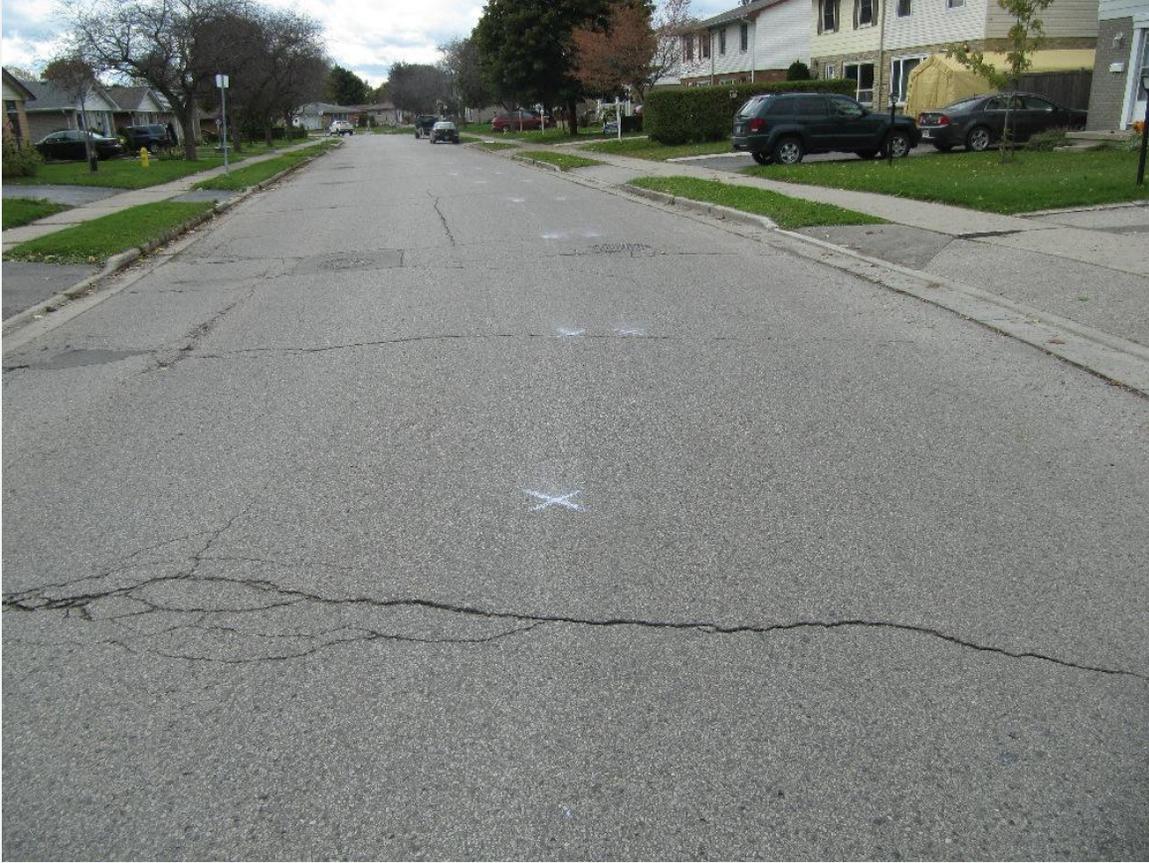
In the photo below we have outlined the path of the yaw marks produced by the southbound, hit-&-run vehicle just as it exited the left curve of Wexford Ave.

Southerly view, showing the tire marks produced by the hit-&-run vehicle as it came southbound around the left curve of Wexford Ave.

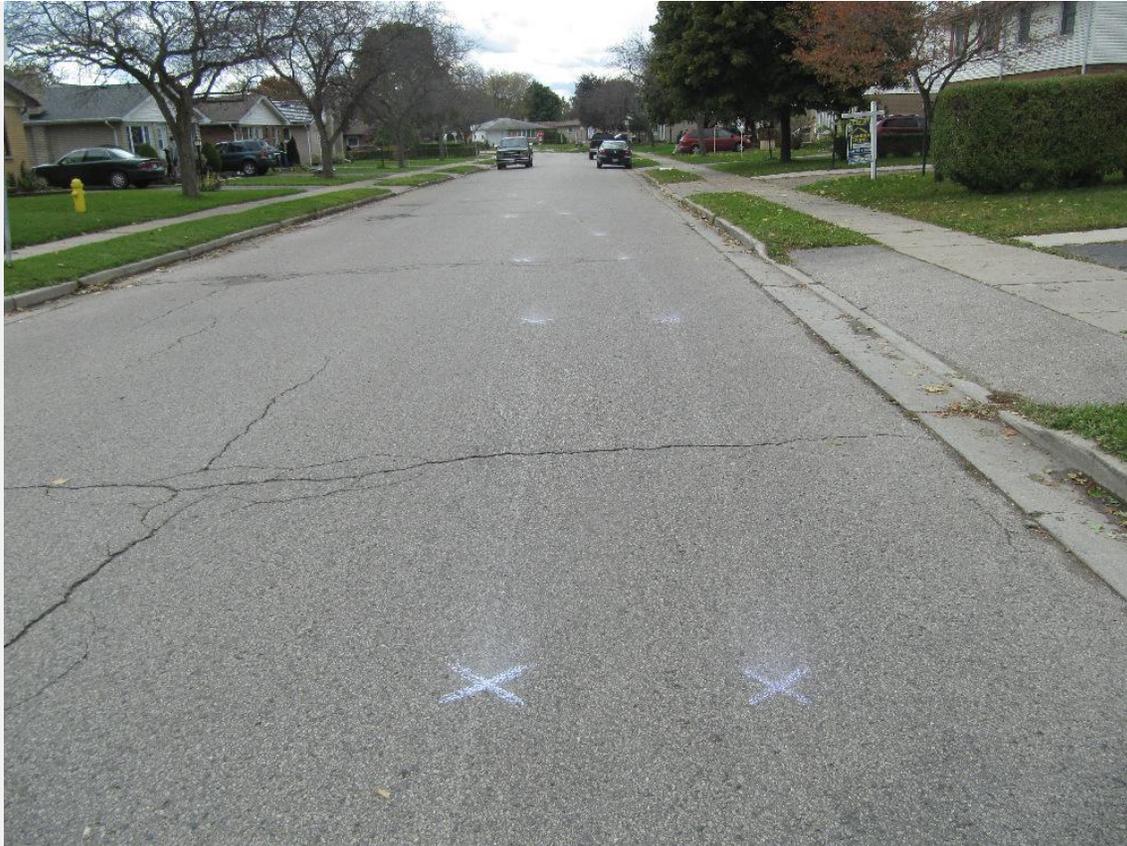
The photo below provides a view further southward with the tire marks of the vehicle marked out in chalk. The two curved tire marks were caused by the right-front and right-rear tires.

Further view of loss-of-control tire marks produced by the hit-&-run vehicle as it rotated counter-clockwise toward the east sidewalk where the 10-year-old was reportedly riding his bicycle.

The whiteness of the tire marks suggests that the road surface was not dry at the time of the collision as tire marks produced on a dry surface would normally contain black transfers from the sliding tires.

In calculating speed from yaw marks it is correct to examine specific characteristics of the yaw marks to determine whether the assumptions on which the critical speed calculation is based have not been violated. So matters such as a noted continuing reduction of the radius of curved travel of the vehicle must be evaluated. Making sure that the chord, or length of tire mark being evaluated, is long enough, say more than 20 metres, is another consideration. Making sure that the chord is taken at the “break out” point as the tire marks begin their separate paths is another consideration. And making sure that there are no other external forces acting on the vehicle other than those assumed for the calculation is another consideration. So all these cautions must be adhered to. We sometimes come across analysts who hold rigidly to the definition they have been taught rather than understanding that it is not the strict definition that is important but that they understand the fundamentals of what they are calculating and why the calculation is valid or may be invalid. When discussing specific definitions those in the know have referred to a book by Thomas W. Gillespie entitled “Fundamentals of Vehicle Dynamics”.

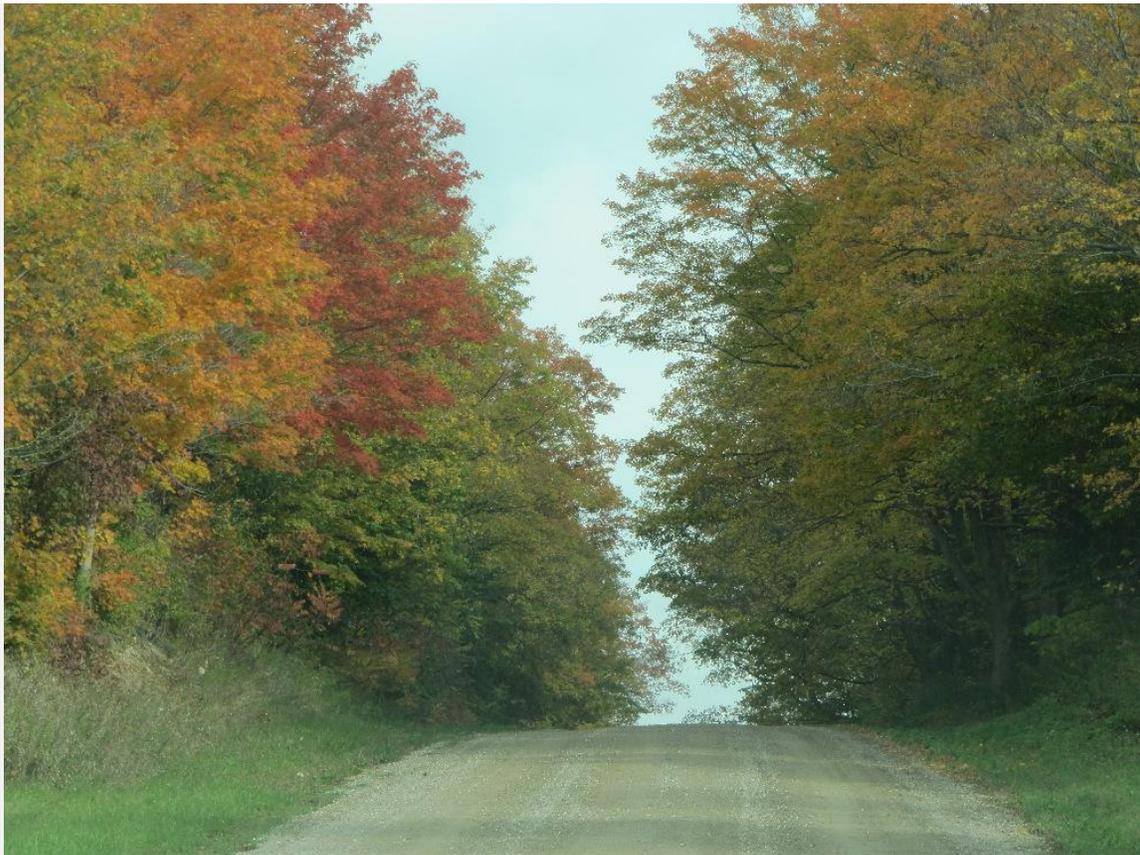
Is there something beyond this hillcrest that the driver will need to avoid? This is why a standard stopping sight distance is required to protect us from unseen dangers.

Indirectly, it probably means that the standard stopping sight distance that is available is not available on this stretch of road and the driver may encounter something ahead that he or she may not be able to avoid in time because they are travelling too fast for the road conditions. In Ontario, a rural roadway posted with a maximum speed of 80 km/h must afford the visibility of an object on the road that is 38 centimetres tall, 138 metres ahead of the approaching vehicle. But, as shown in the photo below, as a vehicle approaches a road feature such as a hillcrest on this stretch of road, the driver will not be able to see far enough ahead to detect something that may be present on the road.

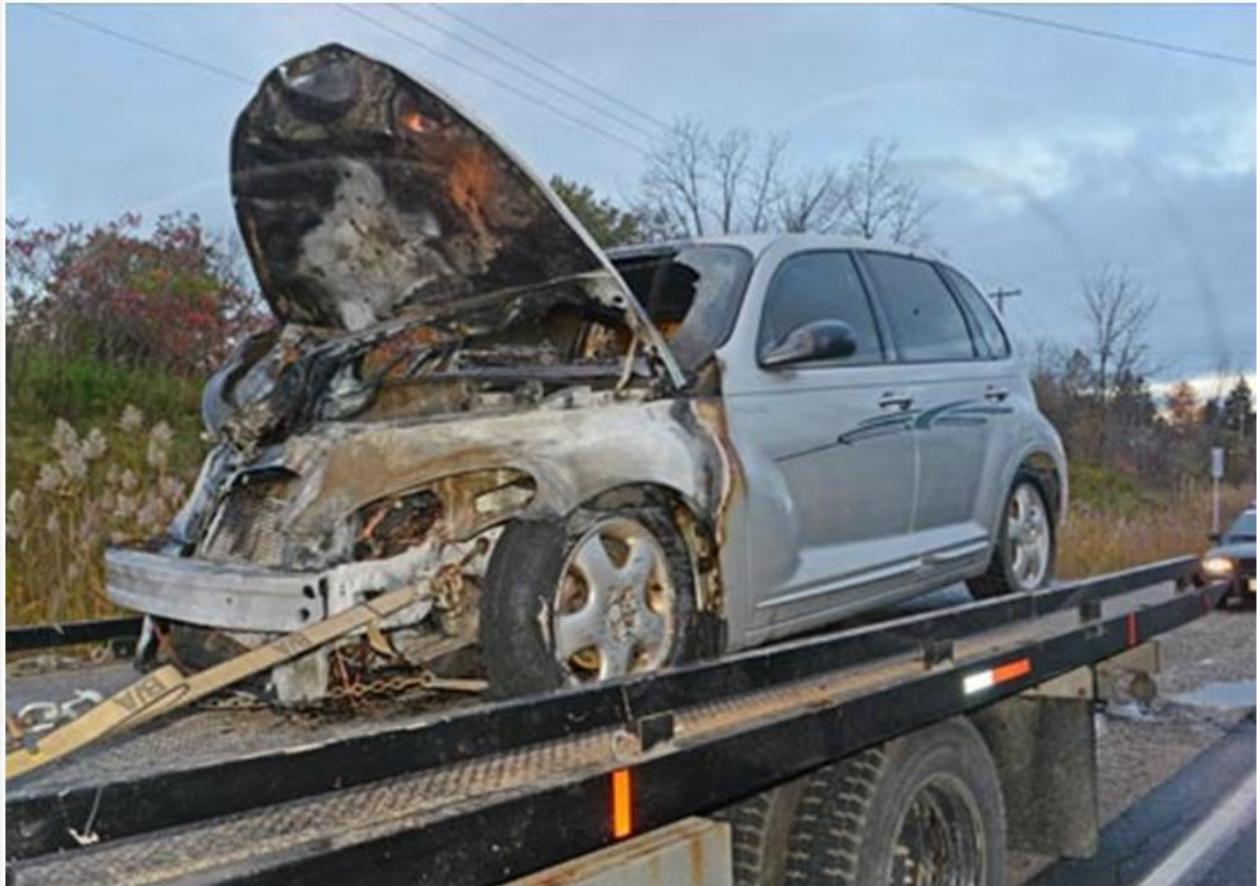
Photo taken by Craig Bradford of the Aylmer Express newspaper showing the result of a fire that consumed the front end of PT Cruiser.

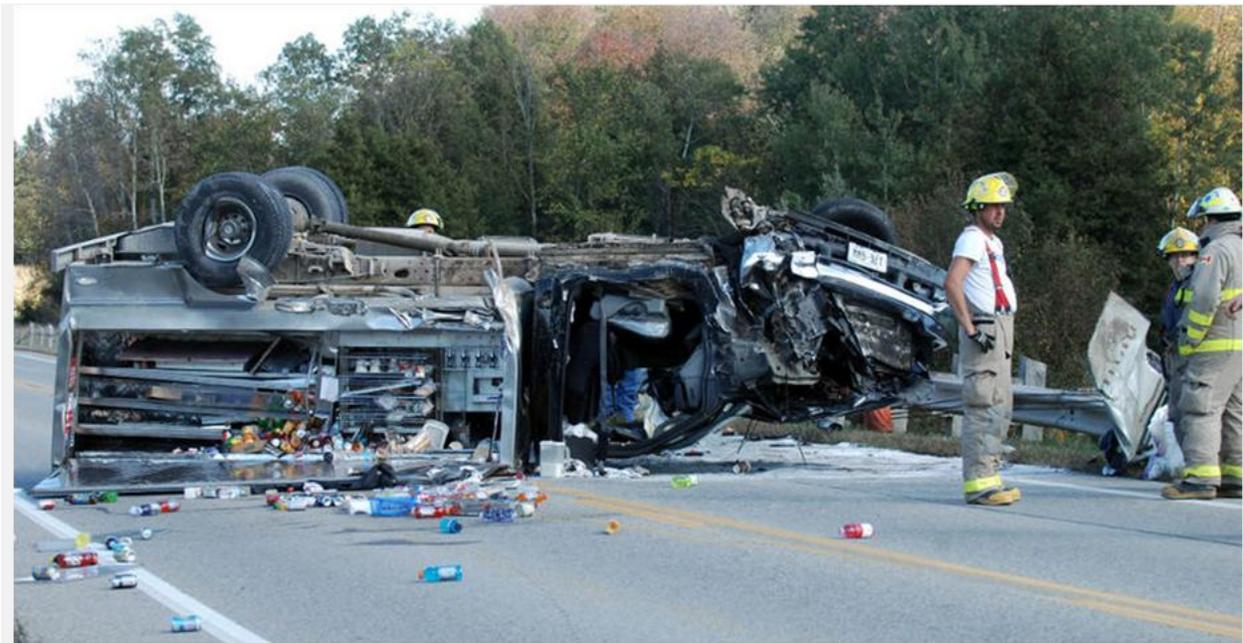
Photo from Woodstock Sentinel-Review newspaper article showing vehicle upside down at its final rest position.

To suggest that a food truck collision on Oxford Road 8, north-east of Woodstock, Ontario on Tuesday, October 8, 2013 was “a single vehicle rollover”, is a bit of a stretch, based on the photo provided in the Woodstock Sentinel-Review newspaper yesterday. The driver of the truck reportedly sustained minor injuries and this would appear to be a rather non-event. However, the photo of the vehicle at its rest position, upside down in the middle of the highway, showed clear evidence of a major, narrow, frontal impact that also progressed rearward along the left side of the vehicle and into the left-rear wheel.

A quick review of the roadway via Google Maps indicates that the area of impact might have been near a bridge that contained both guardrails and a post-and-cable barrier. So where did this narrow frontal impact come from? Did the vehicle penetrate through the installed barriers or did it strike the rail or abutment of the bridge? Otherwise, the only other explanation would have to be that it struck something on the road – which reportedly did not occur. But clearly, this was not just a “single vehicle rollover”.

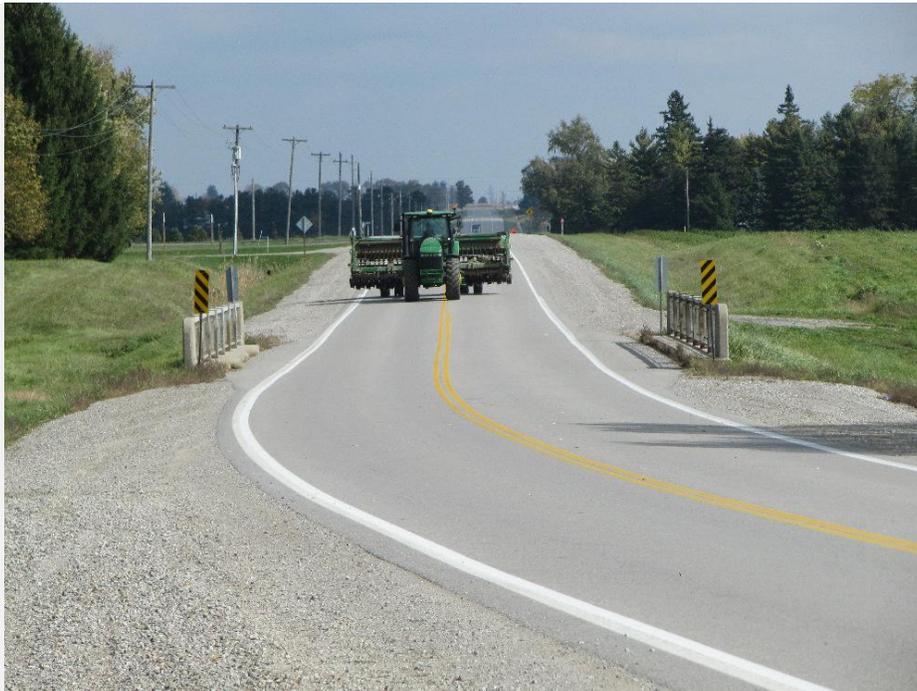
View of a very wide combine approaching a narrow, rural bridge.

The slow speed of the combine means that it will take a long time to pass the confines of the narrow bridge. Given the speed of many vehicles on rural highways it is not unreasonable to expect that a vehicle travelling at high speed could enter into the

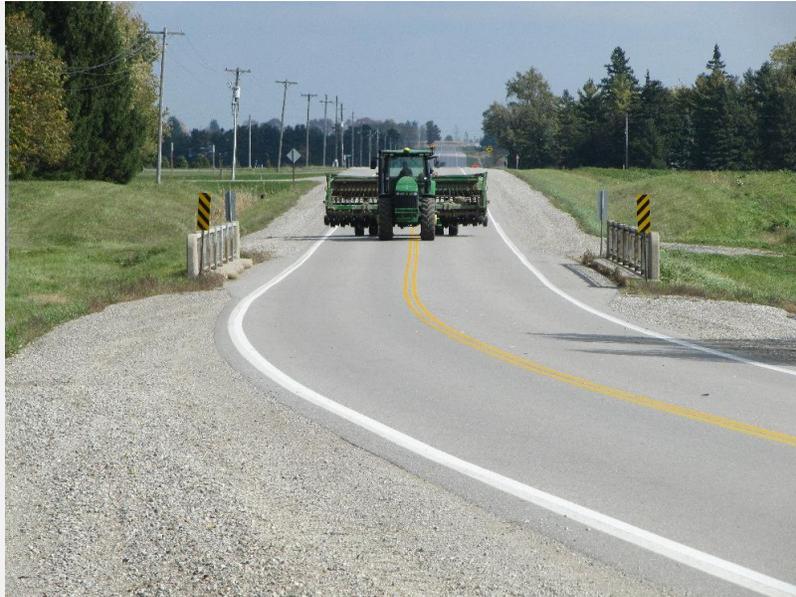
View of approaching combine which is too wide to pass the bridge without interfering with opposing traffic.

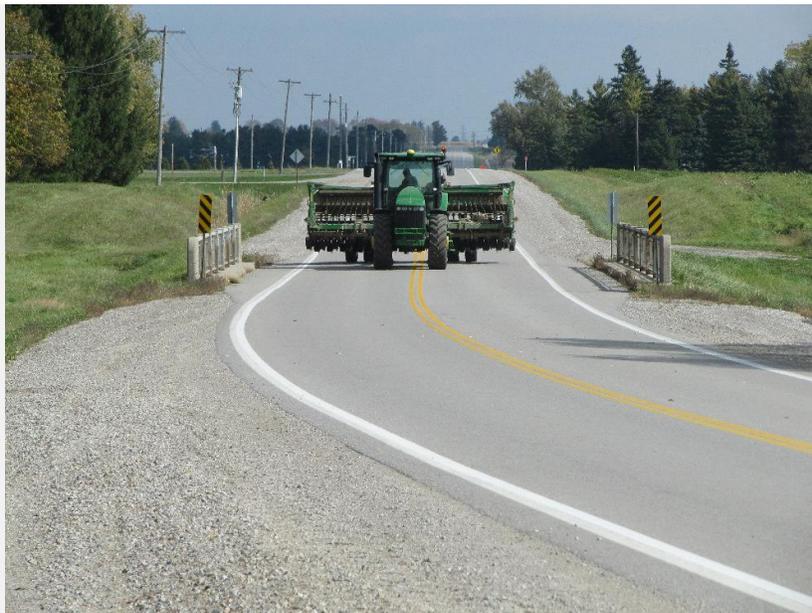
Note below how the combine takes up the full width of the bridge.

View of combine completely blocking the access to the narrow rural bridge.

In many instances the concrete bridge abutments on these narrow, rural bridges are not protected by guardrails or other barriers. Thus, in an attempt to avoid the combine, a fast-moving vehicle driver may steer into the non-yielding bridge abutment. Whether the impact is to the combine or into the concrete abutment the result can be fatal. Even if the fast-moving driver is able to steer off the road surface his vehicle may rollover into the creek or river at the bridge and the possibility of drowning also becomes real.

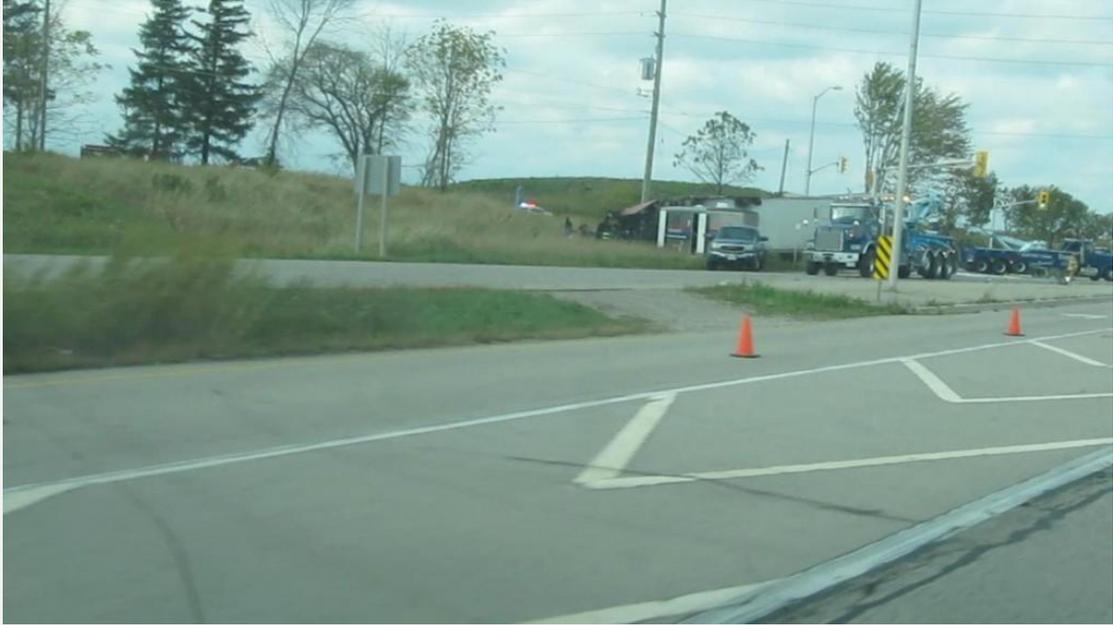
Upon hearing of this incident we drove by the site. It is apparent that a tractor-trailer is stopped on the southwest quadrant of the intersection of Veterans Memorial Parkway (VMP) and Bradley Avenue, as shown in this screen capture from our video as we travelled northbound on the VMP towards the intersection.

View, looking northeast on the northbound approach to the intersection of Veterans Memorial Pkwy (VMP) and Bradley Avenue. The burned out front end of a transport truck can be seen on the west roadside at the southwest quadrant of the intersection.

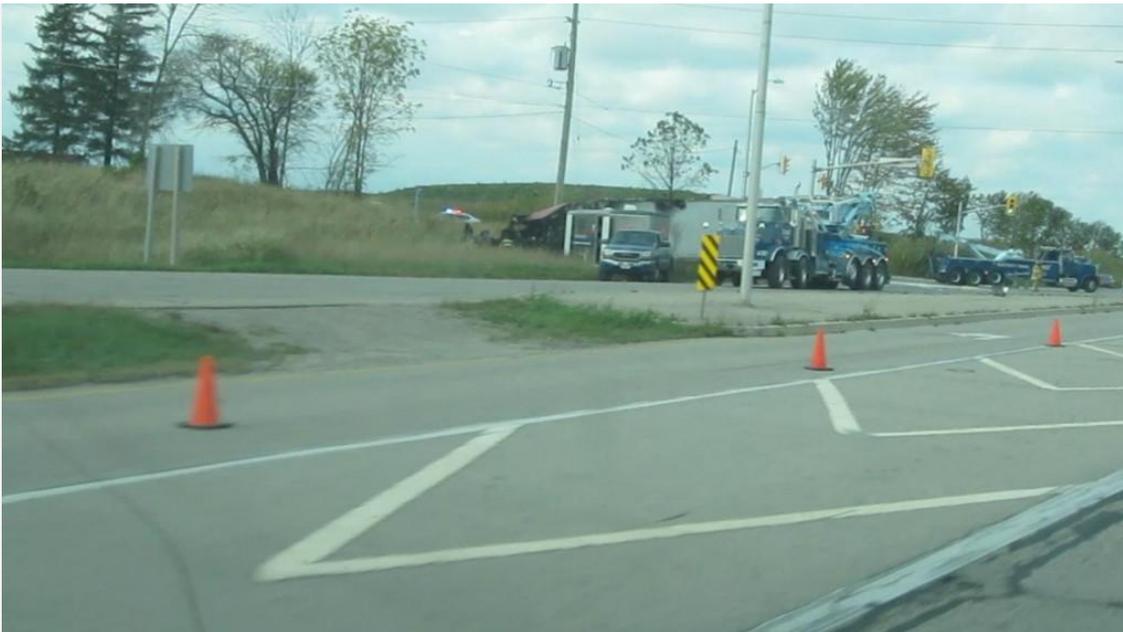
The fire appears to have been prominent at the front end of the vehicle. Below is another view of the truck as we progressed closer to the intersection.

Another view of the burned out TT on the west roadside of the VMP.

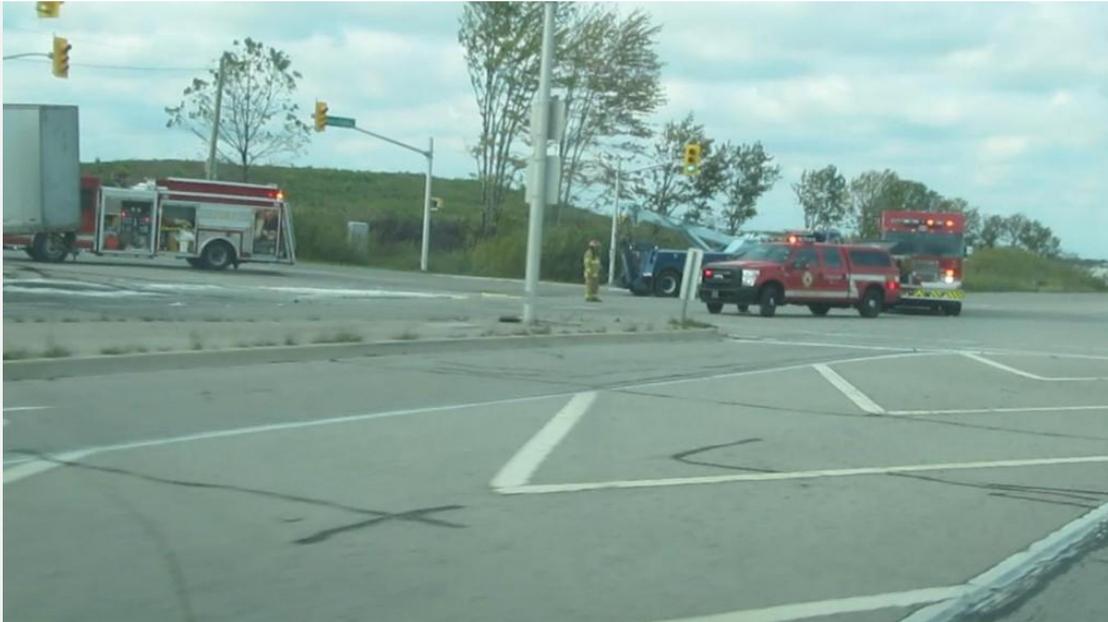
The views that are available cannot provide an indication whether the truck fire was caused following a collision in the intersection. However we noted a trail of fluid and/or debris leading from the intersection toward the truck's rest position and such a trail would often occur if there had been a collision. In that case it would likely involve a westbound vehicle on Bradley Avenue and the southbound truck.

View showing a white trail of absorbent placed over top of some kind of trail of possible fluid suggesting there might have been an impact in the intersection before the fire began.

A witness suggested there was most likely a fatality in the cab of the truck however that may not be so. It is possible that this incident is simply a vehicle fire and the driver was able to escape the cab before it was consumed. Although, the presence of the trail of fluid/debris along the path of the truck is suspiciously suggestive of a collision at the intersection. Given the short time since its occurrence we expect further official word shortly as to the what occurred.
