# Gorski Consulting Website

## Archived News - 2014 - May

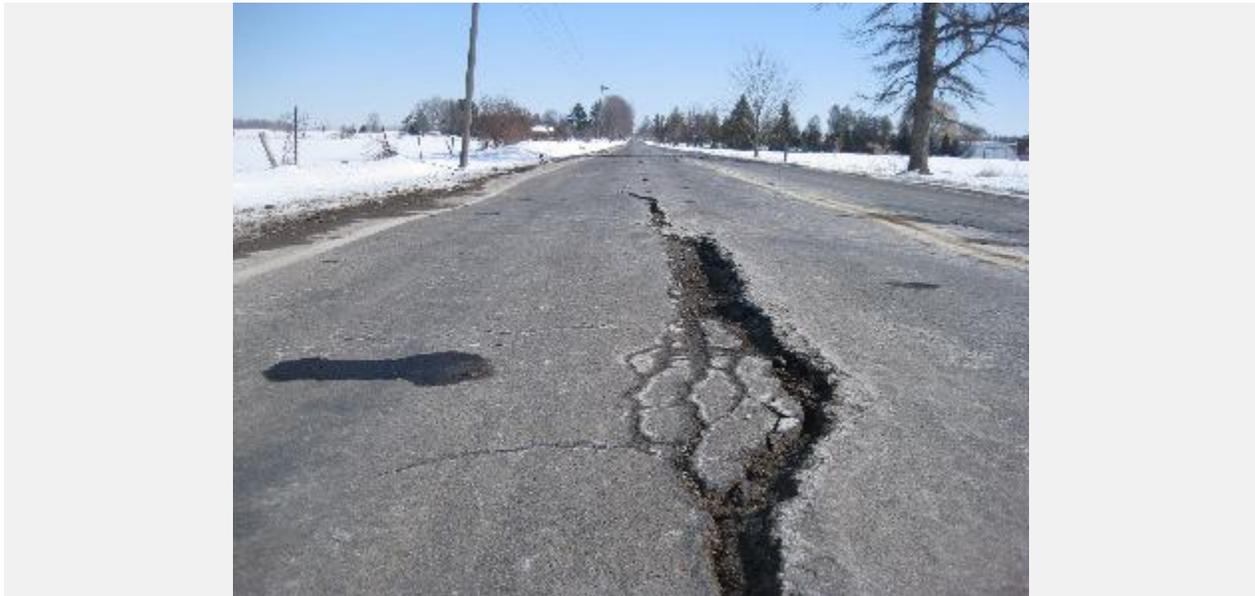
The eastern portion of Sunningdale Road in London, Ontario has had major structural problems in wintertime yet it has never been mentioned in the CAA listings as a bad road, likely because there are few residents in the area that would complain.

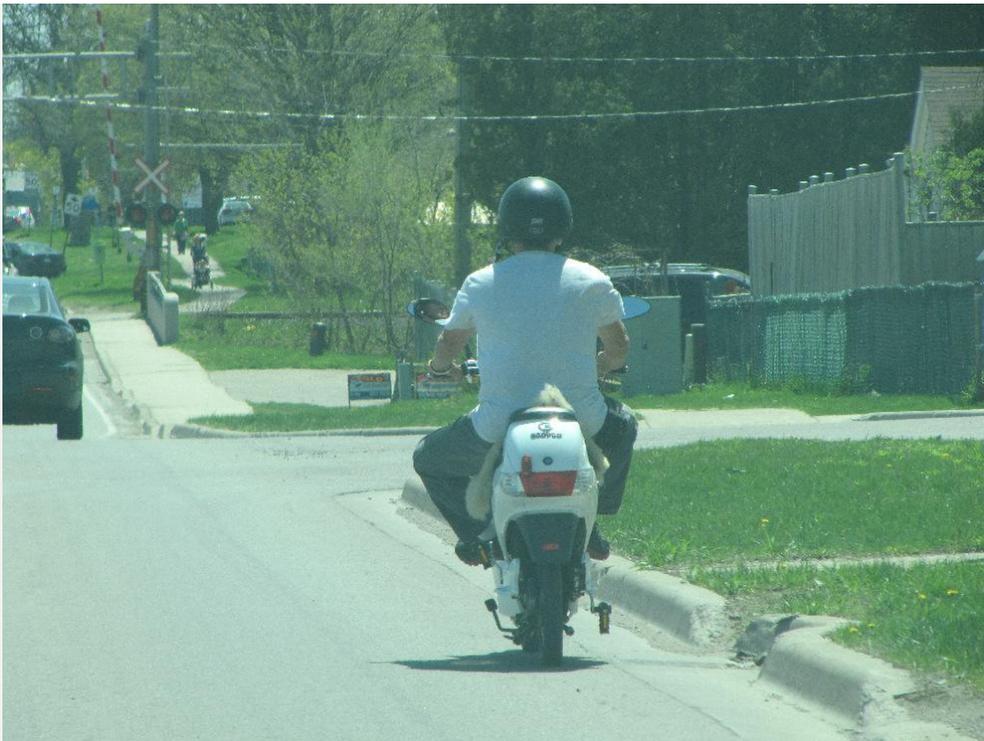
Pedals, hanging out and down to the road surface are a danger to motorized bicycles and scooters.

One additional danger that our Ontario politicians have developed, is the idea that e-bikes must have “pedals” that stick out of the sides near the ground. A bad and dangerous decision. In the tight quarters where e-bikes will share the lane with larger vehicles it is only a question of time before we will recognize that those pedals are striking curbs, the pavement in pot-holed and construction areas and causing riders to lose control and crash.

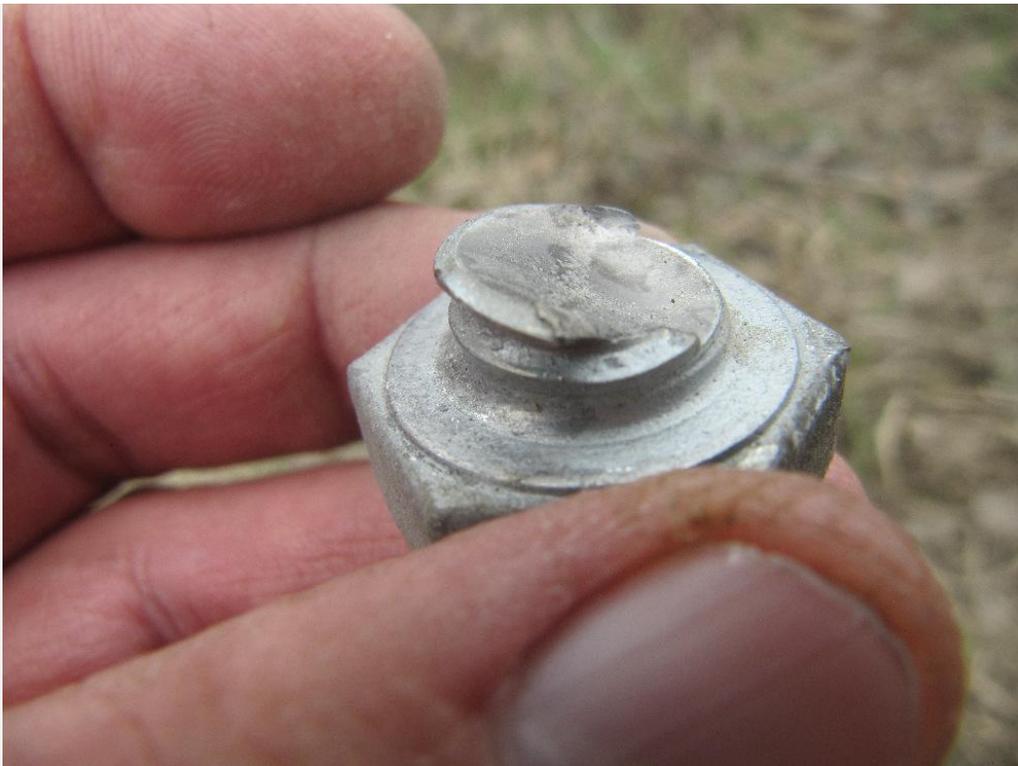
Bolt heads, lying at the collision site could have come from the under ride guard beneath the rear end of the struck trailer. These bolts exhibit overload fracture characteristics.

Trailers are supposed to come with under-ride protection via a bracket system located beneath the floor of the trailer, at its rear end, that hangs down to the level of the bumper of a typical car. This is supposed to provide some protection from under-ride but many such guards are poorly designed and often provide little protection. So what happened in the present case? Was there an issue with the under-ride protection? Did the bracket fail and cause the car to under-ride the trailer? While conducting a brief examination of the site about eight hours after its occurrence, we noted several bolt heads lying on the ground as shown in the photos below.

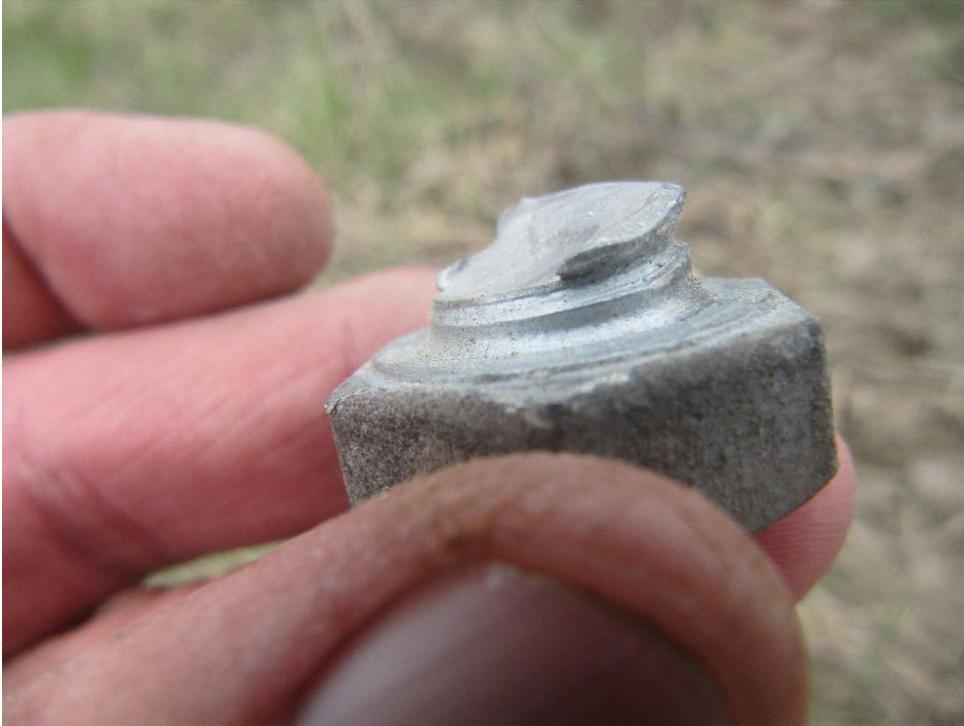
Bolts of a similar type would be used to secure the under ride guard to the trailer. If the anchorages of the guard failed then we would want to be assured that it did so after using up its full ability to absorb as much kinetic energy as the design could withstand. However, a bolt like this that shows minimal evidence of deformation, does not provide us with that needed assurance. However, we are unlikely to know what actually occurred nor is any member of the public.

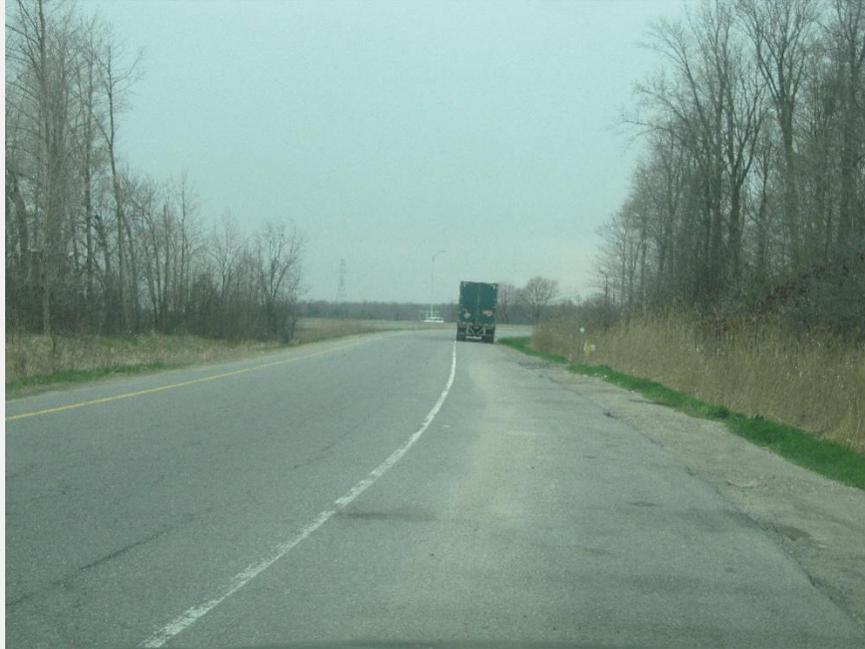
View of tractor-trailer parked on the north shoulder of the Hwy 401 entrance ramp. Note the wide, paved shoulder that resembles the width of a typical lane of a highway. In situations of limited visibility drivers may believe that the shoulder is a lane and the white edge line a the roadway centre-line.

The following two photos were taken on the Highway 401 entrance ramp at the Dorchester exit. They show a tractor-trailer parked on the paved shoulder. However, the width and characteristics of the paved shoulder could make it appear to be a travel lane of a two-lane highway.

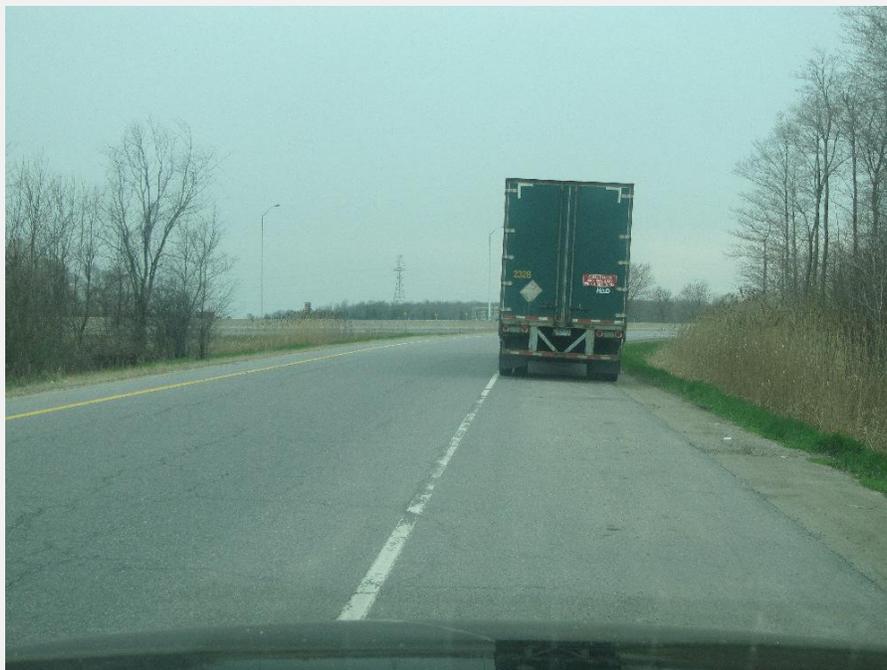
Most drivers should be able to detect the difference between the paved shoulder and the actual ramp lane, however, in situations of deteriorated visibility, fatigue, lack of attention, or drug impairment some drivers could be confused.

We take pains to place various hatched lines to designate paved areas where vehicles should not travel. We also install rumble strips on the sides of highways to warn drivers that they are travelling out of a marked lane. Yet, on a ramp road like this there are no such warnings. Although the collision in the present case occurred several hundred metres further along the ramp lane one can never tell if confusion of a driver might cause interference with other traffic and thus leading to a collision several hundred metres ahead.

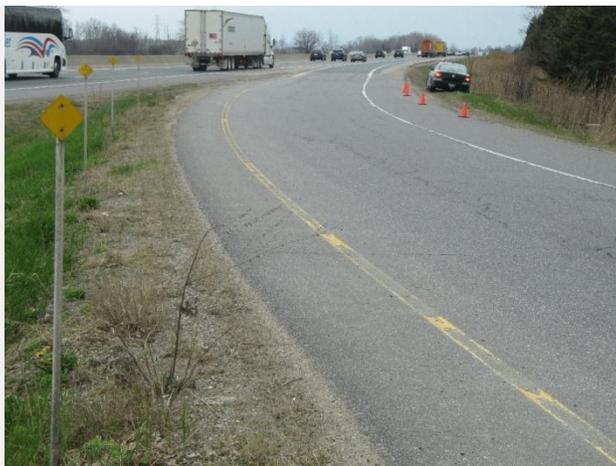
View, looking west, along the Dorchester Road entrance ramp onto Highway 401. The collision site is located about 100 metres passed our parked car on the right (north) shoulder.

The photo below shows a view along the entrance ramp leading to the Highway 401 with our parked car positioned on the right (north) shoulder. The area of impact between the Chevrolet car and tractor-trailer was about 100 metres beyond the parked position of our car.

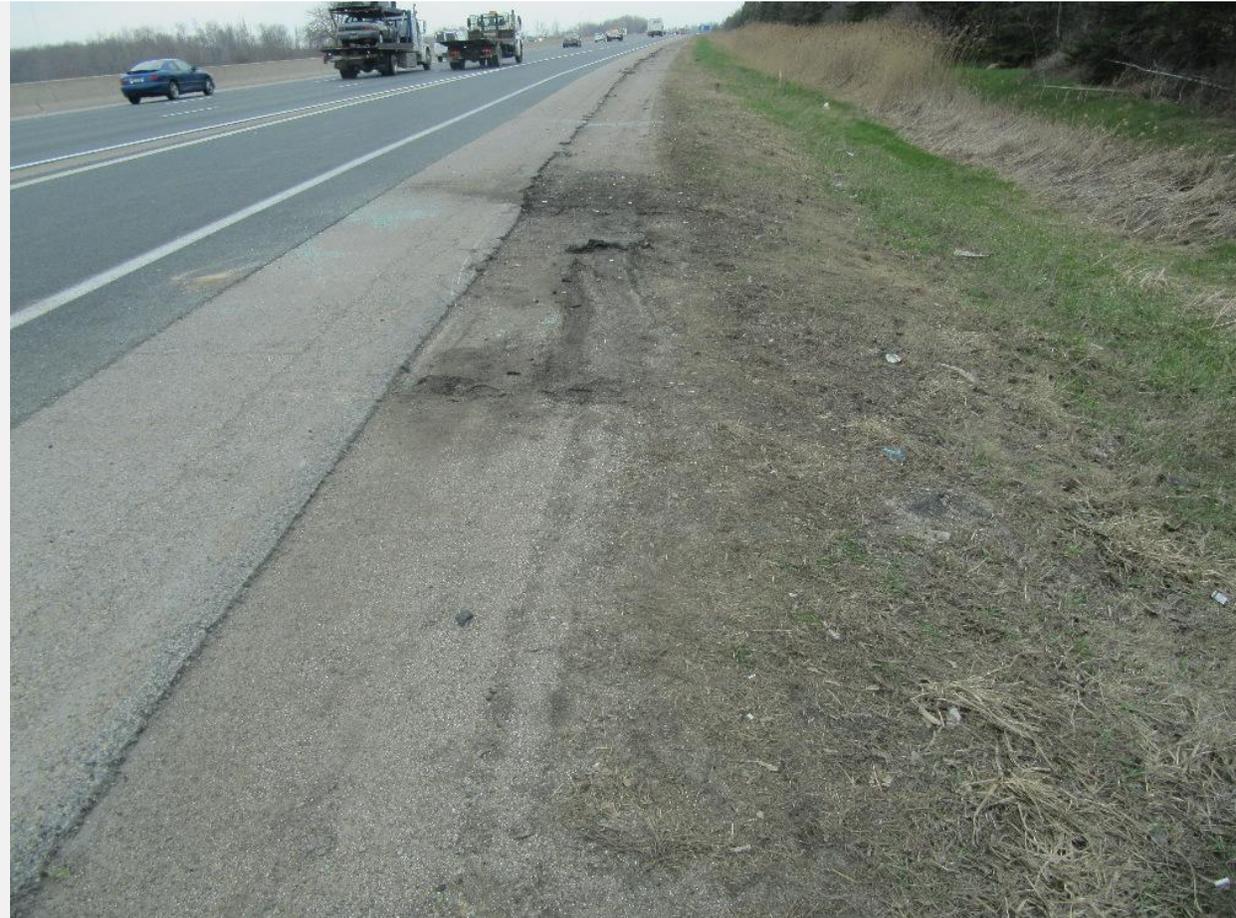
View, looking west, toward the area of impact along the right (north) shoulder just as the entrance ramp merges with the westbound lanes of Highway 401.

The photo below shows a westward view of the area of impact.

One should appreciate from the previous photos that the tractor-trailer was parked in a dangerous location at the end of the entrance ramp, when merging vehicles would be accelerating and its drivers' attention would likely be toward the left rather than to the right where the truck was positioned. Such actions are not uncommon and need to be identified because of their consequences. However, what has been done to inform the public of the presence of these circumstances? None of the news articles even mentioned the fact that this collision occurred at the entrance ramp. So far as the public is concerned they would believe it just happened on a straight section of Highway 401. Where is the education to inform the public of this important danger? If the public was truly aware of the problem there could be more effort to make sure that truck drivers understand where it is dangerous to park their trucks. It would also make drivers more
