Characteristics of Tire Marks Influenced by Soft Shoulders - Part 4

Gorski Consulting has embarked on a research study to document the characteristics of tire marks that exist outside of a paved road surface. This study has involved documentation of hundreds of incidents, both collision-involved, but also incidents of simple travel onto a gravel shoulder.

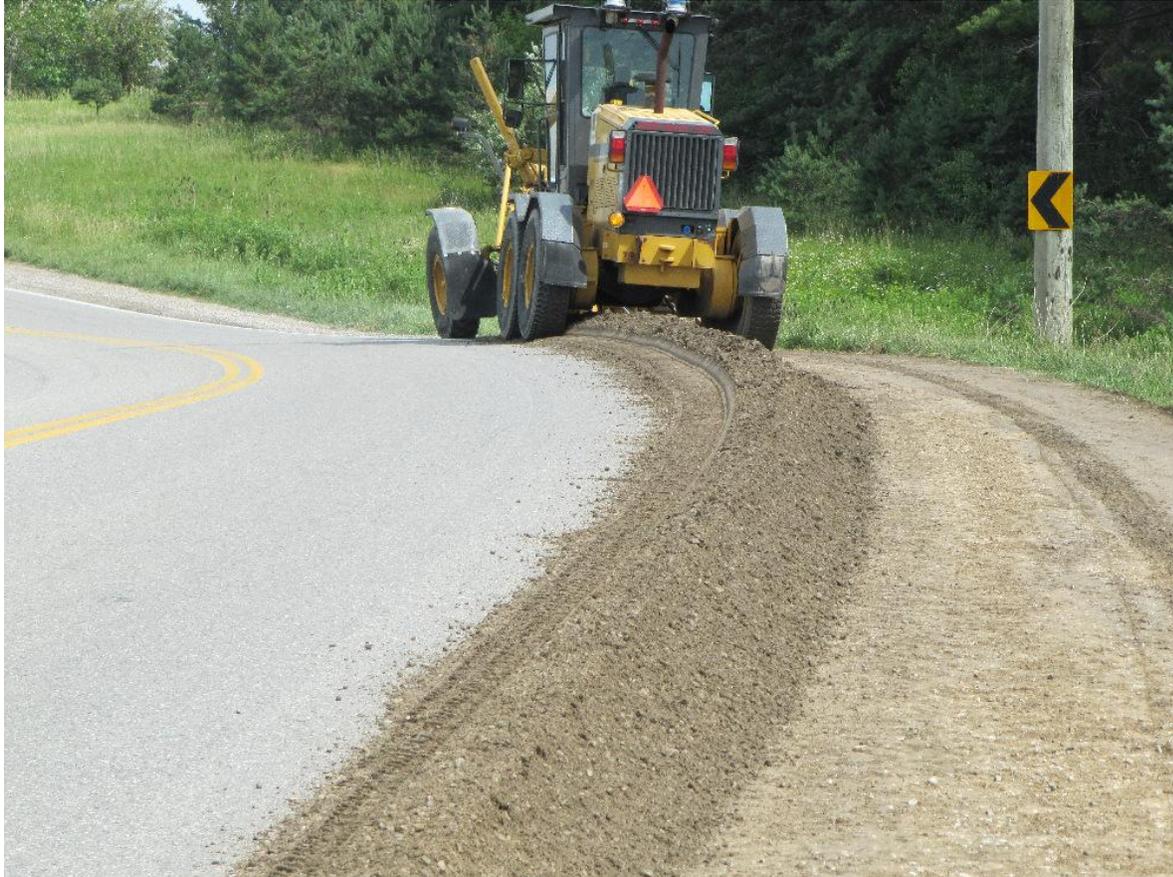
Figure 1: View of a northbound road grader at the site of Clarke Road north of Fanshawe Park Road. Re-grading commences with this initial action of stirring up the shoulder surface and transplanting it toward the pavement edge.

In Figure 1 we see a typical road grader travelling north along the east shoulder at the north end of the S-curve of Clarke Road. The driver is performing a typical maintenance action of stirring up the surface and then transplanting it toward the pavement edge. This is done because, over time, vehicles passing through the curve wander off the pavement edge and push the gravel/soil away thus producing a dangerous "edge drop-off". Edge drop-offs are dangerous because of the vertical wall that is created when the shoulder surface becomes lower than the pavement edge. At speed drivers exiting the pavement edge encounter difficulties when they try to re-enter the pavement in a zone where there is a significant edge drop-off.

For the present we return to the action shown in Figure 1 where the grader's initial action is to scrape the shoulder surface and transplant it toward the pavement edge. Figure 2 shows the result after the grader has completed its initial pass through the site.

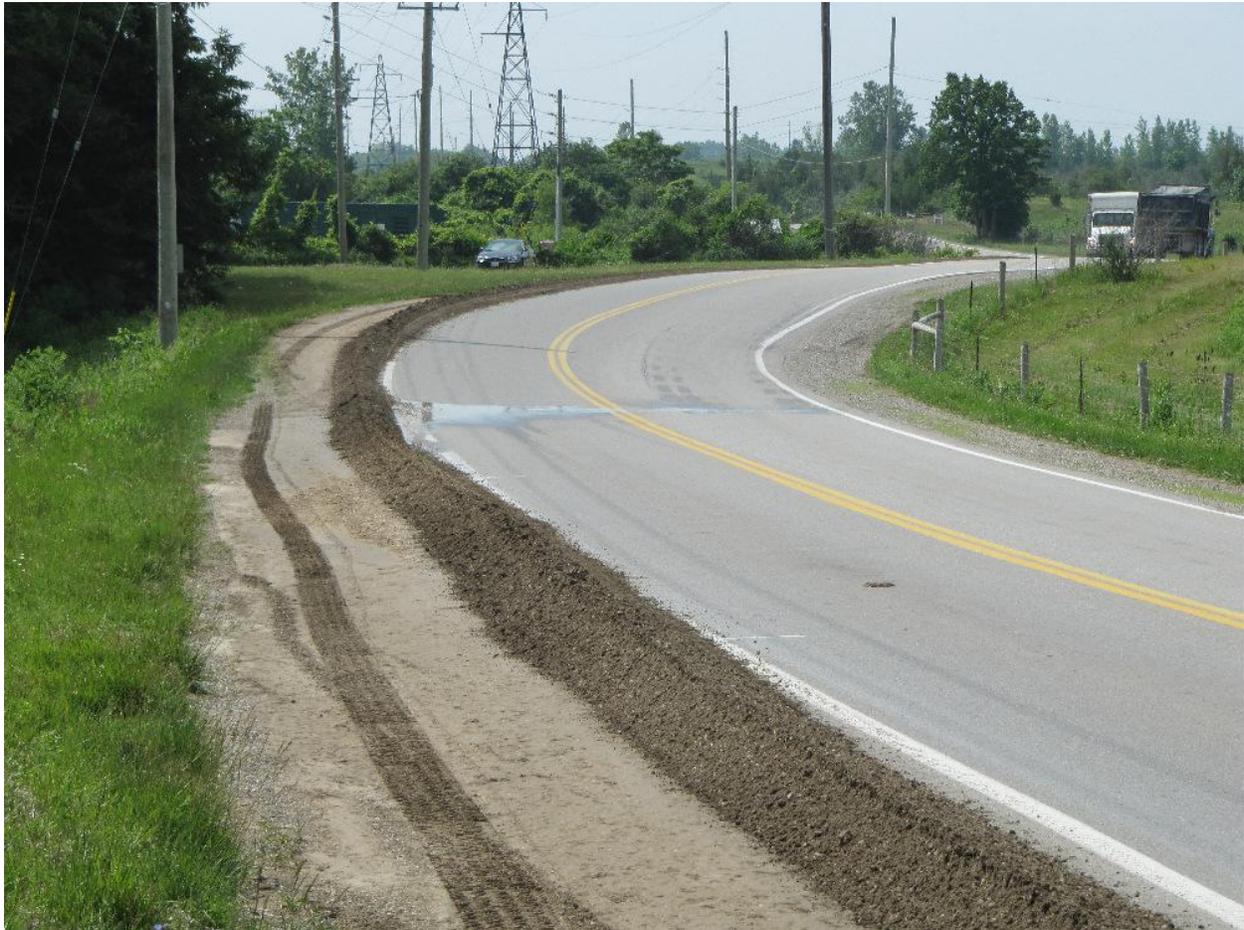
Figure 2: View, looking south, at the scraped surface of the east shoulder that has been transplanted over the pavement edge.

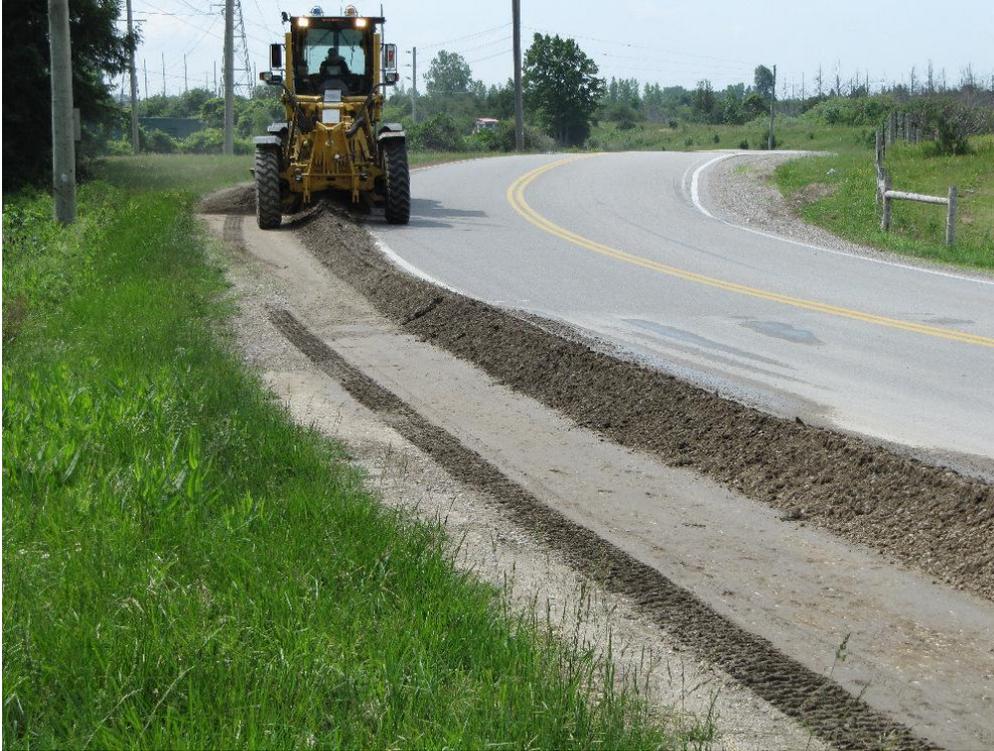
Figure 3: View of the grader during its second pass on the east shoulder of Clarke Road.

The road grader then returns for a second northward pass as shown in Figures 3. and 4. During this second pass the stirred up and transplanted material from the shoulder is pushed back onto the shoulder and away from the pavement edge. Note in Figure 4 that the rear tires of the grader follow behind the plow such that the tire marks created by the rear tires are not erased and are left visible after the re-grading is completed.

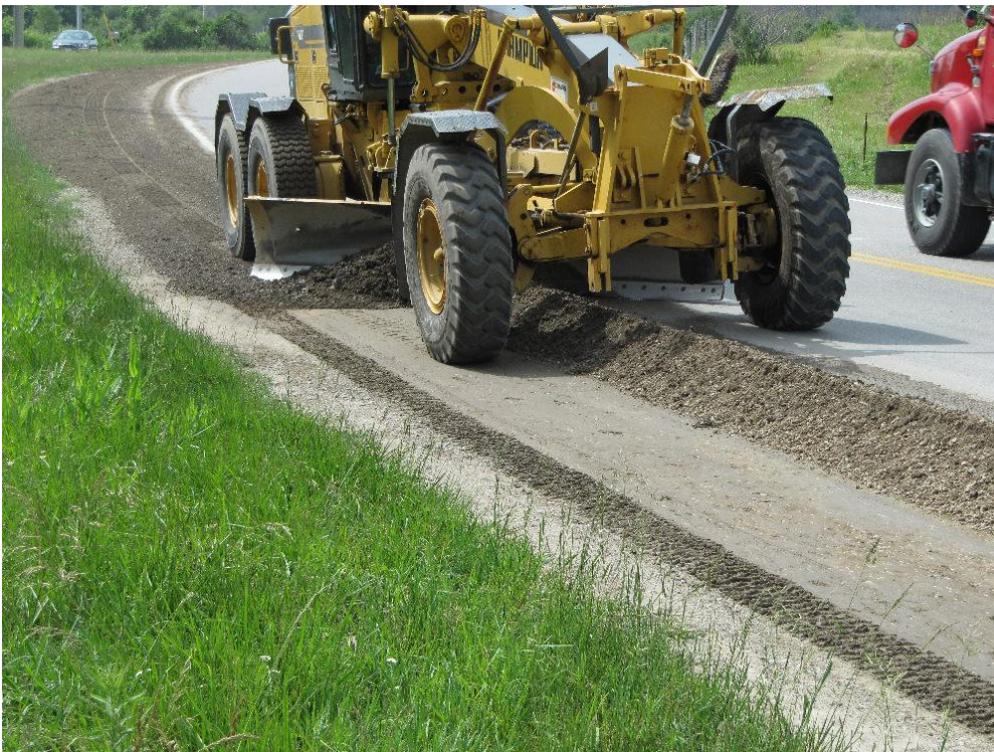
Figure 4: During the second pass the grader pushes the stirred up material back onto the shoulder surface and away from the pavement.

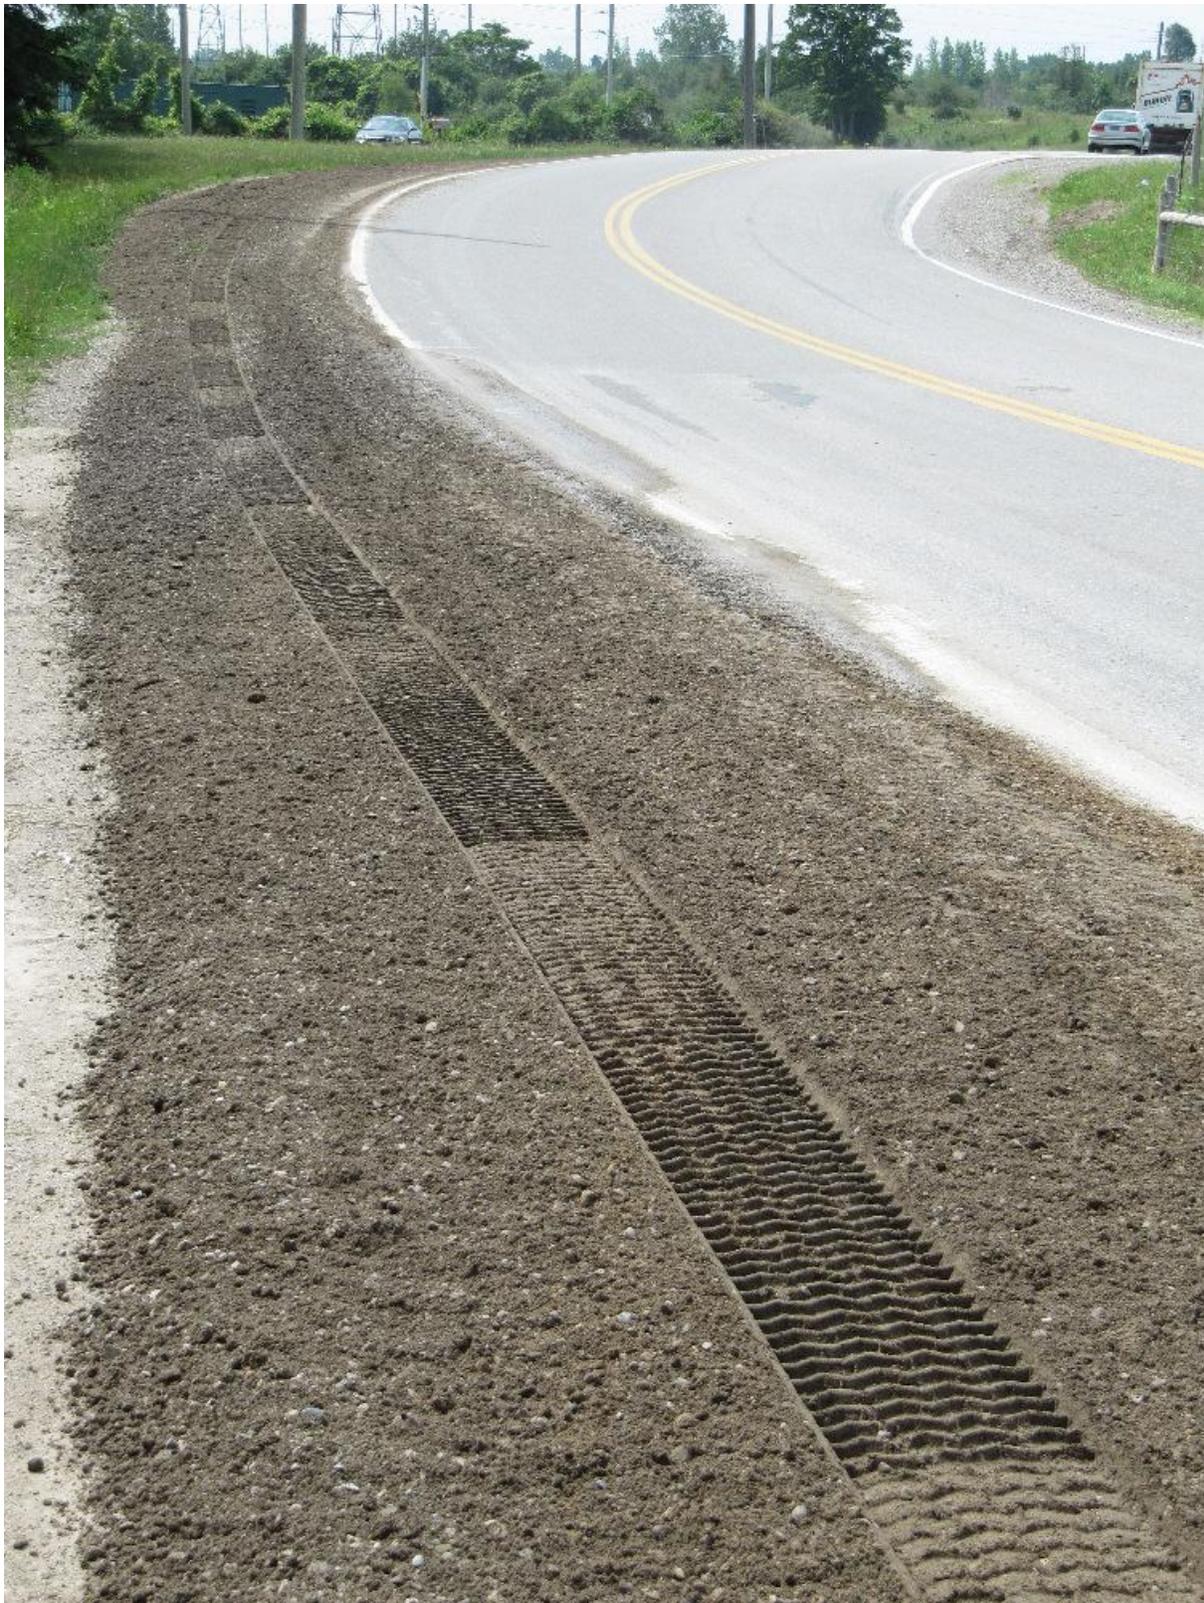
Figure 5: The final result of the re-grading of the shoulder is a single, well-defined tire mark caused by the two right-rear tires of the grader.

The final result of the re-grading is shown in Figure 5. On top of the monotone layer of loose gravel and soil is a single, well-defined tire mark caused by the two, right-rear tires of the grader.

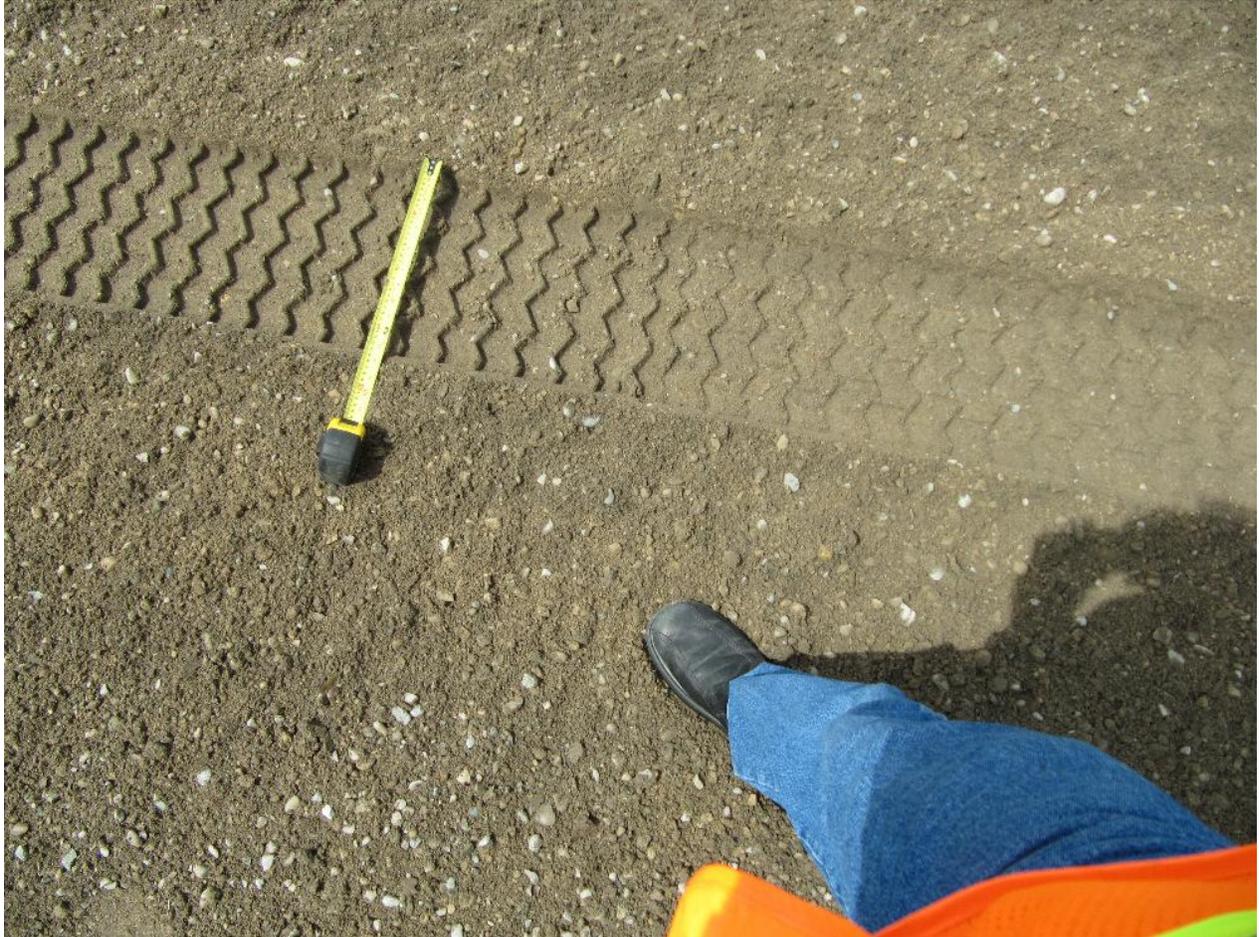
Figure 6: View of the tire mark produced by the road grader. The compression of the graded material by the investigator's shoe demonstrates the softness of the surface.

In Figure 6 an investigator demonstrates some of the characteristics of the graded surface and of the tire mark. The tire mark is about 13 inches in width. The softness of the graded material can be observed by the compression that occurs when the investigator's shoe is applied with normal weight.

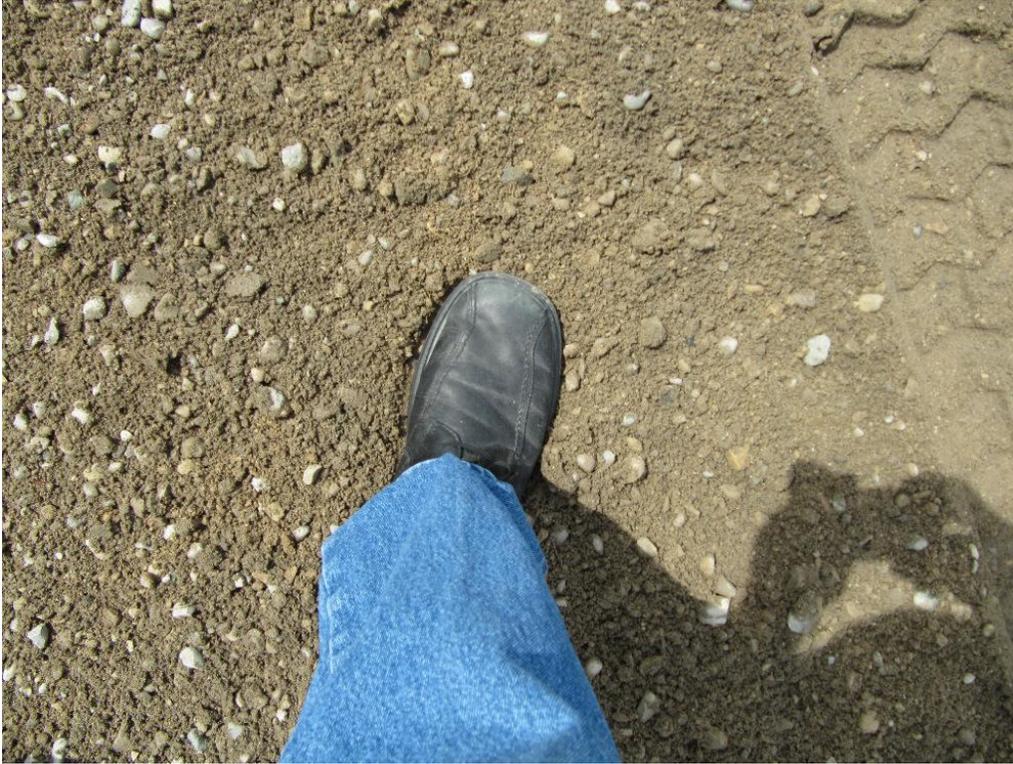
Figure 7: View of the investigator's shoe compressing the loose, graded material.

Figure 7 shows a closer view of the compression caused by the investigator's shoe. Figures 8, 9 and 10 show the resultant imprint of the shoe and the tire mark of the road grader.

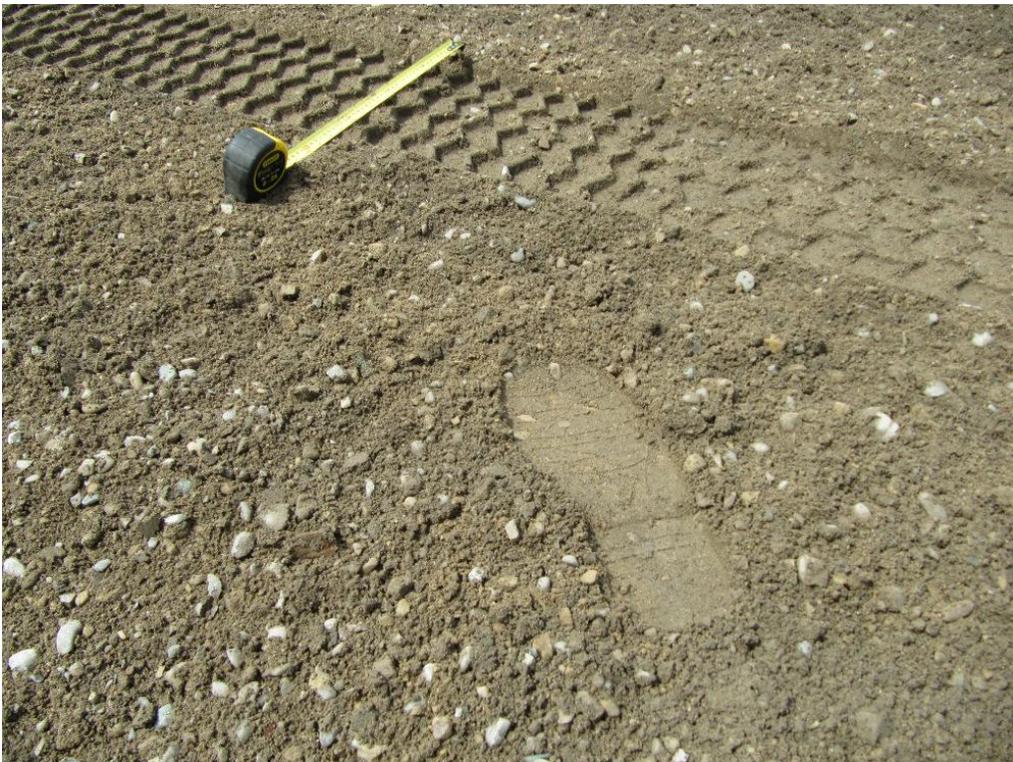
Figure 8: View of the shoe imprint and the tire mark of the road grader.

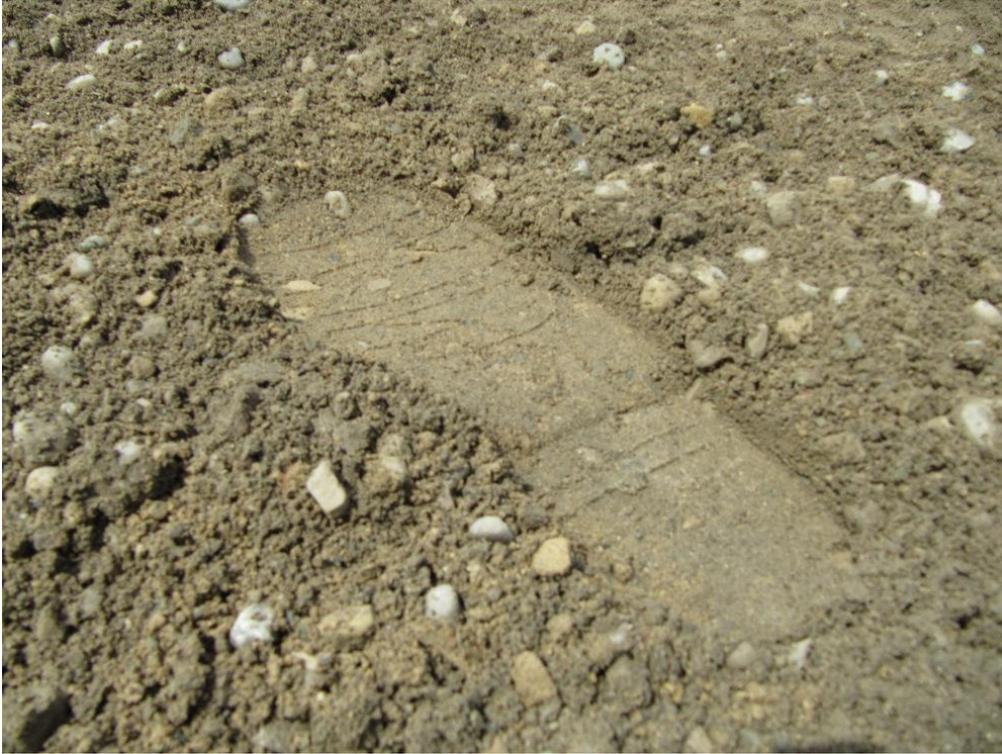
Figure 9: Close-up view of the shoe imprint.

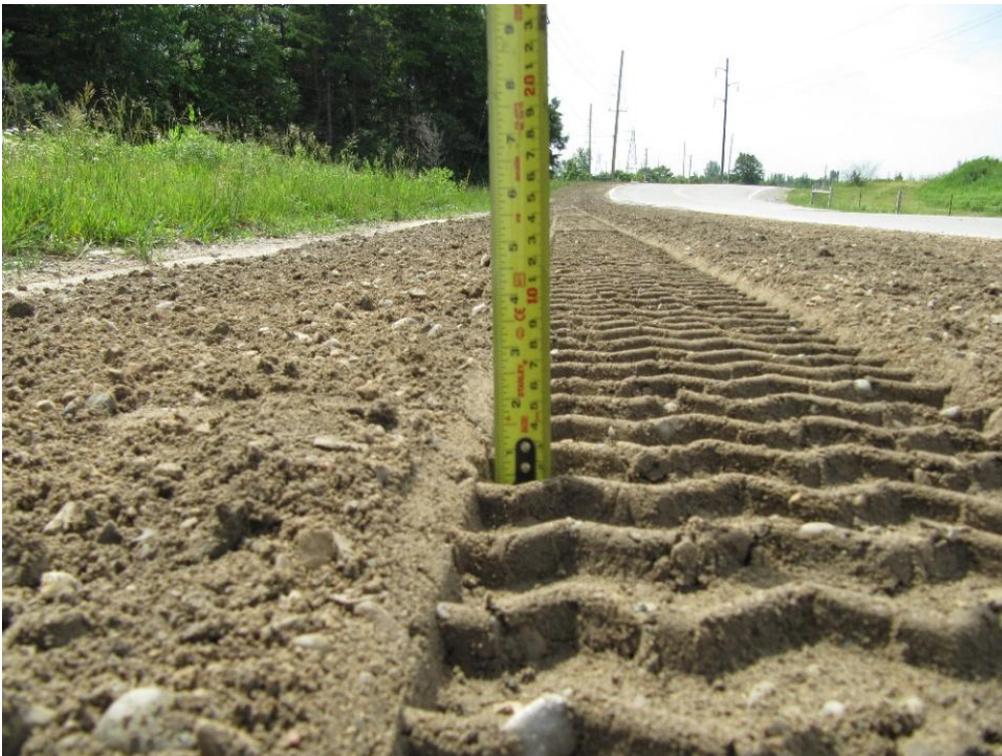
Figure 10: View of the depth of the impression caused by the tire mark of the road grader.

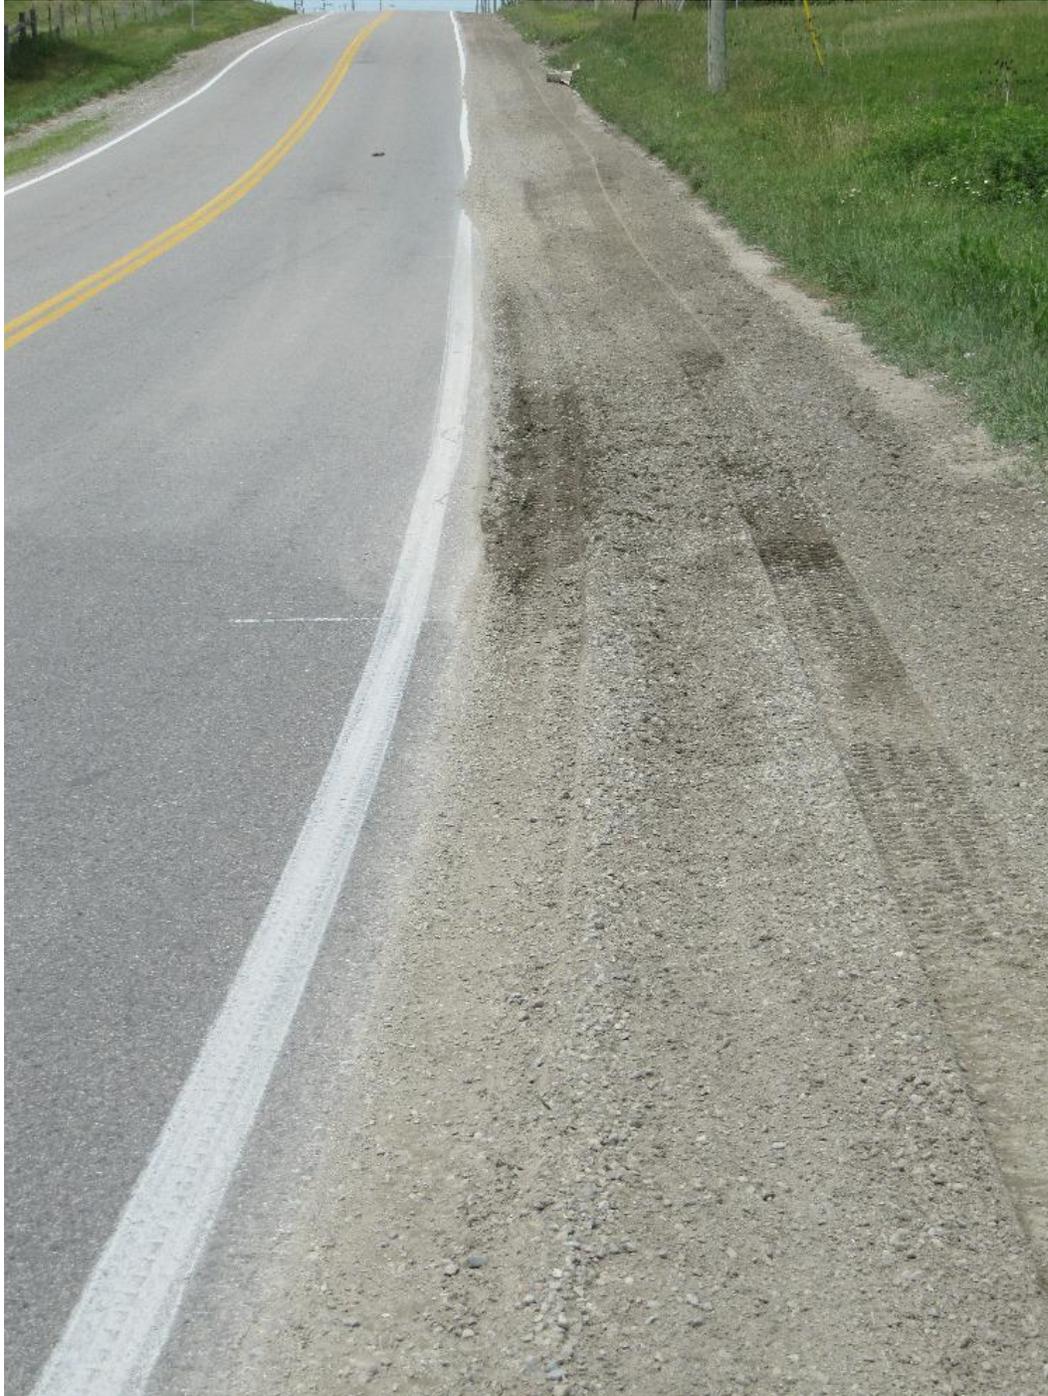
Figure 11: View, looking north, along the east shoulder of Clarke Road. A tractor tire mark (left) was produced on the shoulder after the road grader tire mark (right).

The above photos of the re-grading of the shoulder were taken shortly after 1000 hours on the morning of June 18, 2013. When the site was examined about 2 hours later the right side wheels of a tractor tire had entered the shoulder and produced the tire mark visible in Figure 11. Here we can see that some of the gravel and soil were thrown onto the road grader tire mark which became less visible.

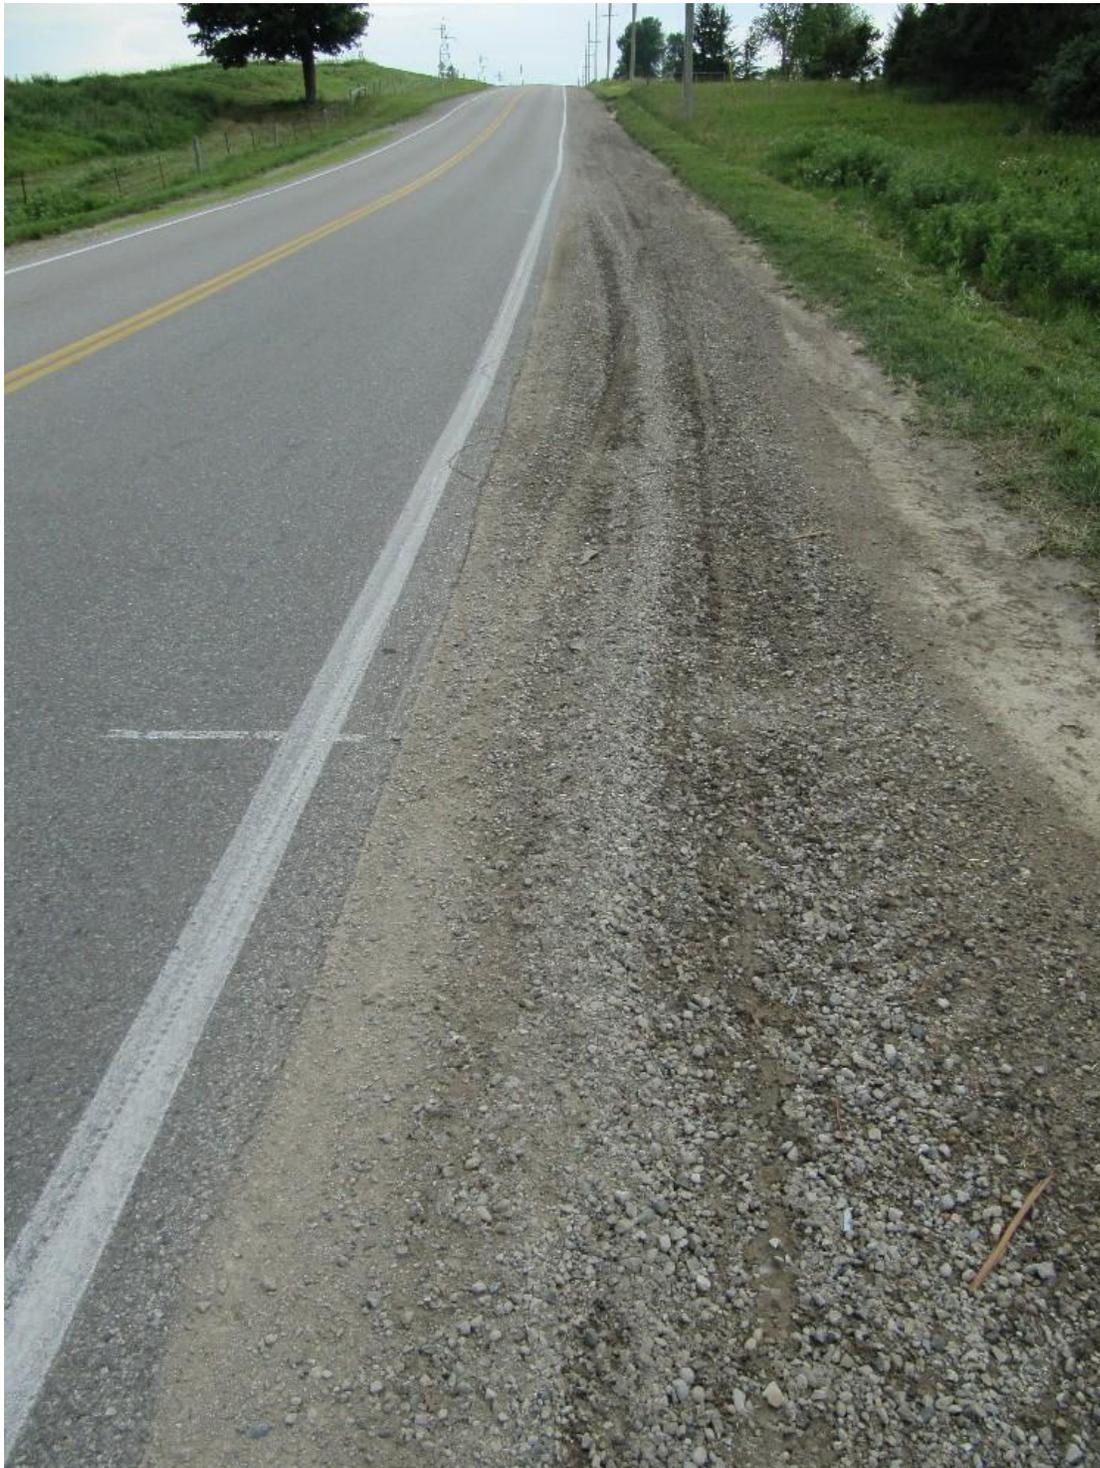
Figure 12: View, looking north along the east shoulder of Clarke Road, on June 24, 2012, showing that the road grader tire mark is no longer visible.

About a week later, on June 24, 2012, the same location was re-examined and the road grader tire mark was no longer visible, as shown in Figure 12. Yet this will not always be the case.

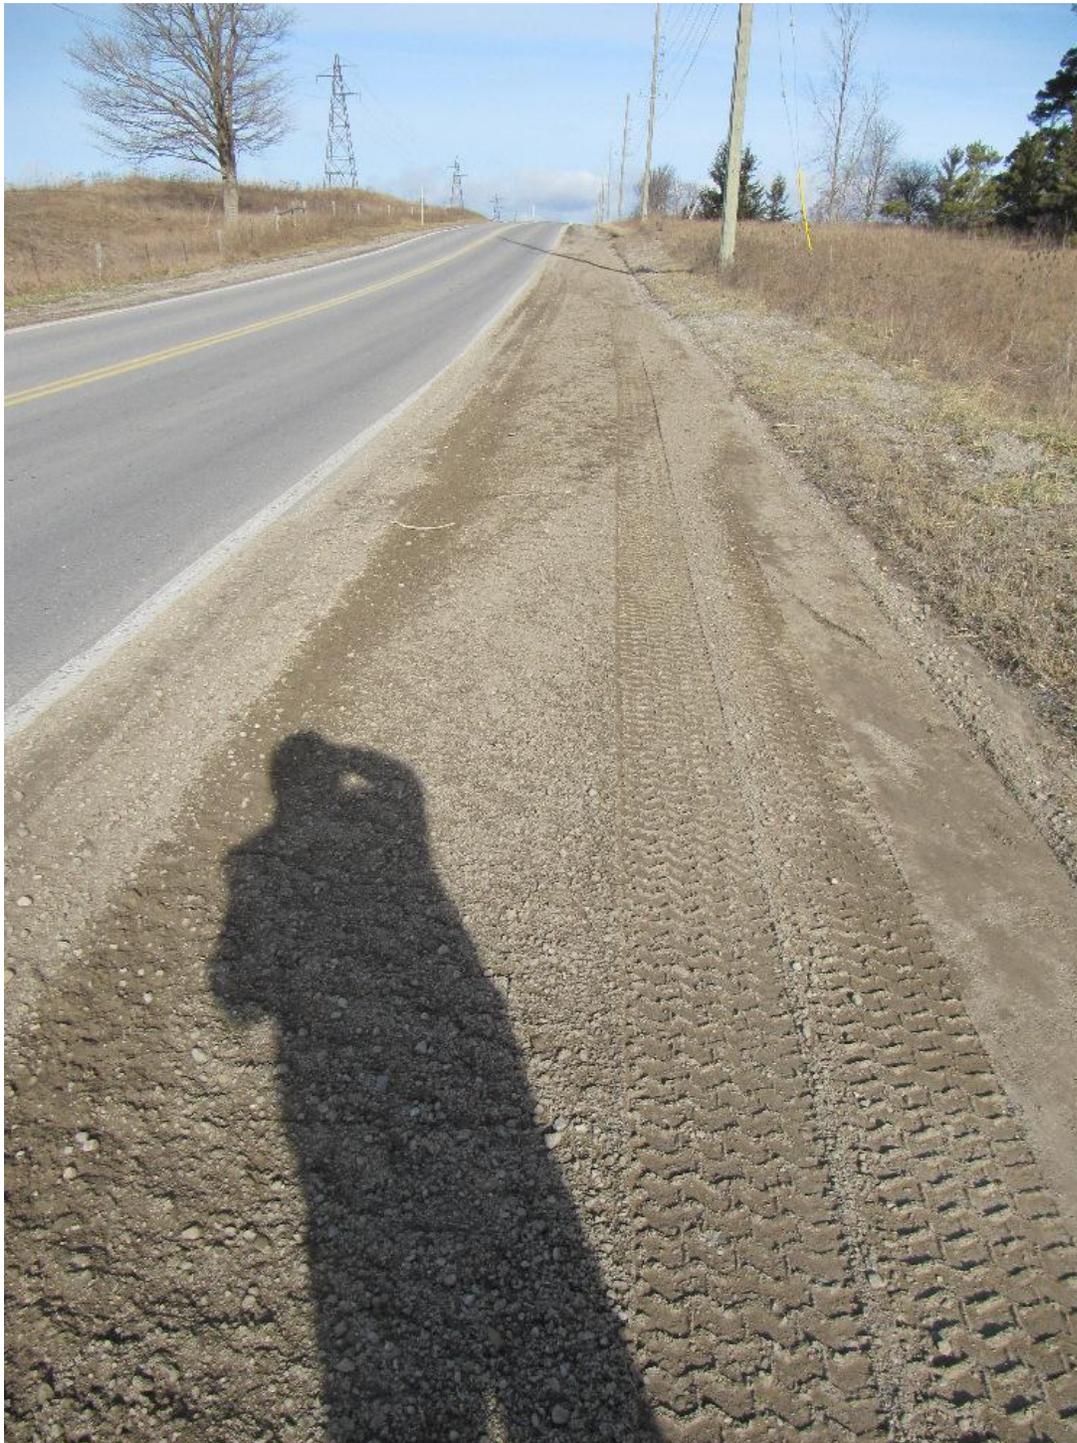
Figure 13: The tire marks from a road grader are clearly evidenced in this view taken on February 8, 2012, two days after the re-grading occurred.

As an example, Figure 13 shows a view taken on February 8, 2012, two days after a road grader passed through the east shoulder of Clarke Road. Here the grader right rear tire marks from both passes of the grader can be clearly seen.

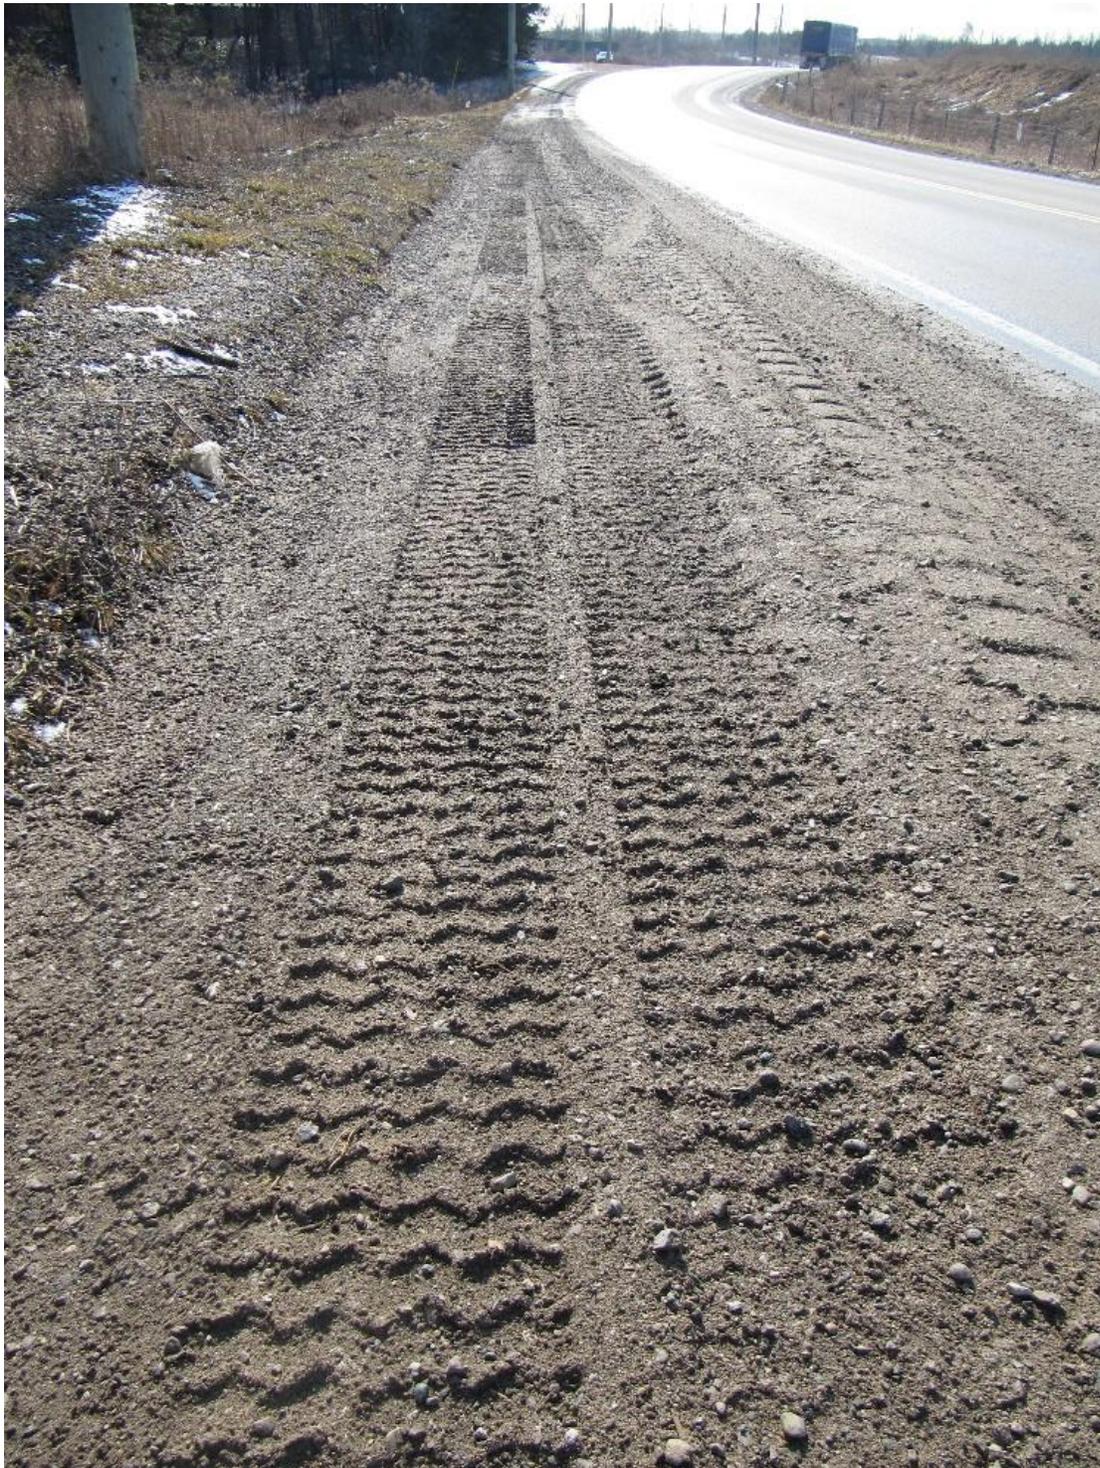
Figure 14: View, looking south along the east shoulder of Clarke Road on February 23, 2012. The two tire marks created by the road grader more than two weeks earlier are still clearly visible.

Then, on February 23, 2012, Figure 14 shows the same location of the east shoulder, however viewed in a southward (opposite) direction. Here we can still see the two tire marks from the two passes made by the road grader over two weeks earlier.

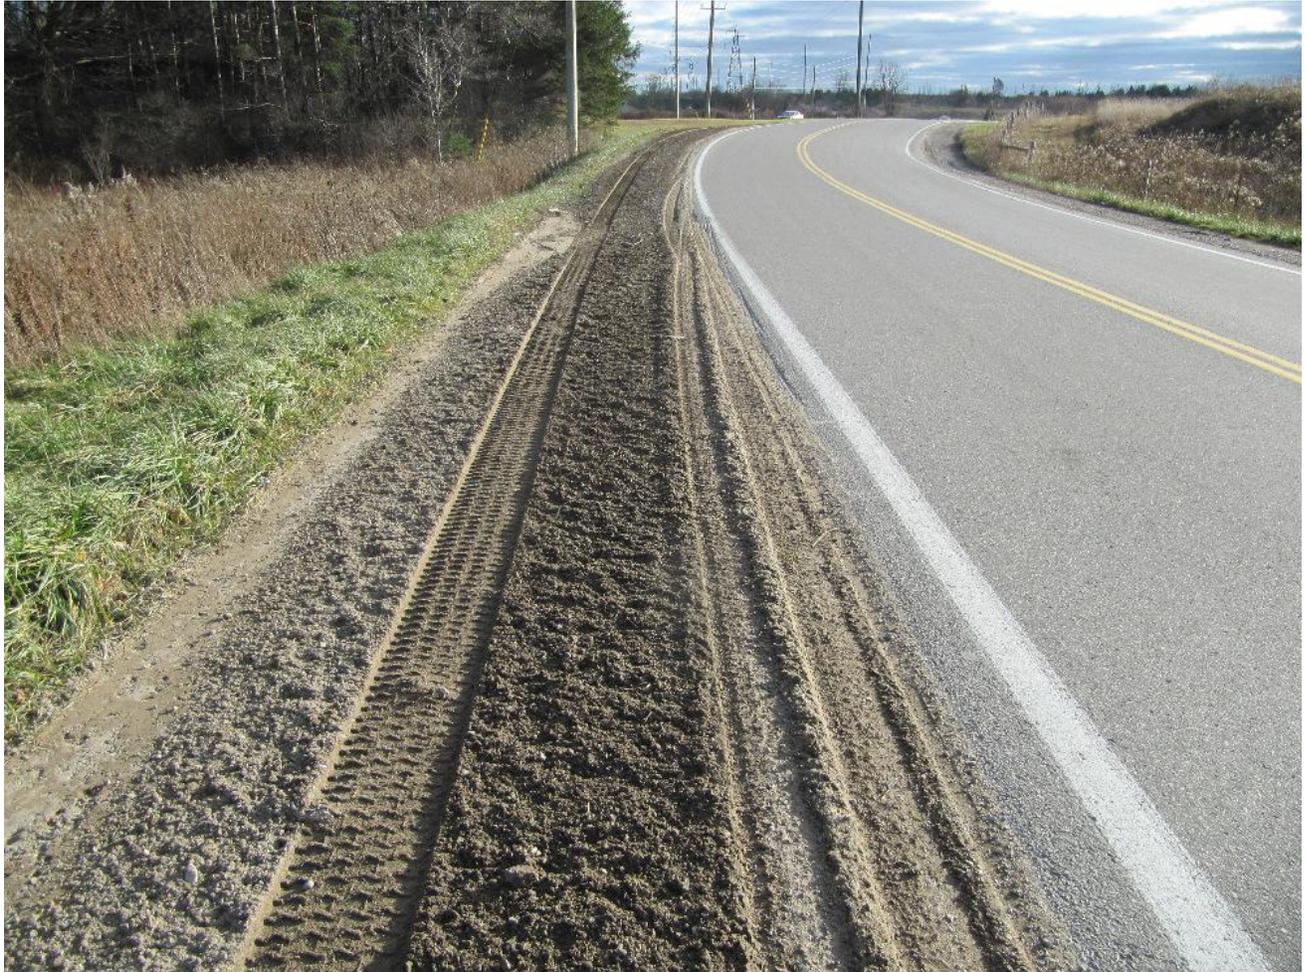
Figure 15: View, looking south, along the east shoulder of Clarke Road a few hours after the shoulder was freshly re-graded.

To become familiar with this type of evidence we can look at another example taken from late afternoon on November 19, 2013, shown in Figure 15 below. This view looking southward shows the east shoulder of Clarke Road which had been re-graded earlier that morning. It should be possible to detect the tire mark on the left which was caused by the road grader. The tire marks near the pavement edge were caused by regular traffic some time after the shoulder was re-graded.

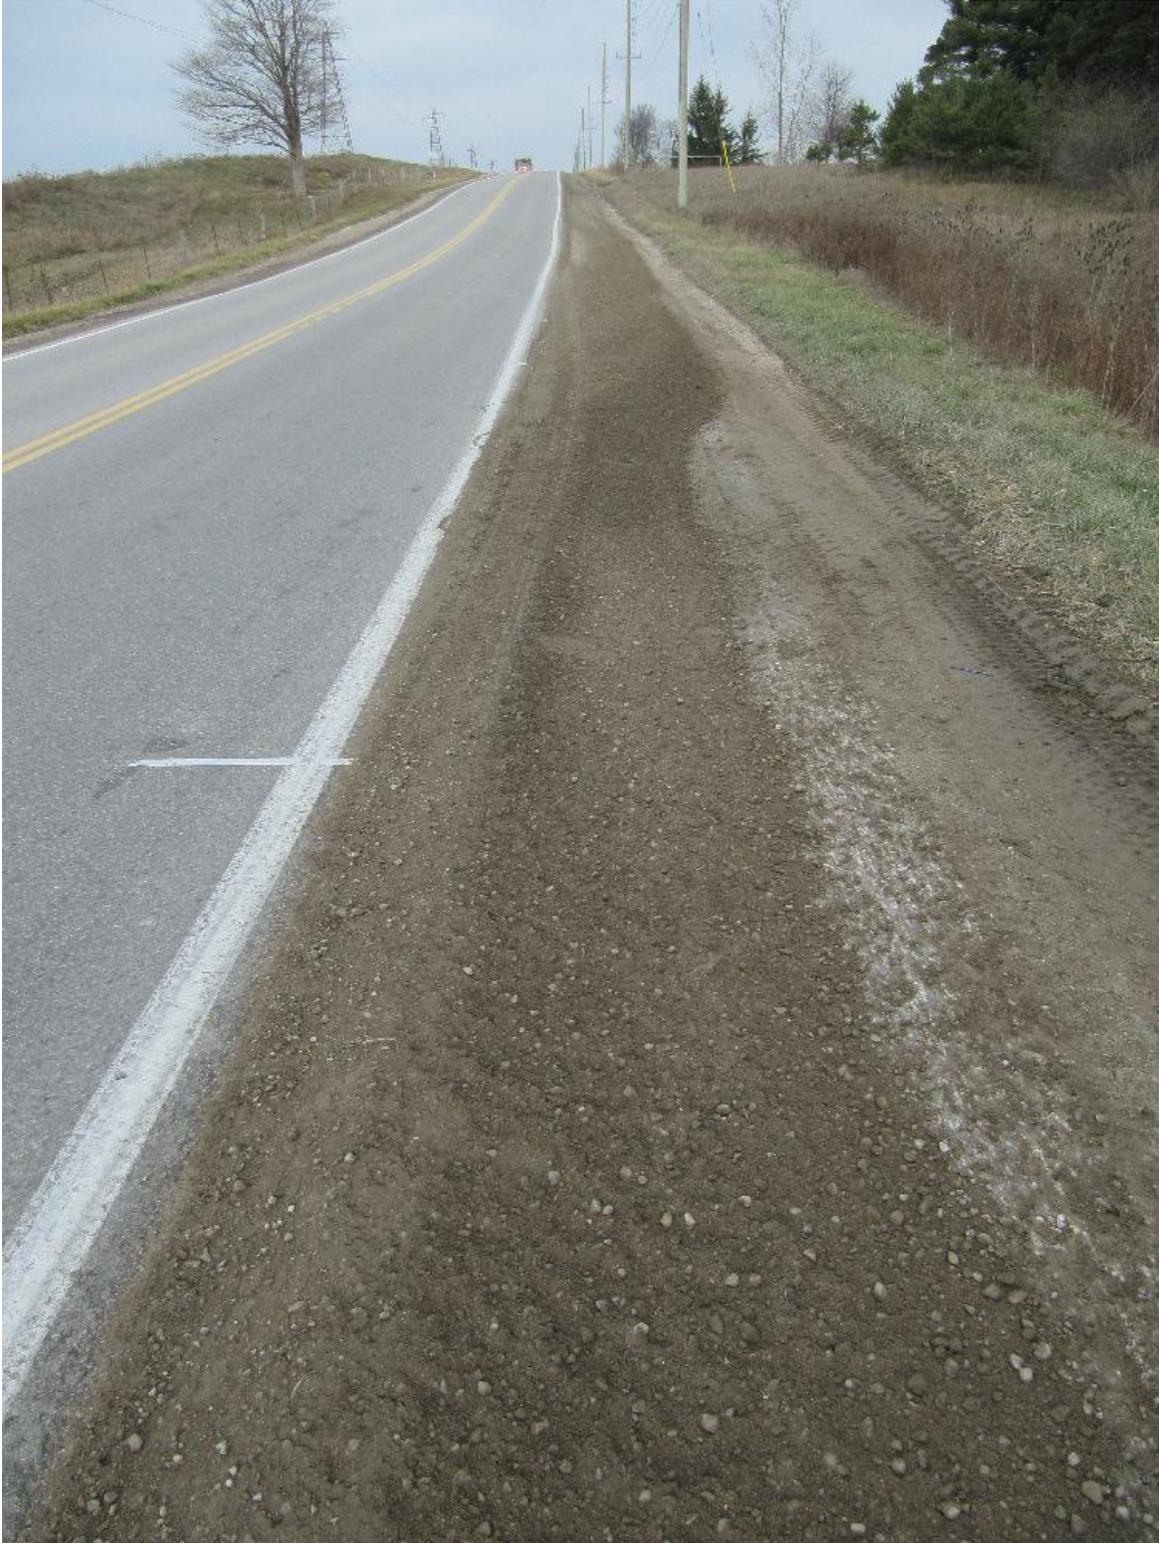
Figure 16: This northward view of Clarke Road, shows that a road grader had re-graded the east shoulder. The right rear tire mark that is normally produced in this action is not readily visible because those tires travelled on a hardened part of the shoulder.

In some instances the tire mark from the road grader may not be very visible. Figure 16 shows such a situation. This photo was taken on November 28, 2013. This view is looking north along the east shoulder of Clarke Road. Here the grader has not stirred up enough of the shoulder surface such that the right rear wheels travelled on the hard surface and did not produce a tire mark that is readily visible. That is why it is important to know what loose gravel looks like independent of the tire mark. The presentation of these examples should make it easier for investigators to identify what a freshly graded shoulder looks like and this is the purpose of this exercise.
