## Characteristics of Tire Marks Influenced by Soft Shoulders - Part 5

Gorski Consulting has embarked on a research study to document the characteristics of tire marks that exist outside of a paved road surface. This study has involved documentation of hundreds of incidents, both collision-involved, but also incidents of simple travel onto a gravel shoulder.

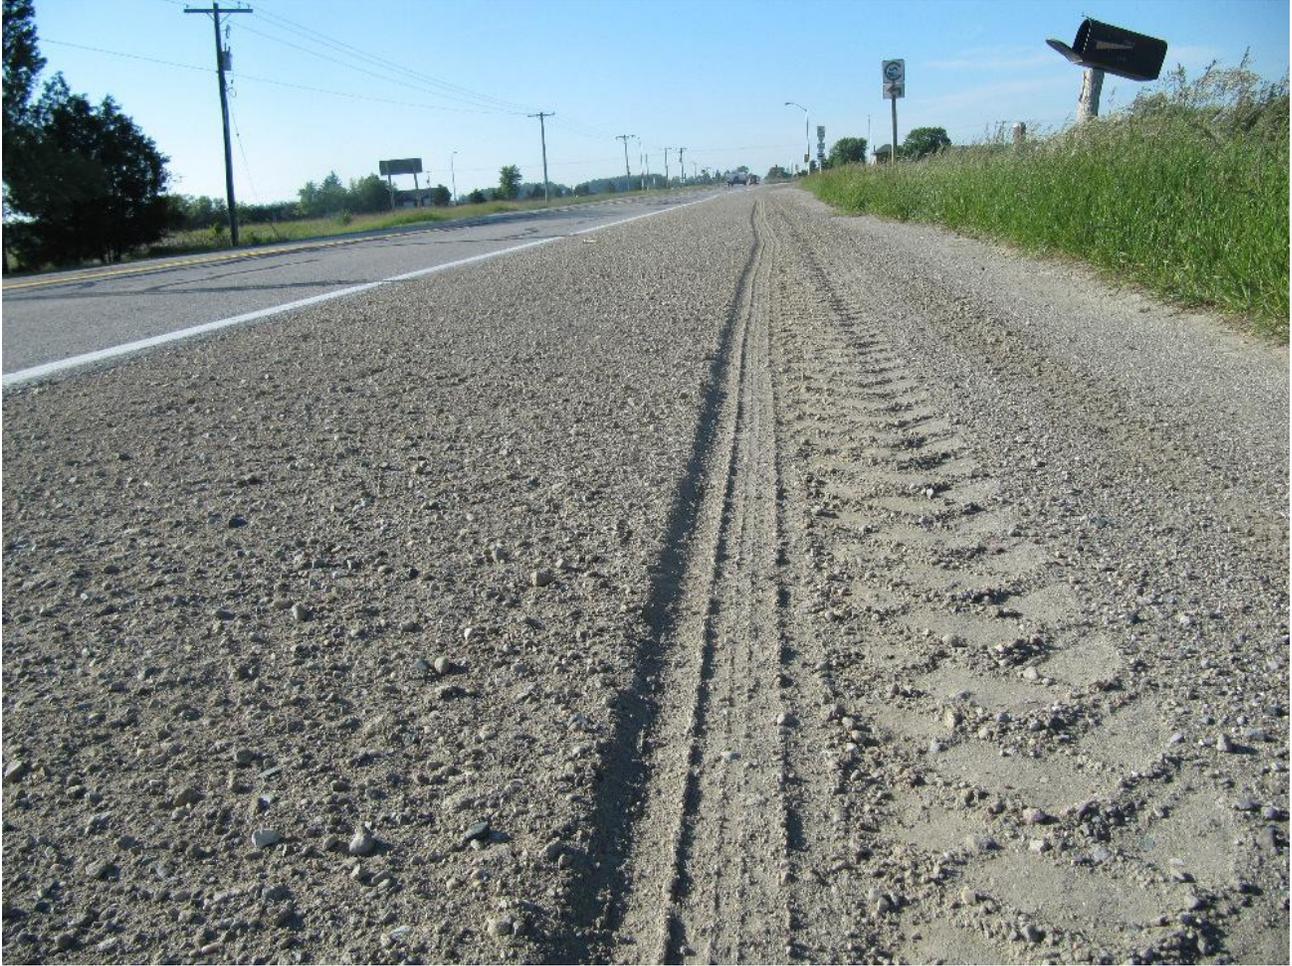
**Figure 1: View, looking north, at the east shoulder of Nauvoo Road which was freshly re-graded by the vehicle that produced the two visible tire marks.**

After studying that view readers should come to the decision that this is a freshly re-graded shoulder, as evidenced by the quality of the surface. It should also be apparent that the double tire mark running parallel within the shoulder was caused by a road grader.

In Part 4 of this series we presented a number of situations showing a tire mark that was created by the right rear wheels of a road grader. The imprint left by those tires was not exactly the same as what we see in Figure 1 as there appears to be a wider "tractor" tire imprint as well as a narrower one just to its left. One might surmise that the wider tractor tire imprint would be positioned "outside" of the narrow one on a typical tractor and that possibly the narrower imprint is from the right front while the wider tractor tire is from the right rear wheel. If the tractor-like grader is travelling forward away from the camera in Figure 1 then the last tire that should make its imprint is the right-rear, or the wider tractor-like tire. So that wider tractor-like tire should ride over and destroy parts of the narrower tire imprint in those mutual locations where the imprints overlap.

So is that what we see in Figure 1? Does the wider, tractor-like tire appear to ride over and destroy a portion of the narrower tire imprint? Looking at the interface where those two tire marks come together the evidence is not particularly clear, but it may be that the opposite is true.

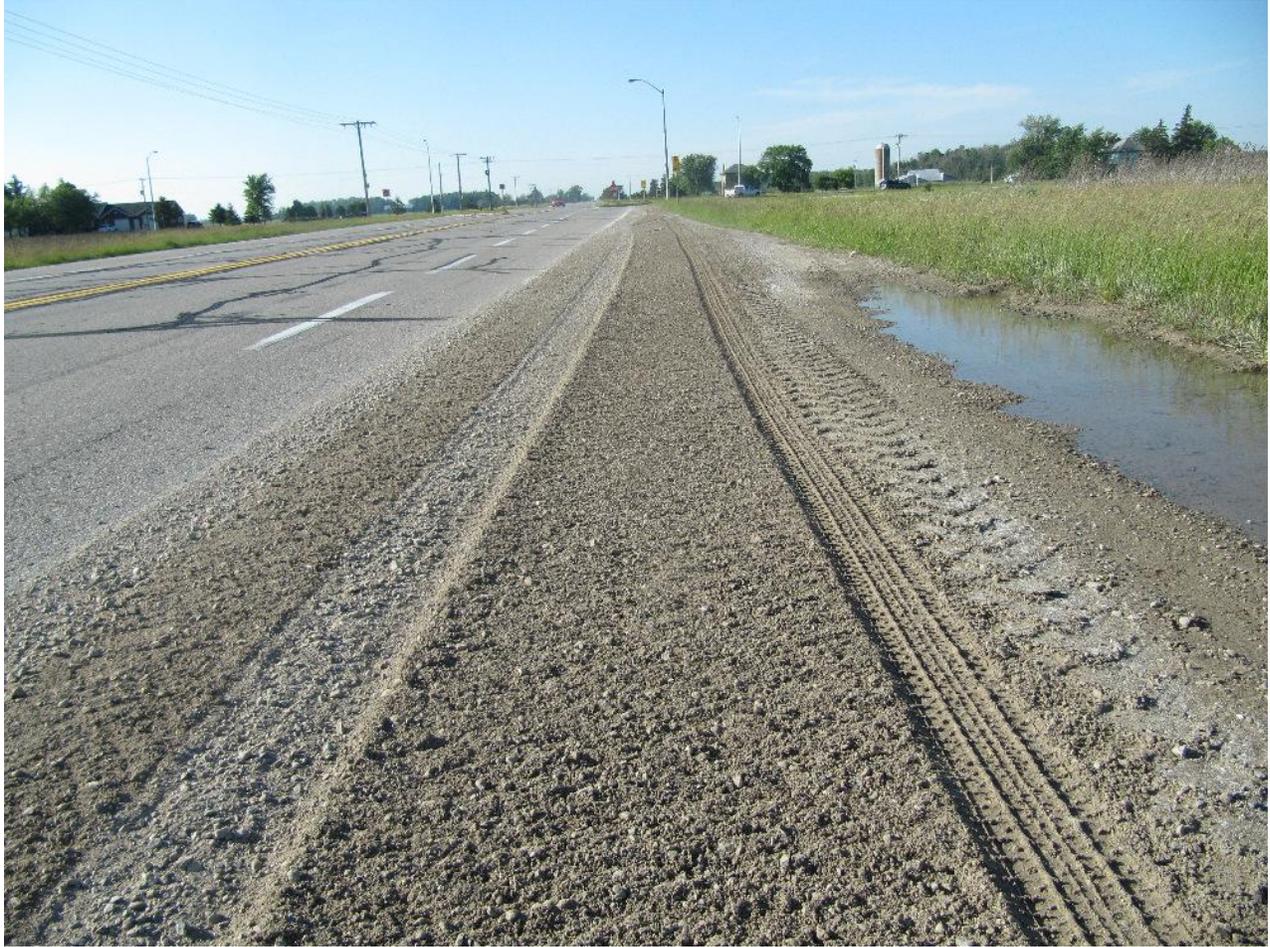
Figure 2: View, looking north, along the east shoulder of Nauvoo Road.

What if we look at another view of those tire marks as we move further north, as shown in Figure 2. Does the wider, tractor-like tire mark appear to destroy the narrower one to its left or is it the other way around? Some of the evidence would suggest that some of the gravel/soil debris lifted up by the narrower tire appears to be thrown onto the wider, tractor-like tire imprint and therefore it would seem that the narrow tire mark was the last one to pass by.

What also becomes apparent in Figure 2 is that we see a new tire mark showing up further to the left of the view and this is caused by an unrelated vehicle. We know this unrelated vehicle passed through the site after the re-grading was done because the tire imprint travelled over top of the newly re-graded, shoulder surface.

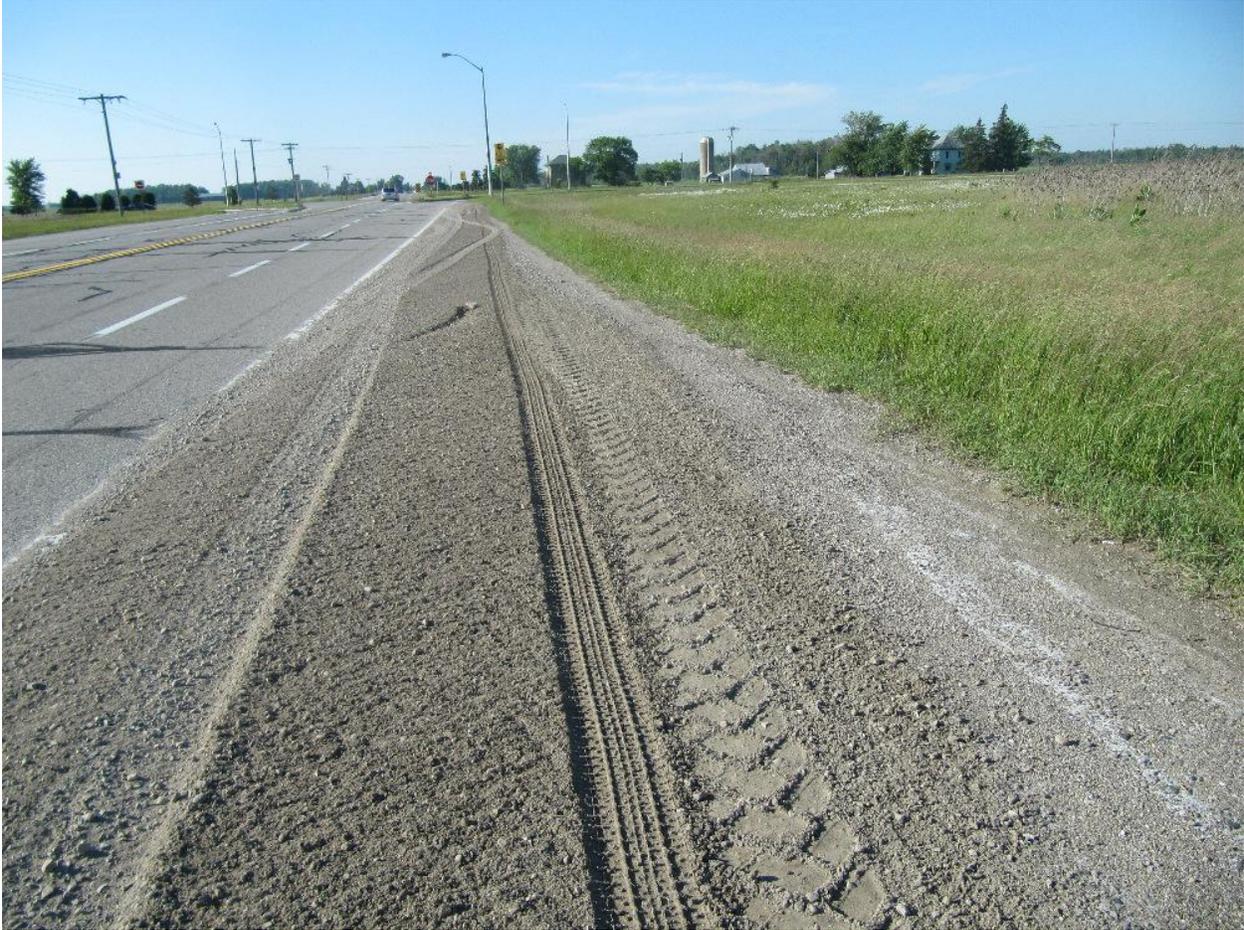
Figure 3: View, looking north, along the east shoulder of Nauvoo Road.

So then we move further north and we see what is shown in Figure 3. Here we still see the two tire marks to the right which we believe are from the road grader. We also see the single tire mark to the left which we believe is from the unrelated, unknown vehicle. We look again closely at the interface between the two tire marks of the road grader to see which tire mark was created last. Again, bits of gravel/soil debris would appear to have been thrown onto the wider, tractor-like, tire mark suggesting that the narrower tire mark was created last and was likely at the back of the vehicle if it was moving northward as one would expect.

In the background of Figure 3 we begin to see a short trail of an object that is lying in the middle of the shoulder. We also see some additional tire marks in the distant background.

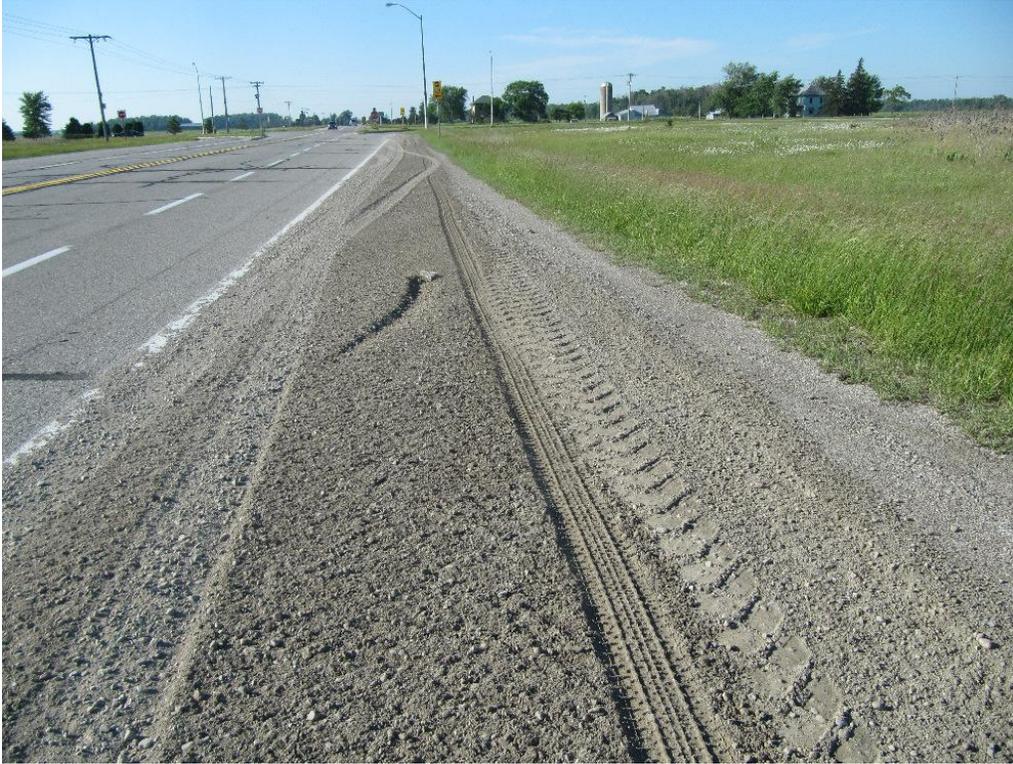
Figure 4: View looking north toward a rock on the east shoulder.

Figures 4, 5 and 6 are additional views that are further north along the east shoulder of Nauvoo Road. Here we obtain a closer view of the short trail and the object that caused it. The object is a rock and the trail indicates the direction that the rock was thrown as it slid to its rest position. It can be understood that, as the road grader moved northward it gathered the rock in its blade and pushed it northward in the direction it was travelling. So this gives the additional confirmation that the road grader was travelling northward.

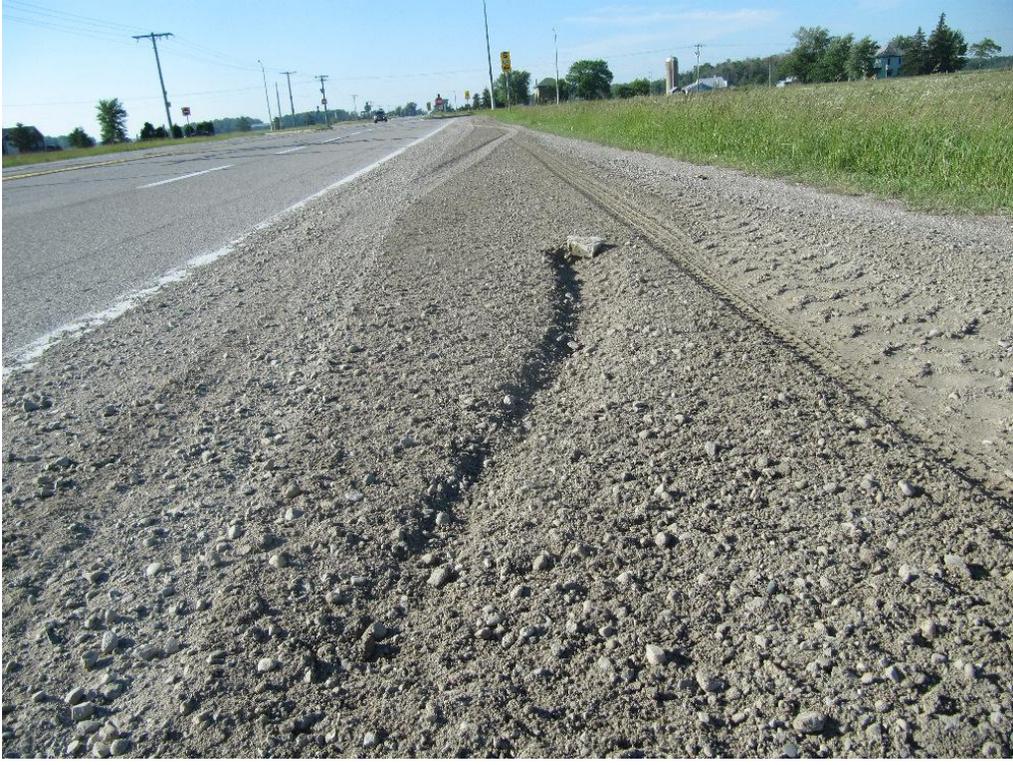
Figure 5: View looking north at a rock lying on the east shoulder.

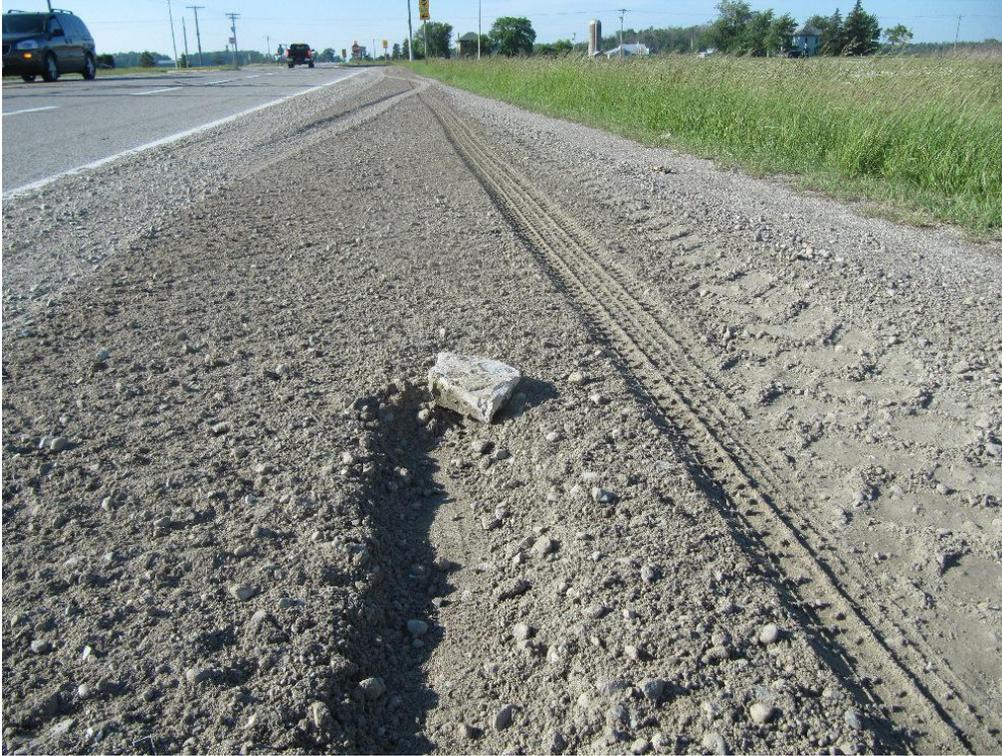
**Figure 6: Close-up view of the trail produced by the rock as it was likely pushed northward by the road grader.**

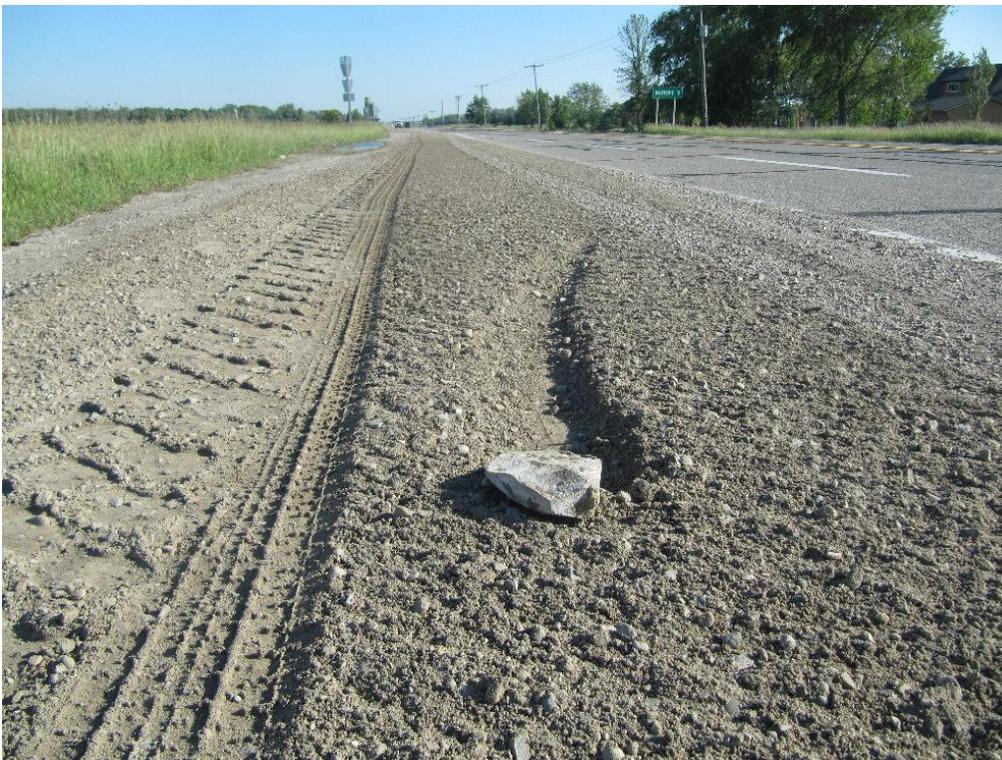
**Figure 7: View, from the rock's resting position, rotated around to face southward.**

Using this rock as a reference we can now turn our view around to face southward from the rock's rest position, as shown in Figure 7. We also provide further views, moving progressively southward, in Figures 8, 9 and 10, showing the tire marks produced by the road grader as they exist well into the southern distance. Thus it is reasonable that such tire marks would exist for this long distance if the road grader was moving along the shoulder and re-grading it. Certainly the evidence does not match that of a vehicle that has briefly strayed onto the shoulder as it would be unlikely that such an action would occur over such a long distance. So all the evidence confirms that we have two tire marks caused by a northbound road grader. These two marks are caused by the right side tires. The narrower tire mark is caused by the right rear tire, or the last tire to pass through the re-graded shoulder.

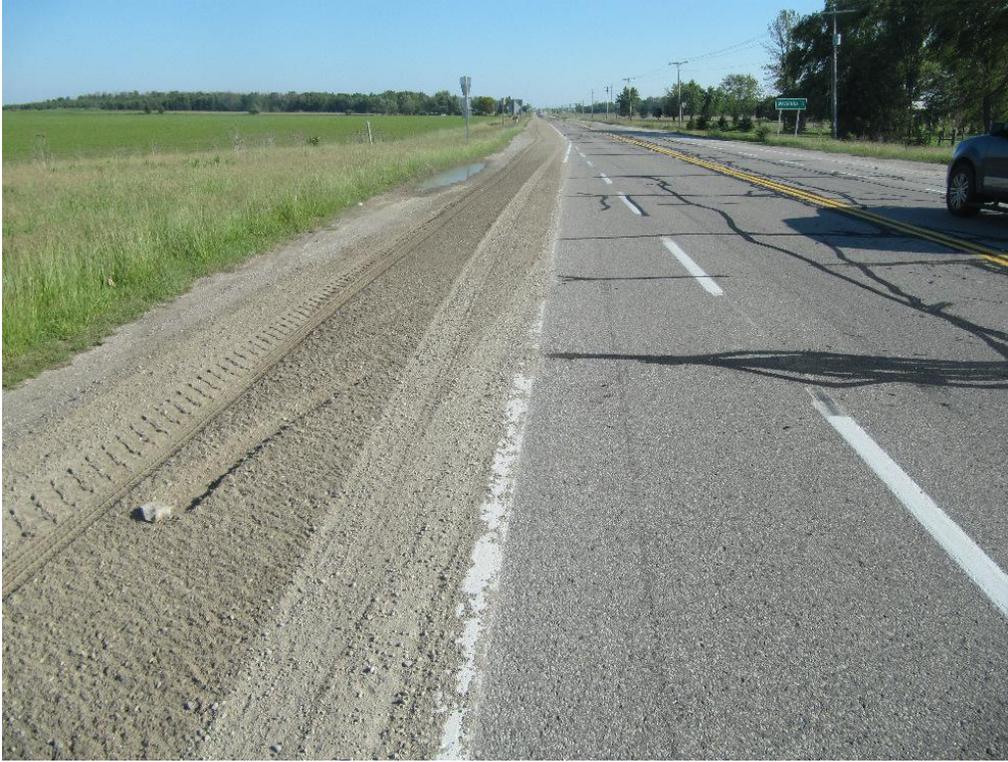
Figure 8: View, looking south from the rock's rest position.

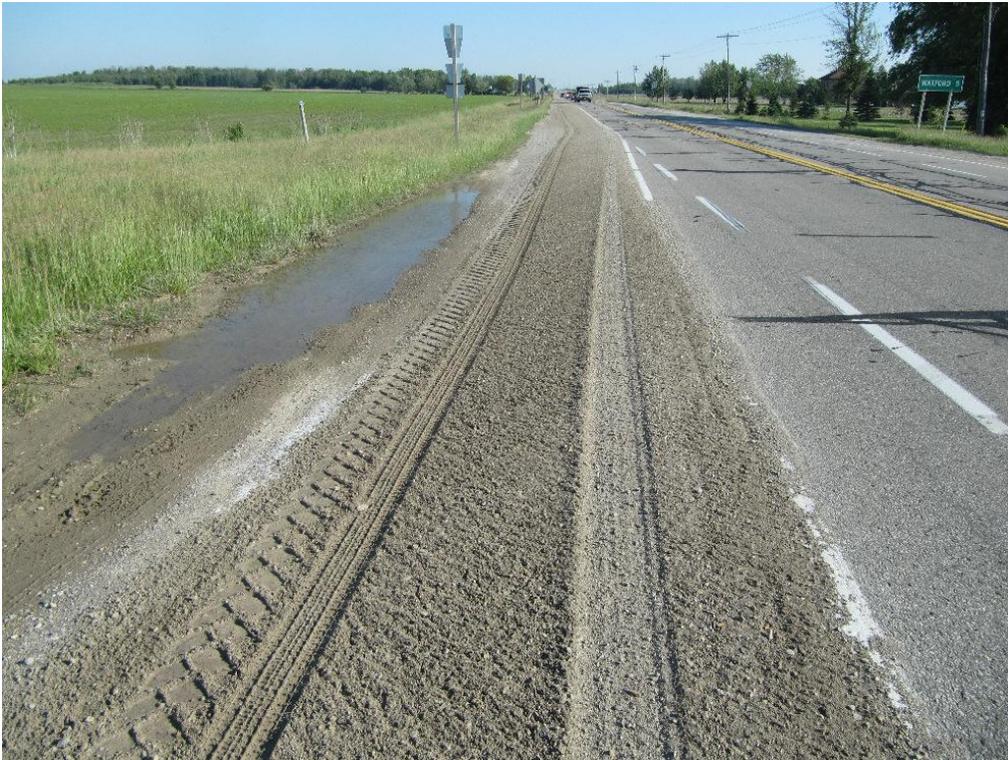
Figure 9: View, looking south along the east shoulder of Nauvoo Road.

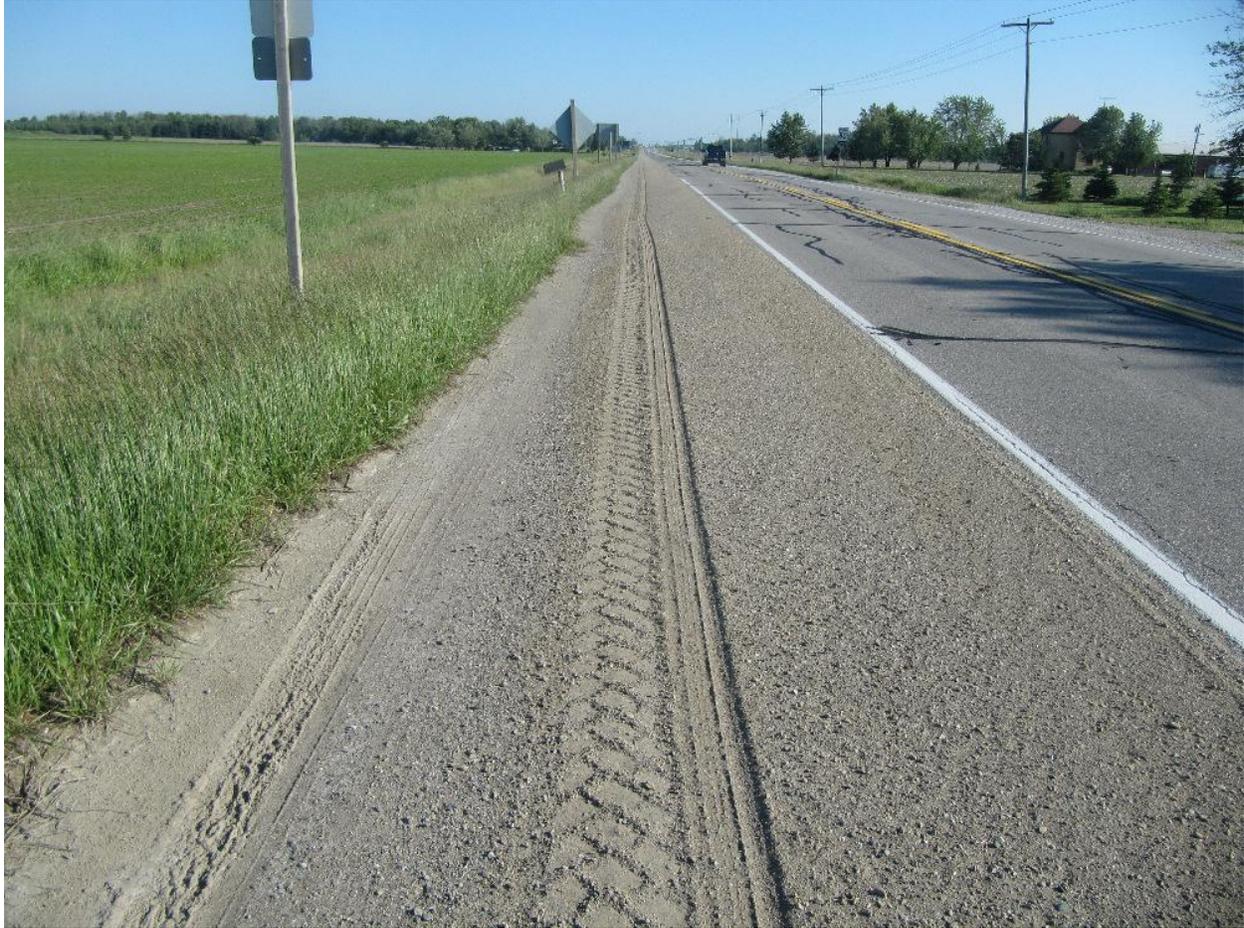
Figure 10: View, looking south, along the east shoulder of Nauvoo Road.

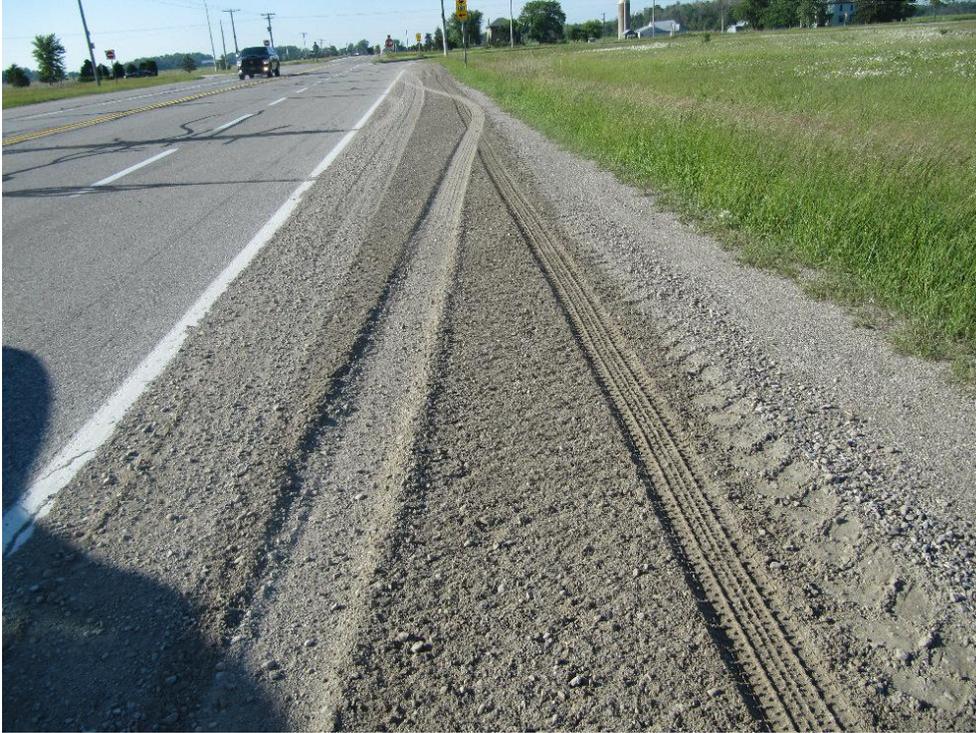
Figure 11: View, looking north, from a short distance north of the rest position of the rock on the east shoulder of Nauvoo Road

Figure 11 takes us a short distance north of the rock's rest position. Here we see a curving tire mark from a vehicle that exited the pavement and travels across the path of the tire marks caused by the road grader. That tire mark then curves back toward the pavement in the background as it re-enters the road. Figure 12 shows a view further north where we see that tire mark crossing back toward the paved road where it disappears as it regains the pavement.

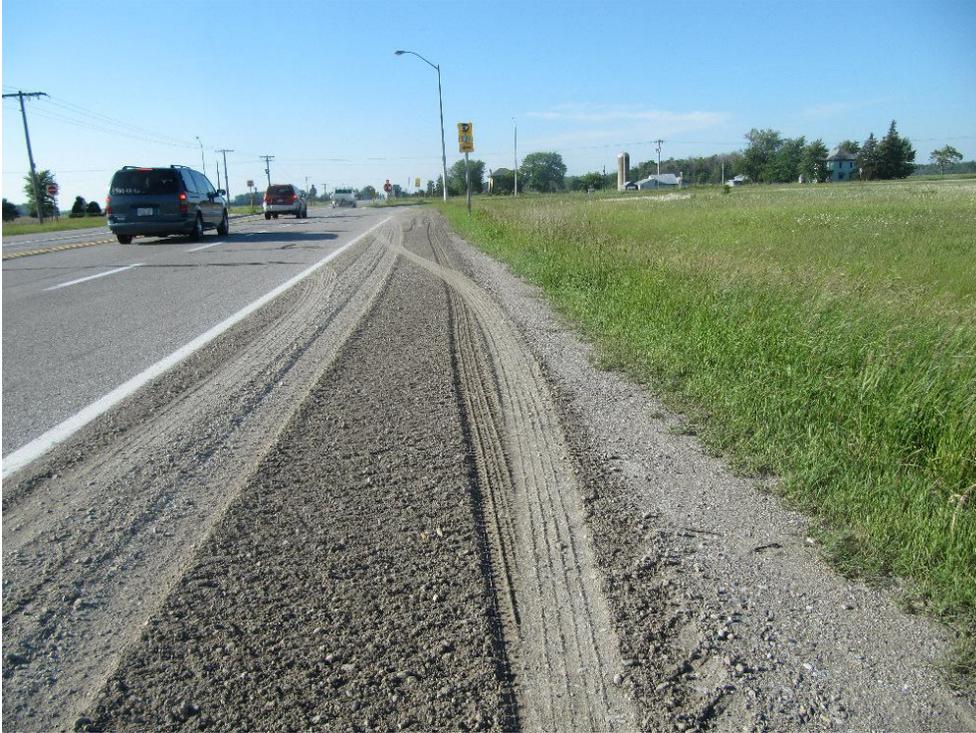
Figure 12: view of the single tire mark that crosses over the tire marks of the road grader as it moves back onto the pavement in the background.

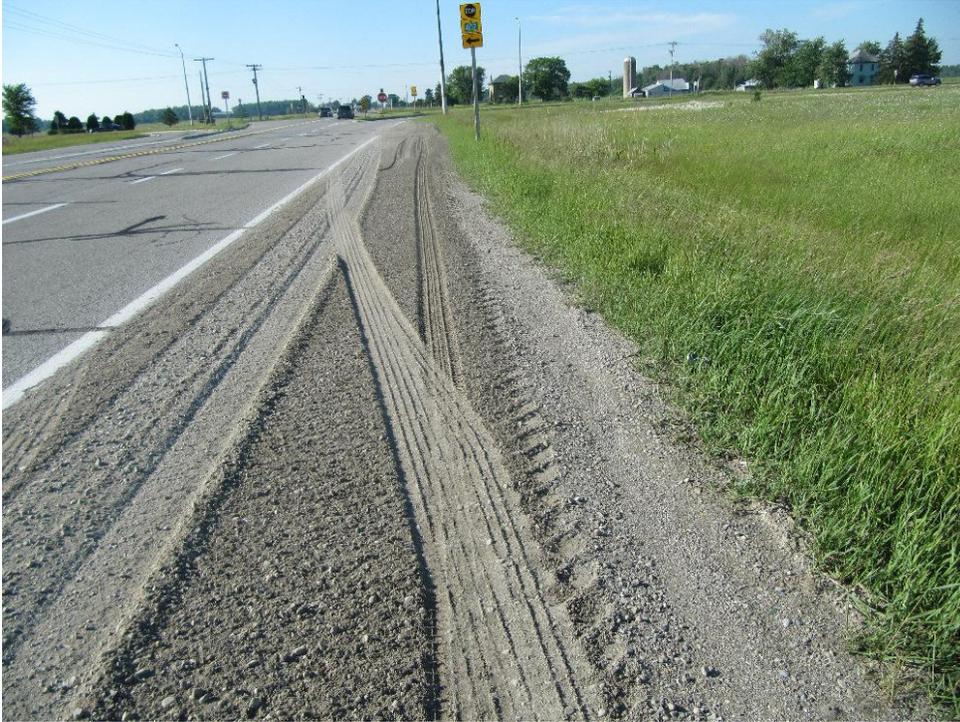
Figure 13: View, looking north, in the vicinity where the unknown vehicle's tire marks re-enters the pavement. In the background we begin to see some tire marks in the middle of the shoulder.

Figure 13 takes us further north as we see the tire marks of the unknown vehicle that crossed the path of the marks created by the road grader. Here we can see more closely in the vicinity where that unknown vehicle re-enters the pavement. We are focused on the path of this unknown vehicle for the specific reason that we want to provide readers with the chain of evidence that leads to an interesting set of tire marks that begin to be visible in the background of Figure 13. In Figure 14 we see the interesting marks in the middle of the shoulder approximately in the area where the tire mark of the unknown vehicle re-enters the pavement.

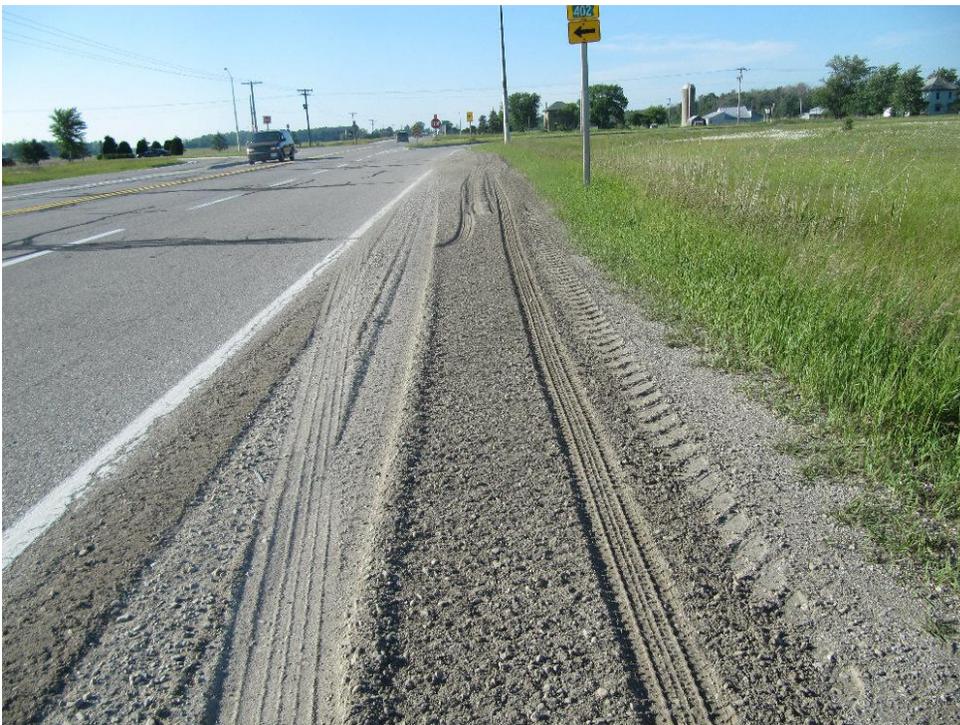
Figure 14: View, looking north, along the east shoulder of Nauvoo Road. At the approximate location of where the tire marks of the unknown vehicle re-enters the pavement there are some interesting tire marks in the middle of the shoulder.

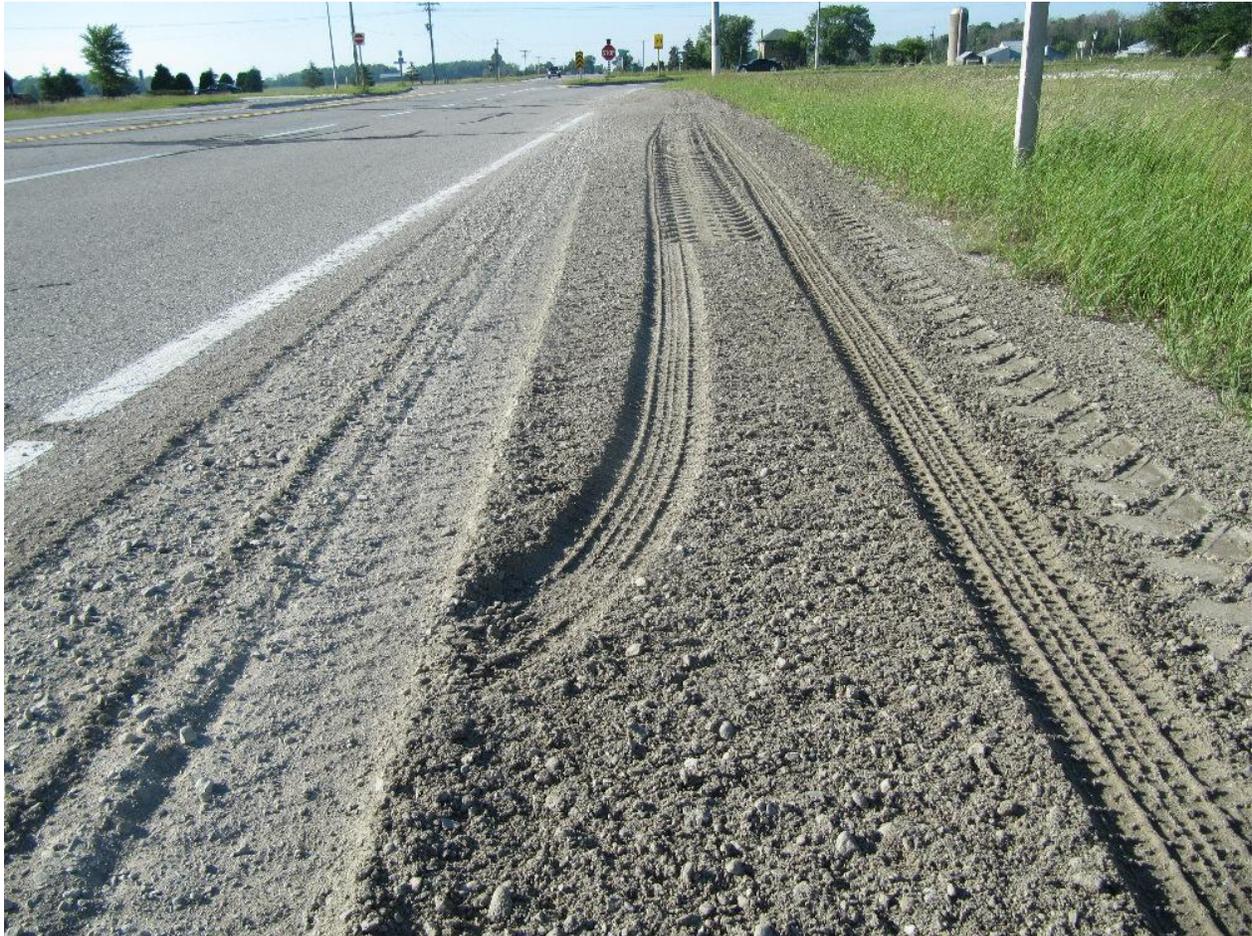
**Figure 15: View of the interesting tire marks in the middle of the shoulder which have a resemblance to the tire marks created by the road grader located to their right.**

In Figure 15 we now see the full view of the interesting tire marks that we described. A narrow tire mark that curves toward the bottom left of the view shows an exact resemblance to the narrow tire mark created by the road grader located to the left. Similarly, slightly further in the background, we see a wider, tractor-like, tire mark that has a similarity to the tractor-like, tire mark caused by the road grader to the right.

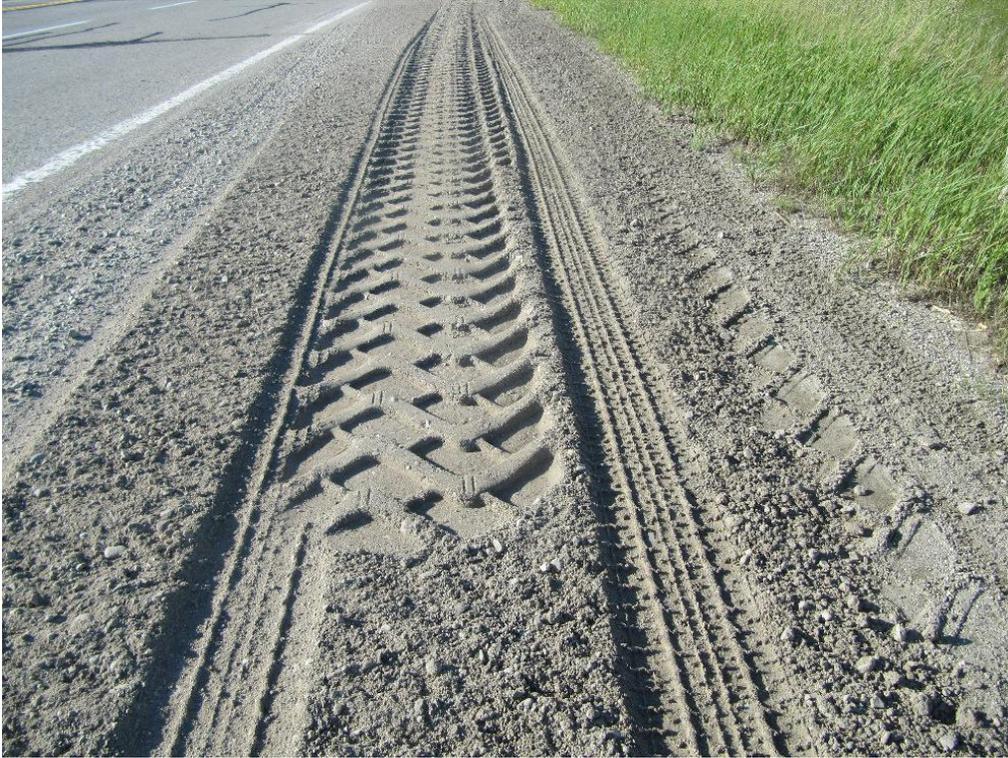
Figure 16: View, looking north, at the end of the tractor-like tire mark on the east shoulder of Nauvoo Road.

Figure 16 provides a closer, northward, view of the wider tractor-like, tire mark. Obviously this tire mark stops in the foreground. It should be fairly obvious that this tire mark and the narrower one were caused by the road grader. Figure 17 provides a view, looking south, of these interesting tire marks.

The remaining mystery for readers to solve is why, after apparently reversing southbound, there is no other tire mark evidence to indicate where the road grader travelled. For example, assuming that the road grader reversed and came to a stop at the end of the wide tractor-like tire mark shown in Figure 18, where did it go afterwards? As it stands, with the end of the wider tire clearly visible in Figures 16, 17 and 18, it

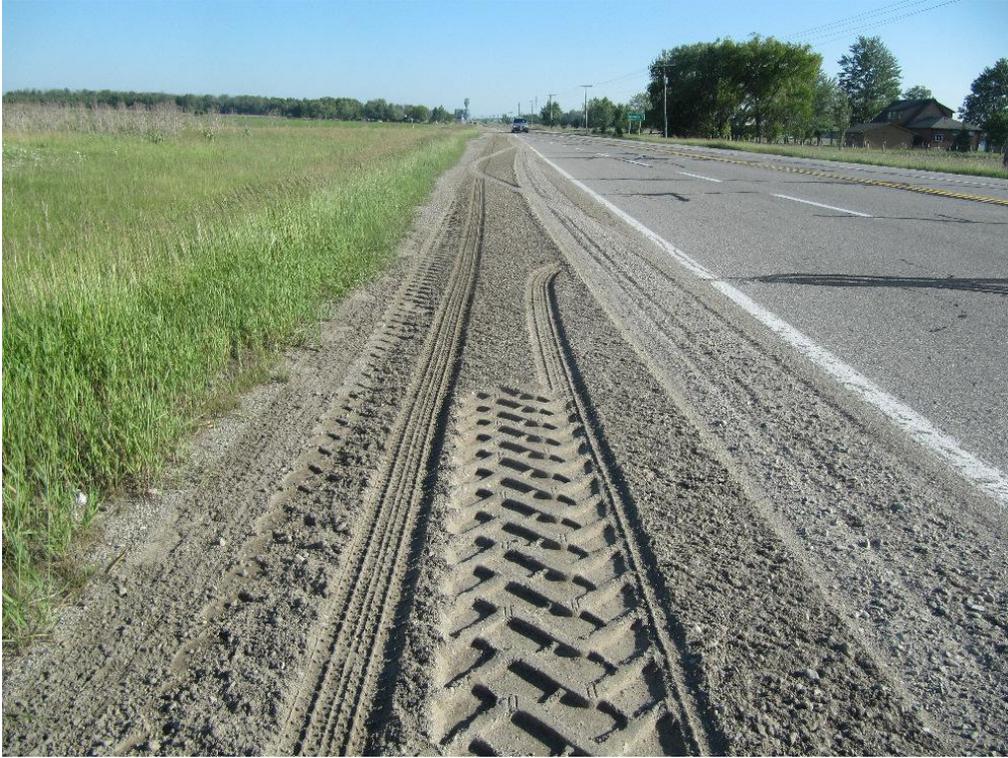
Figure 17: View, looking south, at the interesting tire marks that were created by the road grader.

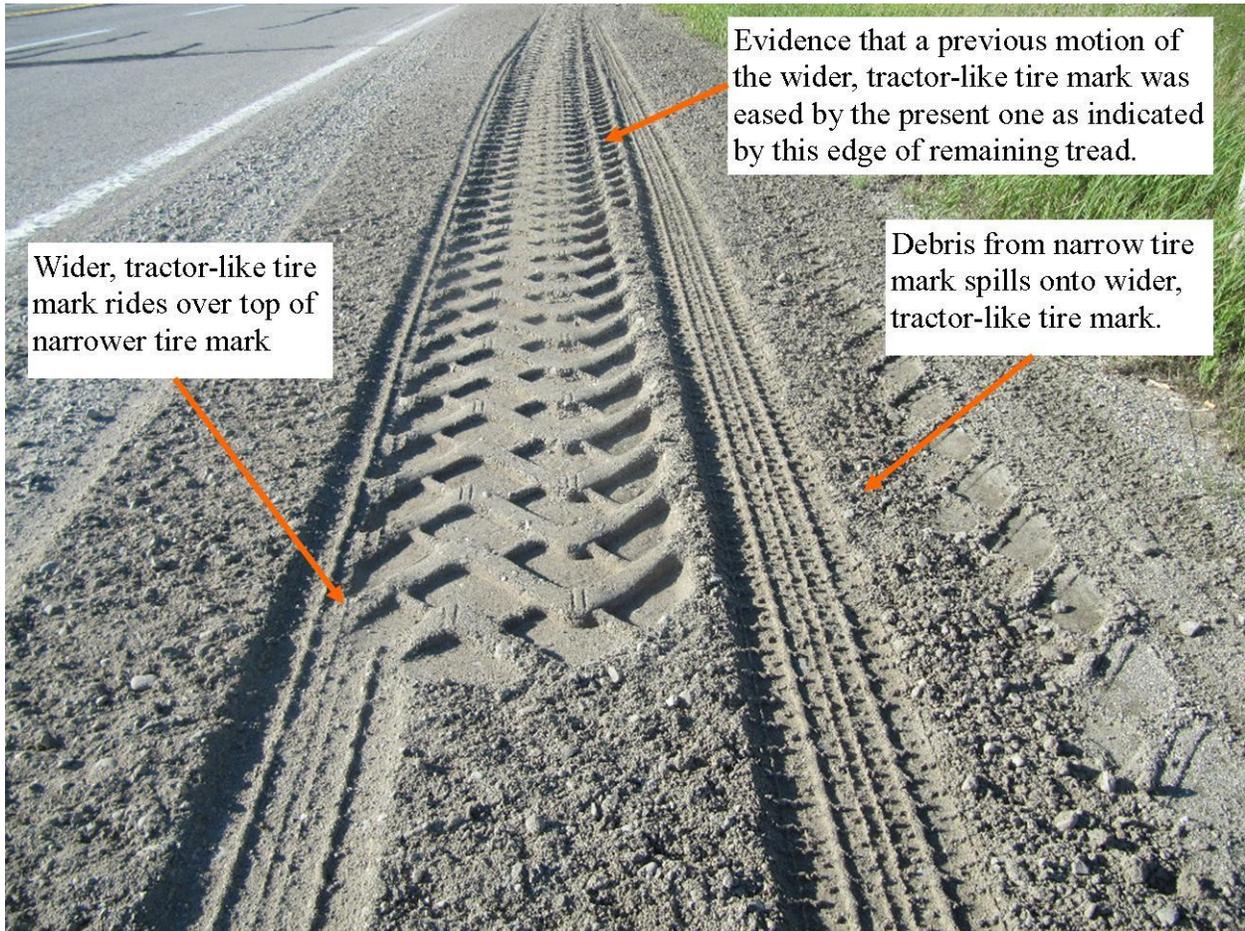
**Figure 18: View showing evidence that the road grader was initially northbound and the second set of tire marks indicate that the grader was moving southbound or possibly backing up.**

As shown in Figure 18, the set of tire marks on the right confirm that the road grader was initially northbound because the narrower tire that was at the rear of the grader trailed behind the wider one as evidenced by the debris that was thrown onto the imprint of the wider tire. However, the set of tire marks on the left show the opposite: the wider, tractor-like tire erases the narrower one confirming that the road grader was travelling in the opposite (southbound) direction.

Because the southbound motion ran over the freshly-graded gravel/soil of the initial, northbound run this confirms that the southbound run was performed after the northbound run. Thus it is likely that the second, southbound run involved a reversing action of the grader.
