# Characteristics of Tire Marks During Acceleration on Gravel Shoulders - Part 1

*Posting Date: 2 Feb-2016*

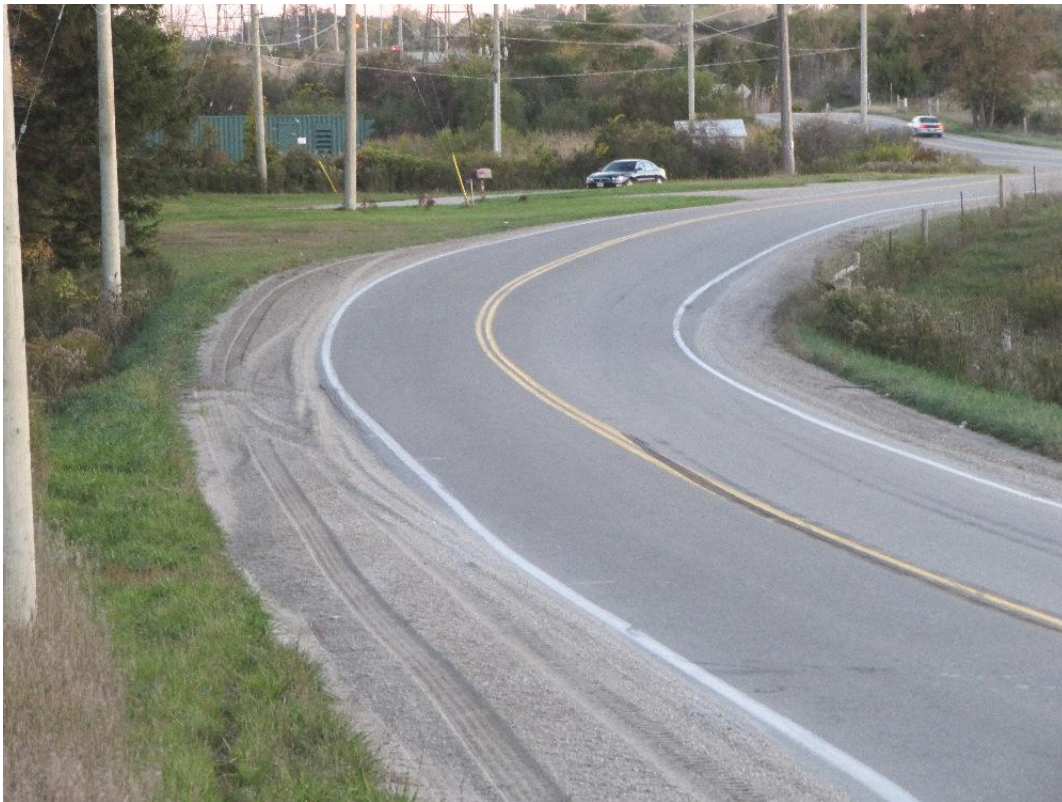
**Figure 1: View looking south at the S-curve of Clarke Road north of Fanshawe Park Road in London, Ontario on October 11, 2013. This is the "Laboratory" where a number research studies have been conducted at Gorski Consulting.**

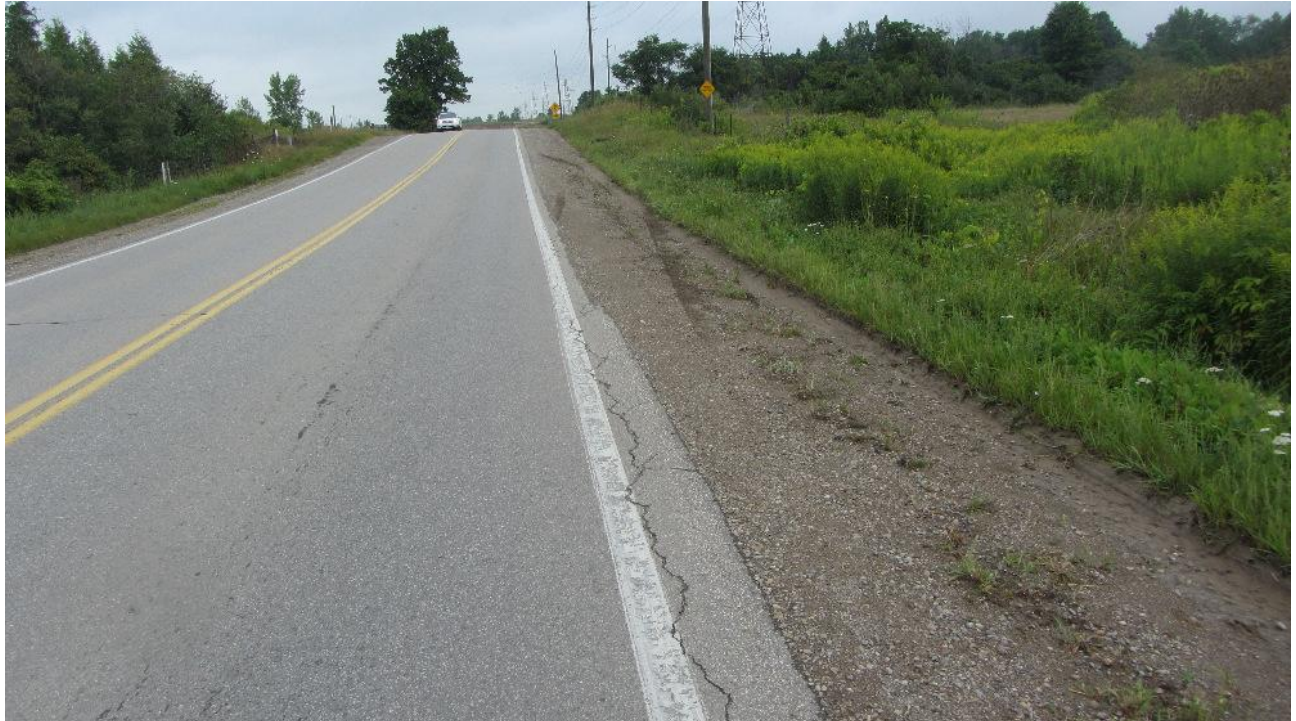
We begin our discussion in Figure 2 where we see a northward view along Clarke Road just a few hundred metres south of the S-curve where most of the historical testing was conducted. Figure 2 shows a general view of the road surface along with the east shoulder where we will see the first instance of the vehicle's travel off of the pavement. As we look at the details of the tire mark on the shoulder we will recognize that there is a deceleration phase, a rolling-tire phase and then an acceleration phase accompanied by slight left steering as the vehicle re-entered the pavement.

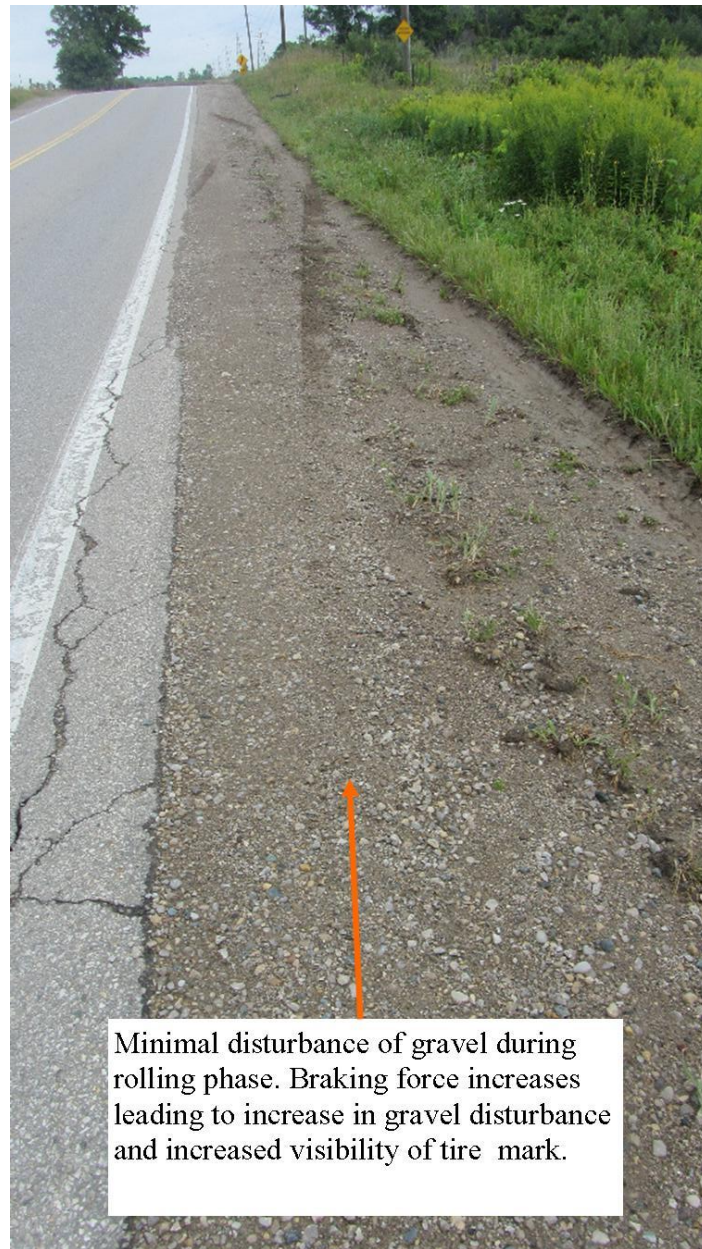
Figure 3 shows that, as the vehicle exits the paved road surface its tire marks are not visible because the tires are rolling. Then, as the driver applies the brake the tires begin to slow their rotation thus there is a progressive increase in the slip of the tires across the gravel surface. This increase in slip causes an increase in the disturbance of the gravel surface until that disturbance begins to be visible as the tire mark.

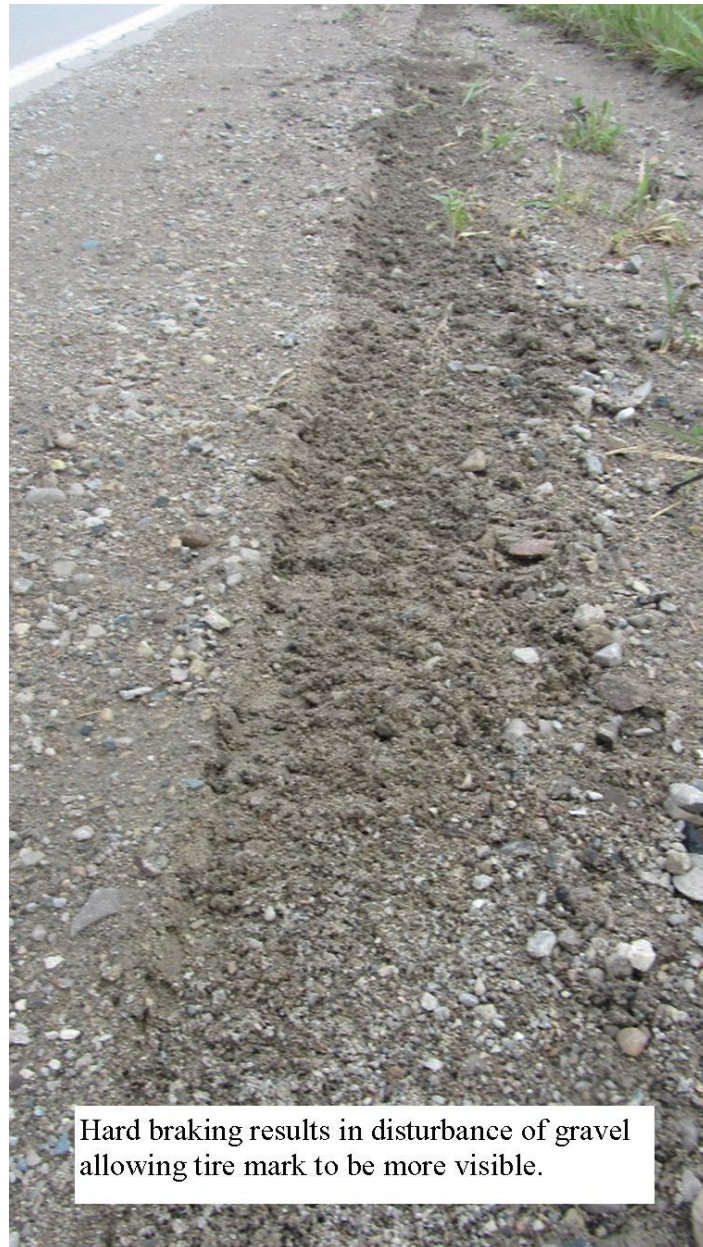
A closer view of the tire mark produced by the right side wheels in Figure 4 shows how the visibility of the mark is increased as braking is increased. We see the obvious disturbance of the gravel and soil of the shoulder as the sliding tire moves across it.

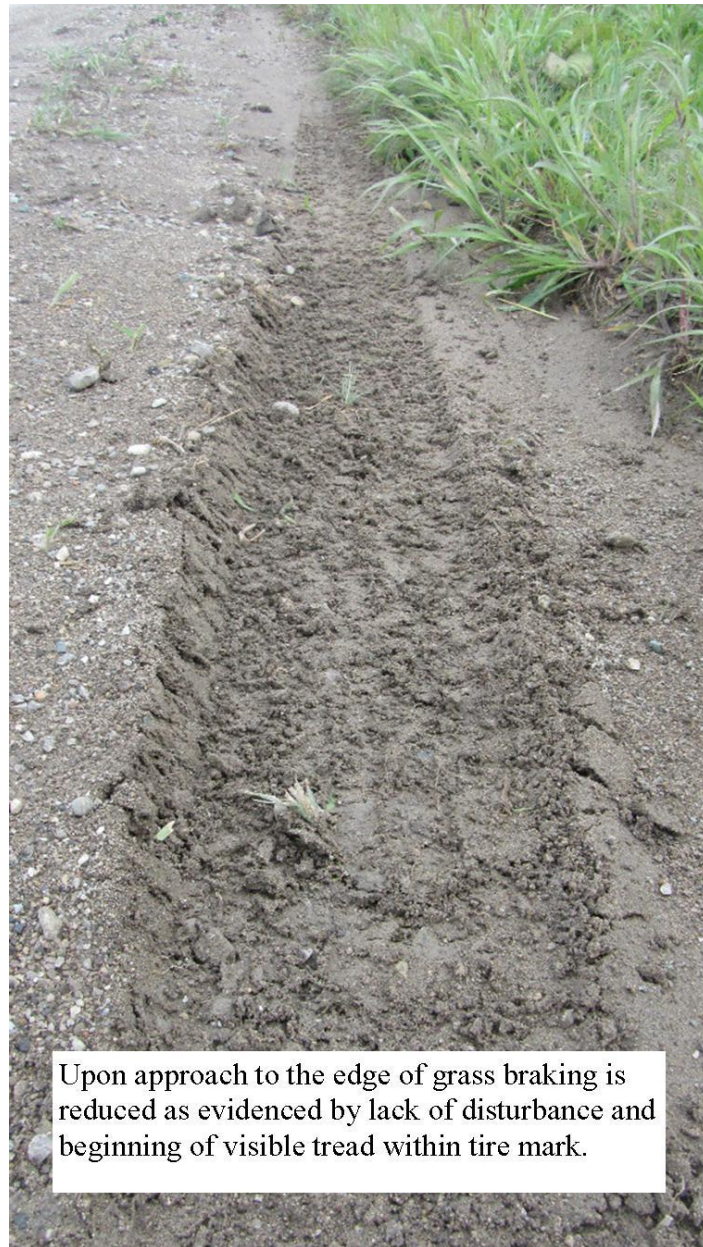
**Figure 5**

Upon approach to the edge of grass braking is reduced as evidenced by lack of disturbance and beginning of visible tread within tire mark.

In Figures 5 and 6 we see that the right side tires eventually move toward the edge of the grass and as they do the brakes are released such that we begin to see the tread of the tire within the tire mark in the background of Figure 6.

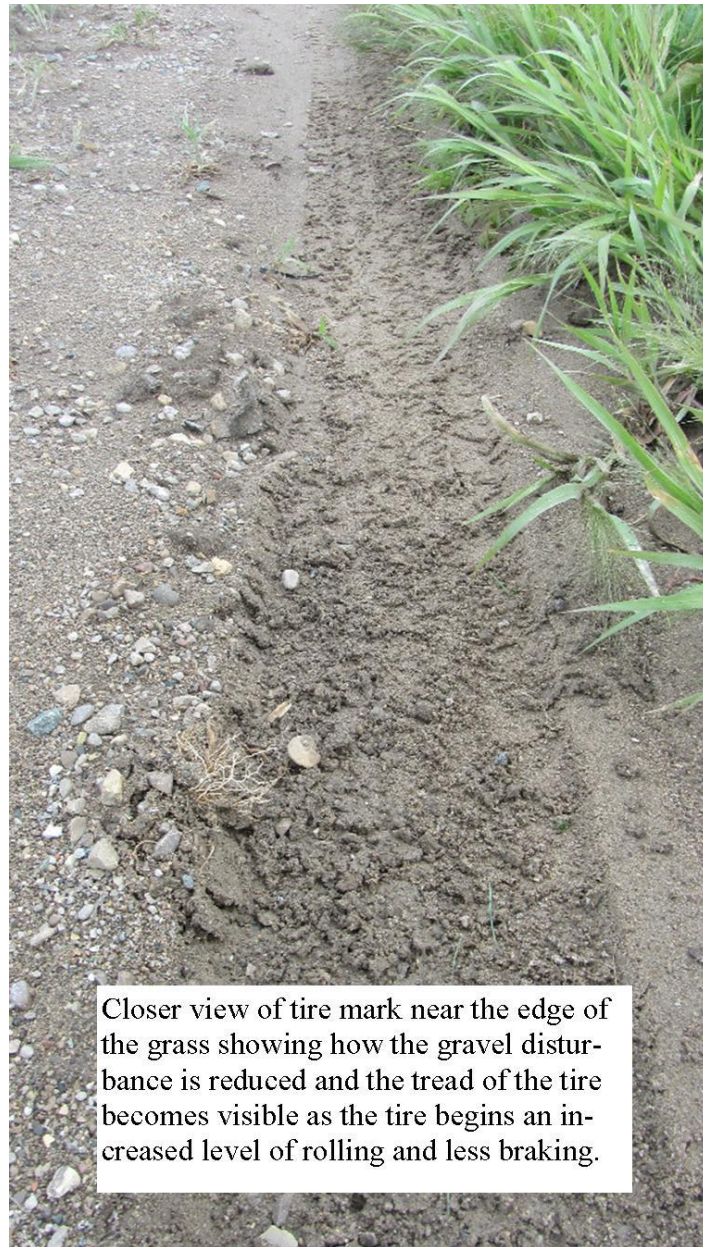
**Figure 6**

Closer view of tire mark near the edge of the grass showing how the gravel disturbance is reduced and the tread of the tire becomes visible as the tire begins an increased level of rolling and less braking.

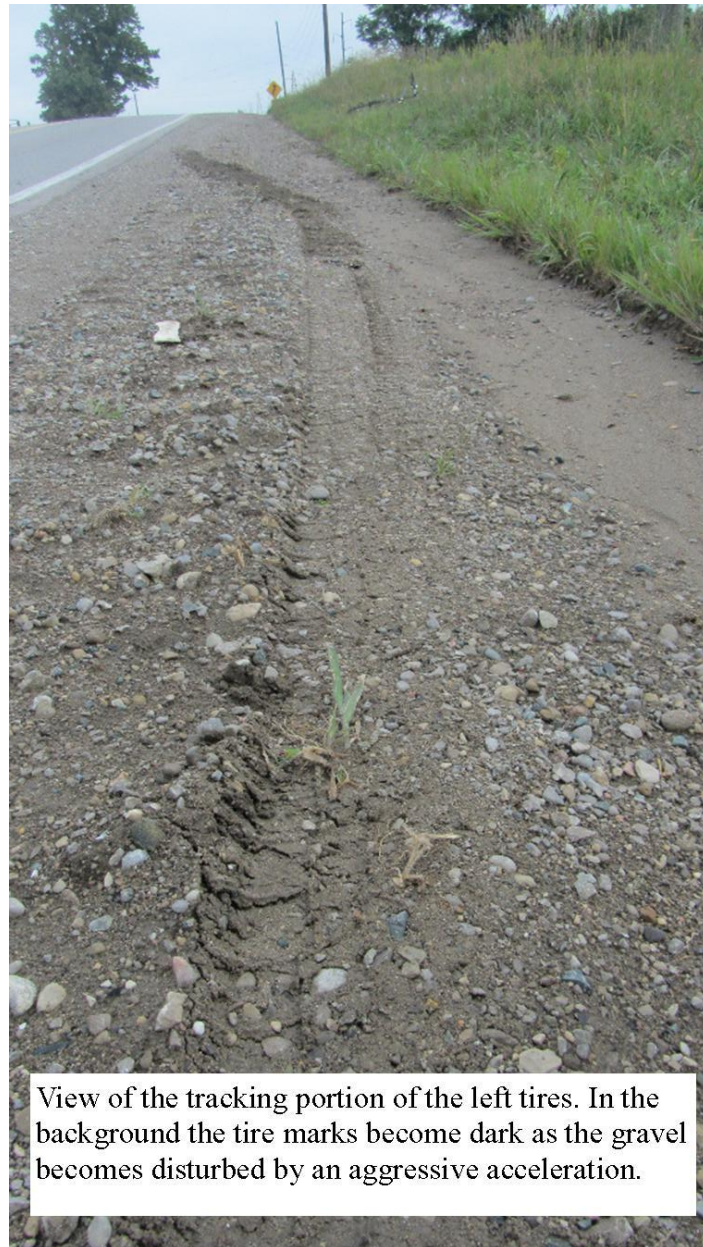
**Figure 9**

View of the tracking portion of the left tires. In the background the tire marks become dark as the gravel becomes disturbed by an aggressive acceleration.

As the right side tires enter the grass it is possible to study the characteristics of the tire mark caused by the left side tires to determine the vehicle's status. Thus Figure 7 is a general view of the area where the left side tire mark becomes visible. Figures 8 and 9

show that the tire mark contains a visible tread indicating a reduction in the extent of braking.

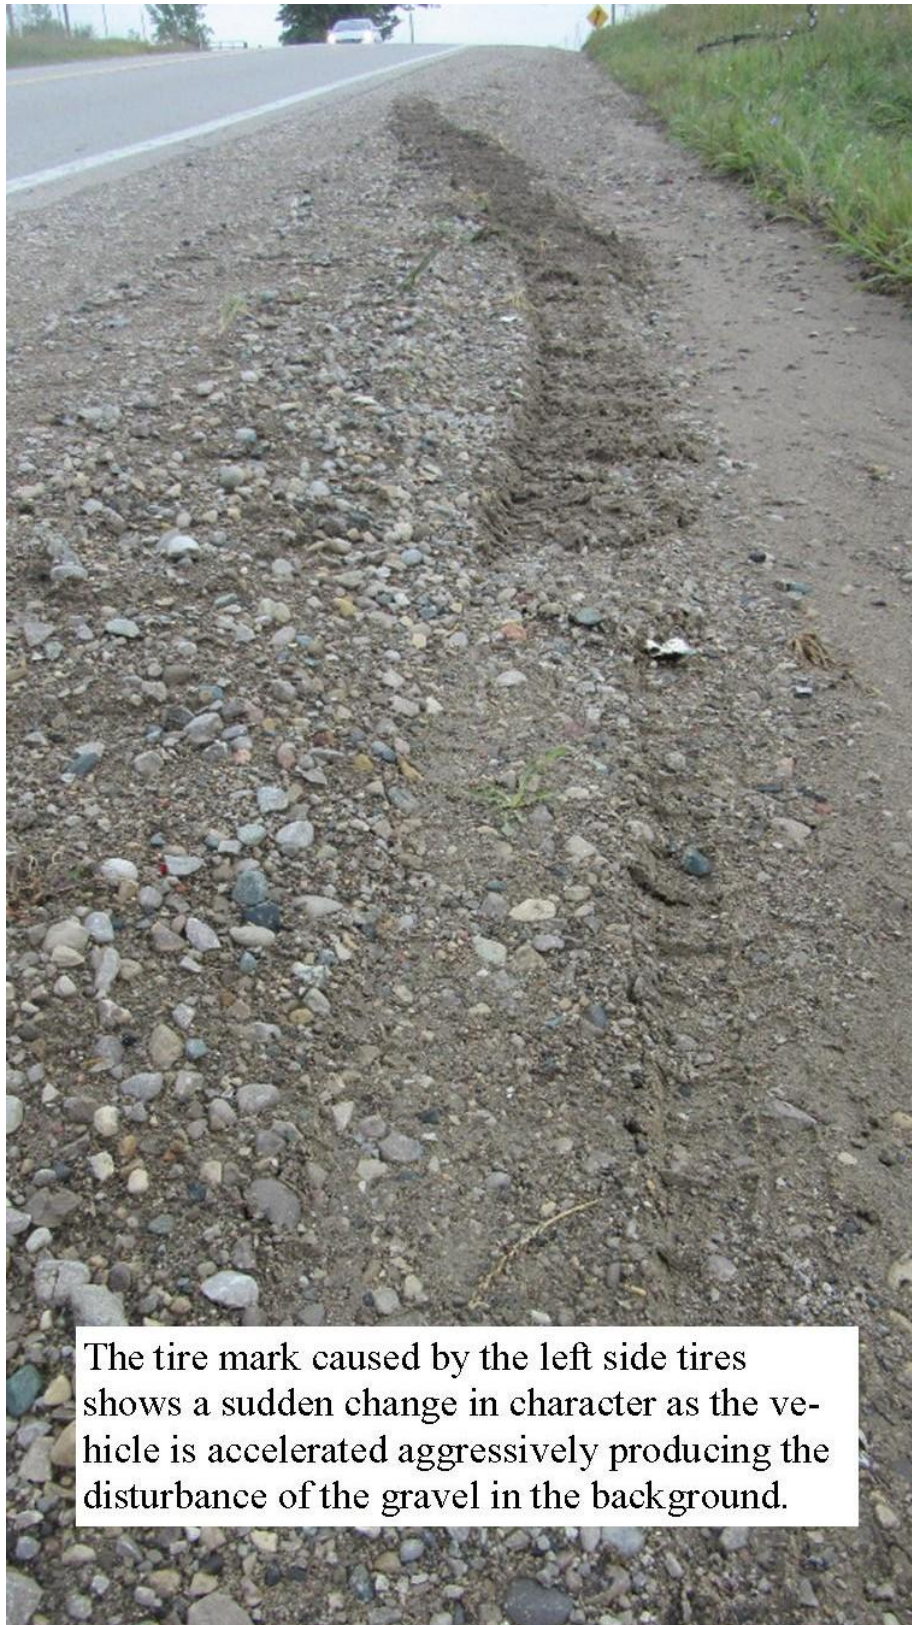
Figure 10

The tire mark caused by the left side tires shows a sudden change in character as the vehicle is accelerated aggressively producing the disturbance of the gravel in the background.

As shown in Figure 10, after riding the shoulder for a short distance the driver steers slightly to the left and applies hard acceleration. The view of the tire mark produced by the left side tires results in the disturbance of the gravel/soil shown in the background of Figure 10. In Figure 11 the acceleration is recognized by the presence of equi-distant "scallops" within the tire mark where the sliding tire has pushed the gravel/soil rearwards during its slippage. As the sliding of the tire increases there is a full upheaval of the surface as shown in Figure 12, such that the scalloping is no longer visible.

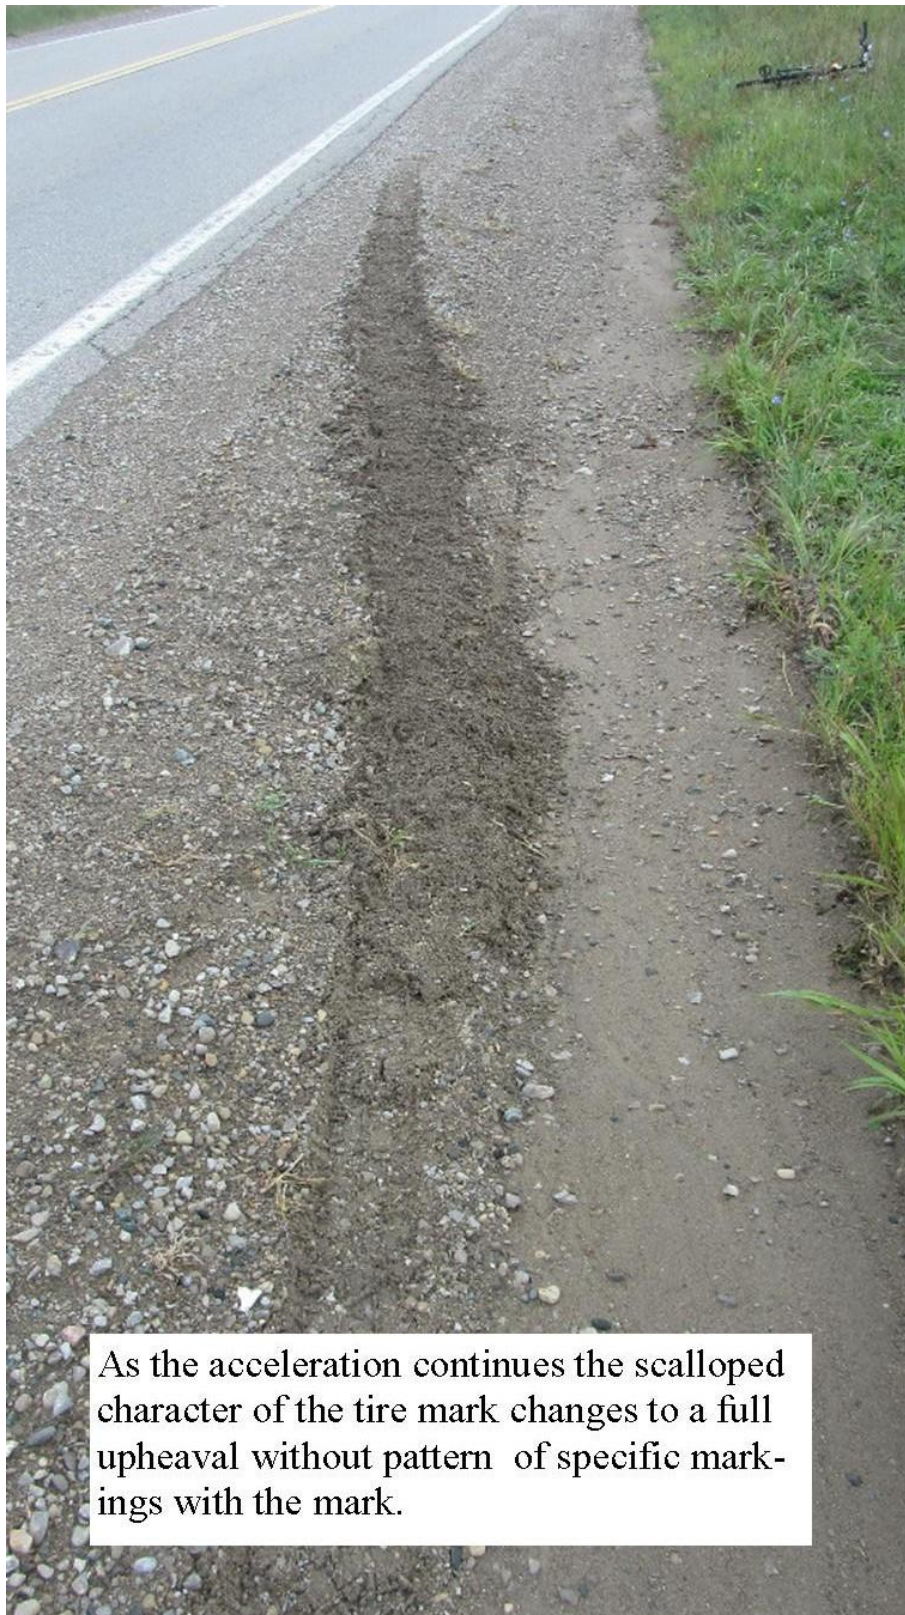
Figure 12

As the acceleration continues the scalloped character of the tire mark changes to a full upheaval without pattern of specific markings with the mark.

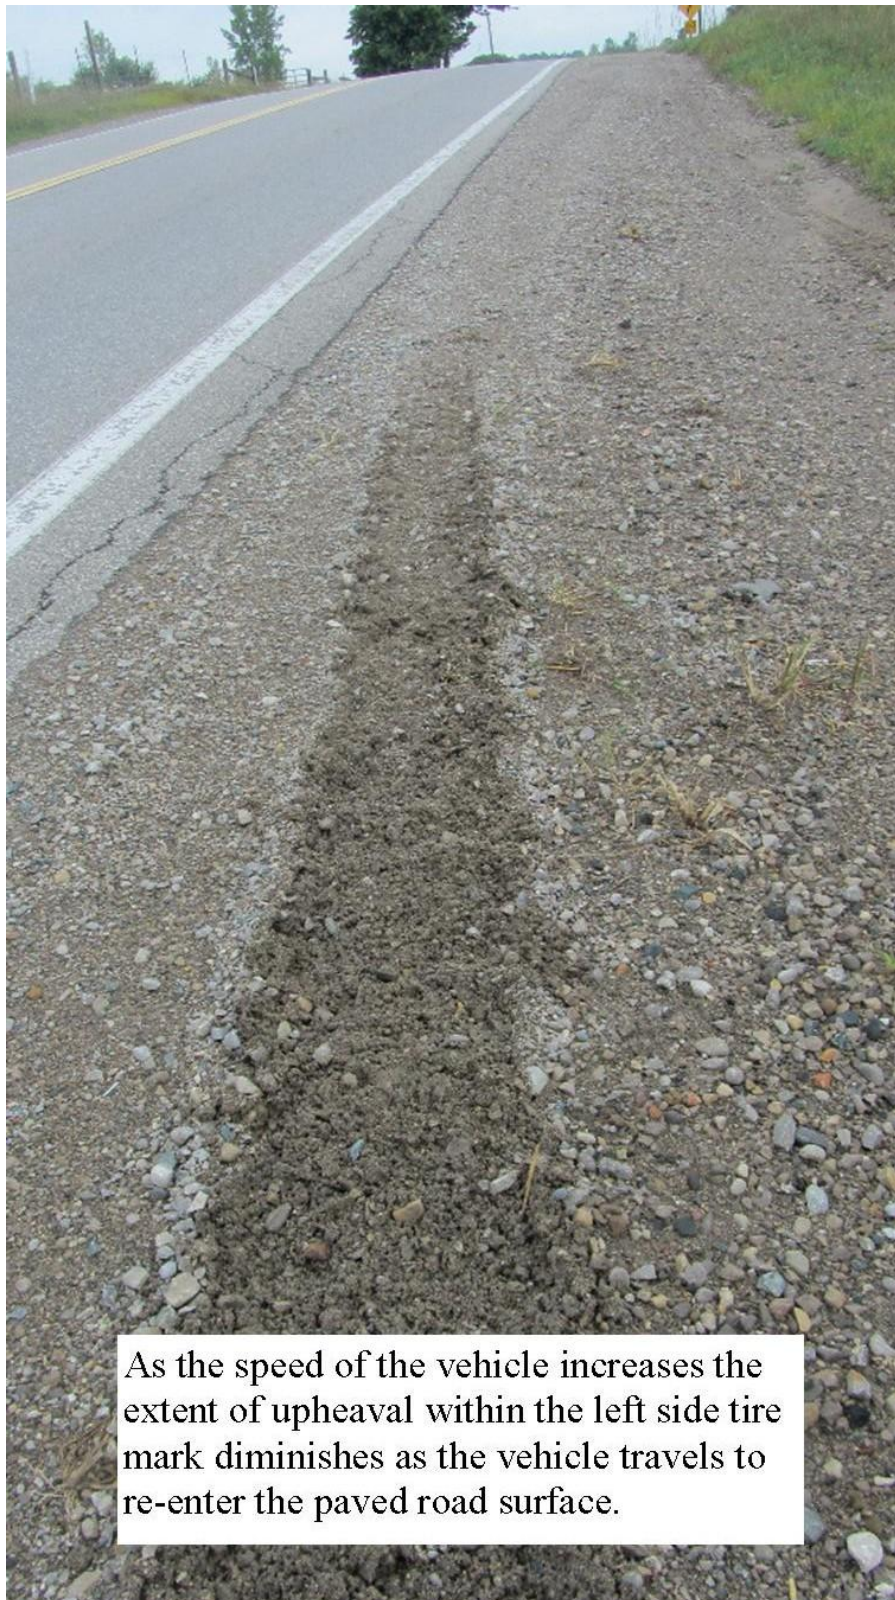
As shown in Figure 13 the vehicle gains speed such that the extent of slippage of the tire is reduced and the extent of disturbance of the surface is reduced. Thus the visibility of the tire mark is also reduced.

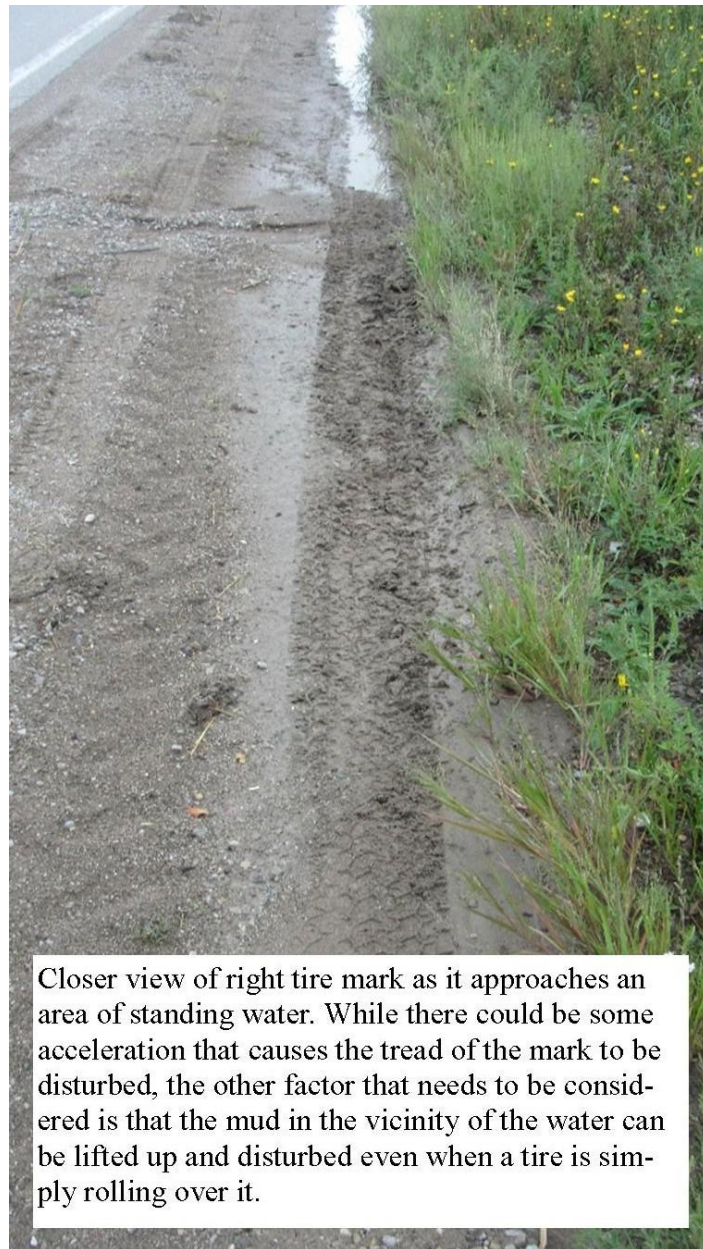
**Figure 15**

Closer view of right tire mark as it approaches an area of standing water. While there could be some acceleration that causes the tread of the mark to be disturbed, the other factor that needs to be considered is that the mud in the vicinity of the water can be lifted up and disturbed even when a tire is simply rolling over it.

Figure 15 shows the tire mark produced by the right side tires of the vehicle as it enters into a muddy area before entering the standing water. In the foreground of Figure 15 we can see a clear imprint of the vehicle's tread indicating, at least, that there is a lack of braking or acceleration, or that the tire is not slipping with respect to the surface. However, just before the tire enters the standing water, we see an upheaval in the mark such that the tread is no longer visible. This might suggest that there was either some braking or acceleration involved. While this is a possibility it also needs to be understood that, in an area of a muddy surface the mud tends to cling to the tire and this might cause the disruption of the surface irrespective of any braking or acceleration. Figure 16 shows a closer view of the transition between the tracking tire and the upheaval prior to entering the standing water.

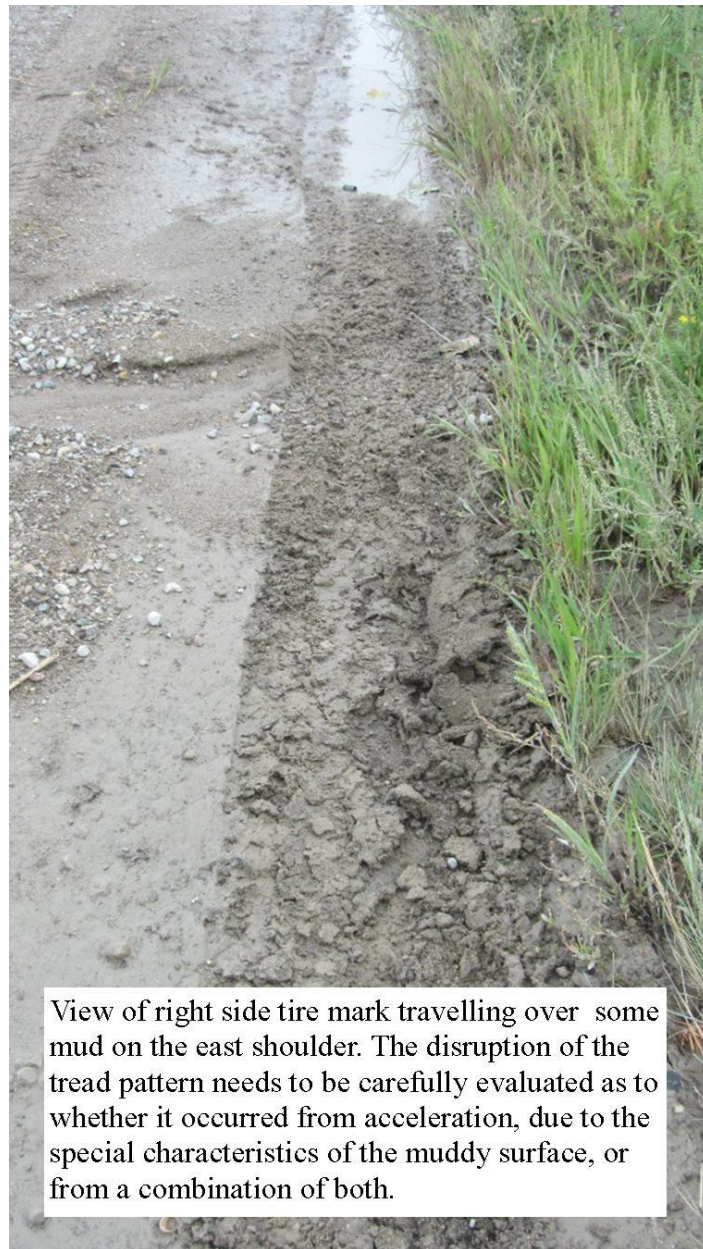
**Figure 16**

View of right side tire mark travelling over some mud on the east shoulder. The disruption of the tread pattern needs to be carefully evaluated as to whether it occurred from acceleration, due to the special characteristics of the muddy surface, or from a combination of both.

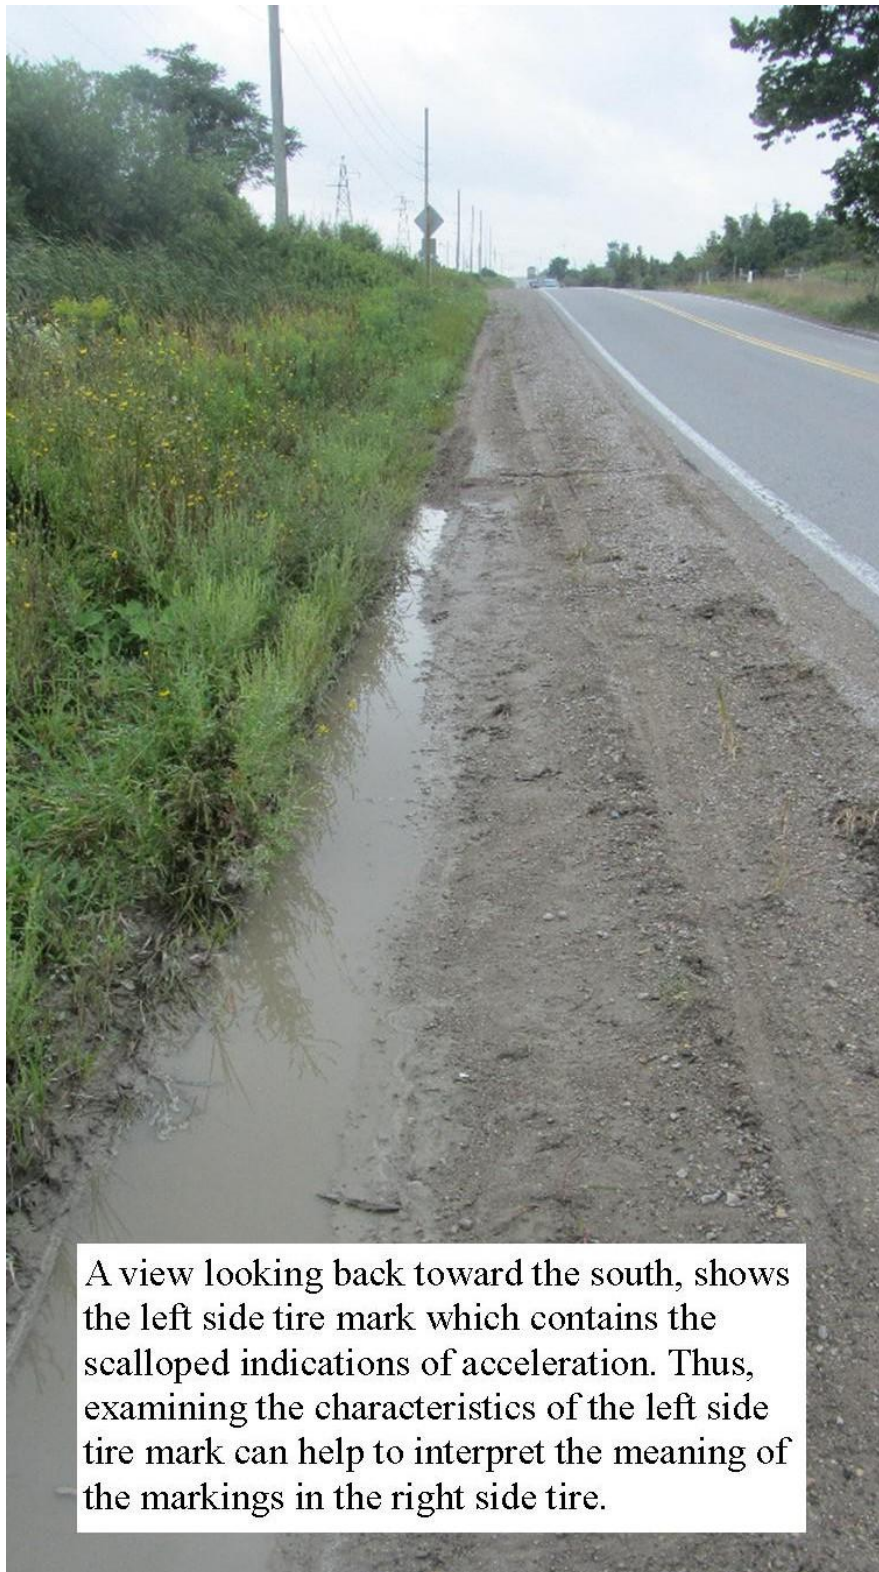
A view looking back toward the south, shows the left side tire mark which contains the scalloped indications of acceleration. Thus, examining the characteristics of the left side tire mark can help to interpret the meaning of the markings in the right side tire.

When in doubt about the conditions at the right side tire mark, it is possible to examine the characteristics of the tire mark caused by the left side tires. Figure 17 shows a southward view of the east shoulder near the standing water and the left side tire mark is visible at the right edge of the view, while the right side tire mark is in the water/grass. It is possible to see the scalloped marks within the left side tire mark. Figure 18 shows a closer view of that left side tire mark and it clearly shows the scalloped markings indicative of acceleration. Thus, when there is uncertainty within one tire mark it is possible to gain further insight by looking at the characteristics of the mark produced by the tires on the other side of the vehicle.

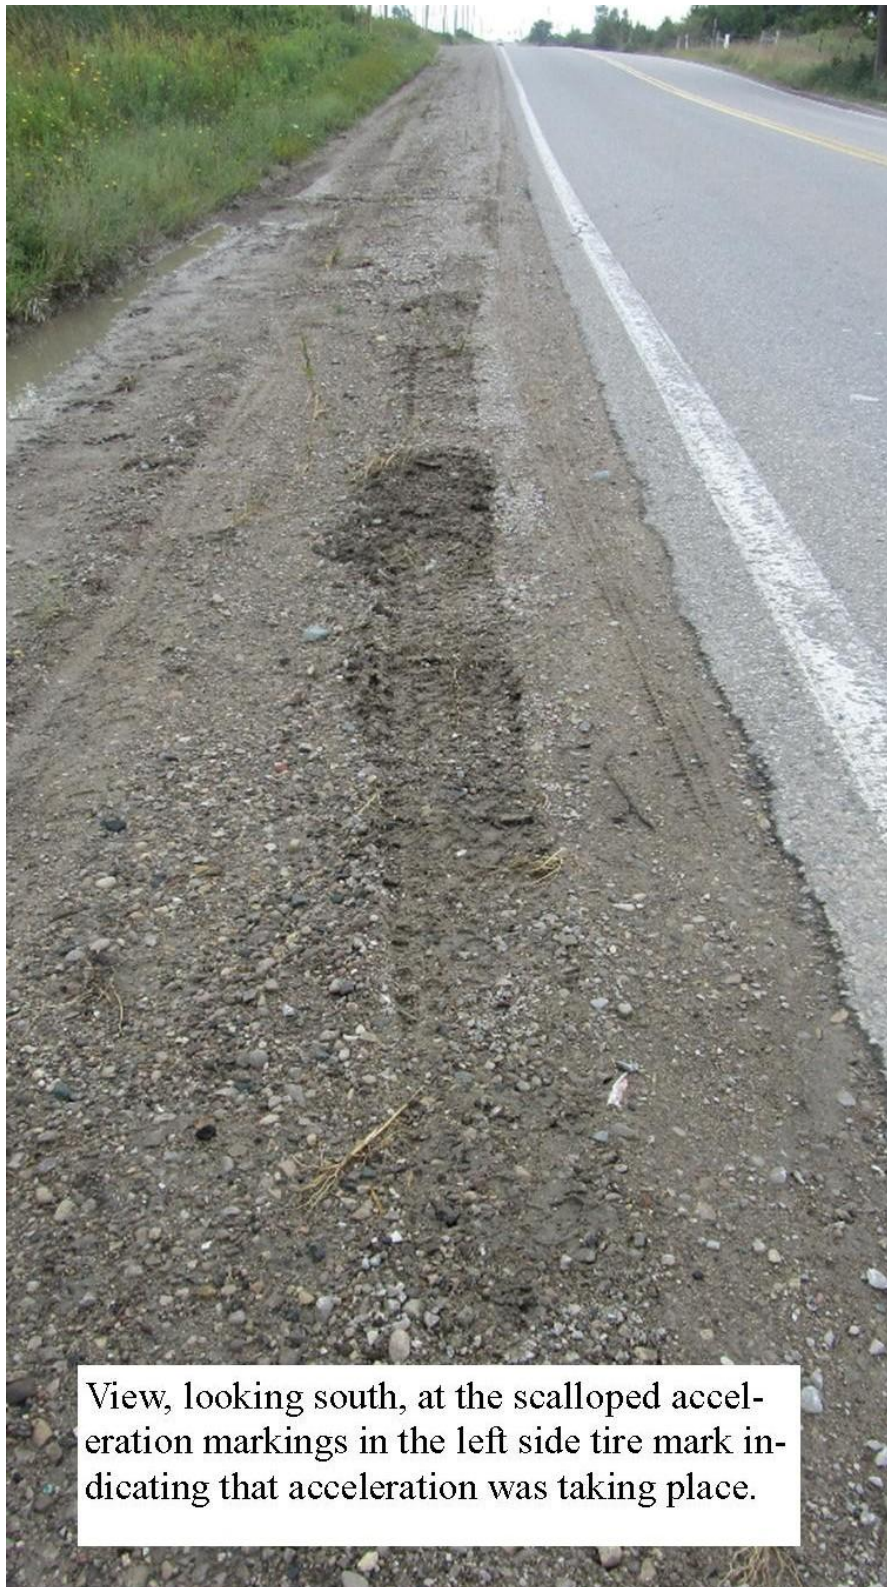
View, looking south, at the scalloped acceleration markings in the left side tire mark indicating that acceleration was taking place.

Figure 18 provides the last view of the second acceleration of the vehicle on the east shoulder. Following this the vehicle re-enters the paved road surface for a second time and continues northward again. It passes through the S-curve and near the end of that curve it is steered off the paved surface and back onto the east shoulder for a third time. However, during this third exit the tire mark evidence becomes more complicated as the vehicle stops on the shoulder, reverses, then stops a second time before accelerating forward while travelling north on the east shoulder. The explanation of the next few tire marks will be challenging however this also offers an opportunity for readers to learn to detect the differences in the characteristics of the tire marks and how it is possible to differentiate one set of tire marks from another.

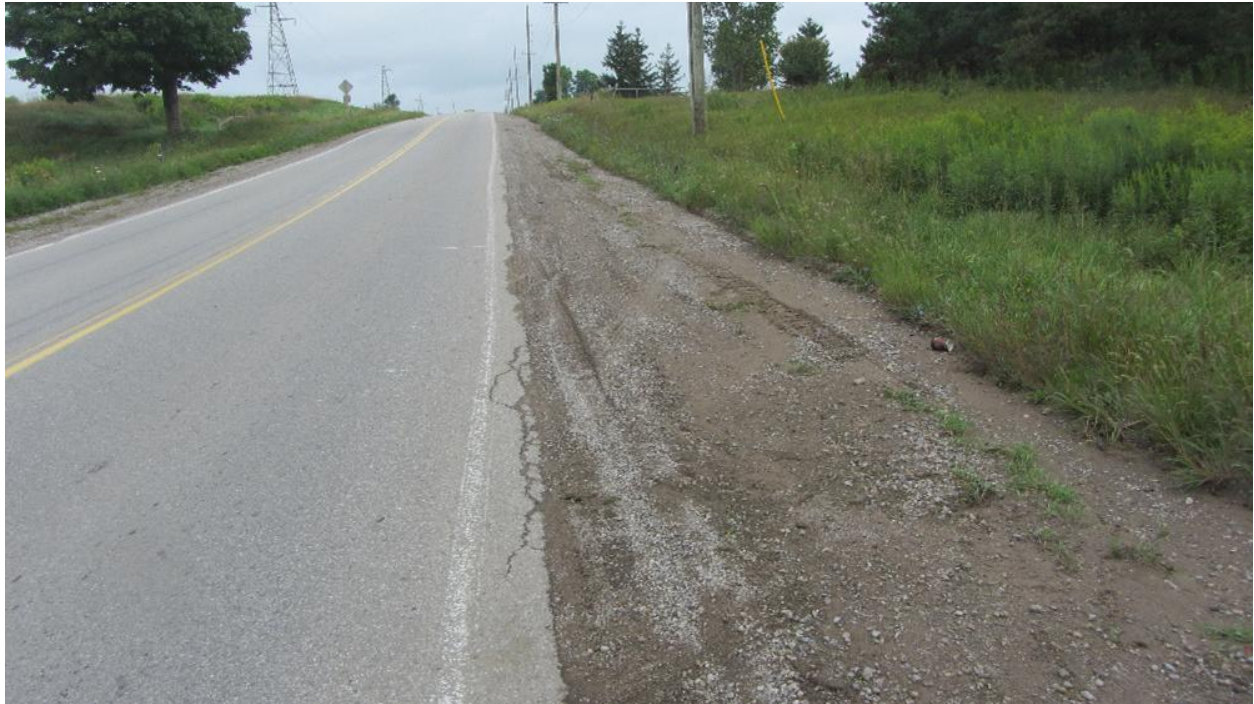
However, as we approach closer to the tire marks we can see in Figure 20 that those marks start to be visible. If one looks in a direction in line with the closest utility pole in the background of Figure 20 it is possible to see some faint tire marks travelling at a diagonal to the length of the shoulder. These marks were caused by the vehicle as it initially exited the pavement and entered the shoulder. Because these marks were created first, portions of these marks were destroyed by the vehicle as it reversed over them and then accelerated over them upon leaving the area. So the challenge is to describe these various marks in a way that can be understood.

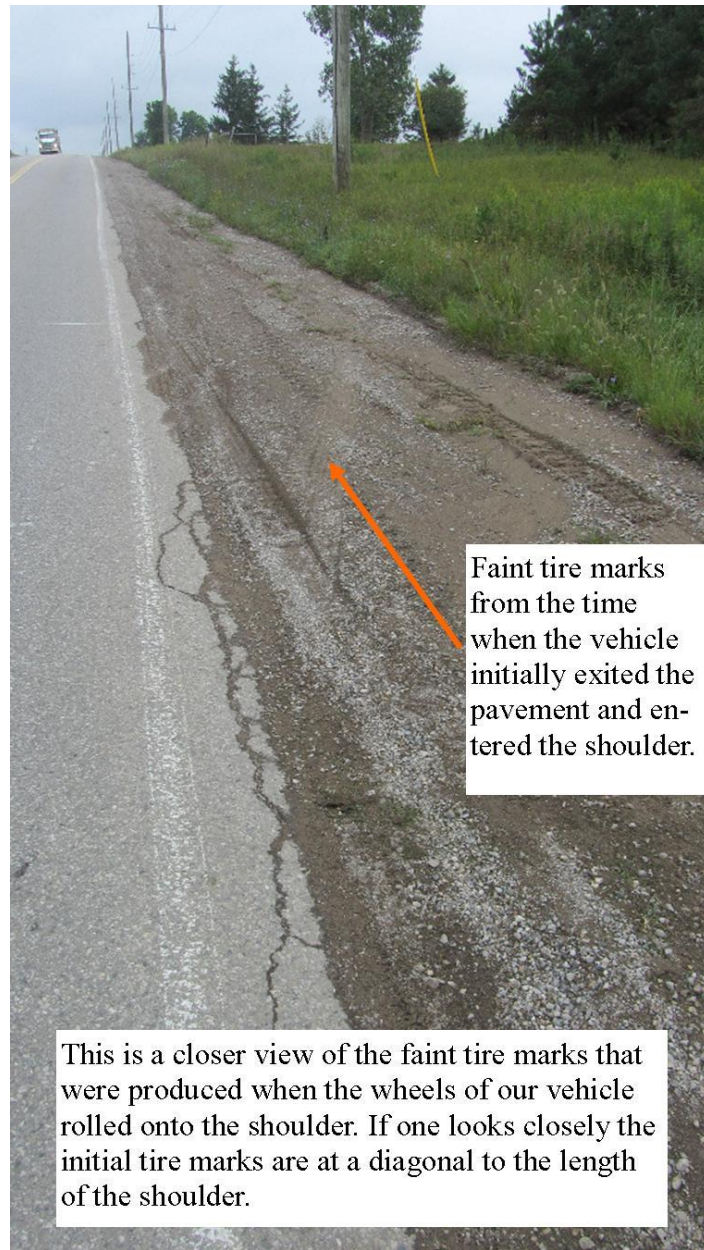
In Figure 21 we show a closer view of the tire marks and an orange arrow points to the location of the diagonal tire marks that were generated when the vehicle entered the shoulder.

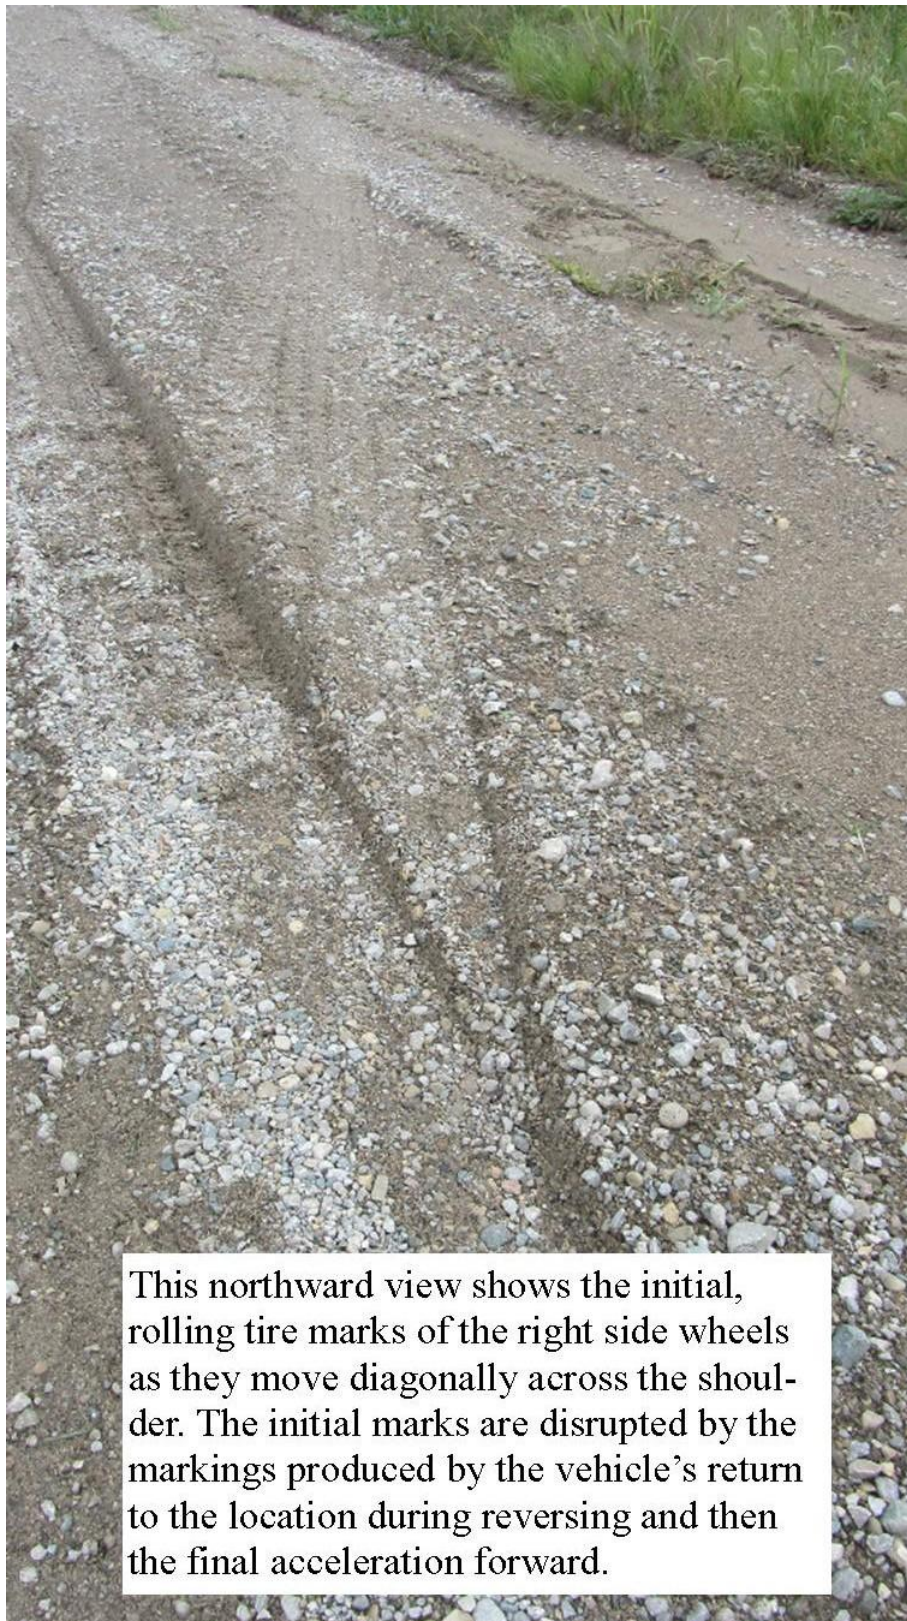
This northward view shows the initial, rolling tire marks of the right side wheels as they move diagonally across the shoulder. The initial marks are disrupted by the markings produced by the vehicle's return to the location during reversing and then the final acceleration forward.

Figure 22 shows an even closer view where the diagonal tire marks are well visualized. Here we can see (in the foreground) the left side tires of the vehicle as it reversed and then accelerated over the same location.

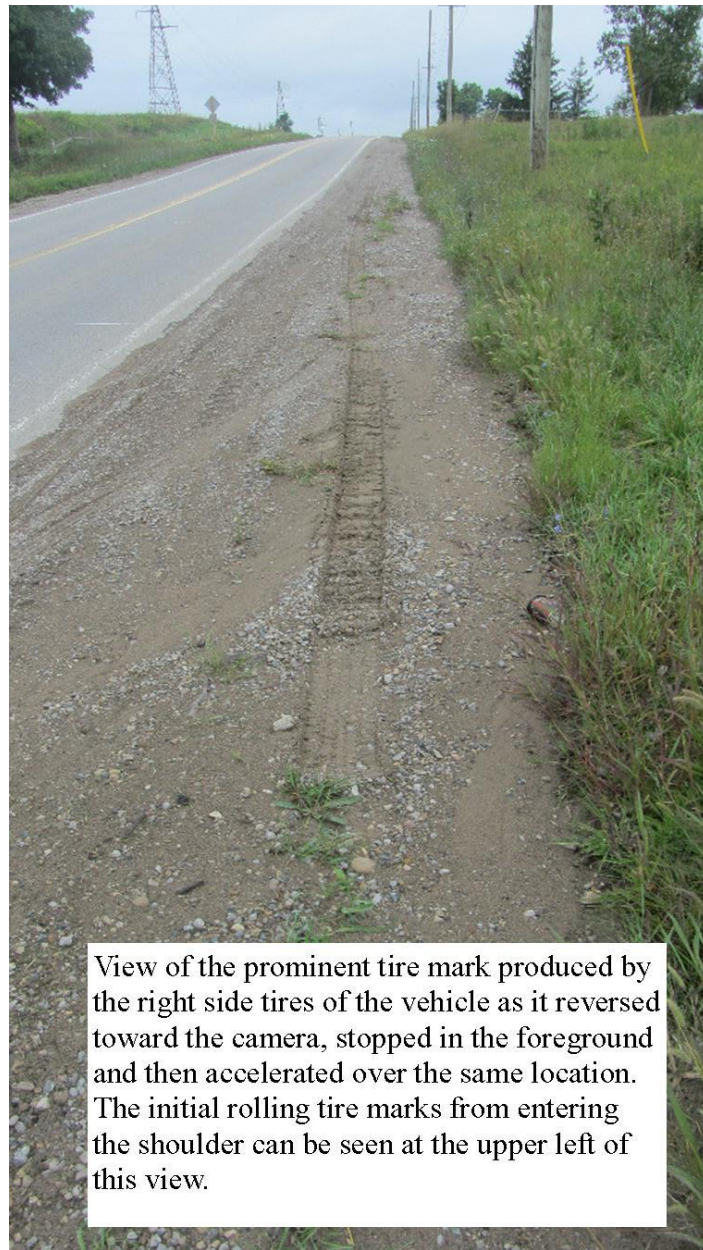
**Figure 23**

View of the prominent tire mark produced by the right side tires of the vehicle as it reversed toward the camera, stopped in the foreground and then accelerated over the same location. The initial rolling tire marks from entering the shoulder can be seen at the upper left of this view.

In the foreground of Figure 23 we see the end of the tire mark produced by the right side tires at the point where the vehicle stopped its reversing. From this end point the vehicle then accelerated forward (away from the camera) over the original, reversing tire mark. Thus the last characteristics that we see in this mark are those of acceleration. Figure 24 shows a close-up of the end of the tire mark where the vehicle stopped reversing and then accelerated forward.

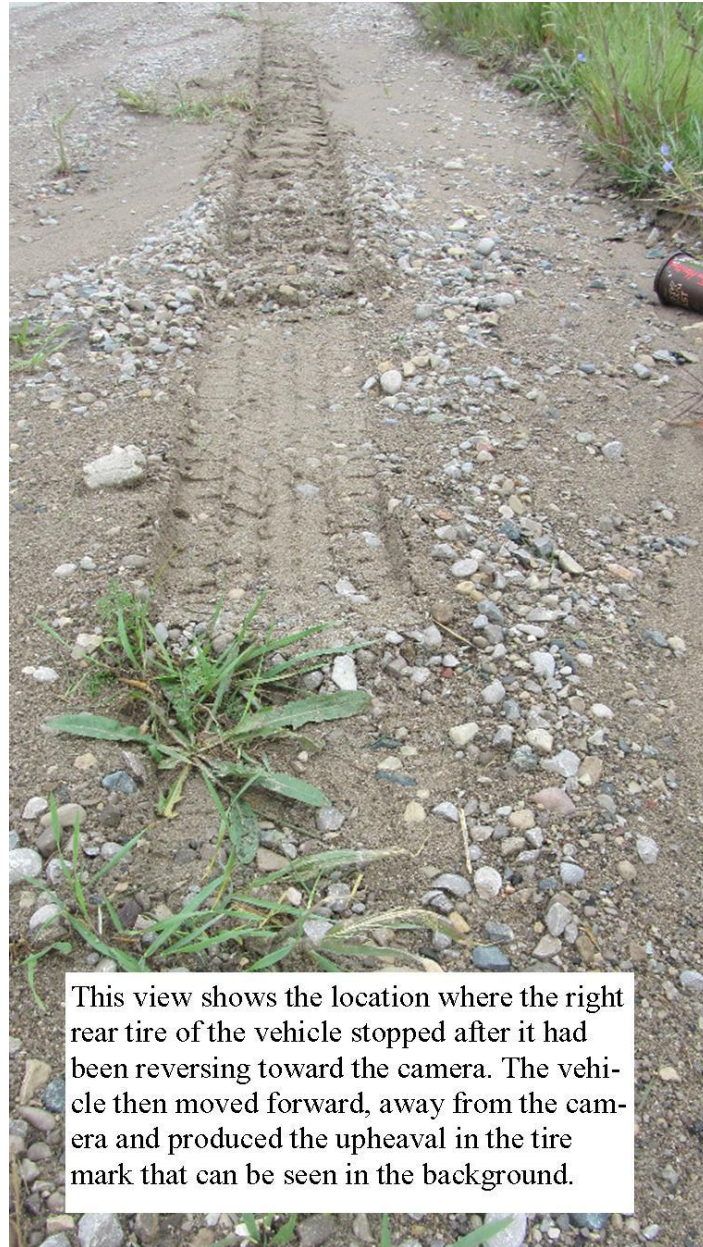
**Figure 24**

This view shows the location where the right rear tire of the vehicle stopped after it had been reversing toward the camera. The vehicle then moved forward, away from the camera and produced the upheaval in the tire mark that can be seen in the background.
