# Characteristics of Tire Marks During Acceleration on Gravel Shoulders - Part 1

*Posting Date: 2 Feb-2016*

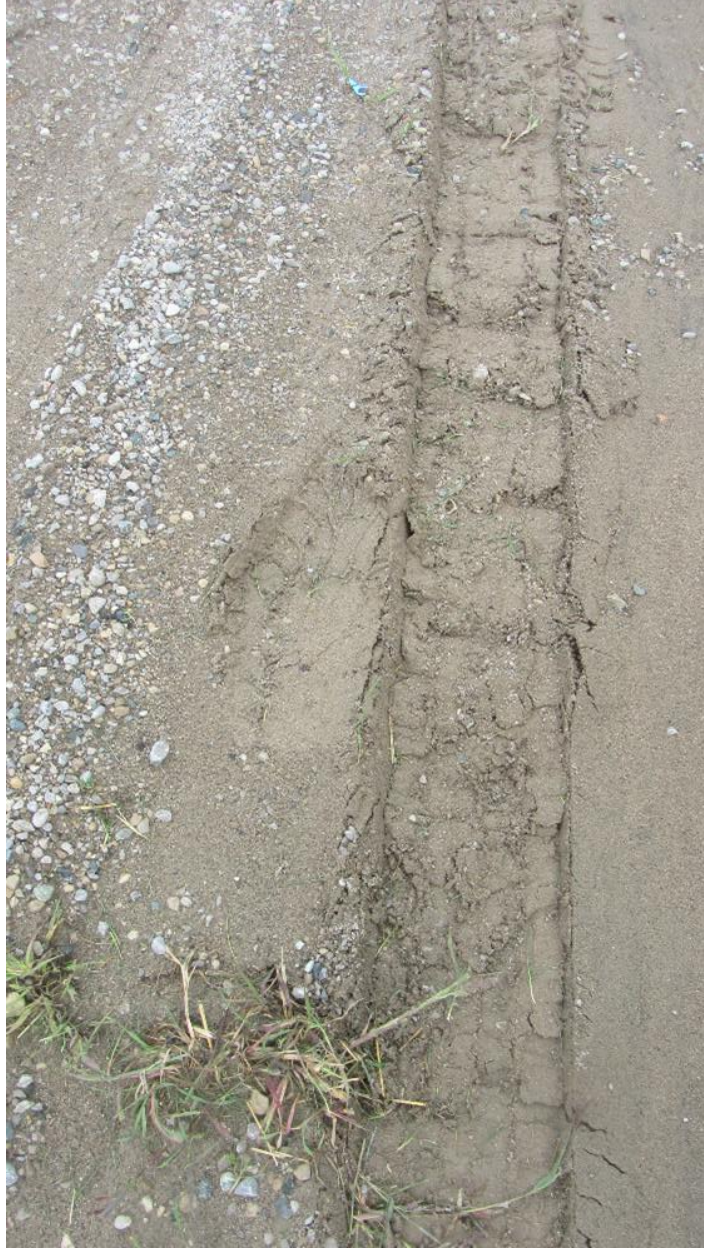
Figure 25 shows the right side tire mark which contains the obvious scalloping imprints within the mark which is indicative of acceleration.

In Figures 25 and 26 we see a somewhat oval looking imprint just to the left of the acceleration tire mark produced by the right side tires. This oval impression is where the right front tire came to a halt at the end of the reversing motion. If one looks closely at the top of Figure 26 the faint imprint from the tire's reversing can still be seen just to the left of the acceleration mark. The reversing mark contains the imprint of the tire's tread.

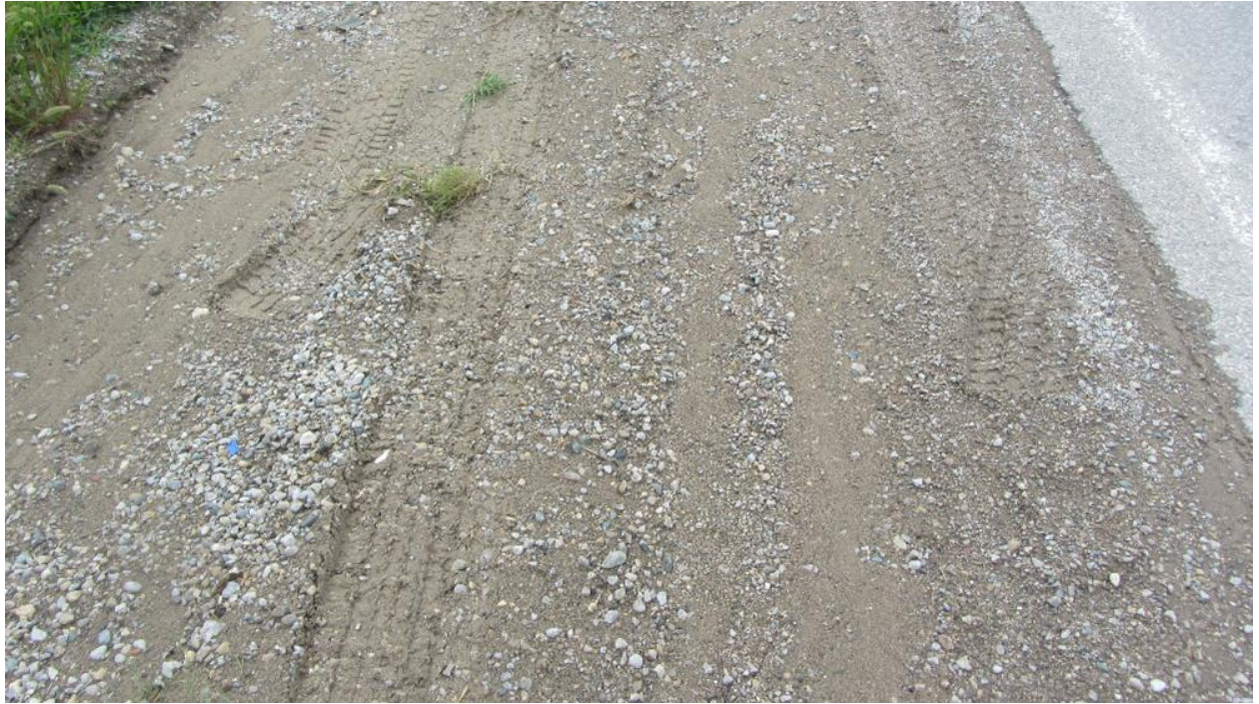
Figure 29 provides a southward view of the location where the vehicle stopped its forward motion onto the shoulder and before it started reversing. Of course this view also shows the acceleration tire marks that rode over the reversing tire marks and erased those reversing tire marks.

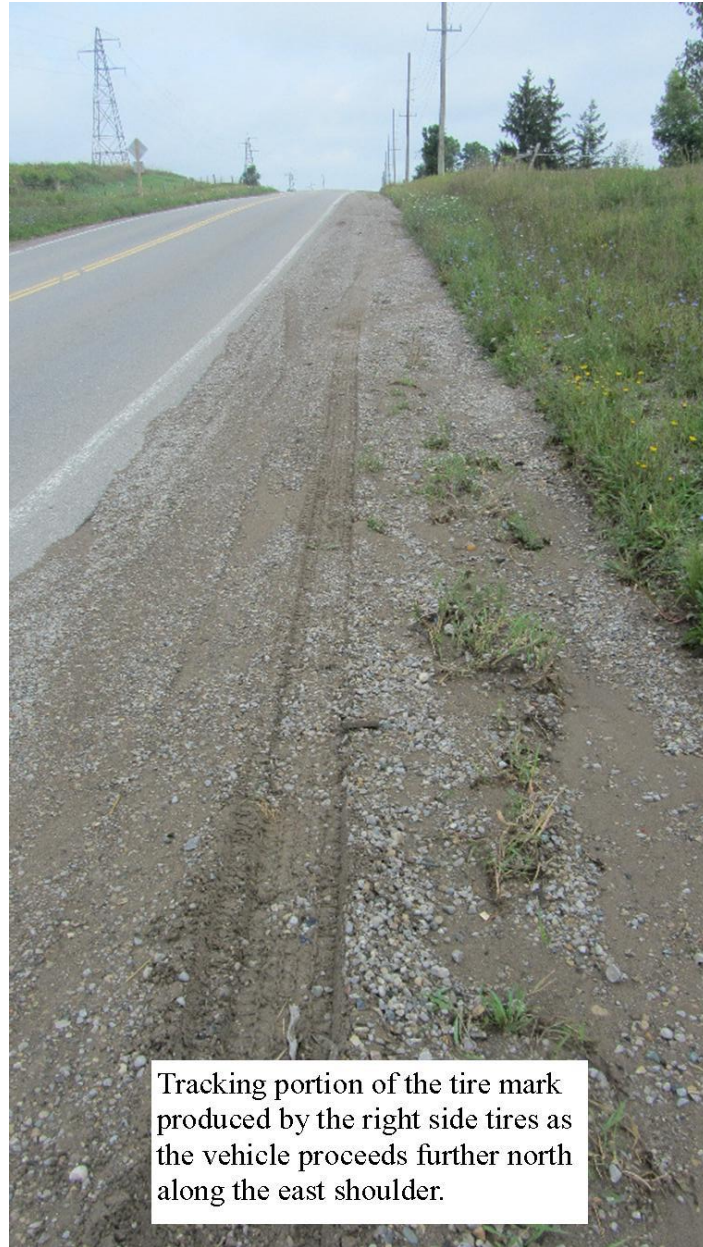
**Figure 31**

Tracking portion of the tire mark produced by the right side tires as the vehicle proceeds further north along the east shoulder.
