# Gorski Consulting Website

## Archived News - 2014 - October

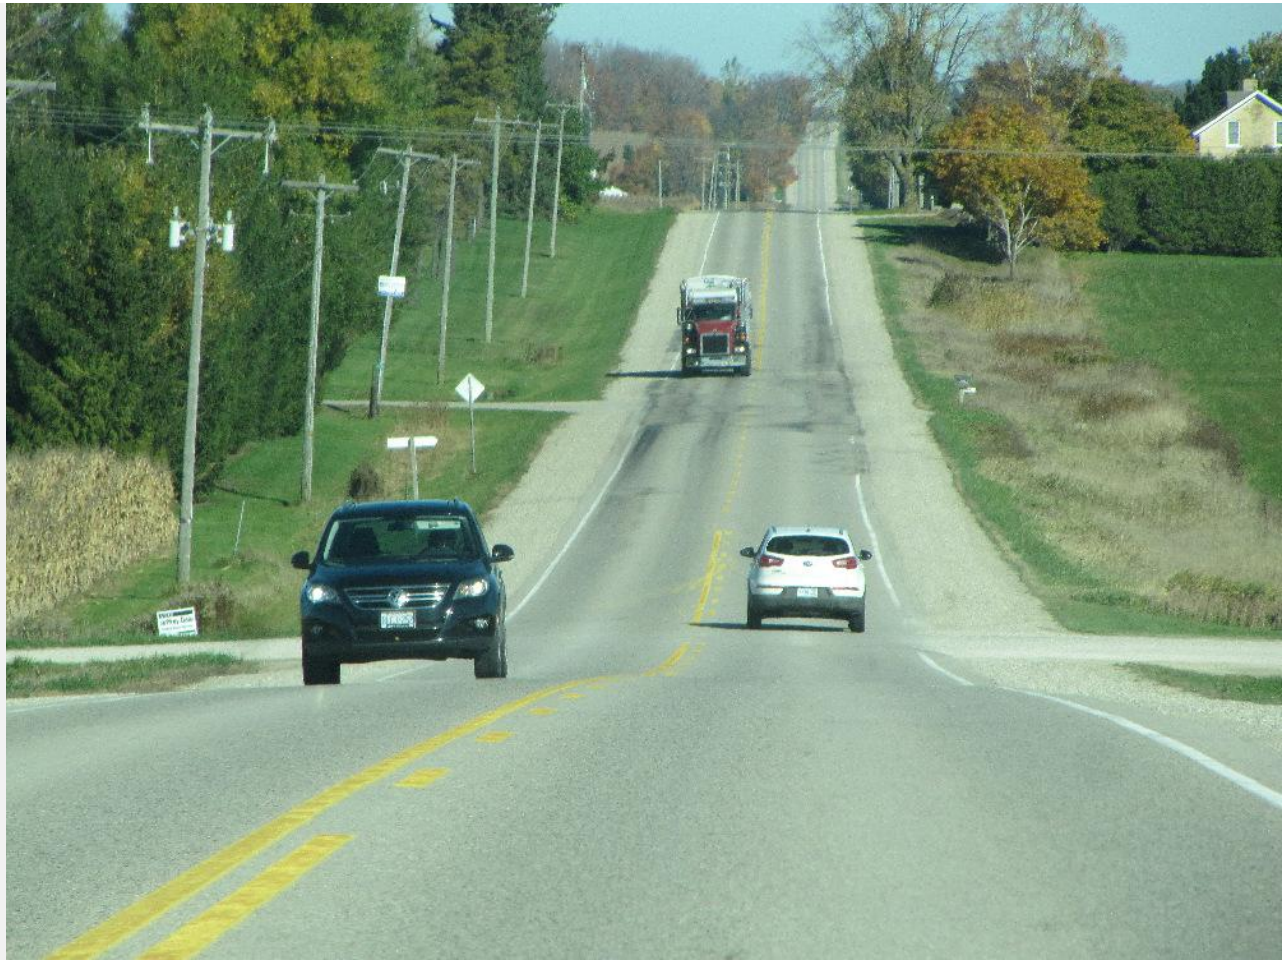
A dangerous condition involves a road surface that is in good condition but contains a segment that is in poor condition while not detectable by the driver.

In our experience, the more dangerous scenarios are those where poor road conditions are not easily detected or clearly visible. An example of this would be a road that is in good condition but contains a spot defect for a short distance such as shown in the above photo. While the above photo might indicate that the spot defect can be seen from a substantial distance, that could change. For example snow cover might hide the defect. Other road traffic in front of a driver might also prevent the defect from being seen in a reasonable time. Drivers who continually travel over that same location become familiar with the reaction caused to the vehicle's motion and this becomes an additional advantage. However, a driver who is unfamiliar with the road, including novice drivers, may have an exceptionally higher likelihood of being adversely affected.

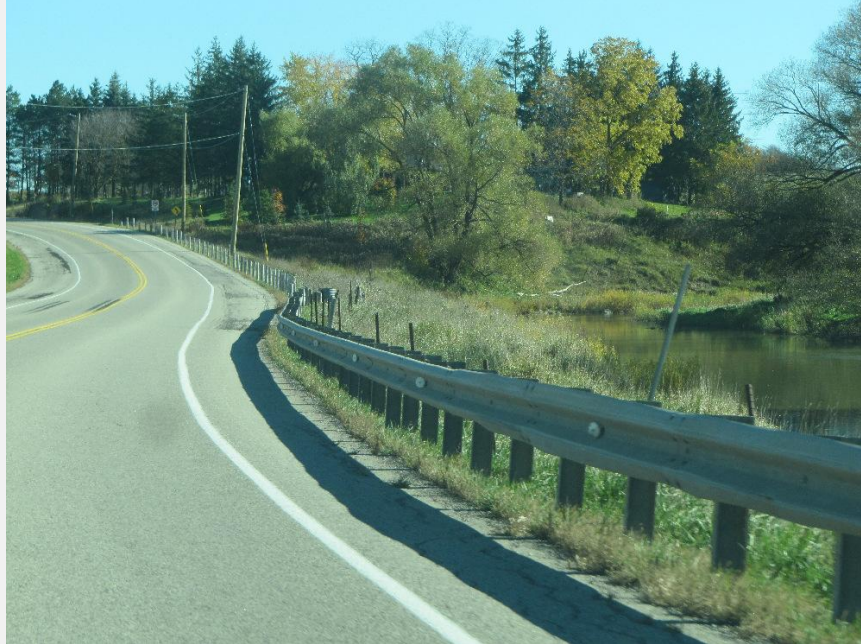
Horizontal and vertical curves along with standing water make for a dangerous combination that requires a proper barrier at a proper location.

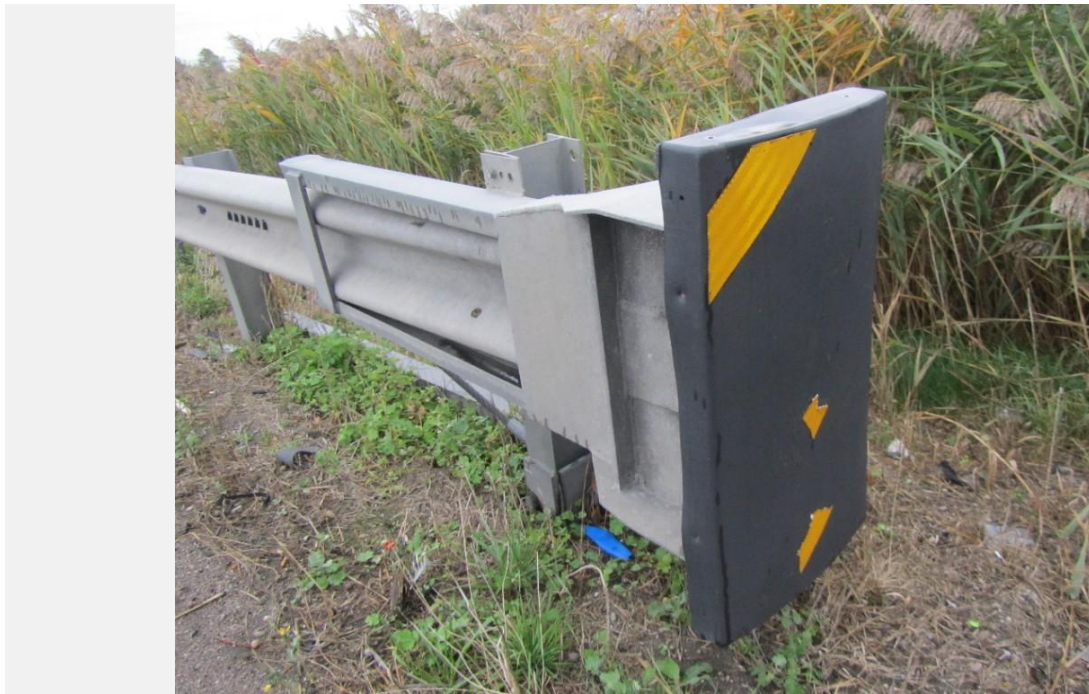
View of typical Trinity guardrail terminal (head or end cap) that is the source of several law suits in the U.S. alleging that they are defective and dangerous.

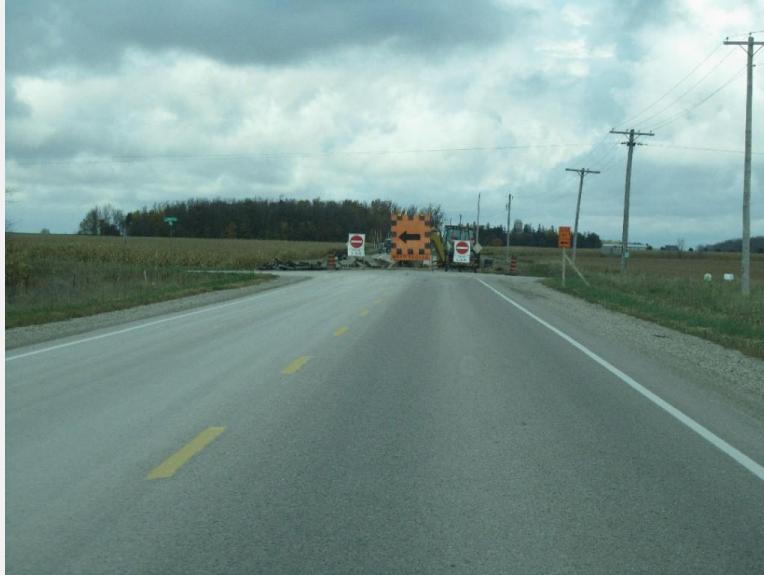
View on approach to road block on Perth Road 135 at Line 49.

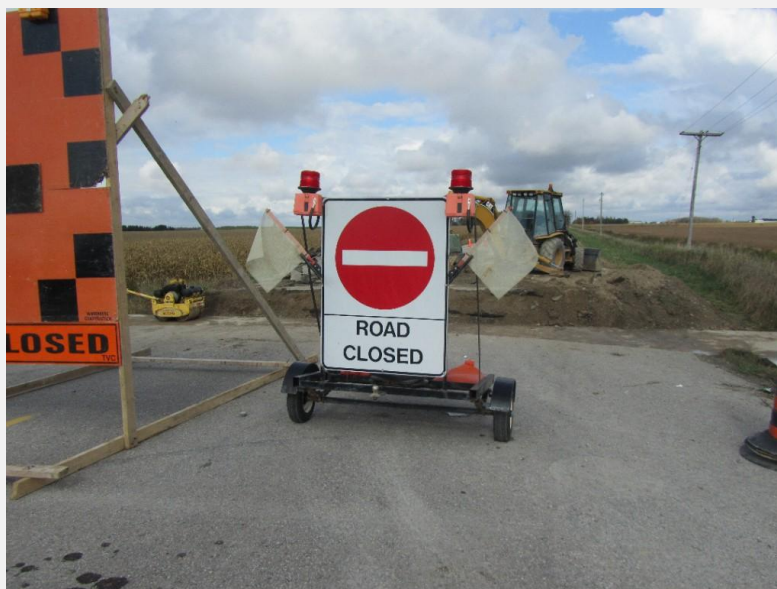
View of Road Closed sign just before the “cut out” area of the road.

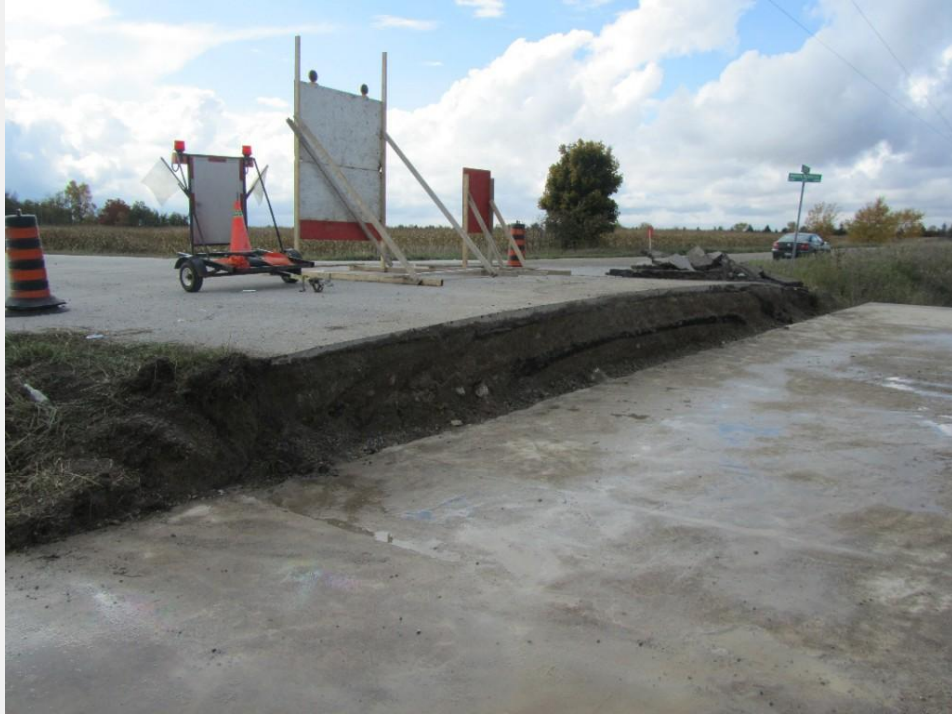
View of the back side of the Road Closed signs and the “cut out” in the road just behind them.

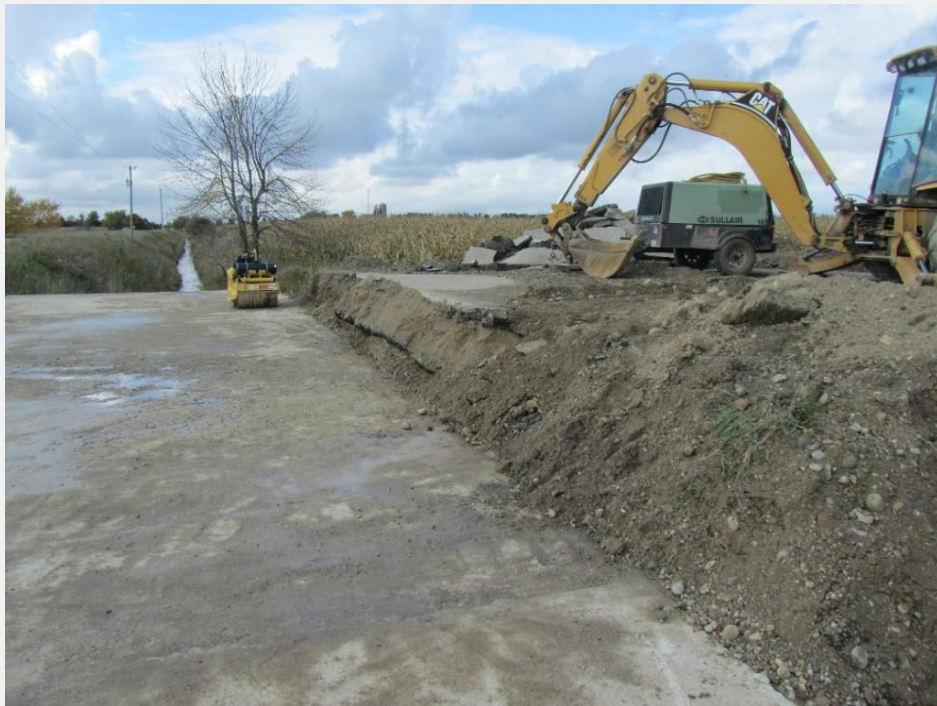
View of far side of “cut out” section of road where the Volkswagen Beetle struck the embankment and Timothy King was killed.

So the official explanation would appear to be that Timothy King's vehicle passed through these large Road Closed signs and then his vehicle slammed into the back side of the "cut out".

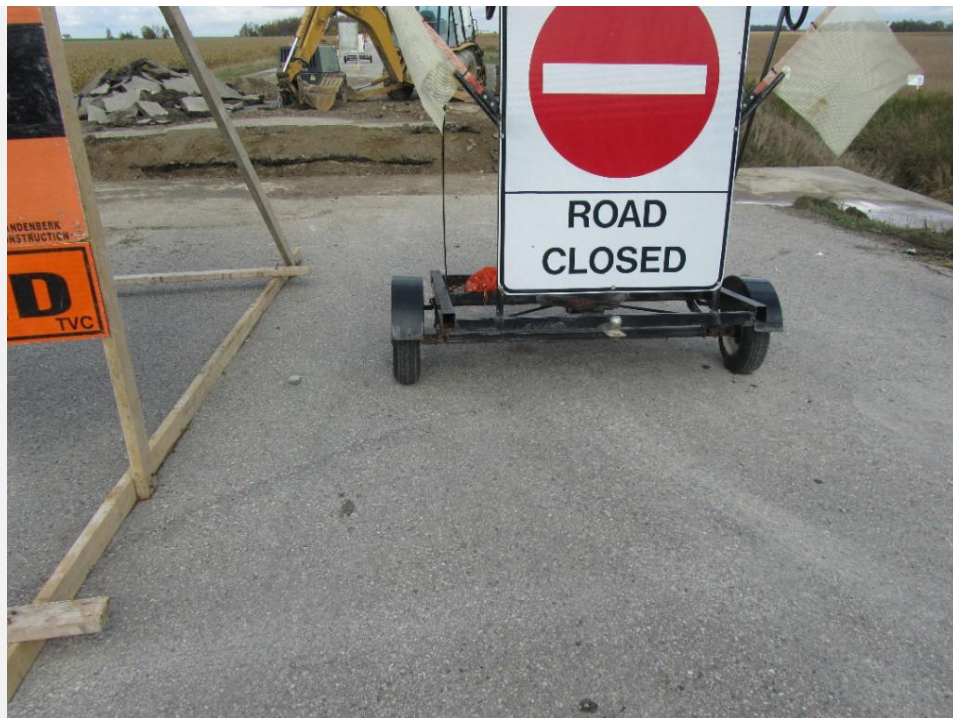
Looking down on the pavement where the Road Closed signs are situated there is no evidence of any splinters of broken wood, scrapes in the pavement or tire marks, or anything what-so-ever.

We would have to believe that the roadway clean-up personnel did an absolutely meticulous job of picking up all the fine bits of debris relating the impact of Mr. King's car with the anchorages to the large Road Closed signs that were there at the time of the collision. And the metal wagon which supports the small Road Closed sign has a metal tongue resting on the pavement but there was no evidence of a scrape from such a tongue being dragged during an impact. This clean up would certainly fool us because, after 34 years of examining hundreds upon hundreds of collision sites, we were unable to find a speck of debris to indicate that a collision took place between a sign and the front end of Mr. King's VW Beetle before its travel into the "cut out".

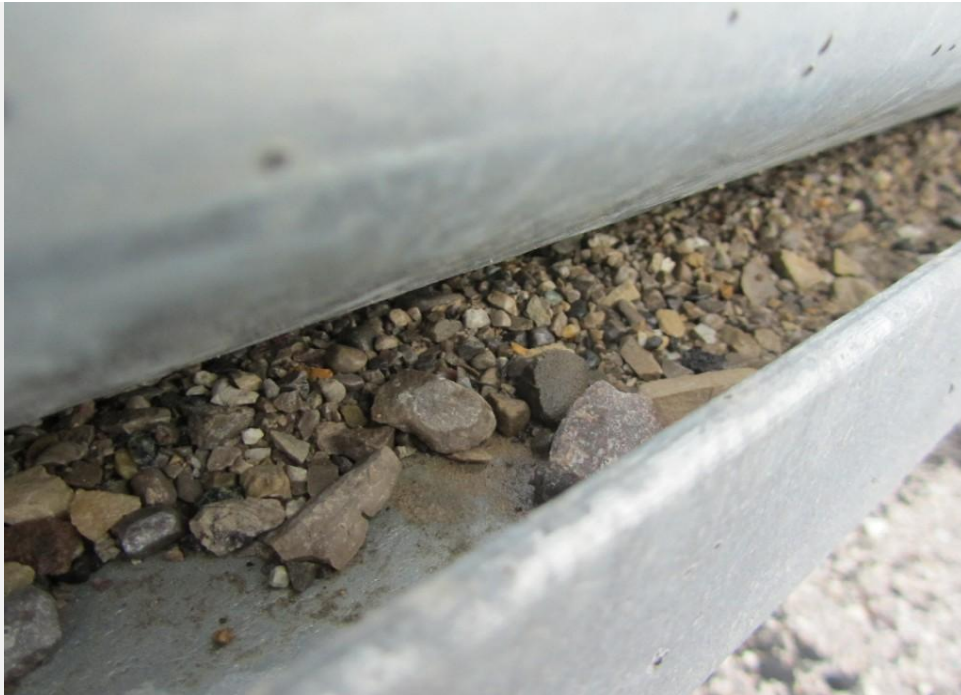
Gravel exists inside the channels of many Trinity end caps of guardrails surveyed along Highway 7 northeast of London, Ontario, Canada. There is an obvious concern that the end cap will not ride properly along the channel when struck by a vehicle and thus the system will not function safely.

While it will take several days before we can complete the articles relating to our further surveys of Trinity guardrail end caps we can indicate a significant finding of gravel existing inside the channels of many of the end caps. The end cap and its channel is designed to ride along the “W” rail of the guardrail when the end cap is struck by a vehicle. When a contaminant such as gravel become deposited within the channel there

is an obvious concern that this material will prevent the end cap from riding properly along the rail. It is this jamming of the system which has been an expressed concern when that channel's width was narrowed by Trinity from 5 inches to 4 inches. While the noted contamination by gravel may not be related to the alleged defective design change, it could be a related safety issue that might also work in concert with the narrowed channels to produce the jamming of the system that eventually leads to harpooning of vehicles.

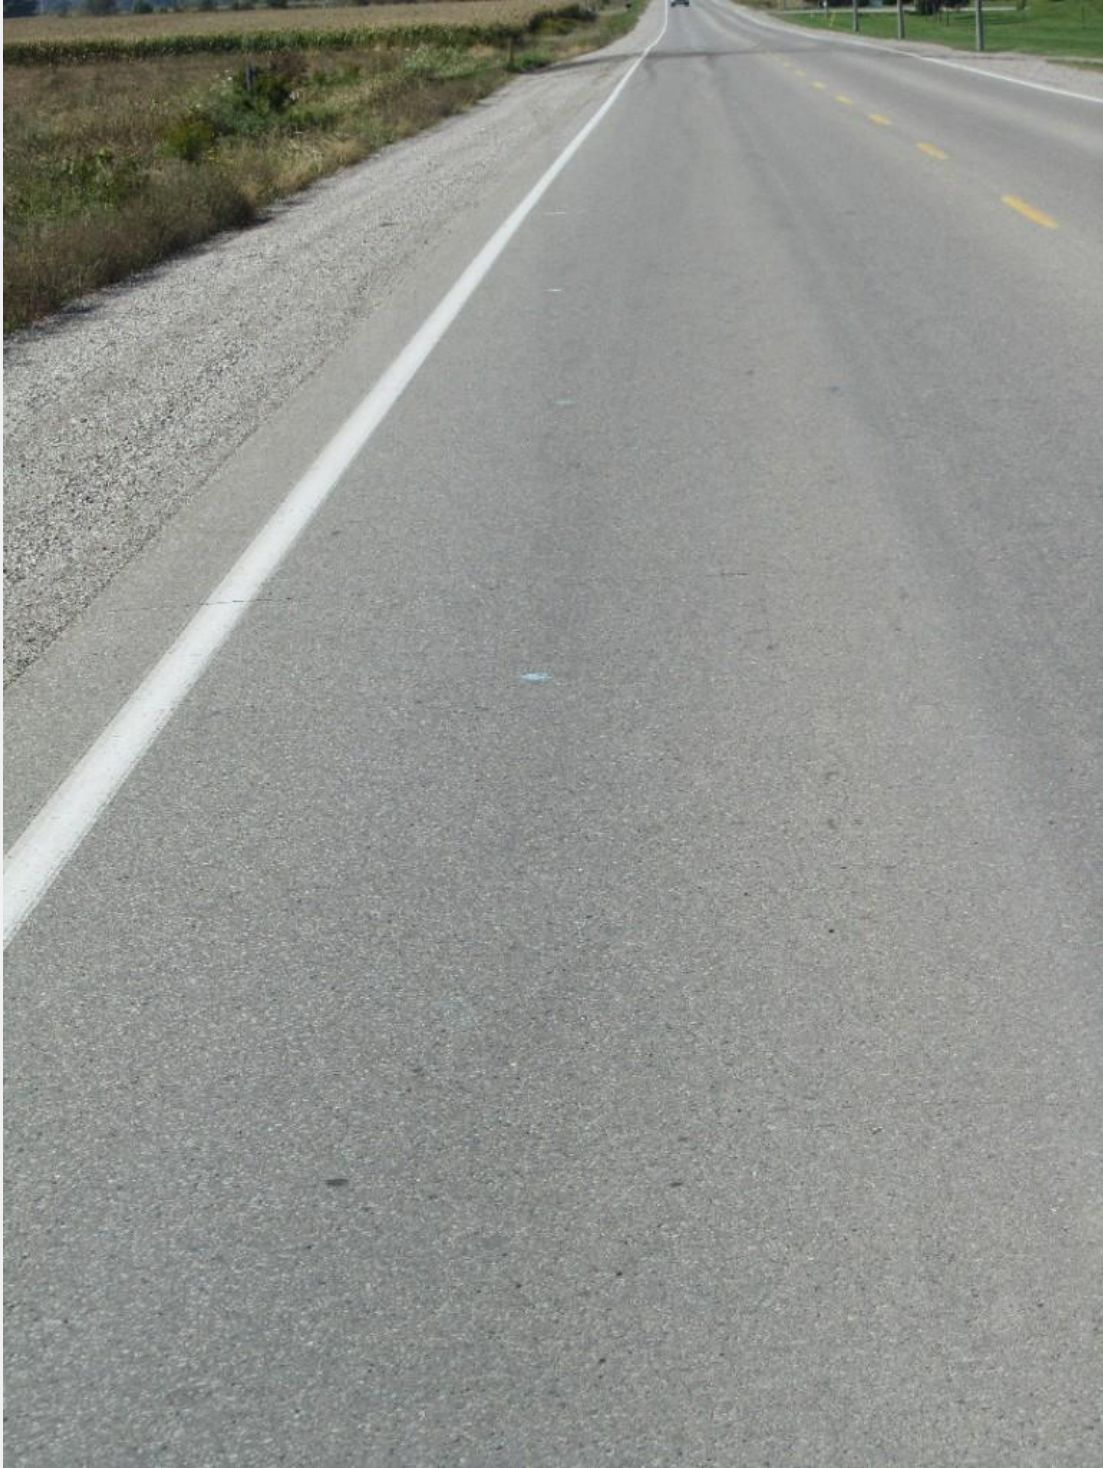
View, looking west, in the eastbound lane of Medway road from a location east the impacts. In this photo one should be able to detect some light-blue crayon marks that we have produced to high-light the location of a tire mark, likely produced by the deceased's vehicle a few seconds before the impacts.

The tire mark starts approximately in the position if a vehicle was travelling normally in a travel lane and then it wanders toward the left (south) shoulder, as indicated by the light blue dots that we created on the pavement. The dark marks in the background is where the vehicles struck each other and we will discuss that shortly.

The photo below shows a view looking west from east of the area of those impacts and we are trying to high-light a tire mark that exists in the eastbound lane which was caused by the deceased's vehicle which was travelling westbound.

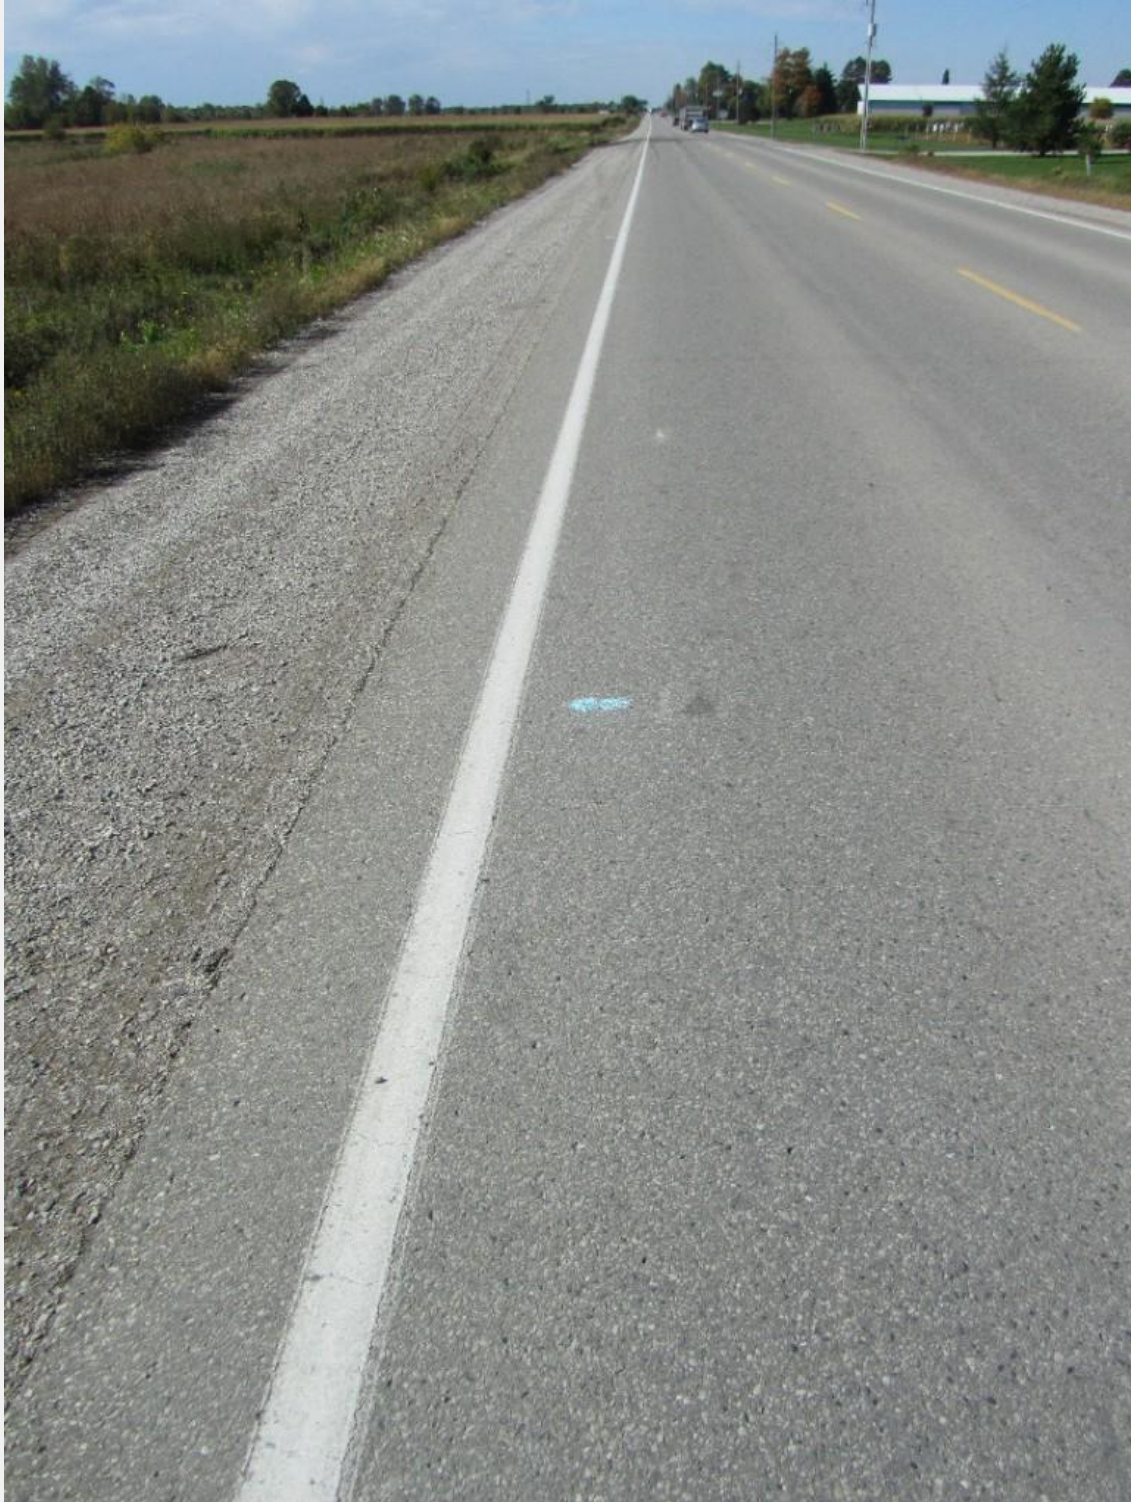
View, looking westward in the eastbound lane at the tire mark that this progressing toward the south shoulder. This tire mark was caused by the deceased's vehicle just before the impacts in the background.

The next two photos will continue the view of that tire mark as we move further westward toward the south shoulder and toward the area of the impacts.

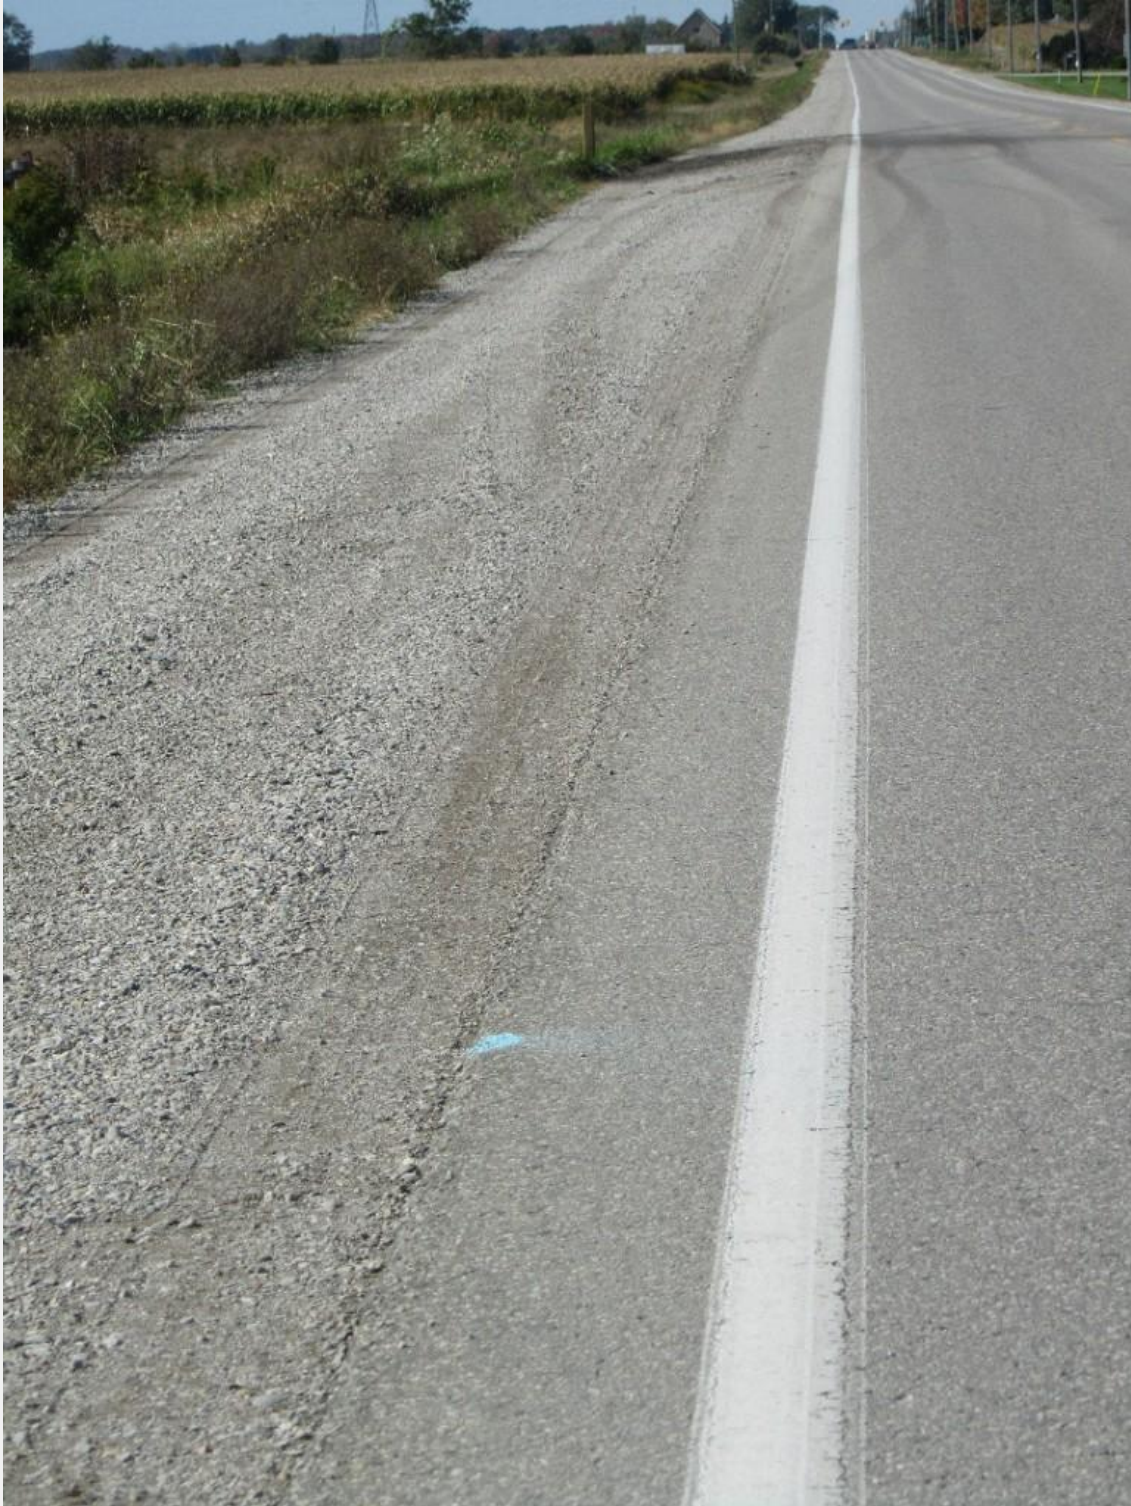
View looking west along the south edge of the eastbound lane of Medway Road. The light blue dot on the edge of the pavement is indicating the location of a tire mark that eventually enters onto the south gravel shoulder in the background.

We appreciate that there would appear to be a maze of tire marks in the background, especially on the pavement, and this may be somewhat confusing, but we ask readers to ignore those for the moment as most of those were created after the fact, although some may still be relevant. What we ask is that you focus on the tire mark that is coming off the pavement edge, as indicated by the light blue dot, and try to follow that tire mark onto the south shoulder where you should be able to see it curve back toward the road surface again.

What you should see in the photo is that the tire mark enters the gravel shoulder as a single mark and then it diverges into two marks. This is indicative of what happens to the two left side tires of a vehicle that is involved in clockwise rotation. The two left side tires begin to travel along different paths as the vehicle continues into its clockwise rotation.

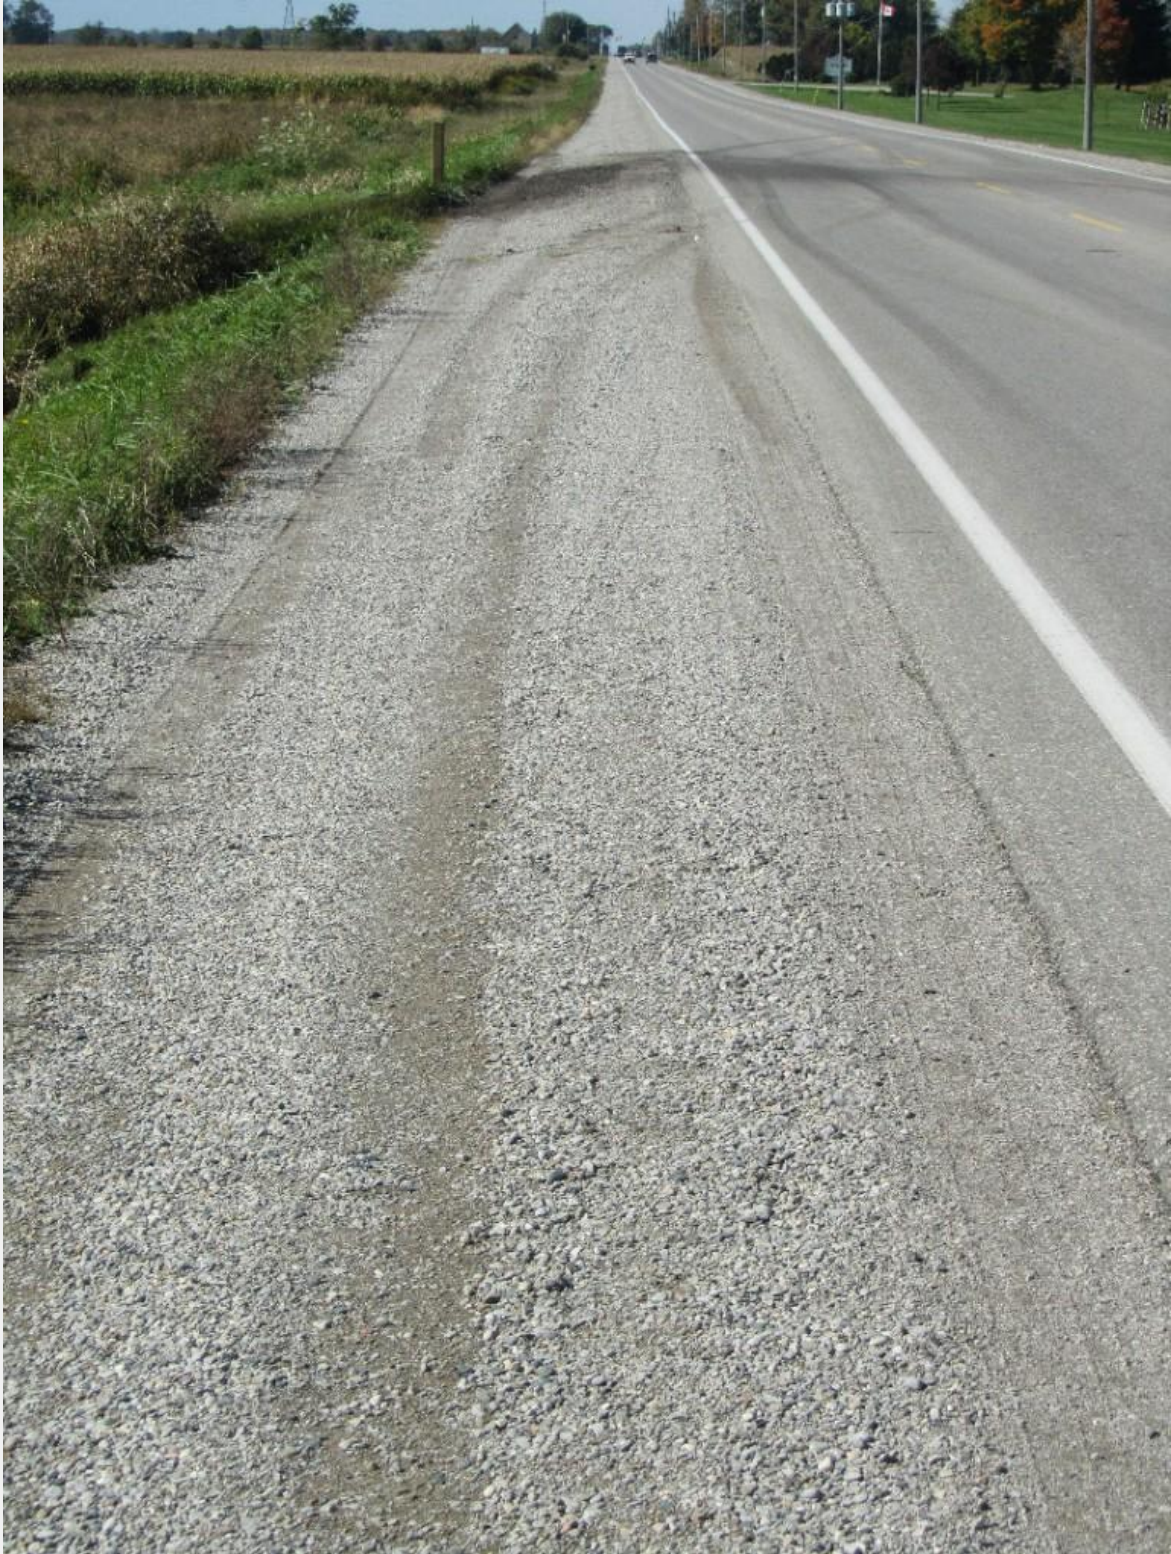
View, looking west along the south shoulder of the Medway Road and showing yaw marks in the gravel caused by the deceased's vehicle as it rotated clockwise and curved back onto the paved road surface.

The two photos below might help to visualize the yaw marks because, at this location, the two left side tires are already tracking along their separate paths and we can see that they curve back onto the paved road surface.

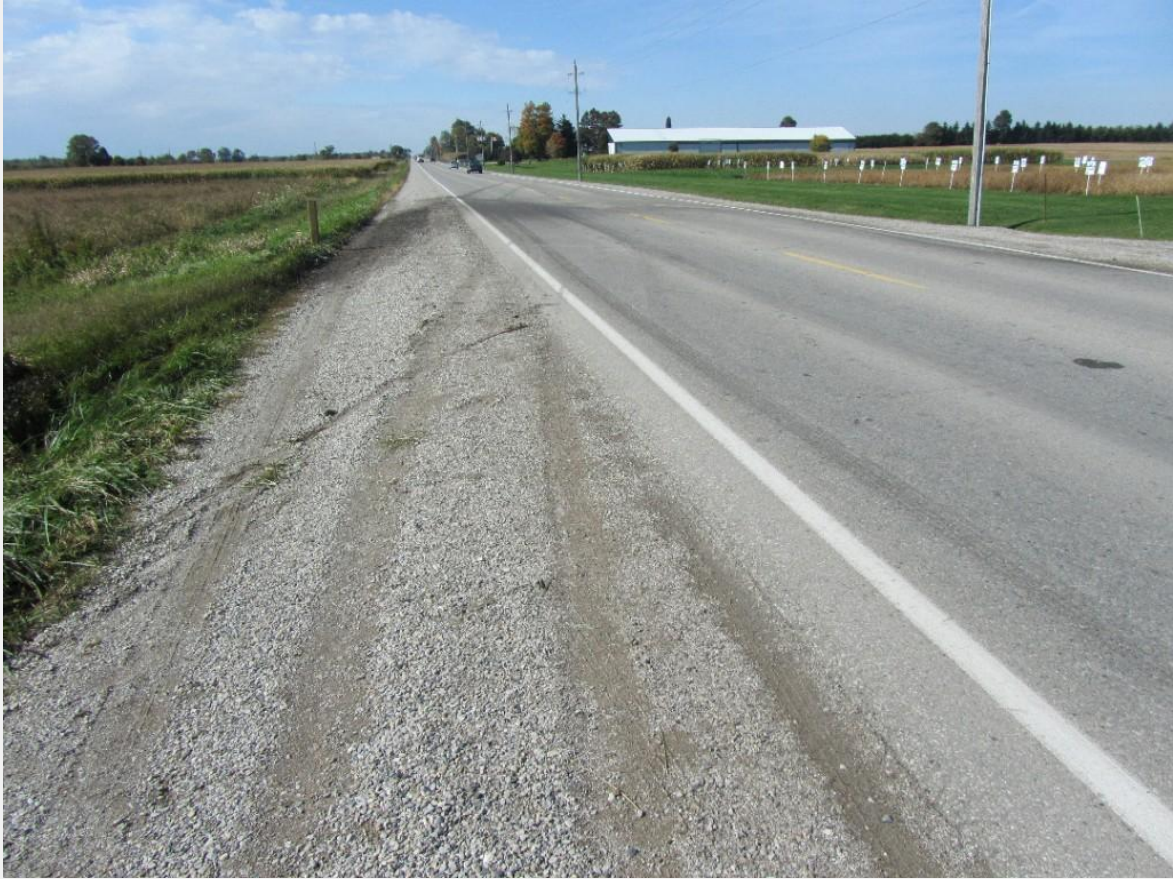
View of the yaw marks heading back toward the road surface as the loss-of-control vehicle continues to rotate clockwise.

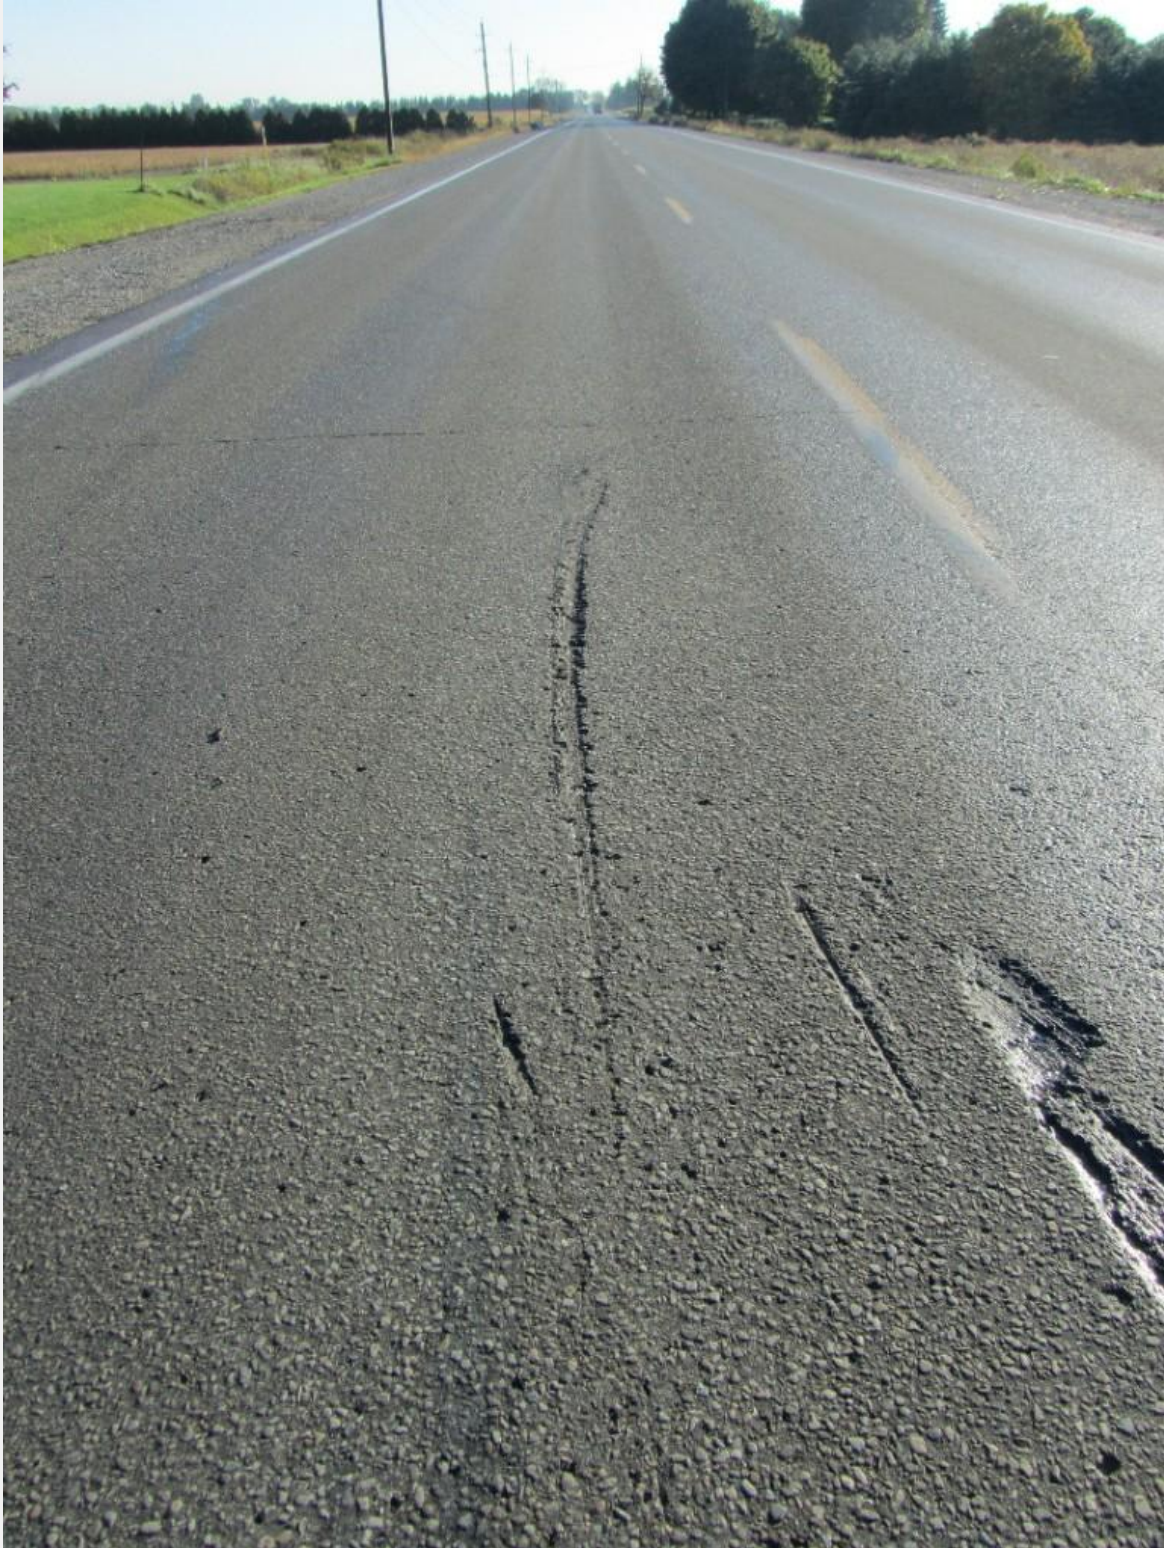
View, looking east, in the westbound lane where deep gouges indicate the location of the initial impact between the deceased's loss-of-control car and the westbound transport truck that it was reportedly passing.

Instead of the vehicle being struck by an eastbound vehicle, it was actually, initially, struck by the westbound vehicle that the deceased driver was reportedly trying to pass. Thus we see deep gouges in the westbound lane in the location where the loss-of-control vehicle progressed during its clockwise rotation. The gouges in the westbound lane are shown in the photo below.

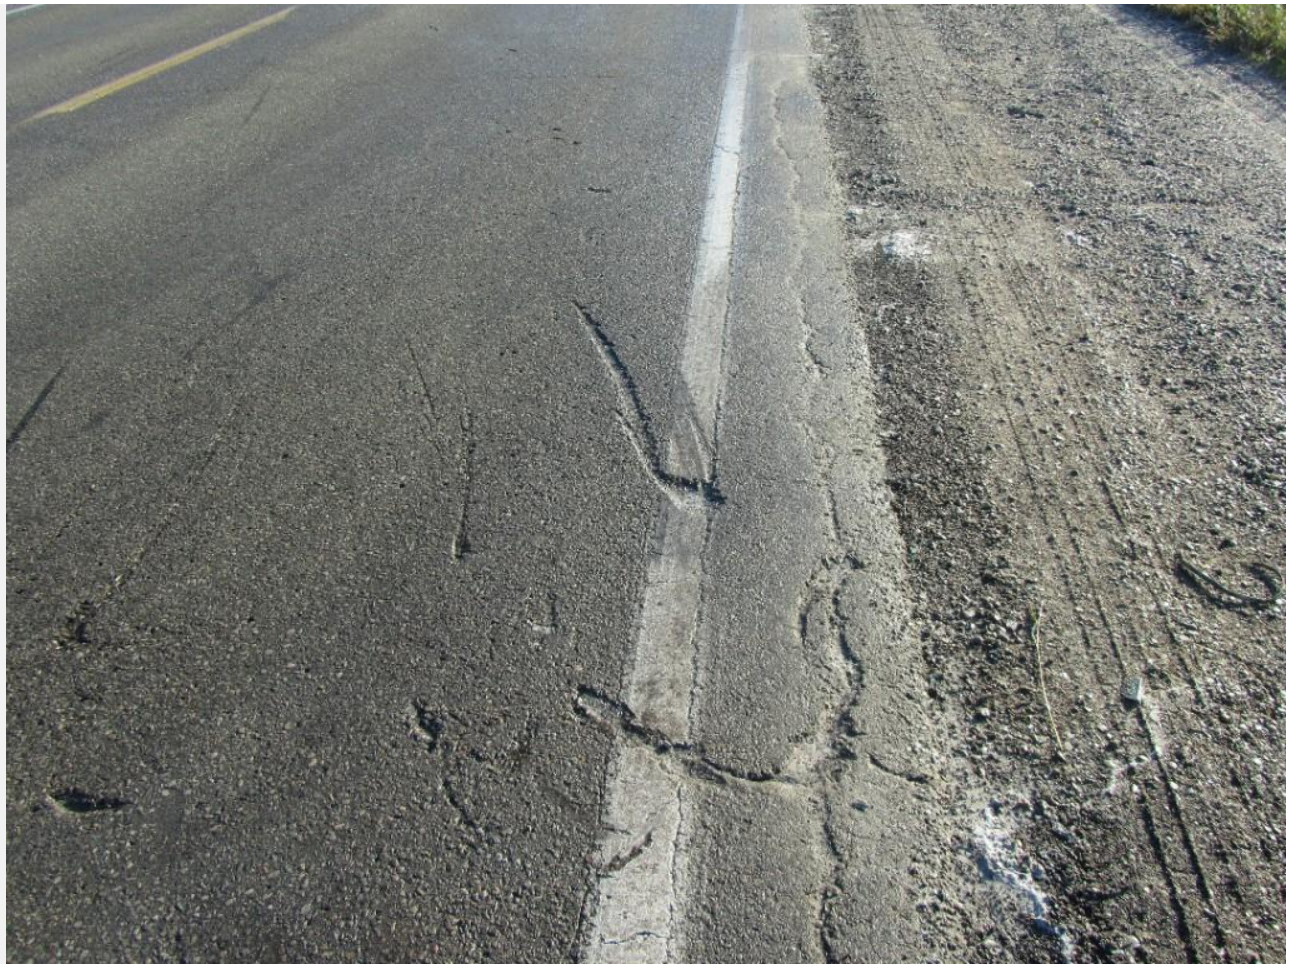
View, looking eastward at the south portion of the eastbound lane where the deceased's car was reportedly struck by an eastbound dump truck.

So, the initial impact occurs and the car is redirected into the eastbound lane where it is struck by an eastbound dump truck. The gouges that indicate the location of this second impact are shown in the photo below.

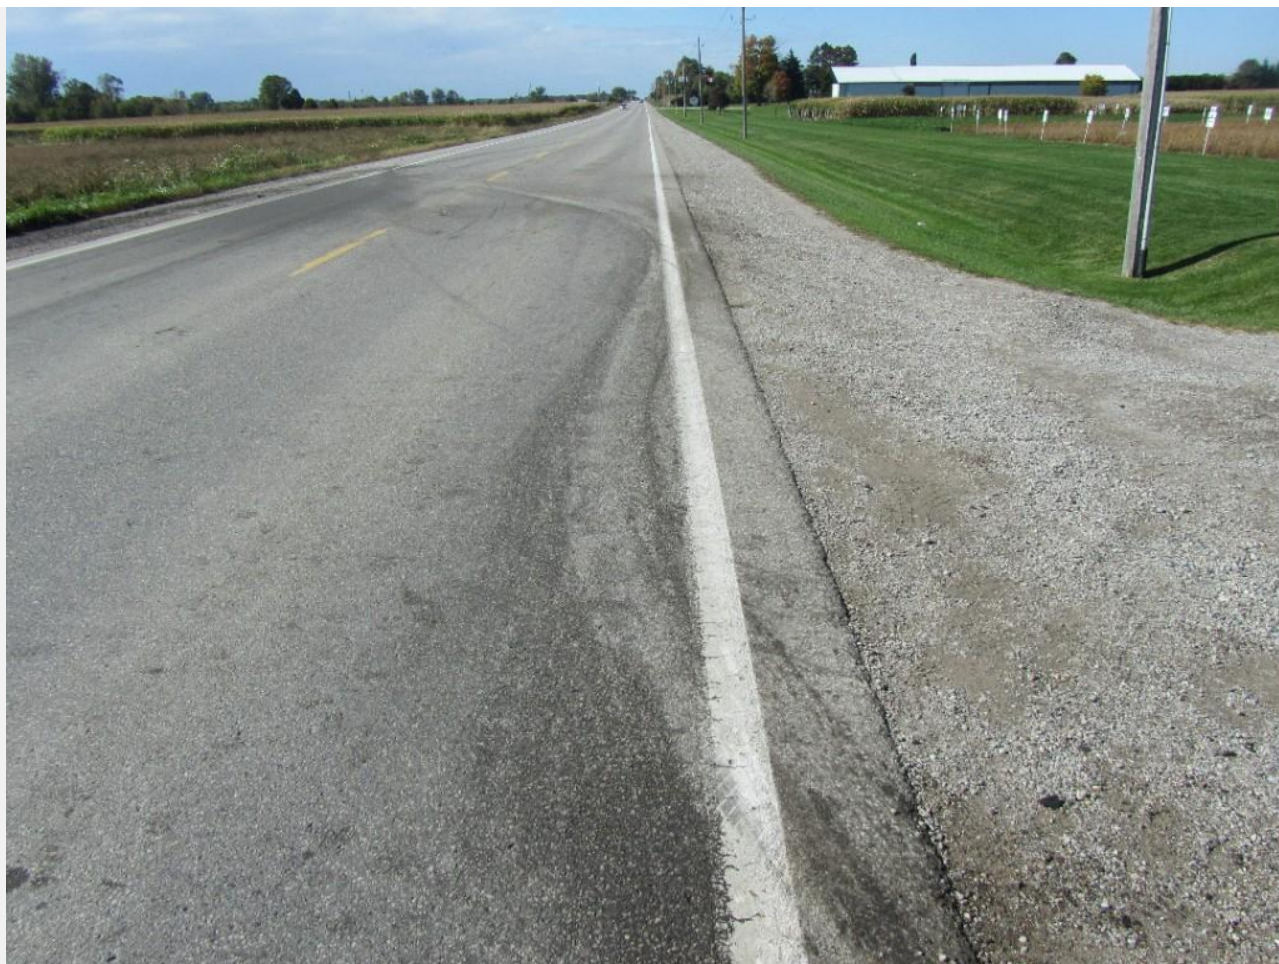
View, looking west, at the fluid trail exiting the area of the second impact in the background toward the final rest position of the deceased's vehicle on the north shoulder, in the foreground.

After the second impact in the eastbound lane the deceased's vehicle was pushed back, in a north-easterly direction, toward the north shoulder where it came to rest, as indicated by the fluid trail in the photo below.

The evidence at the collision scene is somewhat complex. The loss-of-control vehicle was originally westbound and was in the eastbound lane where we first located its tire mark as it exited onto the south shoulder. It then rotated out-of-control back onto the pavement where it was struck by the westbound transport truck that it was passing. The car was then deflected into the eastbound lane where it was struck again by the eastbound dump truck and redirected once more, to the north-east, where it came to rest on the north shoulder.

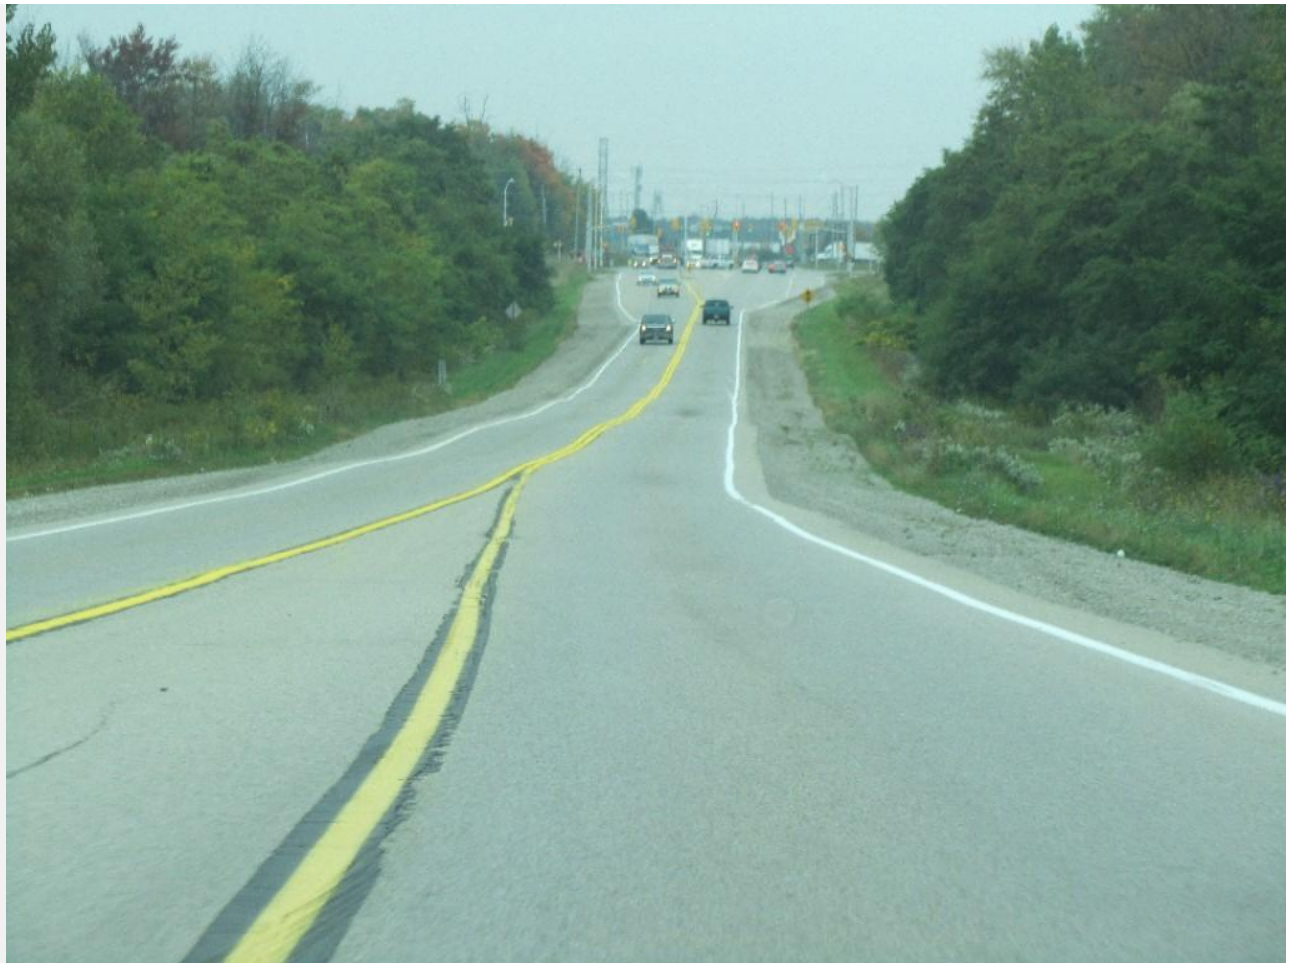
In the last few months we have been observing the development of a “wobble” in the pavement surface of Highbury Ave just south of Wilton Grove Road in south London, Ontario, as shown in the photo below. This development is similar to the more extreme conditions we have been documenting on Sunningdale Road.

View, looking north, toward the development of a wobbling of the pavement surface of Highbury Ave just south of Wilton Grove Road.

The conditions are similar to other similar developments that occur in low-lying areas of a road surface where the water table would be expected to be high. The two additional photos below provide closer views of the area of concern.
