# Gorski Consulting Website

## Archived News - 2014 - October

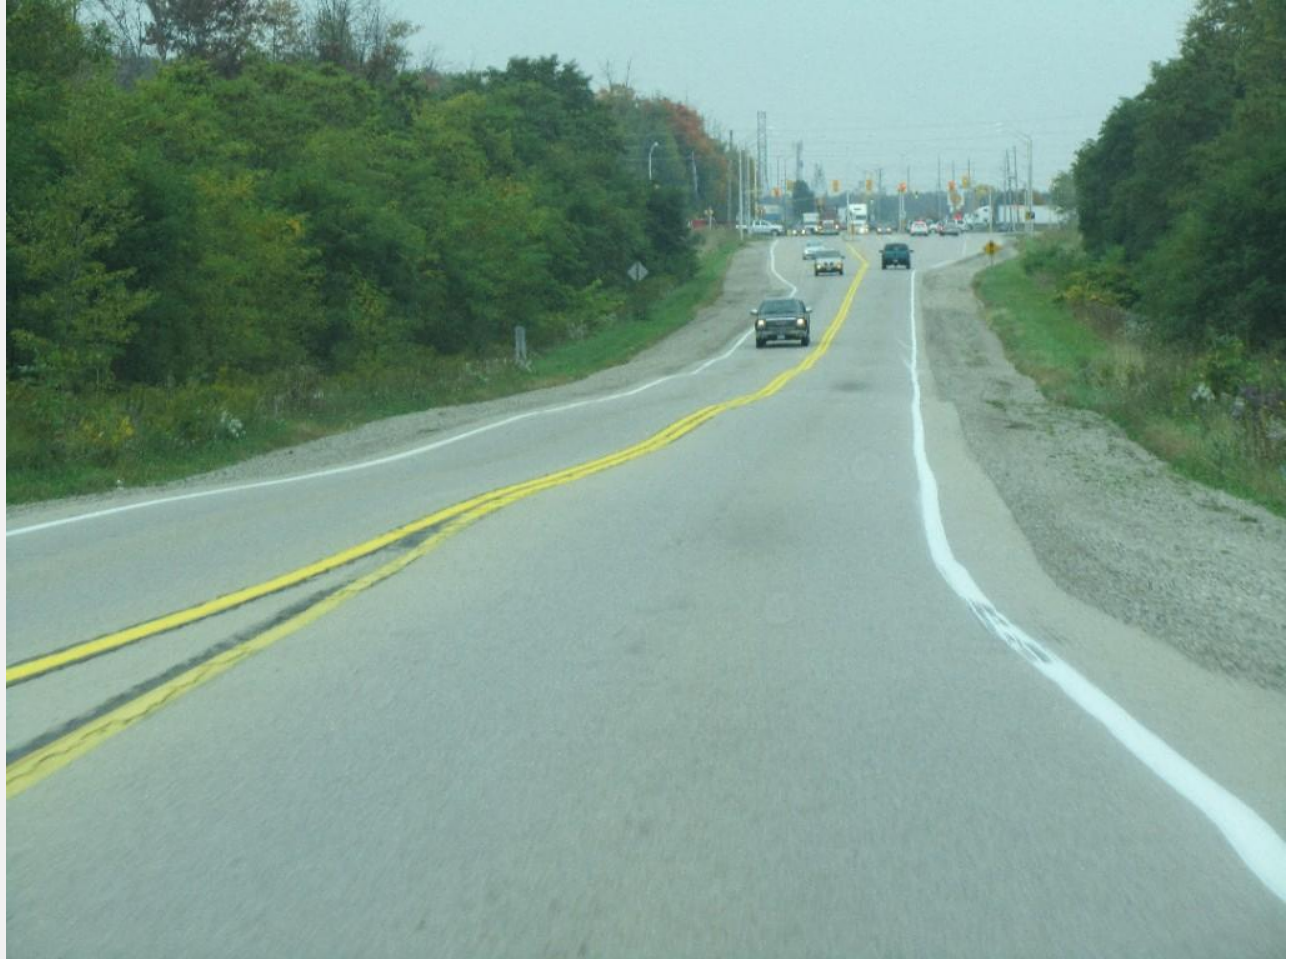
The conditions are similar to other similar developments that occur in low-lying areas of a road surface where the water table would be expected to be high. The two additional photos below provide closer views of the area of concern.

Northward view of wobbling section of pavement on Highbury Ave.

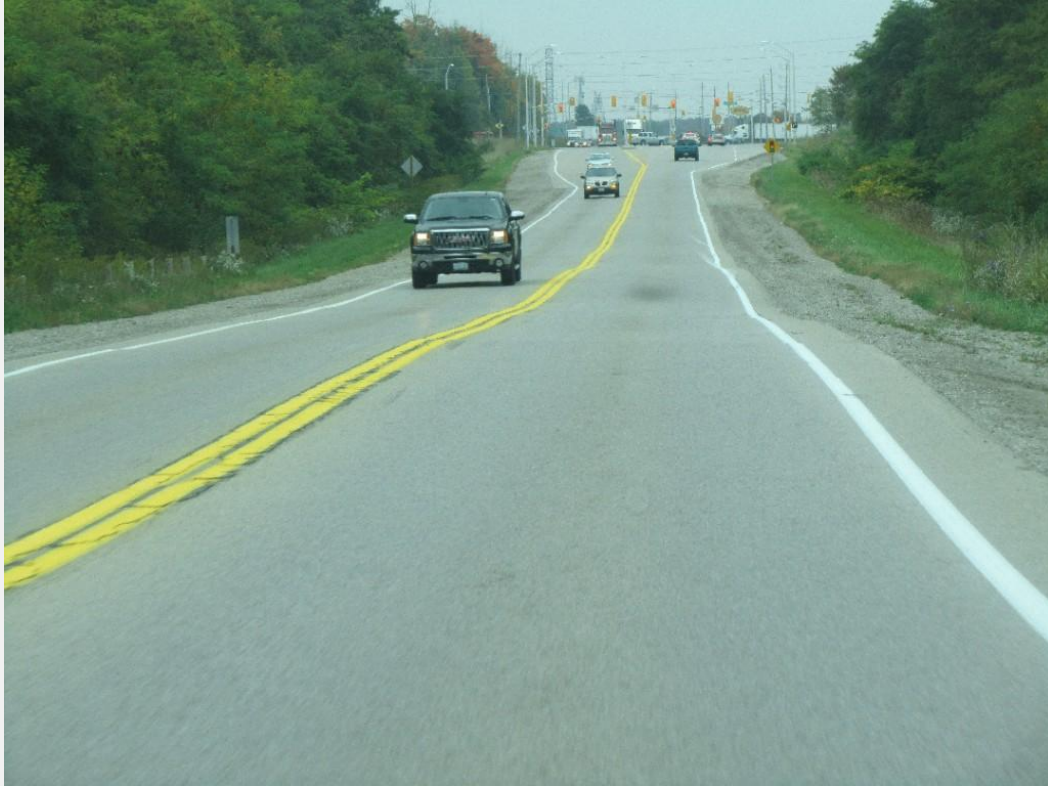
Northward view of the wobbling section of road surface on Highbury Ave.

We have observed in the past that road works departments have been slow to recognize that such unevenness of the pavement can become a problem during environmental conditions producing a slippery road surface resulting in an increased likelihood of a vehicle entering into a state of loss-of-control. As we have no control over the actions of these departments we can only document these facts and observe the response to the deteriorating conditions.

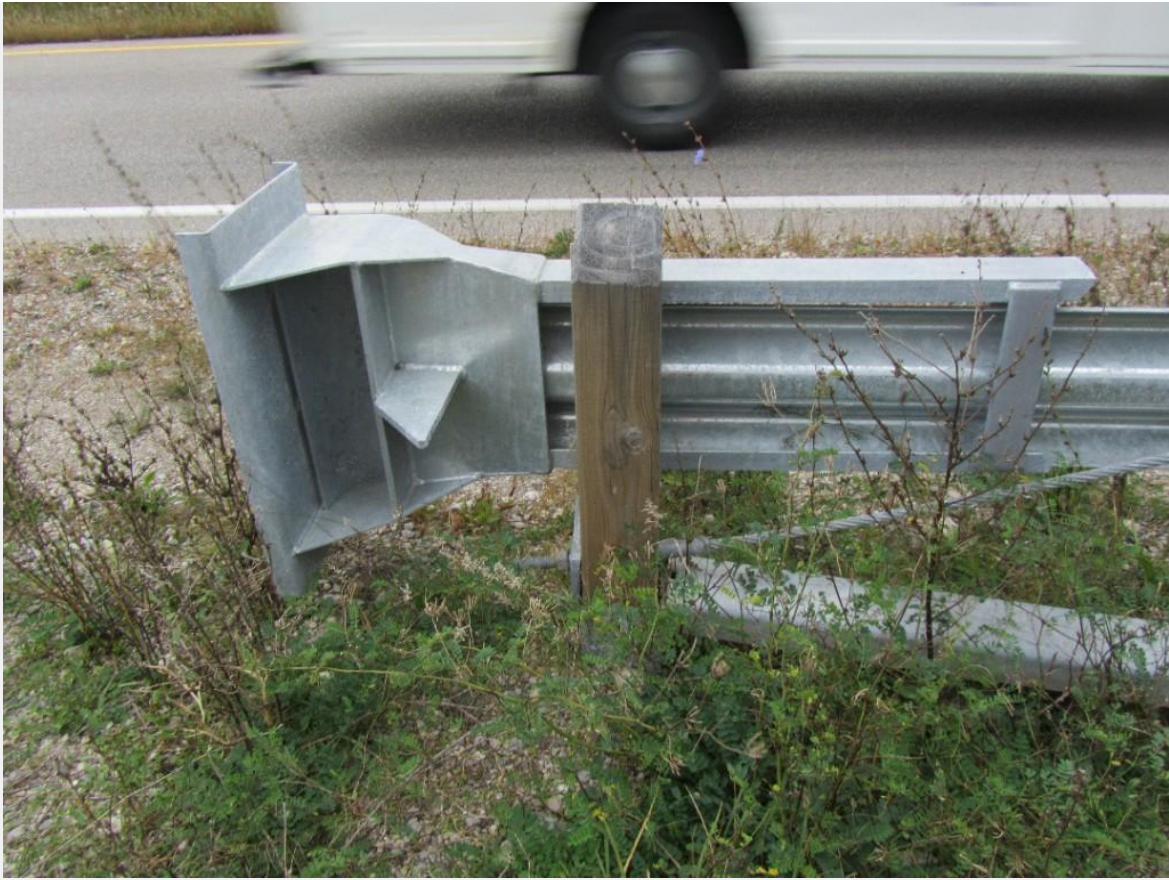
The end of a guardrail should not act as a harpoon that spears a vehicle that makes contact with it. When such a harpooning takes place it needs to be identified if there was a defect in the design of that system.

There has been recent publicity regarding the “harpooning” of vehicles by guardrails designed by Trinity Highway Products of Dallas Texas. Allegations have been made in court that a redesign of their guardrail end caps (ET-Plus) has created a hazard whereby the guardrail system turns into a harpoon when struck by a vehicle. If these allegations are proven to be correct then this poses a tremendous problem as Trinity is reported to be a global manufacturer whose products are installed all over North America and beyond. As the court case regarding these allegations proceeds Gorski Consulting has conducted a brief examination of a guardrail system in London, Ontario which has the characteristics of the defects being discussed. Our article provides some illustrations of what the defect allegations are about. We invite readers to visit our Articles webpage and review the article.

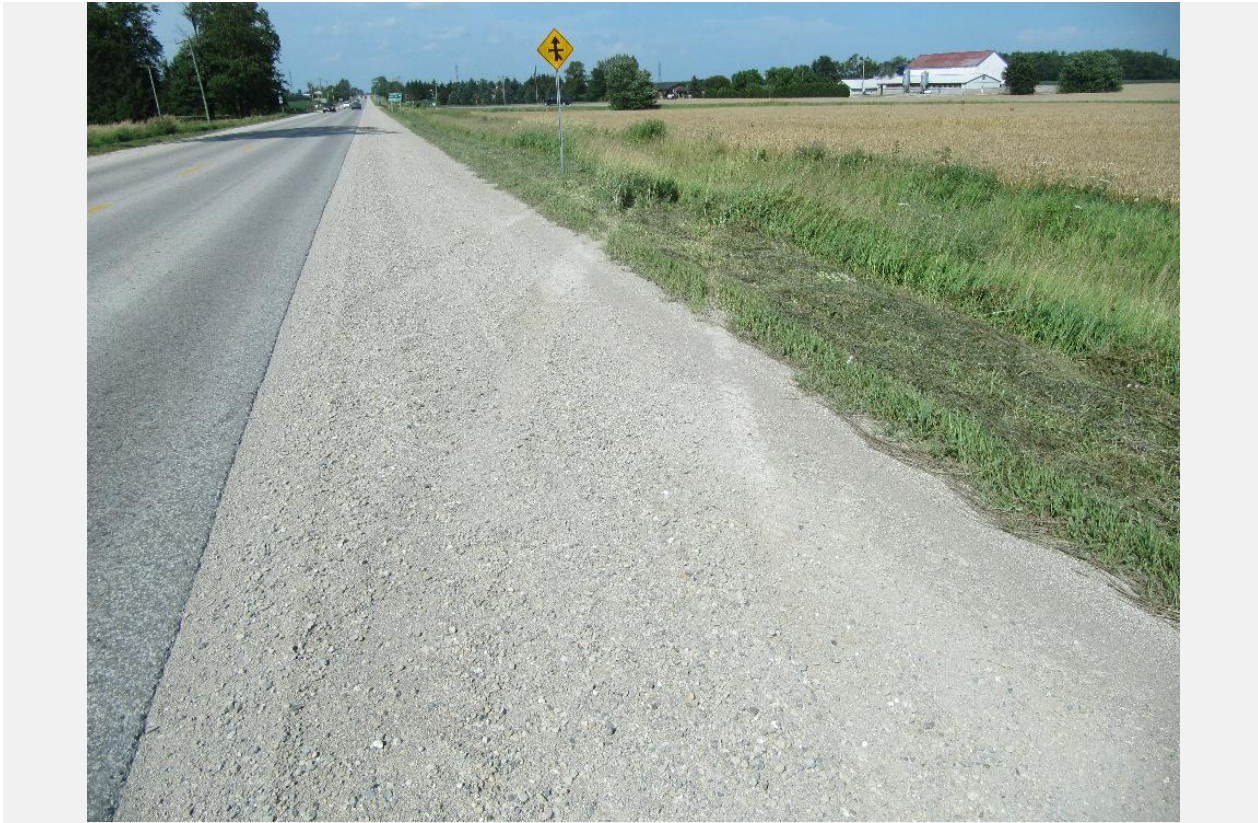
Loss-of-control tire marks on a freshly re-graded gravel shoulder leading to a rollover in grassy roadside of a rural highway.

These events high-light the point that the evidence of vehicular travel on gravel surfaces is an important issue that needs to be studied if we are to obtain objective evidence of how and why a loss-of-control leads to a serious collision. Yet, if one were to examine the contents of any accident reconstruction courses in North America, there is no mention of any instruction for potential investigators to be able to detect and interpret this evidence. And this has always been the case.
