Gorski Consulting Website

Archived News - 2014 - December

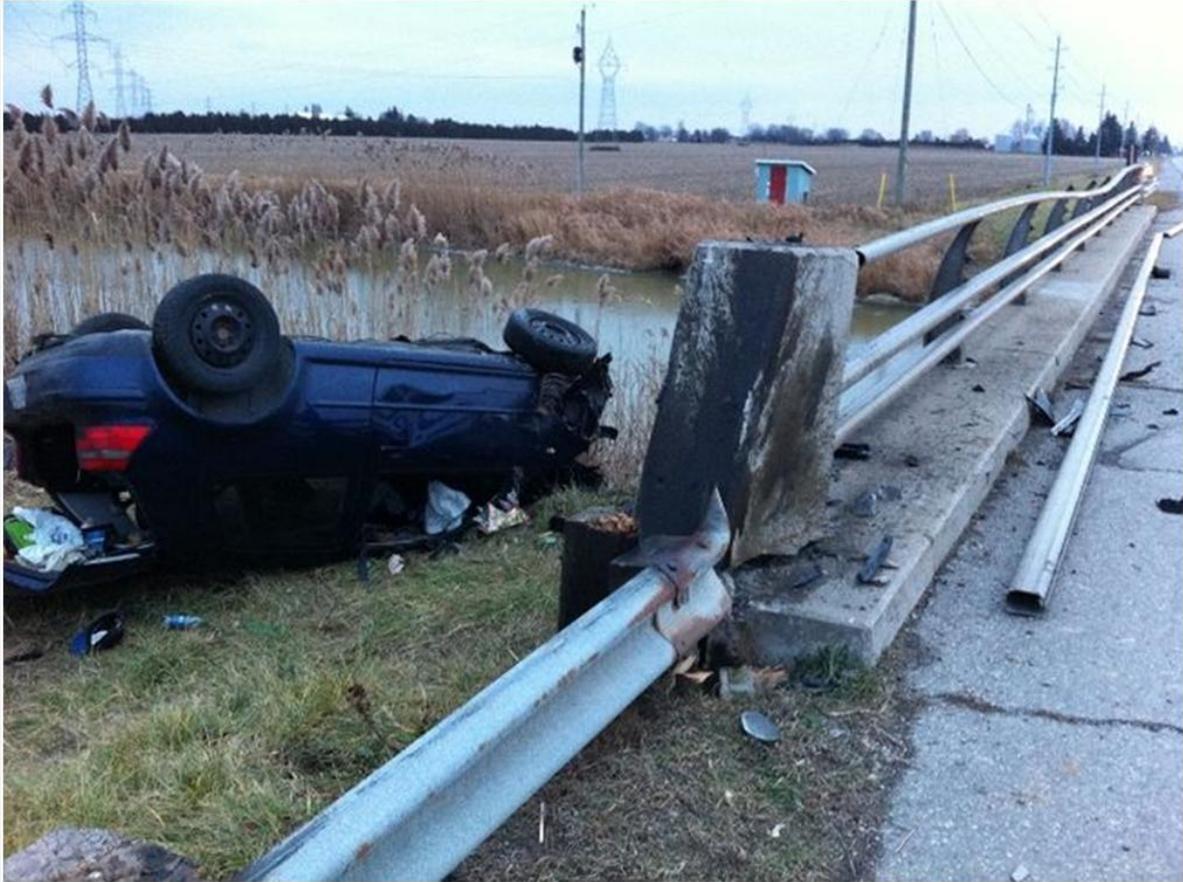
Evidence indicates the Golf slid on top of the guardrail before impacting the concrete bridge abutment.

The presence of blue paint on top of the guardrail is obvious and indicates that, instead of deflecting the vehicle from the abutment the guardrail served as nothing more than a ramp directing the vehicle into the abutment. Even without attending the site it is clear from the photo that the height of the guardrail is much too low and secondly, it is not attached to the bridge abutment as required. Pre-impact views of the guardrail can be obtained from Google maps and this clearly shows a “dug in” end treatment of the guardrail which is old, has been identified as dangerous, and should have been replaced. Obviously that did not happen.

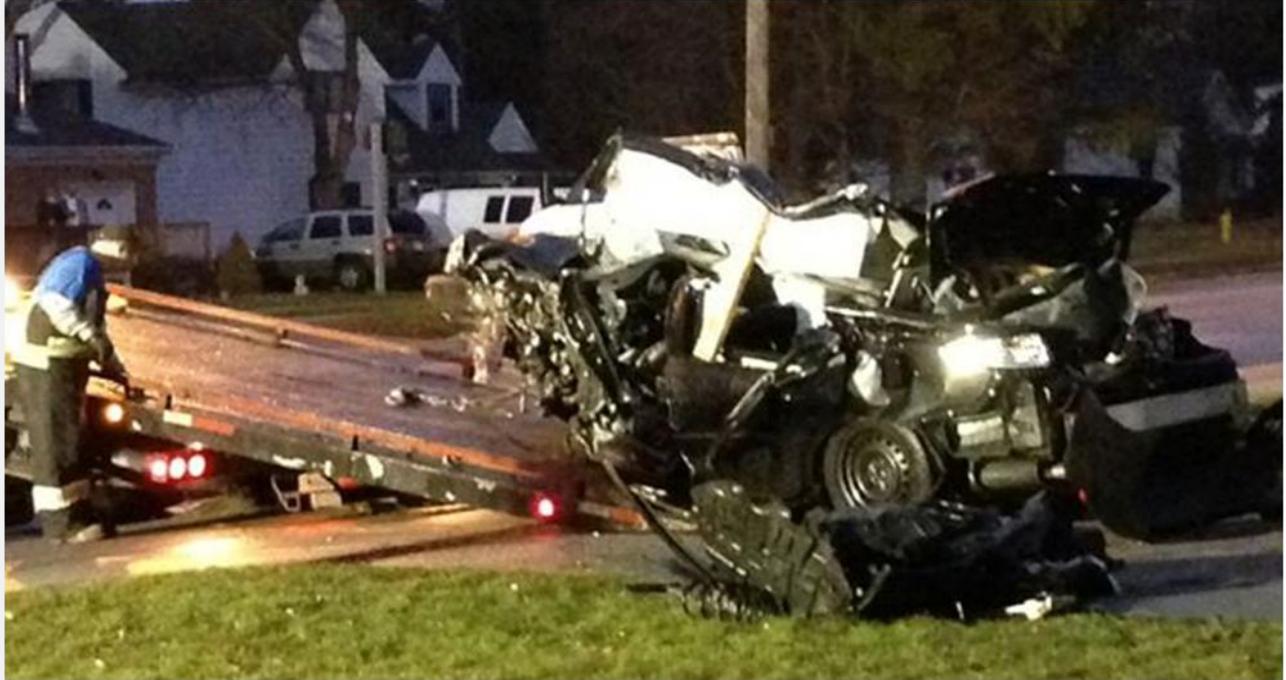
View of damaged vehicle being pulled onto a flat bed trailer.

While the view of the vehicle is not the best it certainly suggests that the impact with the tree was in the area of the left-front and that there would be structural intrusion into where the driver was seated. Yet police reported that he did not sustain serious injuries. At face value the reported facts do not match what would be expected. Such major deformation within where the driver was seated should result in more injuries than to a passenger who would be expected to be remote from that crush. Granted it was also reported that, after striking the tree, the vehicle then collided with the wall of a building and this second collision might relate to the passenger's injuries. But we do not know, we are only left with this curious set of inconsistencies. Having observed the damage to the struck tree it confirms to us that the impact was of a high severity and generally, a subsequent, high-severity impact with the wall of the building would not be likely. So the probabilities make it unusual that the passenger should sustain fatal injuries from that second impact. So this is another unusual incident that has not been explained. Yet the public may often be unaware that they are not provided with the proper facts.

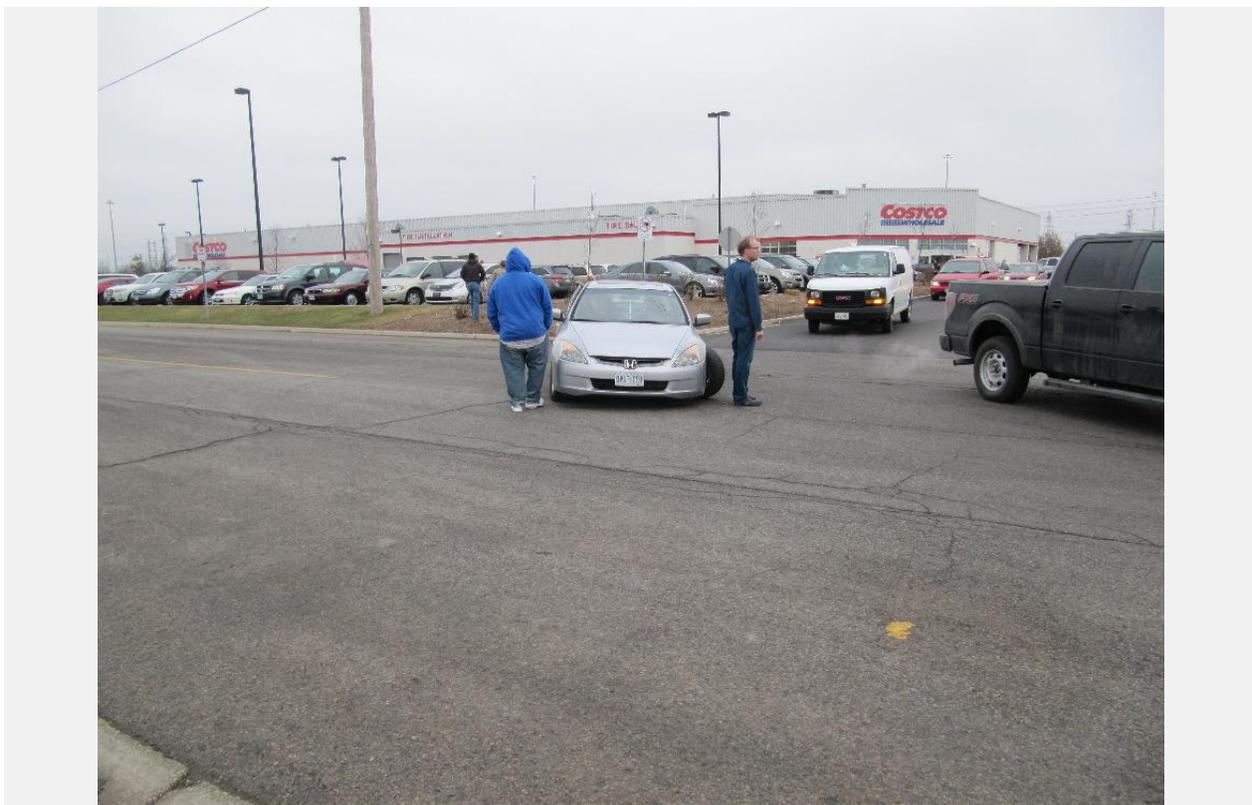
View of the driver and store employee standing by a disabled 2003 Honda Civic that was partially blocking the path of vehicles driving in and out of the Costco store on Wellington Road in London, Ontario on the morning of December 12th, 2014.

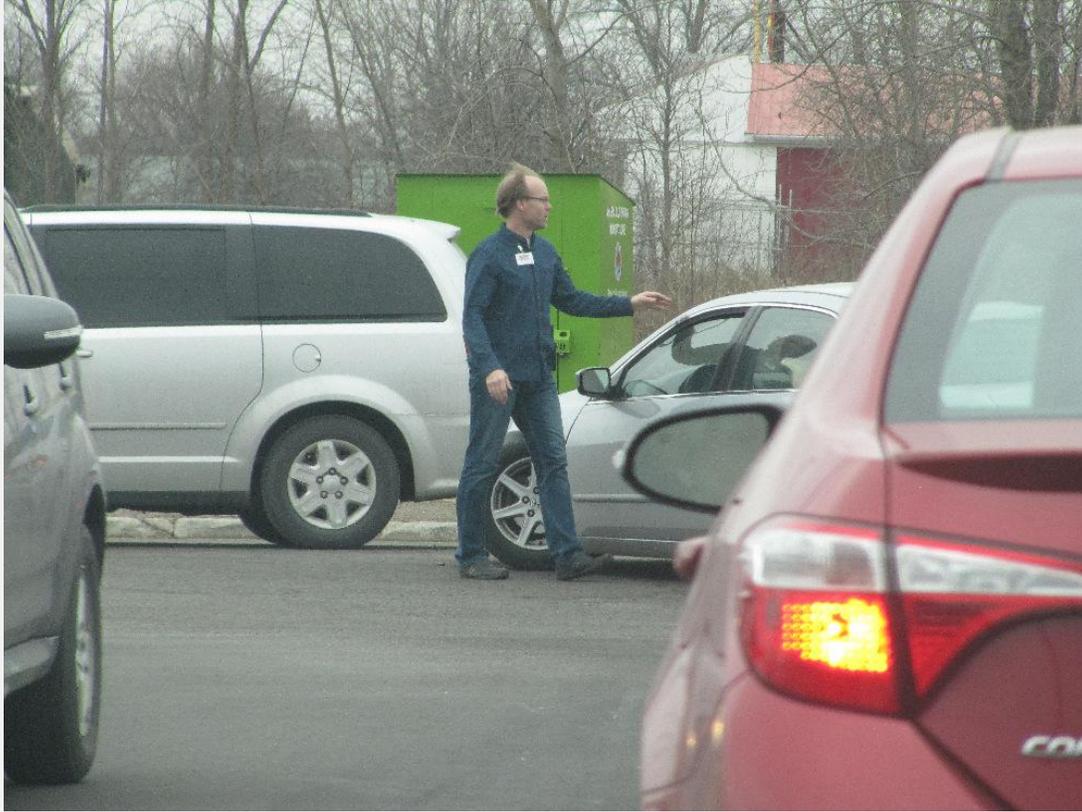
View of Costco store employee trying to play “traffic cop” as he directs busy traffic around a disabled, 2003 Honda Civic at the entrance/exit driveway of the store.

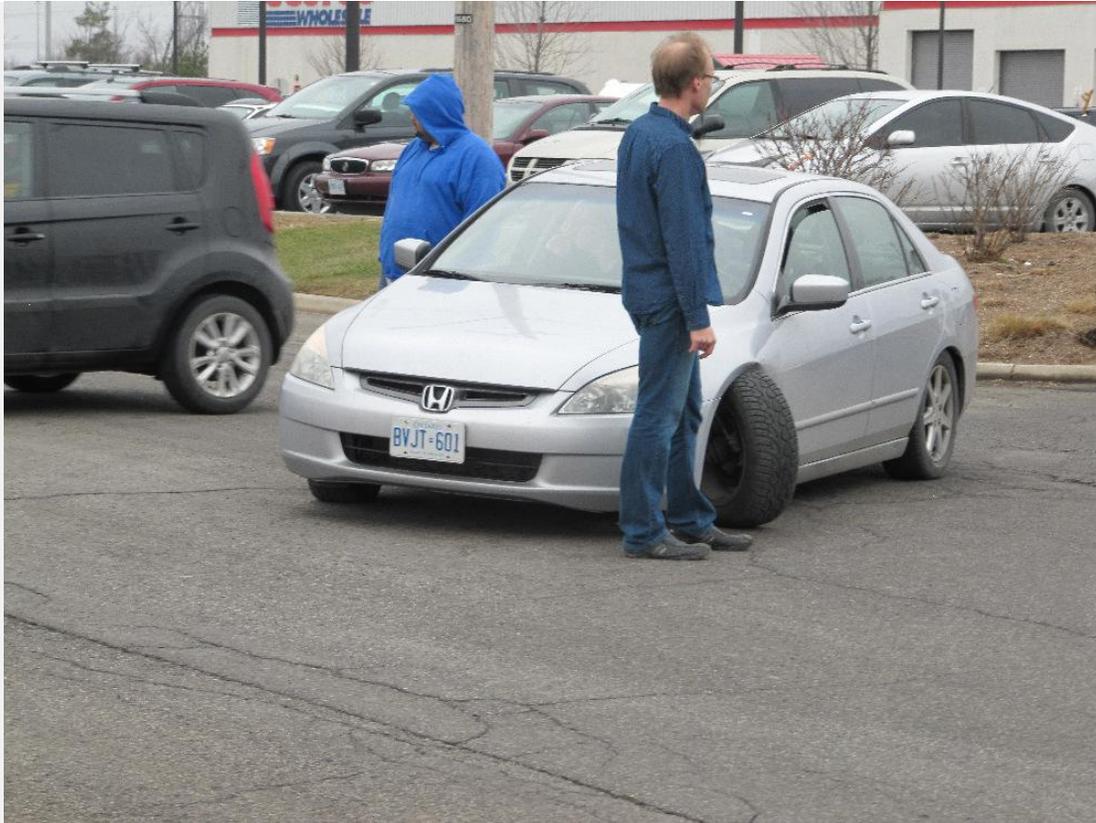
As we came closer to the vehicle it was obvious that the left front wheel was pointing in an extreme angle to the left, beyond what one would expect of a properly functioning steering system.

As we get closer to the disabled vehicle we see that its left-front wheel is pointing at an extreme angle to the left – further than what the steering system should normally be capable of doing.

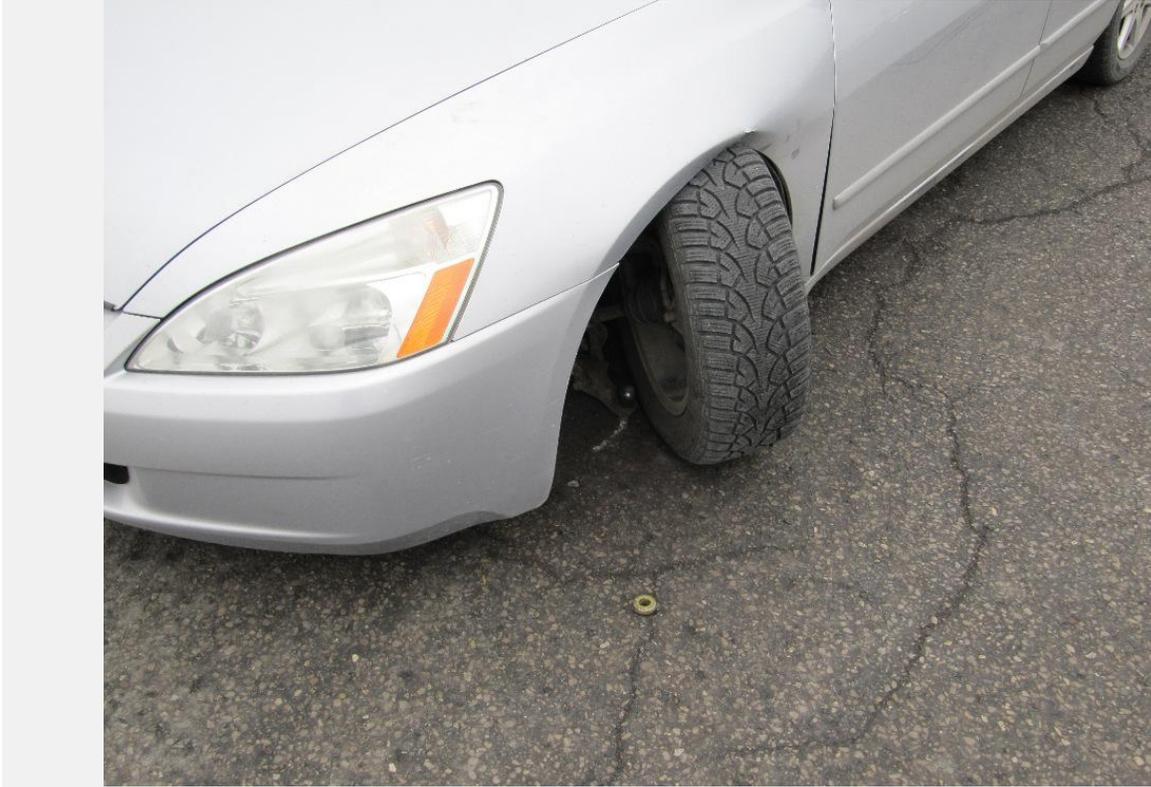
The vehicle seemed to have dropped down onto the left front wheel.

Looking more closely at the left front wheel, it appears the vehicle seemed to have fallen down on it as evidenced by the fender touching the top of the tire.

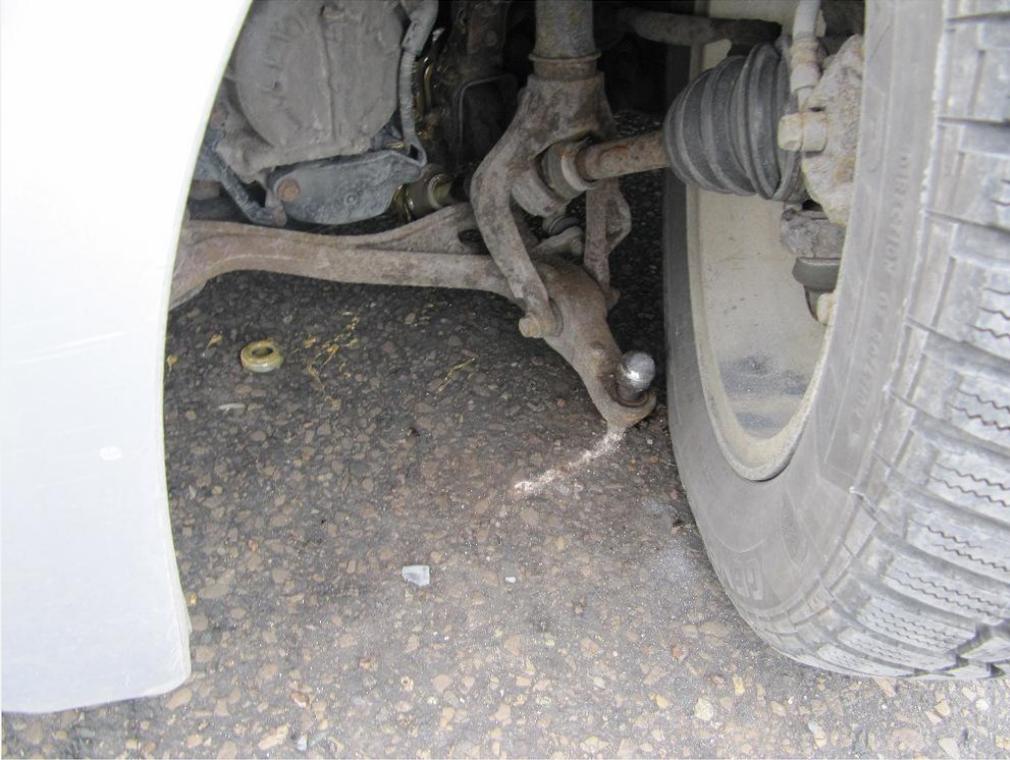
Looking inboard of the left front wheel we could clearly see that the ball joint had separated and had scraped the road surface as the driver attempted to reverse for a short distance.

View inboard of the left front wheel showing that the ball joint is separated and has dragged on the road surface.

The separation of the ball joint also caused the suspension to fall onto the transaxle causing it to pull out of its inner anchorage.

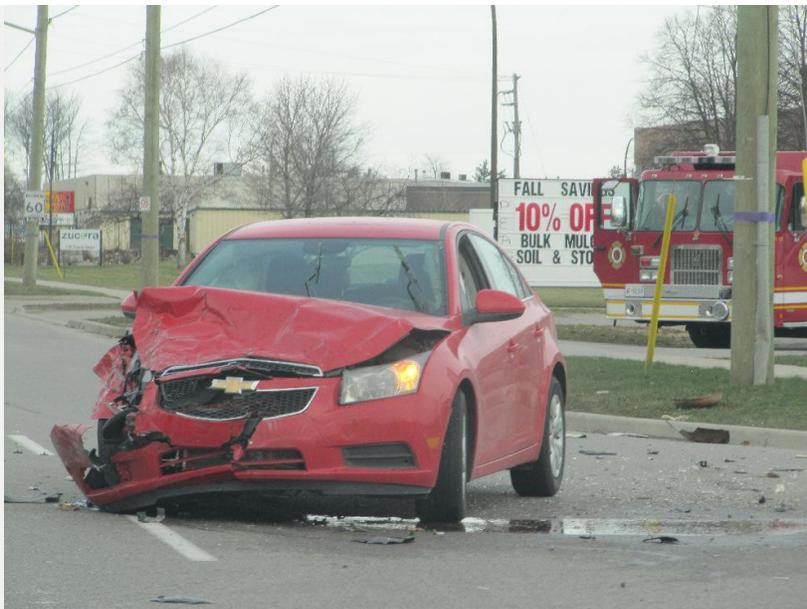
Ambulances dispatched to the site of this collision on Clarke Road near Atlantic Court on the morning of December 2, 2014, were blocked by a CP rail barricade that malfunctioned and required CP employees to attend to lift the barricades. Ambulance drivers fearful of crossing the lowered barricades were forced to travel around a long detour that caused considerable response delay.

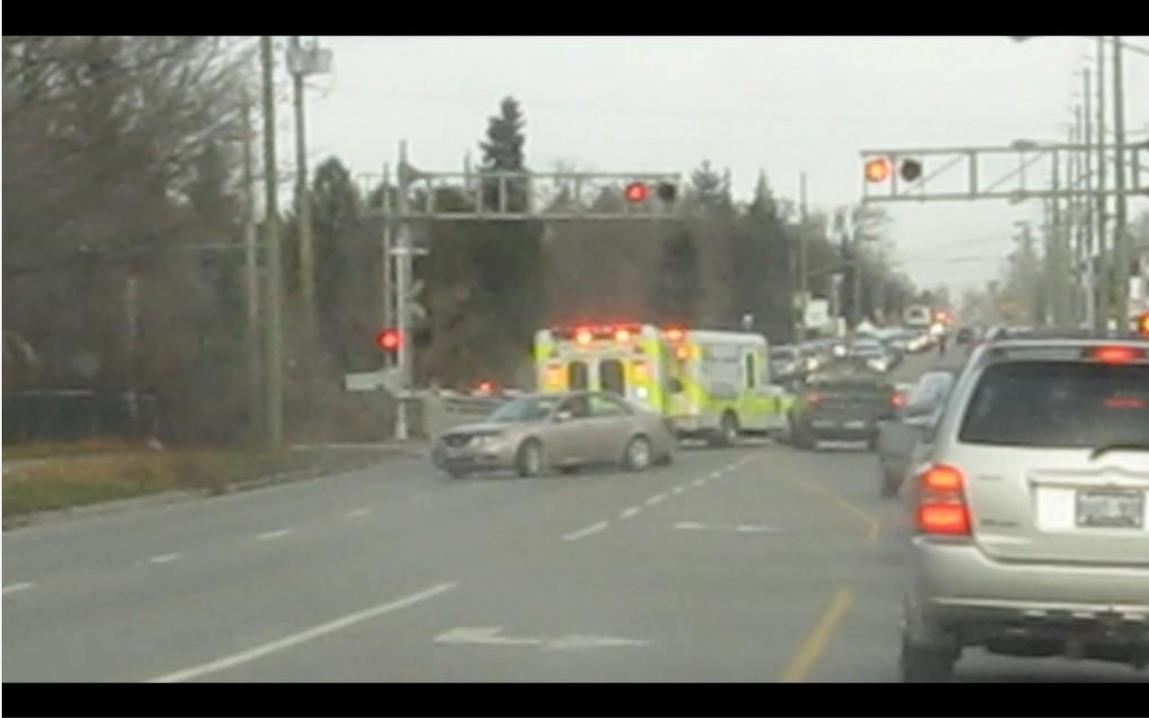
This morning a similar but potentially more disastrous result. Two northbound ambulances had to attend to an emergency involving a significant collision on Clarke Road at Atlantic Court. But, once again, the barricades were down. They must have been down for quite some time due to the fact that many drivers were turning around to take another route and some were crossing through the lowered barricades, just like in the September 26th incident. The drivers of the two ambulances simply could not take that chance, as shown in the captured frame taken of our video of the events.

View of two ambulances, and many other northbound drivers, turning around at the lowered CP barricades because they could not take the chance of passing through them. The ambulances had to reach a collision site that was just a few hundred metres north of their blocked location but had to take a roundabout detour which delayed their response.
