October 31, 2012

Ignorance Abounds - Local News Media Quick To Report Dogma, Slow on Science

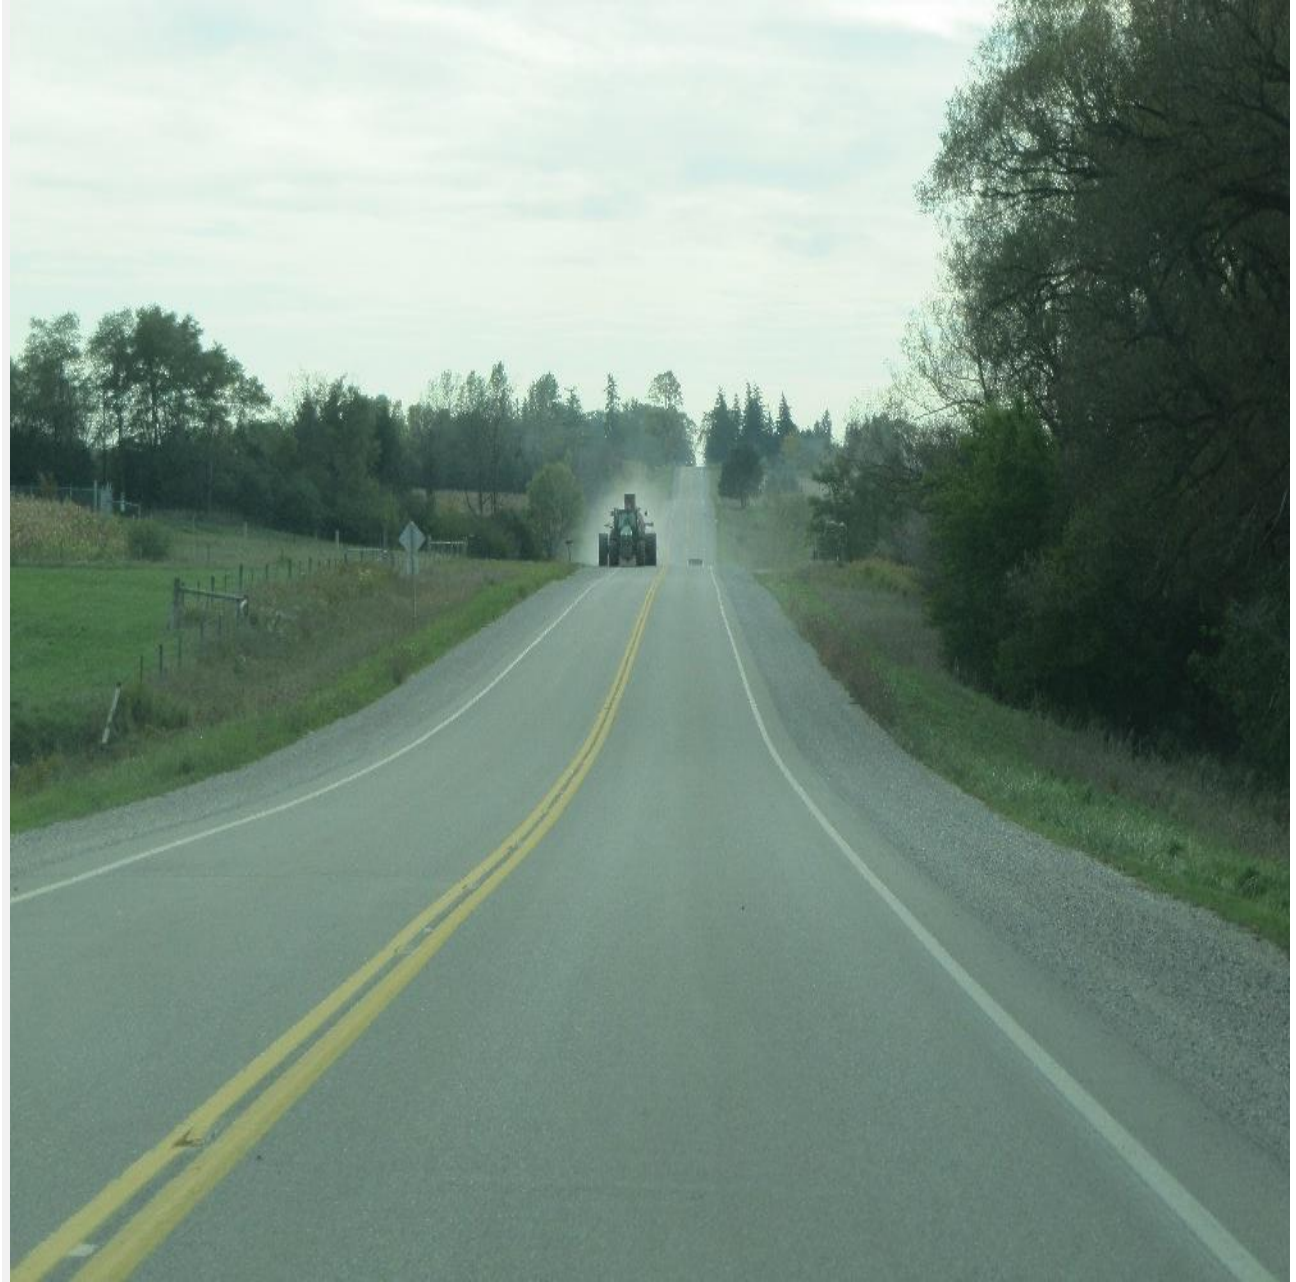
You're minding your own business when you see a farm vehicle approaching from the opposite direction

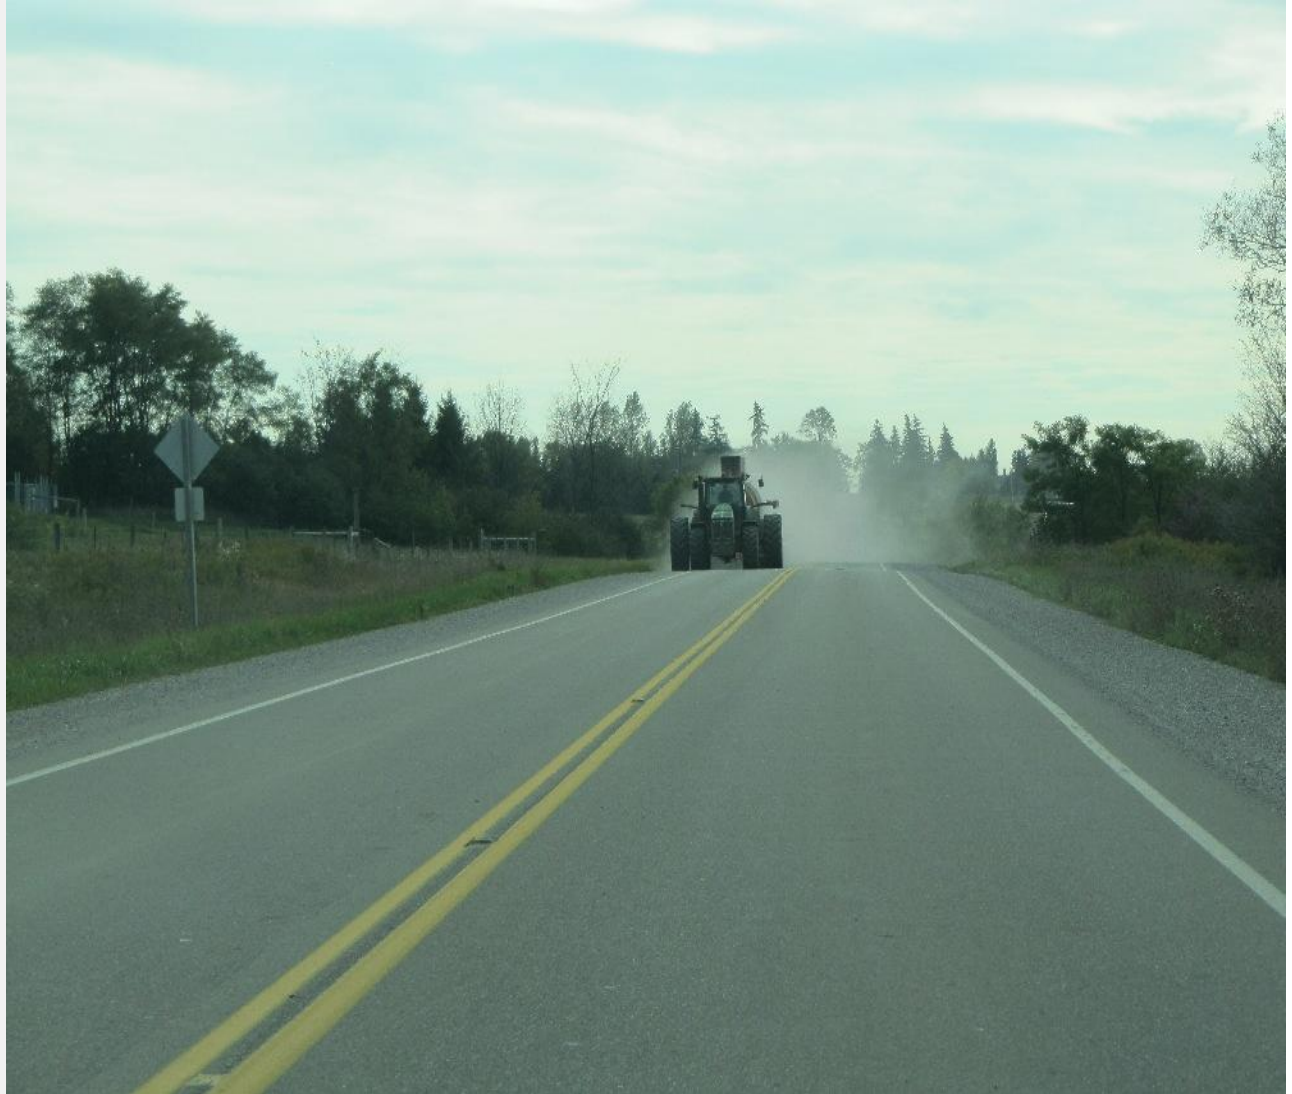
The approaching farm vehicle is riding partly on the gravel shoulder.

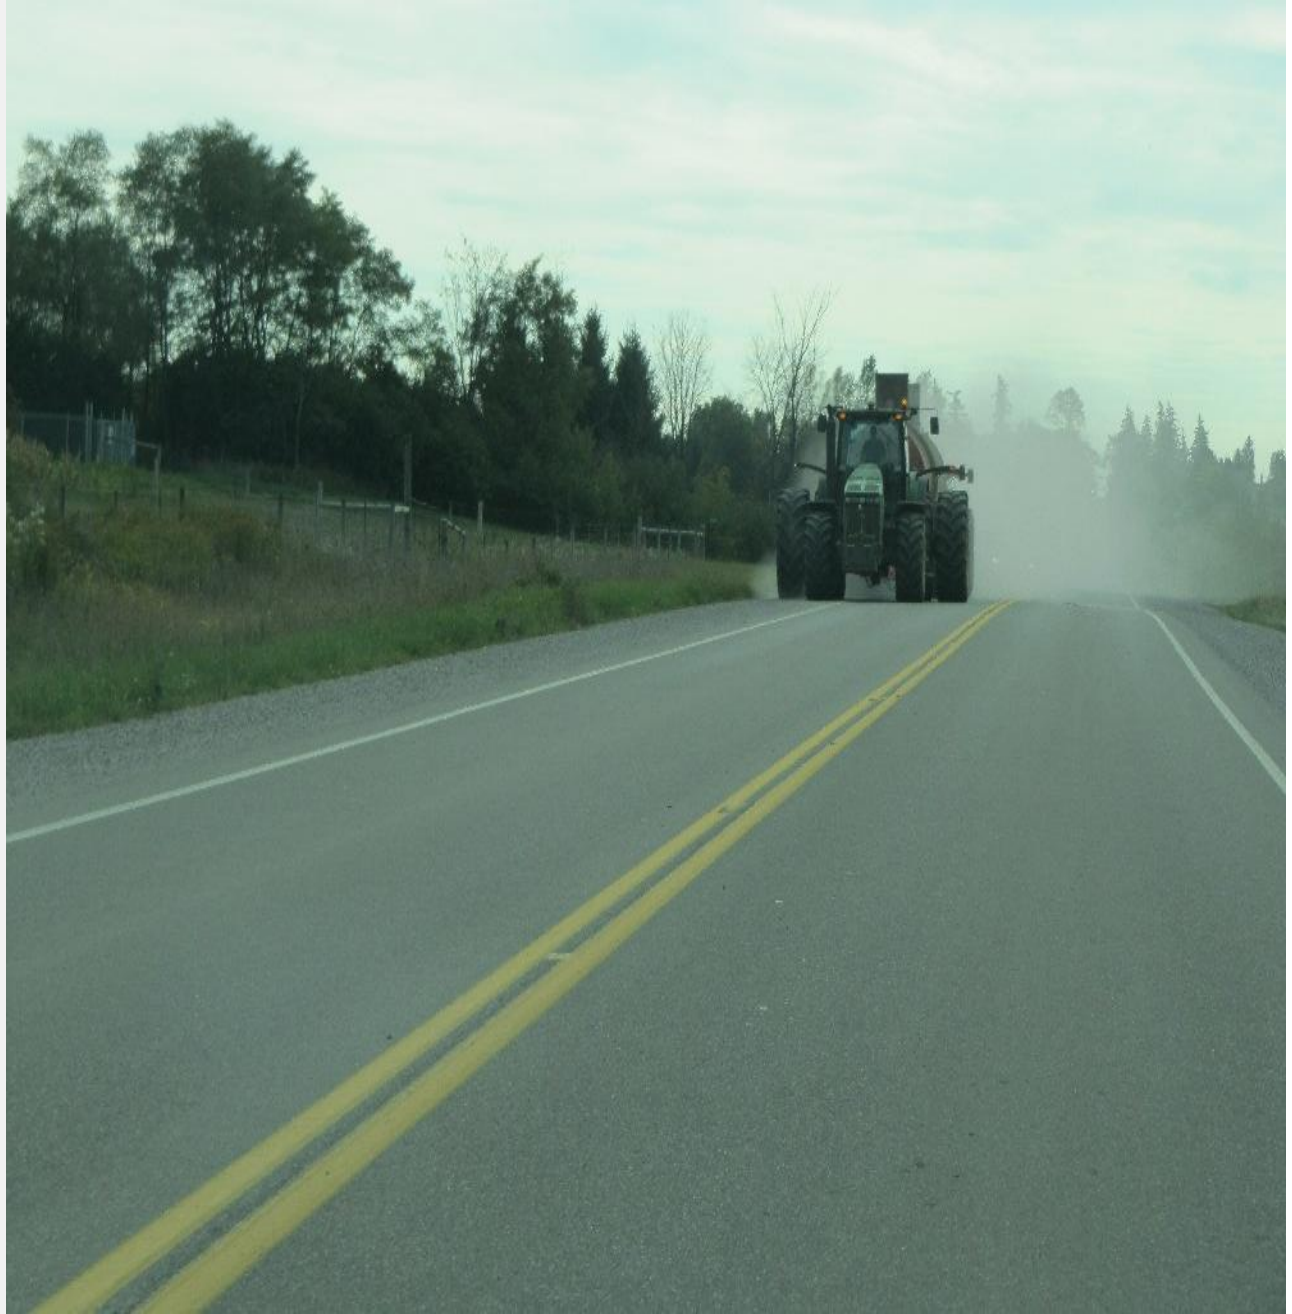
Dust forms like a cloud behind the farm vehicle.

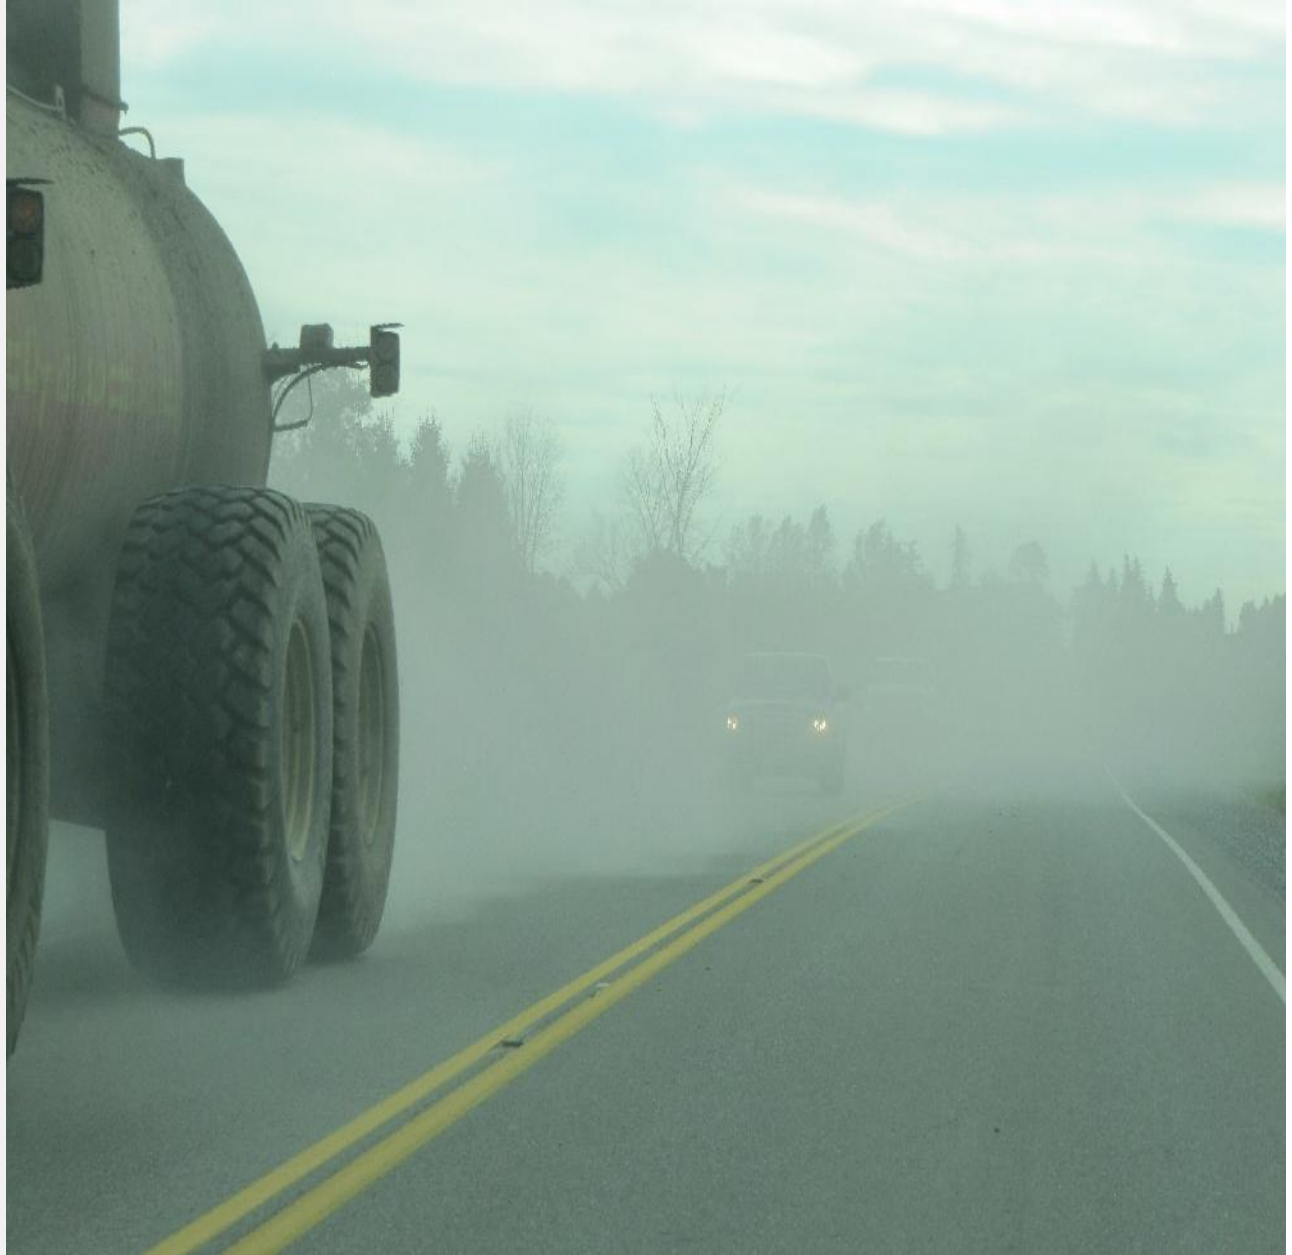
And you can't tell what's ahead of you. But drivers following behind the farm vehicle are also blinded. This is a good time to be alert for impatient drivers who decide to pass even though they cannot see - and you will be the recipient of that misjudgment.

Blinded and impatient drivers could enter into your lane.

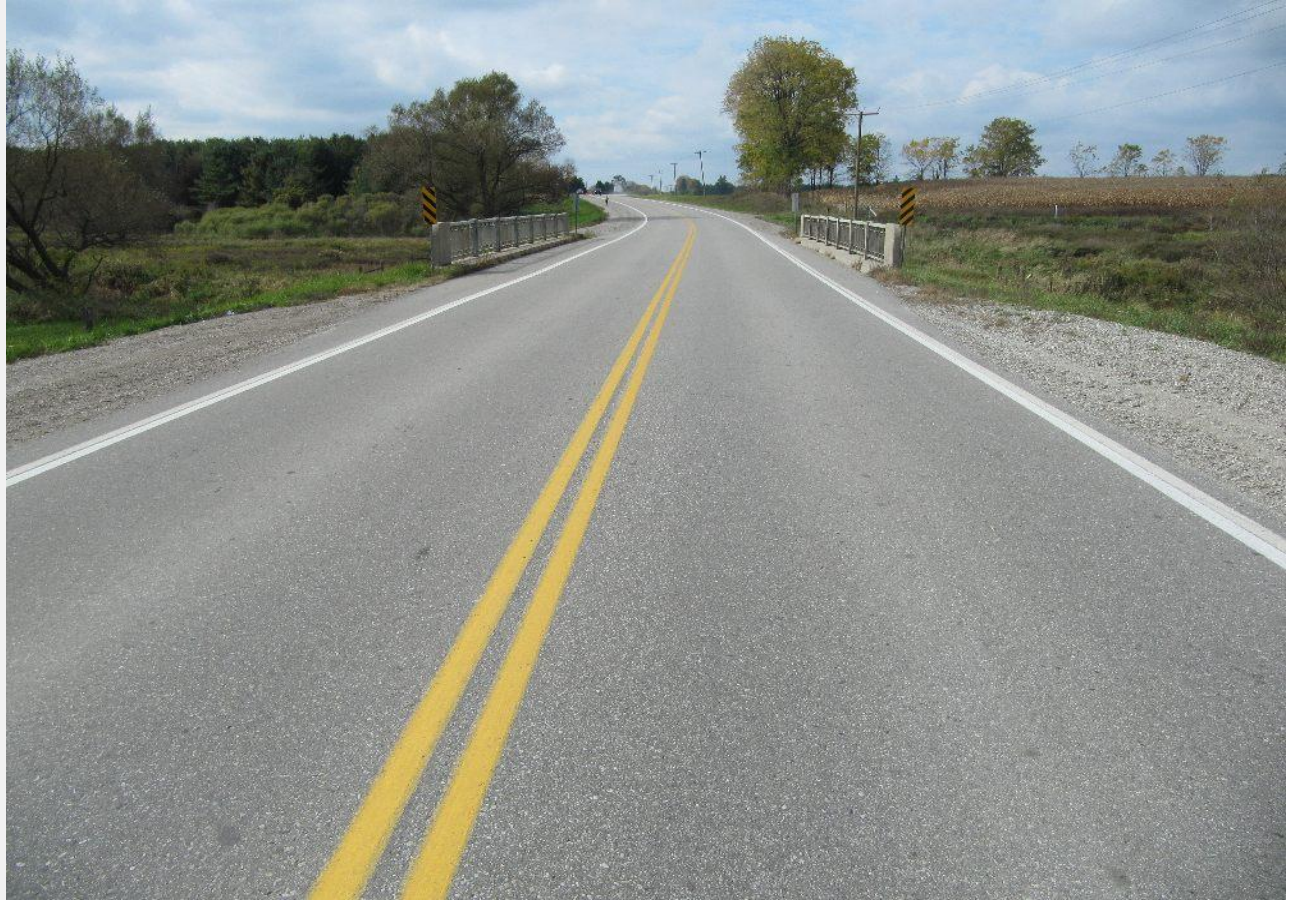
The photo below is looking westward along Road 88, taken from approximately 300 metres east of the area of impact. The westbound vehicle travelled onto the right (north) gravel shoulder a short distance beyond the bridge shown in this view. Then it crossed the road and its left side wheels travelled on the south gravel shoulder. It then re-entered the road while travelling sideways, leading with its left side, and was struck by an eastbound vehicle.

View, looking west along Road 88 from approximately 300 metres east of the area of impact. The point of impact was located approximately 225 metres west of the west end of the bridge seen in this photo.

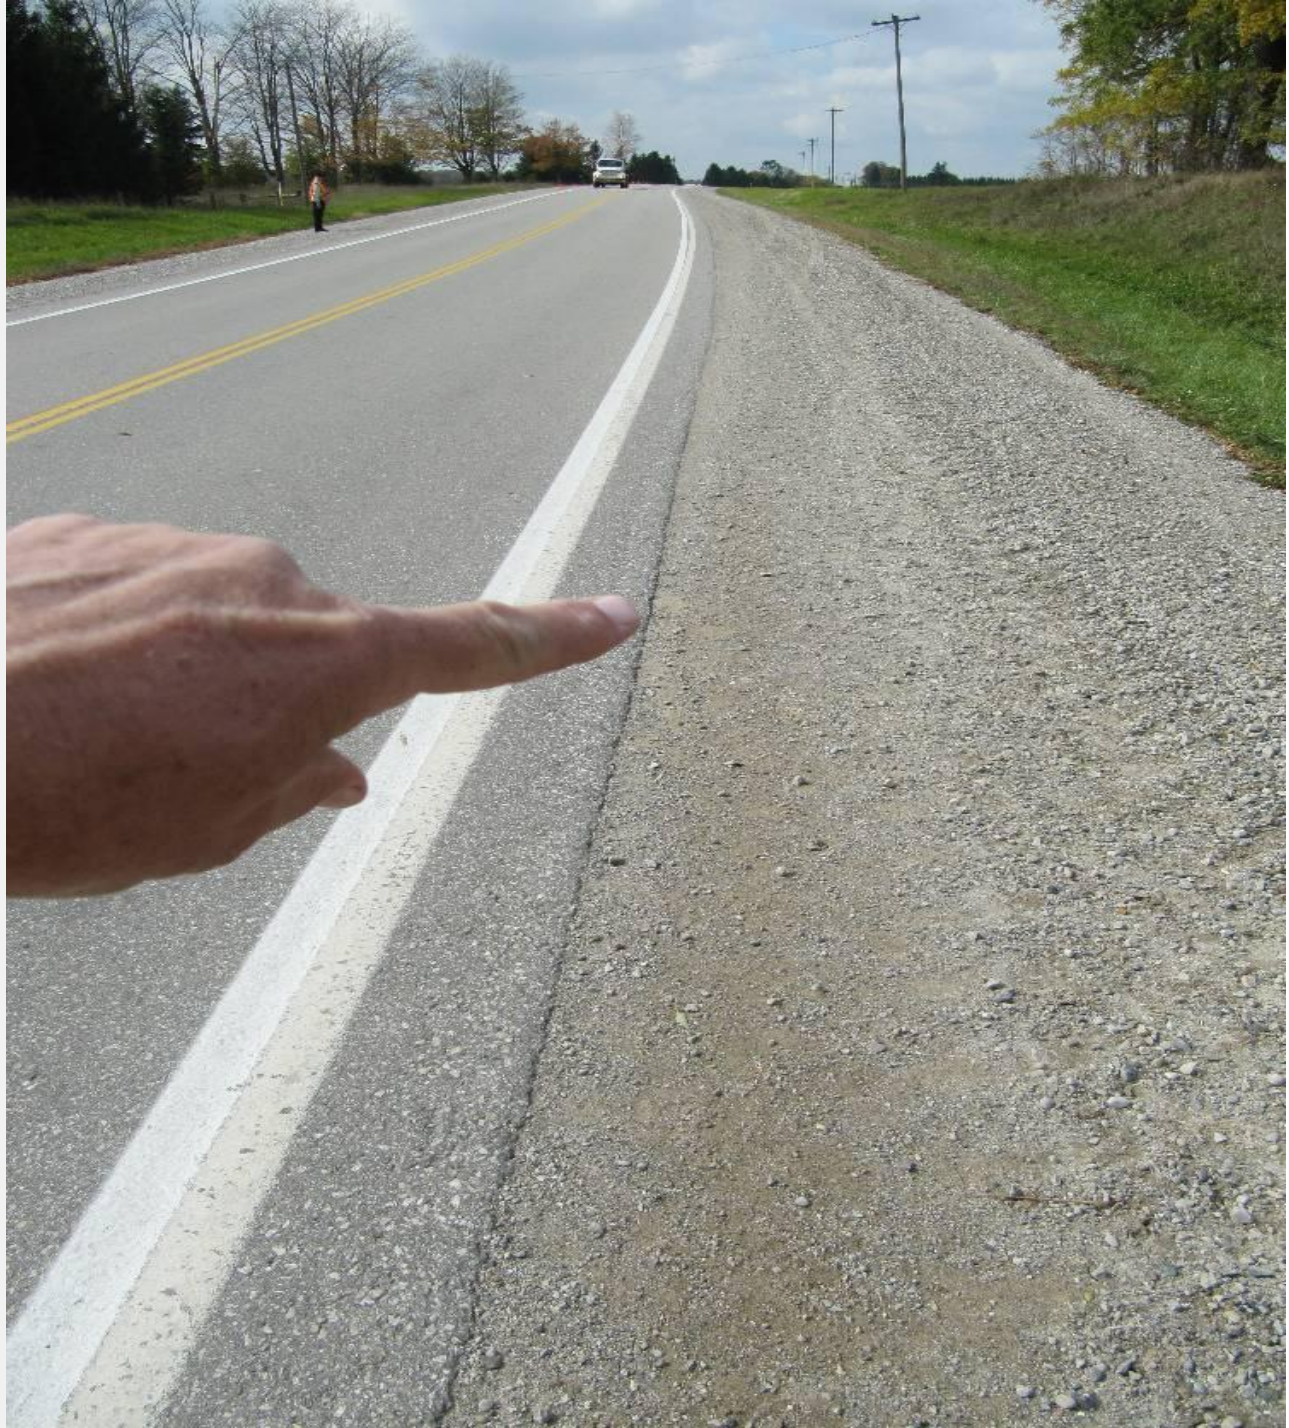
The photo below shows the tire mark on the north gravel shoulder where the vehicle first left the road.

View, looking west, along Road 88. The finger is pointing to a tire mark on the right (north) shoulder where the vehicle initially left the road surface.

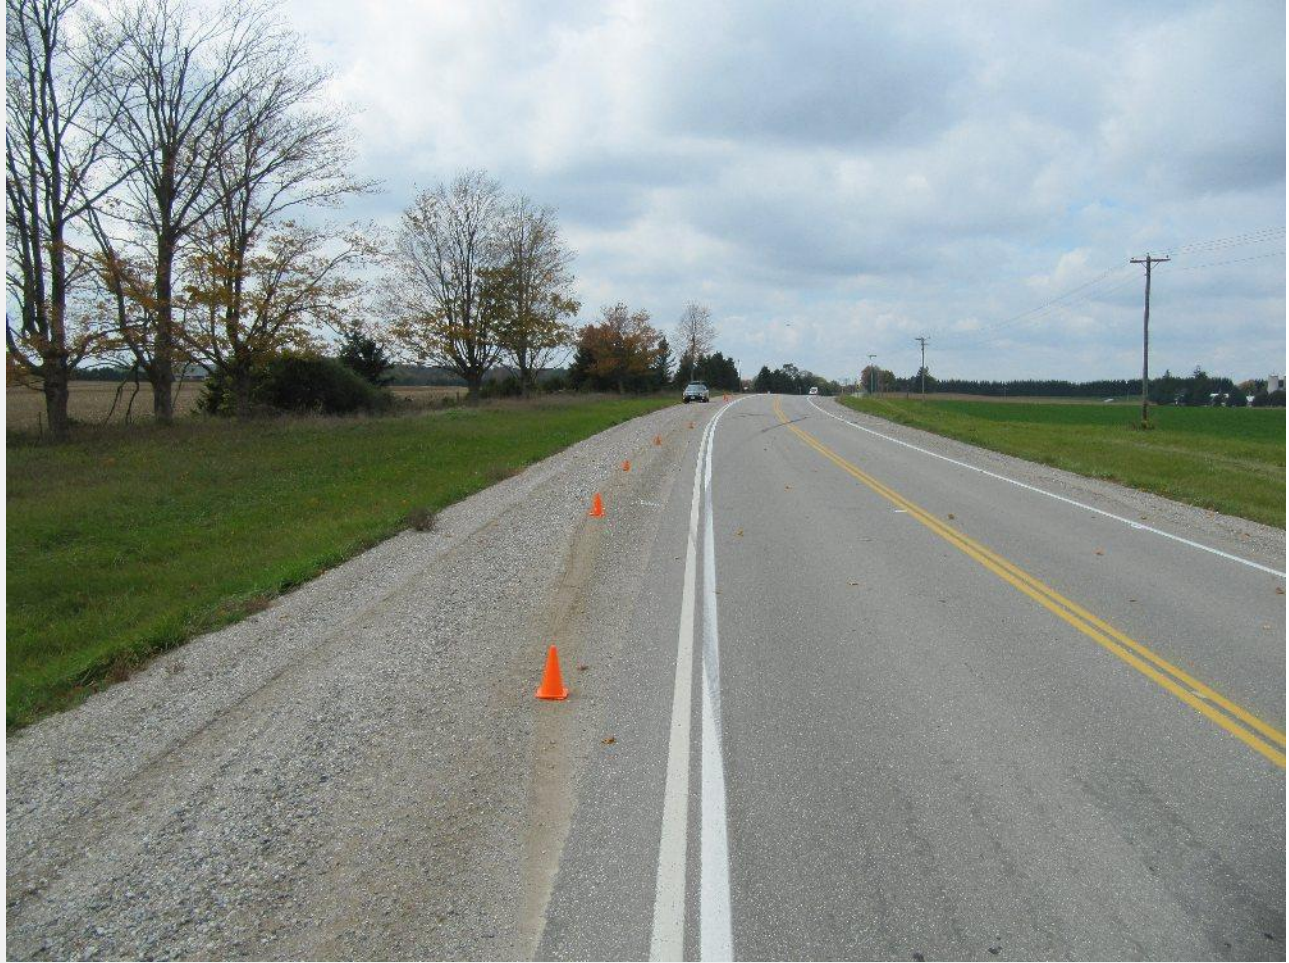
The photo below shows the tire mark on the south shoulder where the vehicle entered and then exited, returning to the road surface where the impact occurred.

View, looking west along Road 88. The orange cones show the path of a tire mark on the south shoulder where the westbound vehicle entered and then returned to the road where the impact occurred.

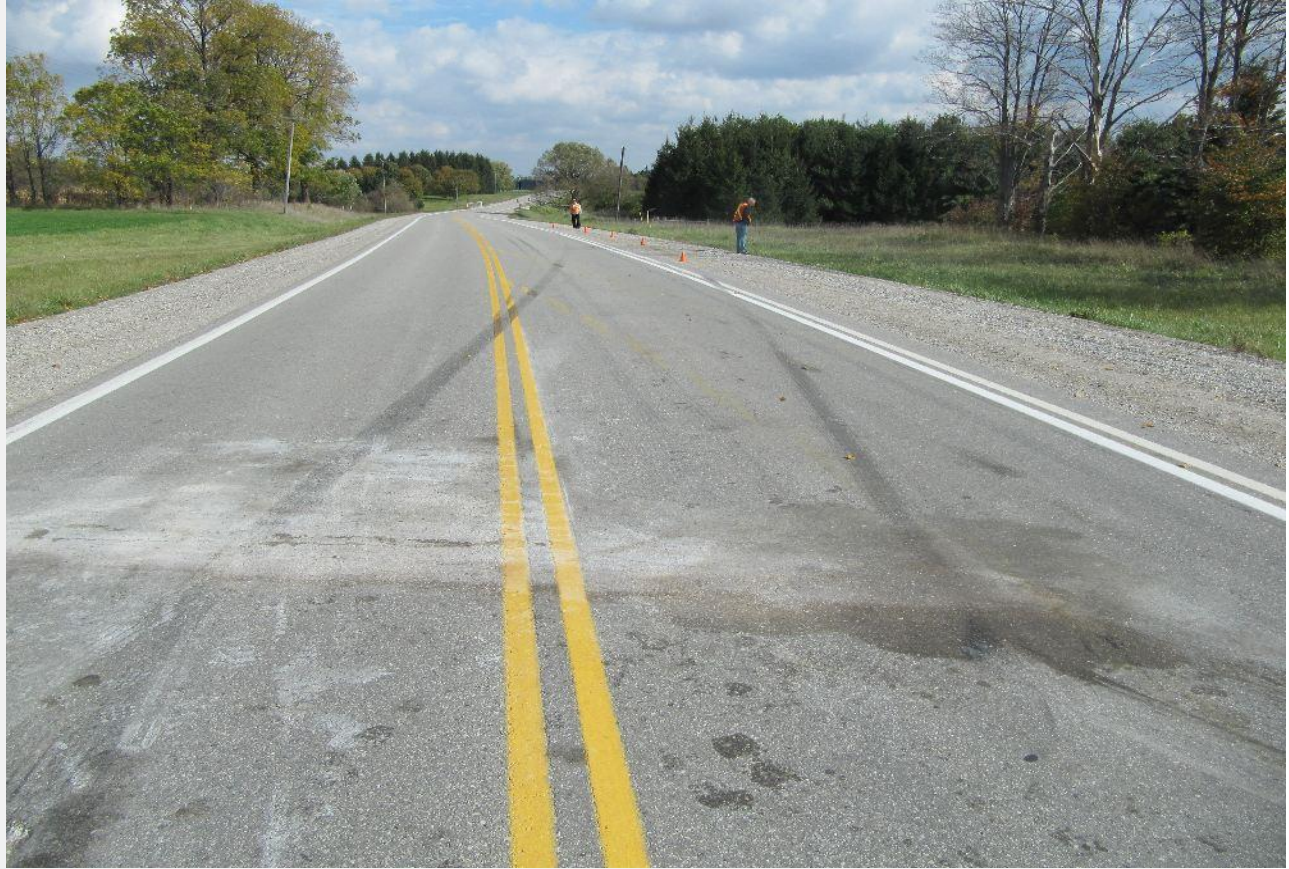
View, looking east along Road 88, from just west of the area of impact. the curve and pre-crash tire marks on the shoulders are located in the background.

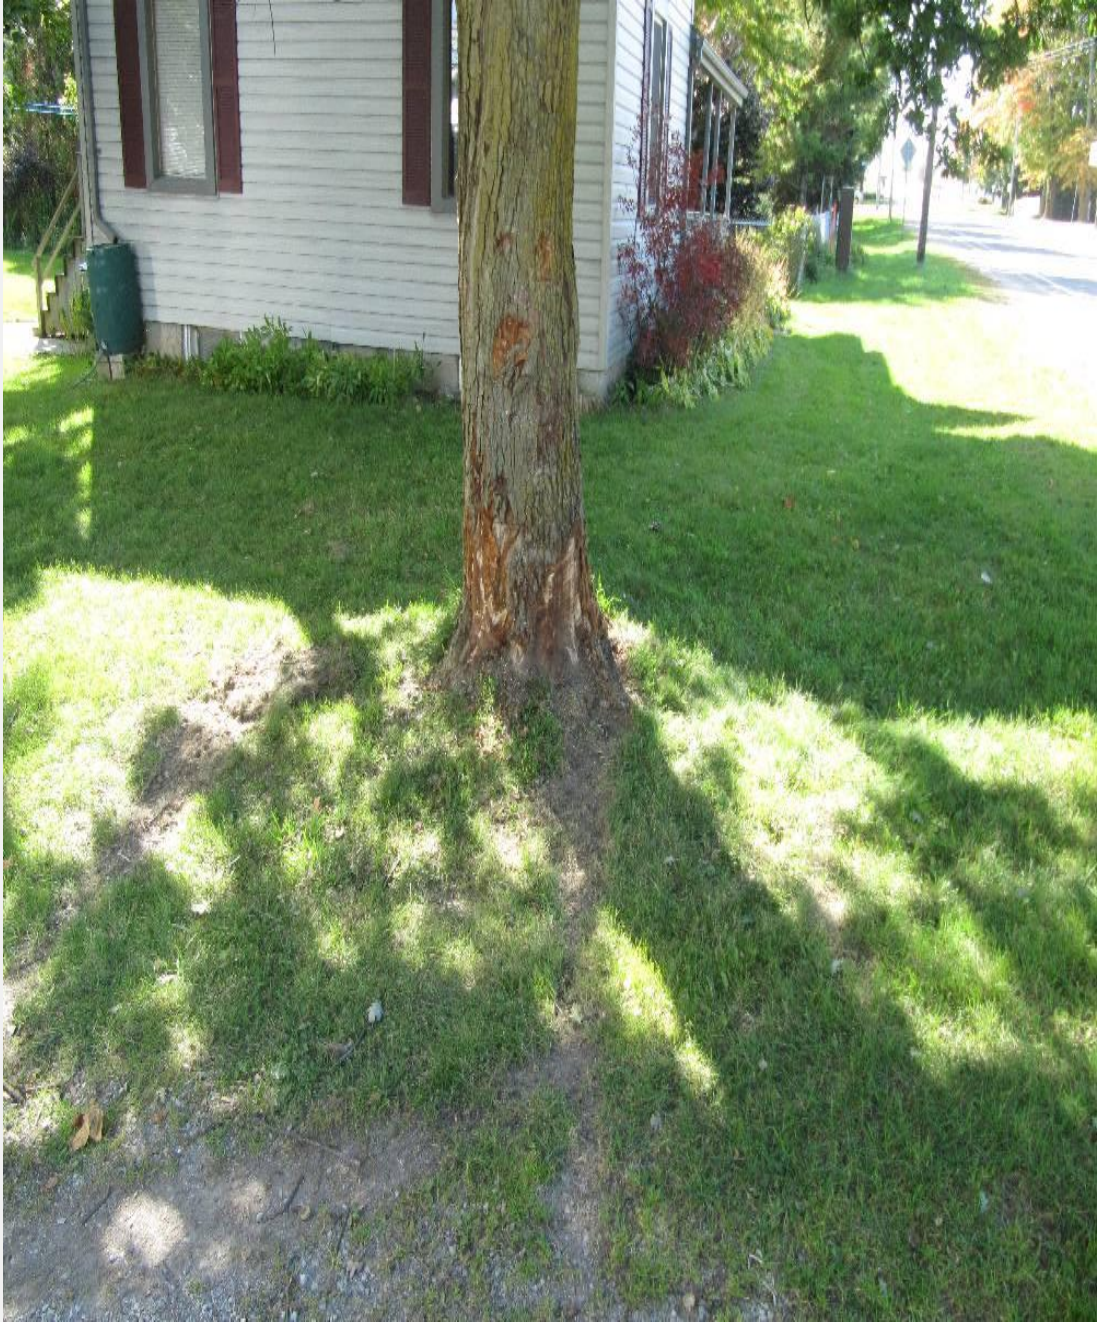
Jody Williams, 41, was driving a Honda Civic westbound on Perth County Road 20, just east of Fullarton Ontario on Friday, September 28, 2012, when her vehicle rounded a curve, the vehicle went out-of-control, and collided with a tree. The pre-impact travel of her vehicle onto a gravel shoulder has resulted in our evaluation whether this was one of the factors that influenced the crash. You can read our article discussing this issue in the Articles webpage of this website.

View of struck tree in Fullarton Ontario where a Honda Civic Driver sustained fatal injuries
