67-Year-Old Female Driver Fatally Injured Near Mt Brydges Ontario Is Another Lesson To Be Learned

Posting Date: 07 Oct 2010

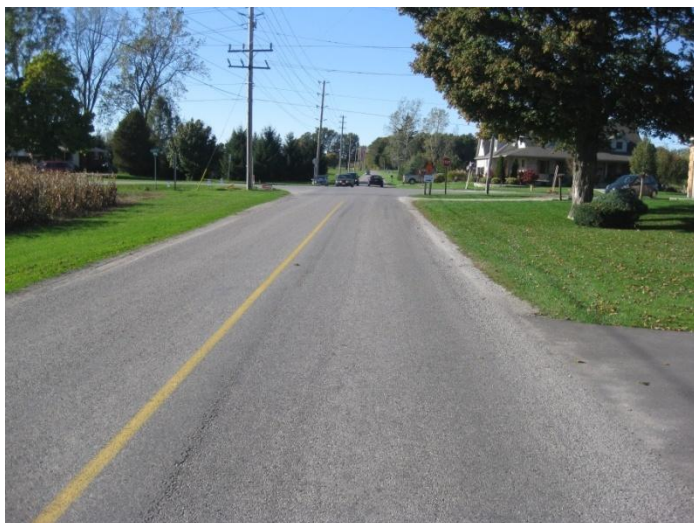
First I want to show you the roadway (Rougham Road) on which the woman was travelling northbound as she approached the intersection at Glendon Drive and below is a view looking north toward that intersection.

Nothing unusual it would seem. A typical, semi-rural intersection. But did you notice the orange Detour sign near the stop sign? How about a closer look? Below is another view just south of the intersection and looking north-east at the Detour sign.

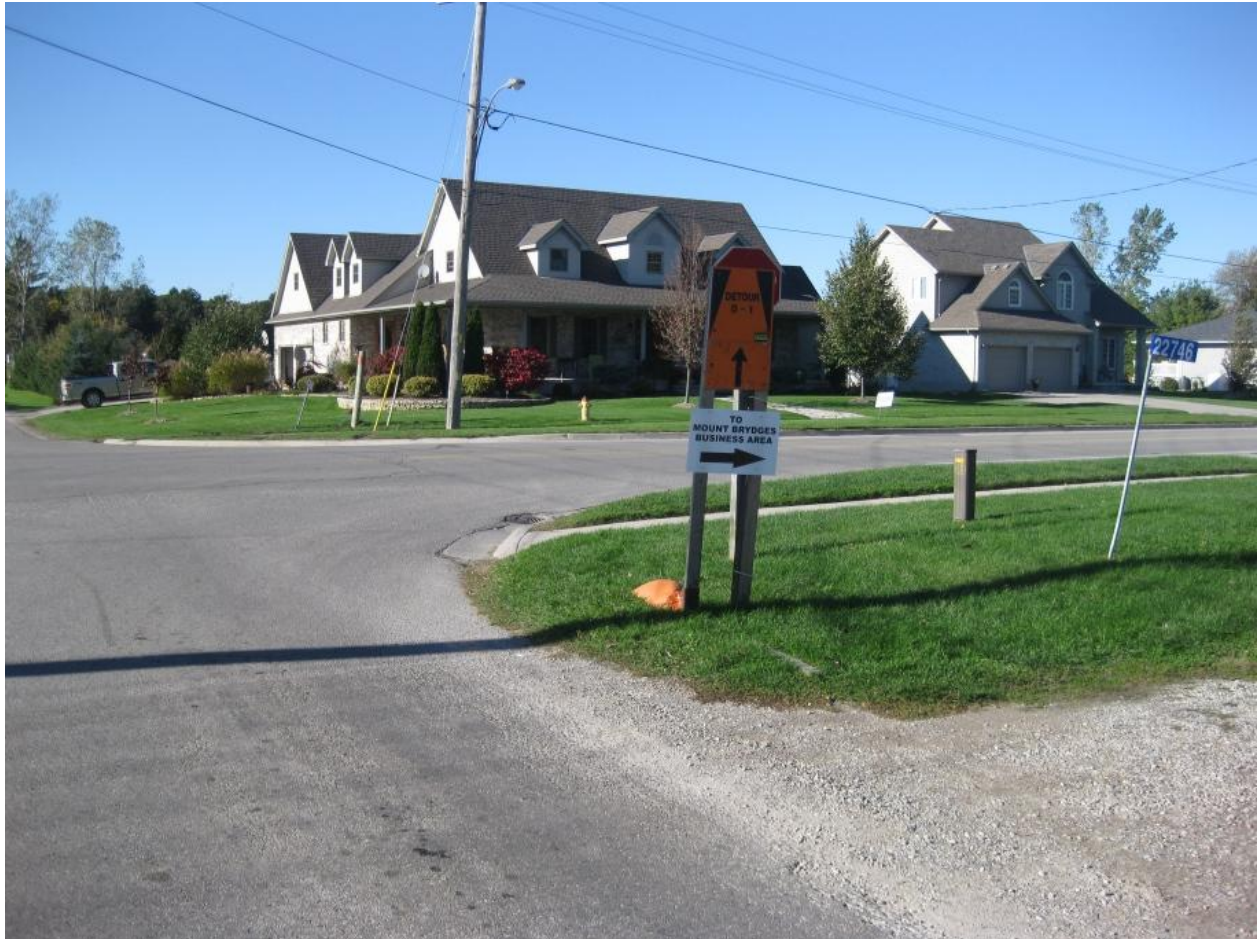
It's a nice Detour sign. Orange. Quite visible. Certainly having it placed where it is makes drivers know precisely where they must go. But the background is somewhat cluttered. There is something behind that Detour sign that is not making it stand out as it should.

So is there a problem? Certainly it does not help that the Detour sign for northbound traffic actually blocks the view of the stop sign for northbound drivers. That may not be a significant problem but one really knows. Heavy rain might have been falling. The driver may have been distracted by other events as she moved toward the intersection and she reduced her speed without actually being certain whether there was a stop sign for her direction or not. She might have glanced toward the direction of where the stop should be but she only saw the Detour sign because the stop sign happened to be directly behind it. So she might have continued into the intersection without stopping.

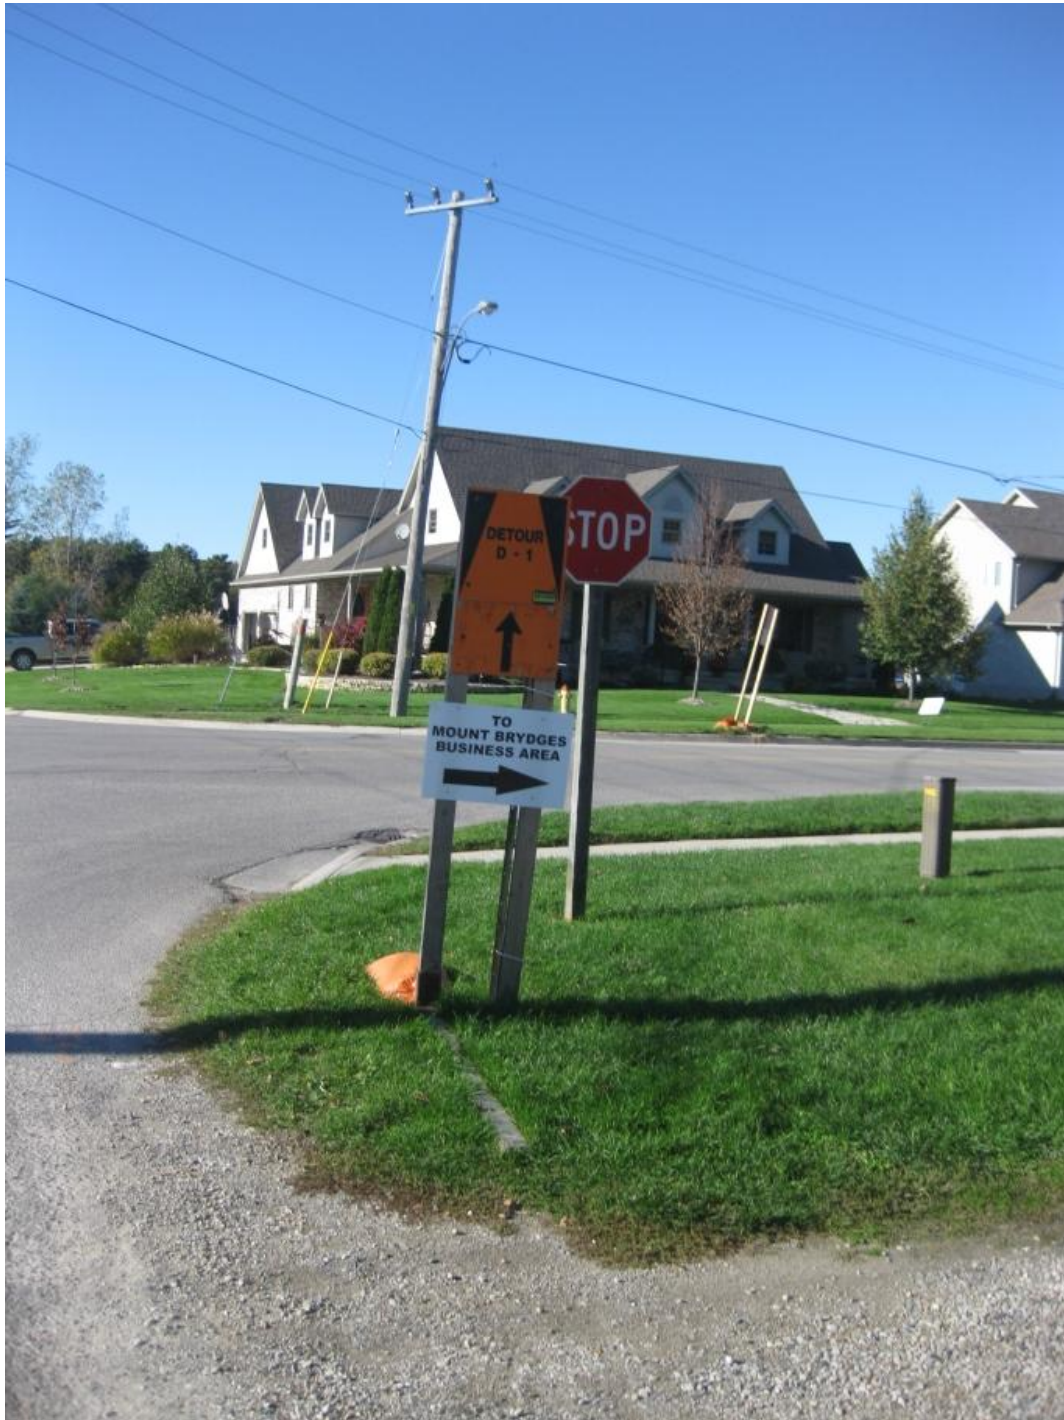
So let's move our camera over a little bit and take another photo as shown below.

Oh, O.K., there was a stop sign behind that Detour sign. But it's O.K. now because we moved over a bit and exposed it. No problem right? Or maybe not. Remember that this driver reportedly travelled through a stop sign and therefore she is likely to be at fault for the collision but she is no longer available to explain. While the Detour sign only blocks the stop sign for a brief distance and time why is it placed there anyway? Is there no

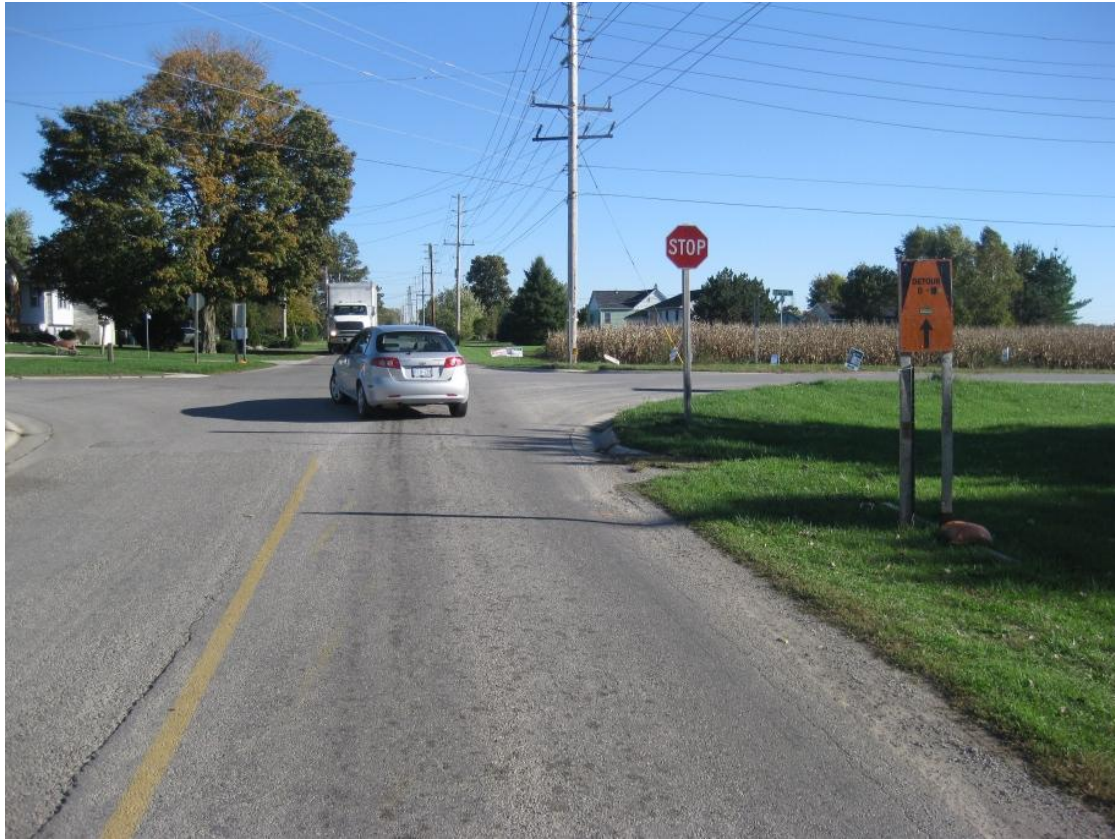
better place to position a Detour sign? Let's look on the opposite side of the intersection and see where the Detour sign is located. The photo below shows a sound bound view on Rougham Road toward the intersection with Glendon Drive.

It should be clear that the Detour sign for southbound traffic is clearly out of the way of the view of the stop sign. The Detour sign for southbound traffic is positioned further away from the road so that it does not interfere with the driver's view of the stop sign.
