Guilt In 17-Yr-Old Driver's Fatal Collision of September, 2008 Is Evaluated

Posting Date: 22 Jul 2010

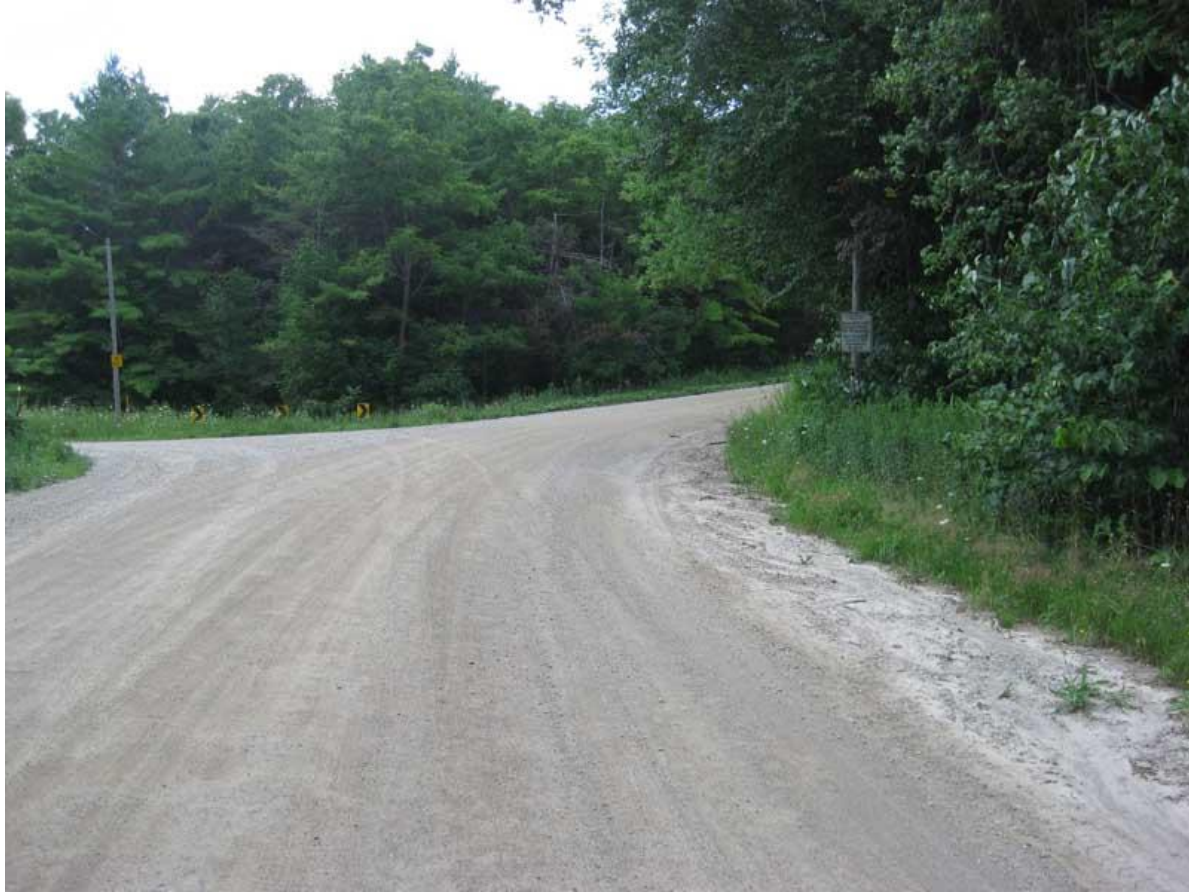
I also say this because of the relatively short distances and sharp curve involved. We need to examine some photos to appreciate this. The case caught my curiosity so I attended the collision site yesterday and took some photos. The photo below is a view looking northward along the path that the Escort took as it approached the right curve.

I want to draw your attention to three, yellow, chevron markers that are in place to inform drivers that the road changes direction sharply to the right (more on this follow). What you should recognize is that this is a sharp curve or that the radius of the curve is very small. In such a case the distance needed to exit the roadway at the curve is very small. For example, if we look at the angle that the Escort travelled toward the impact with the tree, the distance from the normal travel path of a vehicle to the left edge of the road was about 6 metres. Then there was an additional 10 metres of distance through the under-brush to the tree. It would not be uncommon for drivers to travel 70 km/h on roadway that is posted for 60 km/h. In fact, the maximum speed must be set 10 km/h below the "design" speed of a roadway.

If you looked closely at the first photo you would have observed the position of the three chevrons that are to the left of the travel path of the approaching vehicle. Where would the vehicle's headlights be pointing as the vehicle is approaching the curve? Certainly not at the signs but to the right of the signs. Furthermore, the design of headlights is

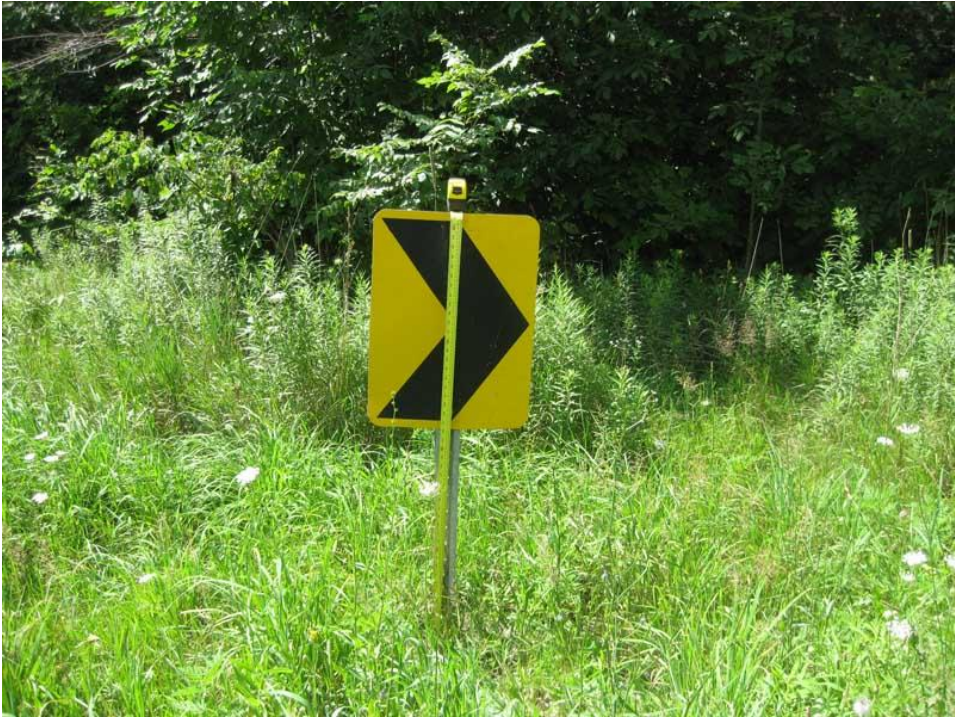
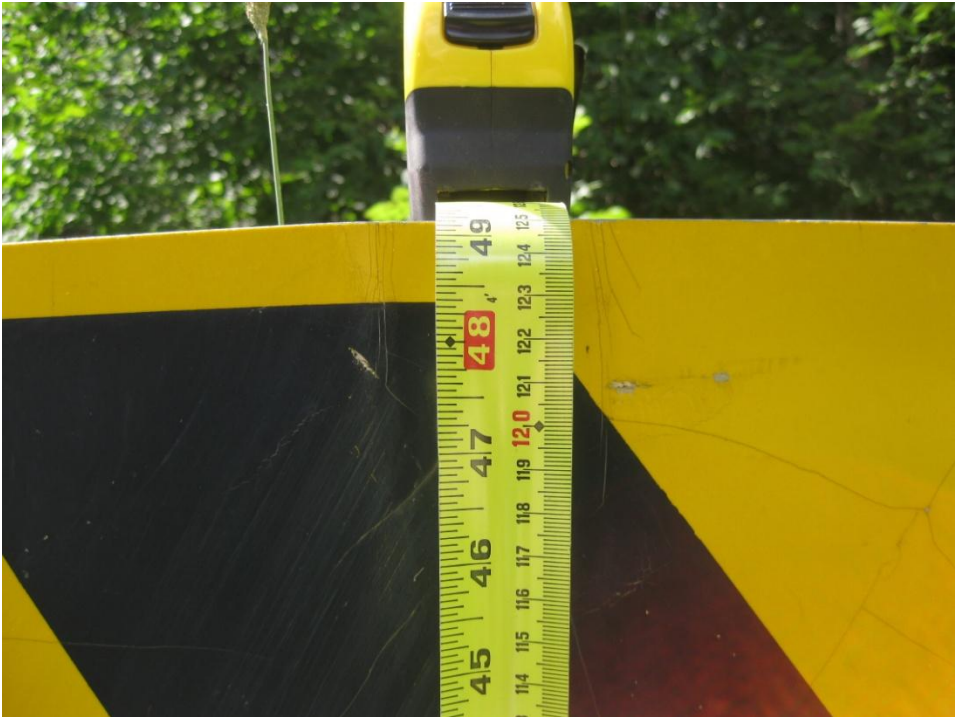
Below is a photo showing my measurement tape placed on top of the east chevron which is the one closest to the vehicle's travel path and therefore the one that would be most exposed by the vehicle's head-lights. Then the photo after that shows the reading of about 125 centimetres above the ground.

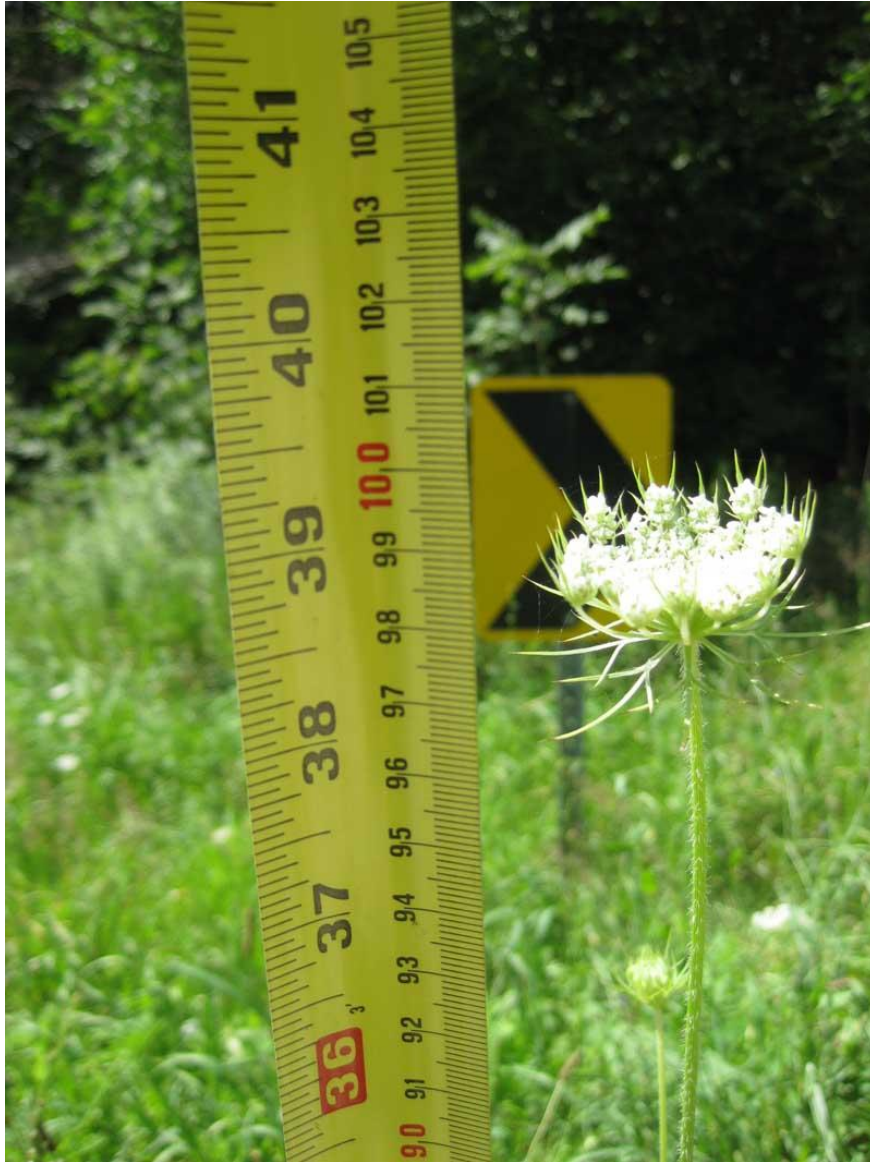
Is there a problem? Well, let's look at the surrounding vegetation on this bright July day. Oh, and recall that the actual collision occurred in September or perhaps two, weed-growing months later than what I show here. The photo below shows my measurement tape identifying the tallest weeds in front of the noted chevron.

You should see that the weed height approaches about 100 centimeters. What will happen with this by September? Many of the weeds will grow much taller and block the view of the sign. But this is daylight and the sign appears visible. What would happen at night-time? Let me go on.

such that illumination of areas to the left of the vehicle is reduced to prevent glare from blinding on-coming drivers. So not only are the headlights not pointing at the sign but the effectiveness of the headlights would also be reduced due to the positioning of these signs. And if the signs are masked by tall weeds then it is understandable that the signs may not be visible to the driver in time to warn him.

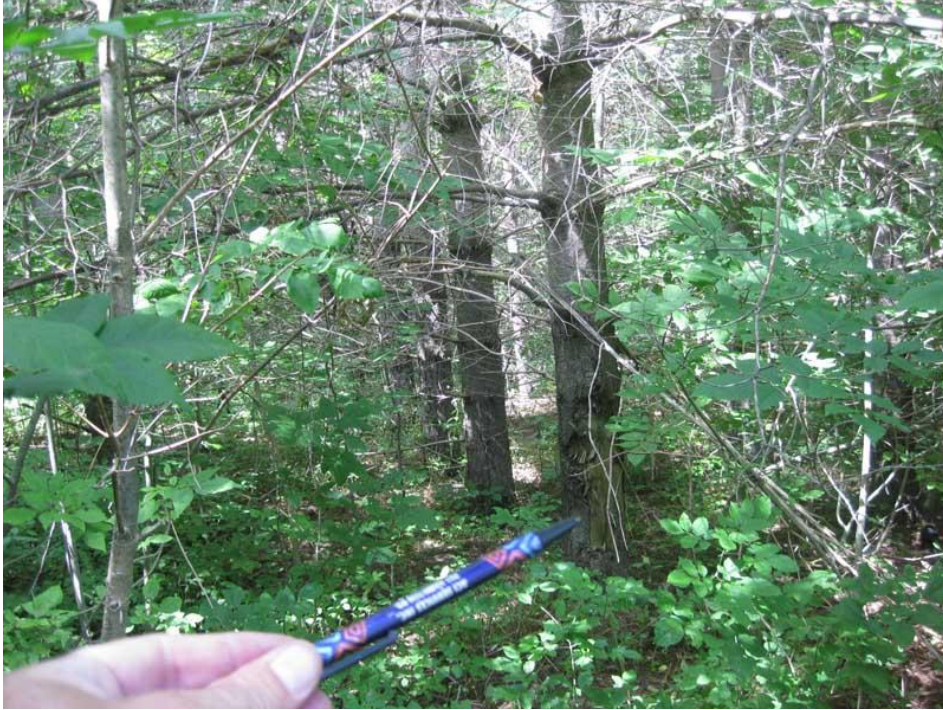
Did anyone inform the court whether other collisions also occurred at this site? I will venture to say, probably not. But let me demonstrate. In another portion of the roadside I found another tree which is shown in the photo below.

Why is there a big scar on this tree some 15 metres into the brush? Below is a closer view.

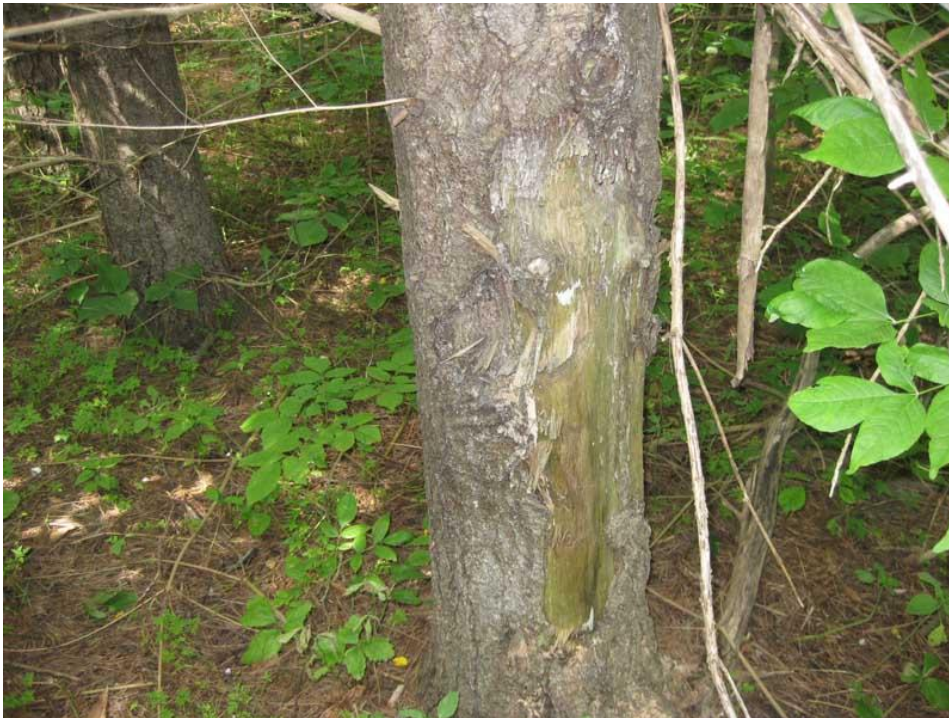
Maybe the lawyers would conclude that a wandering bear (or elephant?) happened to work on it. But I know that this damage is from another collision. If someone had looked

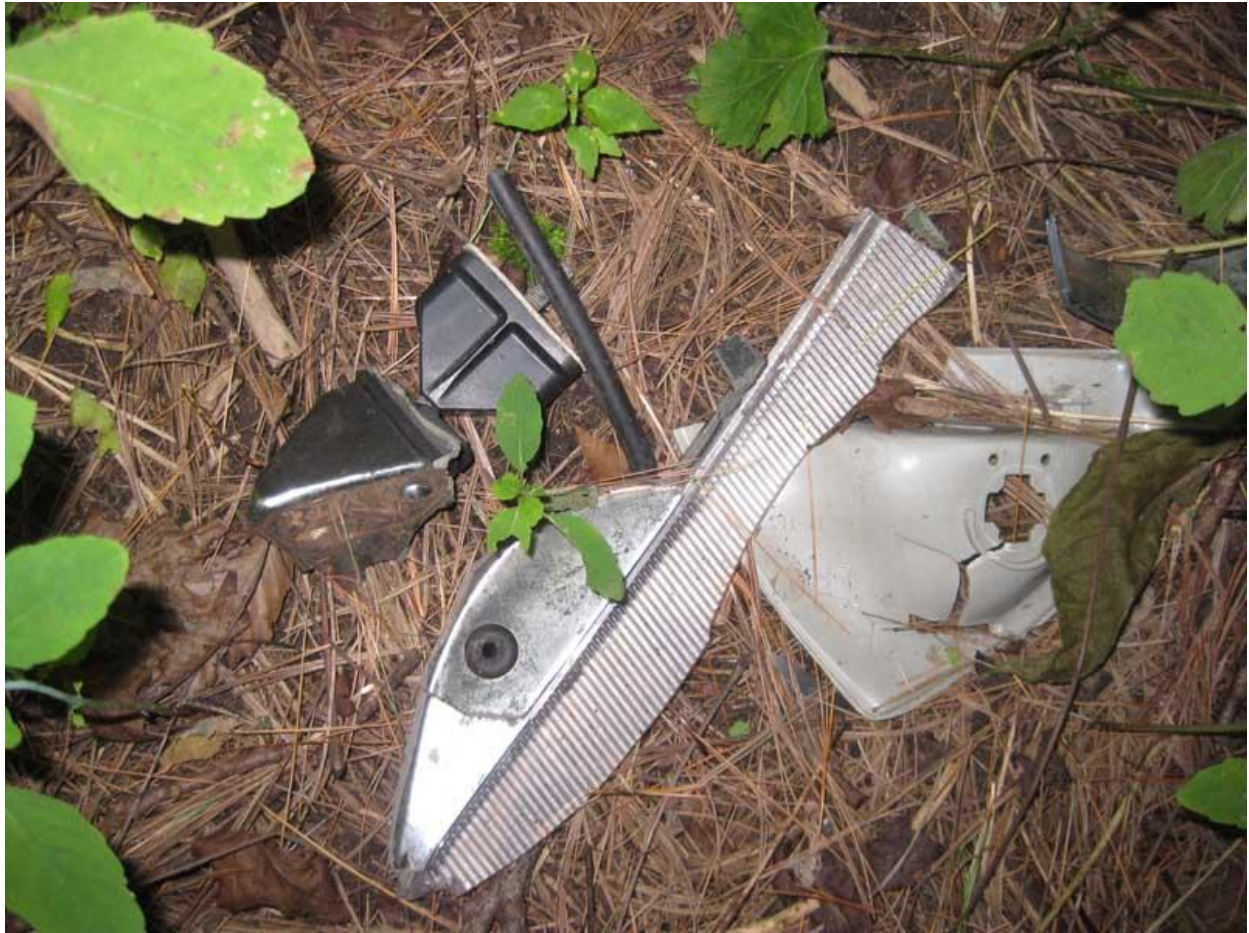
around the tree they would have observed what I did. Some of the evidence is shown in the photo below.

This debris is not from an Escort's roof colliding with a tree. It is from the front end of a different vehicle. So now you can look at the tree damage and know what type of damage is caused to a tree from such an impact. But the Escort must have really caused a lot of visible damage to the tree that it struck if it was speeding - wouldn't it? Well let's take a look. Below is an overall view with my pen pointing to the area

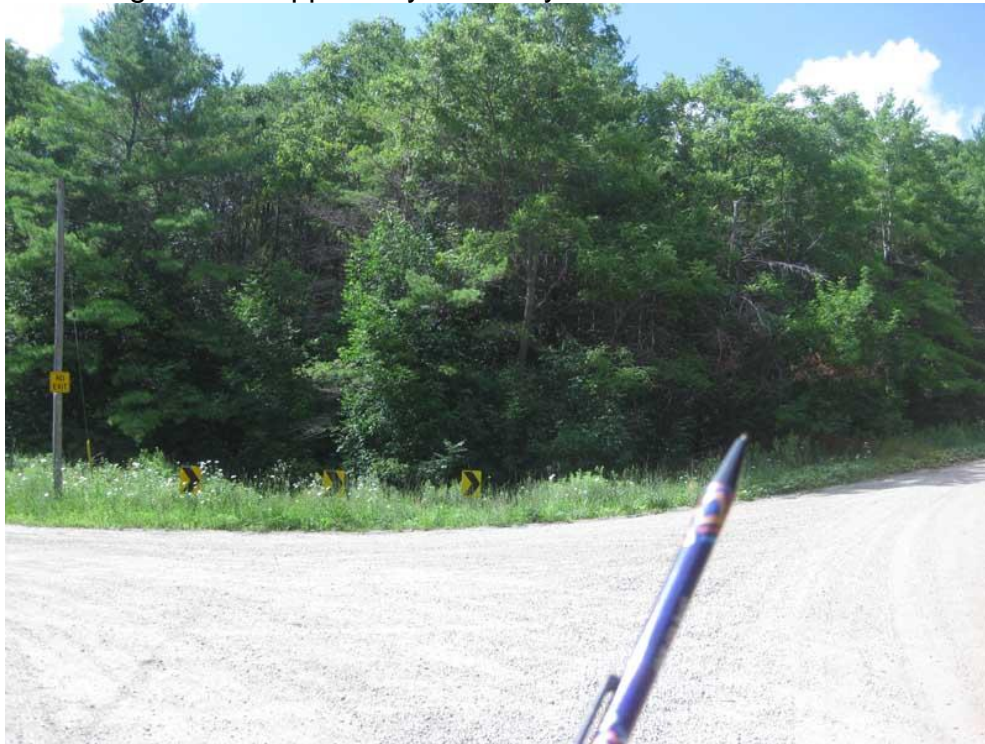
containing the tree apparently struck by the Escort.

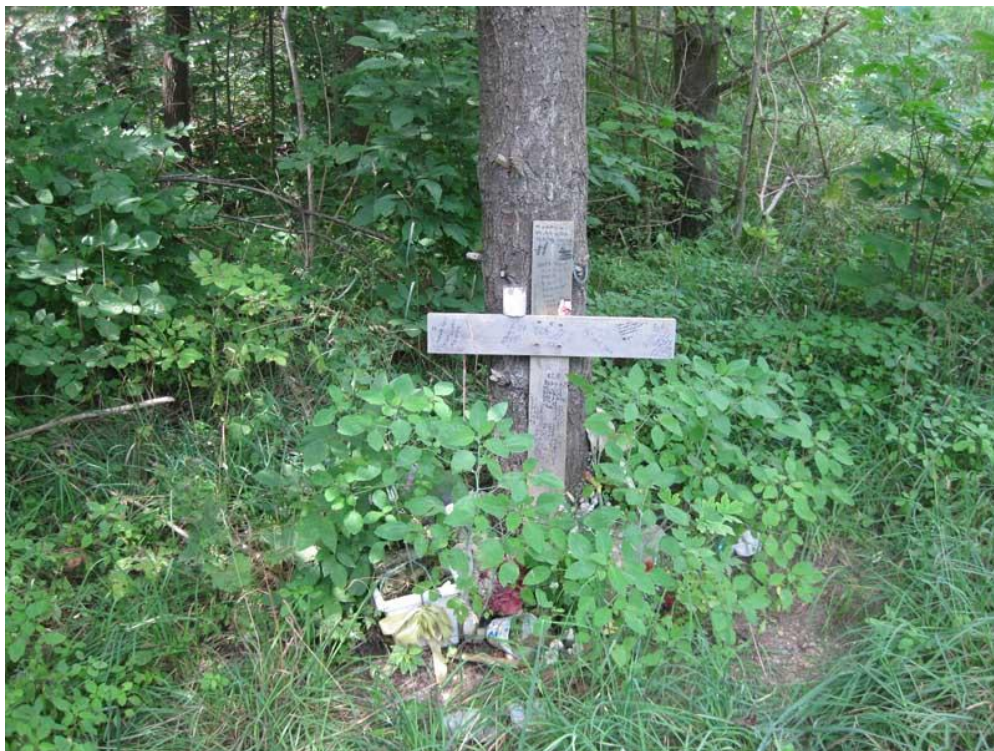
Now the view below is a closer view where we can see the actual tree and a wooden cross erected at the base of the tree as a monument to the tragedy.

Look at the tree. Where is the large scar that was evident in the previous impact I showed you? There is essentially nothing there. I looked closely. Yes there is a minor tear in the bark as shown below.

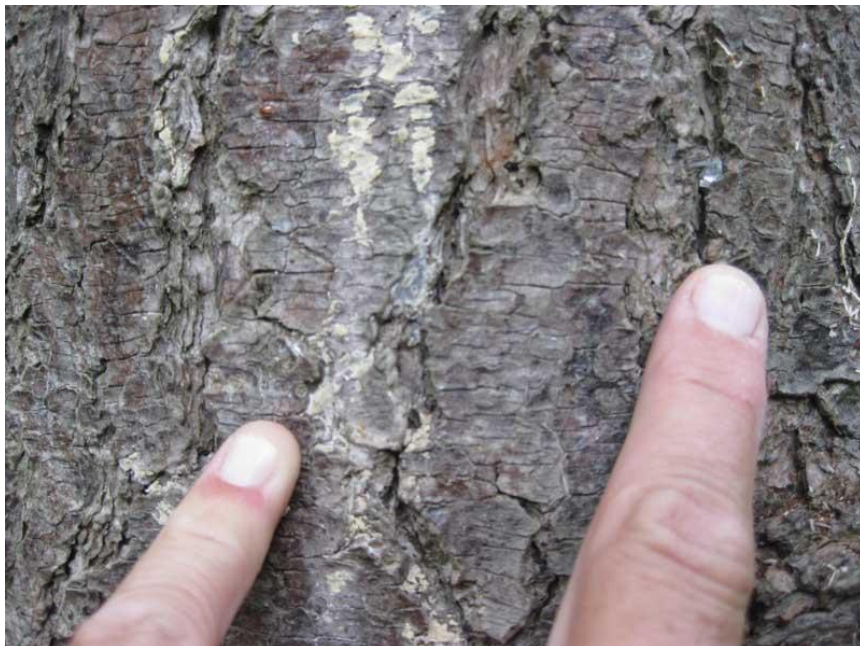
But surely this is minimal compared to the earlier tree damage that I showed you. The only other evidence on the tree is some glass fragments still clinging in the bark as shown in the photo below.
