Horizontal Posts, Fence Boards, Etc. Are Unknown Roadside Dangers

Posting Date: 26 Mar 2011

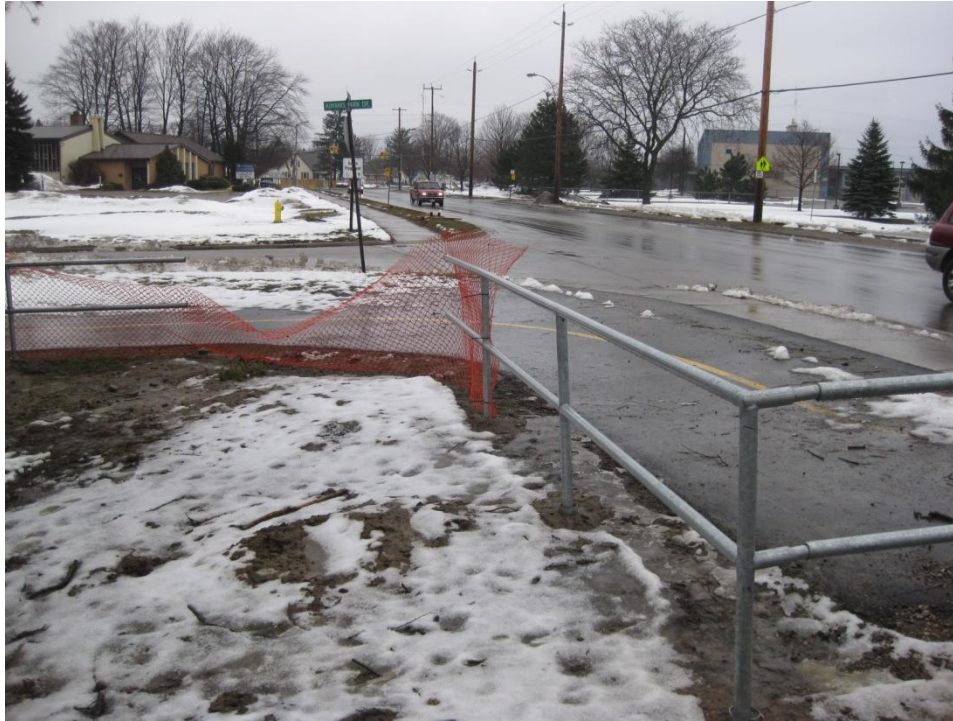
Below is a photo of an unfinished metal-tube railing. In the background, across the street, is one of the two primary schools I was mentioning. This situation has existed for several weeks now.

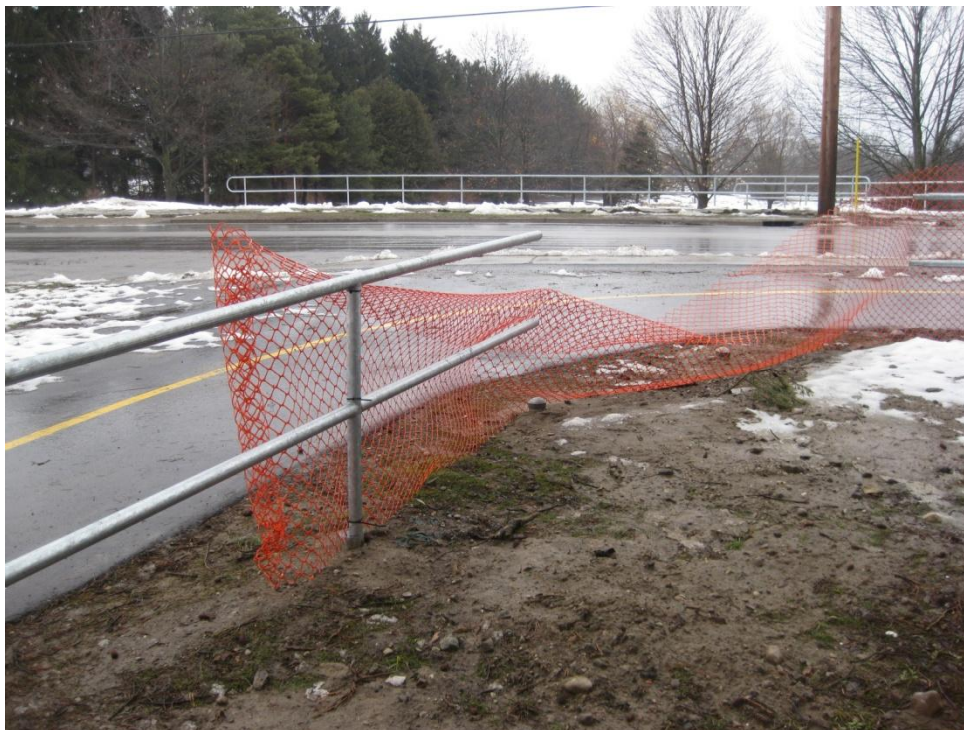
Somehow the workers felt it would protect someone if they placed a bright orange "blanket" over the problem so it cannot be seen. But the photo below shows the extent to which the harpoon awaits the unknowing public.

Thousands of drivers and pedestrians pass this relatively busy road every day but I am sure no one recognized the danger.

This particular railing will likely harpoon passenger cars and pick-up trucks or vans. But there is another chain link fence across the road that I have not been able to photograph yet which is the tall one similar to what harpooned the school bus passenger that I discussed on Highway 401.

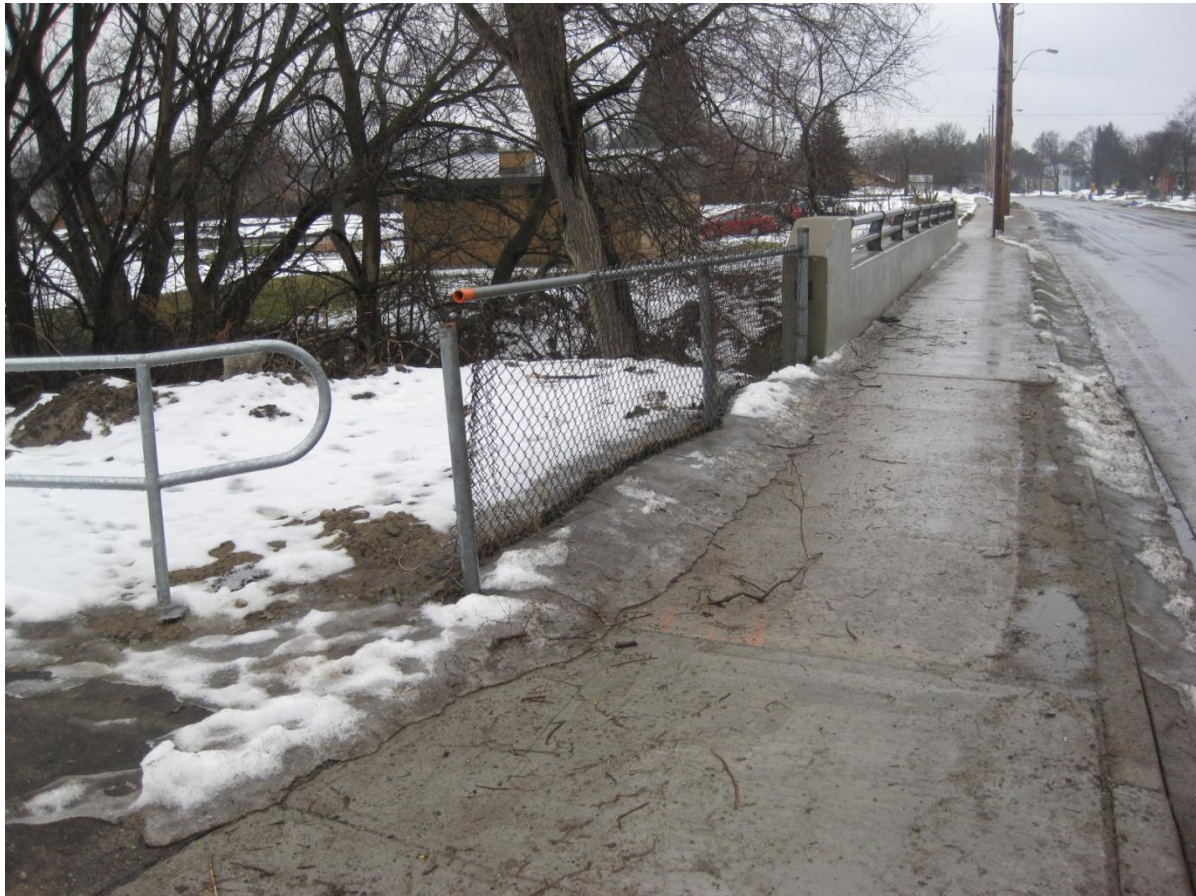
Below is a photo taken from just the other side of the small bridge where I took the photos of the incomplete railing. Here we see another harpoon.

This time the workers were considerate enough to spray some orange paint on the end of the harpoon. Like an invisible force field this orange paint is going to deflect any wayward, out-of-control, 2000 pound vehicles away from the harpoon. OK, maybe I am becoming too sarcastic. But it is frustrating to see these things on a regular basis.
