Death of 17-Year-old Lyndal Huber Marks Annual Beginning of Roadway Killing Season

Posting Date: 21 Mar 2011

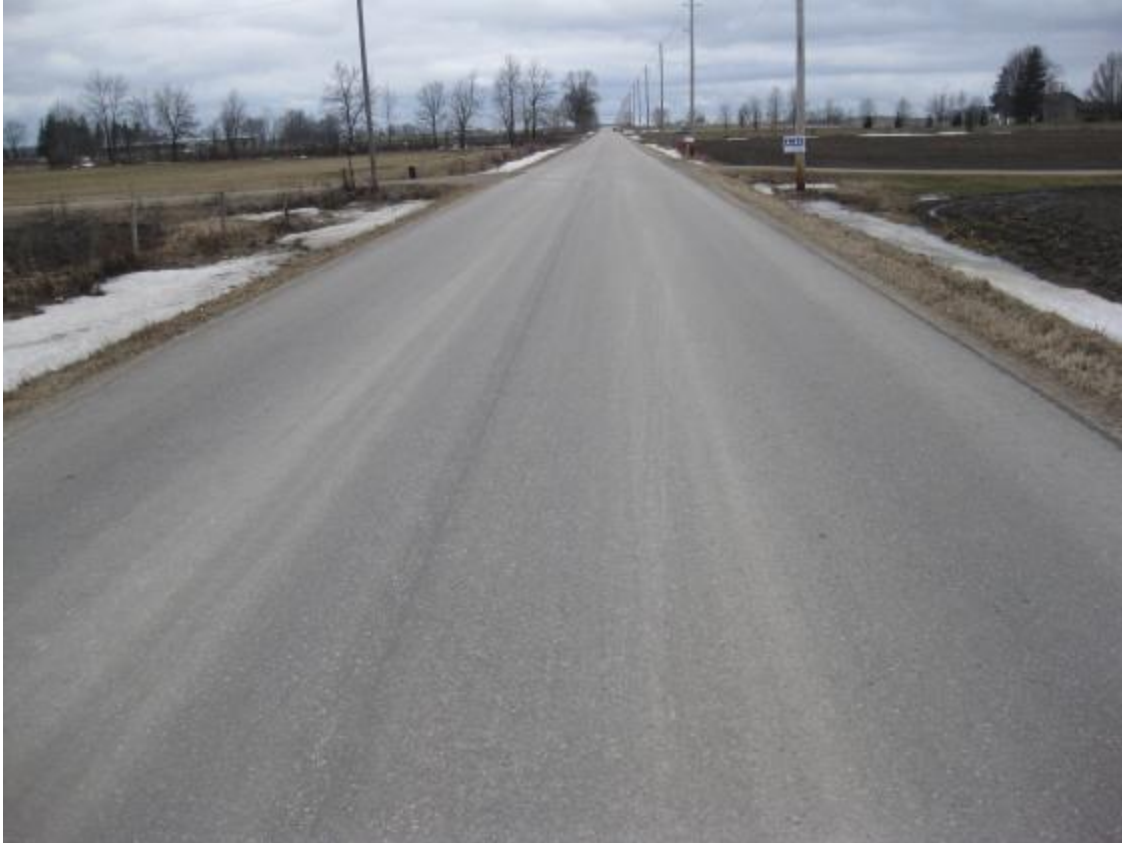
I attended the collision site this afternoon and have the following photos and comments. Perth Road #92 where the accident occurred is a very straight and level roadway. Below is a photo looking west from about 400 meters east of where the Taurus struck the utility pole.

If you look in the far background on the right side of the road you should see a black "speck" which is my black Buick Regal parked on the road just past the pole where the impact occurred. It is a good idea to go back at least this far to examine the road for any relevant issues since sometimes vehicles can travel along a straight and flat road like this at incredible speeds. For example at approximately 145 km/h a vehicle travels about 40 meters every second. So the distance from what you see above to where the impact occurred could be traversed in 10 seconds. You might say 10 seconds is a long time but you never know.

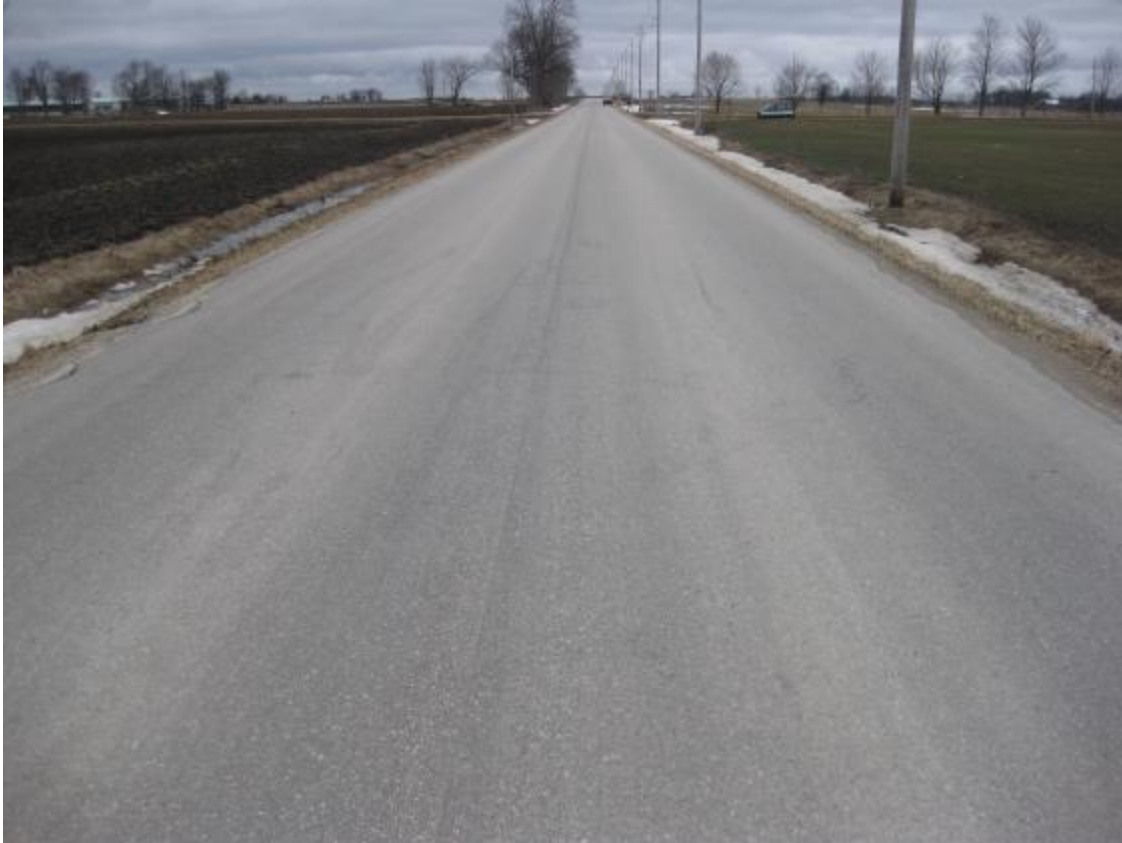
Below is another photo taken from 200 meters east of the point of impact (POI) or pole.

If the vehicle had been involved in some typical loss-of-control events then you would start to see tire marks (yaw marks) on the pavement by about this location. But notice there are no tire marks here. I'm sure you are already looking at the orange cones in the background thinking that they show some collision evidence - and you are right.

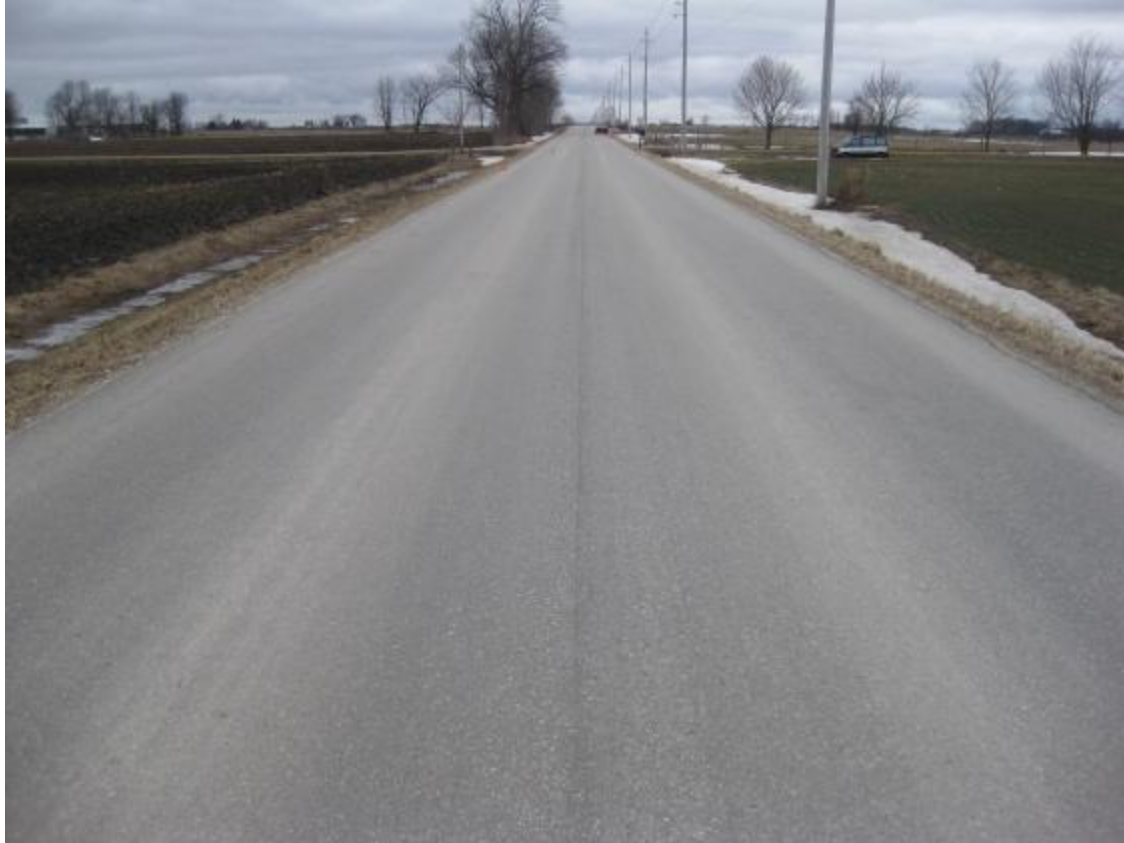
The photo below was taken from 150 metres east of the POI (Pole). Now you should start to see two small orange cones on the left asphalt edge where the first visible evidence was produced by the vehicle.

But wait, you say, the vehicle was travelling westbound or the same direction as this photo, and we don't drive on the left side of the road like in Britain - so what is the vehicle doing way over on the left side of the road? Let's take a closer look.

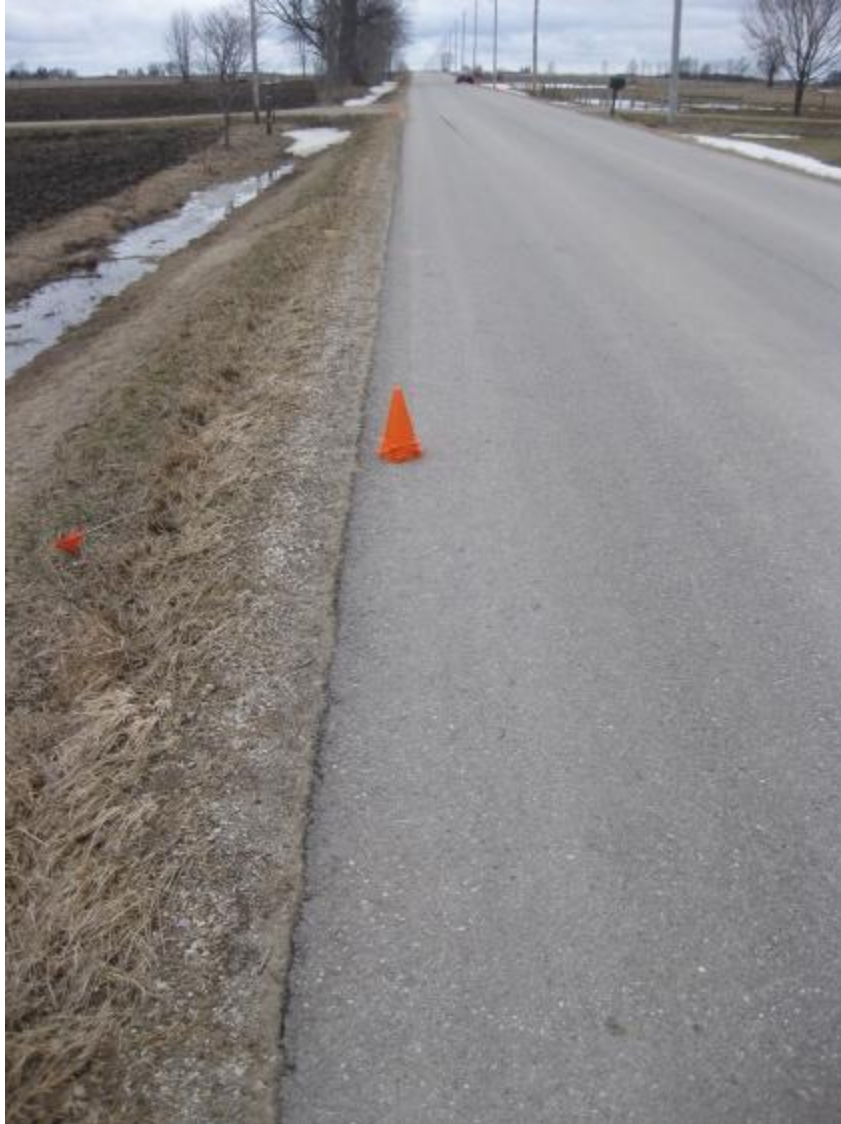
The photo below was taken from 110 metres east of the POI. The cone you see in the foreground marks the location of the first visible evidence caused by the Taurus. This evidence is in the form of a tire braking mark that is travelling off of the pavement and onto the narrow strip of gravel on the south roadside.

If you look further in the background you will be able to pick-up the right side skid mark that is darker and on the pavement. I can tell you now that it is not a good idea to be skidding with your left side tires on gravel and the right side tires on pavement. This is what classically results in the loss-of-control effect that has occurred here.

Note that the visible braking marks start at about 105 metres east of the POI. Even if we assigned an overall deceleration rate of $.4g$ over that distance we would be losing about 104 km/h. But the vehicle still had substantial speed when it struck the pole. So do I need to say any more about the speed issue?

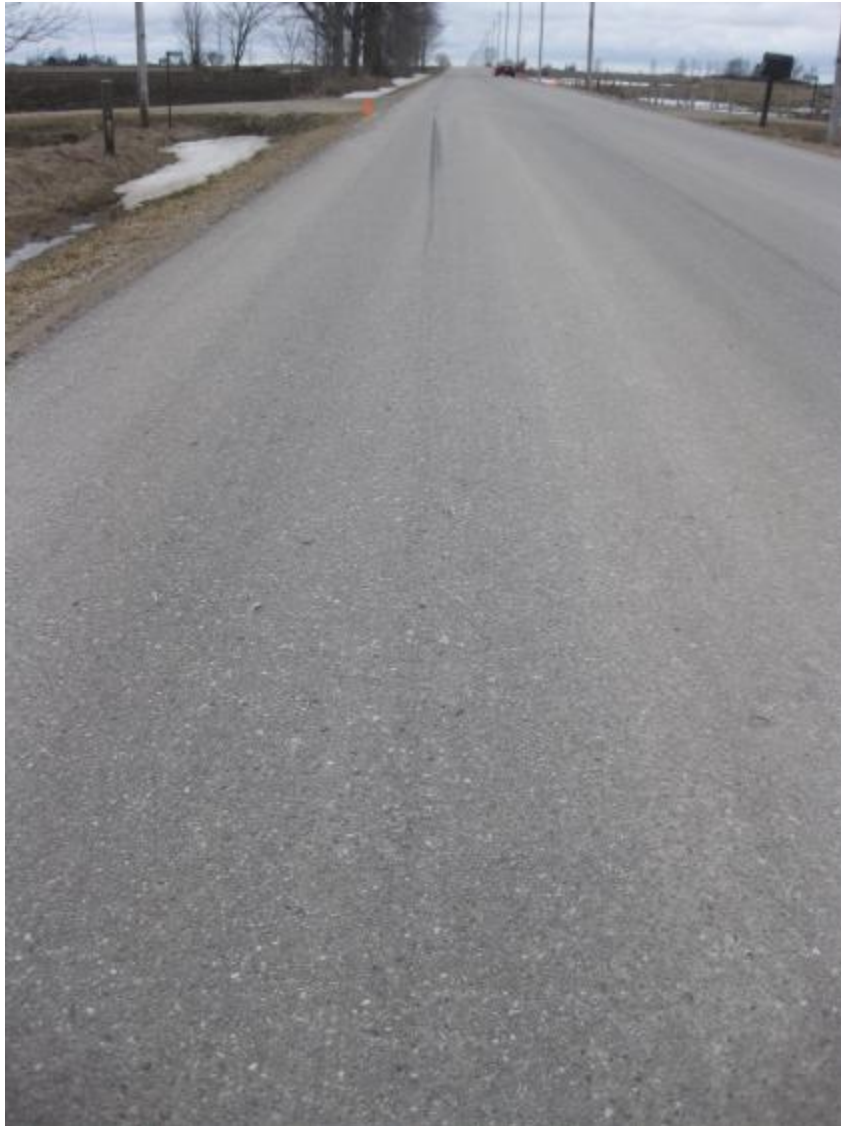
Below is another photo taken from 90 metres east of the POI and this is showing the darker, right side skid mark.

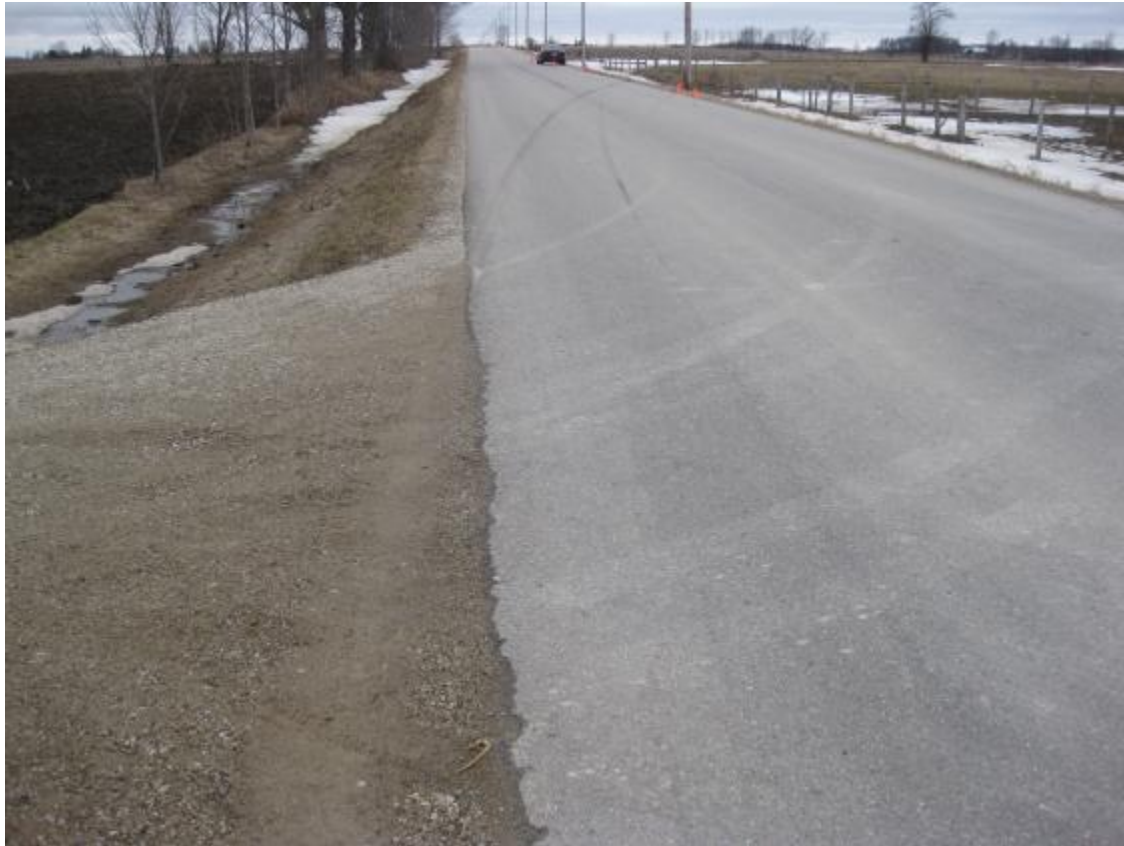
First a view from about 50 metres east of the POI looking from the south side of the road, along the yaw marks and toward the pole in the background on the north side of the road.

You can see as the vehicle leaves the south gravel area at the driveway that it begins to rotate clockwise as evidenced by the curved "yaw" marks. The marks from the rear tires combine to the left while the marks from the front tires combine to the right of this photo.

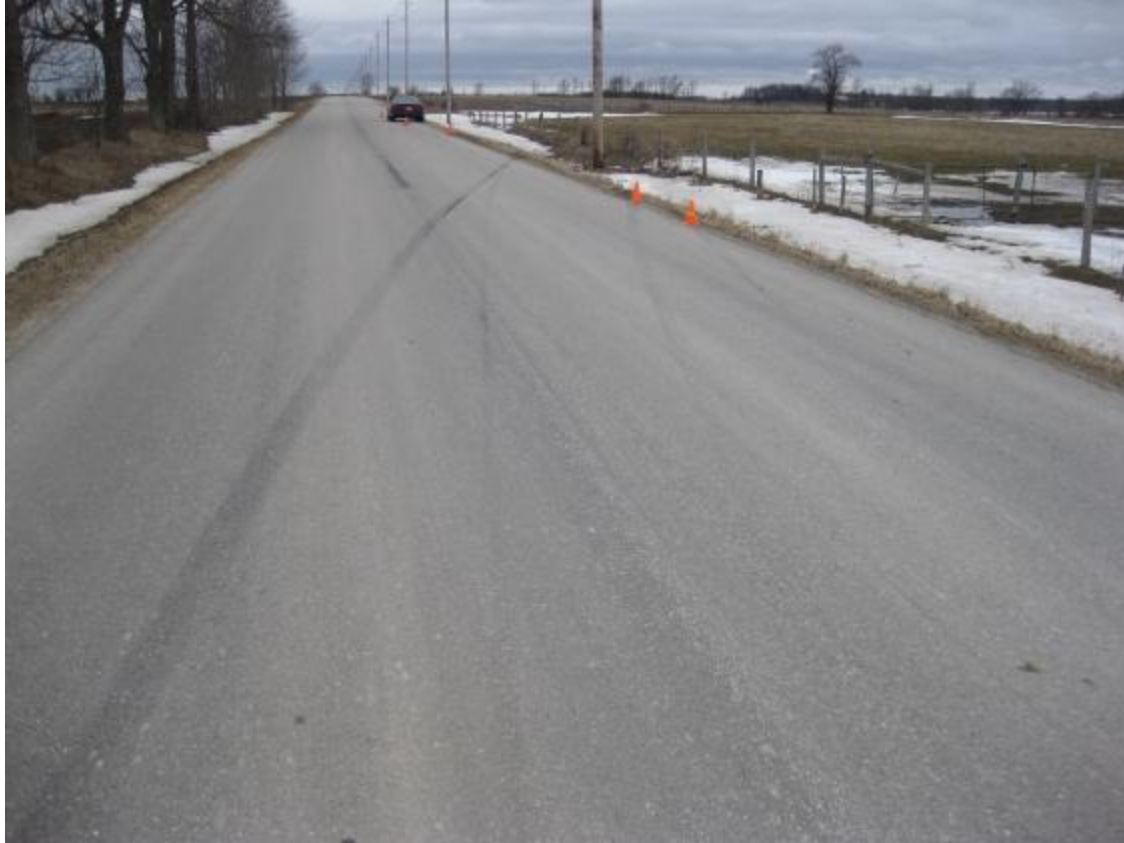
Below is a further view from 30 metres east of the POI where we can clearly see the yaw marks. For the benefit of those who cannot understand which marks were caused by which tires I have placed two orange cones on the north road edge to indicate the marks that were caused by the front tires of the vehicle. So the vehicle was essentially travelling sideways, leading with its left (or driver's side) when it reached the pole. Such a motion is not uncommon. If the vehicle had not countered the obstruction it would likely have rolled over, tripping over its left side tires as they dug into the earth. Given that there was a fence just north of the pole it might have acted as a "catcher's mitt" and perhaps reduced some of the consequences, but one never knows.

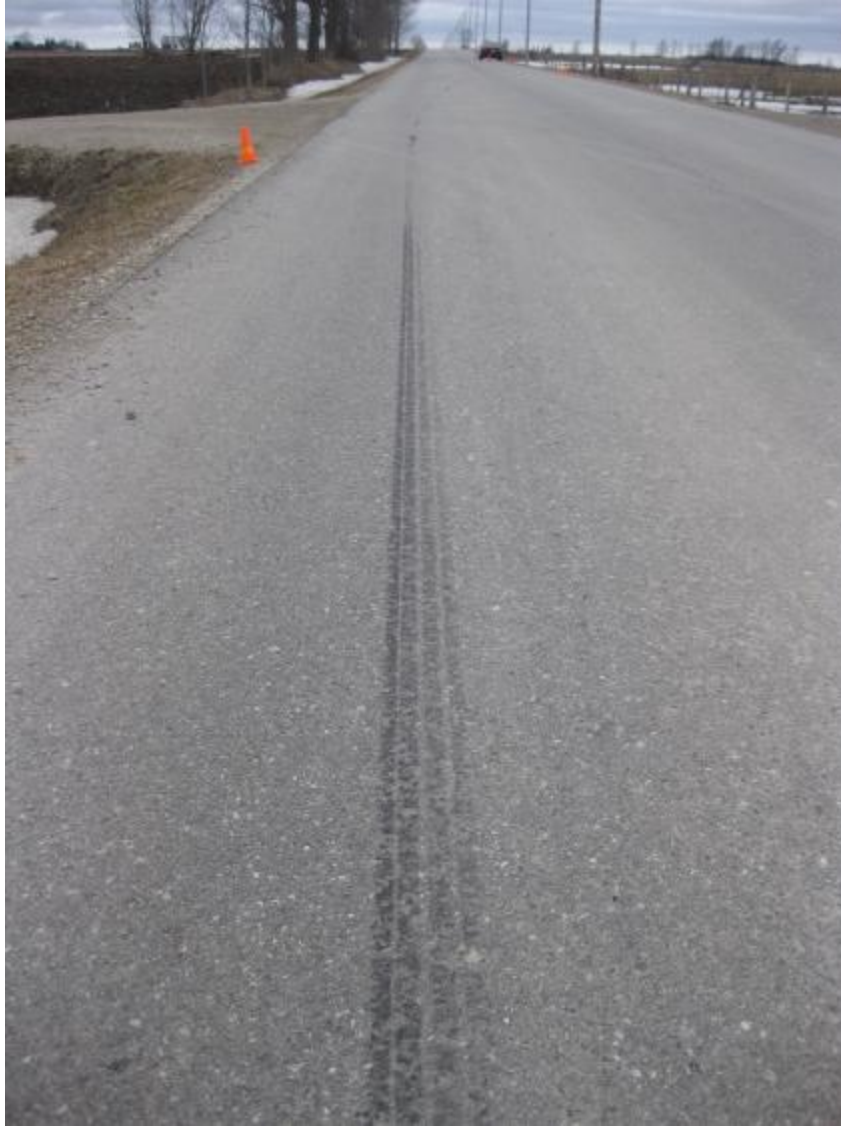
Let's look a little more closely at those skid marks before the driver lost control. The photo below was taken from 75 metres east of the POI (Pole) and it is looking west along the skid mark caused by the right side of the vehicle. Note how dark and straight it is in the foreground and then it seems to lose itself adjacent to that orange cone.

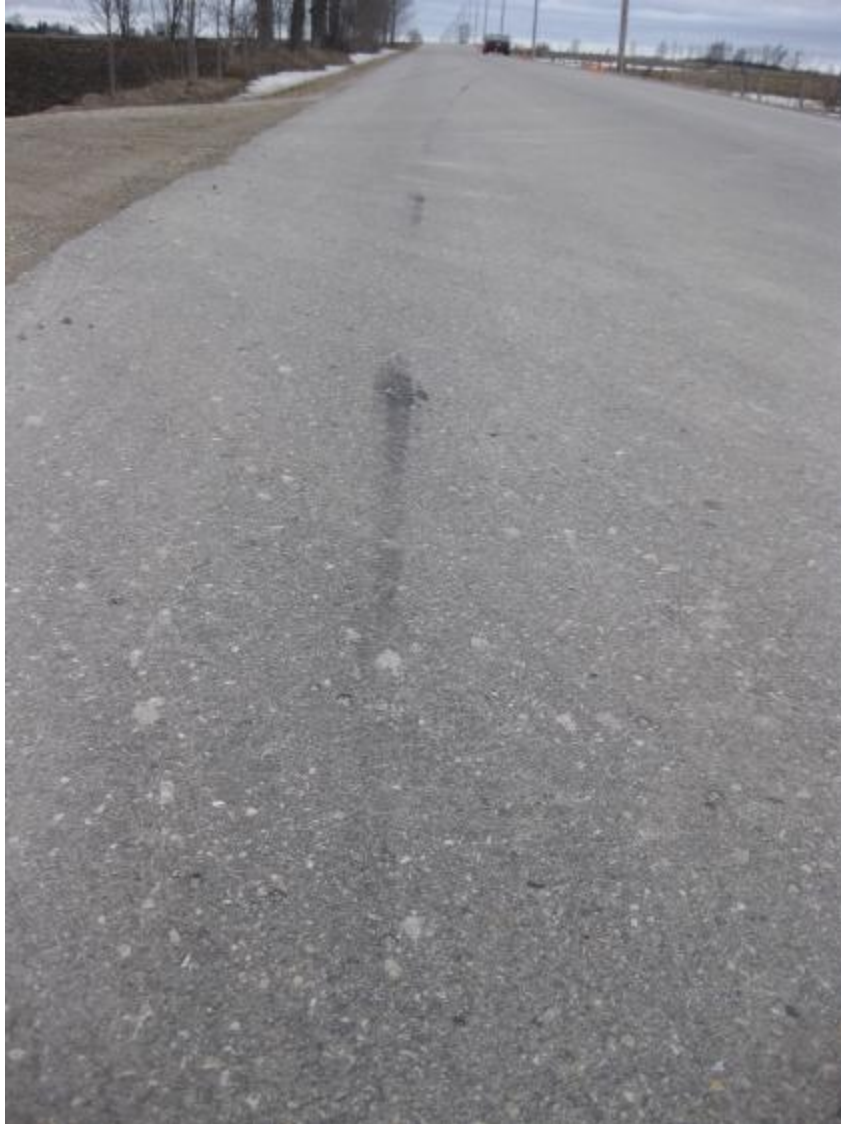
What I mean by "lose itself" is that the right tires stop producing a visible black transfer for brief periods. You can see one of those gaps in the right skid mark in the photo below which was taken about 65 metres east of the POI.

Now I imagine this skip may have something to do with the weight transfer as the vehicle begins to slip sideways as a result of encountering the less-aggressive gravel of the south shoulder and driveway. But it is not an easy explanation.
