Mount Salem Site of Fatality Reveals Complicated Traffic Issues

Posting Date: 2 Oct 2011

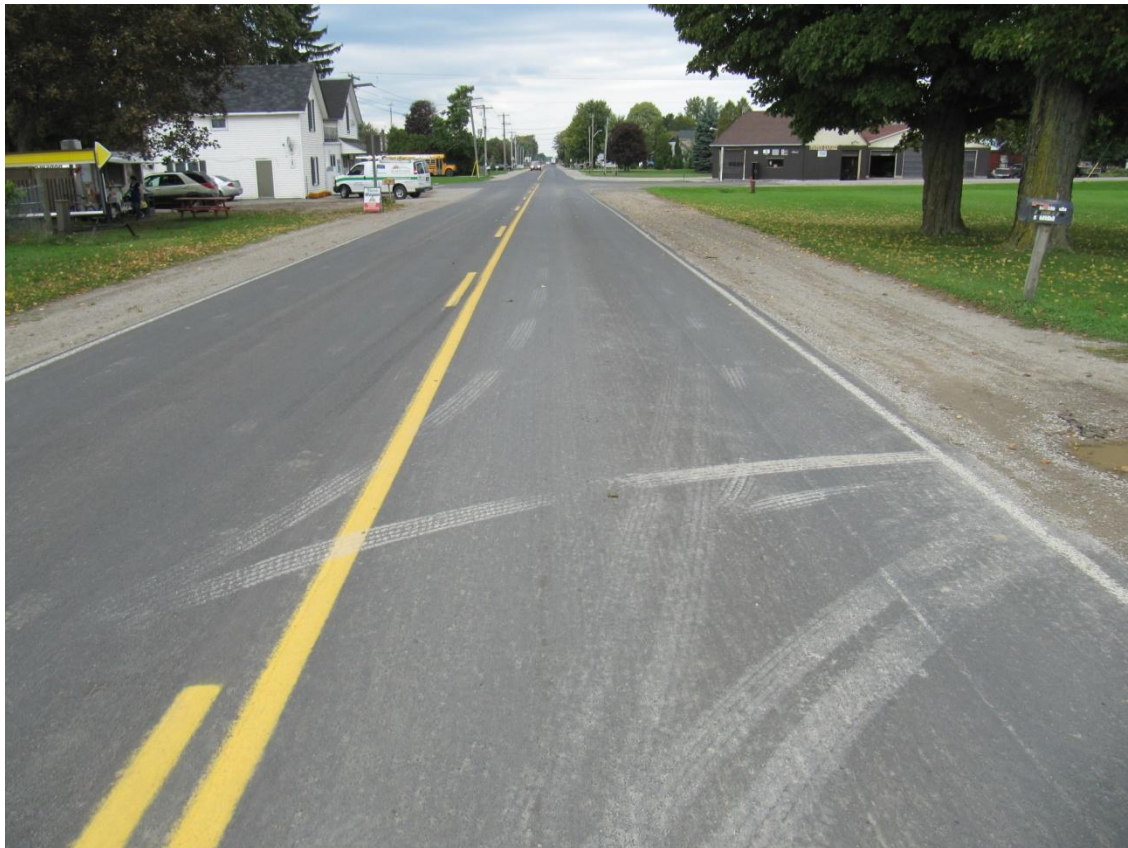
And this was the scenario that revealed itself when we attended the site a few days later to evaluate what occurred. Arriving in the mid-afternoon we observed that the intersection was indeed relatively peaceful and quiet. Below is a photo, looking north, along Springfield Road, along the direction that Craig Chittenden travelled as he approached the intersection in the background.

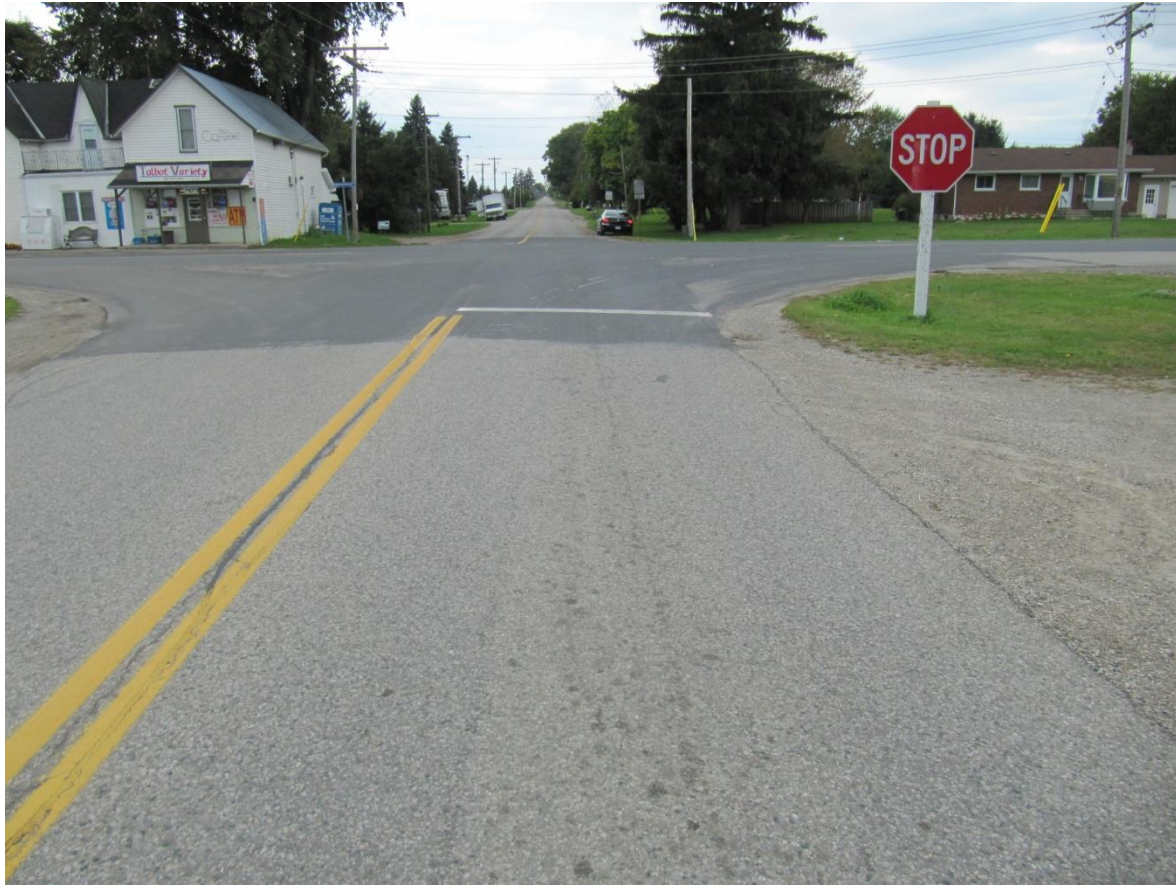
And a similar view could be seen from the impaired driver's viewpoint as he travelled westbound on Calton Line toward the same intersection as shown in the photo below.

The oversize stop sign in the above photo was not enough for the impaired driver to indicate that he must stop and he entered the intersection at highway speed just as Chittenden's vehicle did so as well. In a single instant many persons' lives changed.

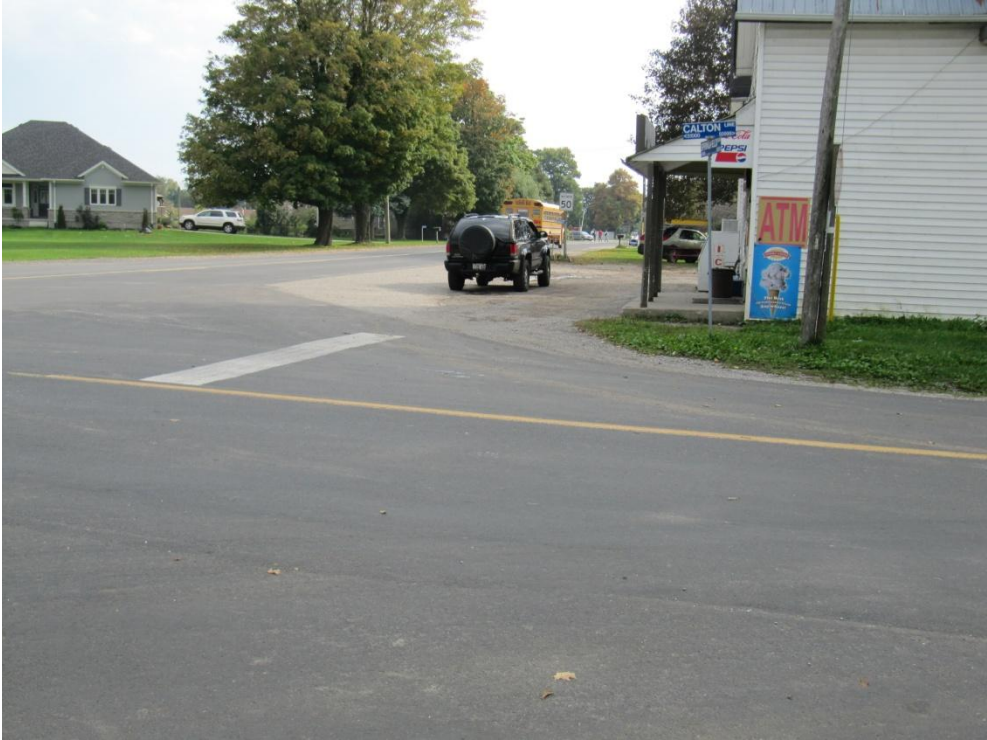
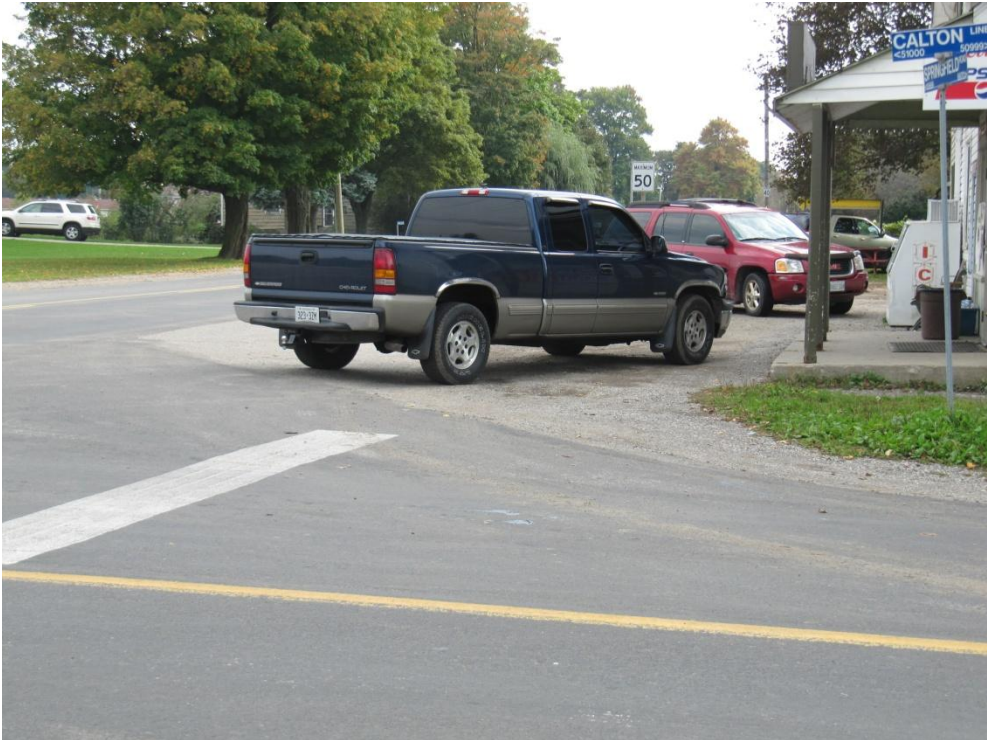
By approximately 1515 hours a number of school buses began to pass through the area and some of these buses stopped to let off passengers. Suddenly this increased the number of pedestrians in the area. Some of these unsupervised pre-teens fooled around and jumped onto the road as they walked home. At the same time a lonely looking variety store located on the south west corner of the intersection, had hardly seen any customers in the first hour or two that we stood at the site. But shortly after 1500 hours a number of vehicles began stopping in the gravel area in front of the store, as shown in the top photo of the following page. This started as just a single vehicle but

as the minutes passed many drivers began their attempts stop on this gravel area, as shown in the bottom photo below.

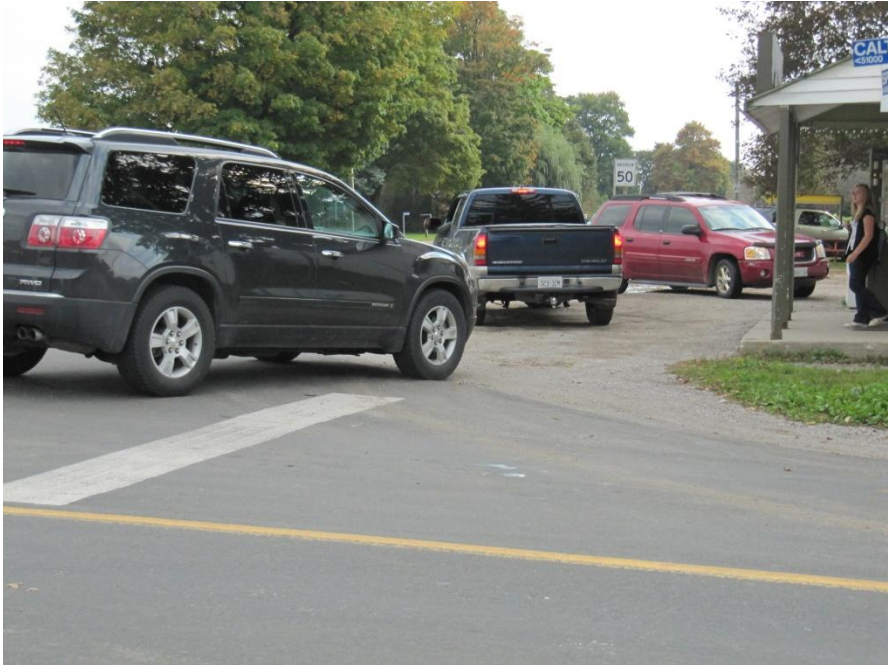
As one vehicle exited the area another was ready to take its spot as shown in the photo below.

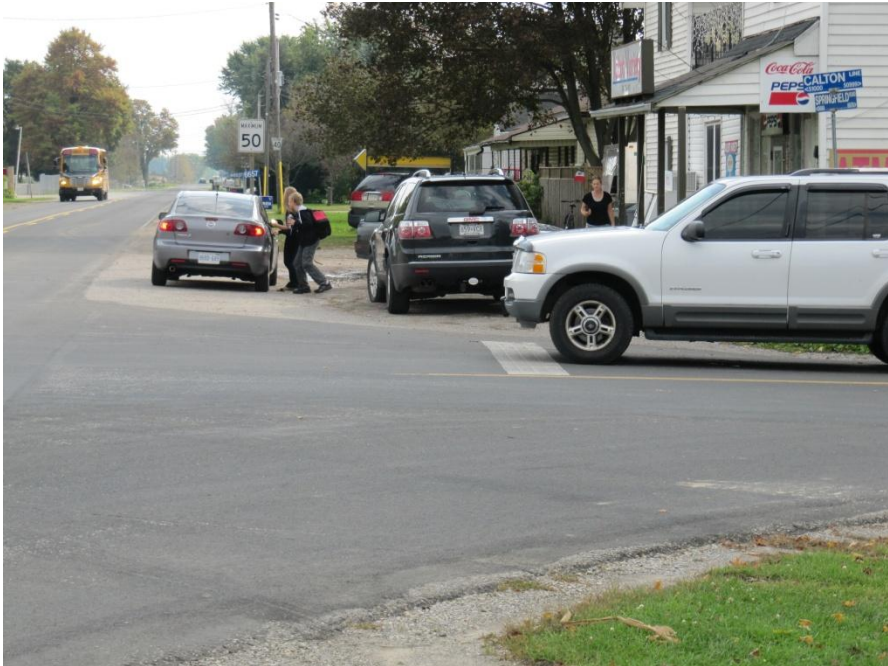
Such a calamity seemed to be the norm. Yet, eastbound drivers who stopped at the intersection would need to see through this maze in order to determine with it was safe to enter the intersection. The photo below is an example of such an eastbound driver trying to look past the parked vehicles.

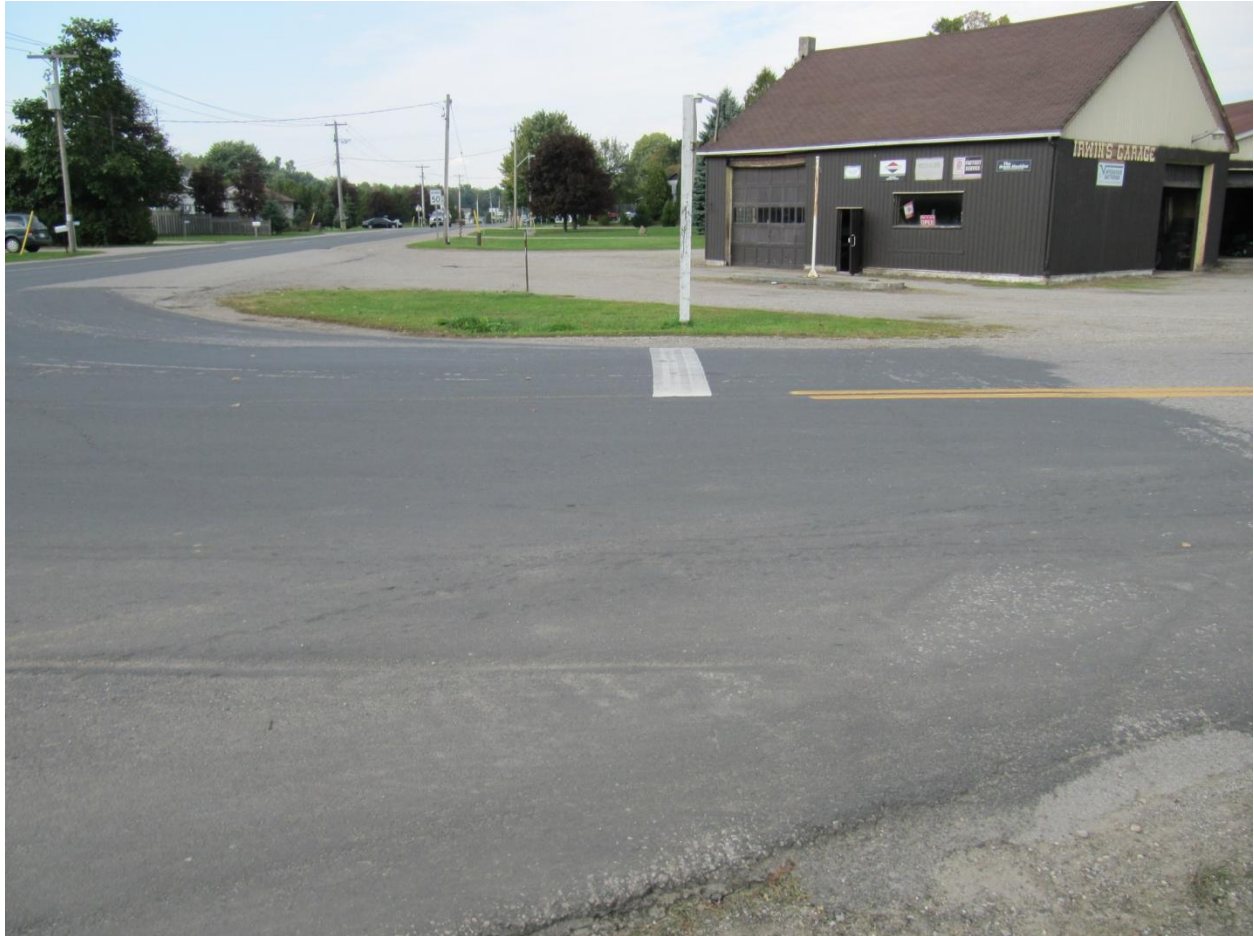
Over at the westbound traffic stop bar we observed as vehicles came to a stop, some at the stop bar and others past it. The photo below is a view looking northward at the westbound stop bar and you can see how far back it is from Springfield Road.

We observed that the westbound traffic stop bar was positioned very far back from the intersection and we wondered how drivers adjusted to this unusual position. So we set-up a number of video cameras and began documenting the time required for westbound vehicles to clear the intersection. While this taping was taking place we stood by and observed the developments and several facts began to unfold.

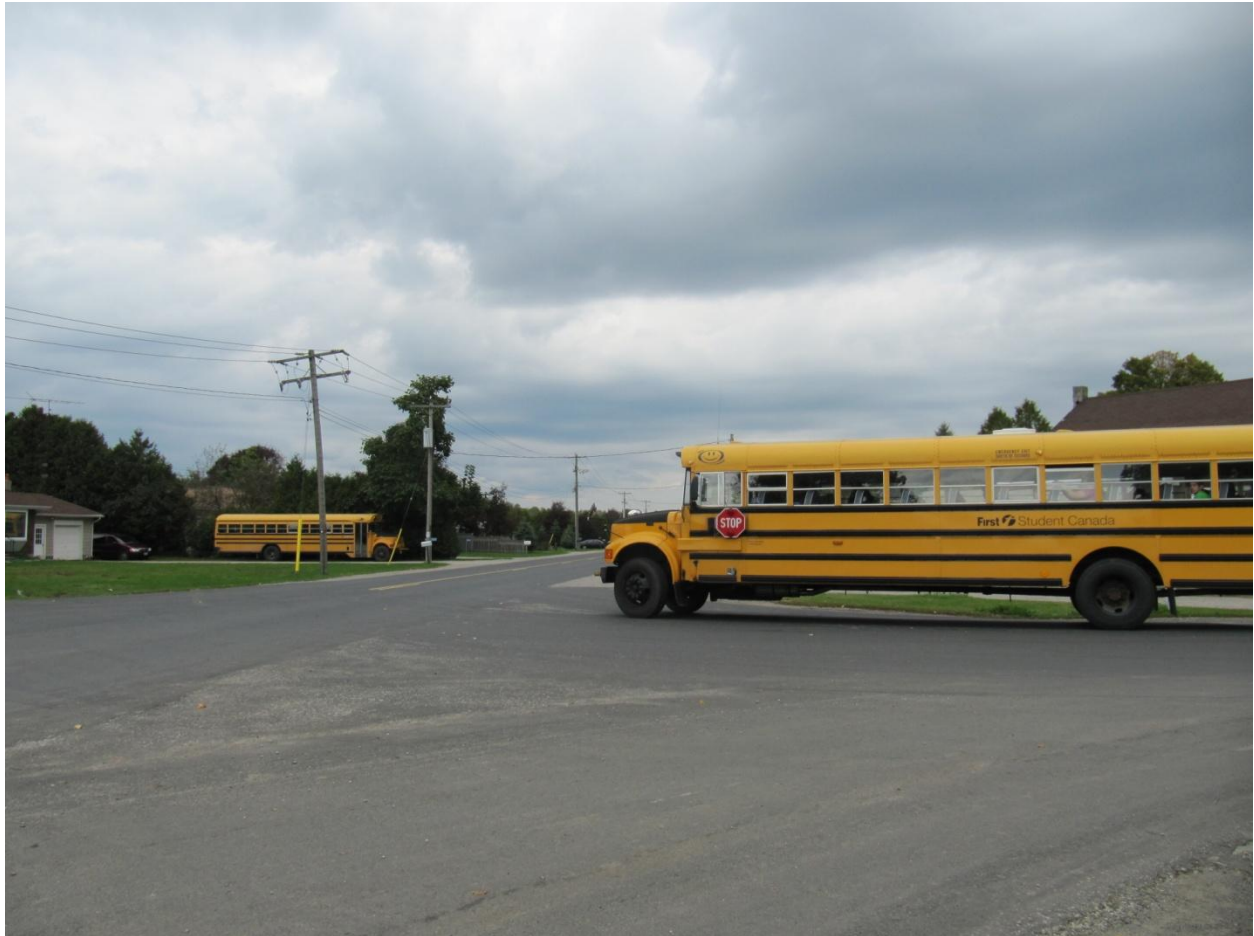
And on the following page you can see a westbound school bus as its driver tries to deal with making a turn or travelling straight ahead from a position well past the traffic stop bar. You are required by law to stop at the bar but what you do afterwards to make a safe crossing or entrance of the intersecting road is up to you.
