# Description of Multiple Video Cameras and iPhone Accelerometers Using in Brake Testing And General Vehicle Motion Analysis

*Posting Date: 07-Feb 2013*

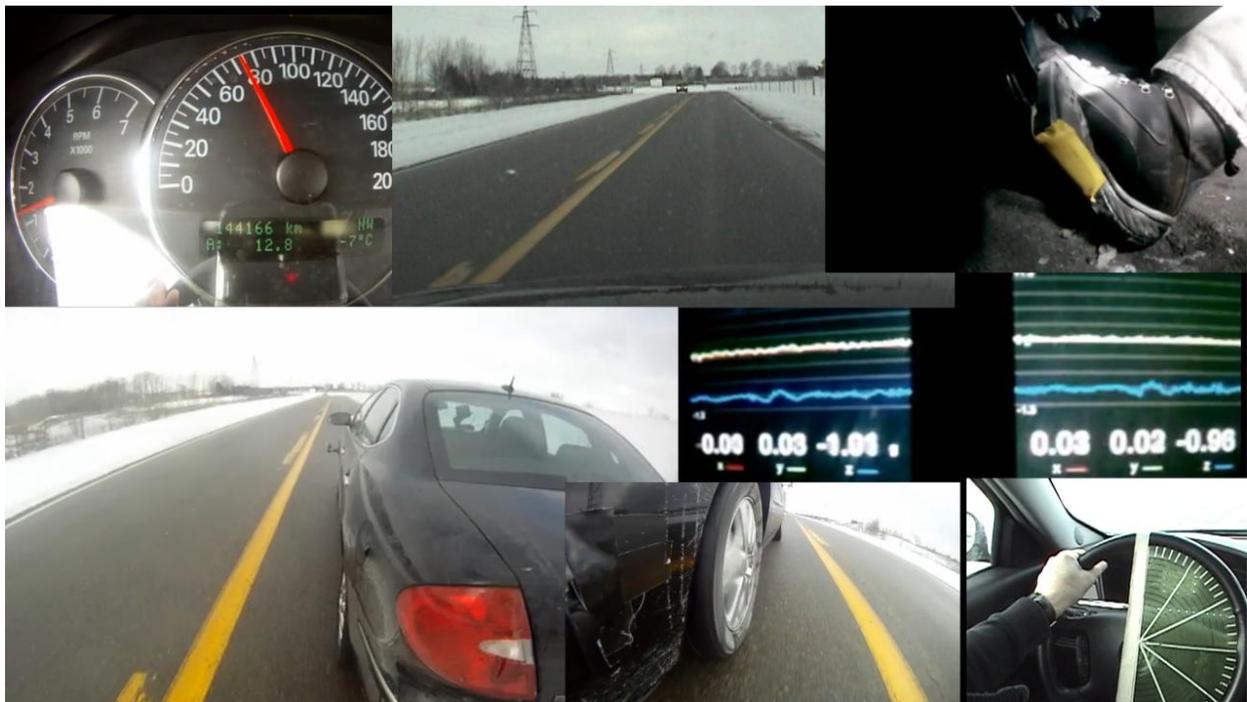
At the upper left is the view of the vehicle's speedometer and tachometer. Next, in the centre-upper area, is a view looking forward through the windshield of our test vehicle.

Next, on the upper right is a view, looking from the left to the right, at the driver's foot pressing the accelerator pedal. A piece of yellow tape had been placed on the side of the brake pedal so that its position stands out more clearly when it is depressed.

In the bottom left is a view from a camera that is mounted to a horizontal bar that itself is anchored to a bike rack at the back of our vehicle. This view shows the taillights of the vehicle so that we can see when they first illuminate as well as when they extinguish. This view also allows us to see the lateral position of our test vehicle with respect to landmarks such as the roadway centre-line.

Next, in the bottom center of the screen, is a view from a camera pointing backwards toward the left front tire. This close-up view is used to explore the rotation rate of that tire during braking as well as what qualities of the surface the tire is riding on when braking takes place. We are also able to see the characteristics of the tire mark produced by this tire before the left rear tire riders over it and characteristics are destroyed.

Next, at the bottom right corner of the screen is a view of our steering wheel with a large protractor attached so that we can observe the rotation rate and magnitude of steering input during the vehicle testing.

Finally, in the centre-right is a close-up view of the screens of the two iPhones. The display to the left is from the iPhone 5 while the one to the right is from the iPhone 4S. If the two accelerometers (and XSensor app) are performing reliably then the values on both phones should be identical, minus any confounds such as anchorage issues. Overall it can be seen from this view that the displays are generally the same.
