## Truck Trailer Impacts Highway 19 Overpass at Ingersoll Ontario In Early Hours of August 10, 2011

*Posting Date: 11 Aug 2011*

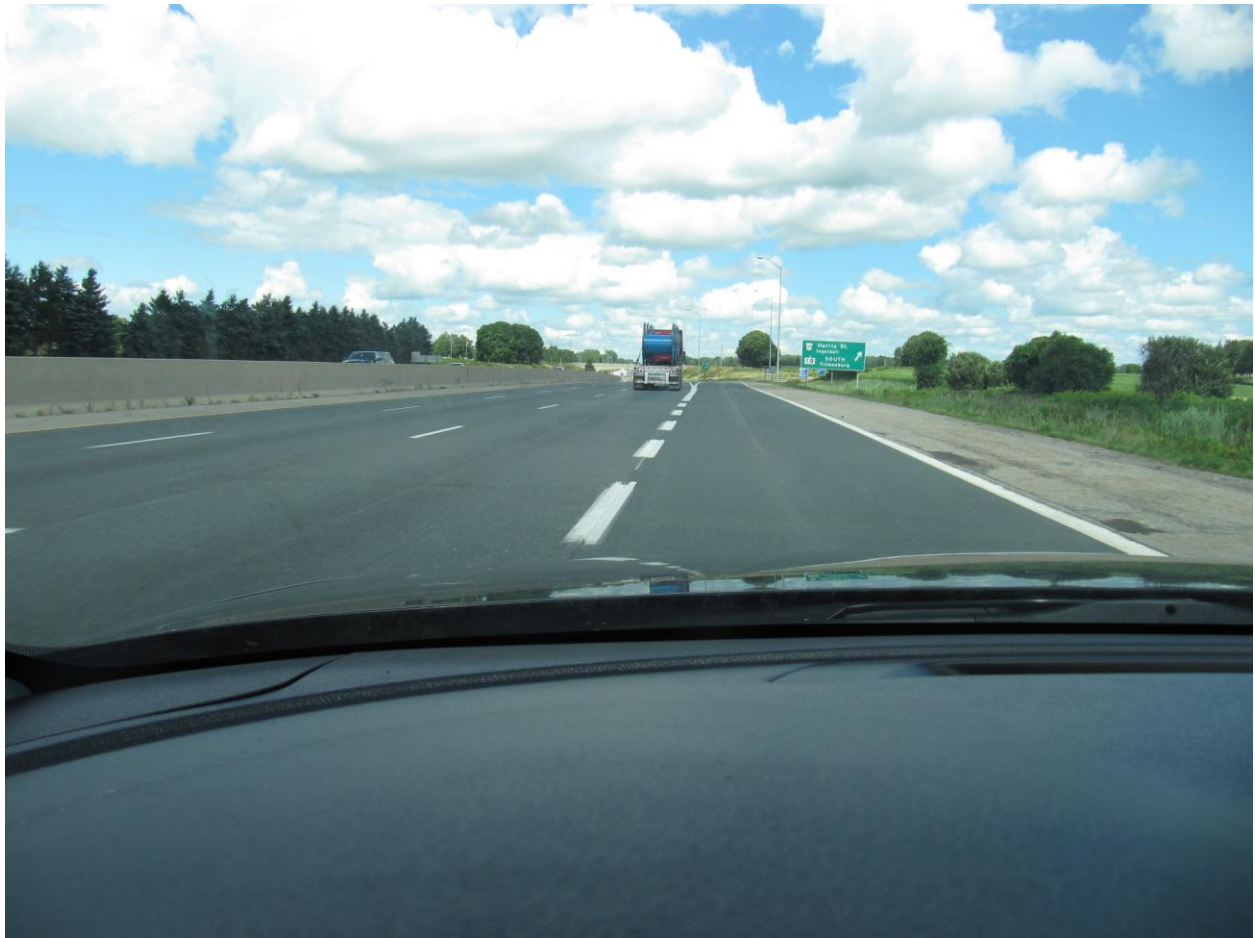
The photos below show the sequence as the eastbound truck approaches the Highway #19 overpass. The scenario unfolds similar to the photo shown below where an eastbound truck is shown travelling in slow lane next to the off ramp. Note that the highway bends slightly to the left.

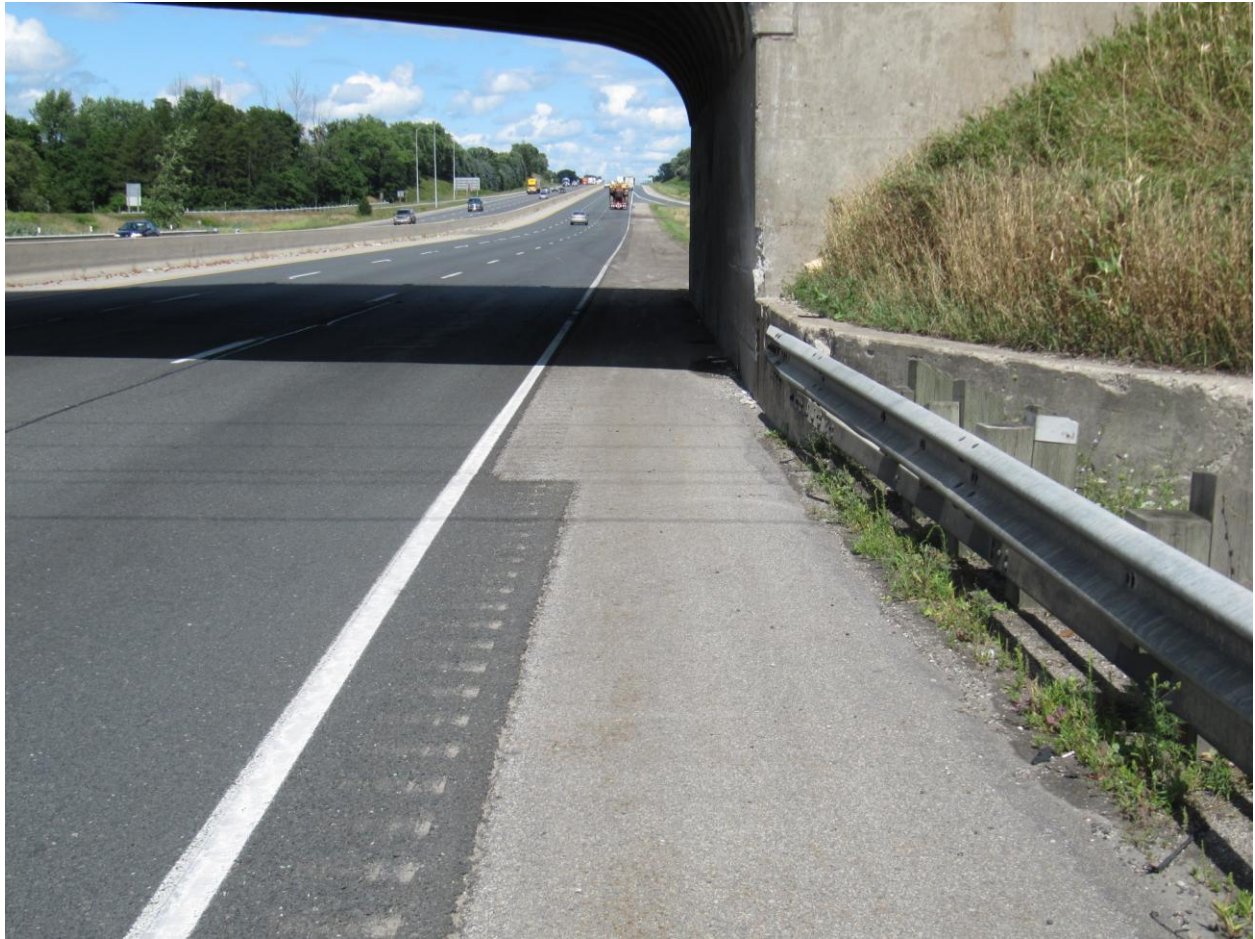
As the truck approached the overpass it would likely have been too far over to the right and the road tractor was likely partly off the right side of the lane, as shown below.

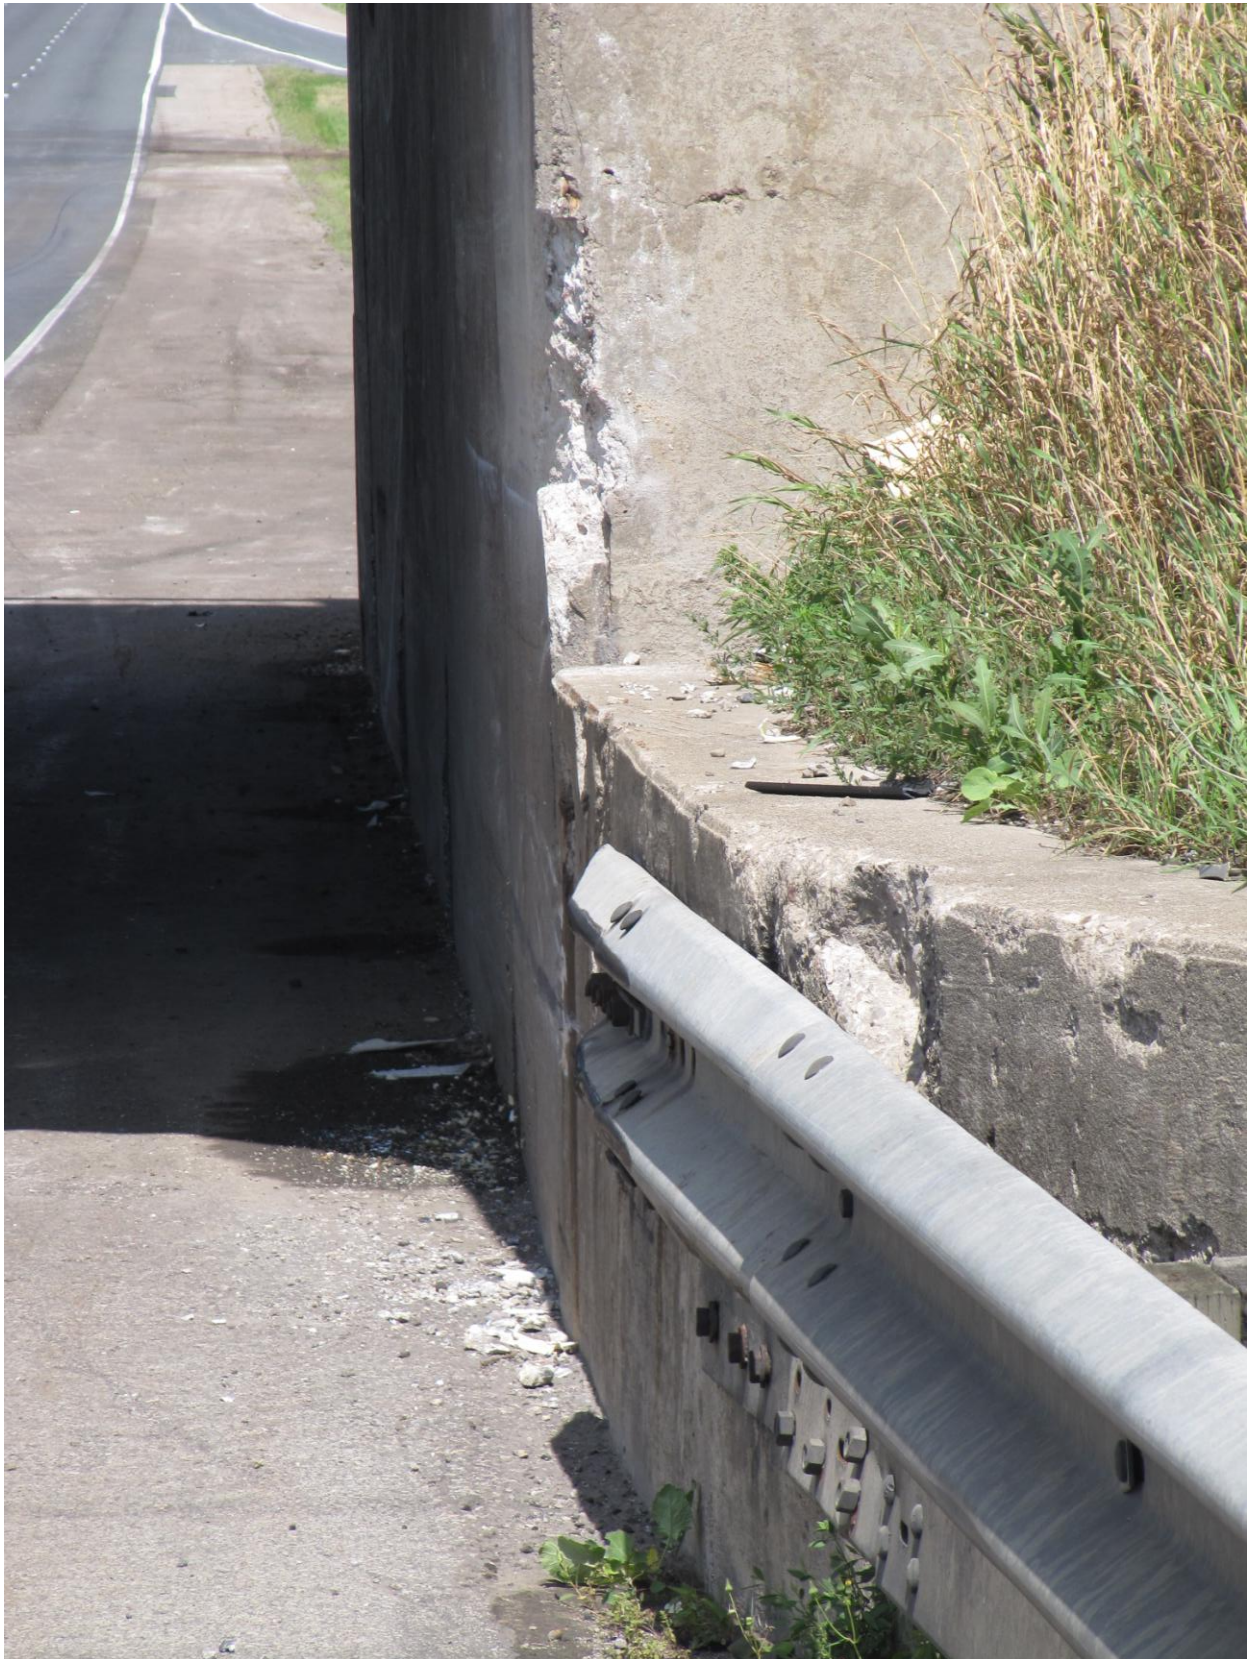
There was no evidence of any tire marks leading up to the area of impact and it can be seen that there is no damage to the guard rail. Yet note how close the guard rail is to the wall of the overpass. It is questionable how an impact could take place to the concrete of the bridge support yet not produce any evidence of damage to the guard rail. You can see in the following photo where there is a fresh impact and damage to the concrete yet the guard rail below shows very little evidence of damage. You might recognize a tiny bit of black marking just on the end of the metal of the guard rail where there was likely contact by one of the tires of the trailer.

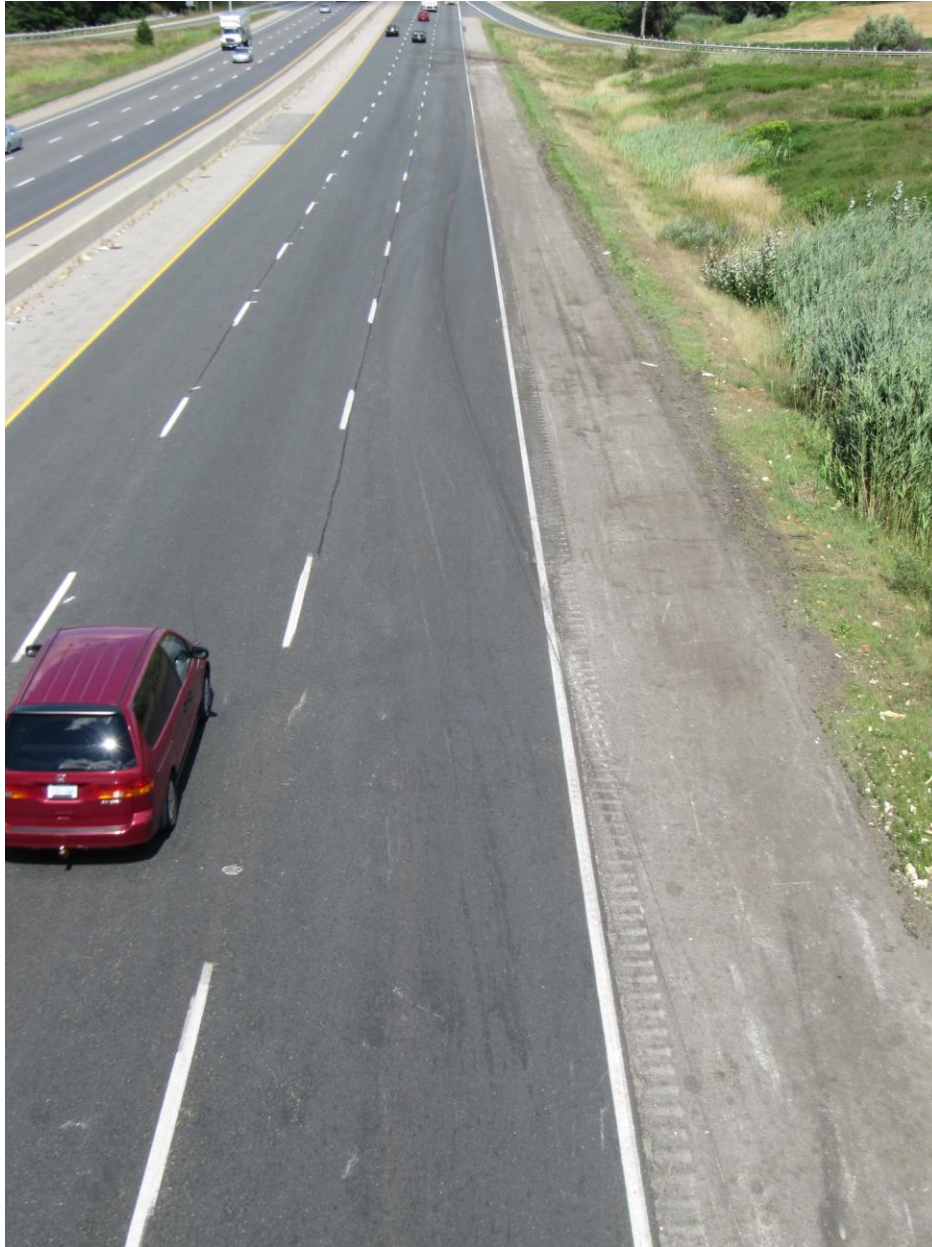
Also, reportedly there was no contact between the road tractor and the concrete support. The truck glanced off this impact and travelled several hundred metres down the road in the background. The photo below shows the evidence to the east of the overpass. Here you can see how the vehicle moves back into the land and then comes to rest in the distant background.
