Trinity Guardrail End Cap Survey - Part III

The present article will review 10 end caps at three sites whose installations were found primarily north-east of London, Ontario, mostly along Highway 7.

16. Highway 7 at Railway Bridge West of Cobble Hills Road, Middlesex & Perth Counties Border

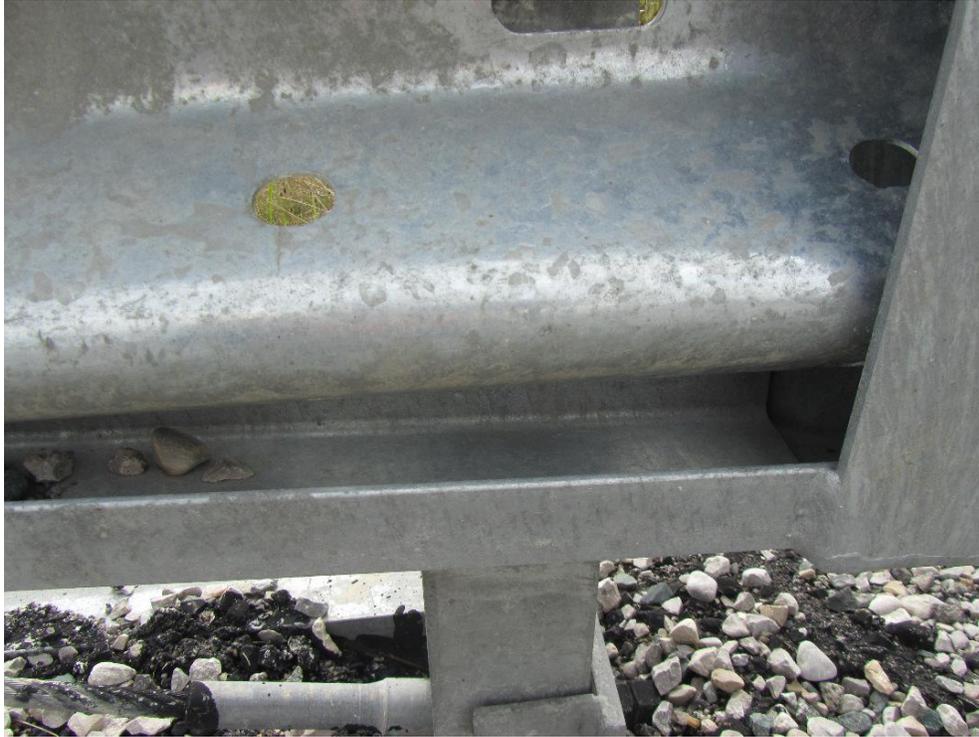
Figure 5: View of bottom of channel showing some gravel lying within it.

The unusual finding about this set of end caps is that 8 of the 10 units contained contaminants of gravel within the crevice between the bottom of the rail and channel. This finding would appear to be significant as it is vital that the end cap ride in an unobstructed manner along the rail when it is displaced by the impact of a wayward vehicle. It is this motion of the end cap that allows the rail to pass through the narrowing throat, flattening out the rail and then bailing the rail out the side of the end cap. From our understanding, the basis of the defect allegations against the ET-Plus system is that modifications that narrowed the dimensions of its channel caused the rail to become jammed and the rail would not pass through the end cap as it was designed. If extraneous materials such as gravel are placed in the channel where the unobstructed motion is critical, such jamming of that motion would seem likely. It would seem that, aside from any other potential defects, the design of the ET-Plus system with its open channel, can cause foreign objects to enter into the channel and obstruct the motion of the system, thus making it fail.

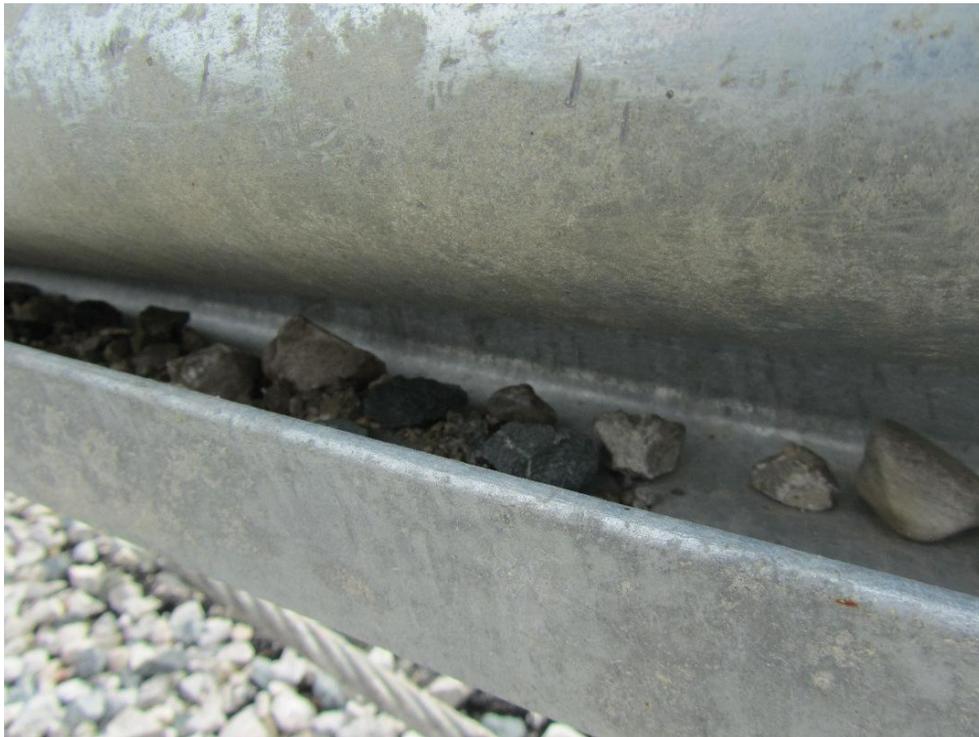
Figure 6: View looking through crevice in the bottom of the channel at a substantial amount of gravel that is lying on the bed of the channel.

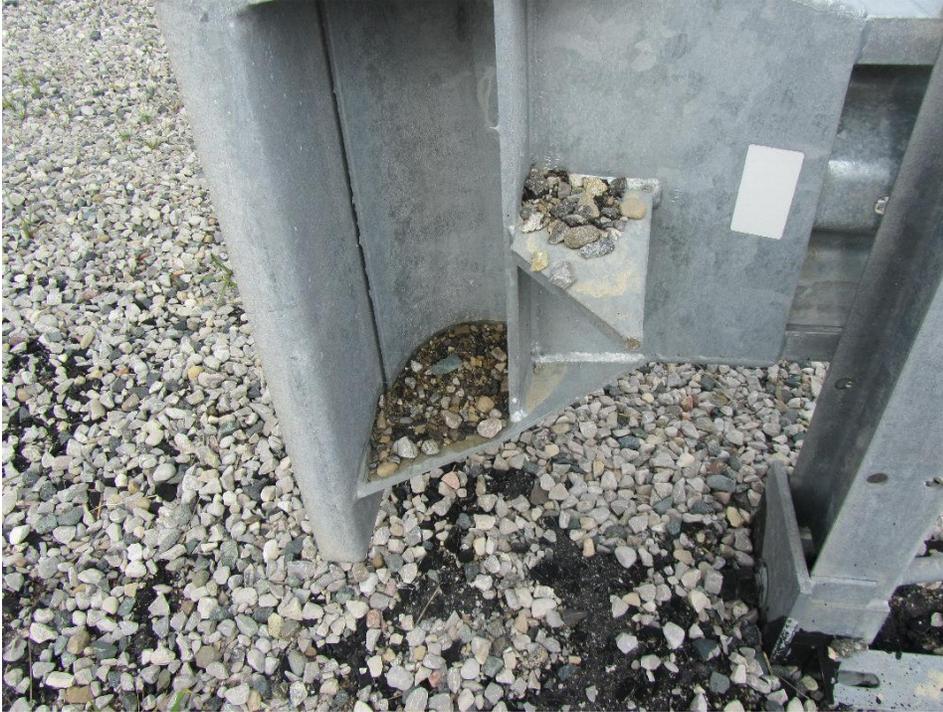
Figure 9: Ditch side view of the end plate showing a substantial amount of gravel lying on the flat portions of the unit.

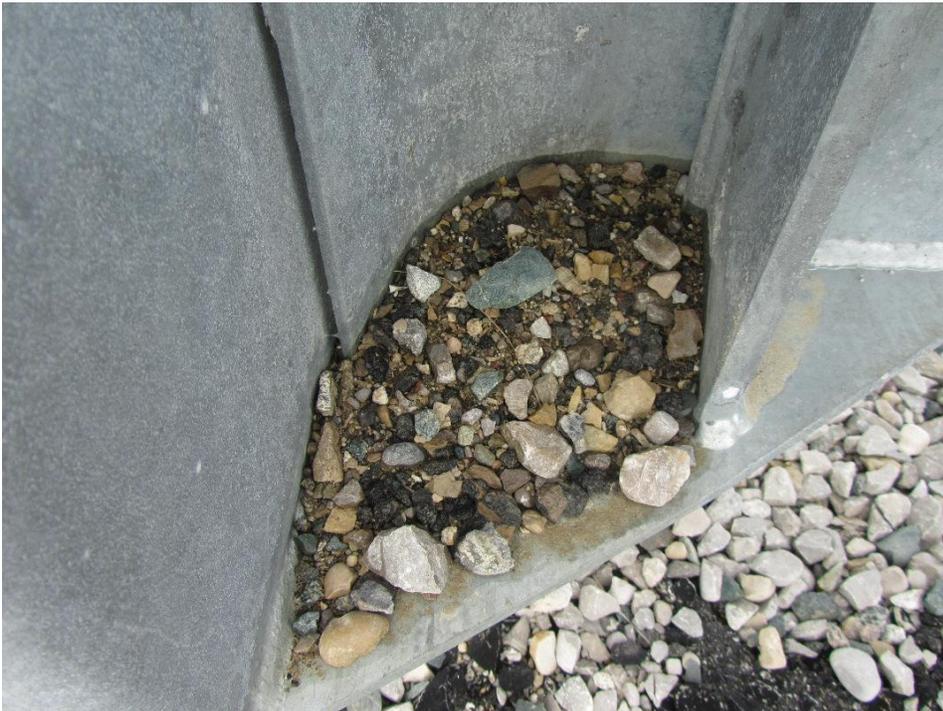
Figure 10: View of substantial amount of gravel lying at the throat of the channel where the flattened "W" rail is supposed to exit when the end is displaced by an impact.

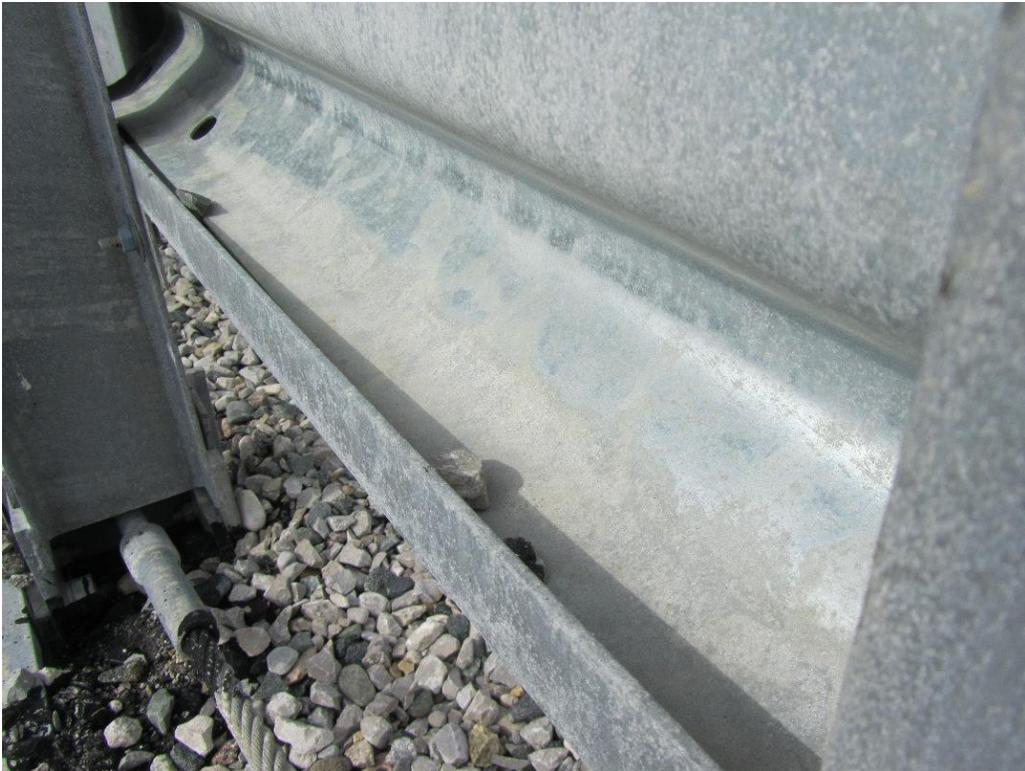
Figure 12: View of backside of "w" rail and channel showing gravel lying at the interface between the bottom edge of the rail and the channel.

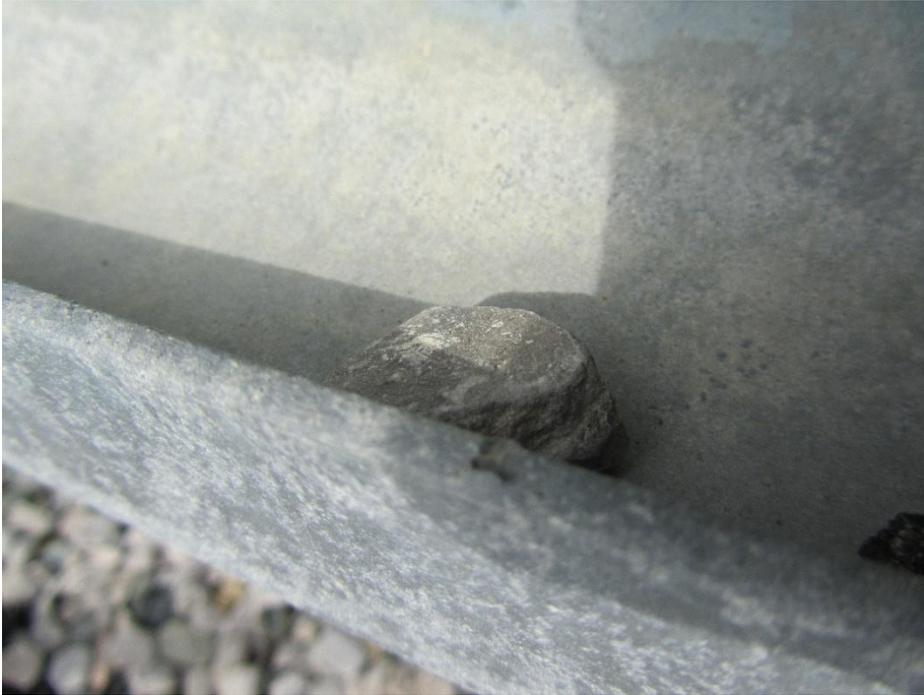
Figure 13: Close-up view of typical stone from the gravel lying within the interface of the channel and rail.

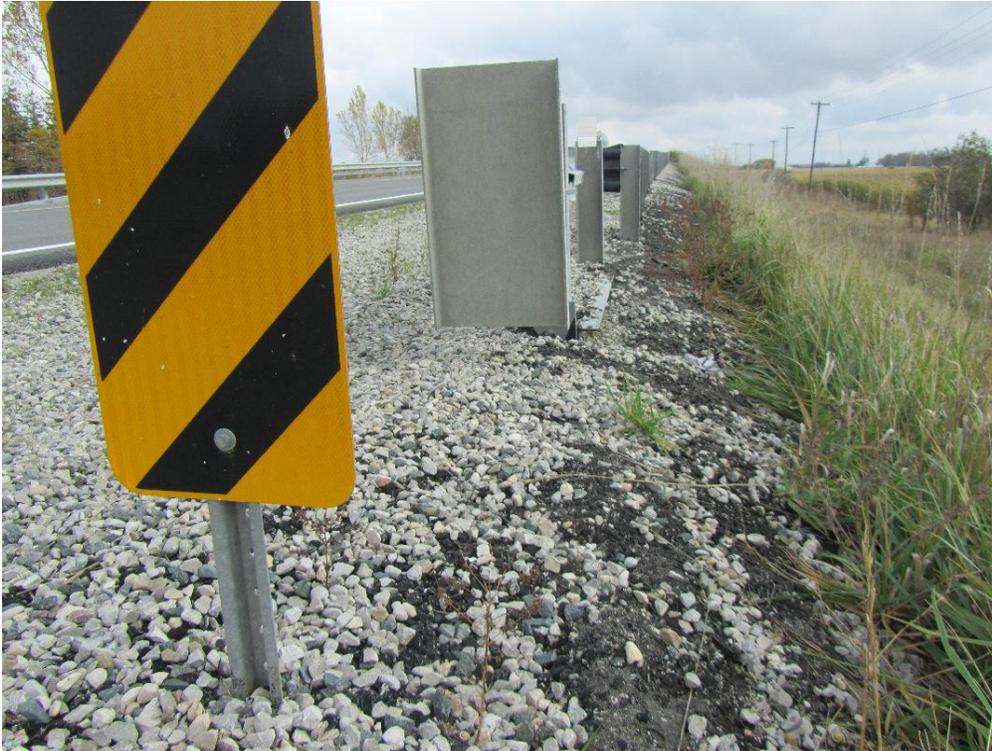
Figure 21: View showing that there is a substantial drop of the gravel surface on the ditch side of the end cap that could have an effect on the height at which a striking vehicle makes contact with the end plate.

We have also observed that, at several installations, the ground on the ditch side of the end cap and guardrail is at a steep angle, often toward a deep ditch. This condition

would appear to be substantially different than the conditions under which the system is tested for compliance.

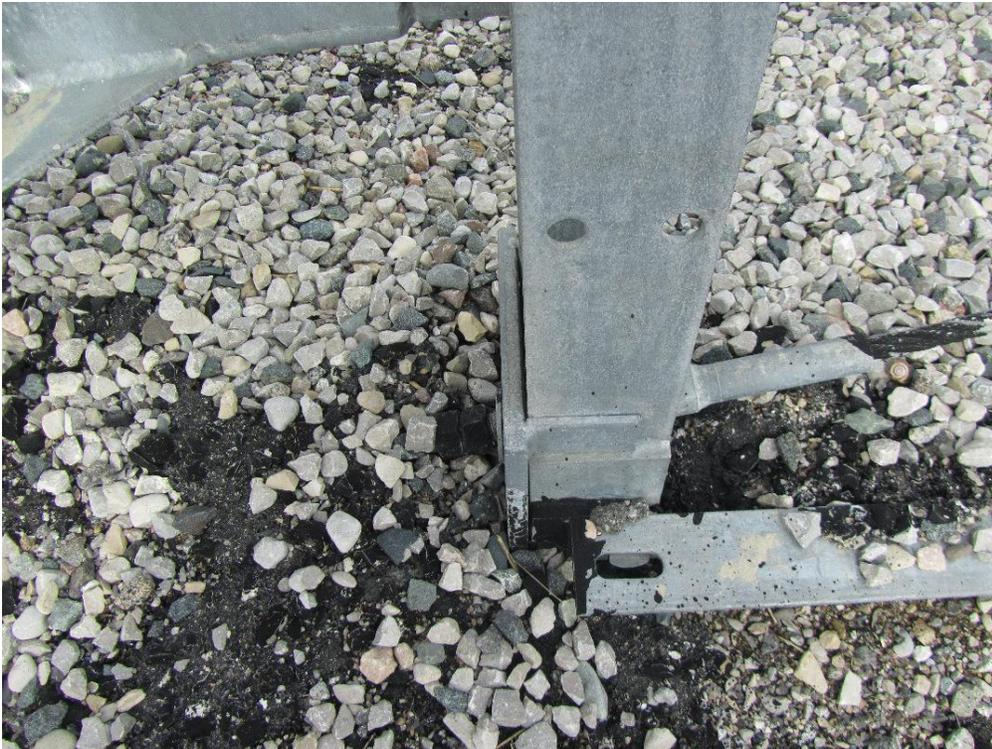
Figure 22: View of the bottom anchorage of the vertical post just behind the end plate. There is a separation in the slip fit of the longitudinal bottom rail and this vertical post at the lower anchorage bolt.

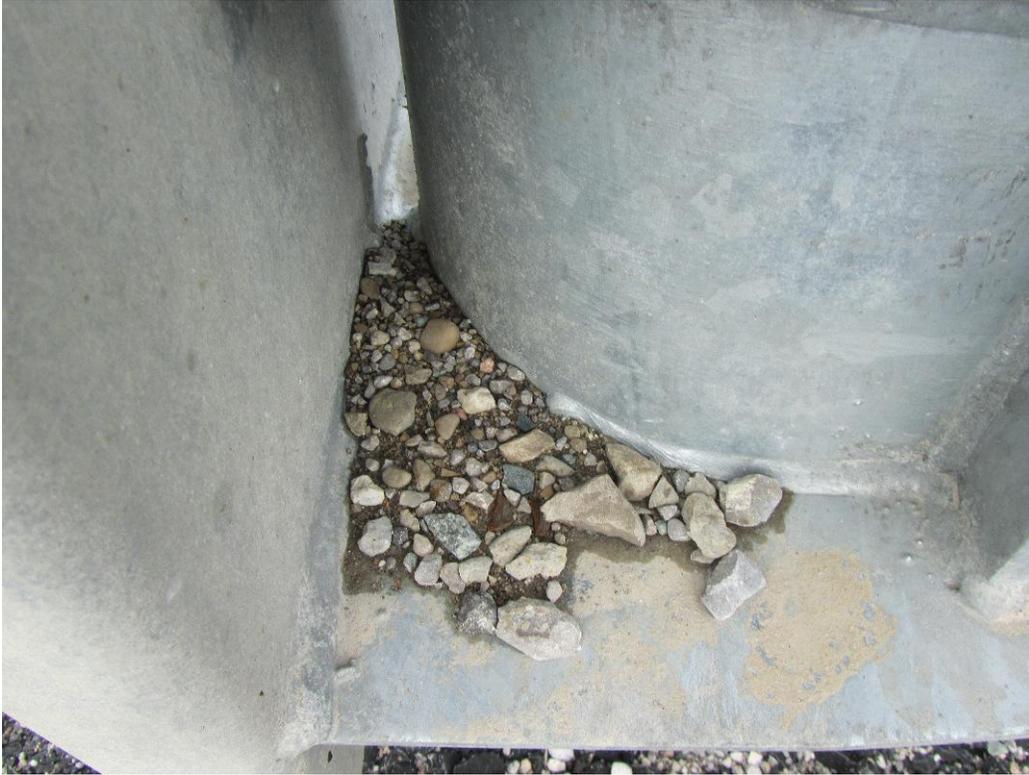
Figure 25: View of gravel lying on the flat surface of the end cap just behind the end plate.

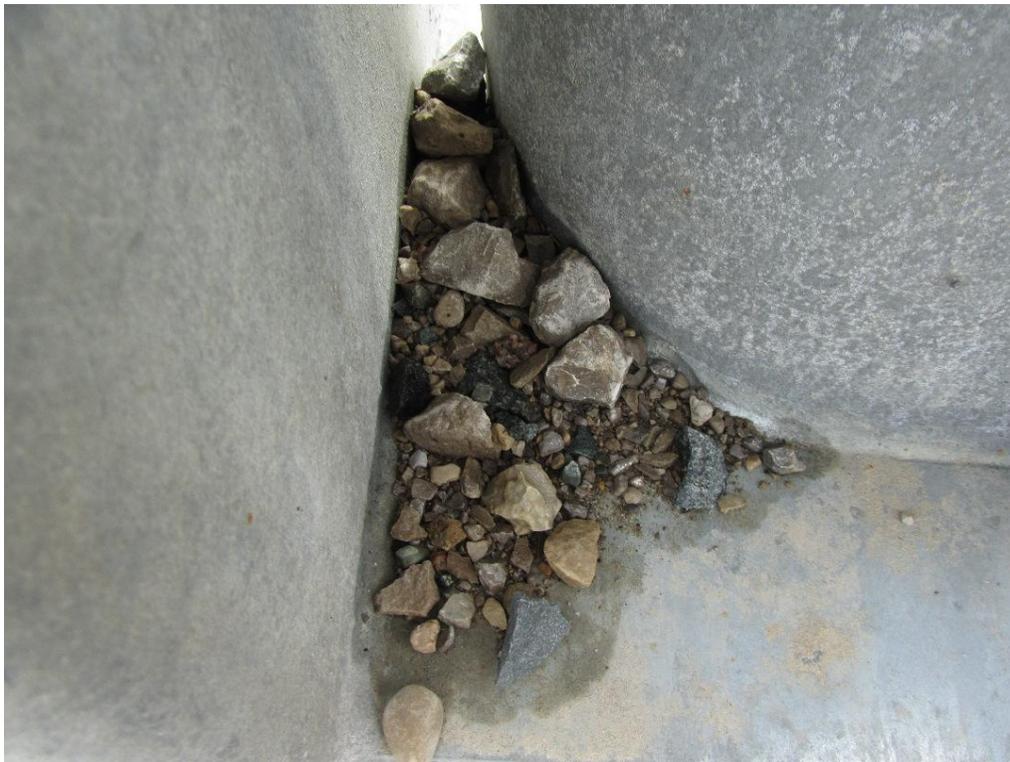
Figure 38: Close-up view of deposit of gravel resting in the horizontal recess behind the end plate

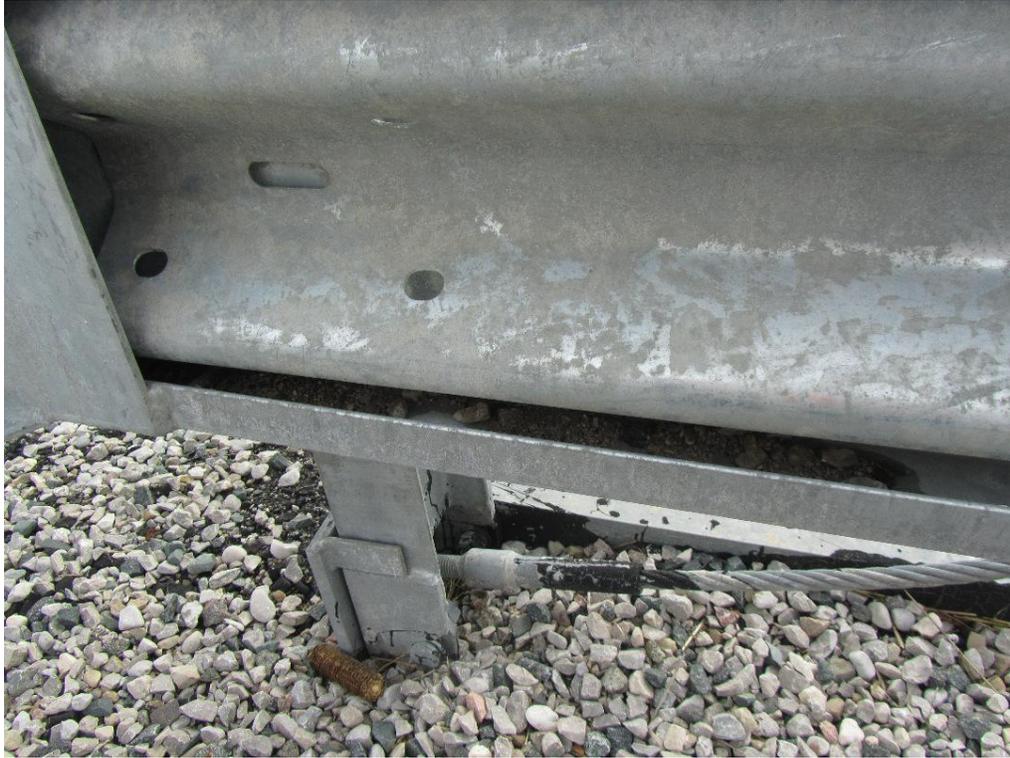
Figure 39: View of the bottom edge of the channel and rail showing the existence of gravel accumulated in the recess.

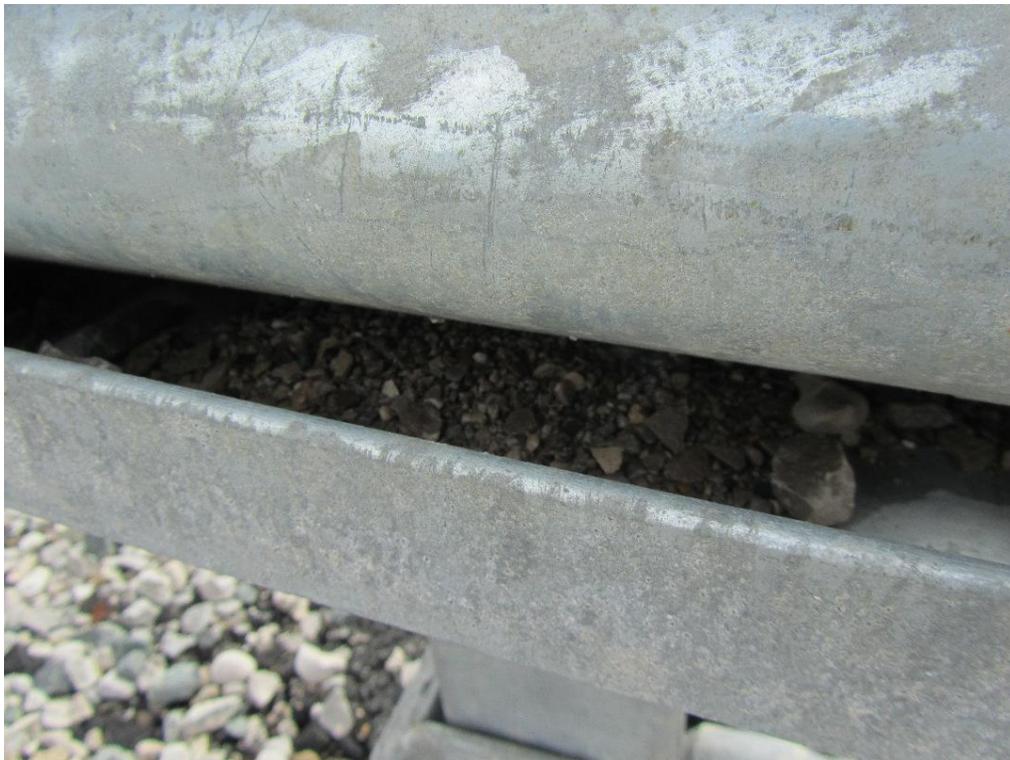
Figure 40: View of substantial amount of gravel lying in the bottom recess between the channel and bottom of the rail.

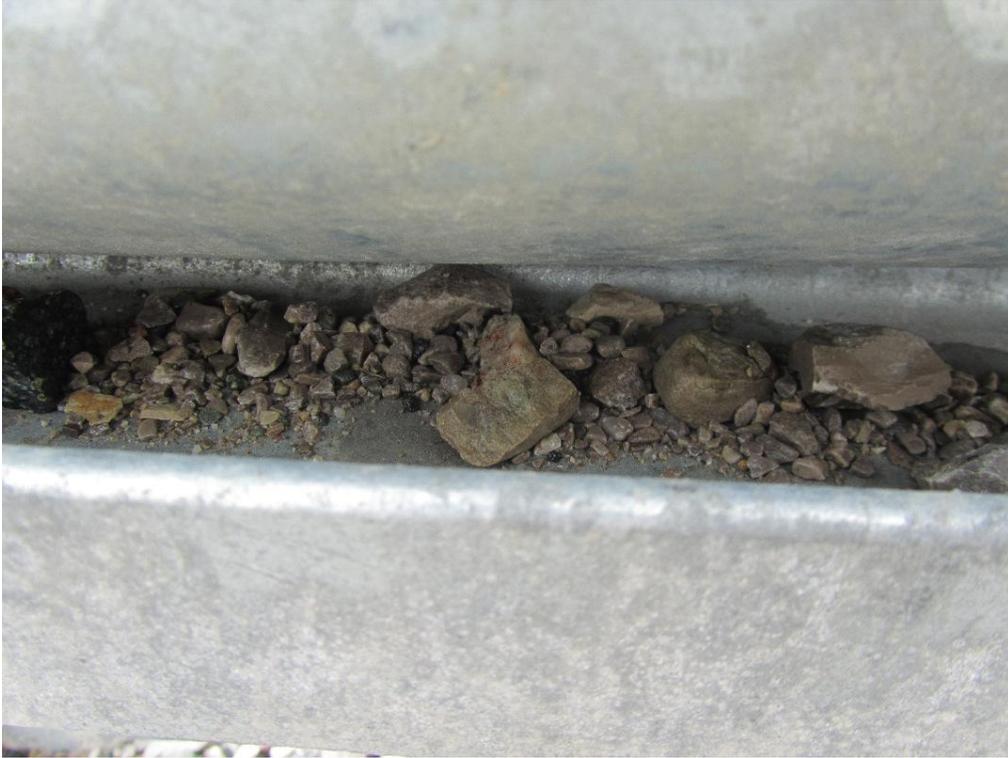
Figure 41: Close-up view if extensive amount of gravel lying in the recess of the channel along the bottom of the rail.

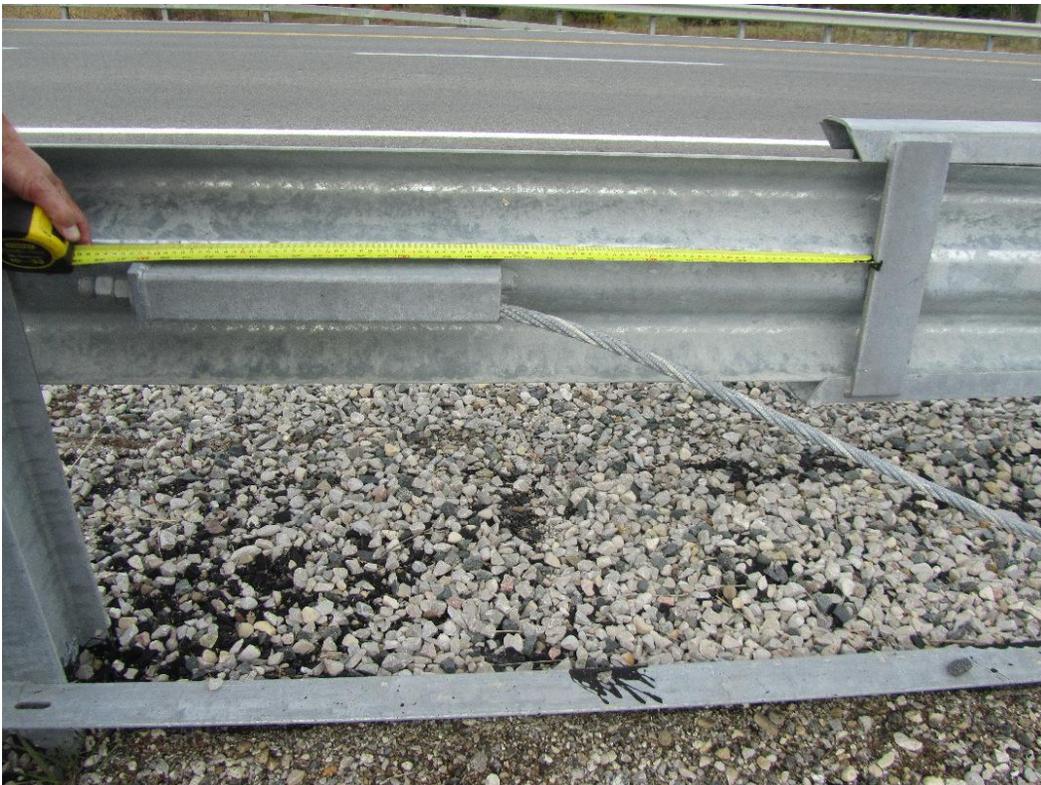
Figure 45: Ditch side view of end plate and channel.

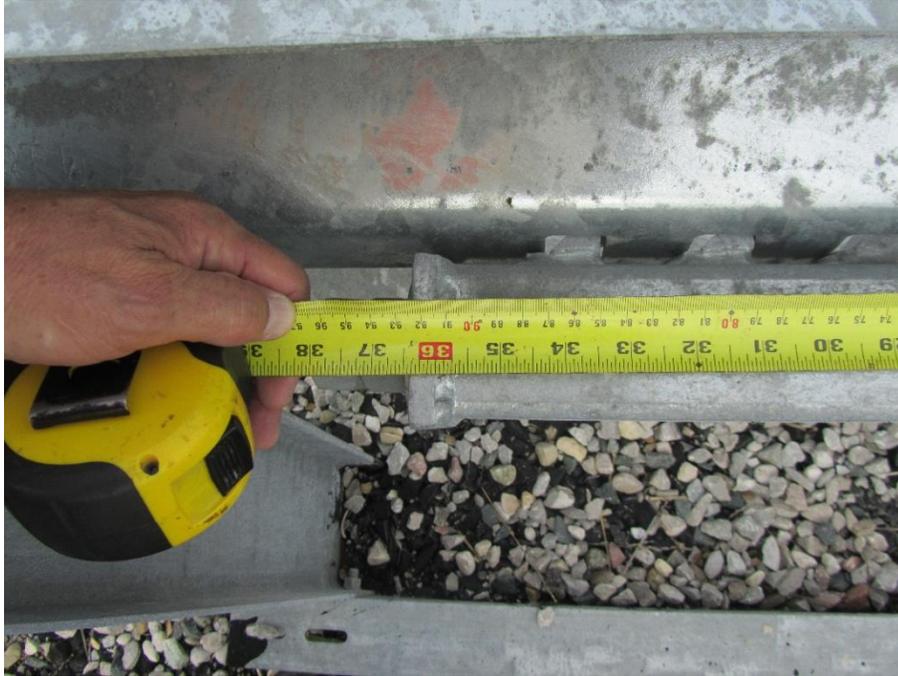
Figure 46: View of standard measurement being taken to establish the position of the end cap.

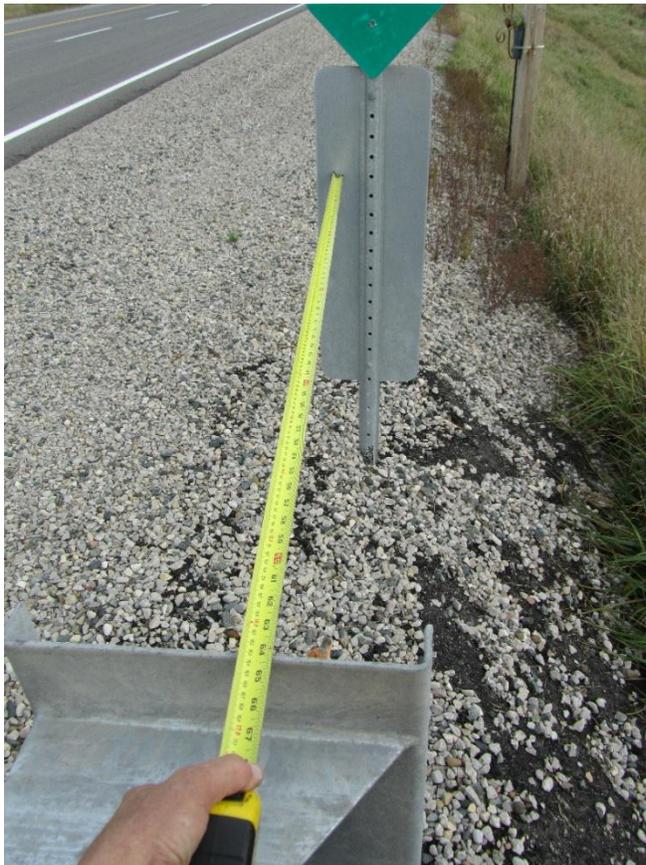
Figure 47: Result of measurement indicates a distance of 36.25 inches.

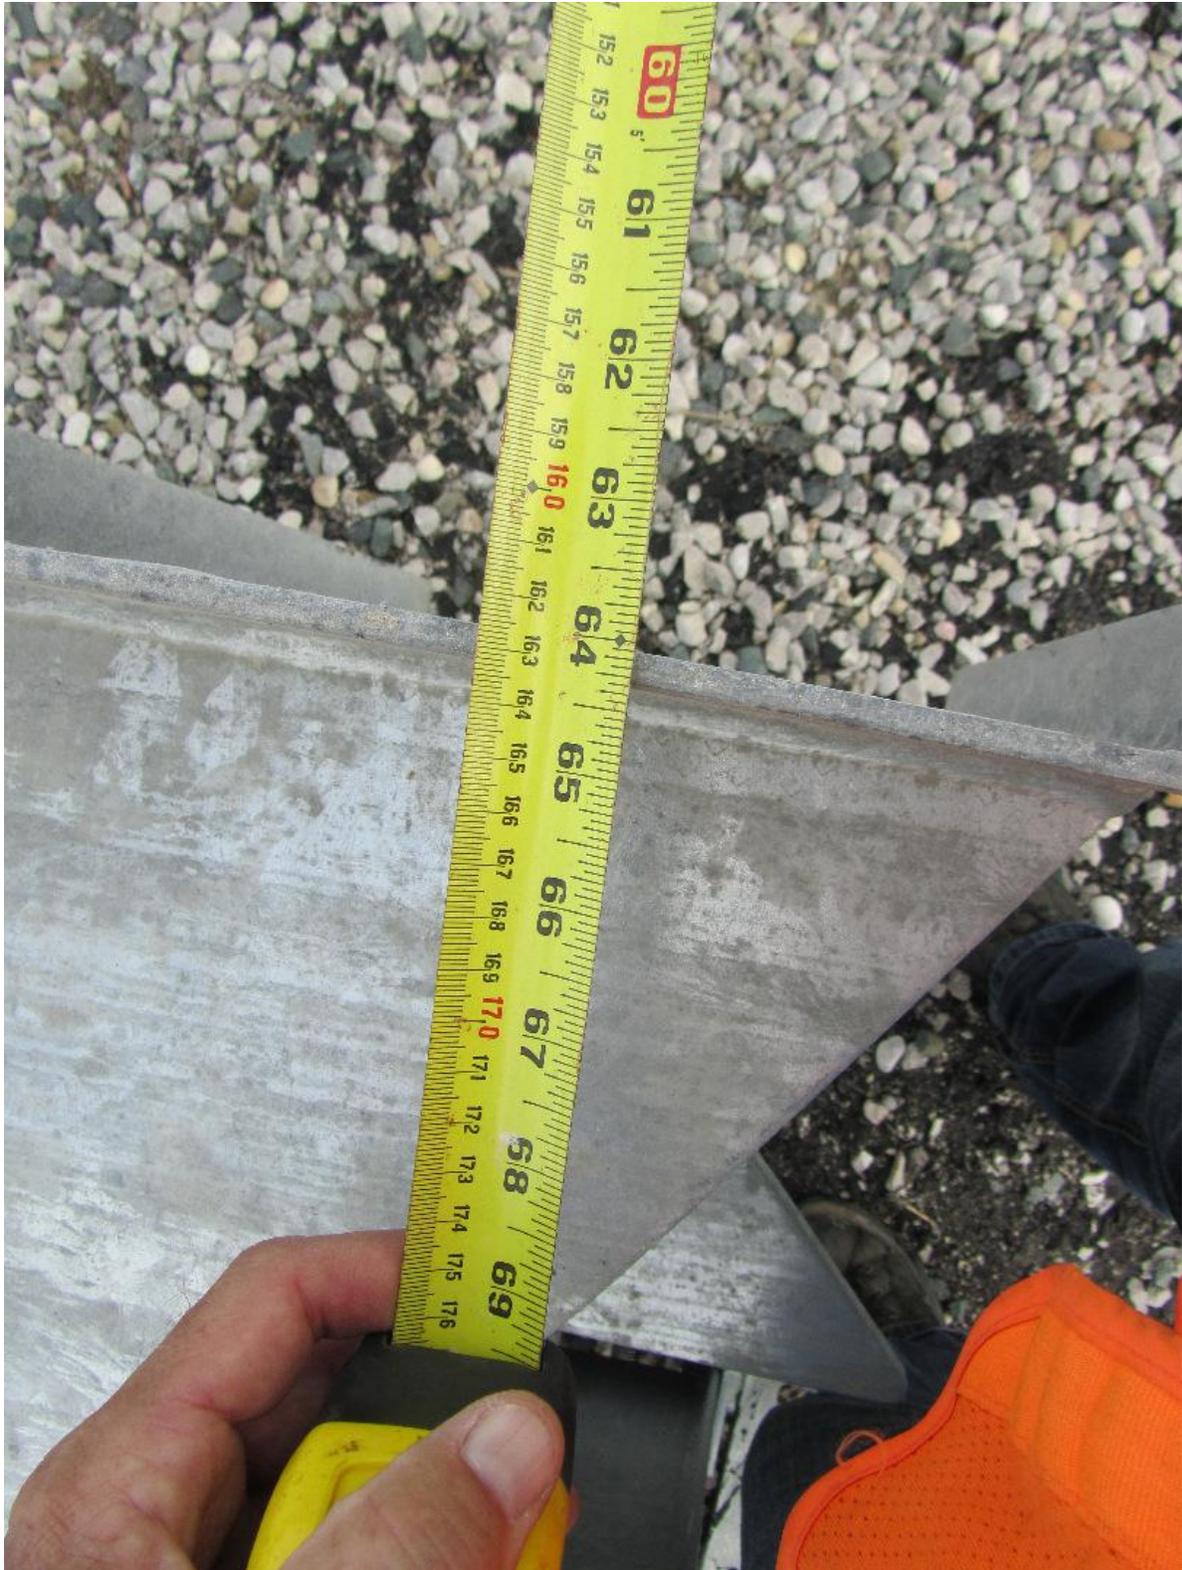
Figure 48: Measurement being taken to determine the distance from the post of the hazard warning sign to the end plate.

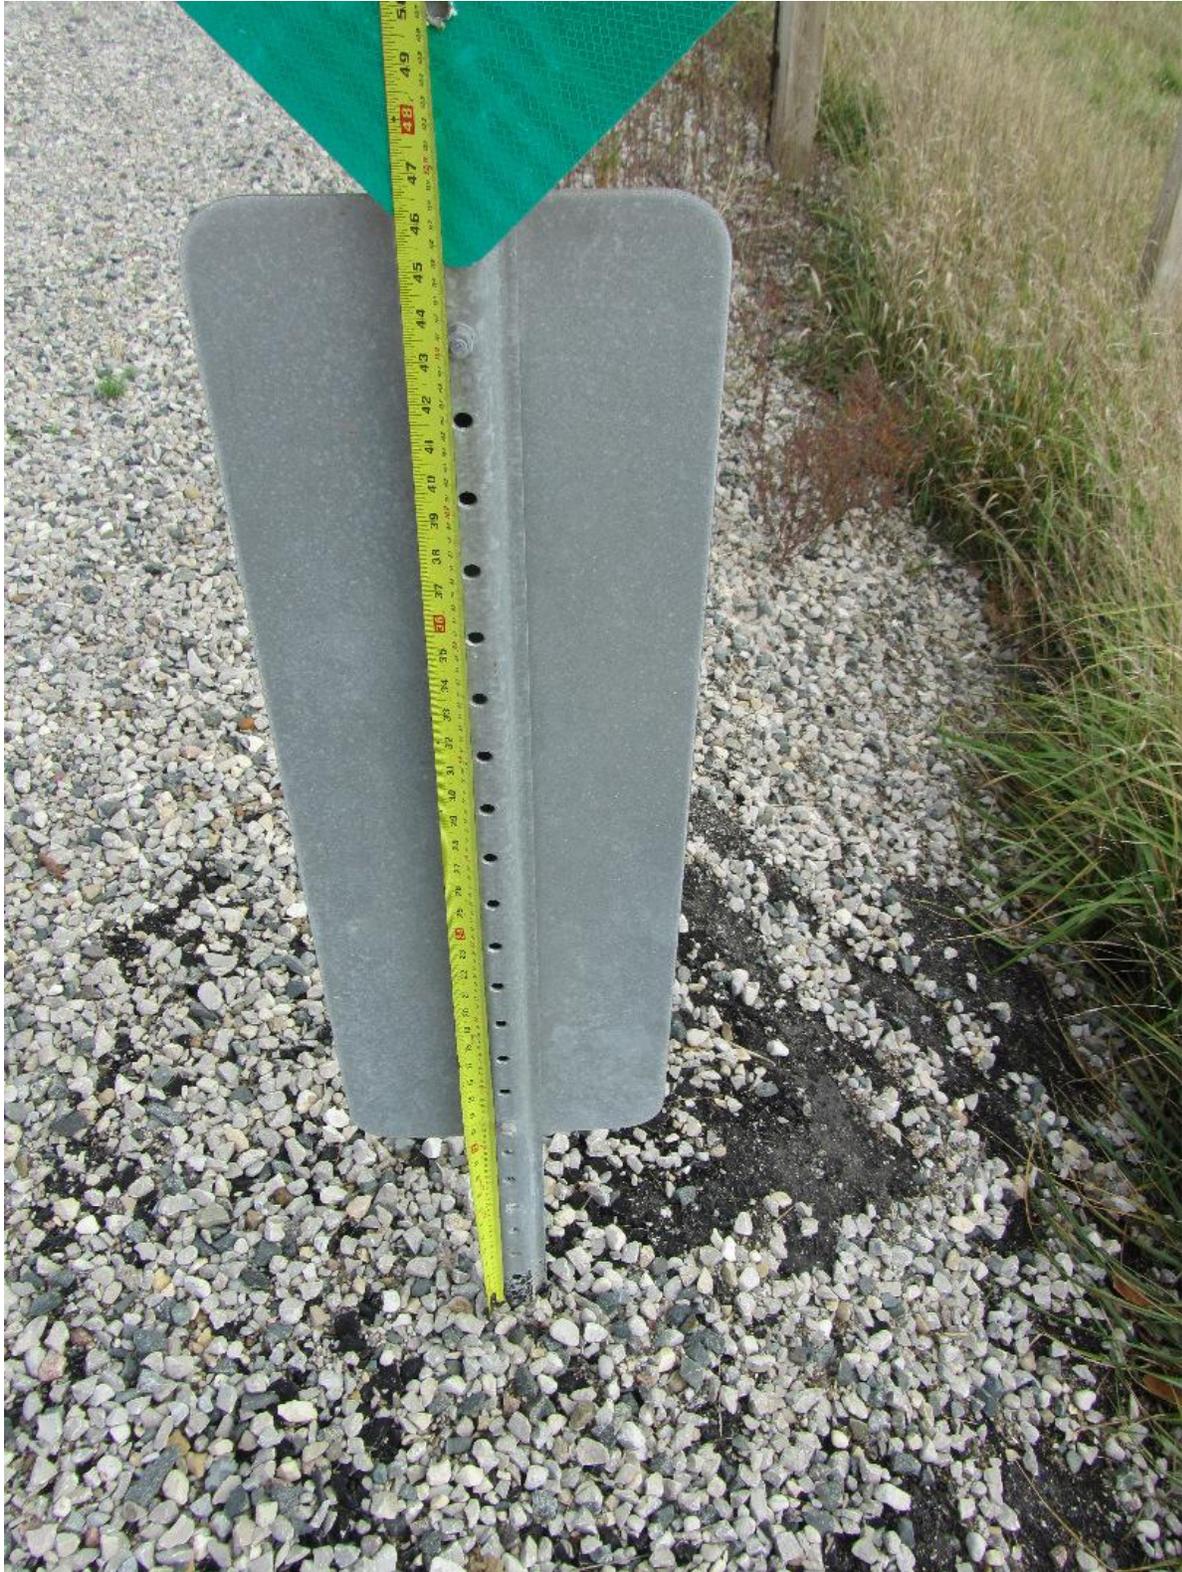
Figure 49: Result of measurement indicates a distance of 64 inches.

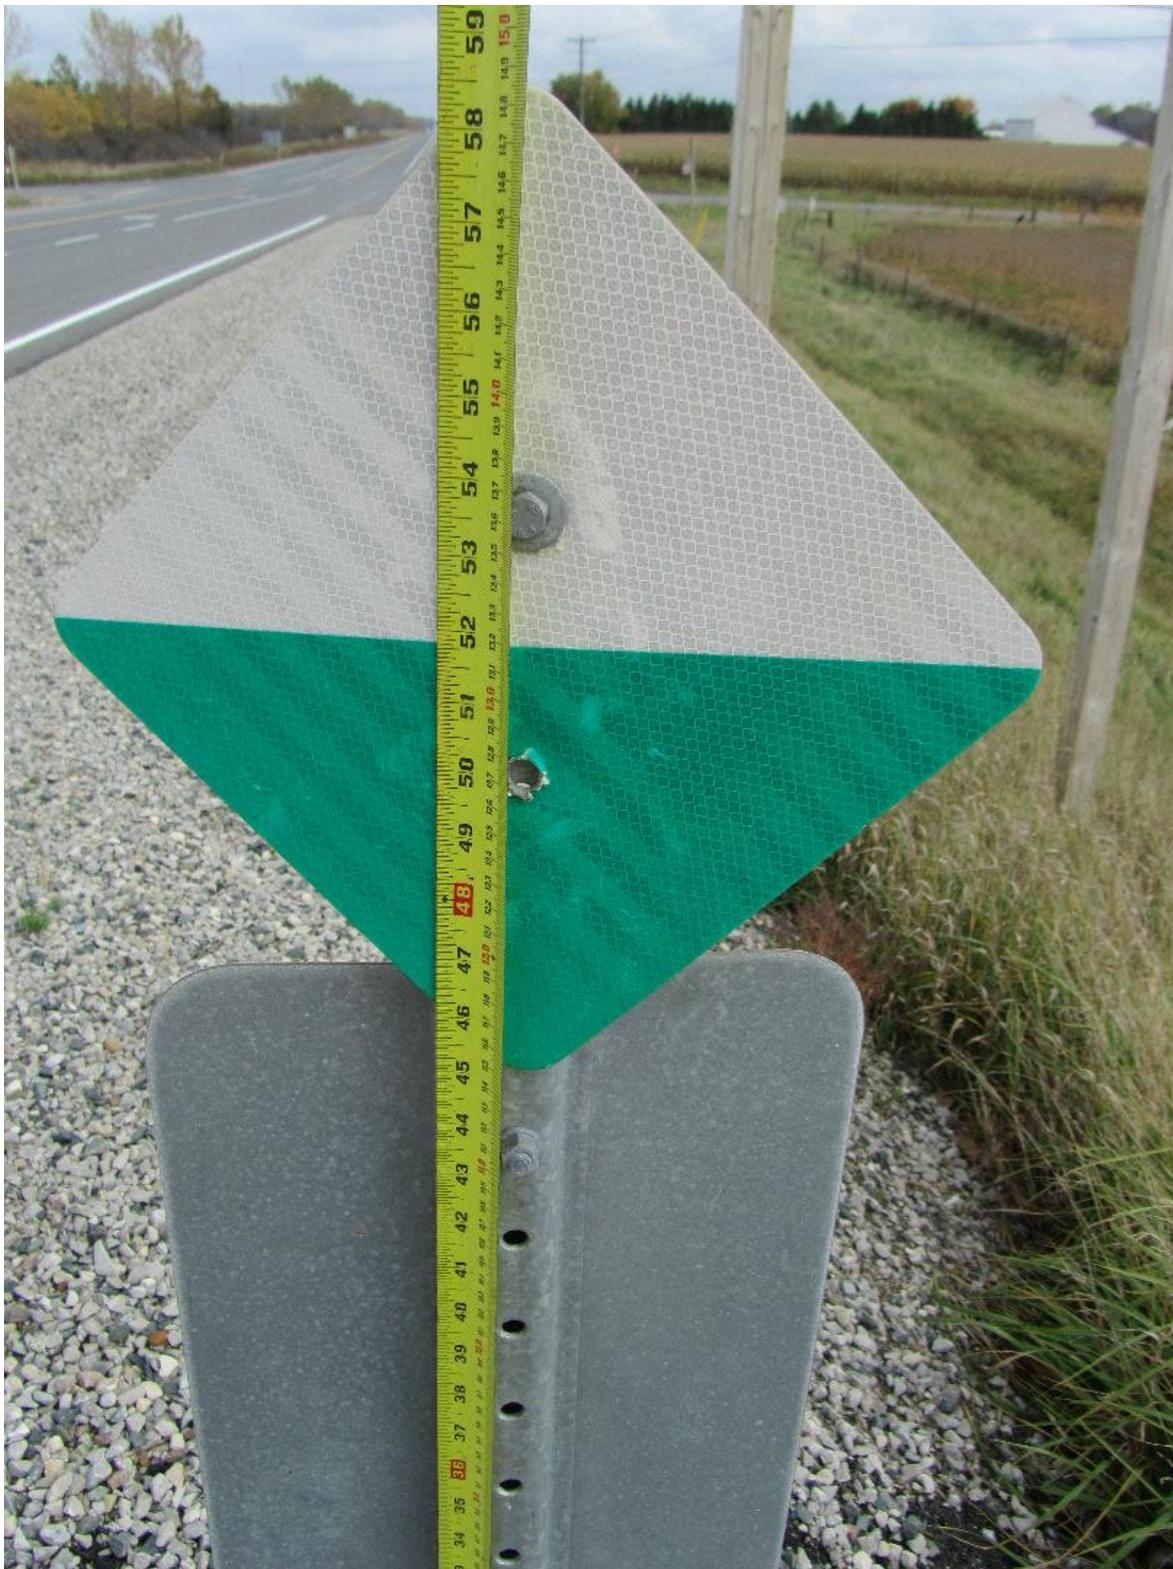
Figure 50: View of measurement taken to establish the height of the hazard warning post and sign.

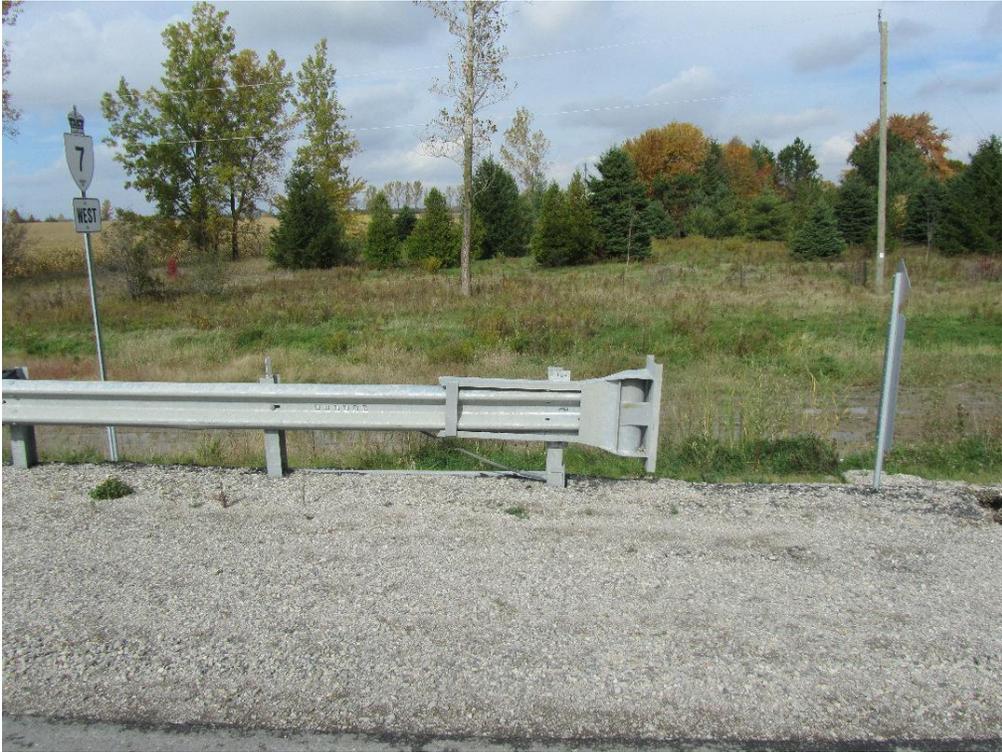
Figure 51: View indicating that the height of the hazard warning is about 58.5 inches.

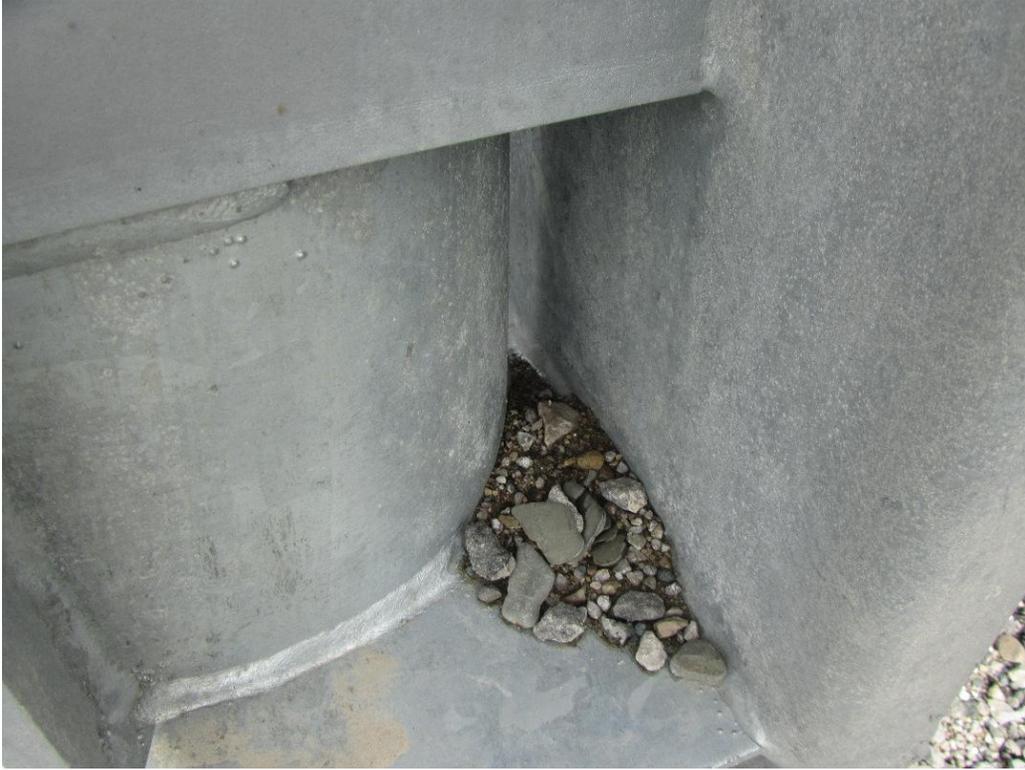
Figure 54: View of typical deposit of gravel on the horizontal landing just behind the end plate.

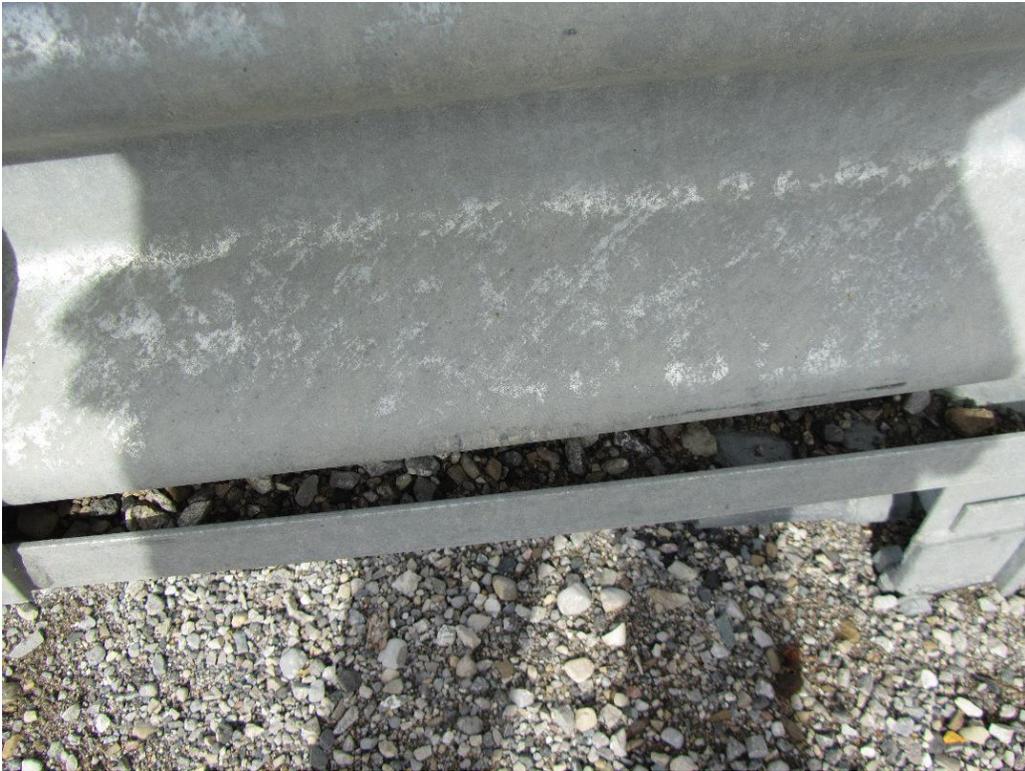
Figure 55: View of substantial deposit of gravel in the recess of the bottom of the rail and channel.

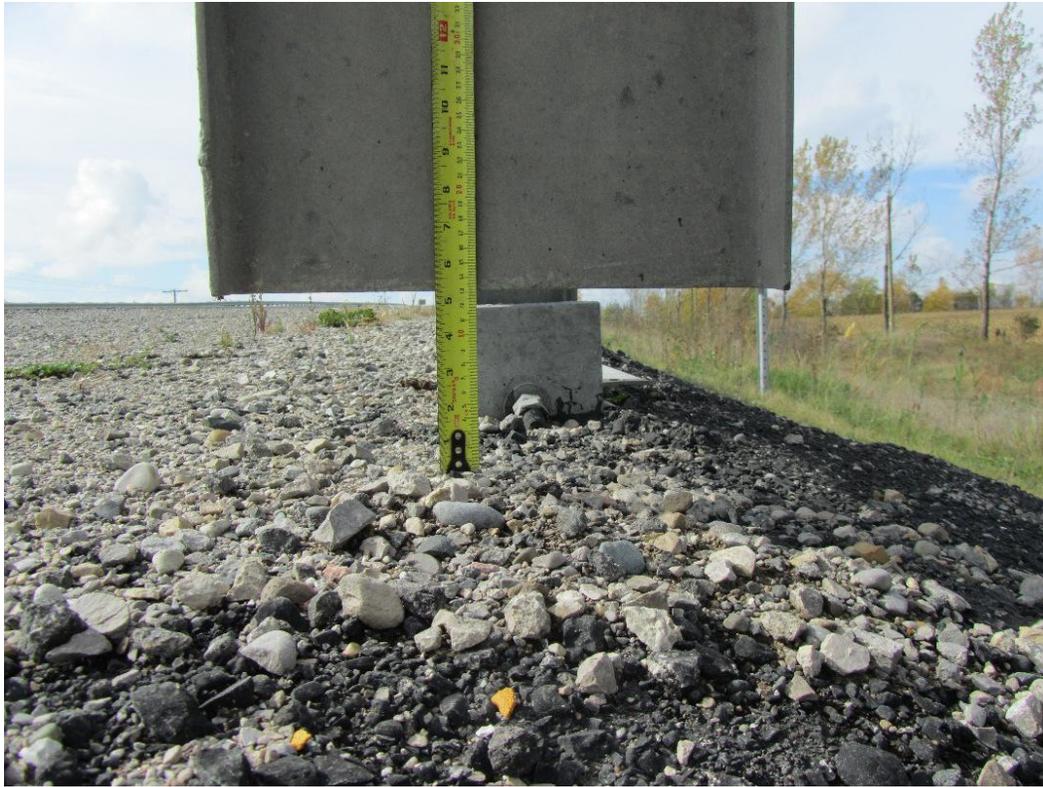
Figure 58: Measurement indicating that the bottom of the end plate is about 5.25 inches above the ground.

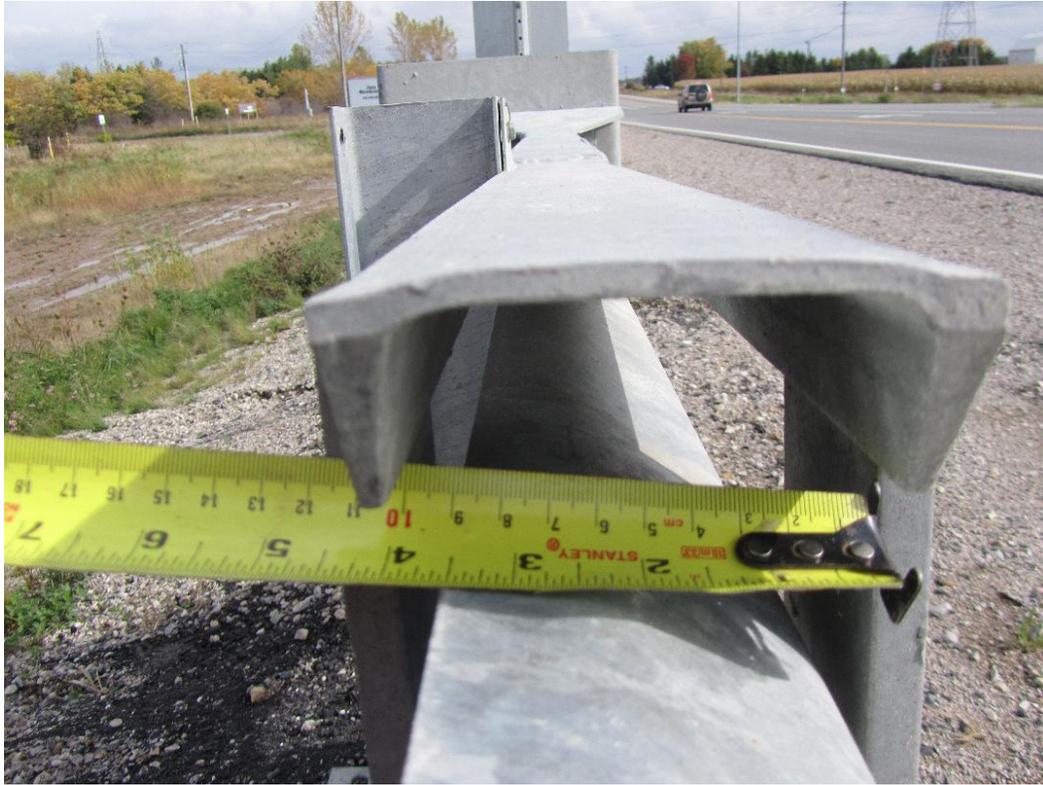
Figure 60: Measurement confirming that this is a 4-inch-wide channel.
