Trinity Guardrail End Cap Survey - Part III

The present article will review 10 end caps at three sites whose installations were found primarily north-east of London, Ontario, mostly along Highway 7.

16. Highway 7 at Railway Bridge West of Cobble Hills Road, Middlesex & Perth Counties Border

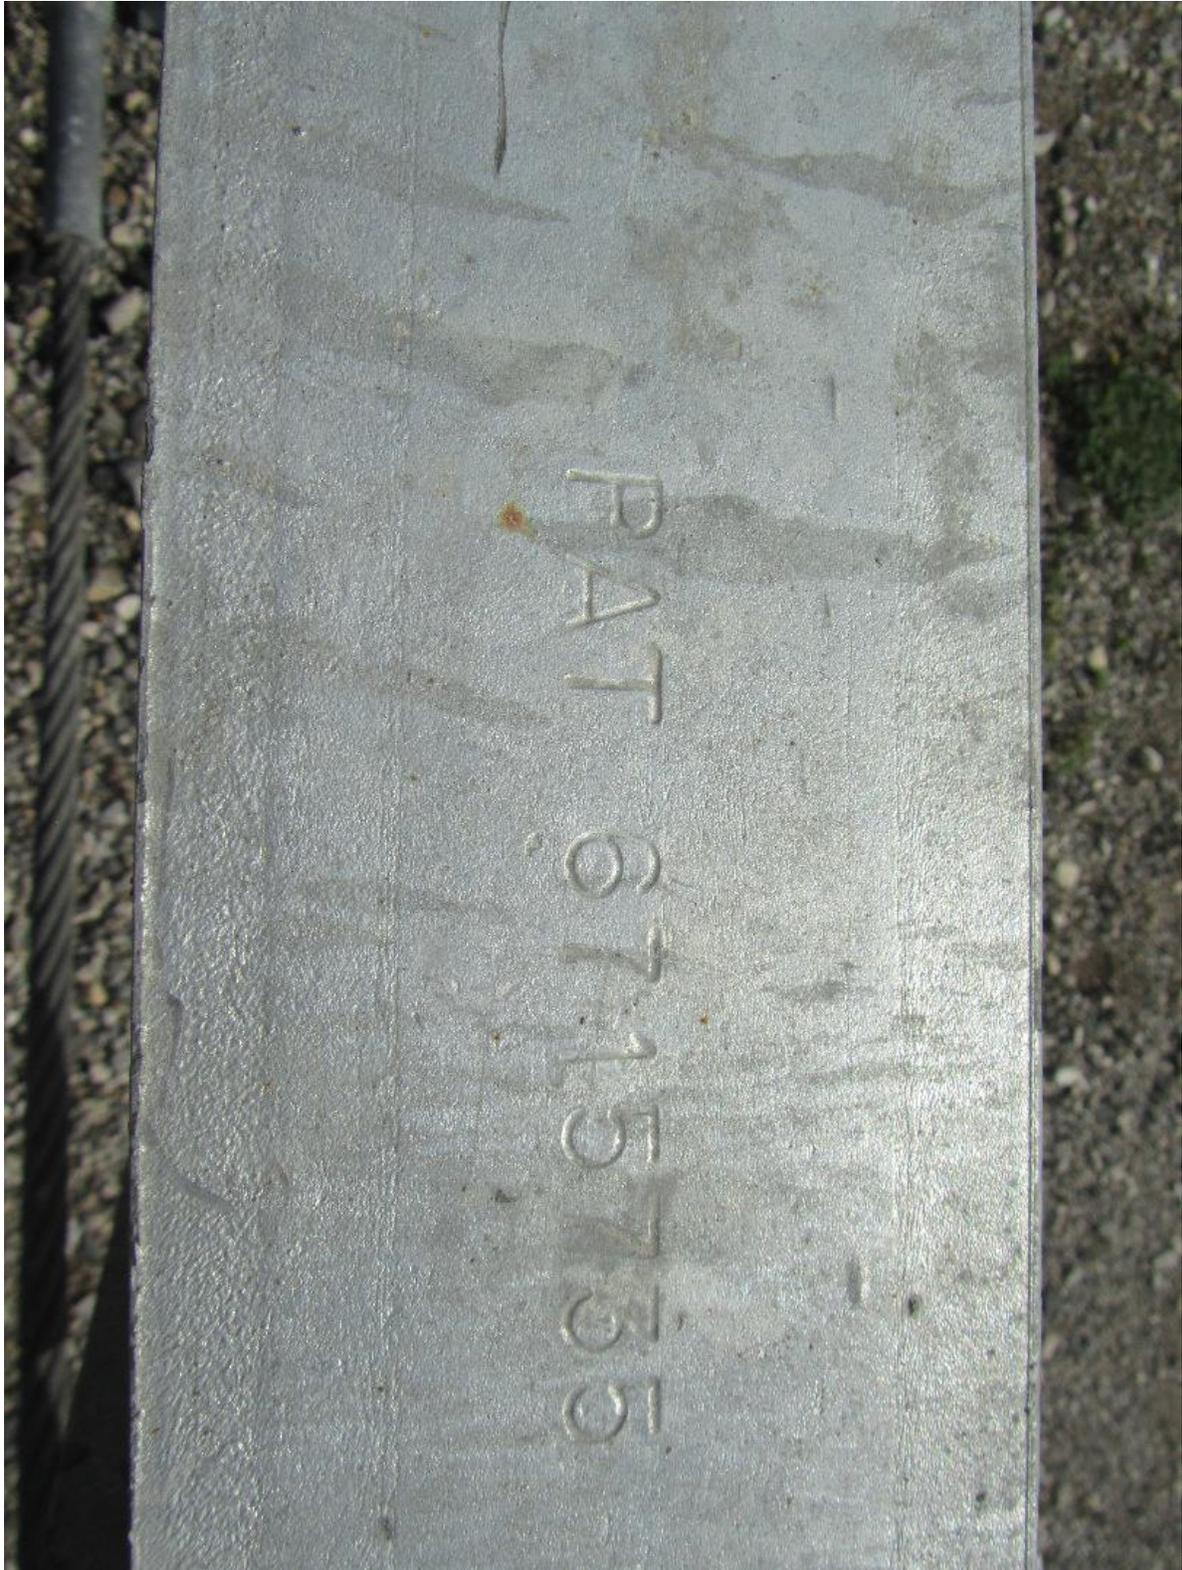
Figure 63: View of patent number stamped to the top of the channel.

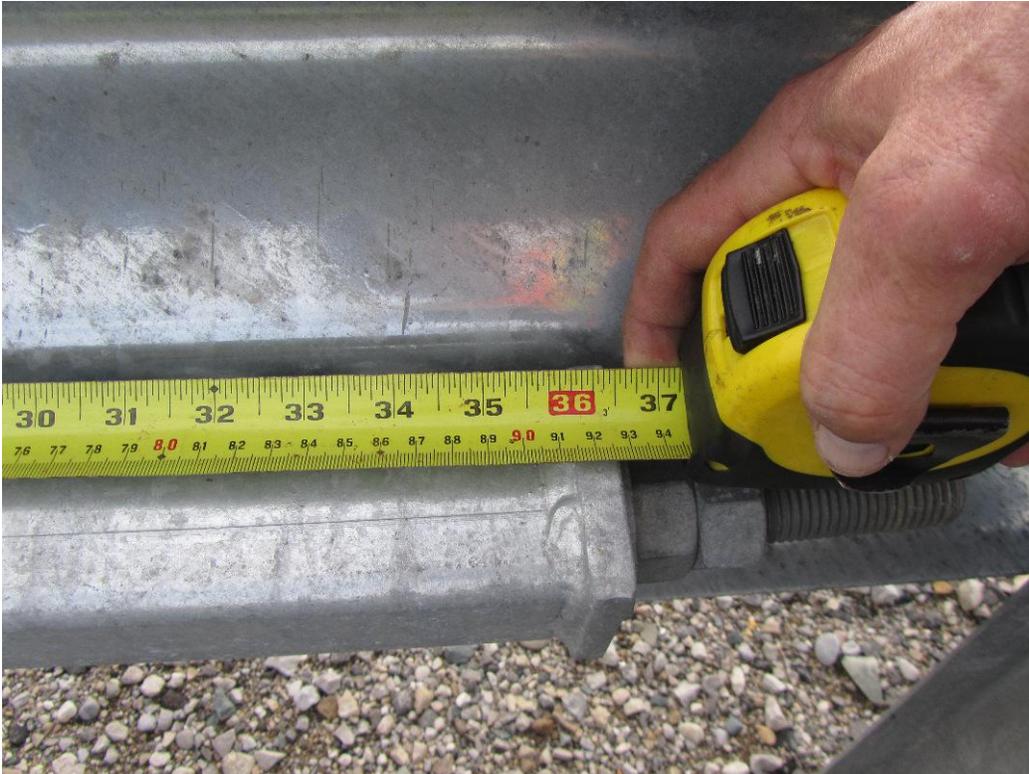
Figure 65: Result of measurement indicating a distance of 36.5 inches.

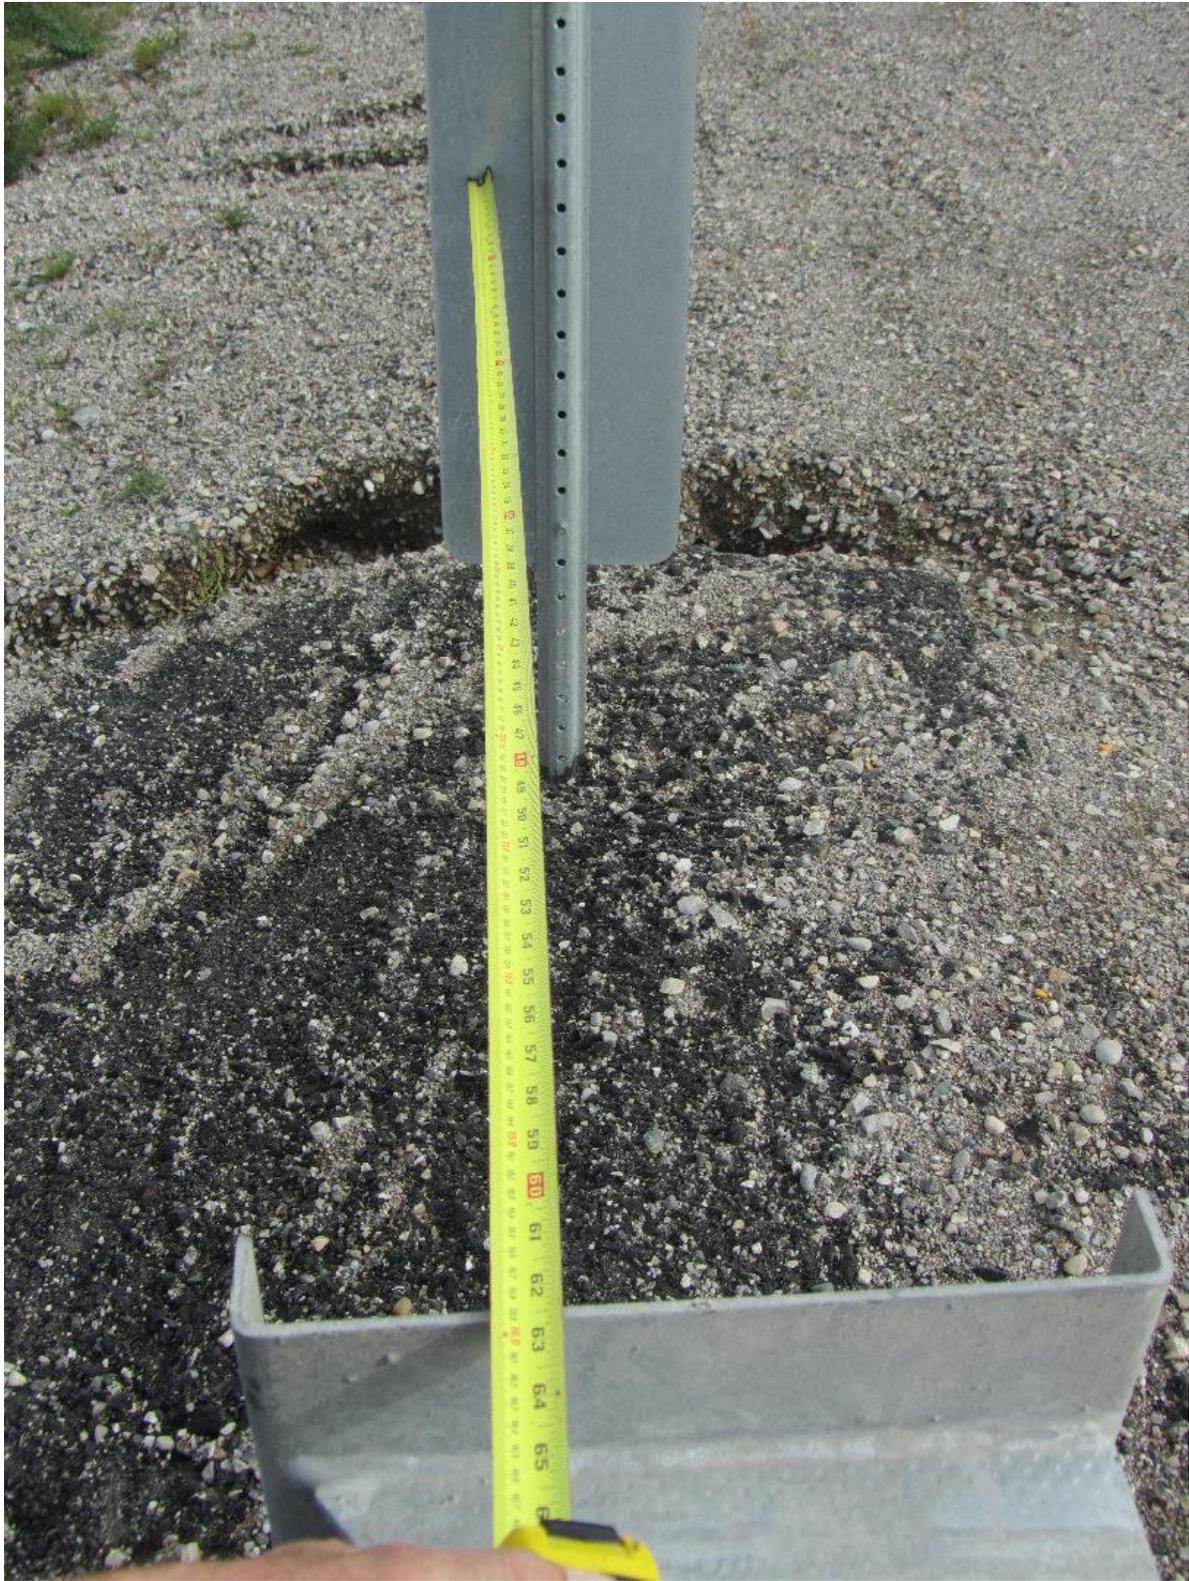
Figure 66: View showing the distance between the hazard warning sign and the end plate is about 62.5 inches.

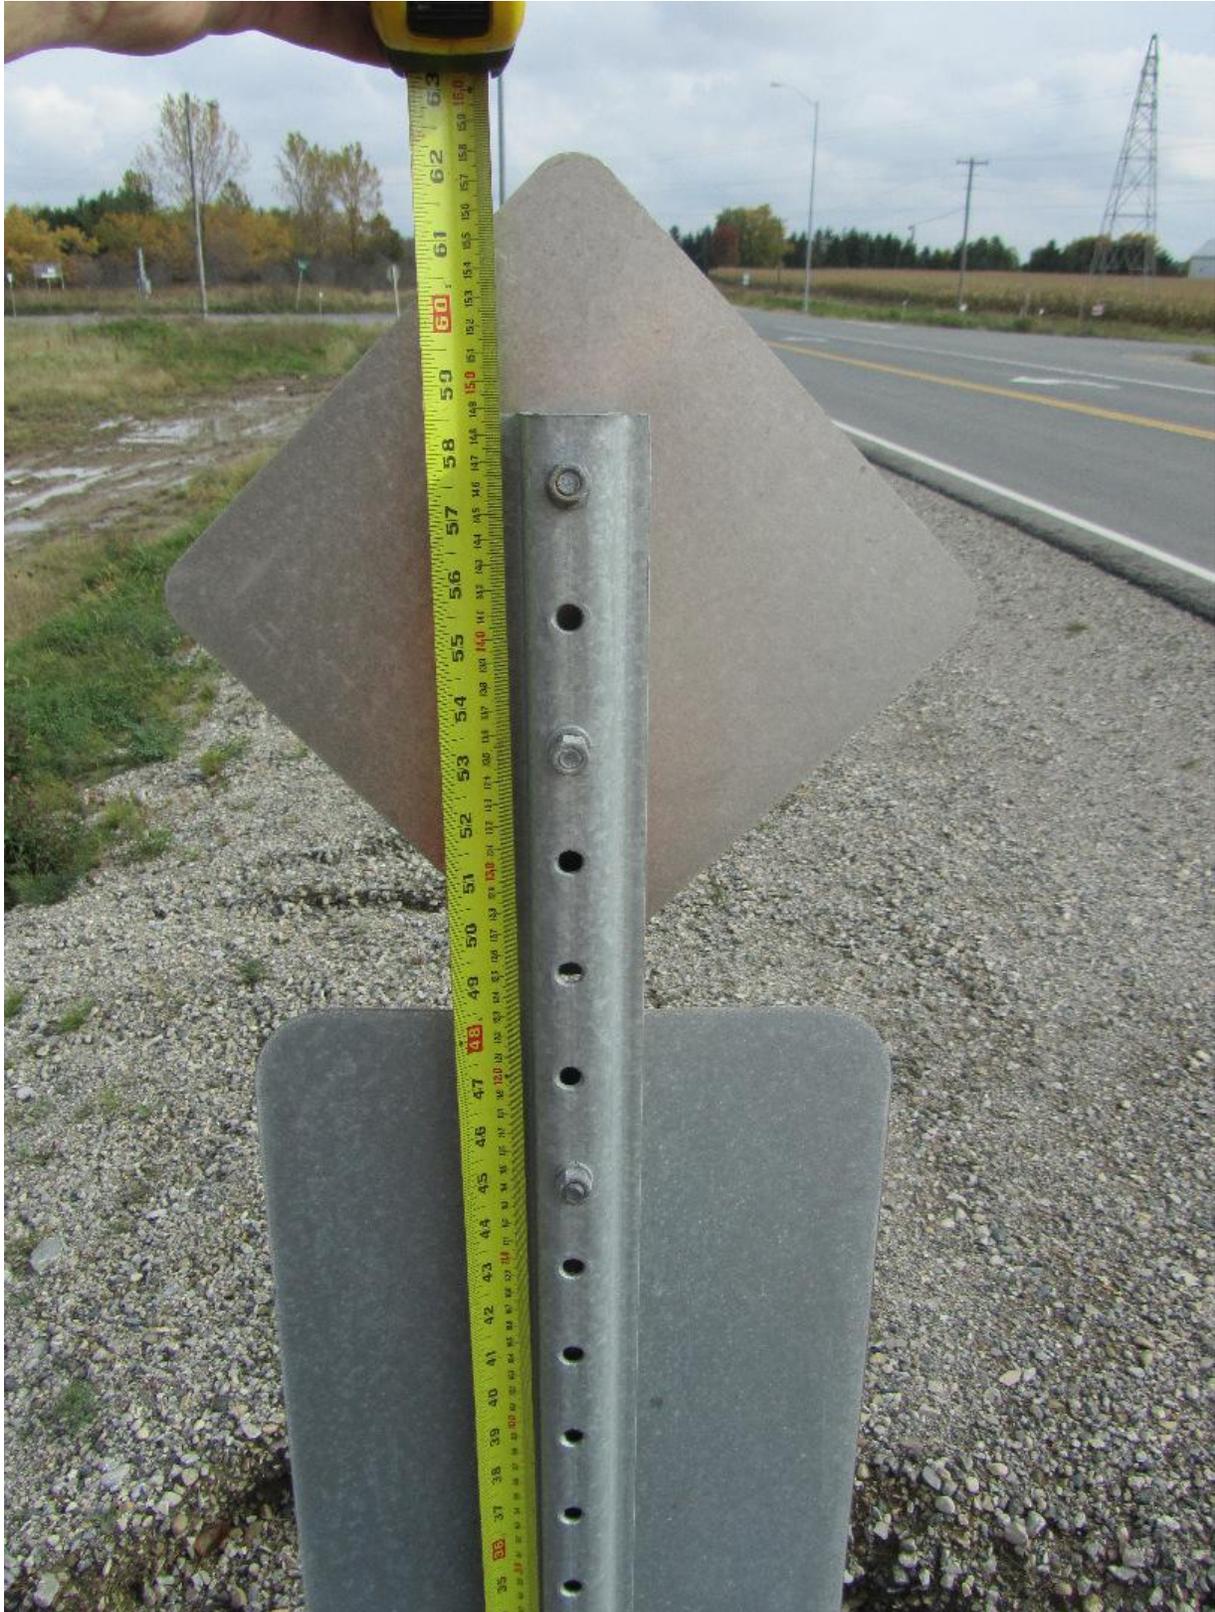
Figure 67: Measurement showing that the height of the hazard marker is about 62 inches above the ground.

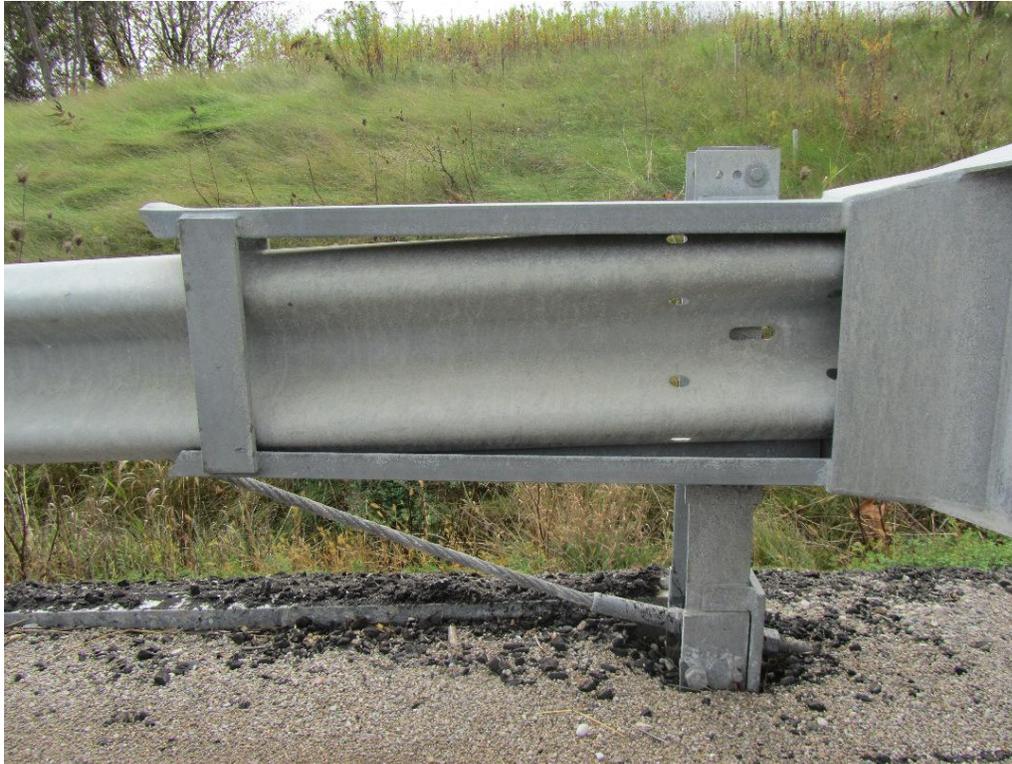
Figure 71: View of difference in horizontal angle of the rail and the channel.

After examining a total of 32 end caps we have begun to recognize a pattern where many of the channels are at a substantially different horizontal angle as compared to the rail that fits inside. We might consider that the instructions for the installation of the system could require that difference in angle, however it remains questionable what purpose that would achieve. The alternative hypothesis is that the weight of the end plate and channel might cause this unit to pivot downward and thus raising the rear edge of the channel. Again, at this early stage of our evaluations, we cannot be certain which hypothesis is true, or what other issues may be at play.

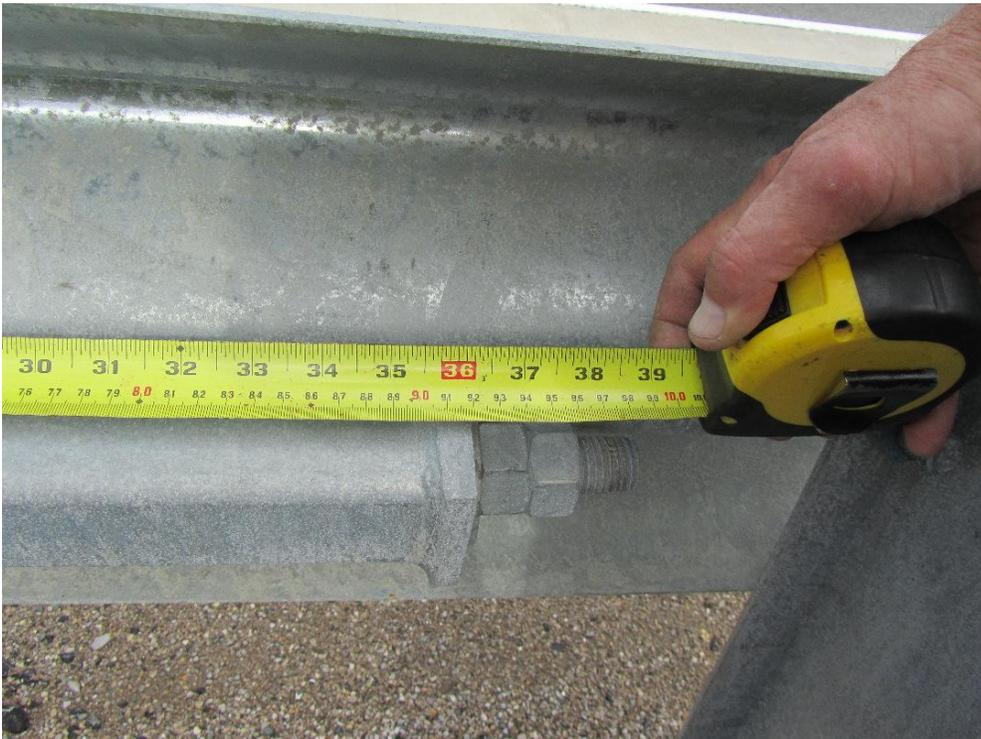
Figure 76: Result of measurement indicating a distance of 36 inches.

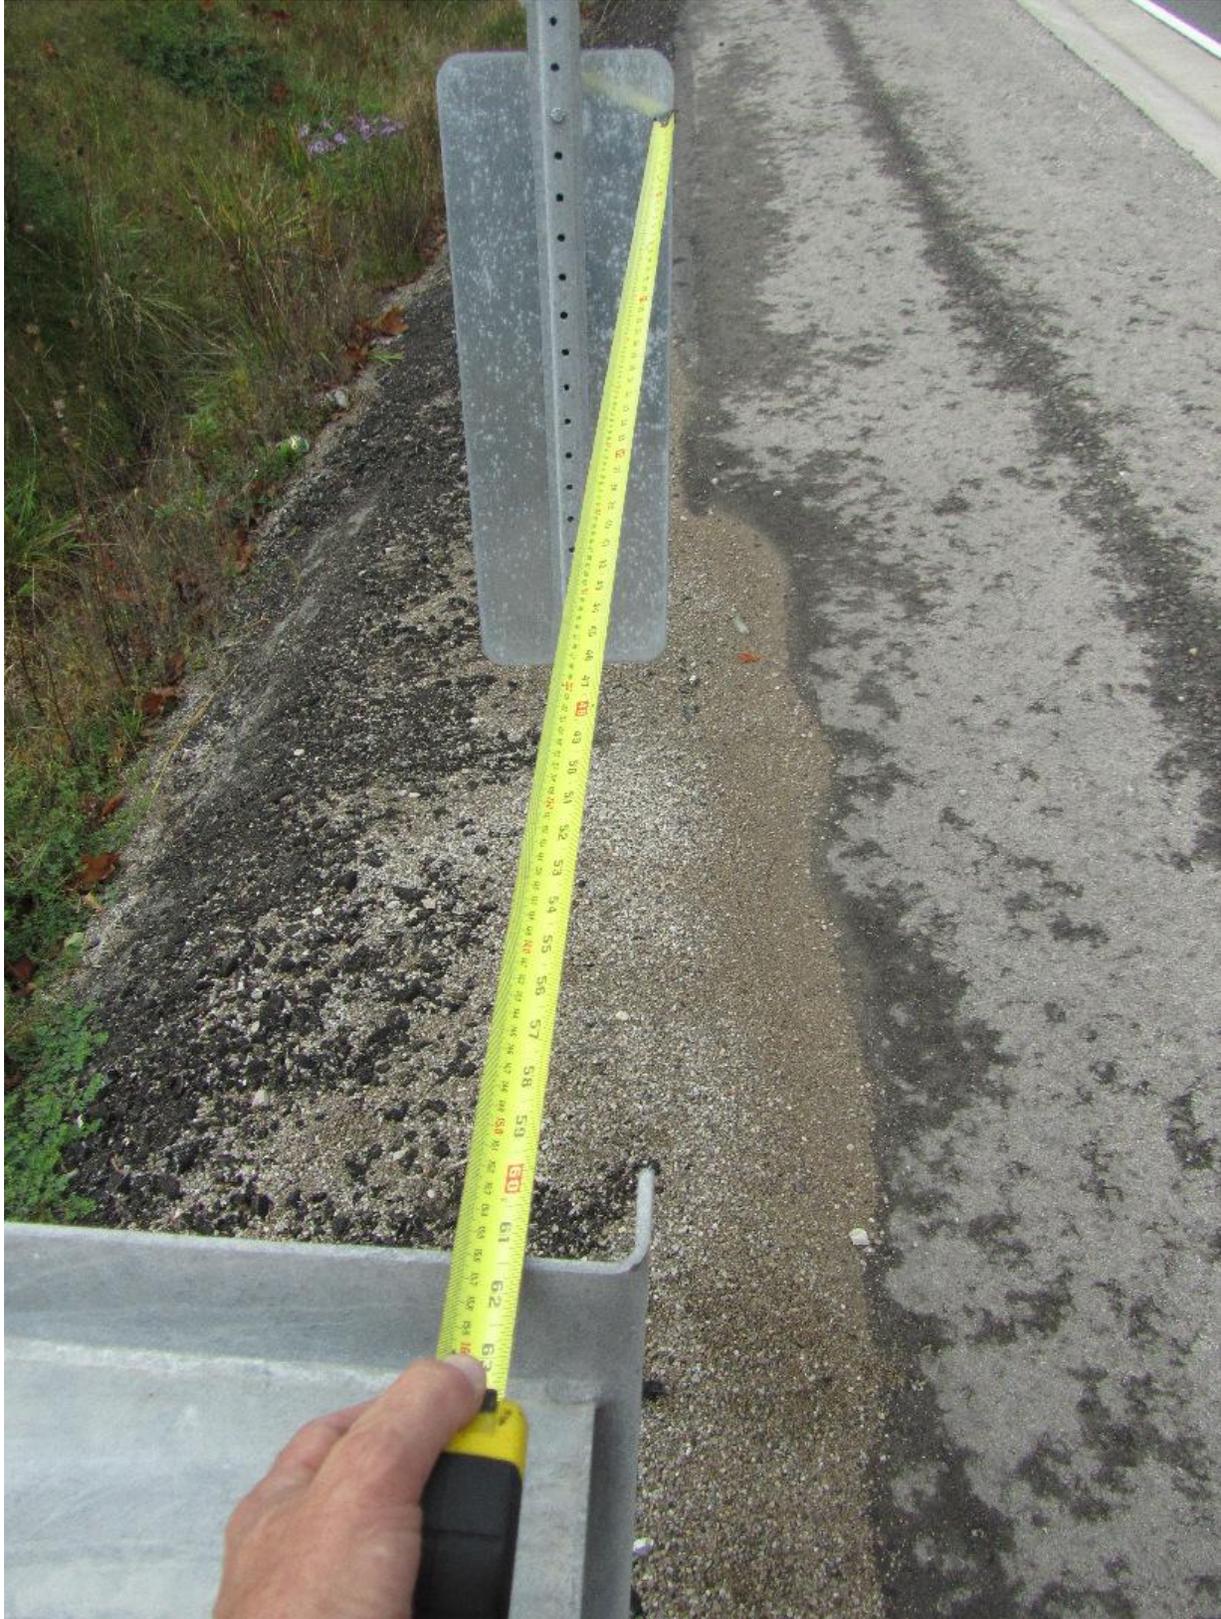
Figure 77: View of measurement indicating that the distance between the end plate and hazard warning sign is about 61 inches.

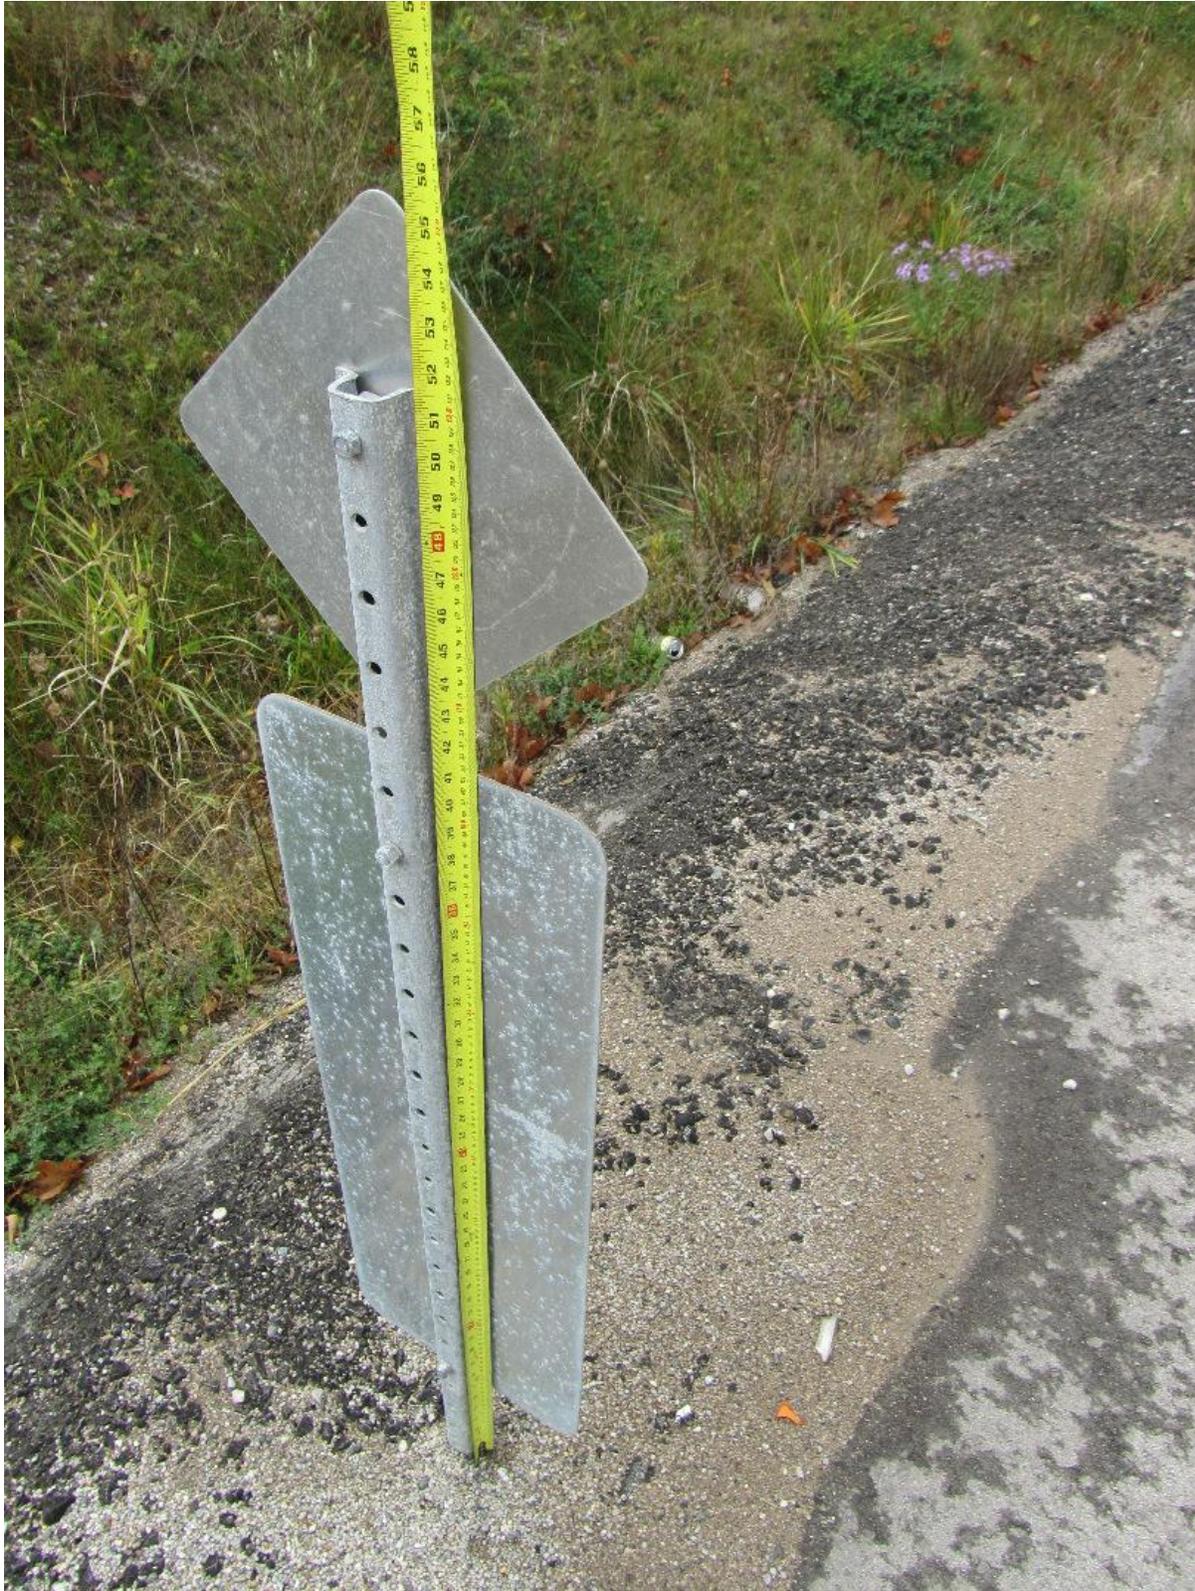
Figure 78: Measurement showing that the height of the hazard warning is about 56 inches.

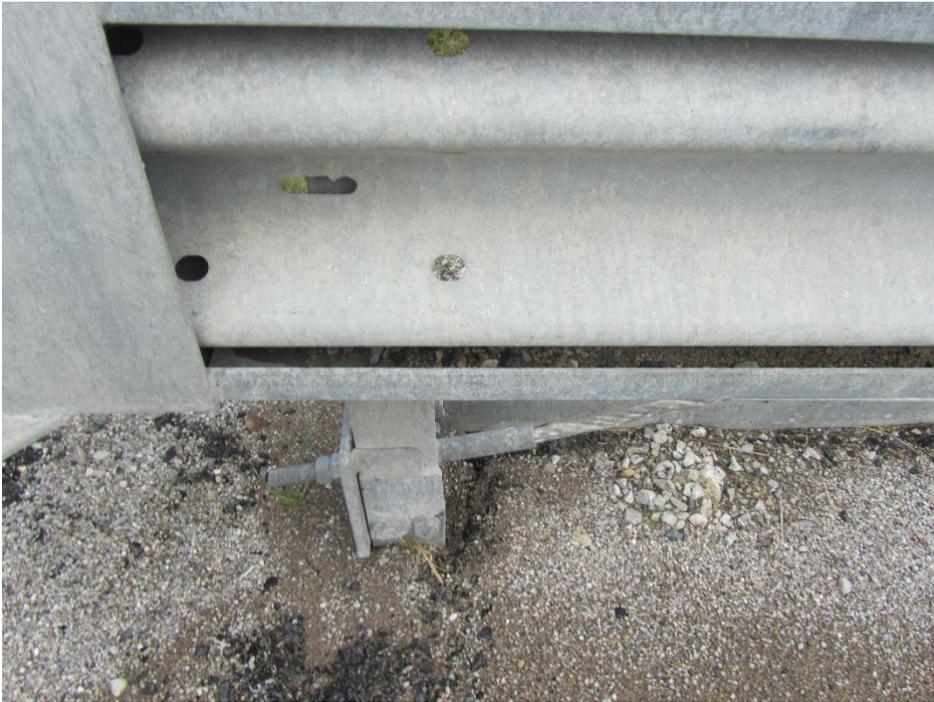
Figure 80: Street side view of channel showing a substantial quantity of gravel lying in the recess between the bottom of the rail and channel.

The unusual finding about this set of end caps is that 8 of the 10 units contained contaminants of gravel within the crevice between the bottom of the rail and channel. This finding would appear to be significant as it is vital that the end cap ride in an unobstructed manner along the rail when it is displaced by the impact of a wayward vehicle. It is this motion of the end cap that allows the rail to pass through the narrowing throat, flattening out the rail and then bailing the rail out the side of the end cap. From our understanding, the basis of the defect allegations against the ET-Plus system is that modifications that narrowed the dimensions of its channel caused the rail to become jammed and the rail would not pass through the end cap as it was designed. If extraneous materials such as gravel are placed in the channel where the unobstructed motion is critical, such jamming of that motion would seem likely. It would seem that, aside from any other potential defects, the design of the ET-Plus system with its open channel, can cause foreign objects to enter into the channel and obstruct the motion of the system, thus making it fail.

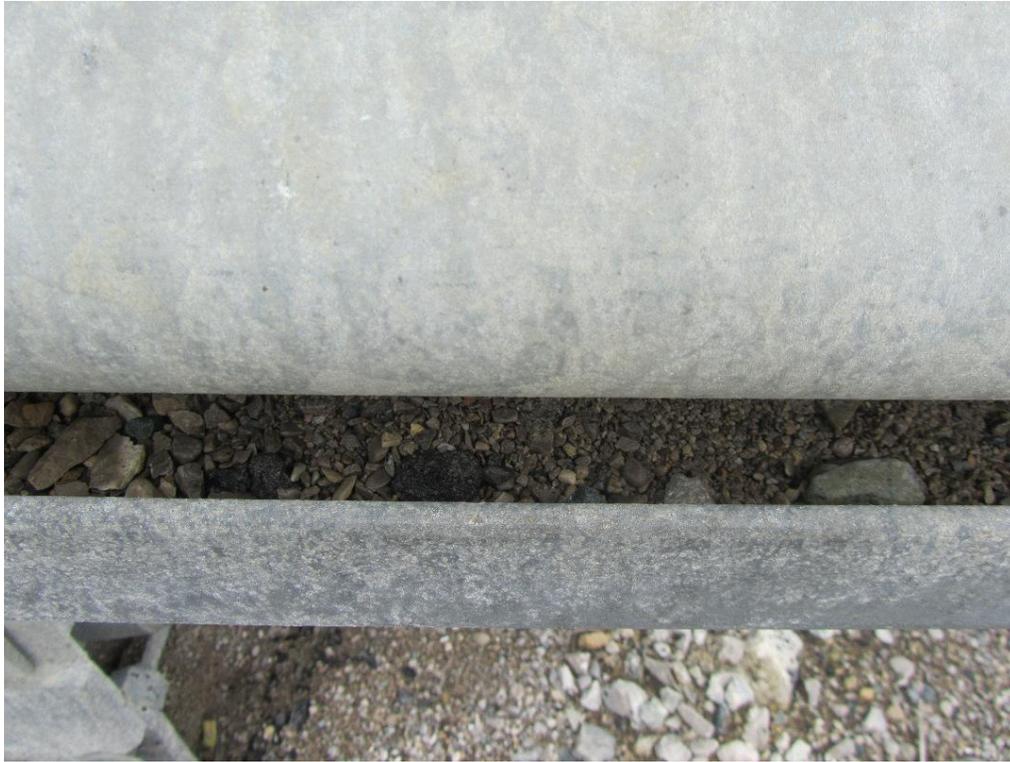
Figure 81: Closer view of deposit of gravel lying the recess at the bottom of the rail and channel.

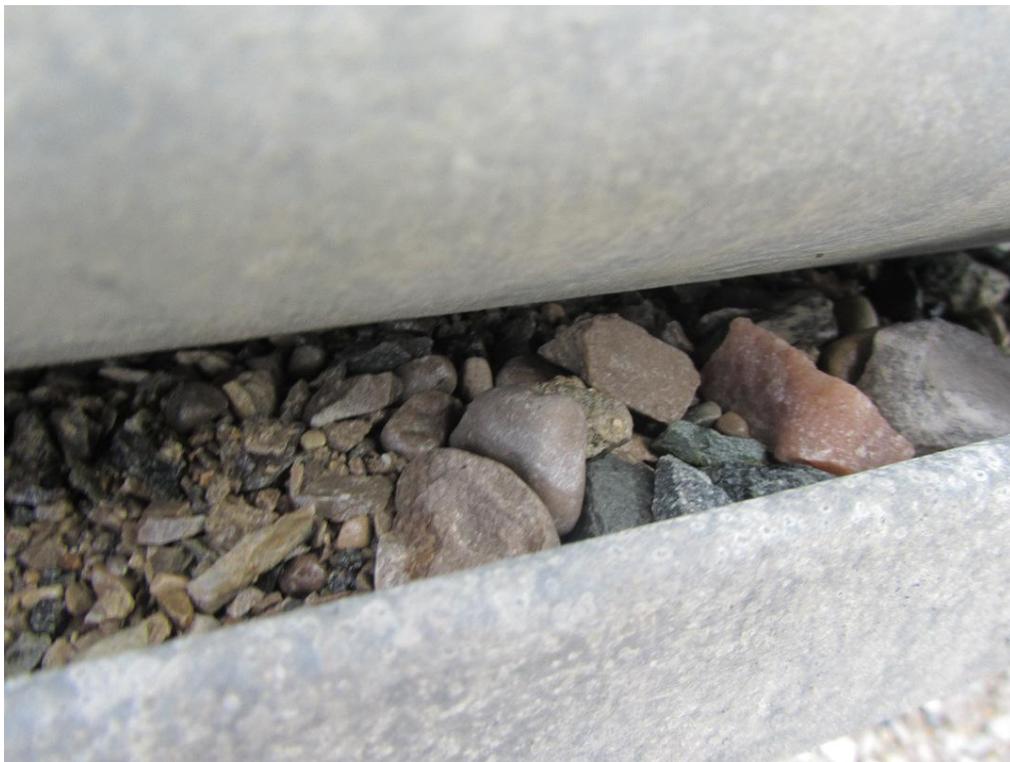
Figure 82: Close-up view of large quantity of gravel deposited in the recess at the bottom of the rail and channel.

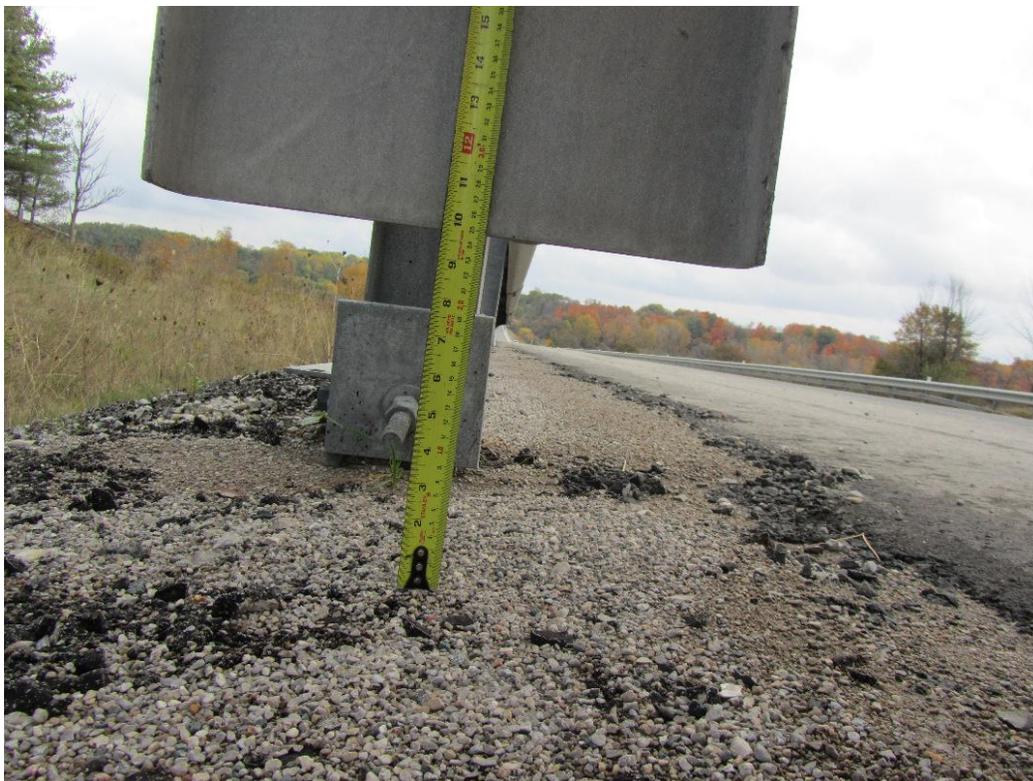
Figure 84: Measurement indicating that the bottom edge of the end plate is about 10 inches above the ground.

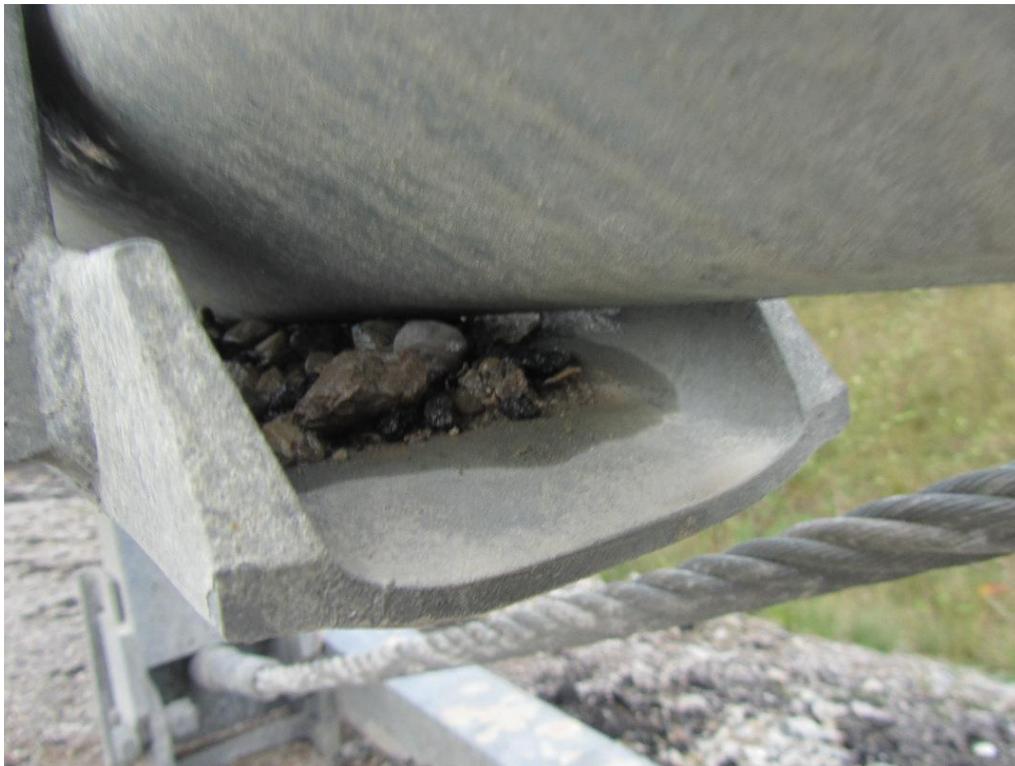
Figure 86: Additional view of gravel lying in the bottom of the channel near its rear edge.

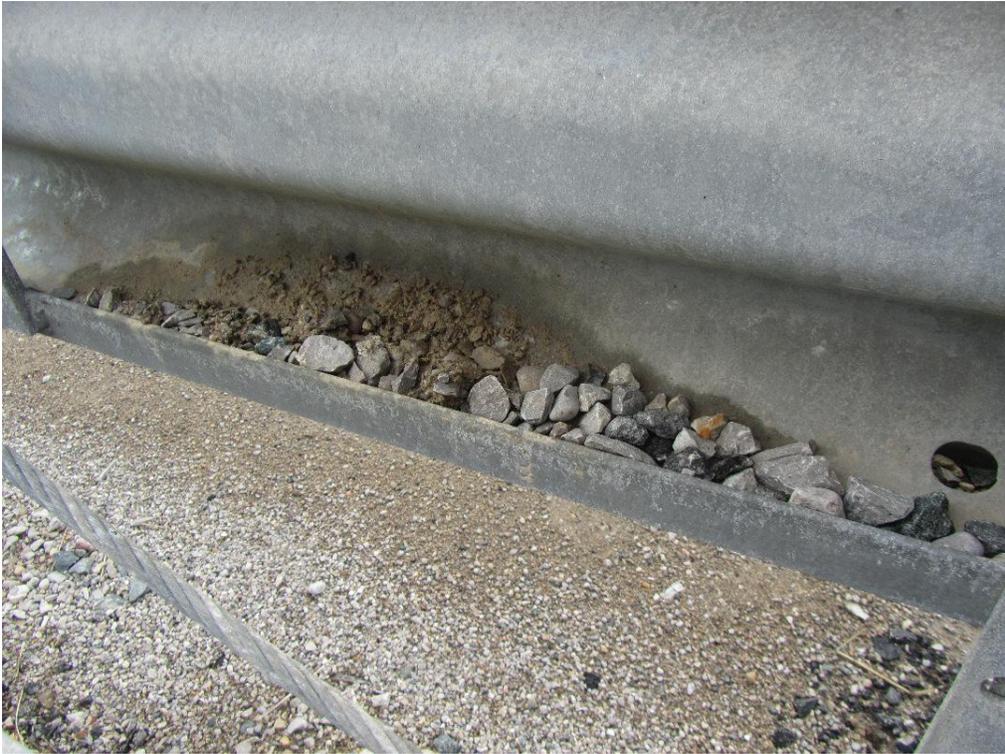
Figure 88: View of substantial quantity of gravel lying in the recess between the bottom of the rail and channel.

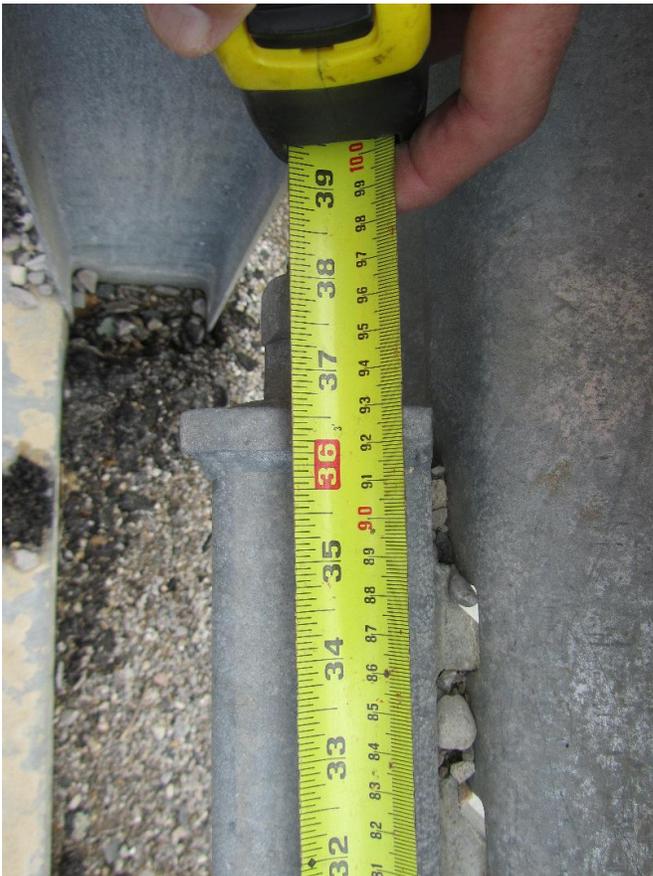
Figure 89: View of standard measurement being taken to determine the position of the end cap.

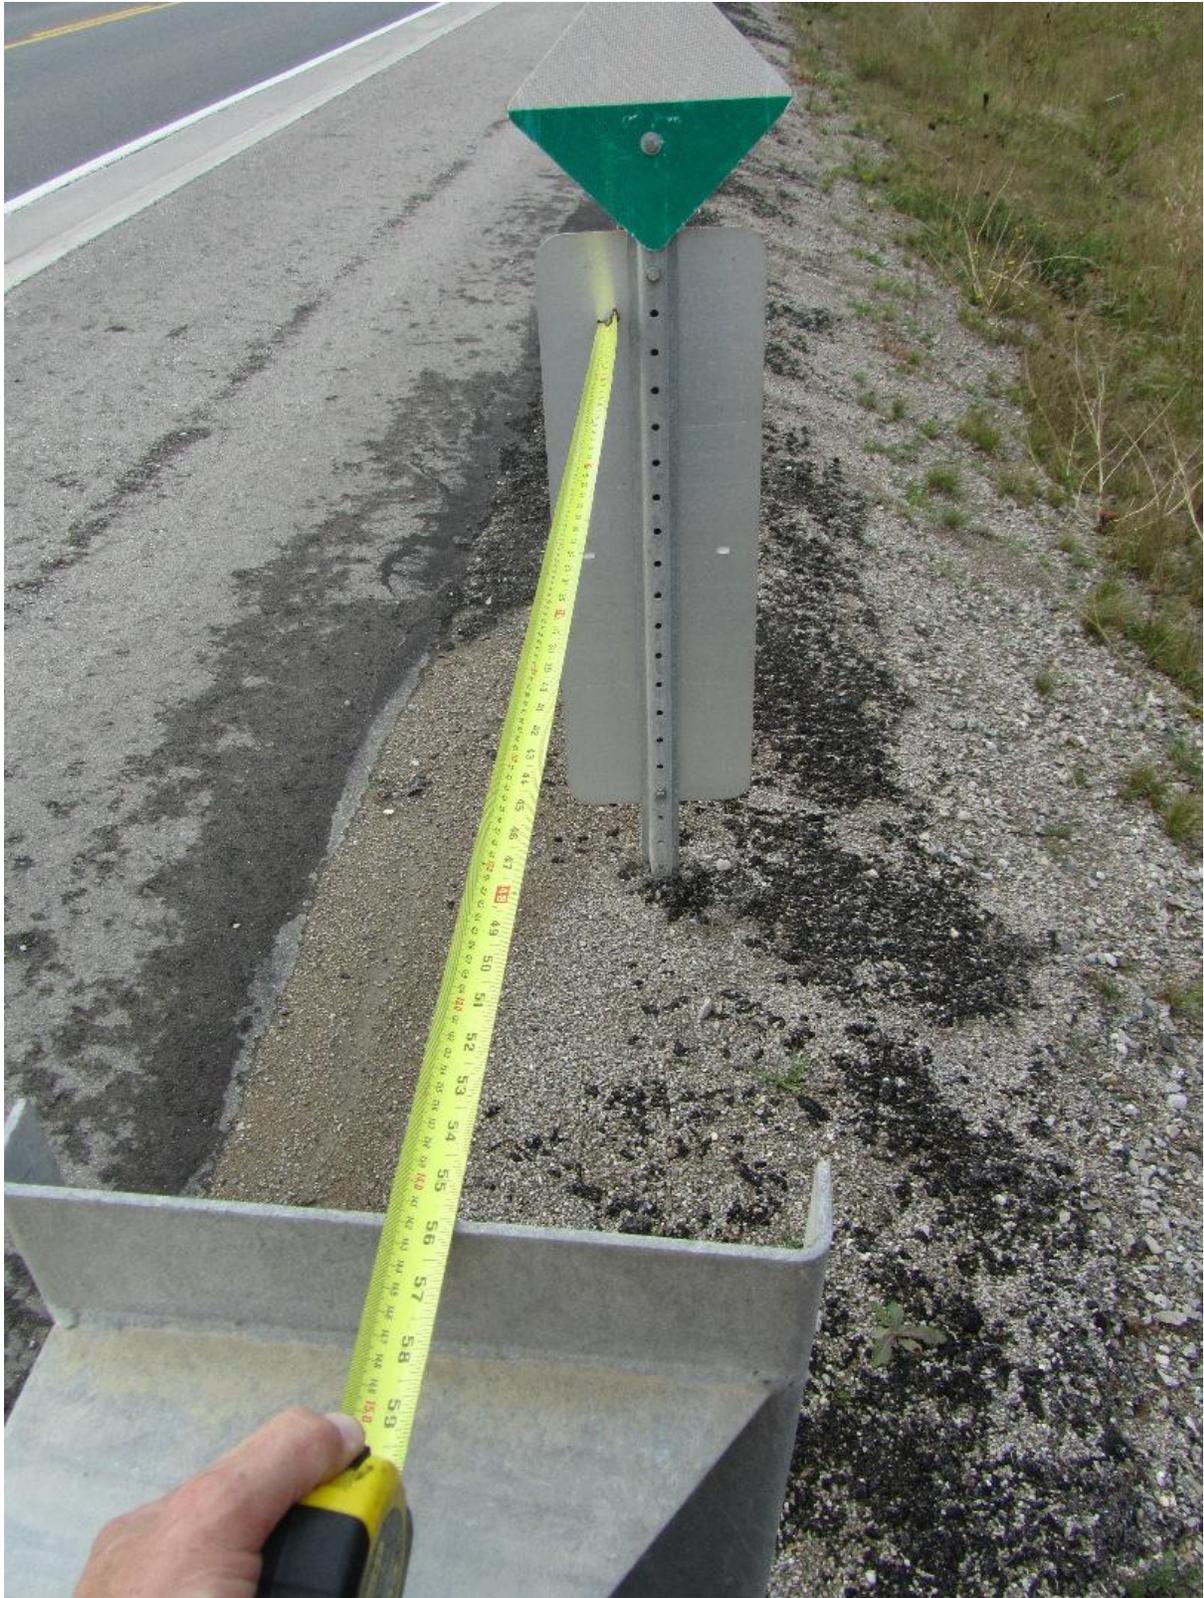
Figure 90: Result of standard measurement indicating about 36.5 inches.

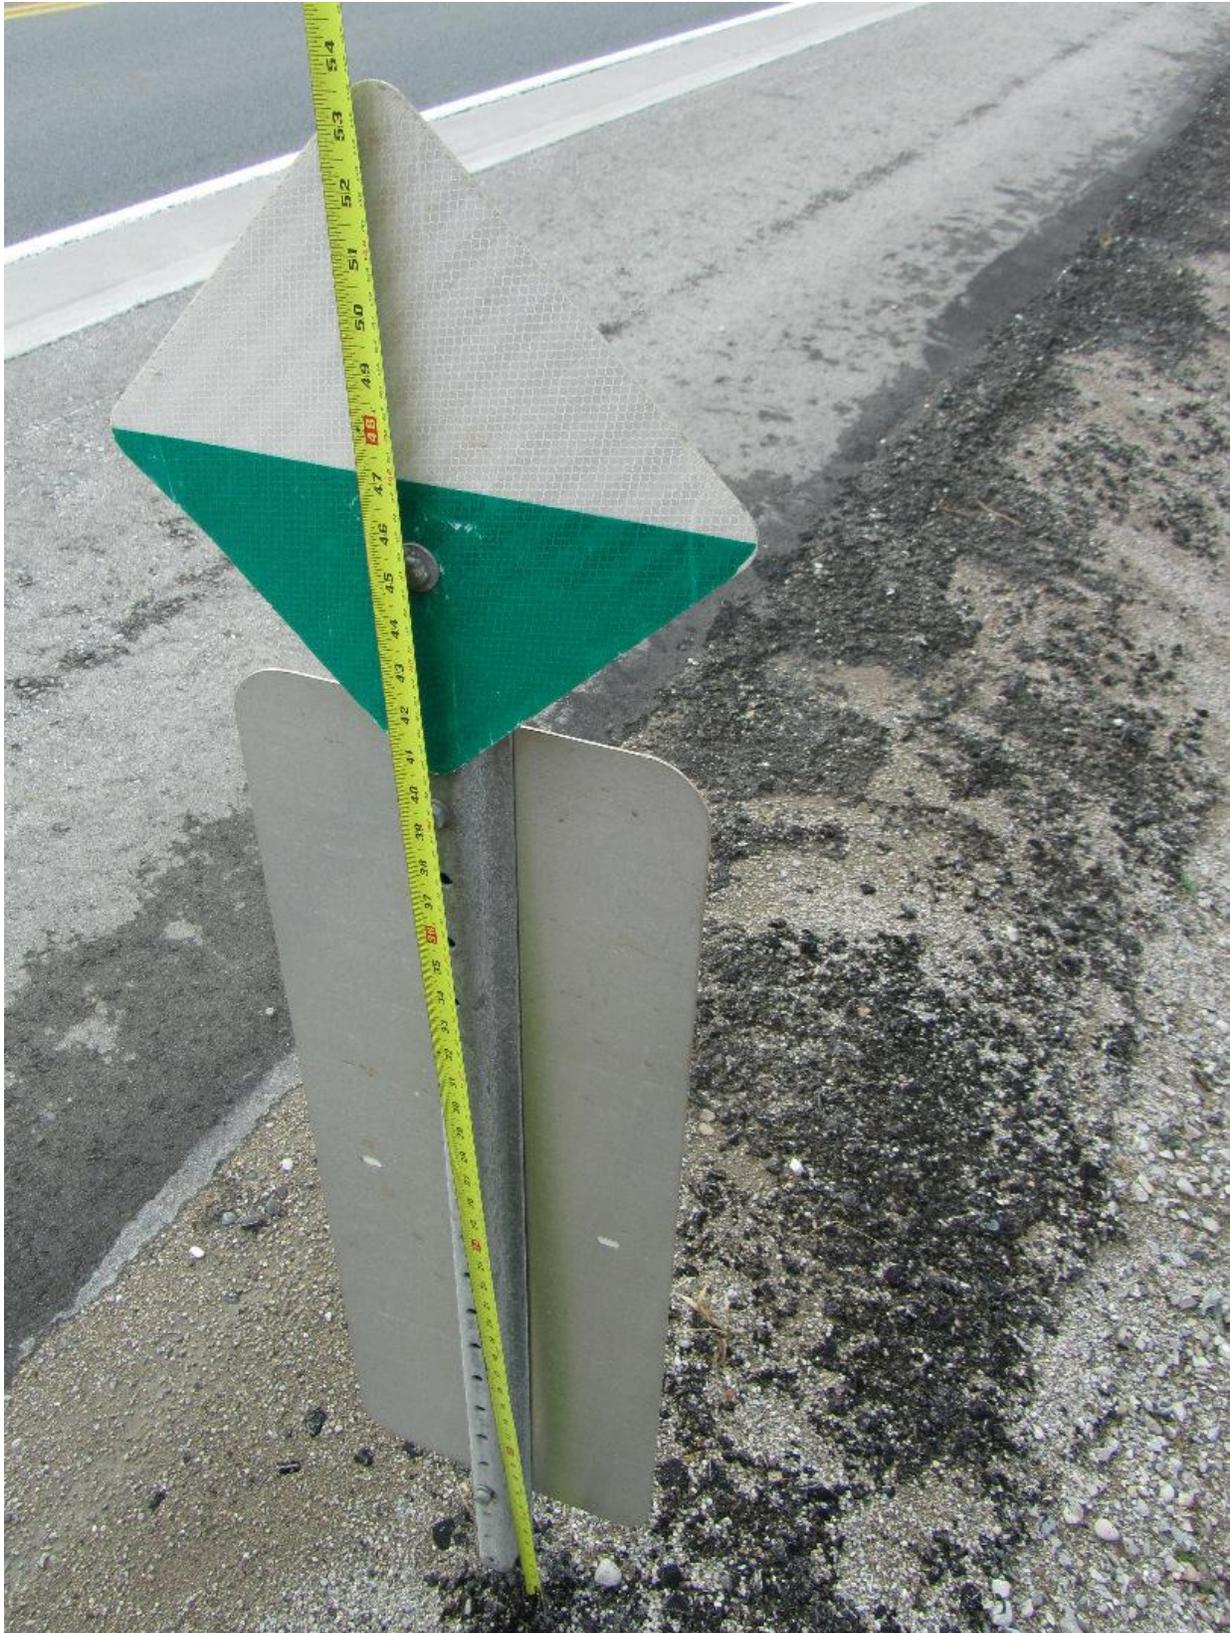
Figure 91: Measurement indicates the distance between the end plate and hazard warning sign is about 55.5 inches.

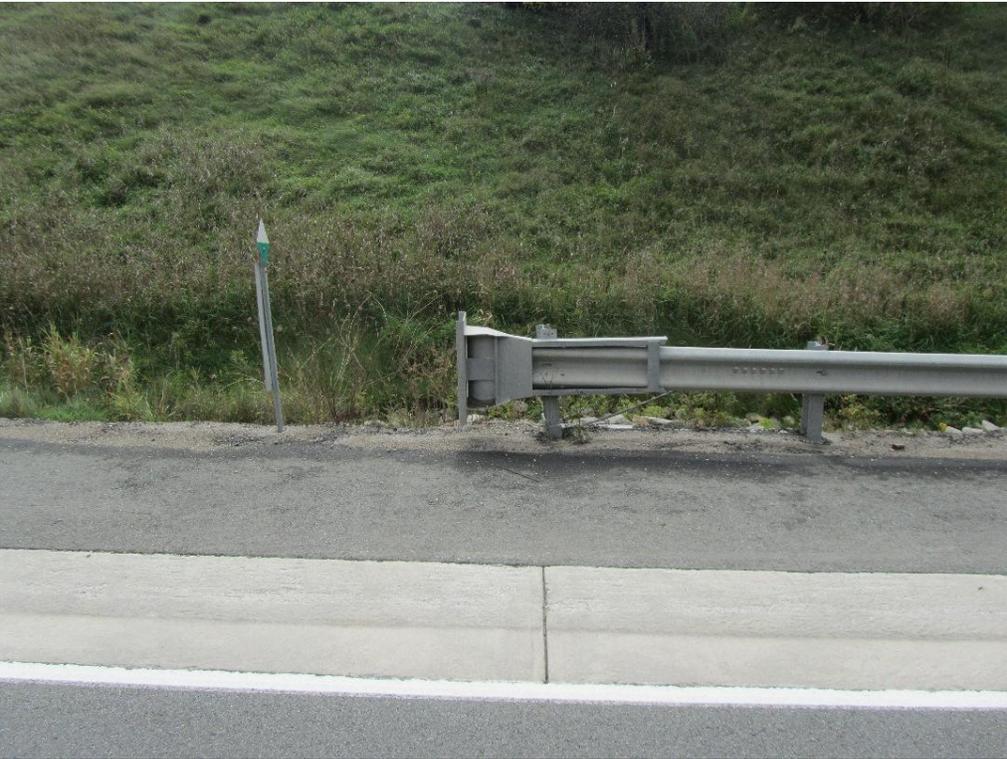
Figure 93: Overall view, looking west, toward the east end cap on the south guardrail east of the Thames River Bridge.
