Trinity Guardrail End Cap Survey - Part III

The present article will review 10 end caps at three sites whose installations were found primarily north-east of London, Ontario, mostly along Highway 7.

16. Highway 7 at Railway Bridge West of Cobble Hills Road, Middlesex & Perth Counties Border

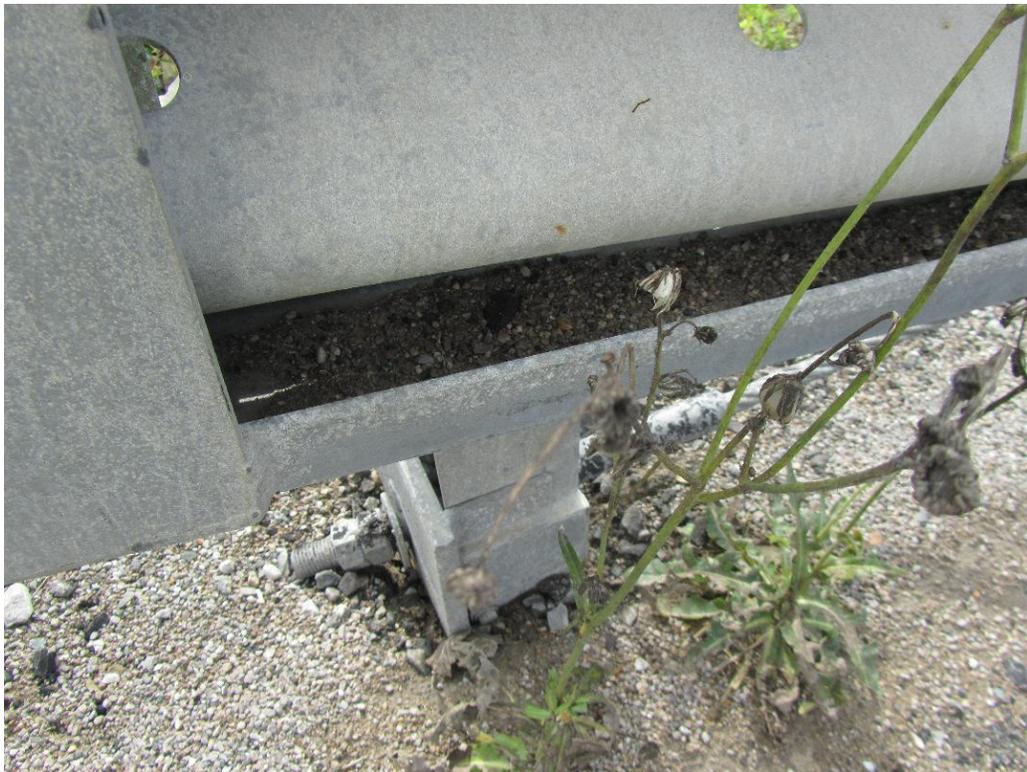
Figure 95: Street side view of end cap showing substantial difference in the horizontal angle between the channel and the rail.

After examining a total of 32 end caps we have begun to recognize a pattern where many of the channels are at a substantially different horizontal angle as compared to the rail that fits inside. We might consider that the instructions for the installation of the system could require that difference in angle, however it remains questionable what purpose that would achieve. The alternative hypothesis is that the weight of the end plate and channel might cause this unit to pivot downward and thus raising the rear edge of the channel. Again, at this early stage of our evaluations, we cannot be certain which hypothesis is true, or what other issues may be at play.

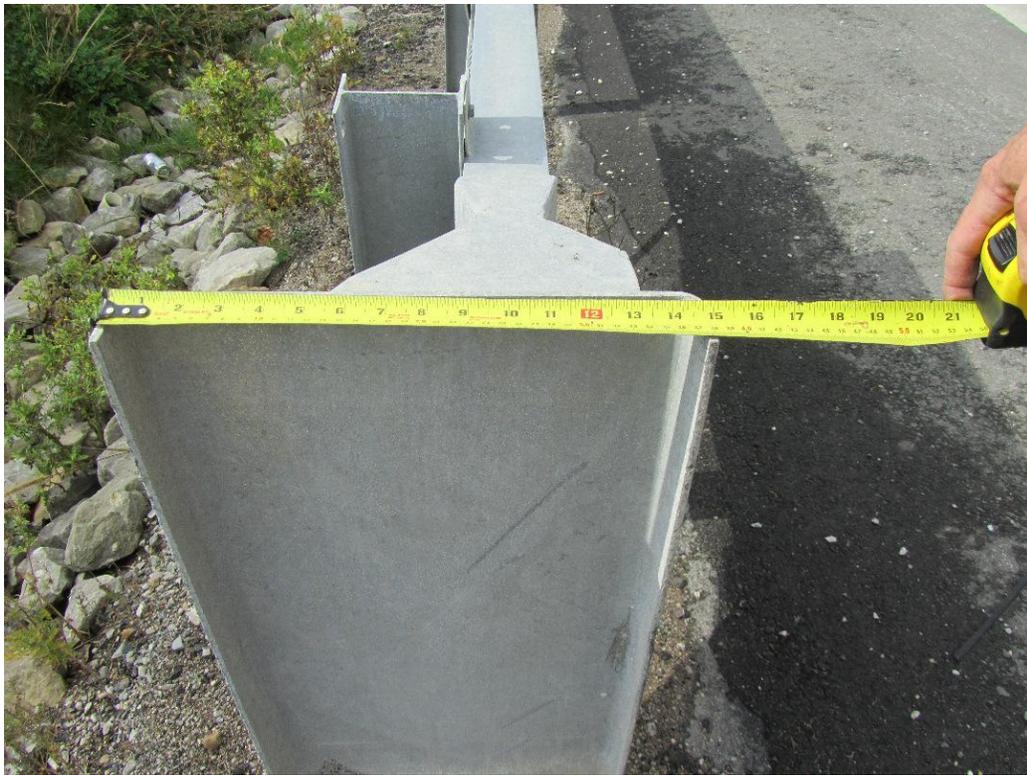
Figure 96: View of gravel and sand lying in the recess between the bottom of the rail and channel.

The unusual finding about this set of end caps is that 8 of the 10 units contained contaminants of gravel within the crevice between the bottom of the rail and channel. This finding would appear to be significant as it is vital that the end cap ride in an unobstructed manner along the rail when it is displaced by the impact of a wayward vehicle. It is this motion of the end cap that allows the rail to pass through the narrowing throat, flattening out the rail and then bailing the rail out the side of the end cap. From our understanding, the basis of the defect allegations against the ET-Plus system is that modifications that narrowed the dimensions of its channel caused the rail to become jammed and the rail would not pass through the end cap as it was designed. If extraneous materials such as gravel are placed in the channel where the unobstructed motion is critical, such jamming of that motion would seem likely. It would seem that, aside from any other potential defects, the design of the ET-Plus system with its open channel, can cause foreign objects to enter into the channel and obstruct the motion of the system, thus making it fail.

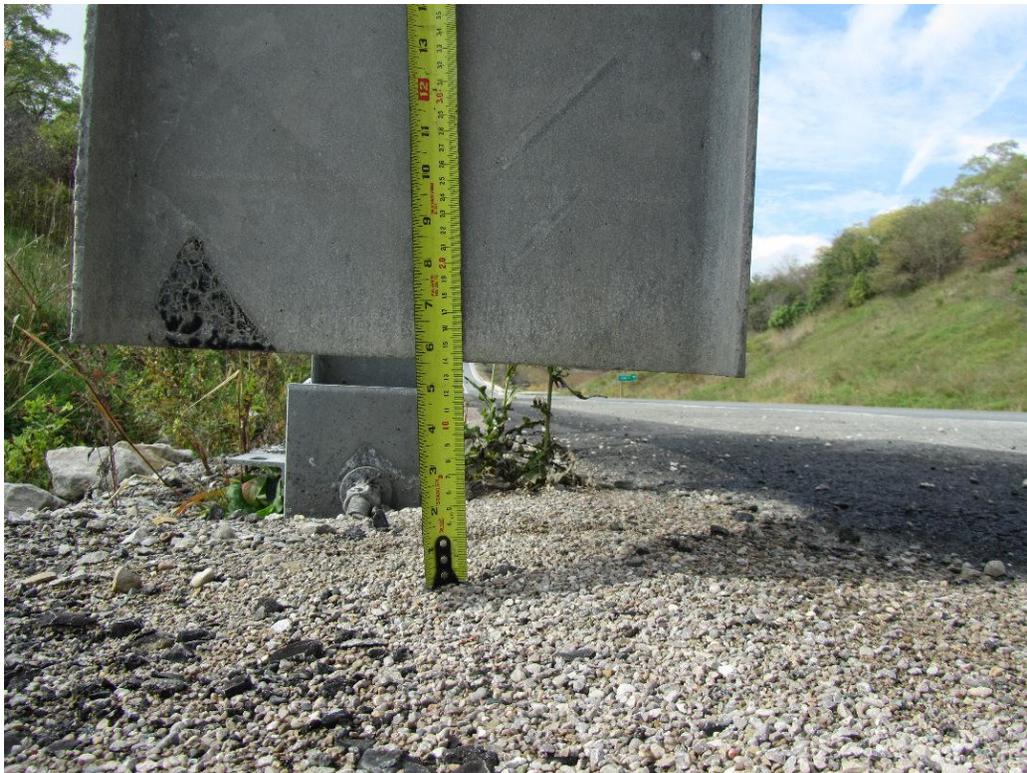
Figure 97: Measurement demonstrating the 15 inch width of the end plate.

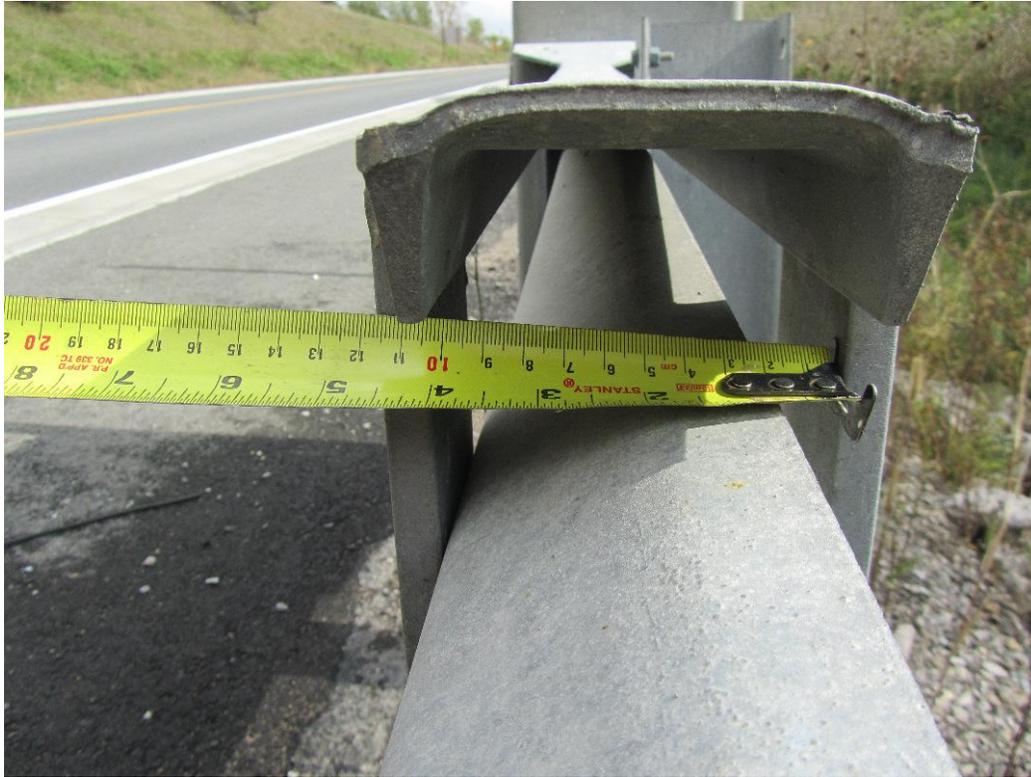
Figure 98: Measurement indicating that the bottom of the end plate is about 5.5 inches above the ground.

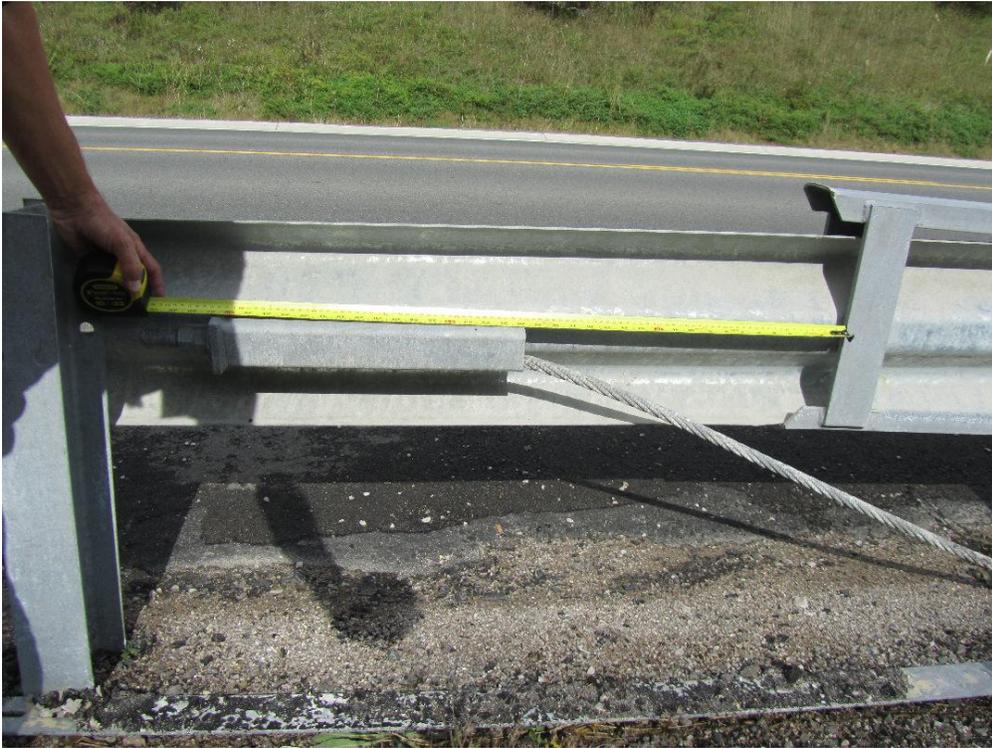
Figure 101: View of gravel and sand lying the horizontal surfaces of the ditch side of the end cap.

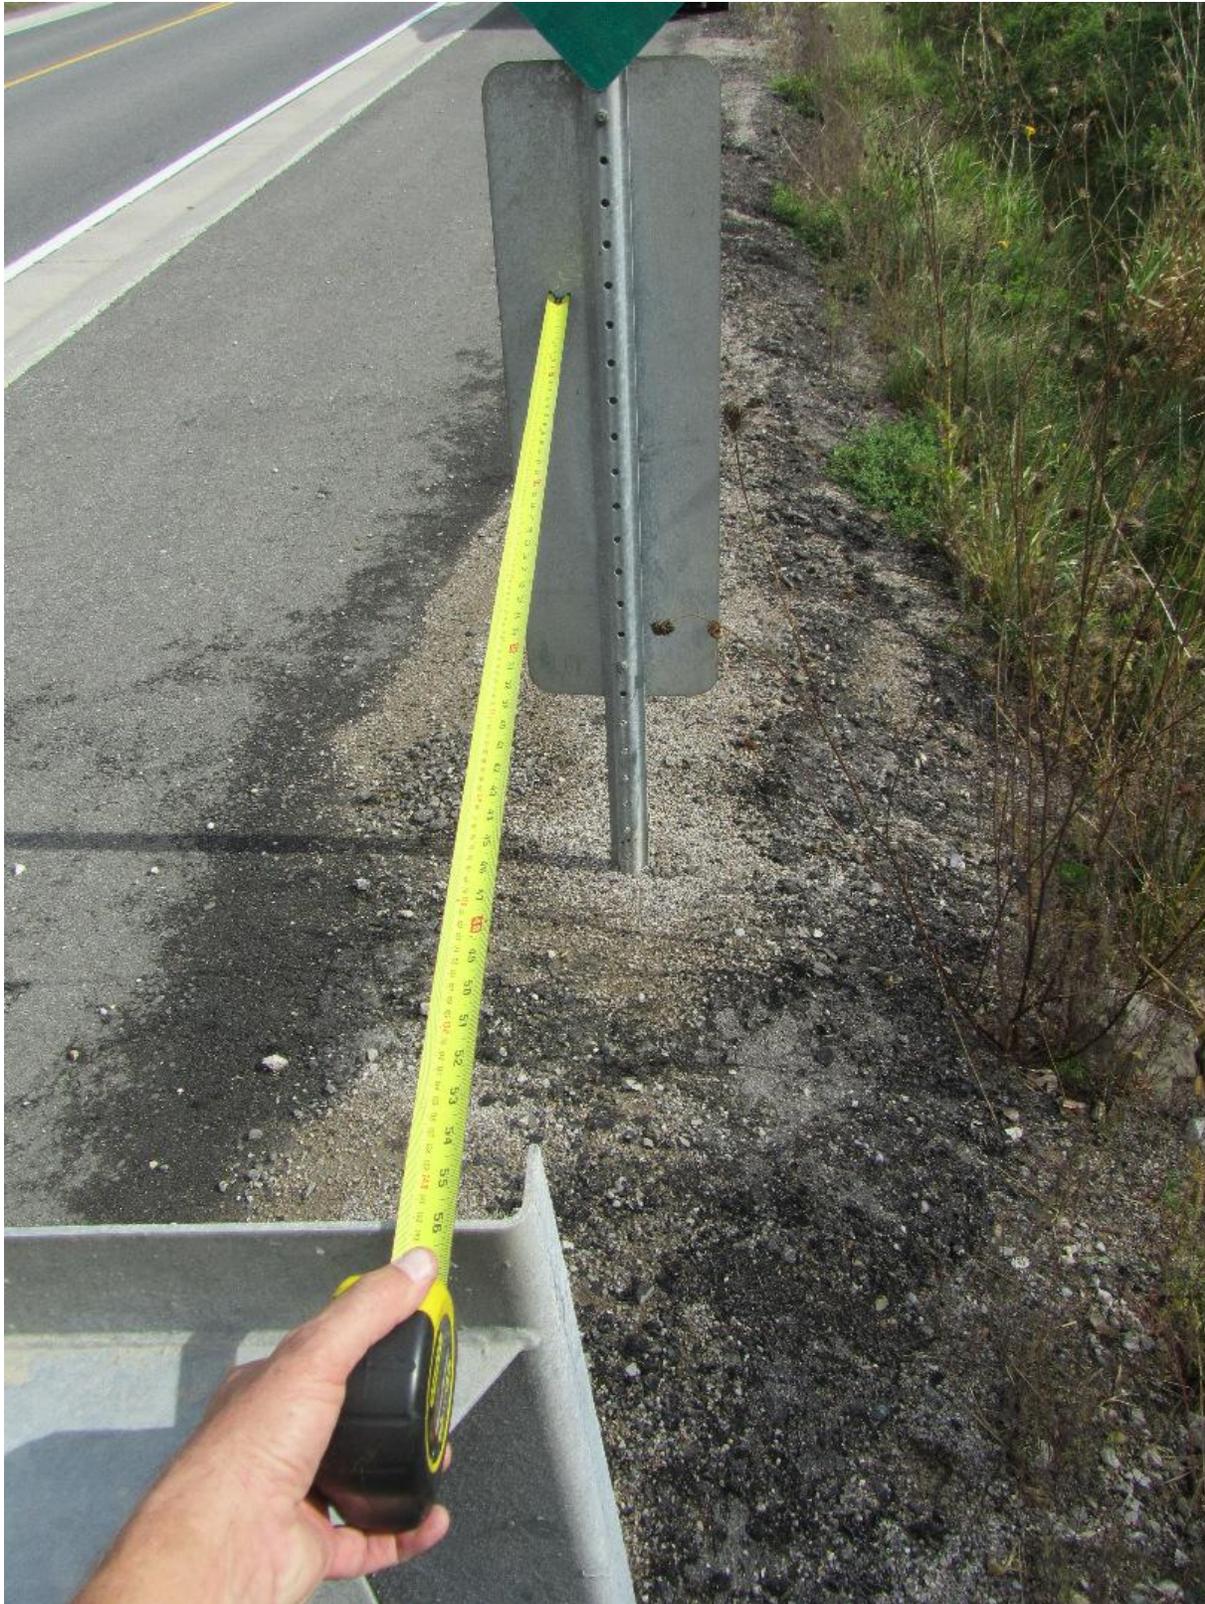
Figure 103: Result of measurement indicates a distance of about 37 inches.

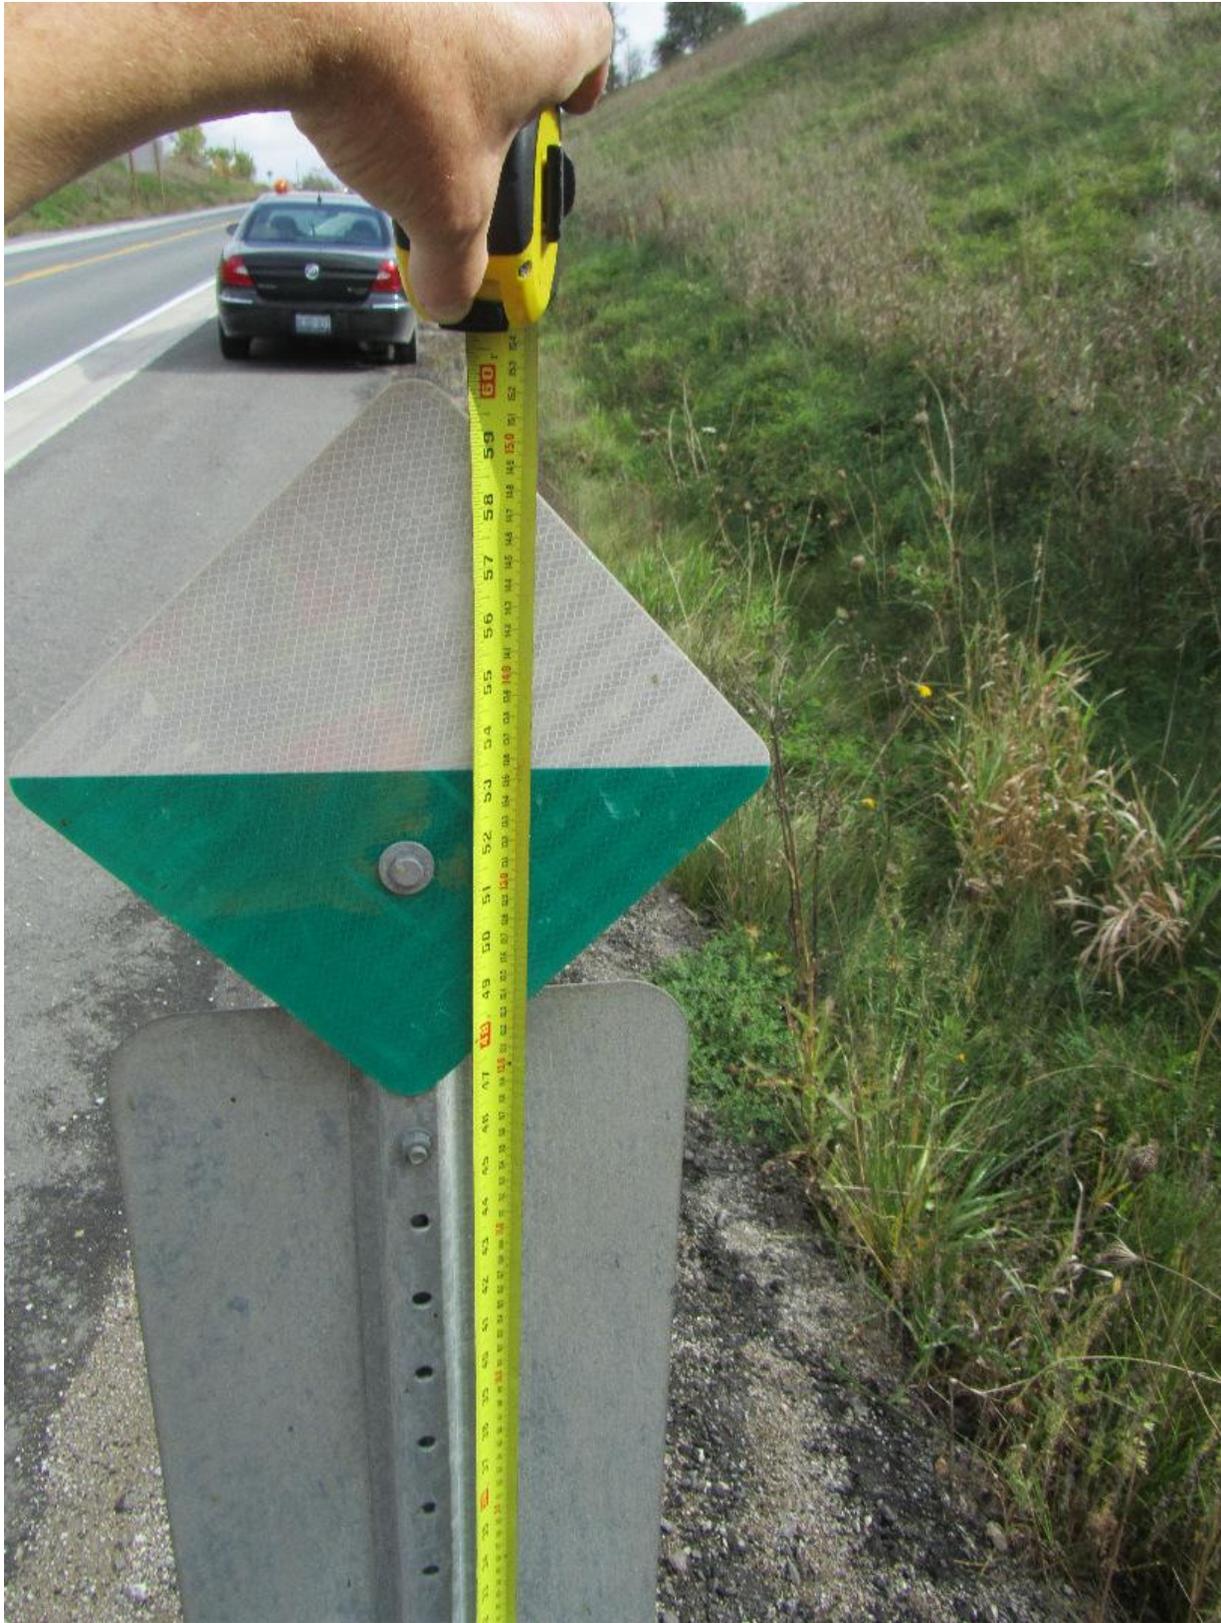
Figure 105: Result of measurement indicates 56 inches.

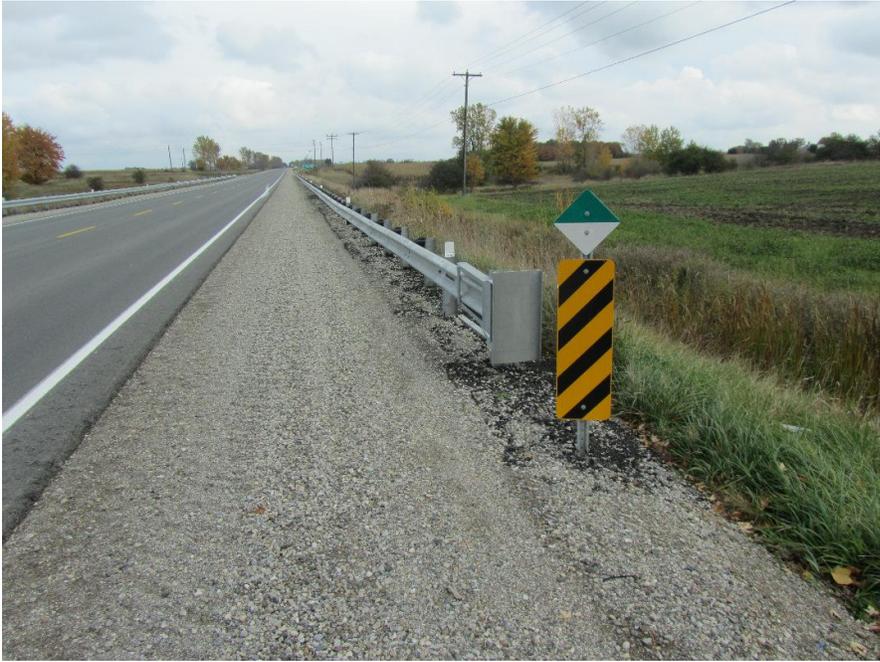
Figure 106: Measurement indicating height of hazard marker is about 60 inches.

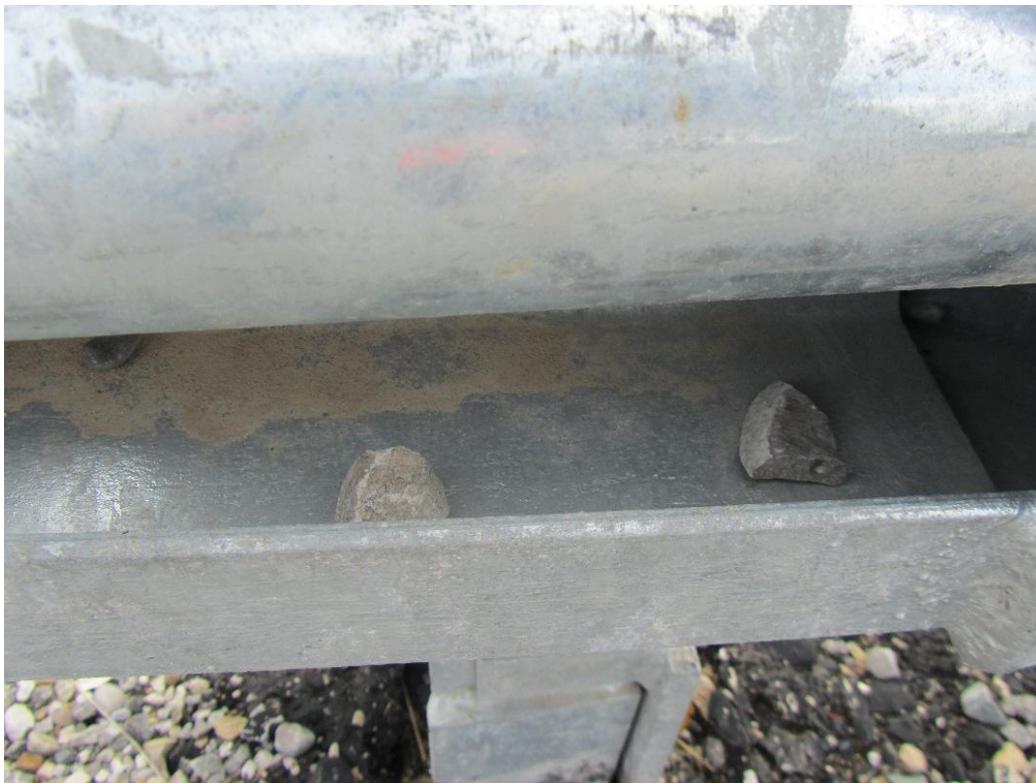
Figure 109: View of a few stones lying within the recess at the bottom of the rail and channel.

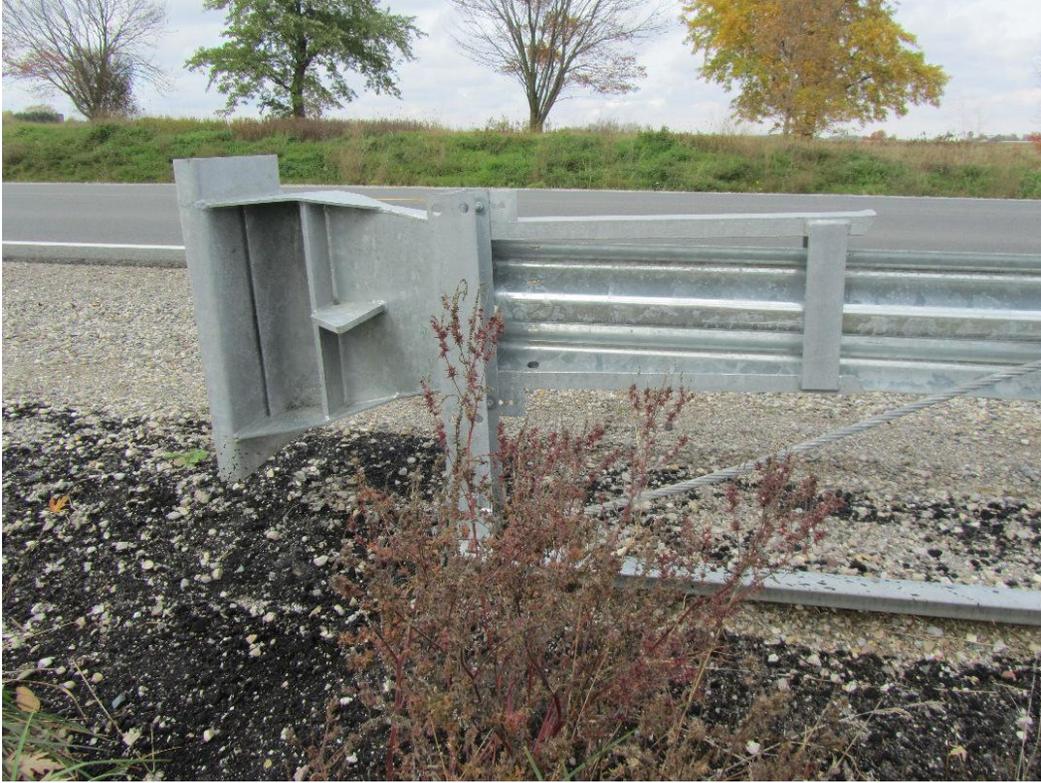
Figure 112: Measurement indicating that the base of the end plate is about 6.5 inches above the ground.

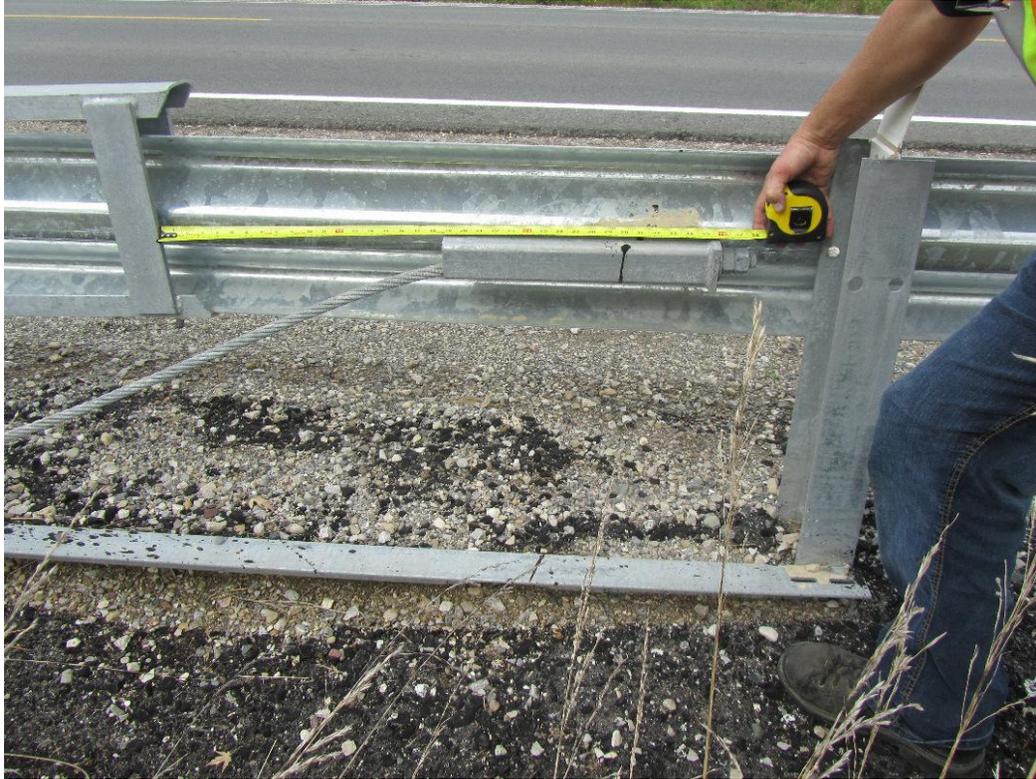
Figure 115: Additional evidence of gravel lying on the backside of the recess of the bottom of the rail and channel.

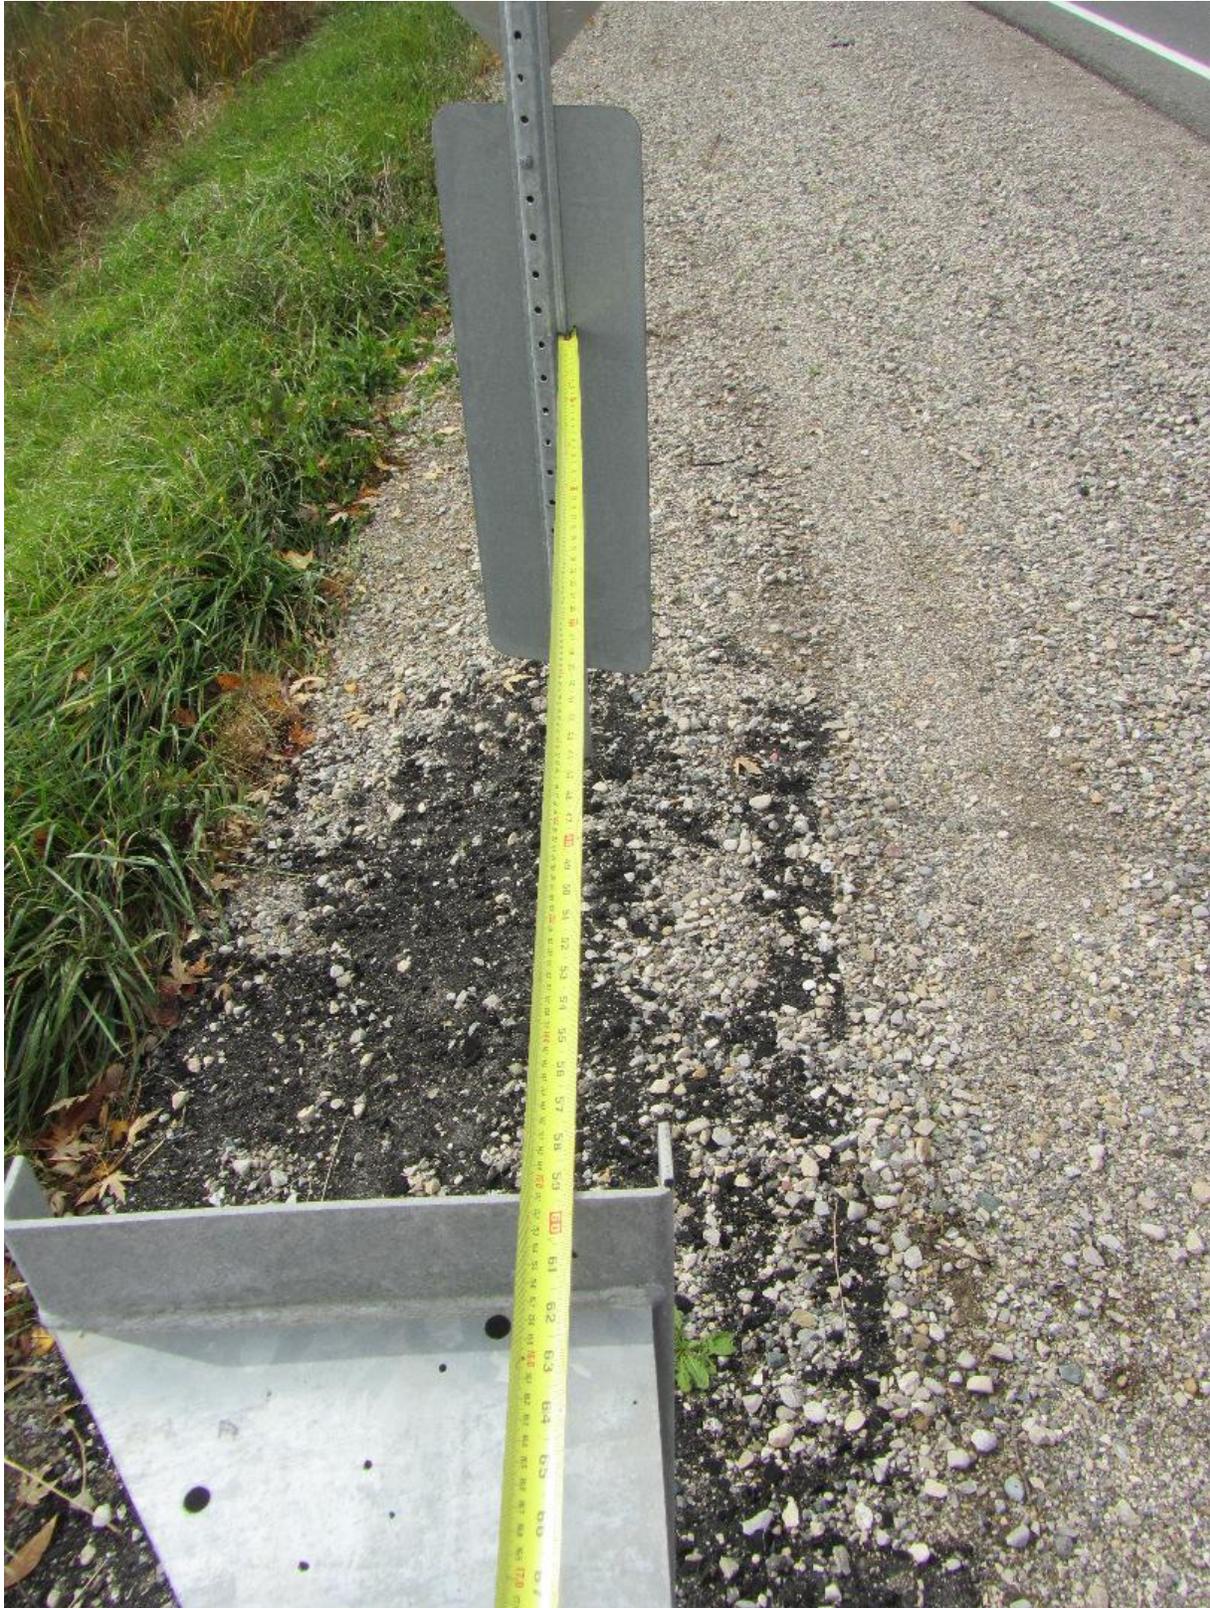
Figure 117: Result of measurement indicates a distance of about 35.75 inches.

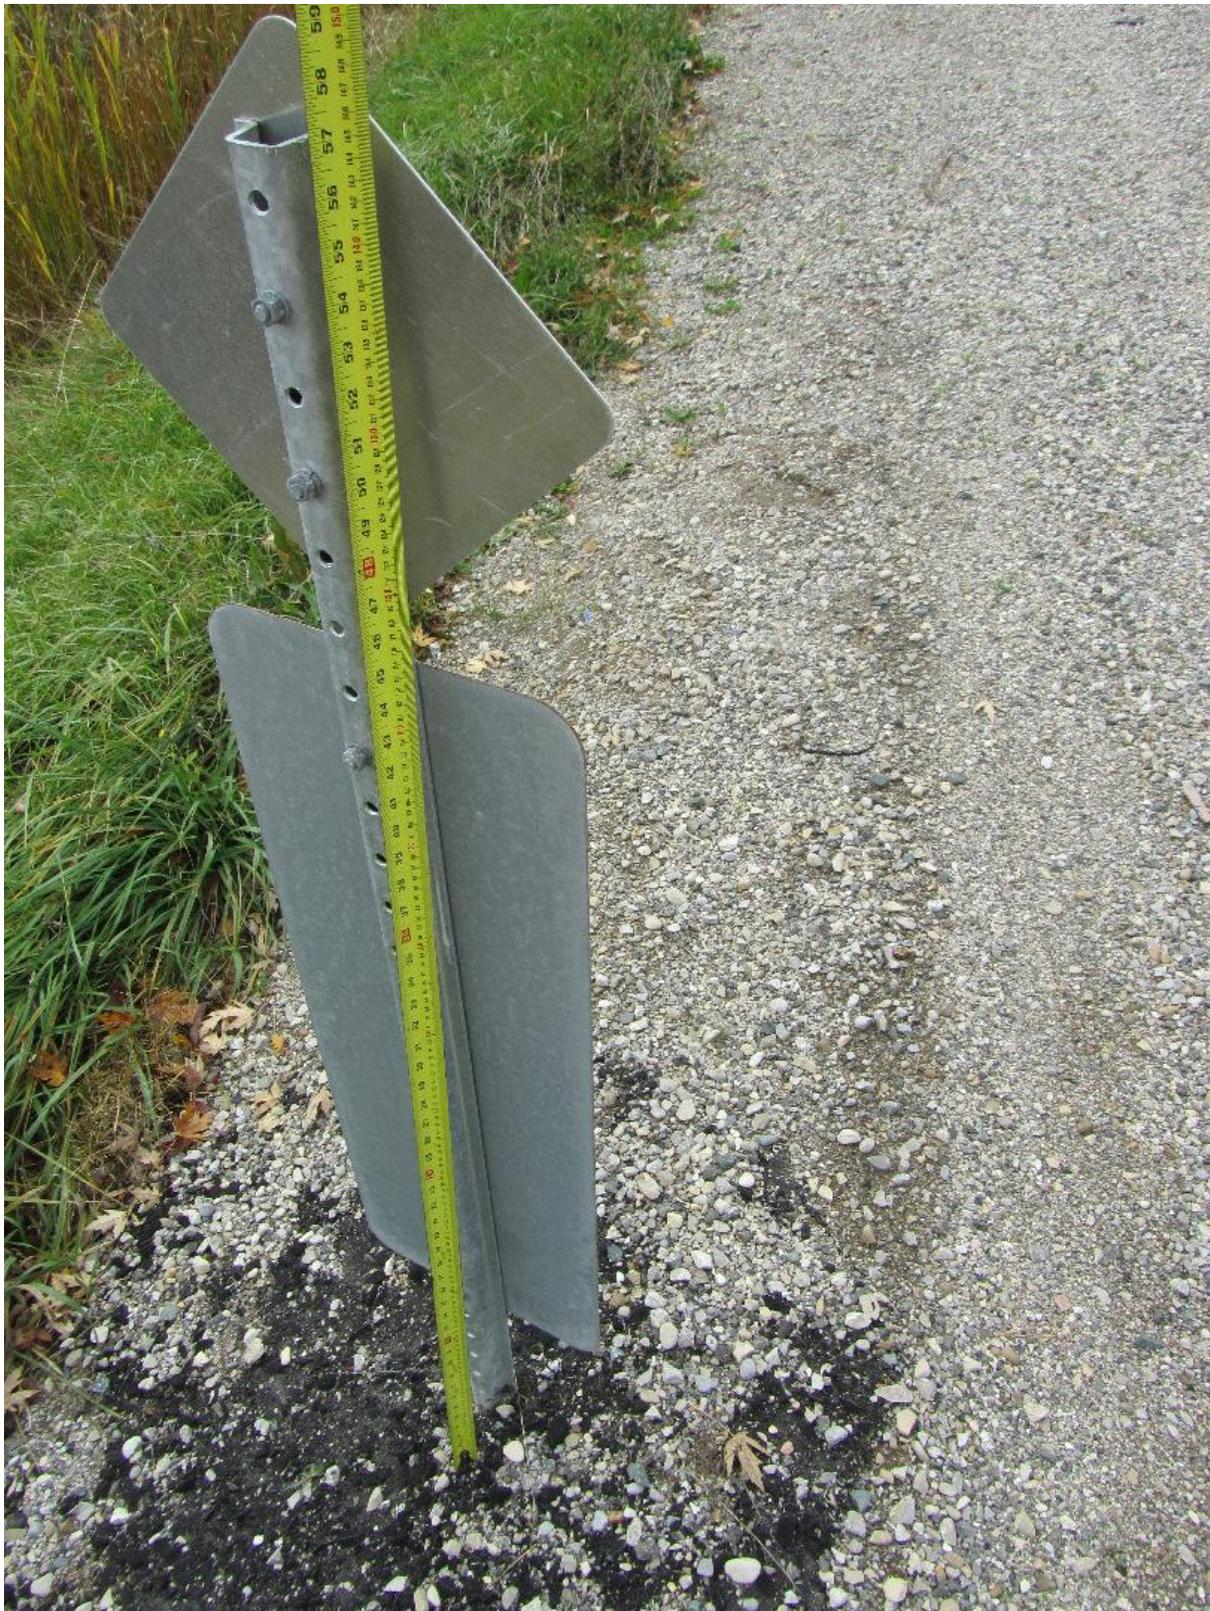
Figure 118: View of measurement indicating that the distance between the end plate and hazard warning sign is about 59.5 inches.

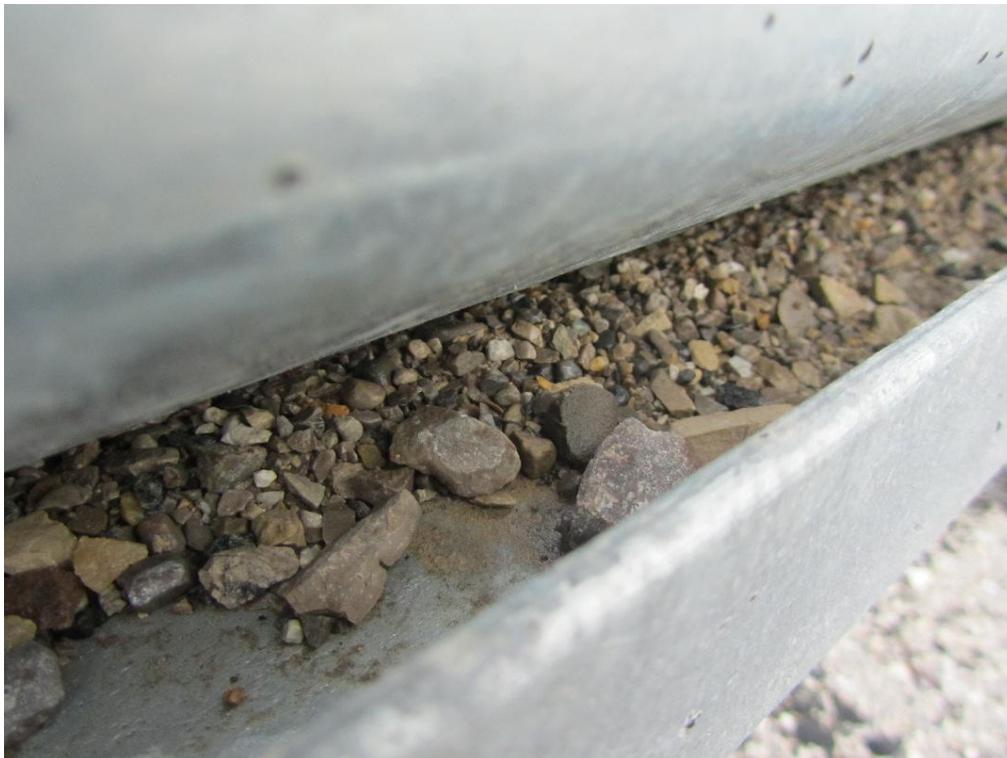
Figure 122: View of gravel lying on the horizontal plate just behind the end plate.

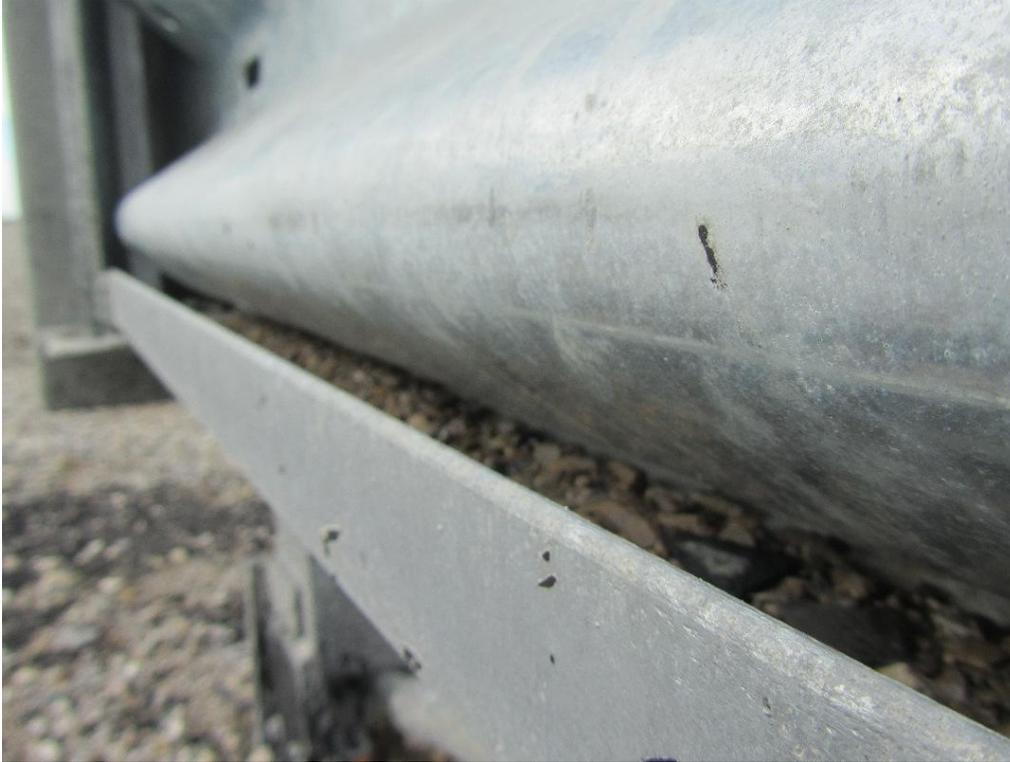
Figure 123: View of large quantity of gravel lying in the crevice between the bottom of the rail and channel.

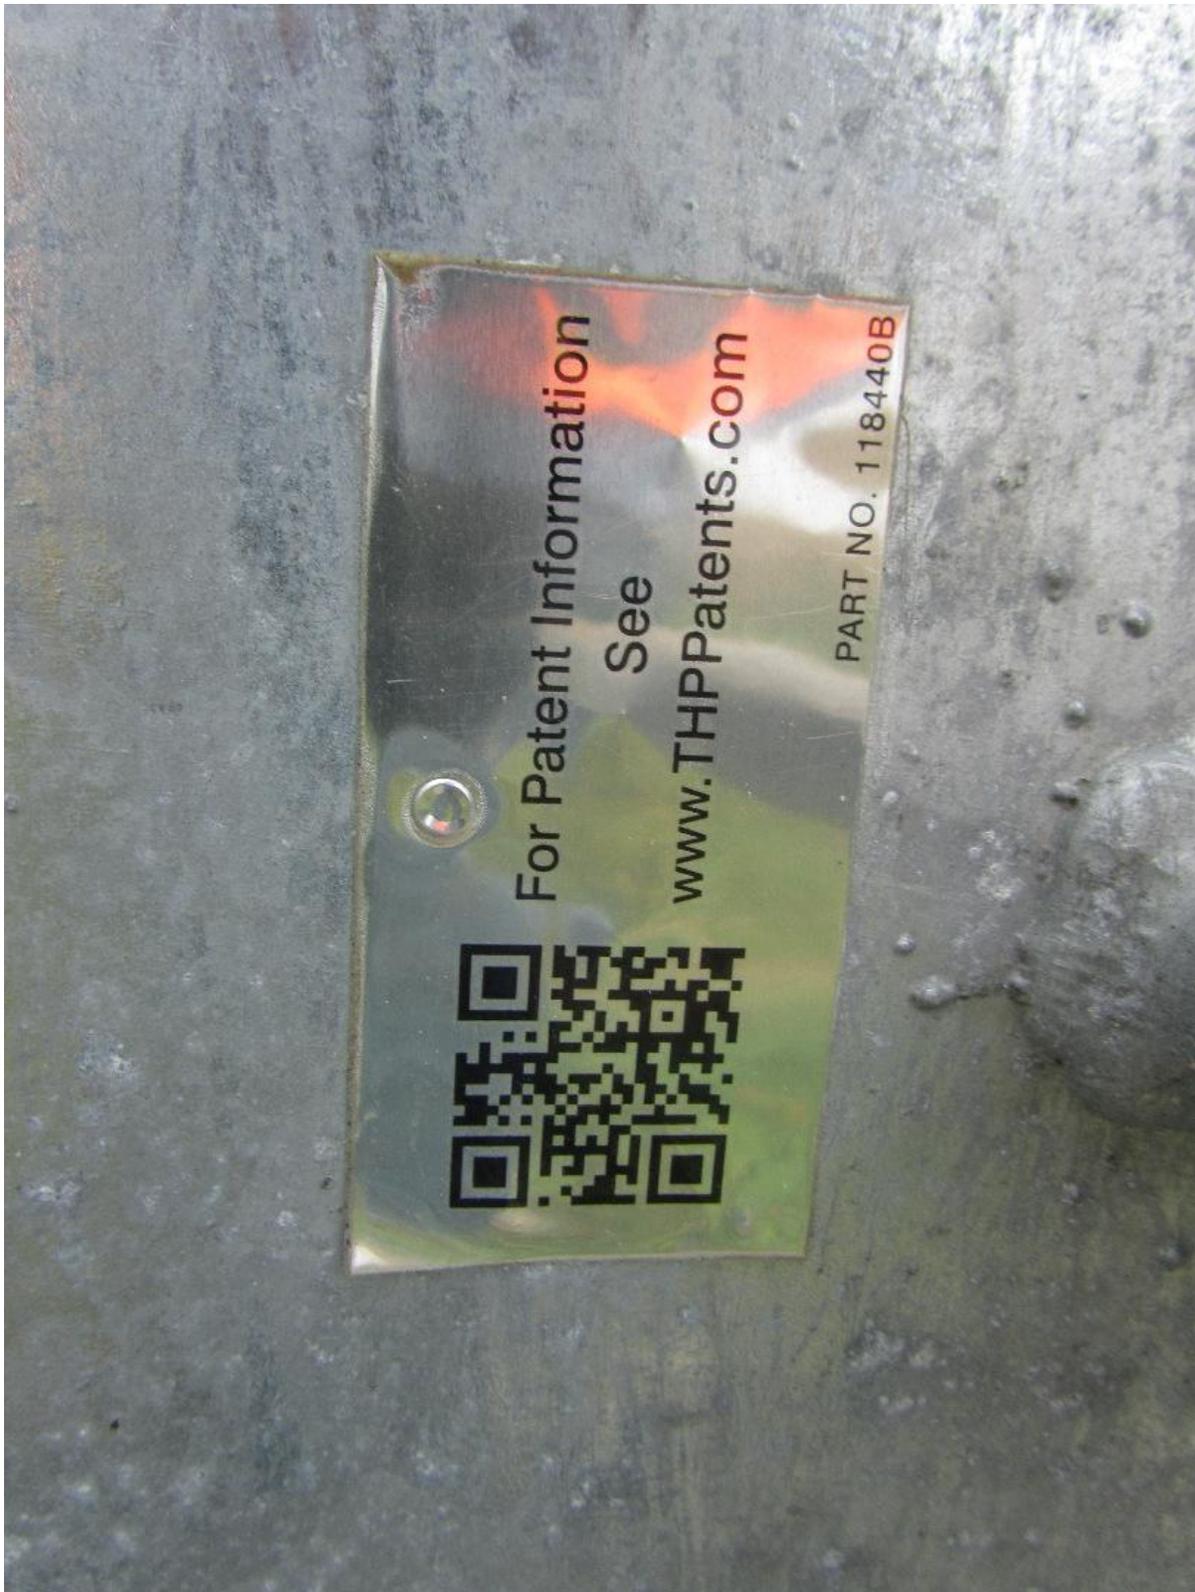
Figure 129: View of Trinity Highway Products label attached to the vertical wall behind the end plate.

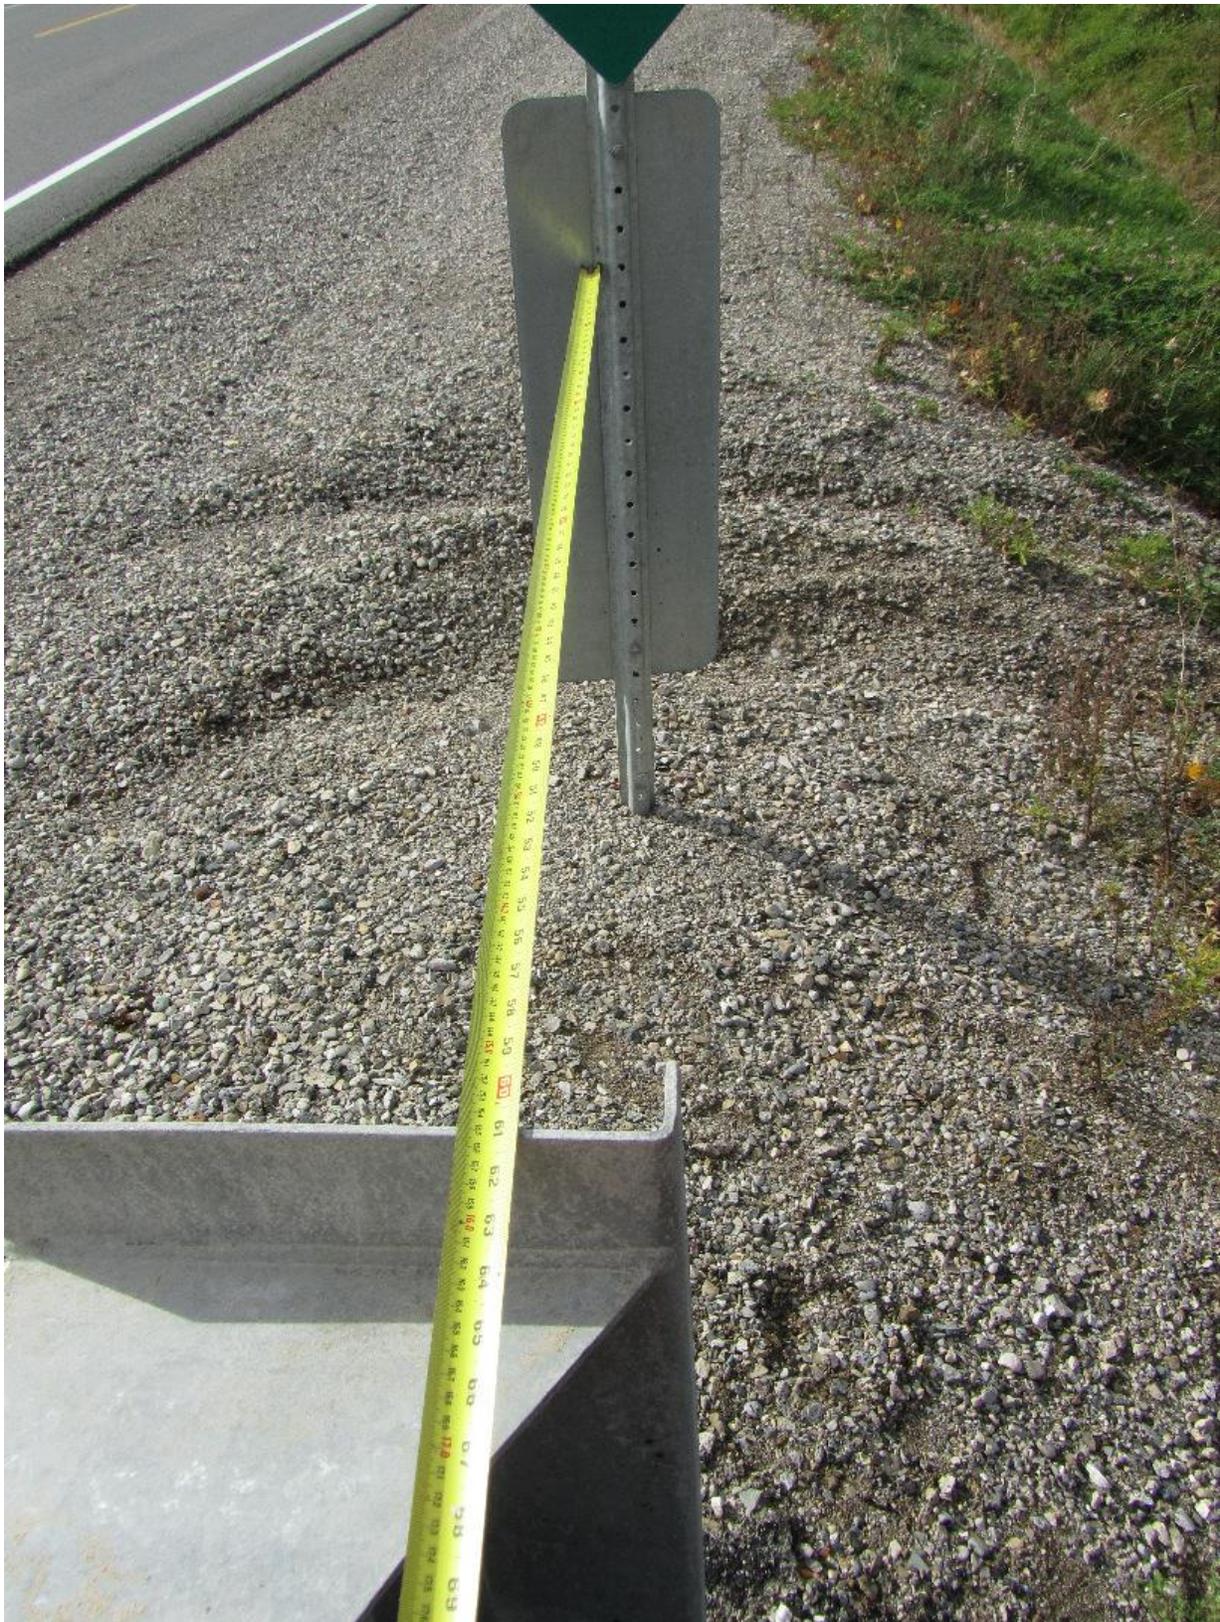
Figure 134: Result of measurement of the position of the end cap indicates a distance of about 37.5 inches.

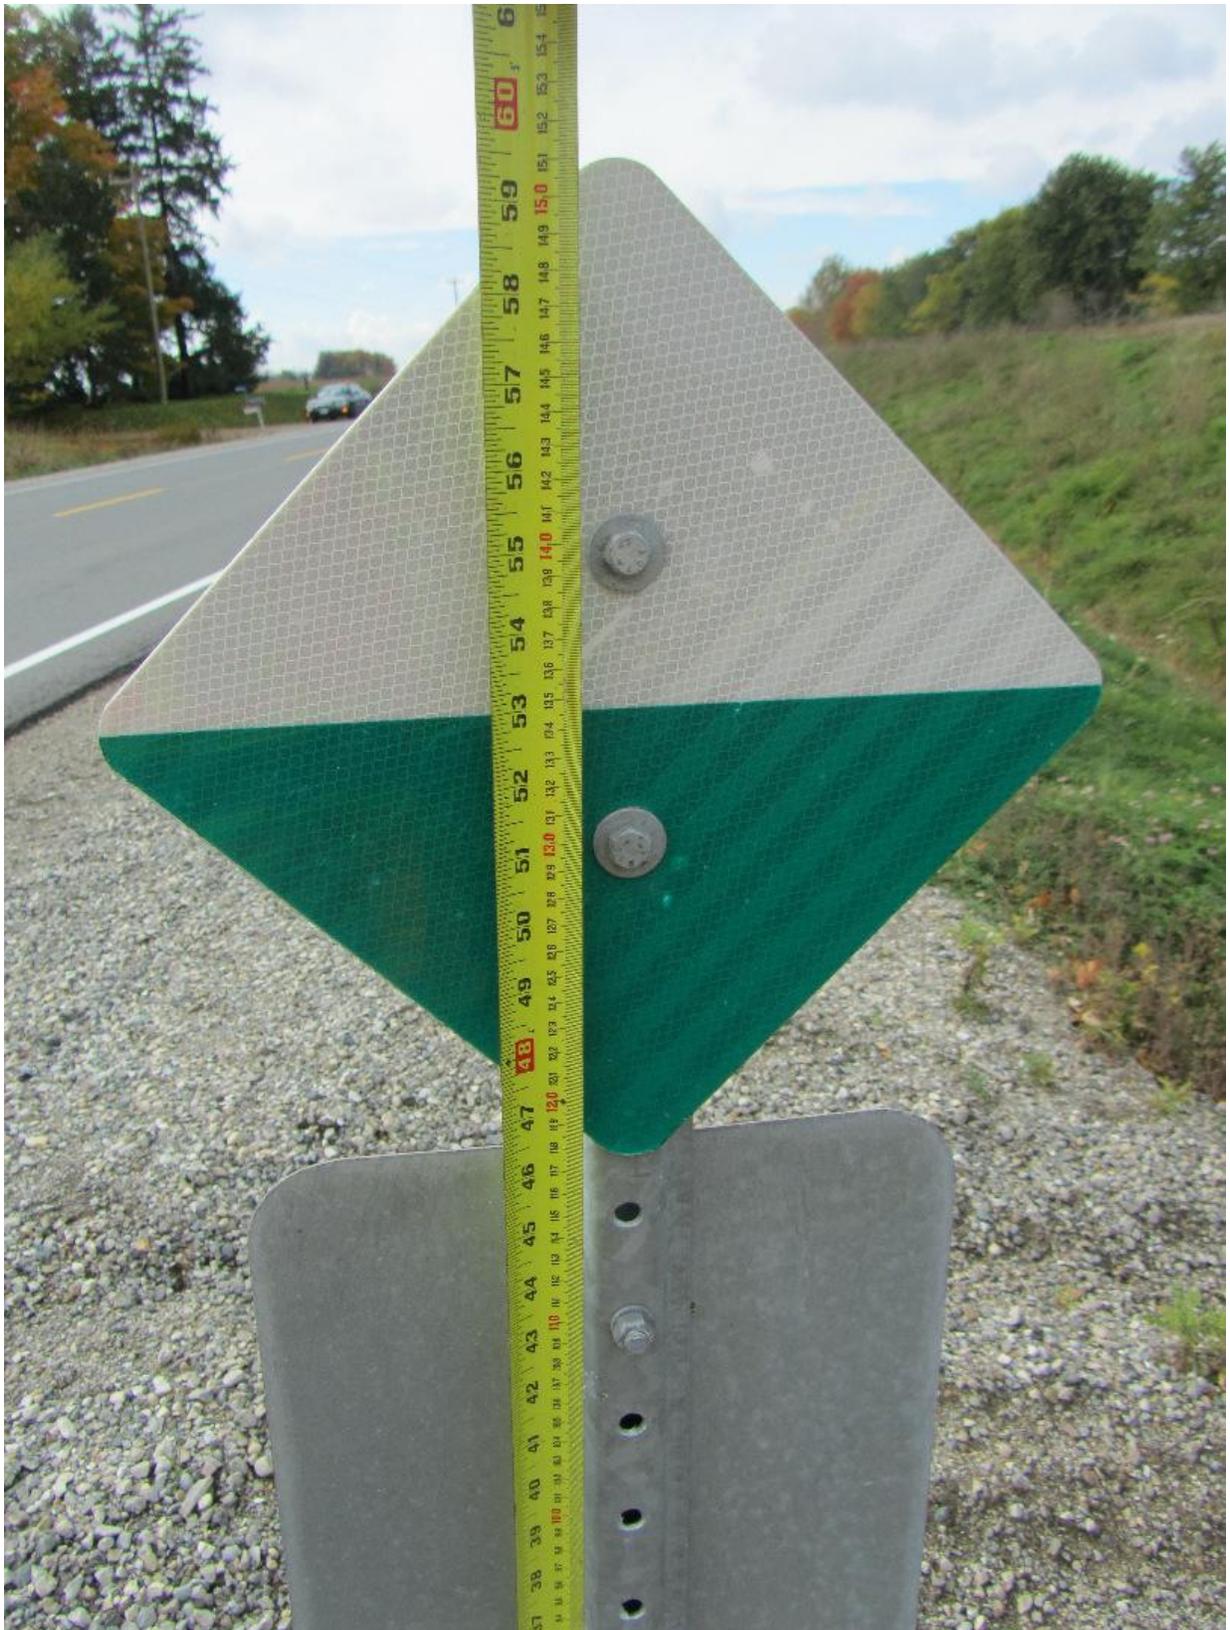
Figure 135: Measurement indicating that the distance between the hazard sign and end cap is about 61 inches.
