Trinity Guardrail End Cap Survey - Part III

The present article will review 10 end caps at three sites whose installations were found primarily north-east of London, Ontario, mostly along Highway 7.

16. Highway 7 at Railway Bridge West of Cobble Hills Road, Middlesex & Perth Counties Border

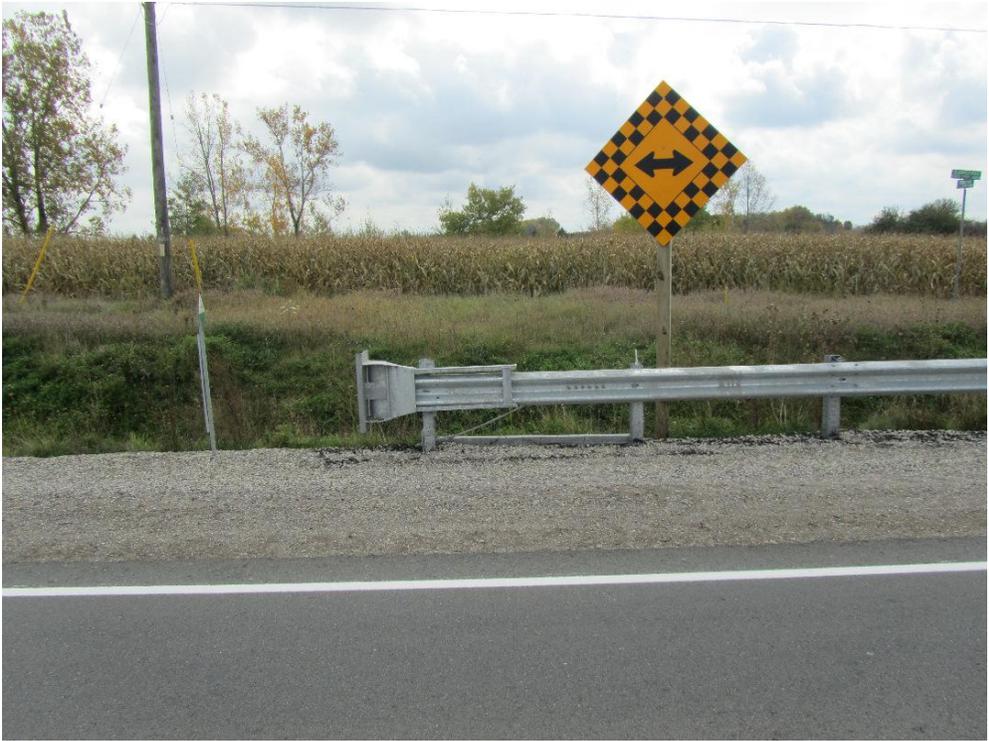
Figure 137: Overall view, looking west, at the hazard marker, end cap and south guardrail.

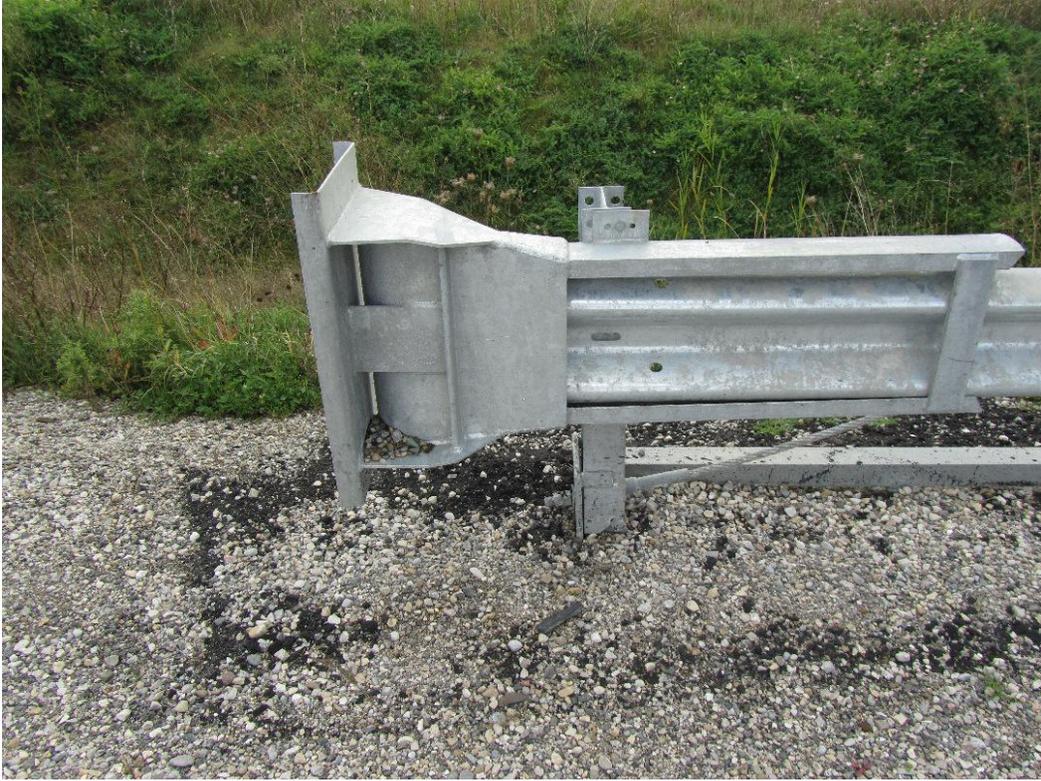
Figure 138: Street side view of hazard sign, end cap and south guardrail.

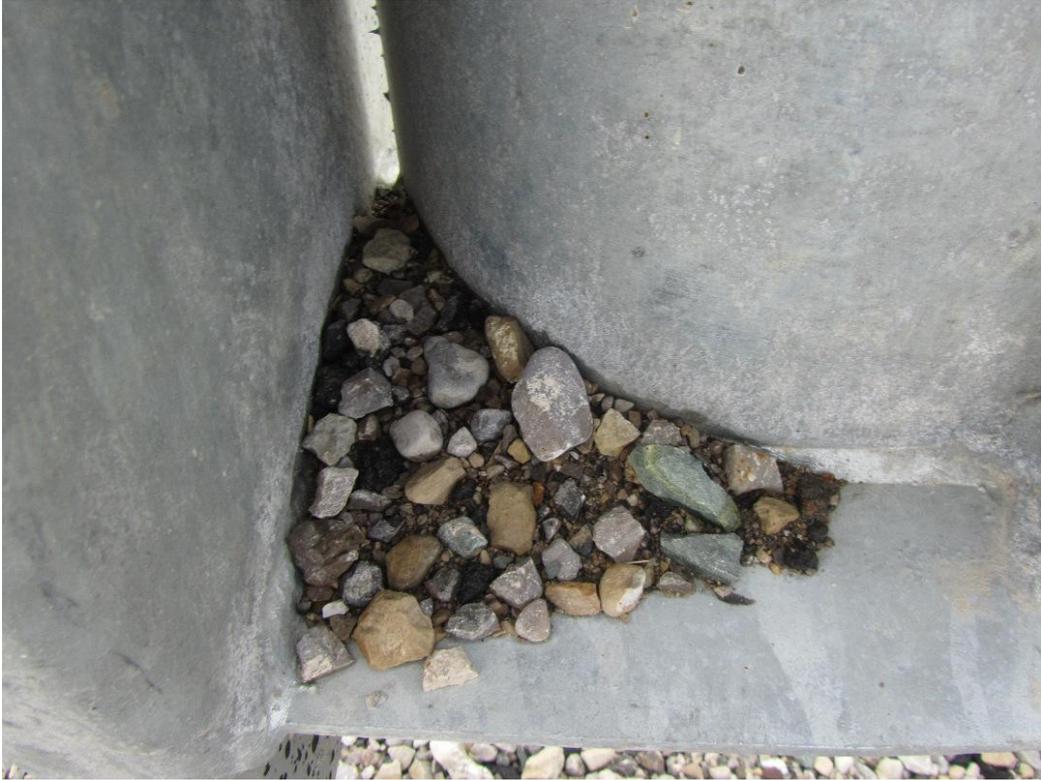
Figure 139: Street side view of end cap.

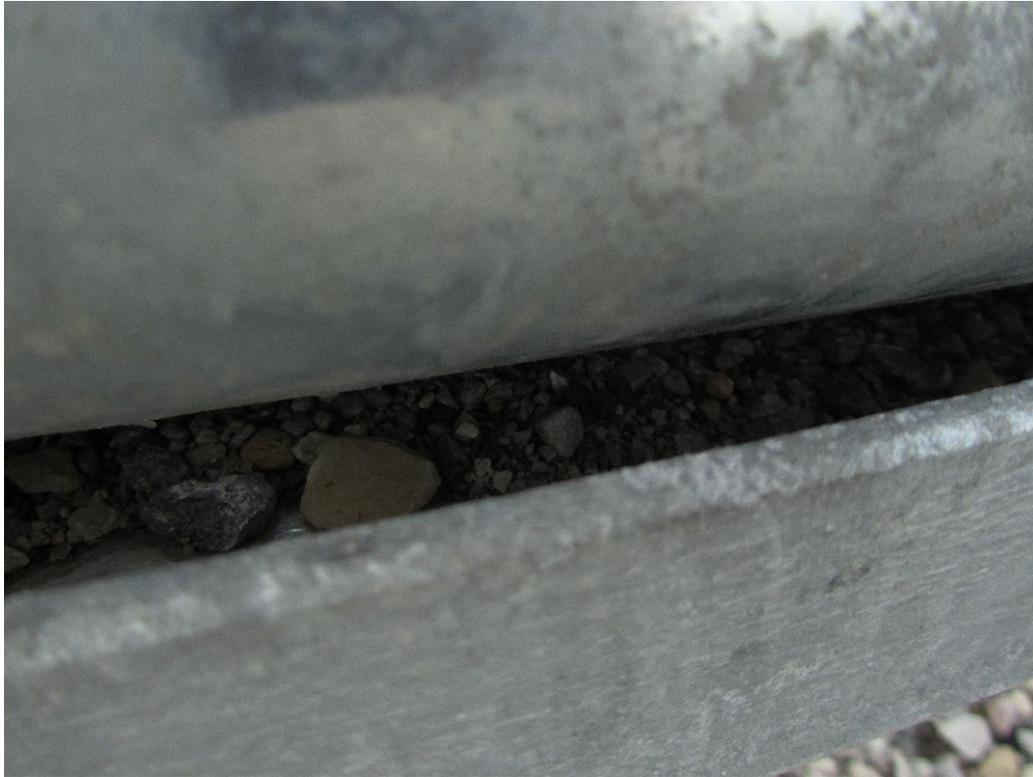
Figure 140: View of gravel lying on the horizontal plate just behind the end plate.

The unusual finding about this set of end caps is that 8 of the 10 units contained contaminants of gravel within the crevice between the bottom of the rail and channel. This finding would appear to be significant as it is vital that the end cap ride in an unobstructed manner along the rail when it is displaced by the impact of a wayward vehicle. It is this motion of the end cap that allows the rail to pass through the narrowing throat, flattening out the rail and then bailing the rail out the side of the end cap. From our understanding, the basis of the defect allegations against the ET-Plus system is that modifications that narrowed the dimensions of its channel caused the rail to become jammed and the rail would not pass through the end cap as it was designed. If extraneous materials such as gravel are placed in the channel where the unobstructed motion is critical, such jamming of that motion would seem likely. It would seem that, aside from any other potential defects, the design of the ET-Plus system with its open channel, can cause foreign objects to enter into the channel and obstruct the motion of the system, thus making it fail.

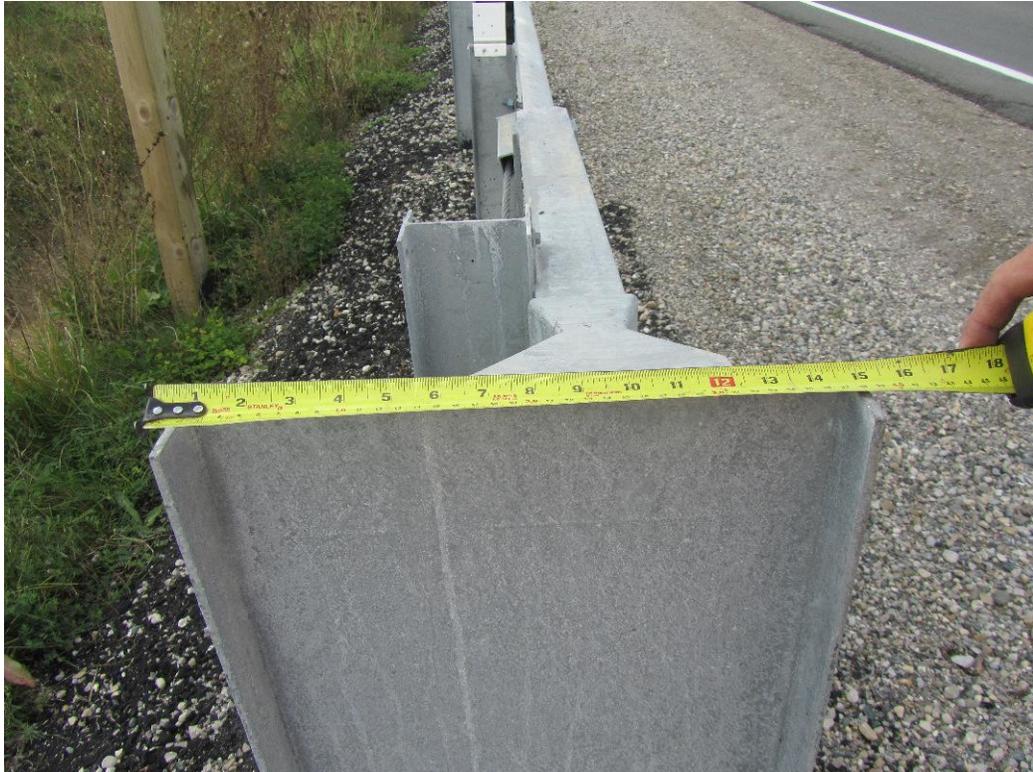
Figure 141: View of large quantity of gravel lying within the crevice between the bottom of the rail and channel.

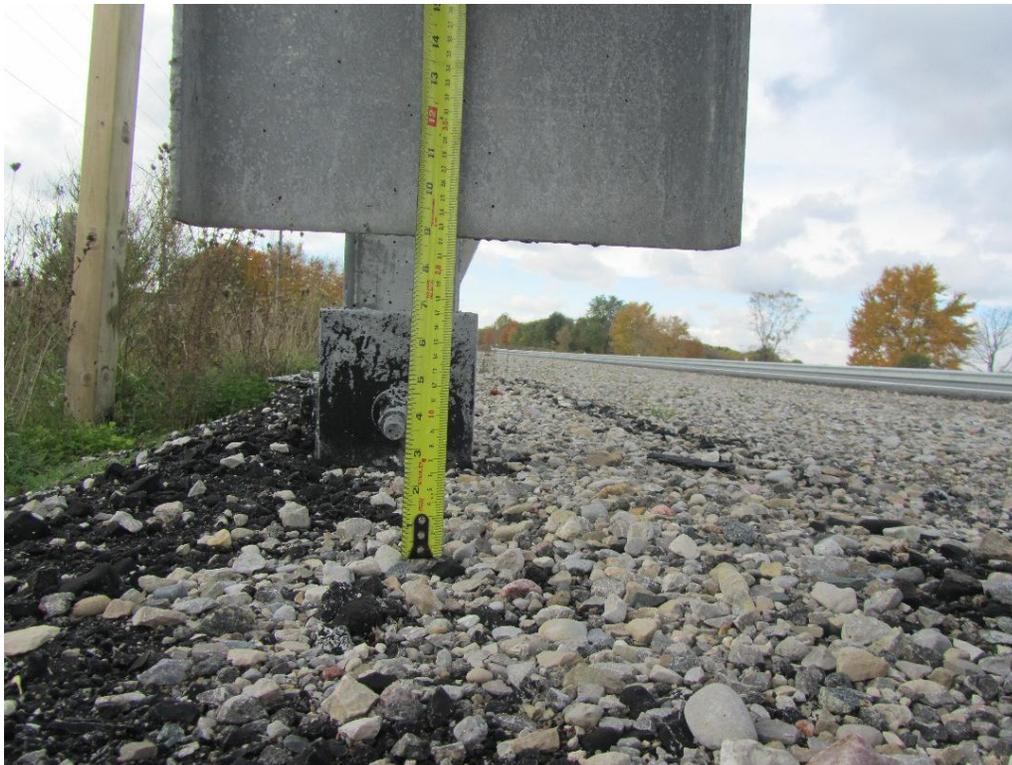
Figure 142: Measurement confirming the 15-inch-wide end plate.

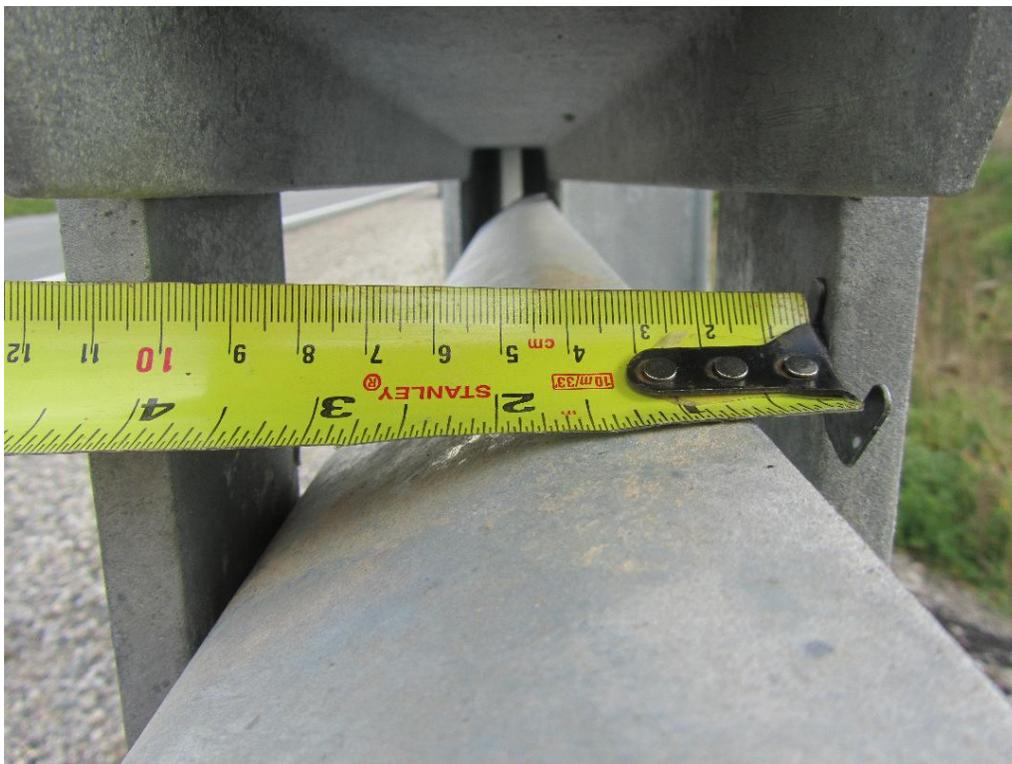
Figure 143: Measurement indicating that the base of the end plate is about 9 inches above the ground.

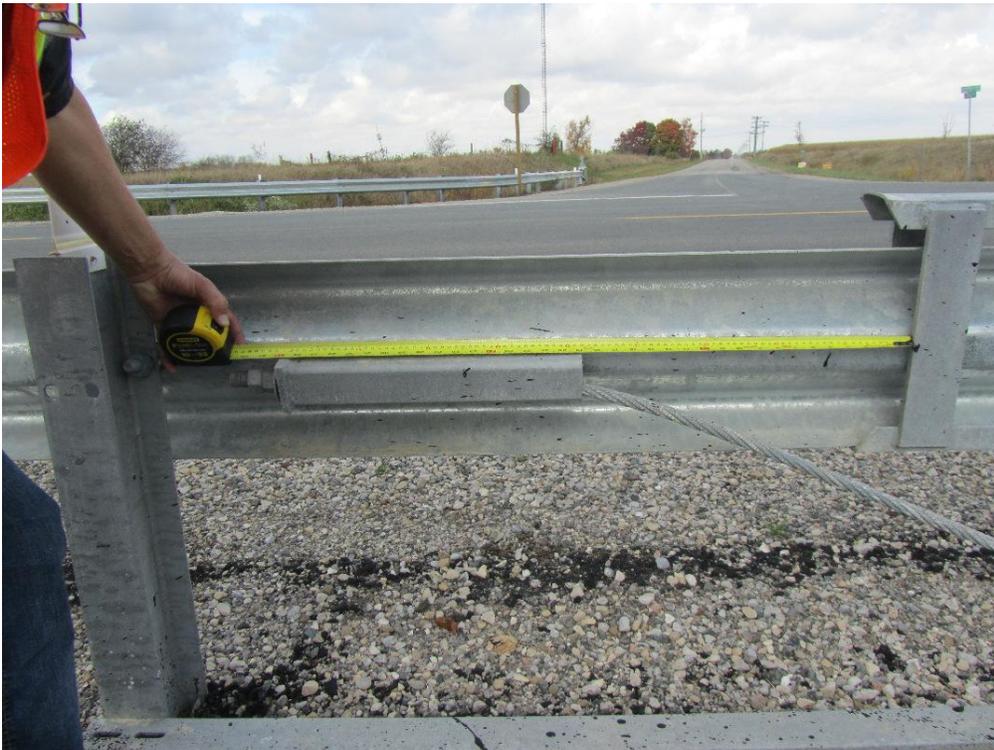
Figure 145: Ditch side view of the end cap.

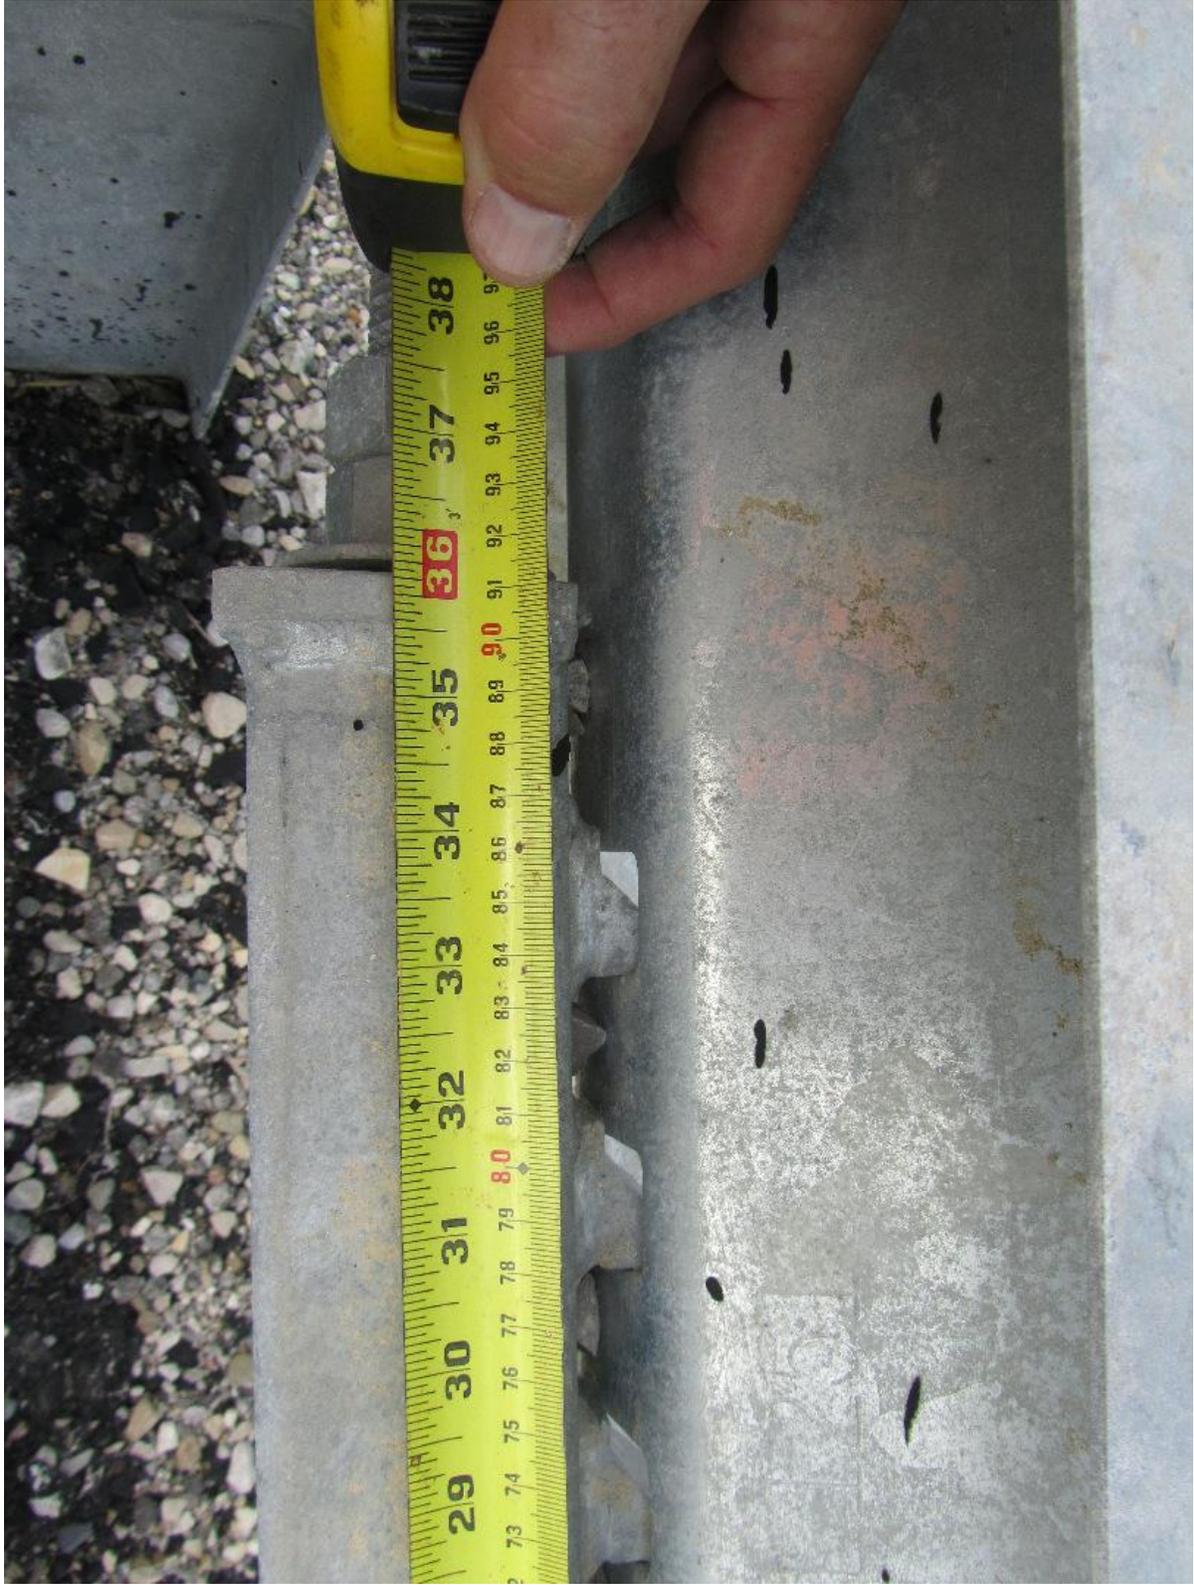
Figure 146: View of measurement being taken to document the position of the end cap.
