Trinity Guardrail End Cap Survey - Part IV

Posting Date: 23-Oct 2014

Survey of Trinity End Caps

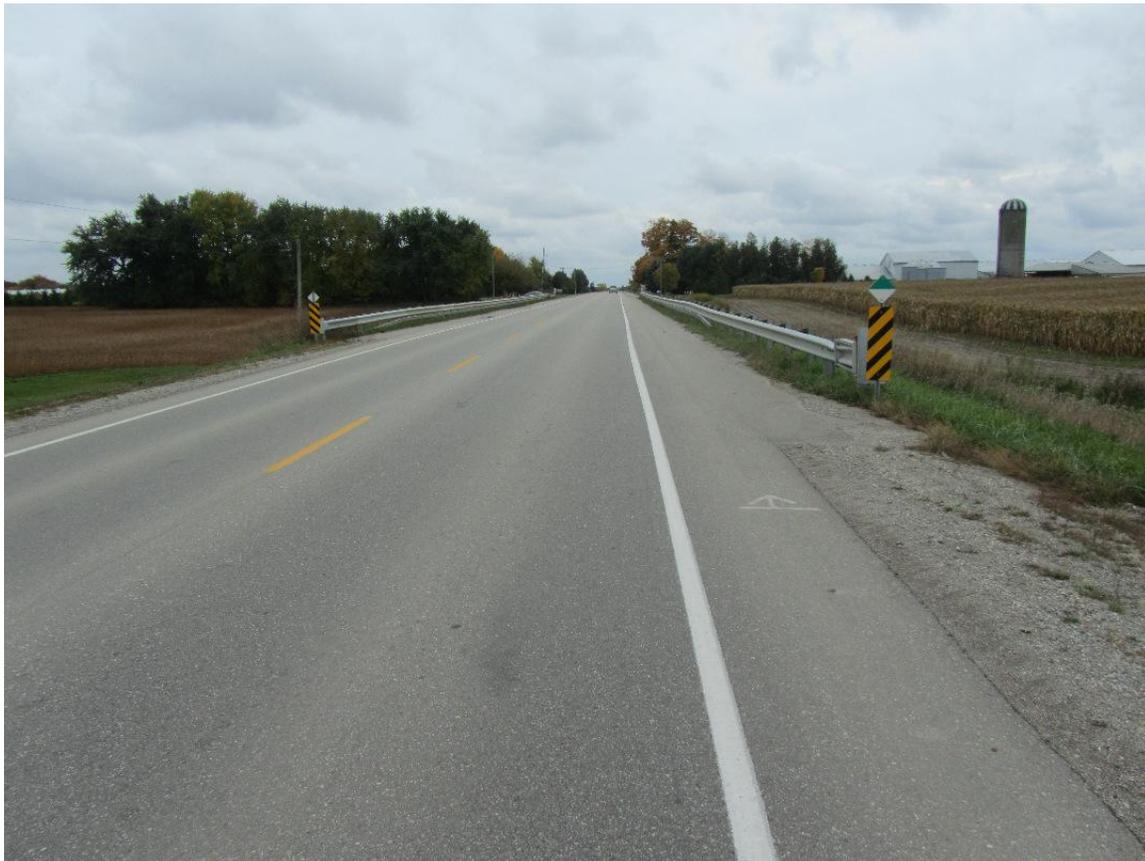
Figure 1: Overall view, looking south, at the two guardrails north of Oxford Road 88 in Oxford County. Our first review will be of the north end cap located on the west guardrail which is visible in the right foreground of the above photo.

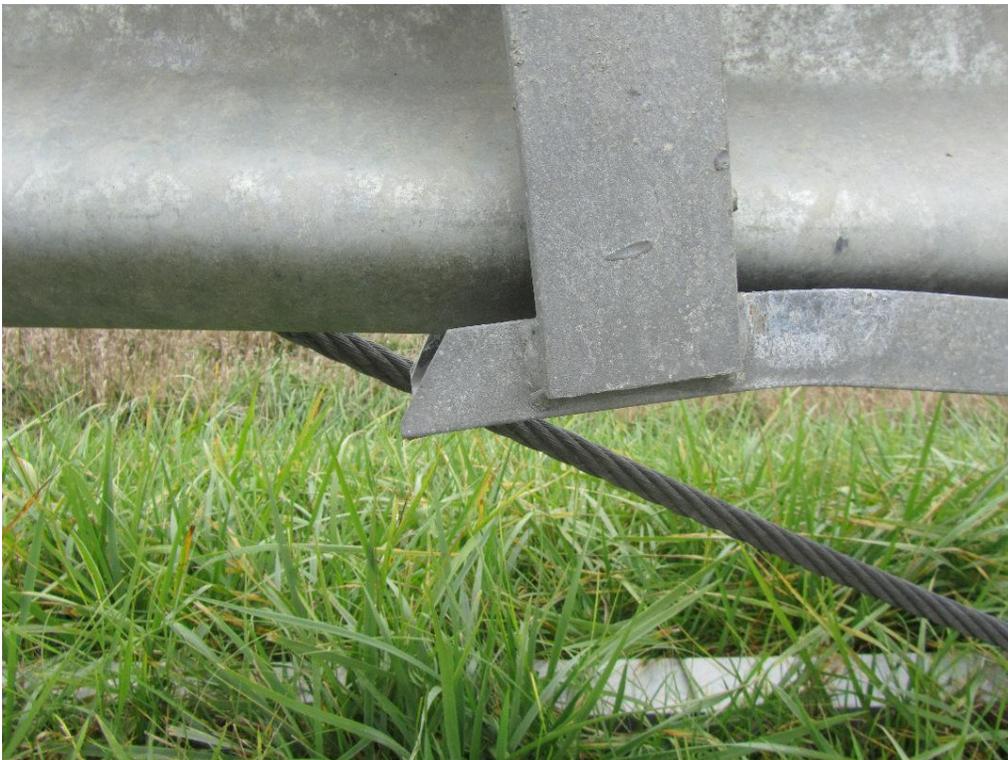
Figure 5: View of deformation to the bottom rear of the channel.

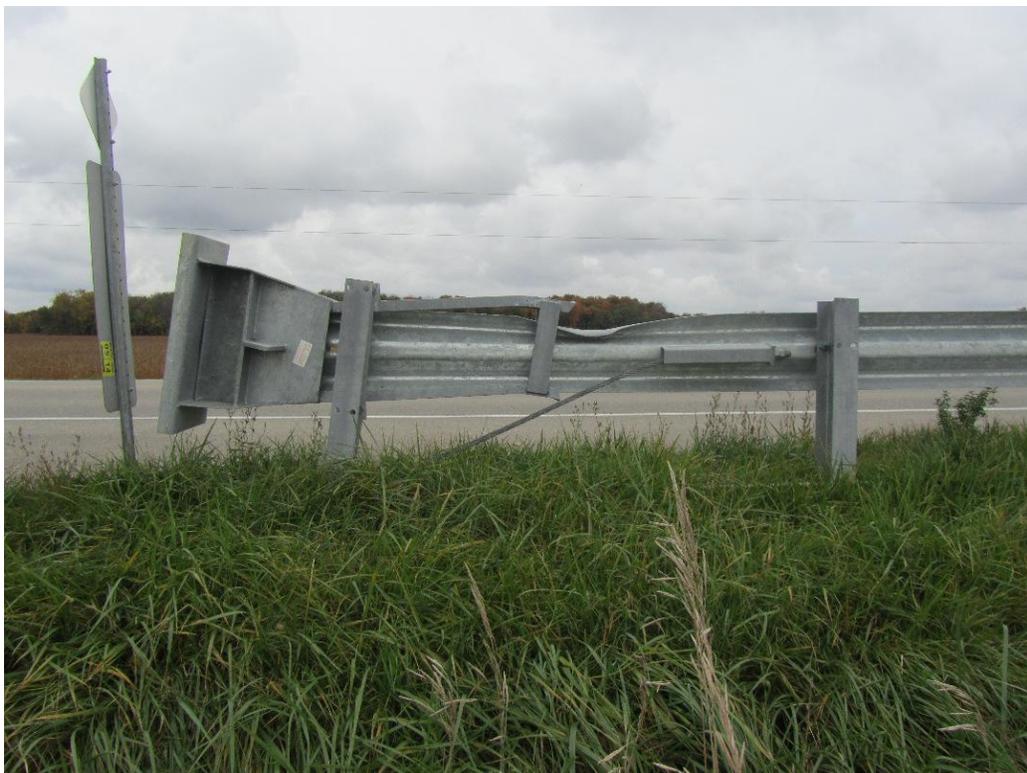
Figure 8: Measurement indicating that the base of the end plate is about 12.5 inches above the ground.

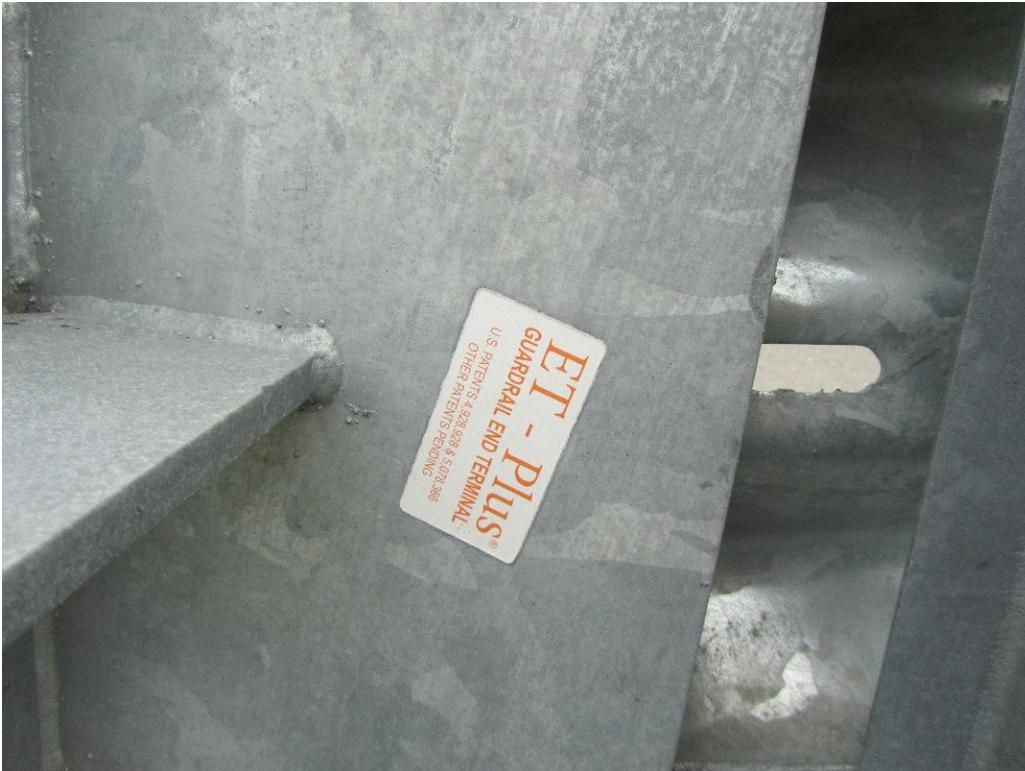
Figure 10: View of deformed status of channel.

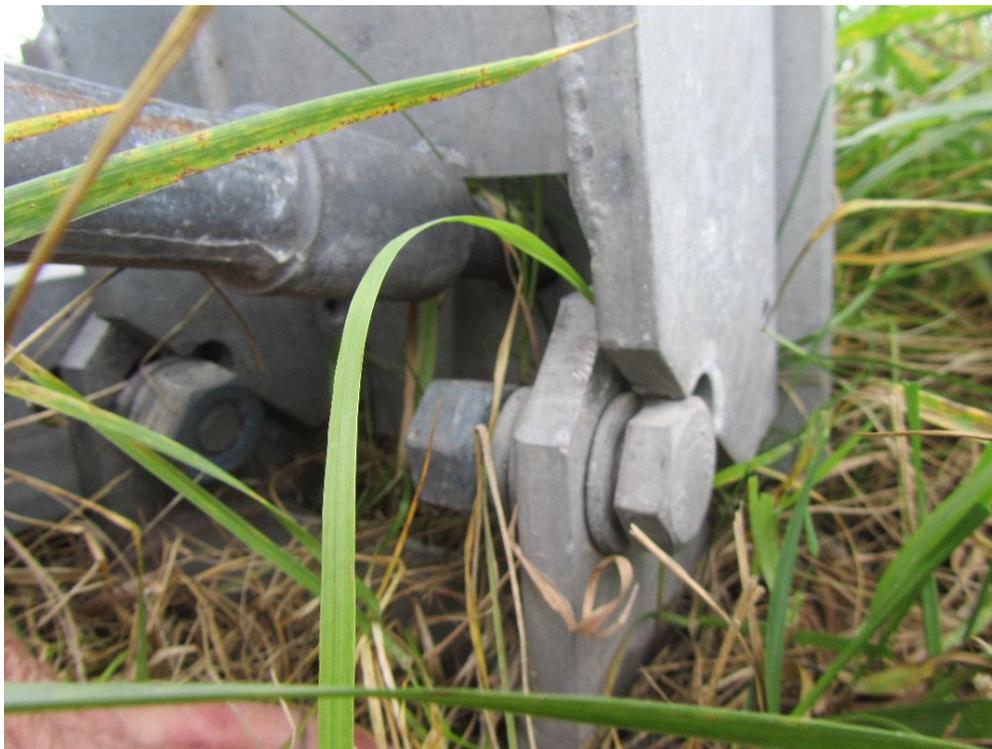
Figure 12: View of deformed top edge of rail at the deformed rear edge of the channel.

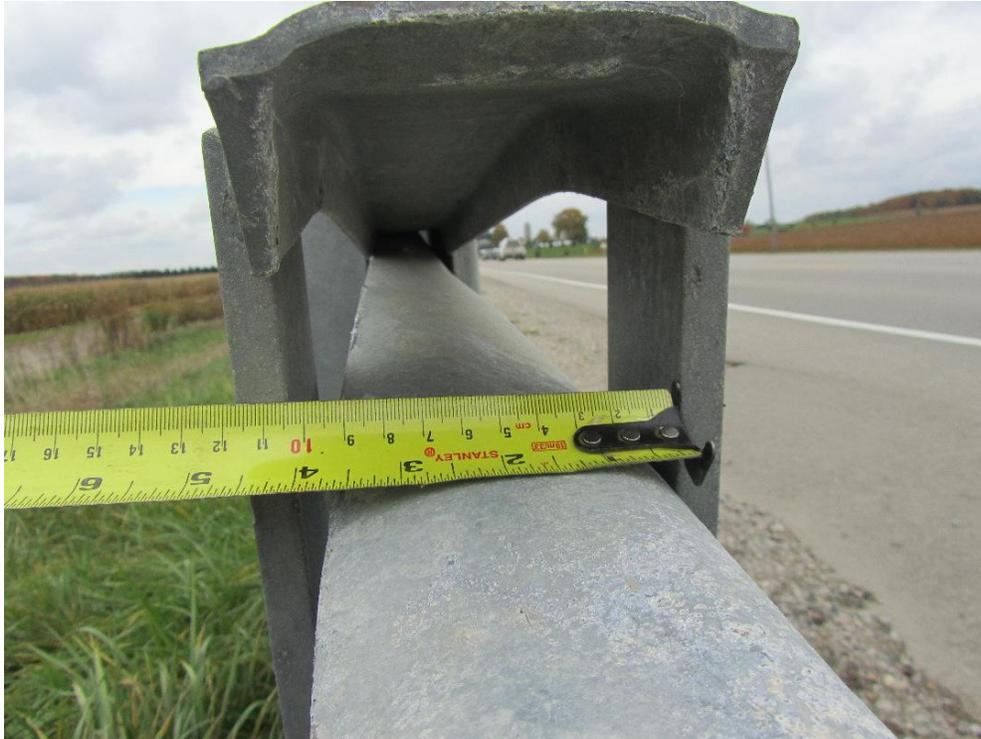
Figure 13: View of bottom anchorage to the vertical support beam just behind the end plate which has slipped out of its press fit position.

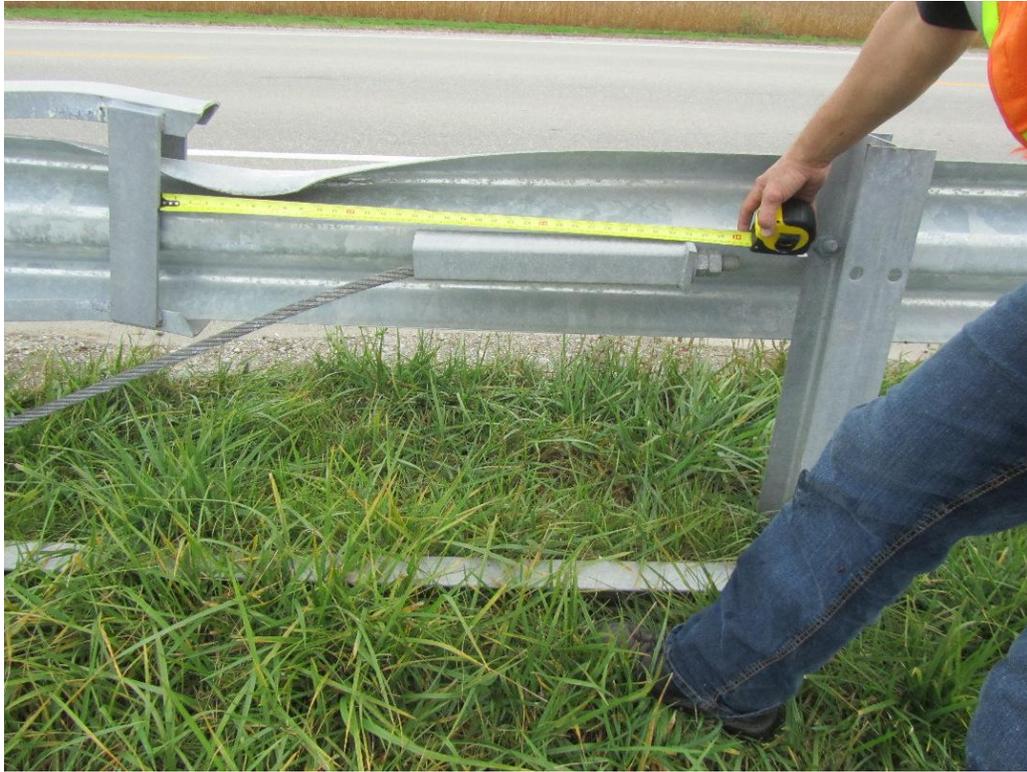
Figure 16: Close-up view of front edge of rail inside the channel showing the buckling and rupture of the rail.

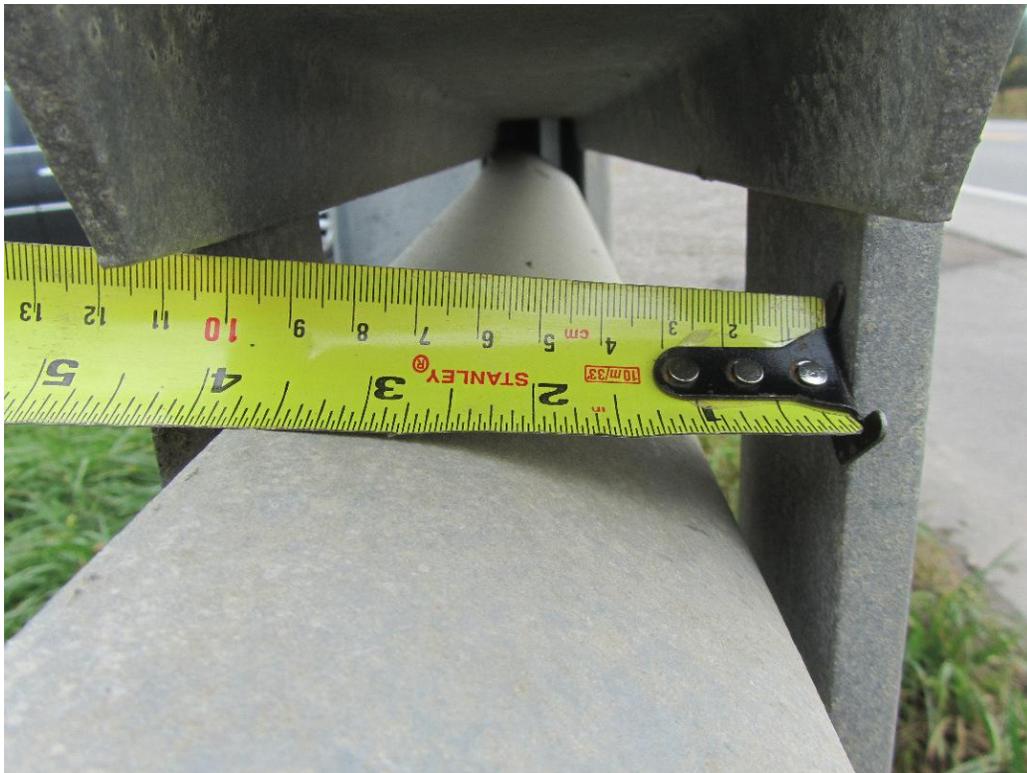
Figure 29: Measurement indicating that the base of the end plate is approximately 9 inches above the ground.

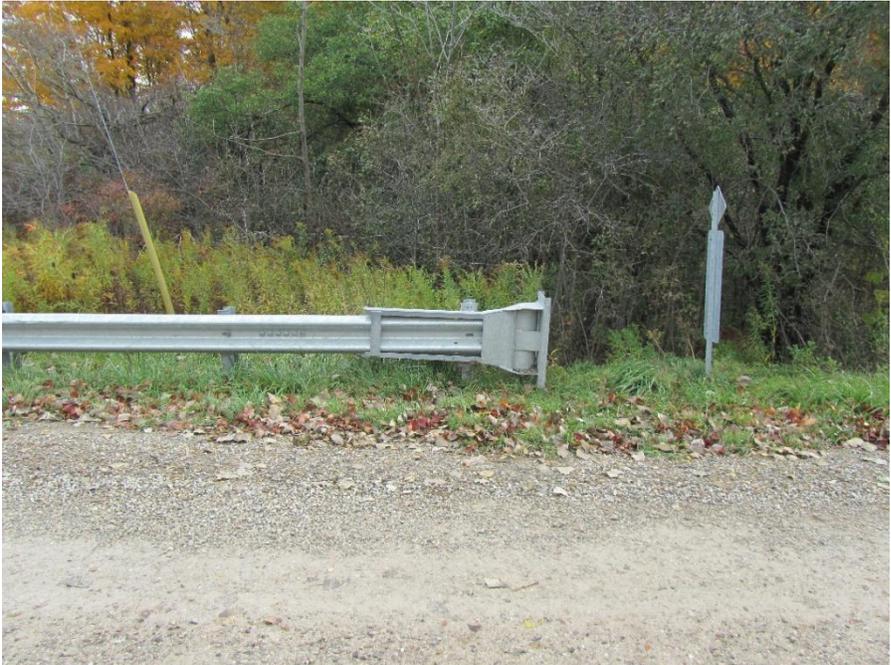
Figure 36: View of rail and end cap showing the substantial difference in their horizontal angles.

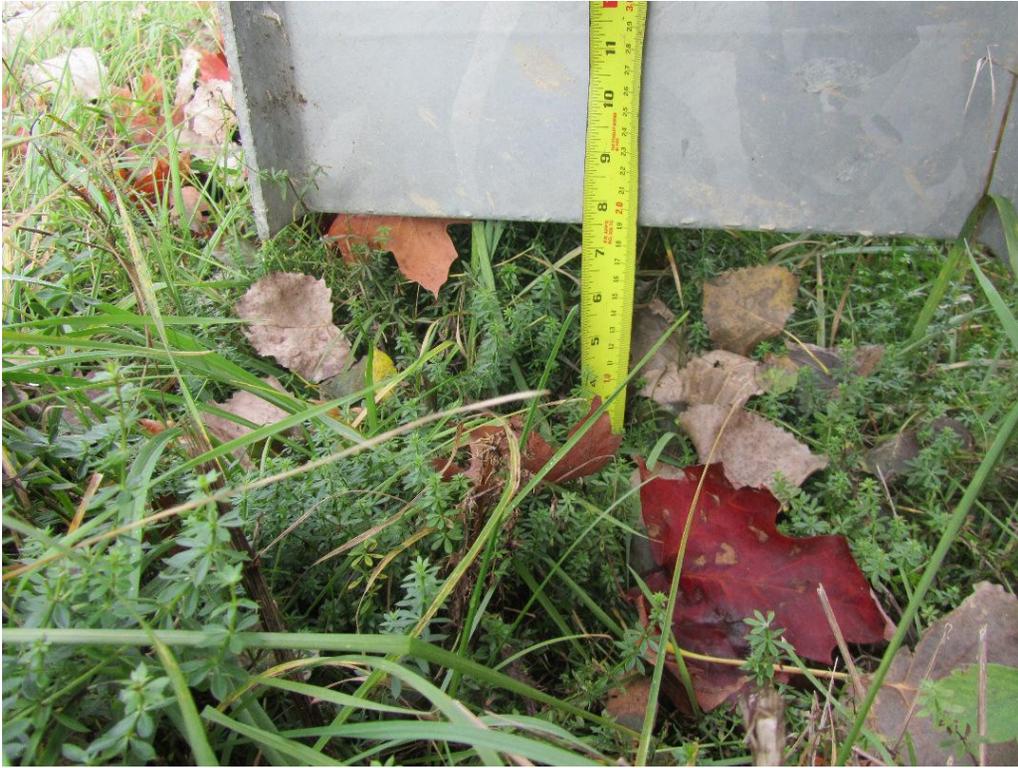
Figure 38: Measurement indicating that the base of the end plate is about 7.5 inches above the ground.

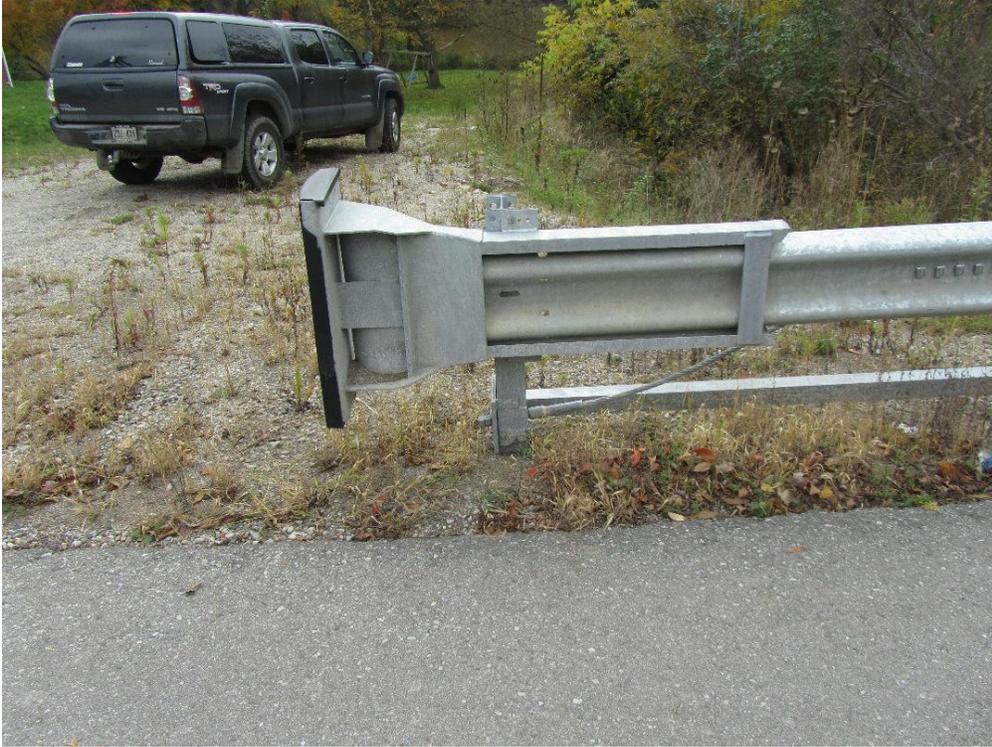
Figure 48: Street side view of end cap and guardrail.

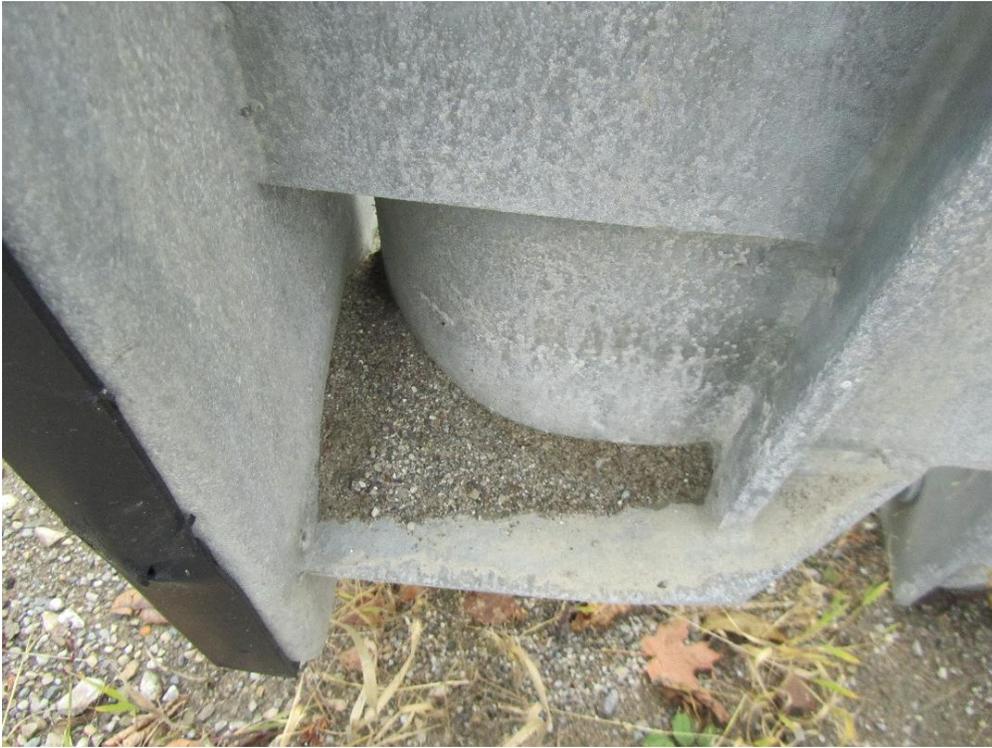
Figure 49: Street side view of end cap and rail.

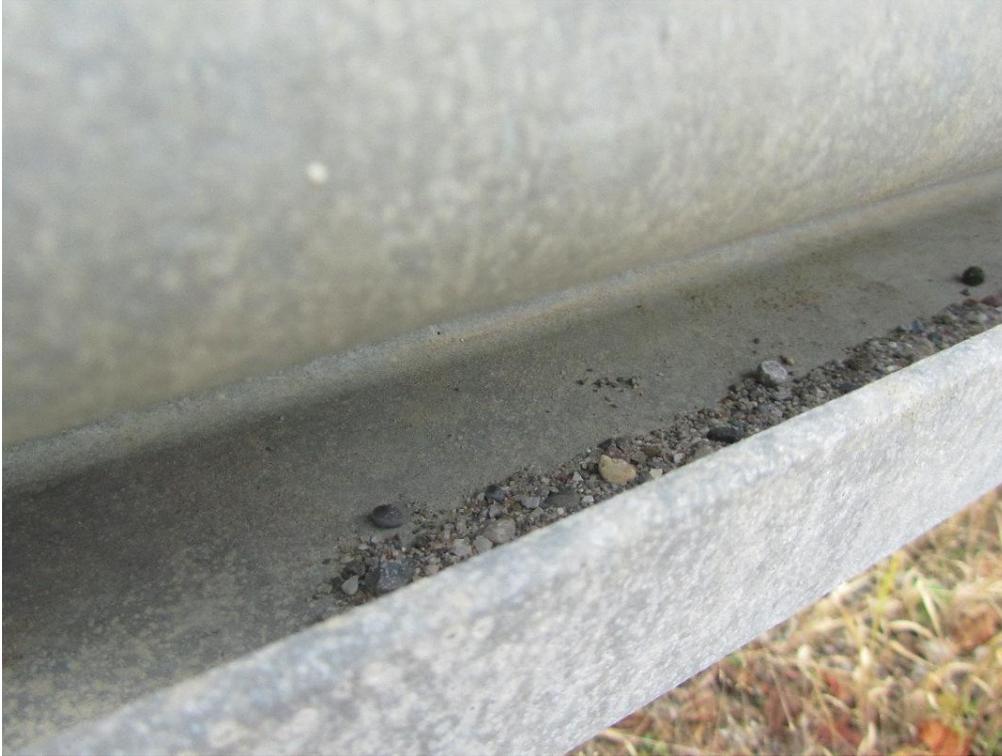
Figure 50: View of sand accumulated in the horizontal plate located just behind the end plate.

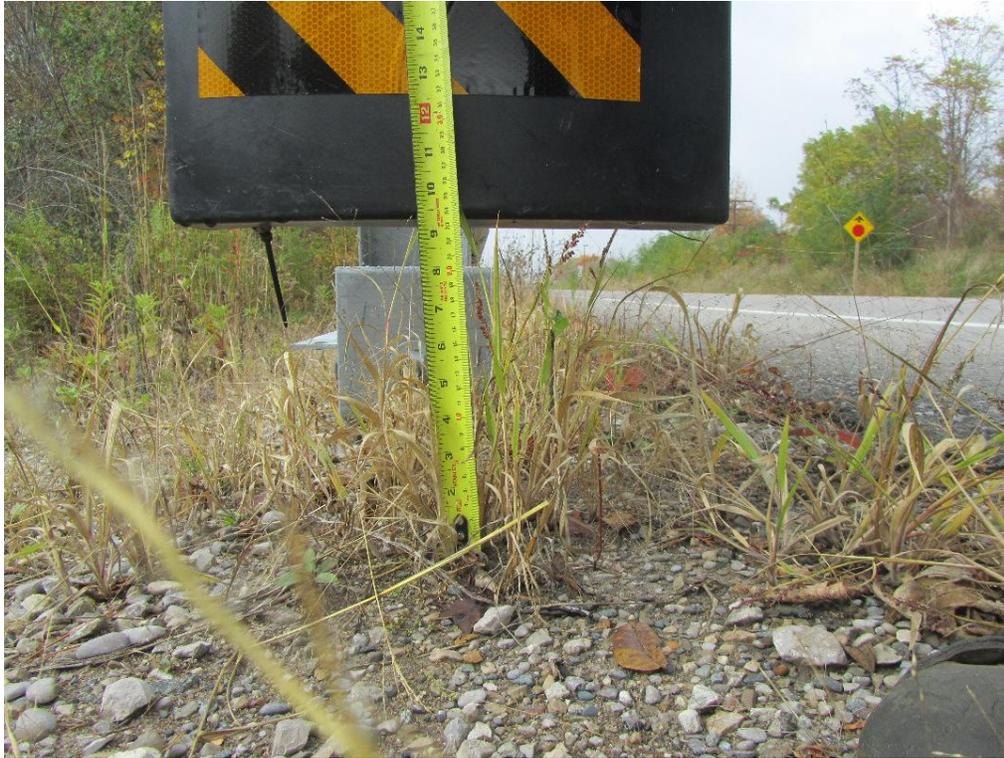
Figure 52: Measurement indicating a width of 15.5 inches for the black cover of the end plate.

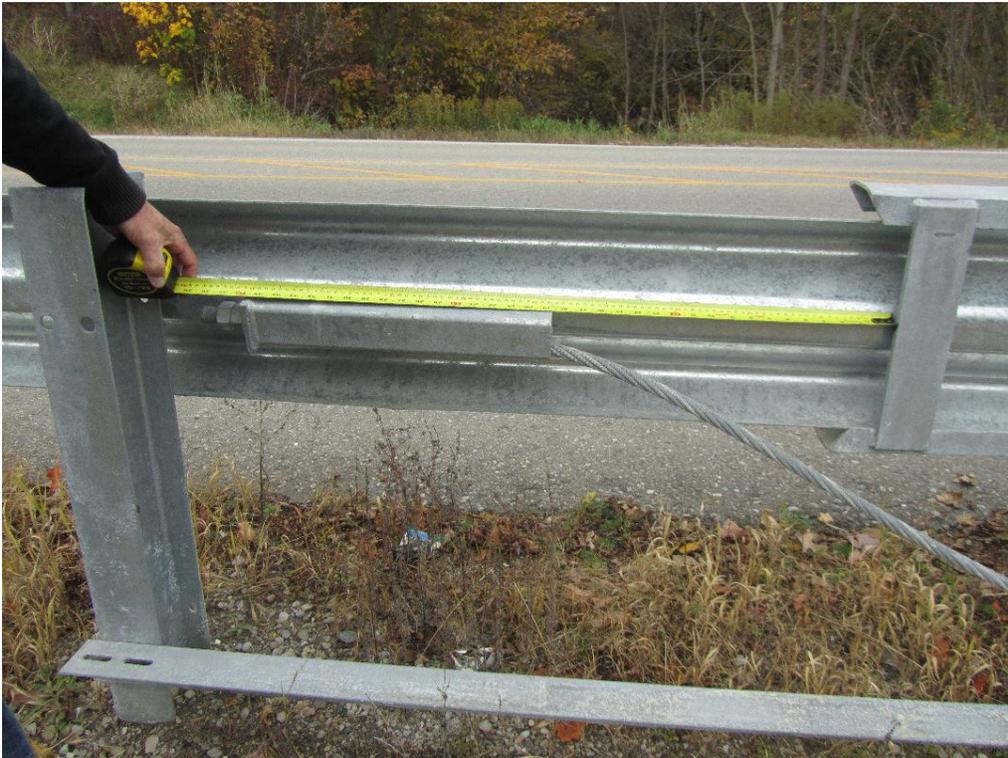
Figure 55: Measurement confirming 4-inch width of channel.

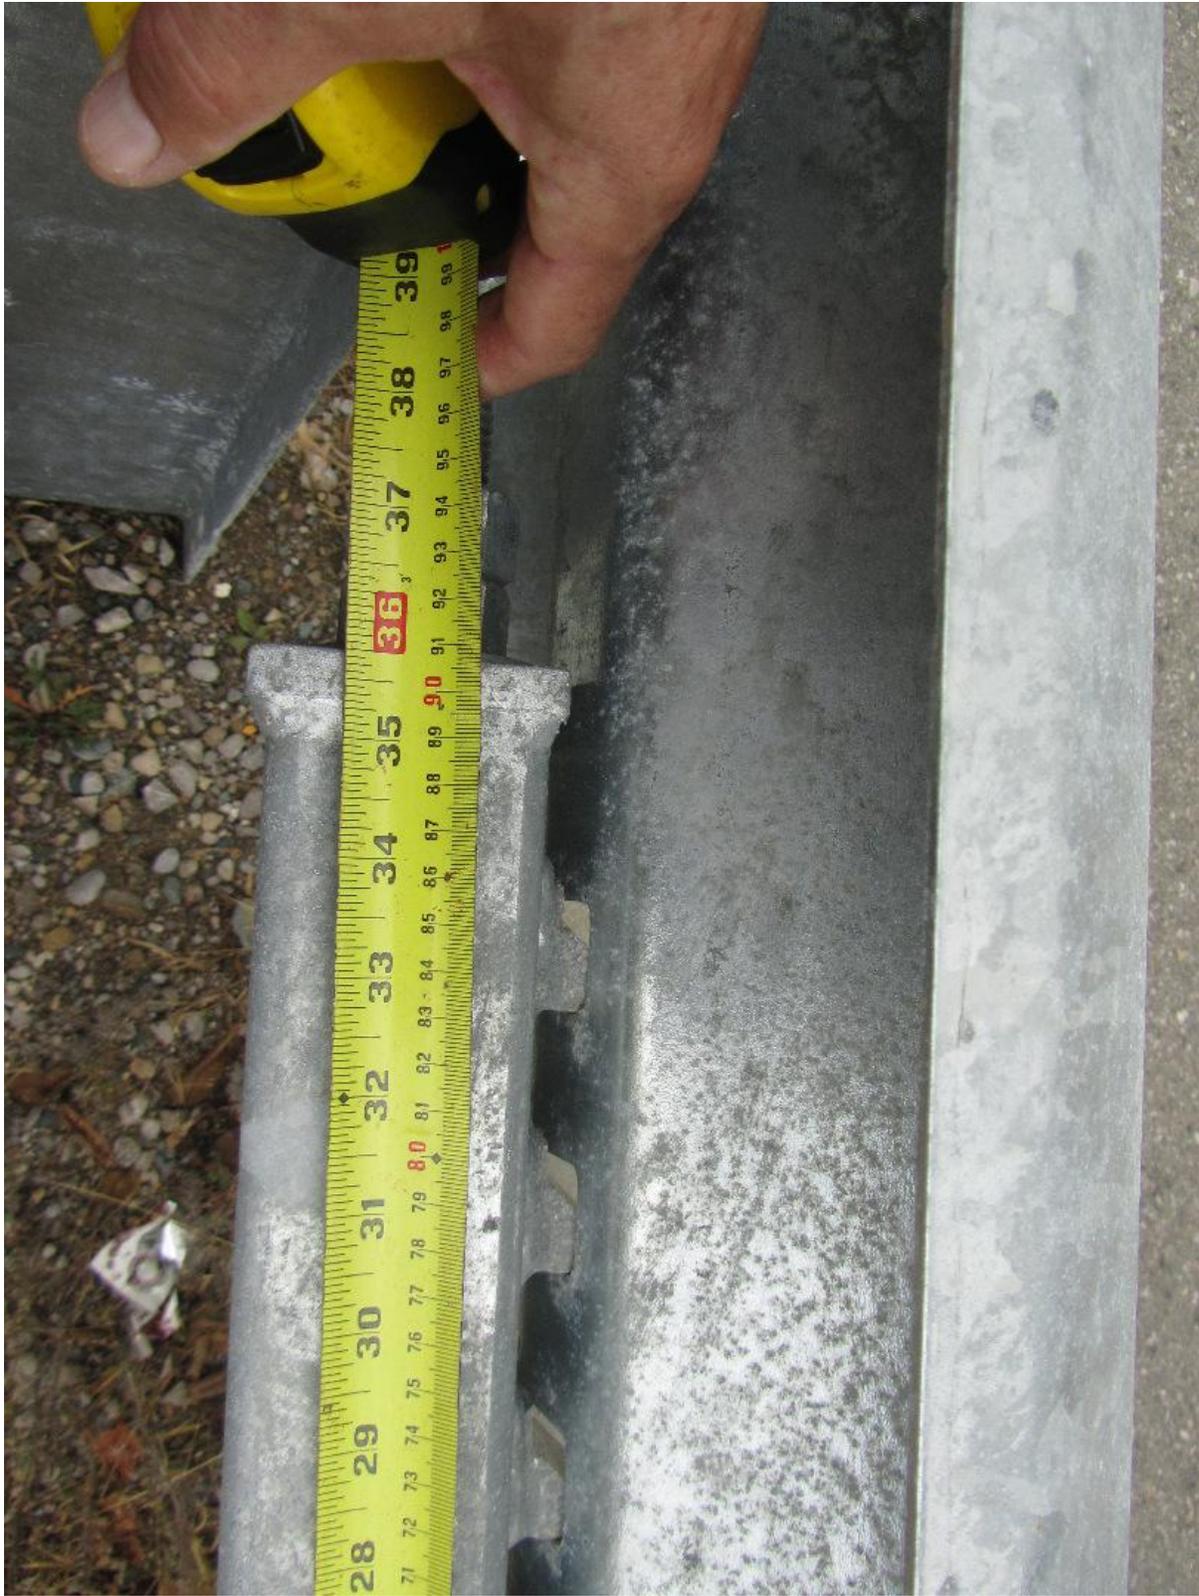
Figure 56: View of measurement being taken to establish the position of the end cap.

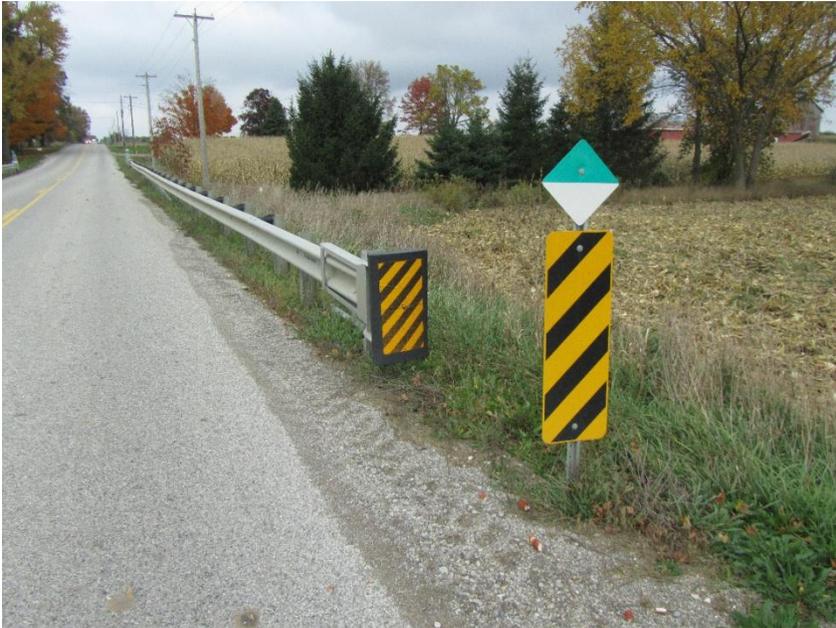
Figure 57: Result of measurement indicating as distance of 35.75 inches.

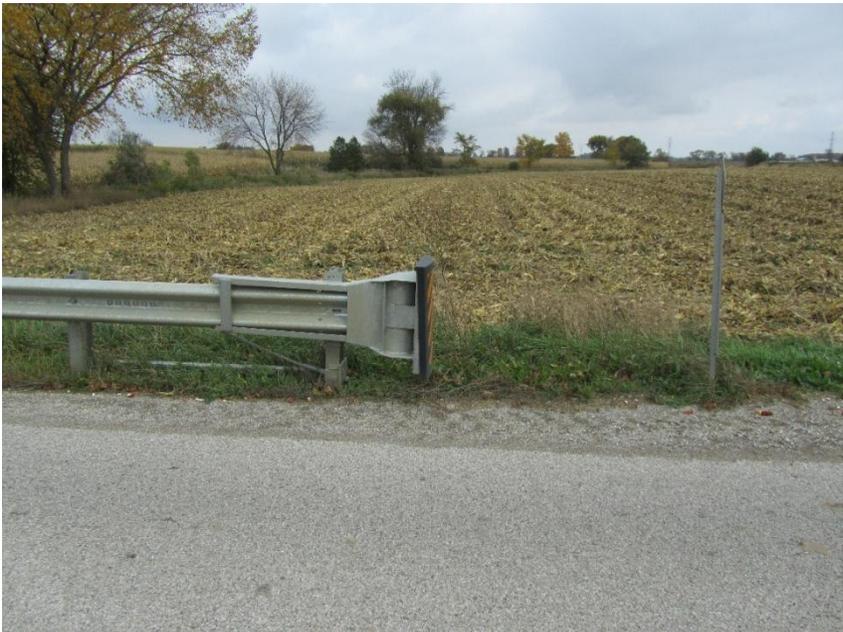
Figure 58: Overall view of hazard warning marker, east guardrail and end cap.

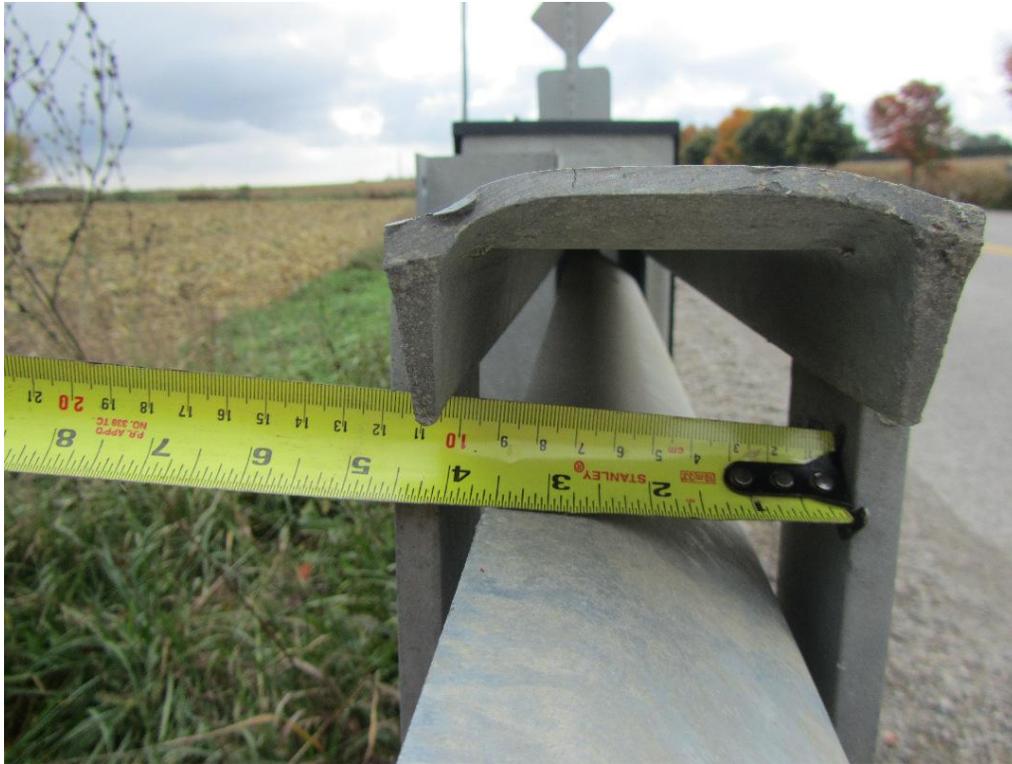
Figure 65: Ditch side view of end cap and rail.

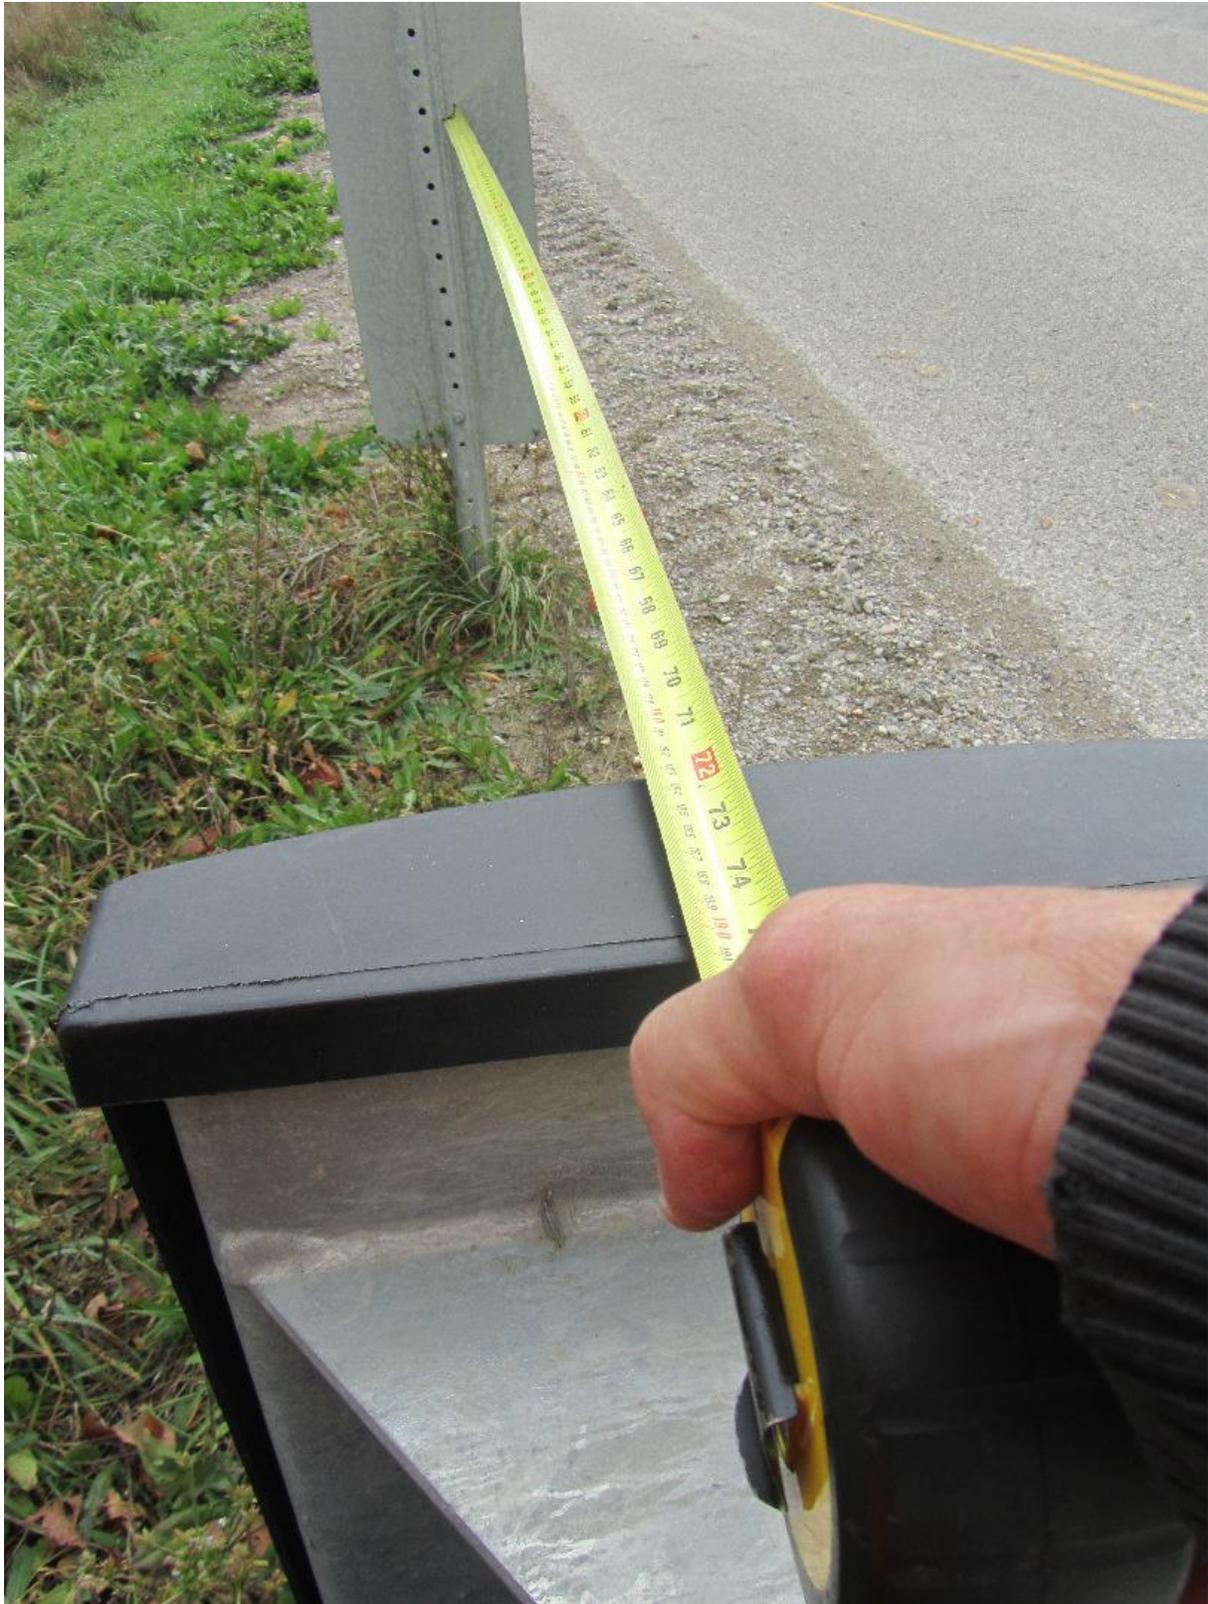
Figure 67: Result of measurement to determine the position of the end cap indicates a distance of 36 inches.

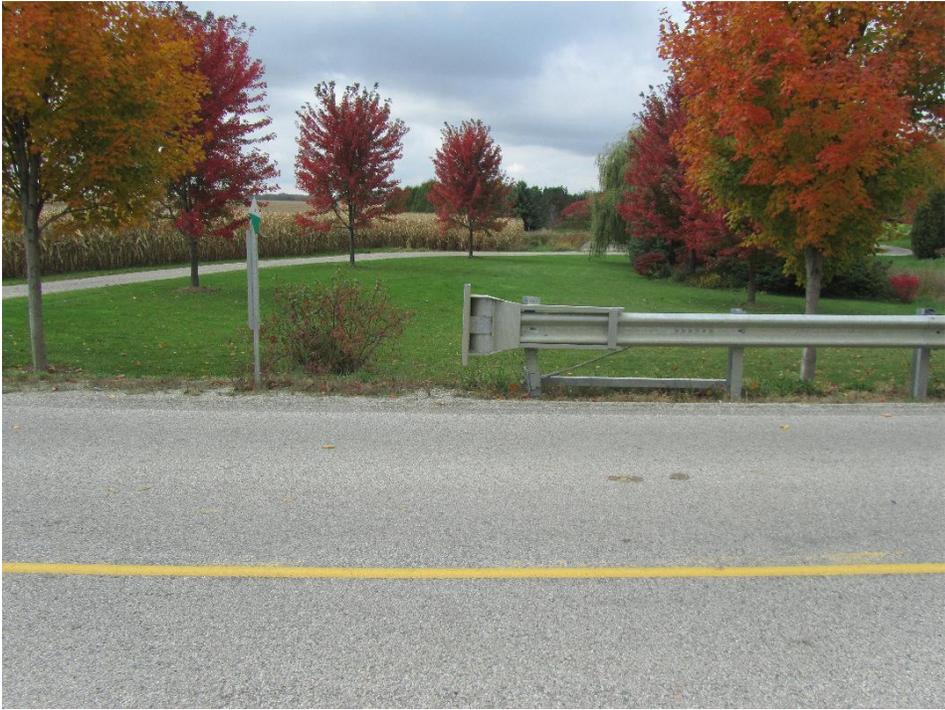
Figure 69: Measurement indicating the height of the hazard marker sign is about 63 inches.

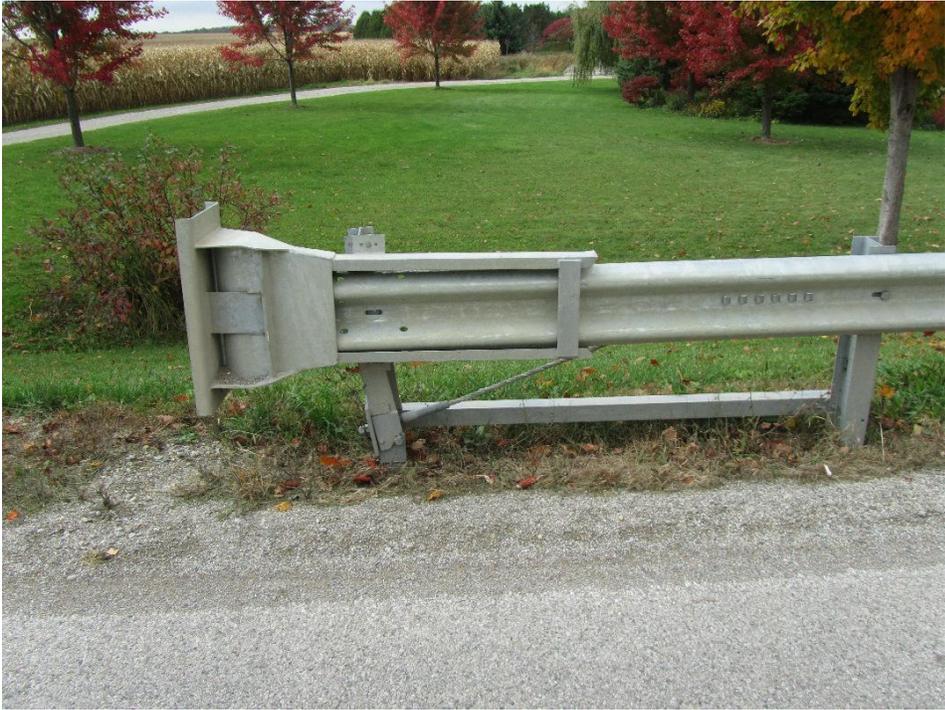
Figure 70: Overall view of the hazard marker, end cap and guardrail.

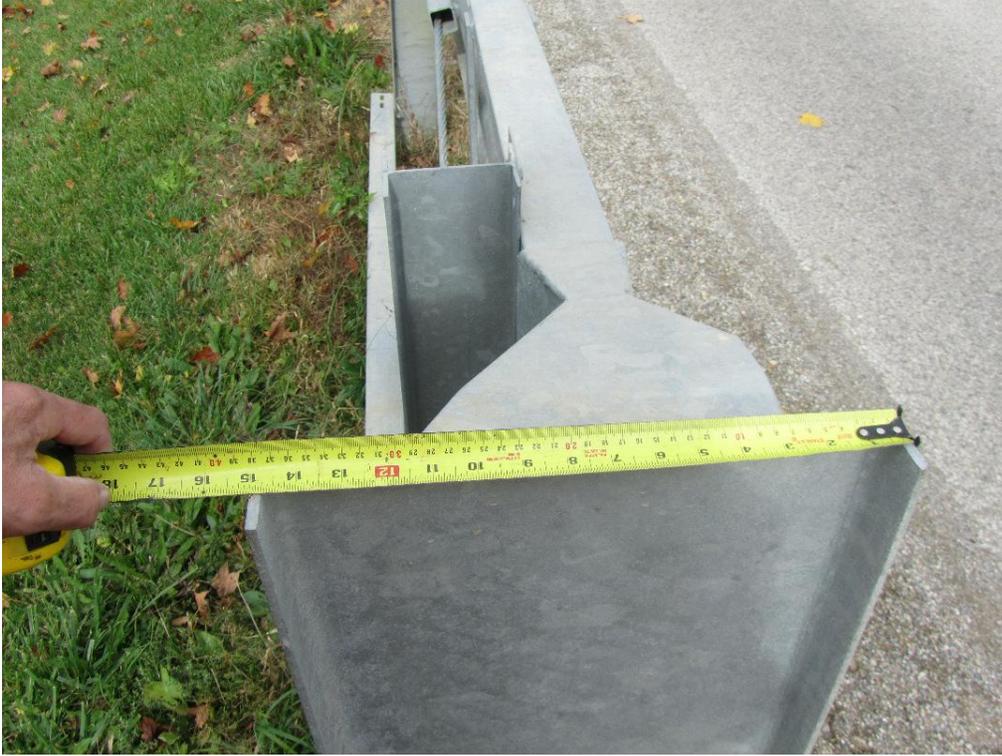
Figure 71: Street side view of end cap and west guardrail.

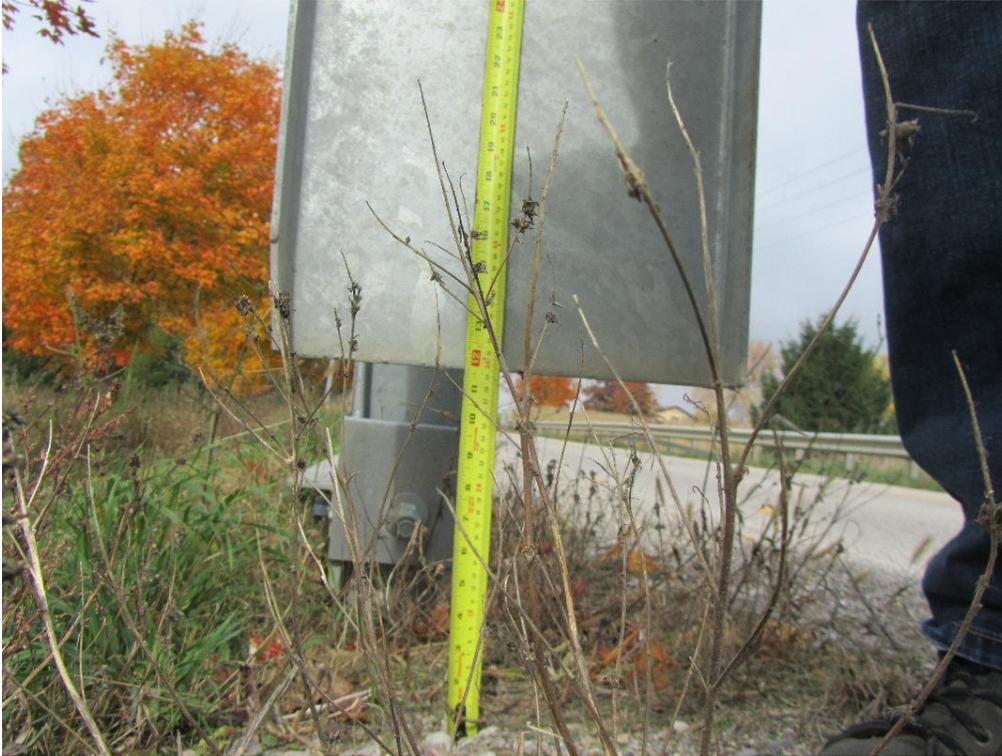
Figure 72: Measurement confirming 15-inch-wide end plate.

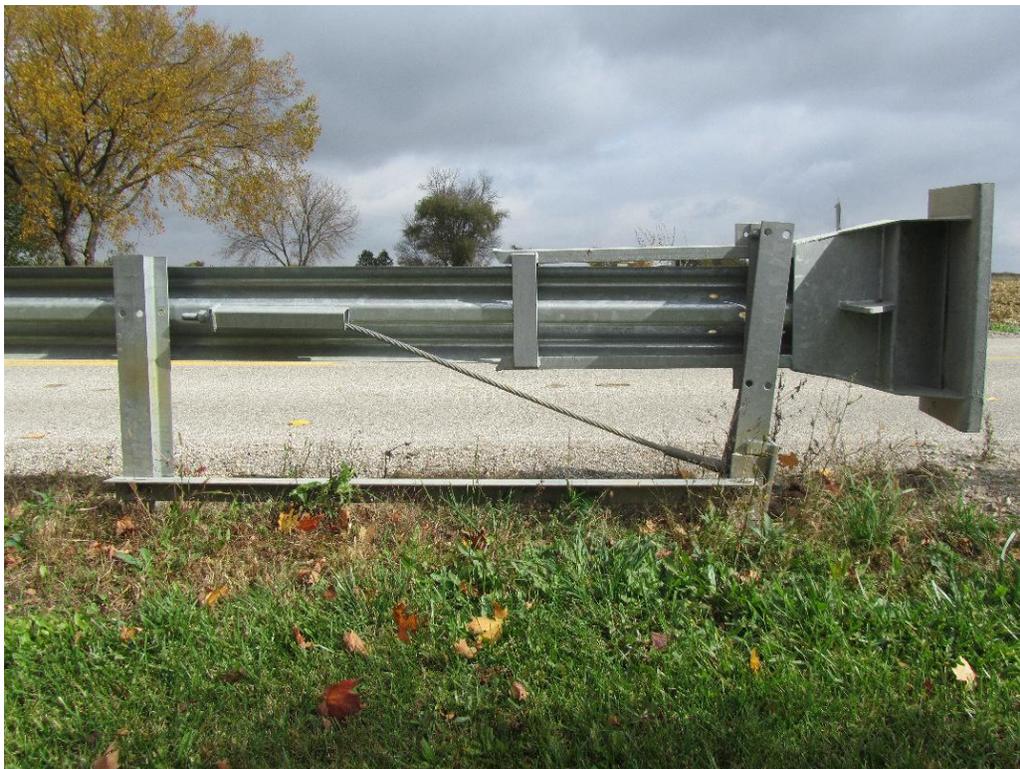
Figure 76: Close-up view showing how the vertical post has been displaced out of its press fitting at its anchorage bolt.

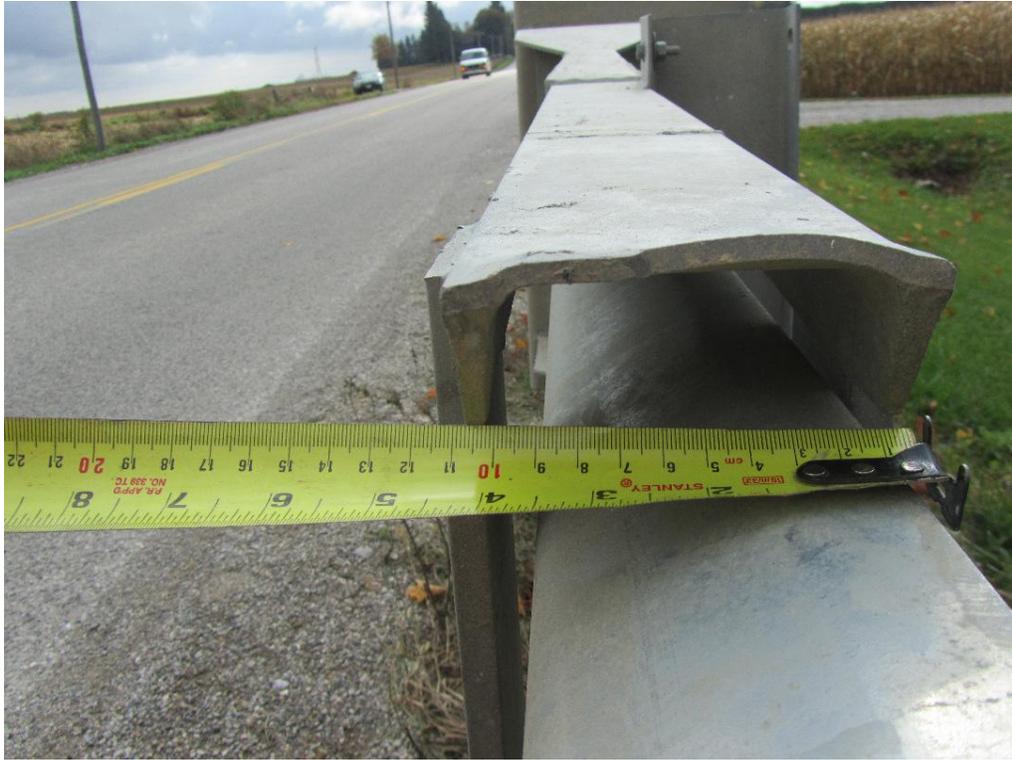
Figure 77: Ditch side view of end cap and rail.

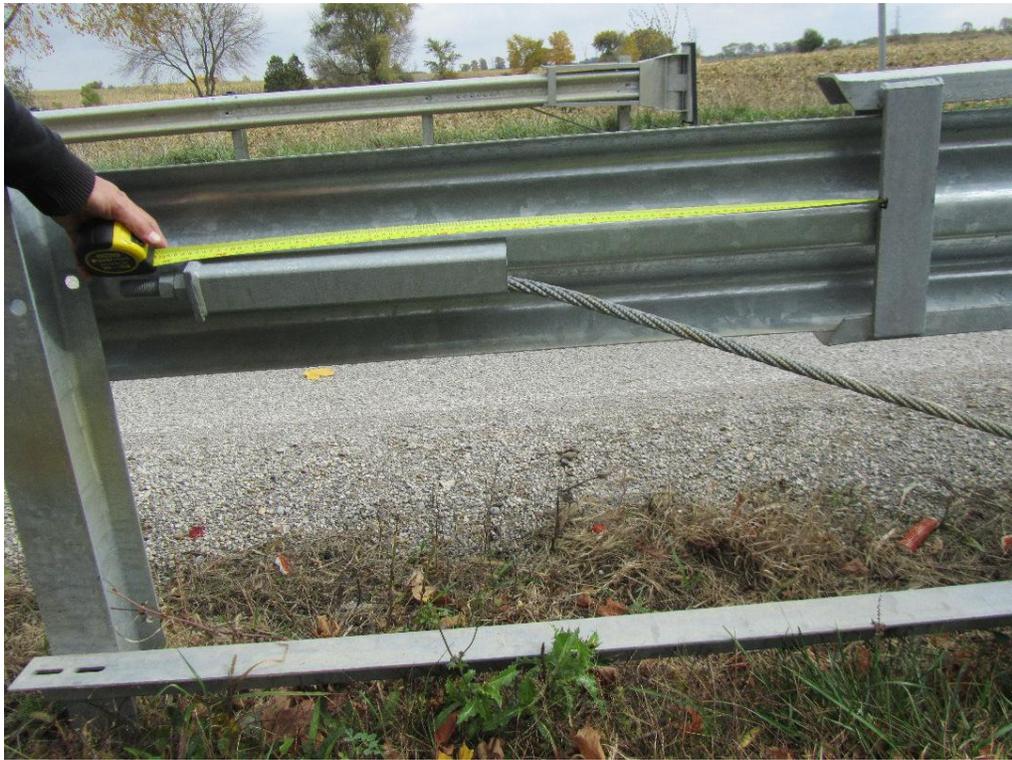
Figure 78: Measurement indicating that the channel is 4 inches wide.
