Trinity Guardrail End Cap Survey - Part IV

Posting Date: 23-Oct 2014

Survey of Trinity End Caps

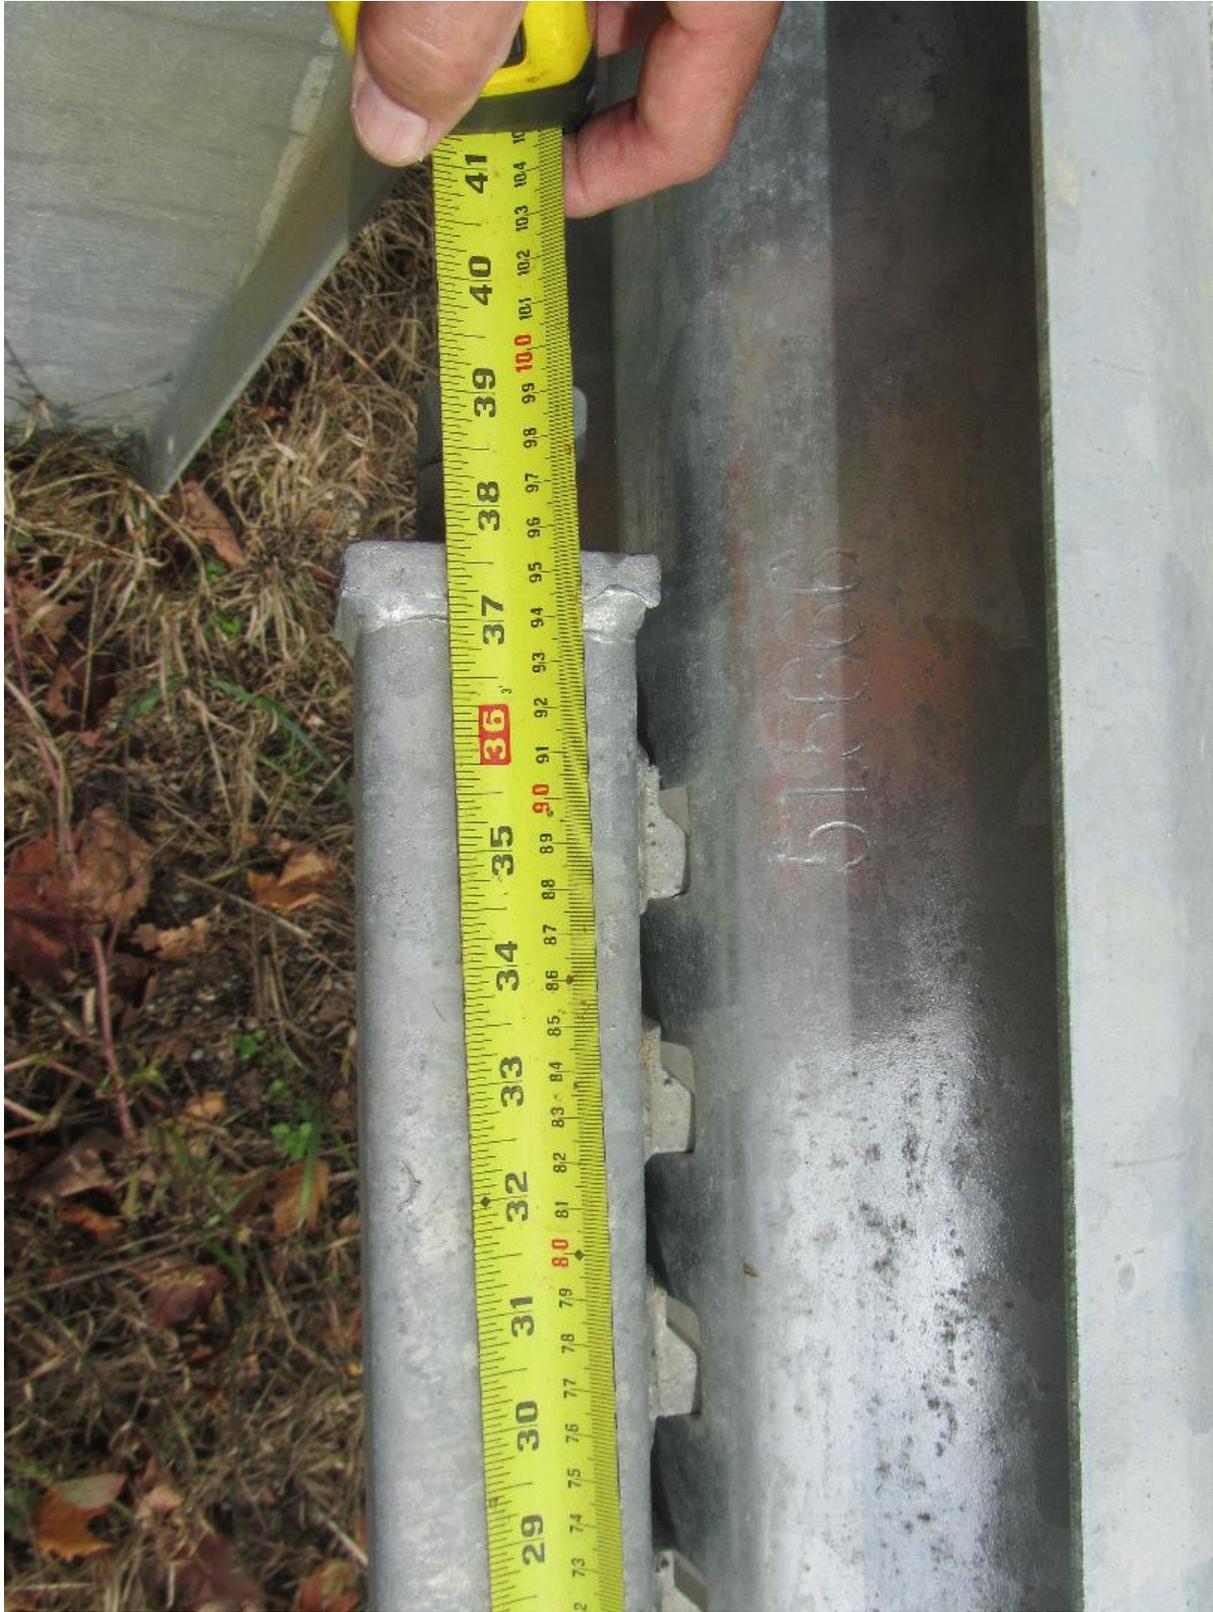
Figure 79: View of measurement being taken to determine the position of the end cap.

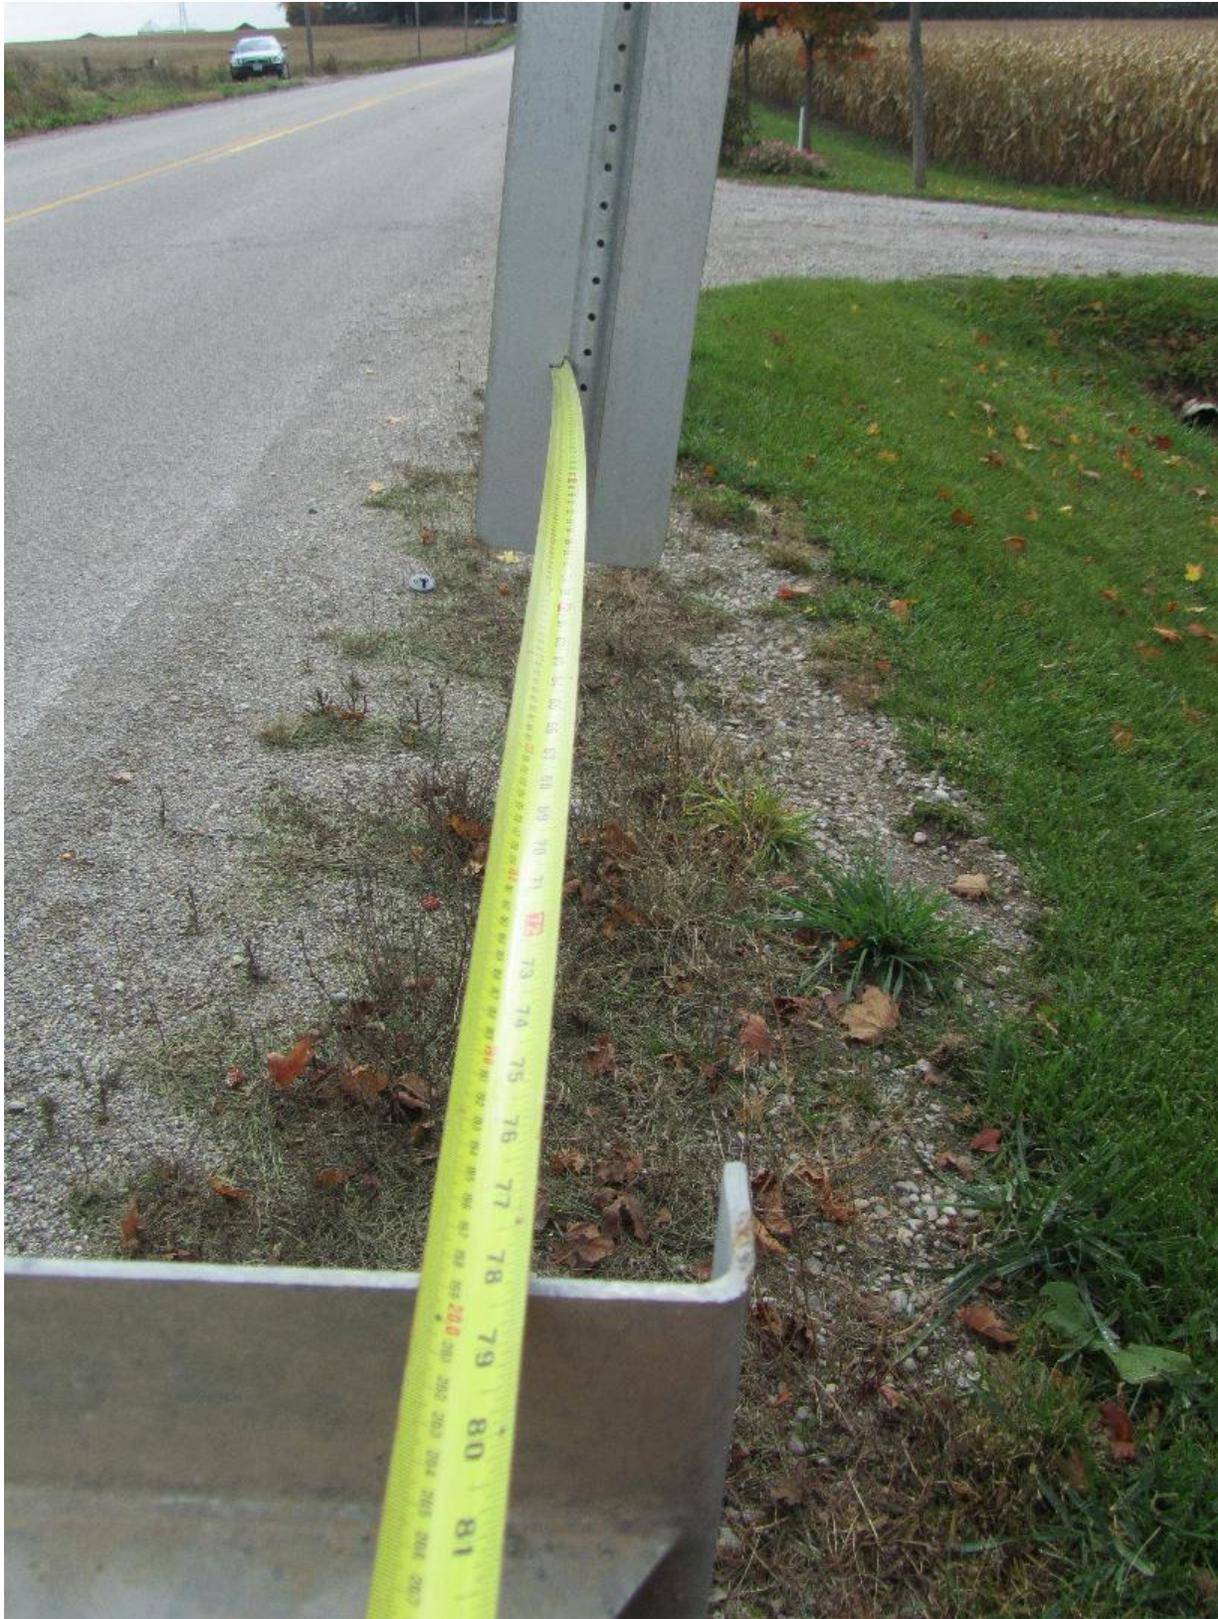
Figure 80: Result of measurement indicates a distance of 37.75 inches.

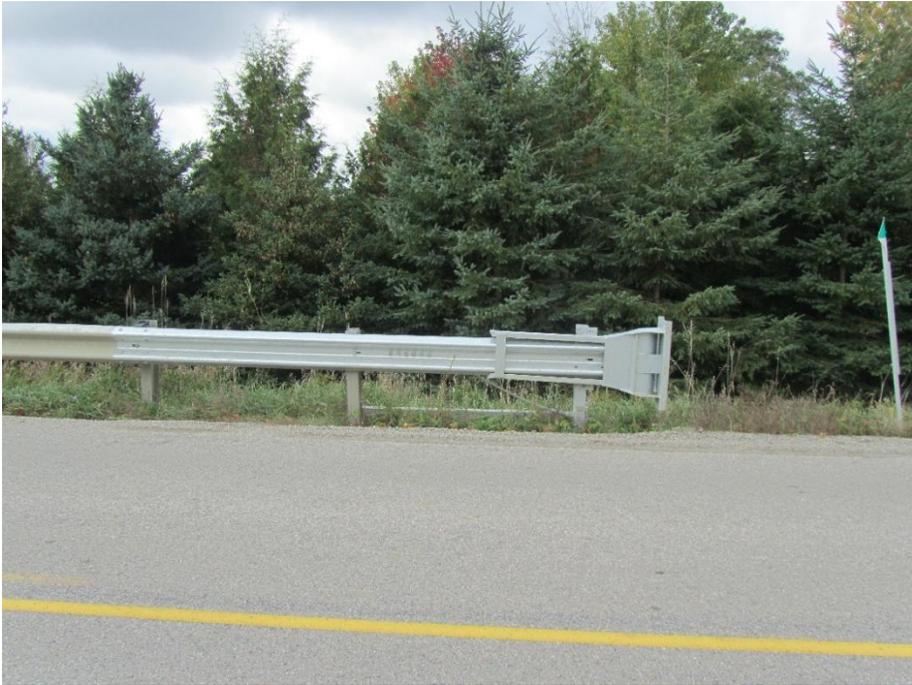
Figure 81: Measurement indicating the distance from the end plate to the hazard marker is about 78 inches.

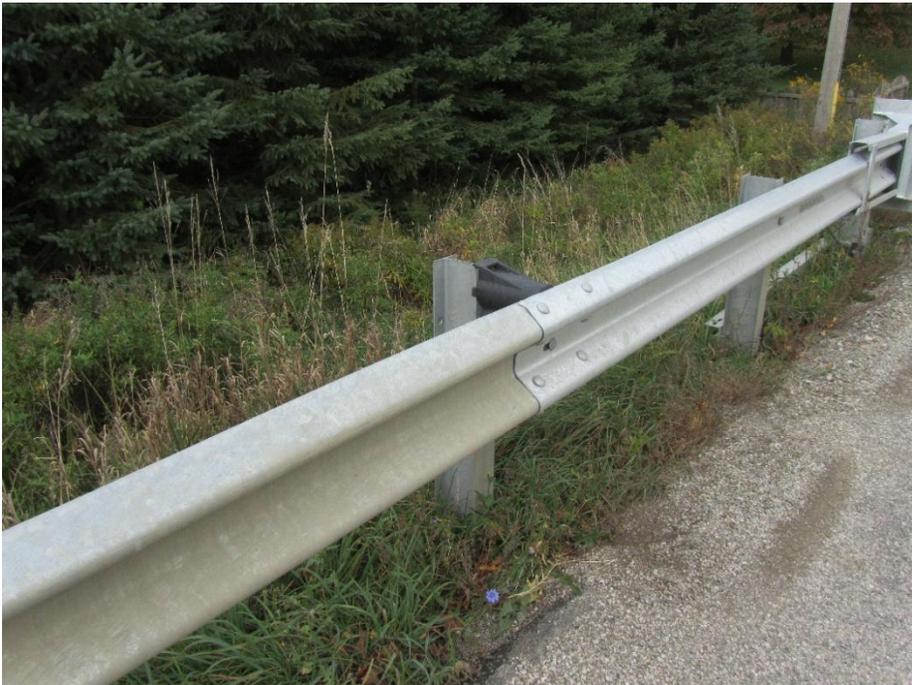
Figure 82: Street side view of hazard marker, end cap and guardrail. Note there is a newer section of rail while the older portion is visible at the left end of the photo.

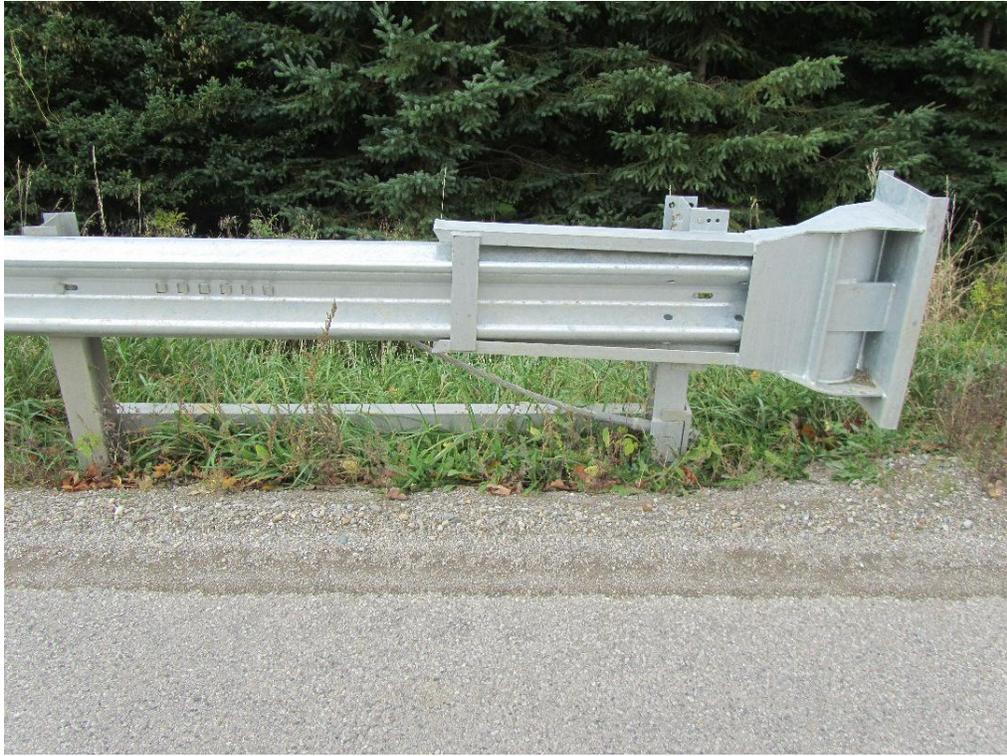
Figure 83: View showing portion of guardrail where the newer rail overlaps with the older portion.

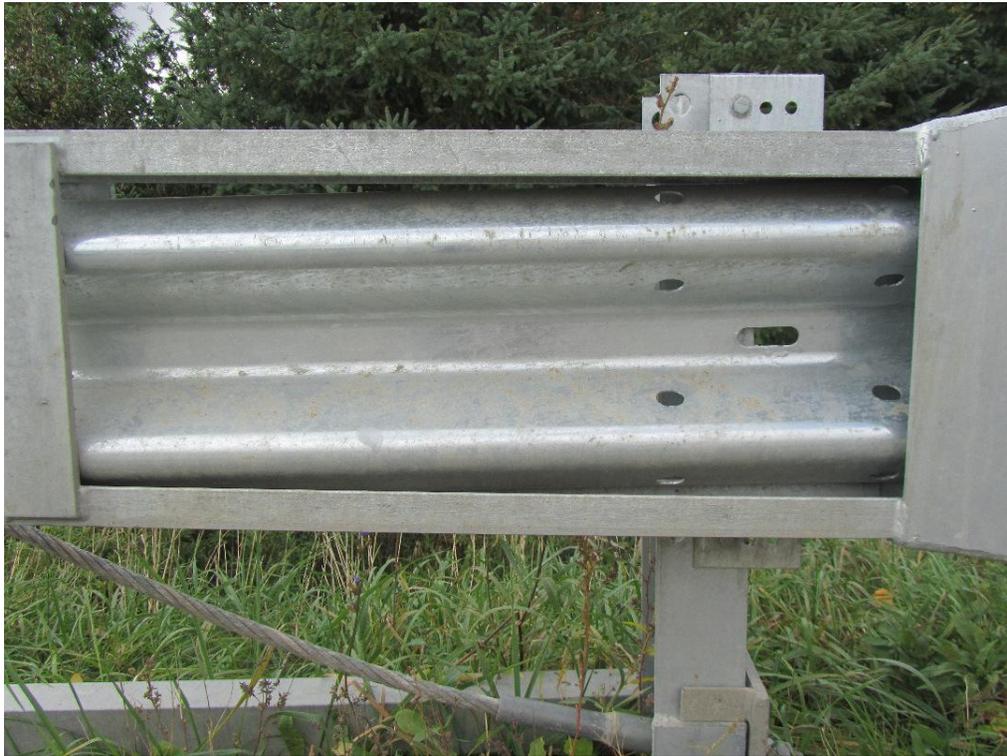
Figure 84: Overall view of end cap and rail.

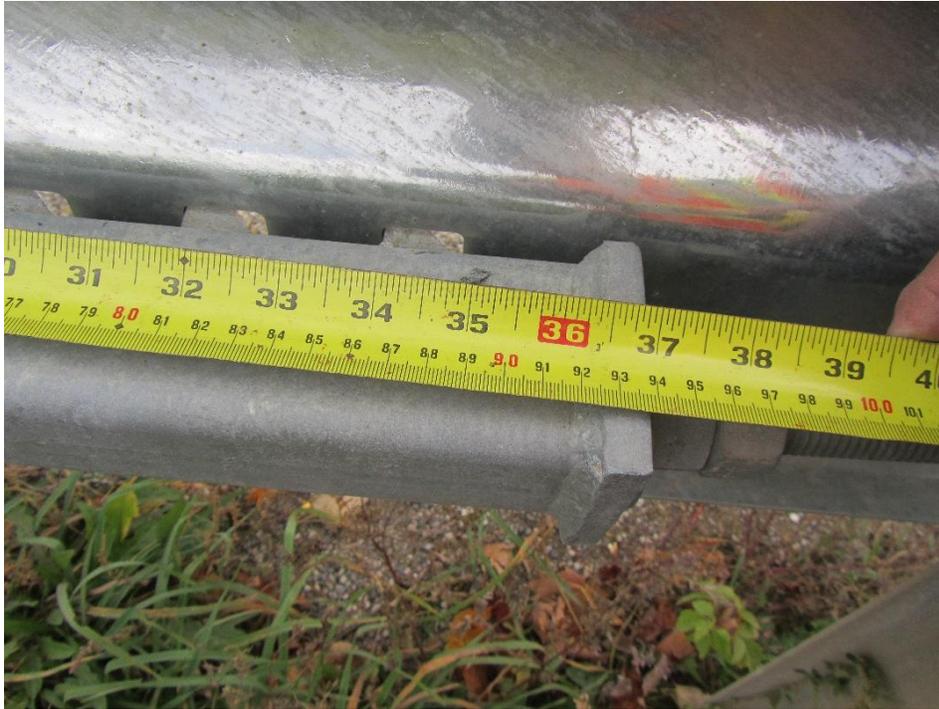
Figure 92: View of measurement being taken to document the position of the end cap.

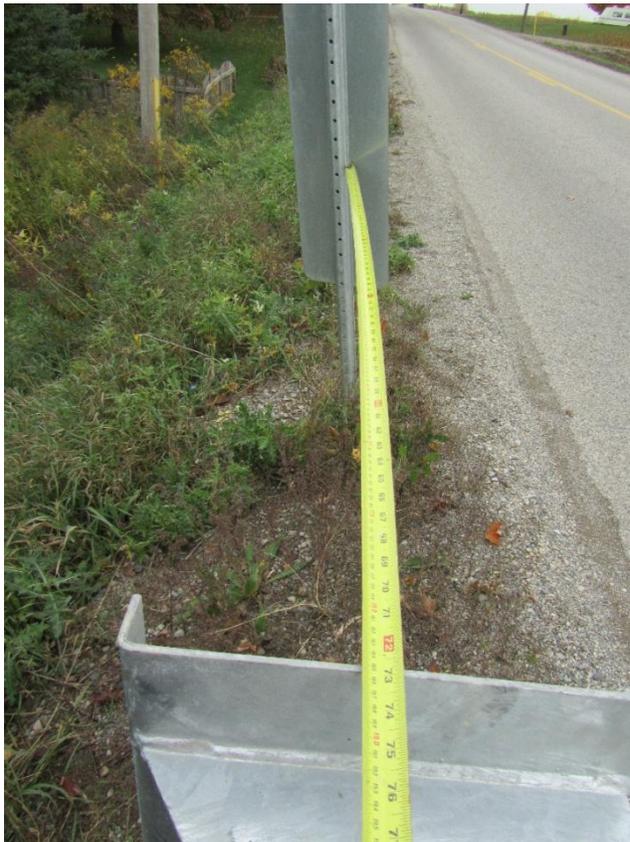
Figure 93: Result of measurement indicating a distance of 36.75 inches.

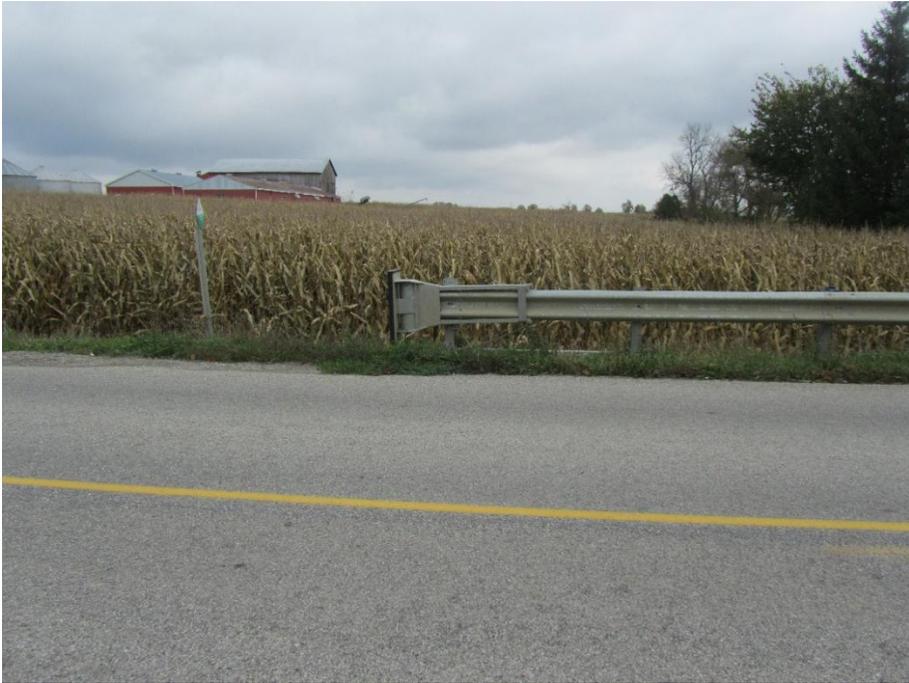
Figure 94: View of measurement indicating the distance between the end plate and hazard marker is about 73.5 inches.

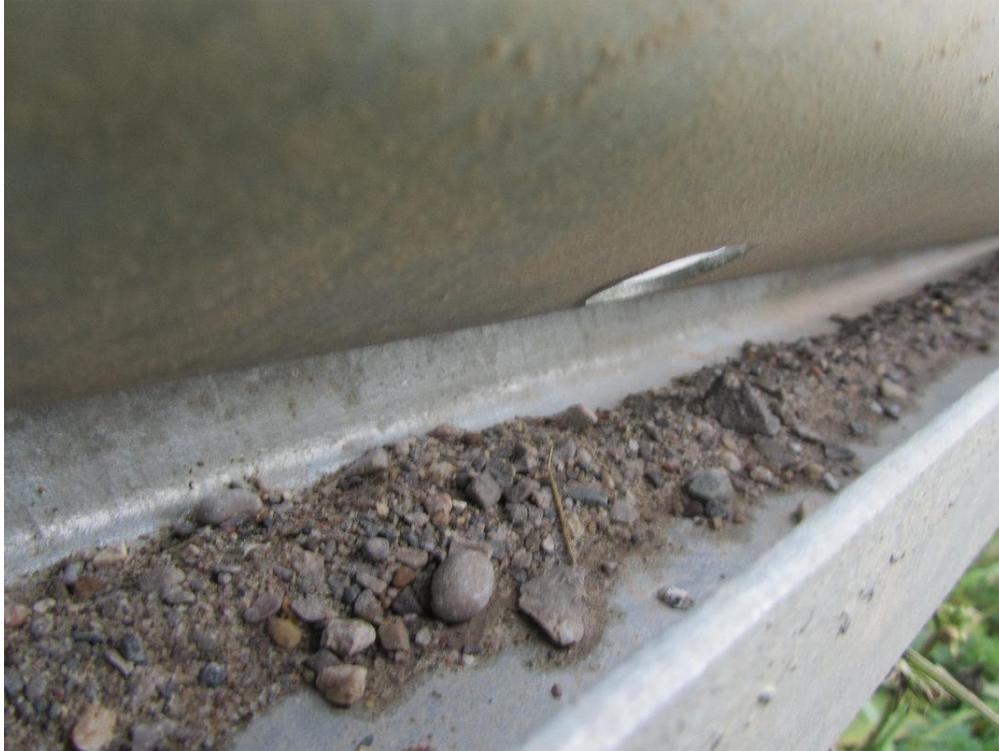
Figure 98: Close-up view of gravel lying on the horizontal platform just behind the end plate.

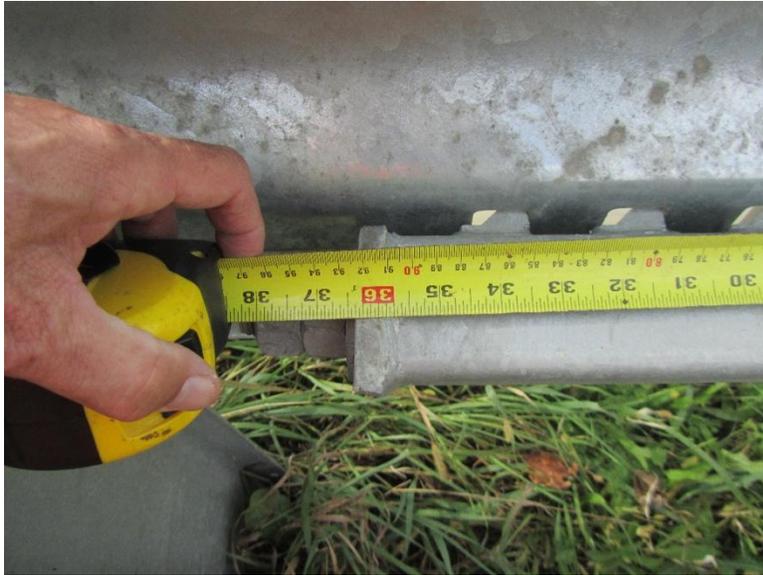
Figure 106: View of measurement being taken to document the position of the end cap.
