Trinity Guardrail End Caps In & Near London Ontario - Survey of Locations & Condition

Posting Date: 09-Oct 2014

Survey of Trinity End Cap Location & Condition

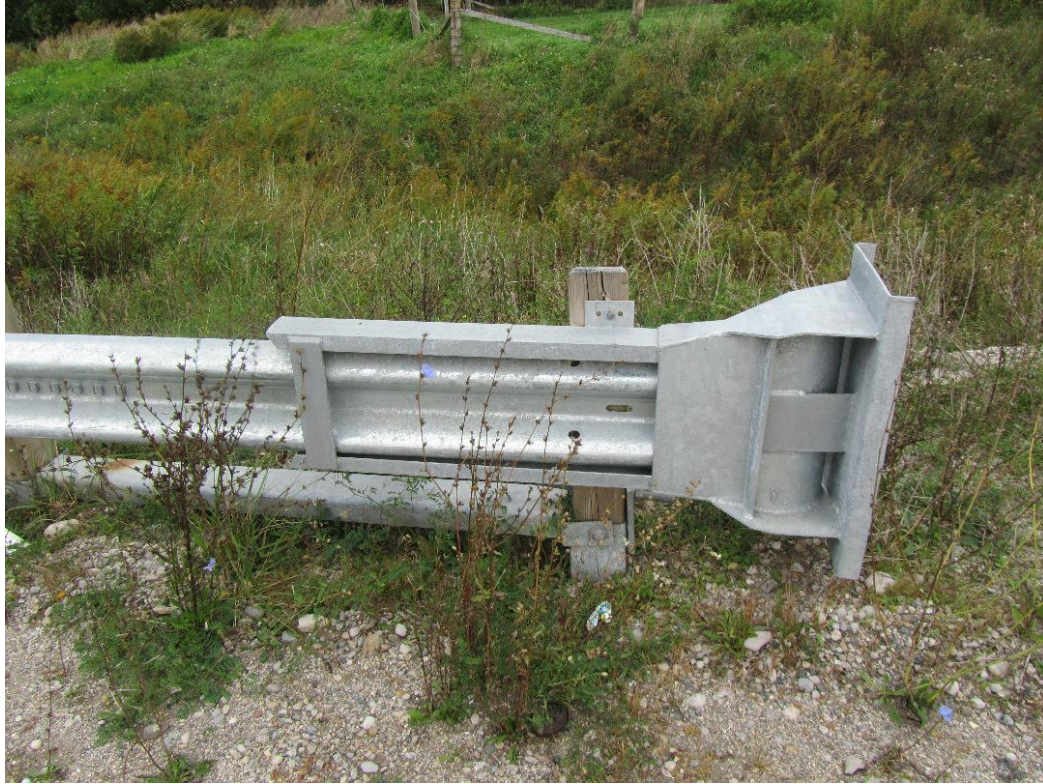
Figure 2: Side view from street.

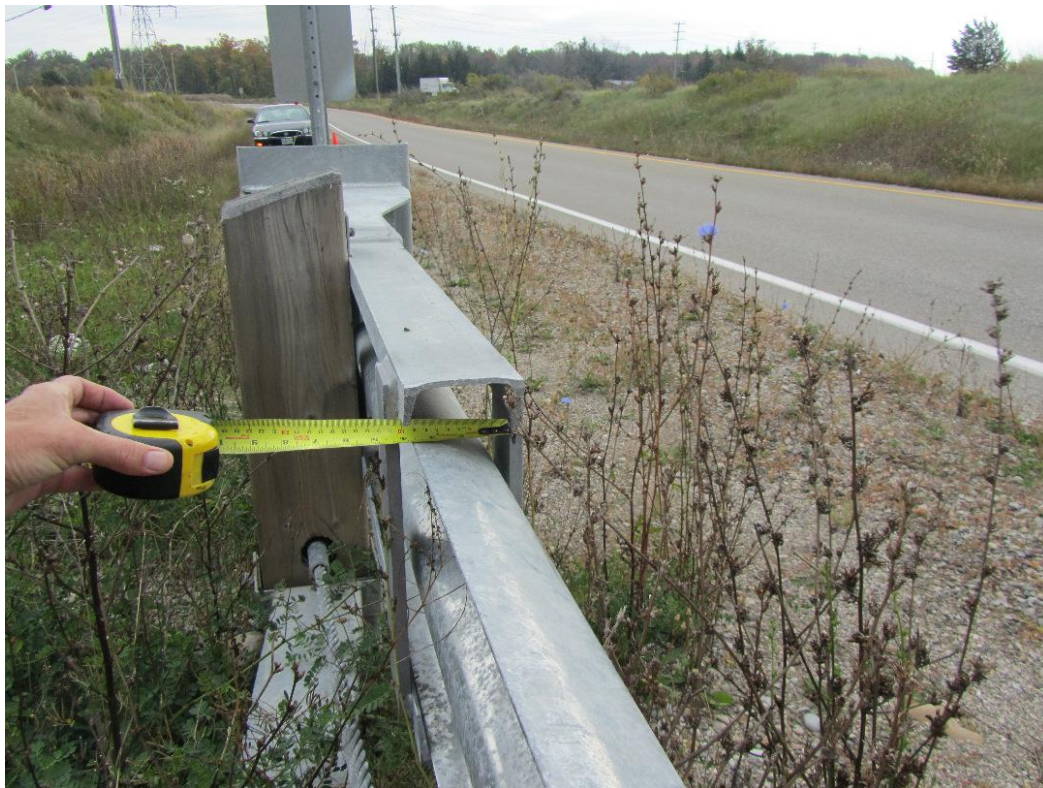
Figure 3: Measurement of channel indicating a width of 4 inches.

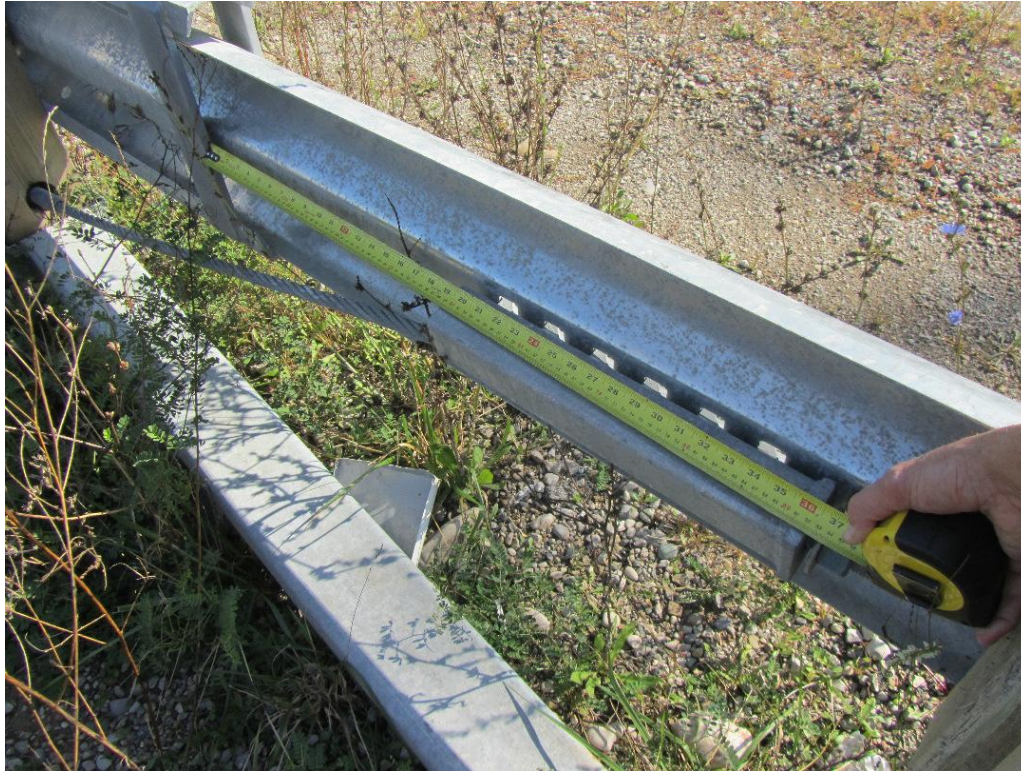
Figure 4: View of standard measurement being taken to identify the position of the end cap with respect to the guardrail.

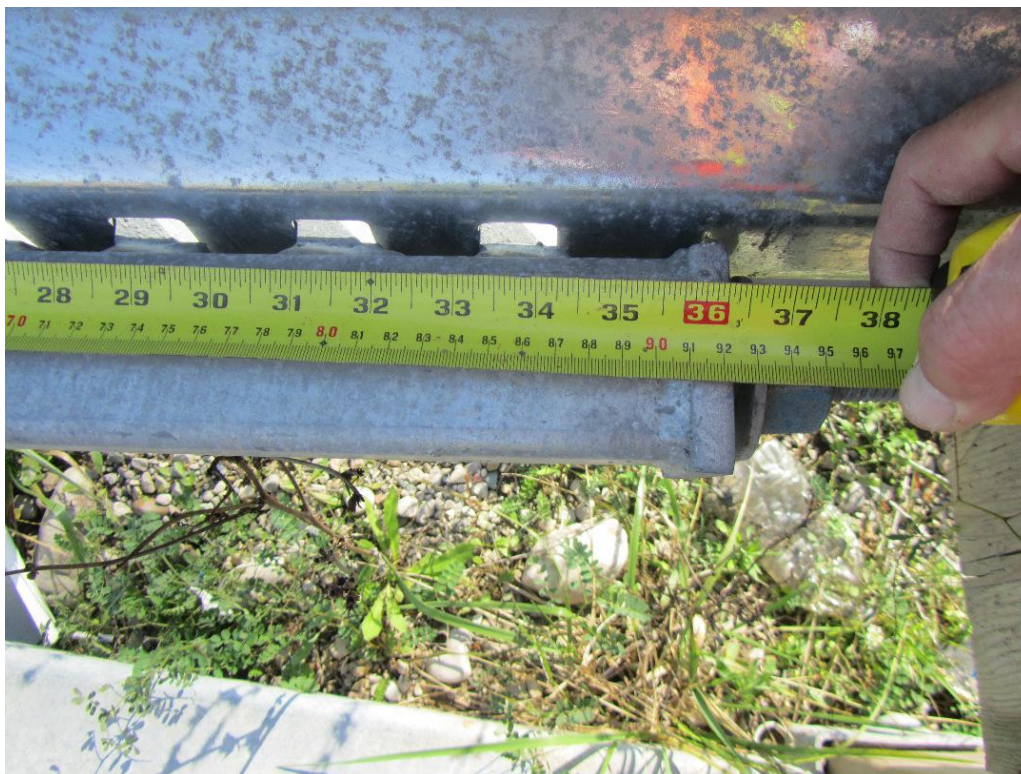
Figure 5: Result of standard measurement is about 36.25 inches.

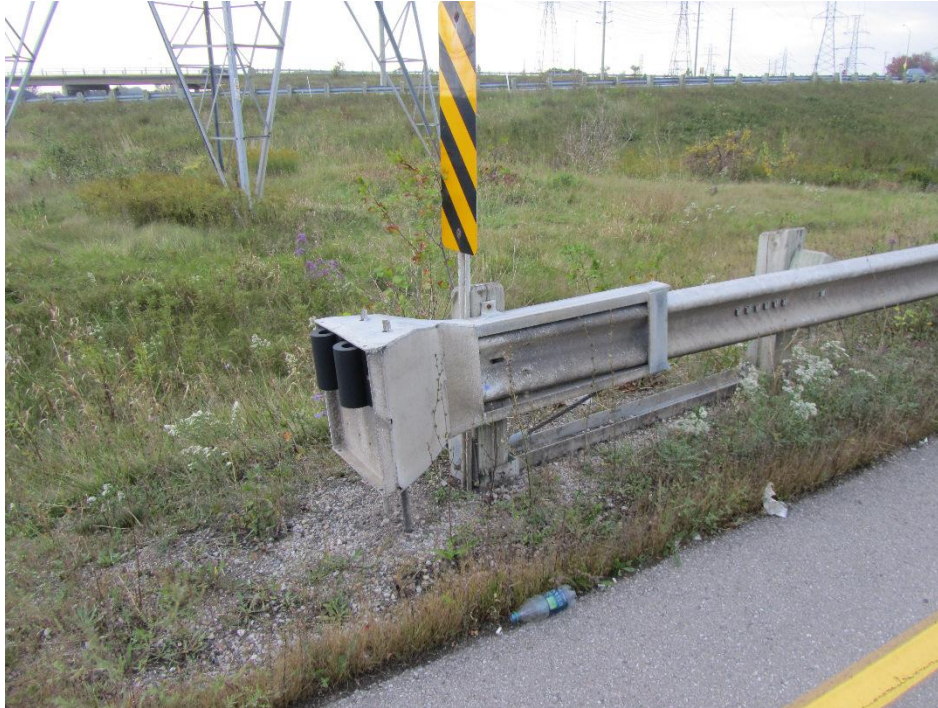
Figure 6: This is likely the original end cap. It is more square.

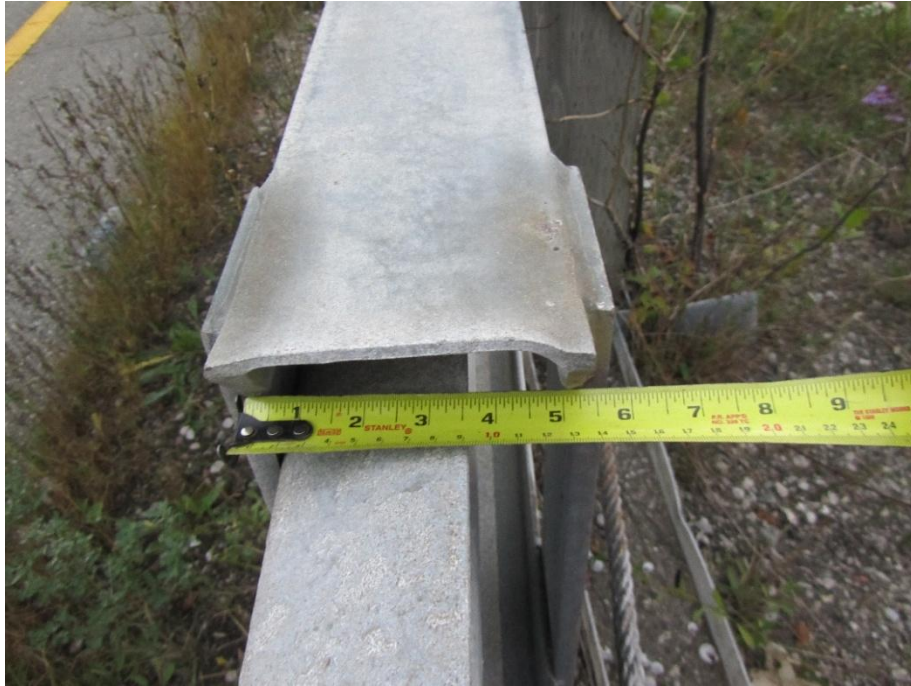
Figure 8: Measurement of channel indicating that it is 5 inches wide.

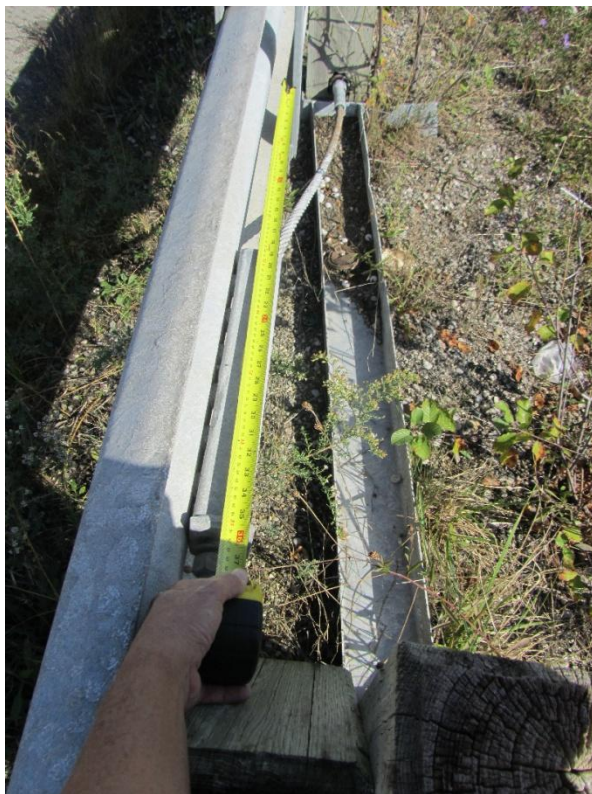
Figure 9: View of standard measurement being taken on the east guardrail.

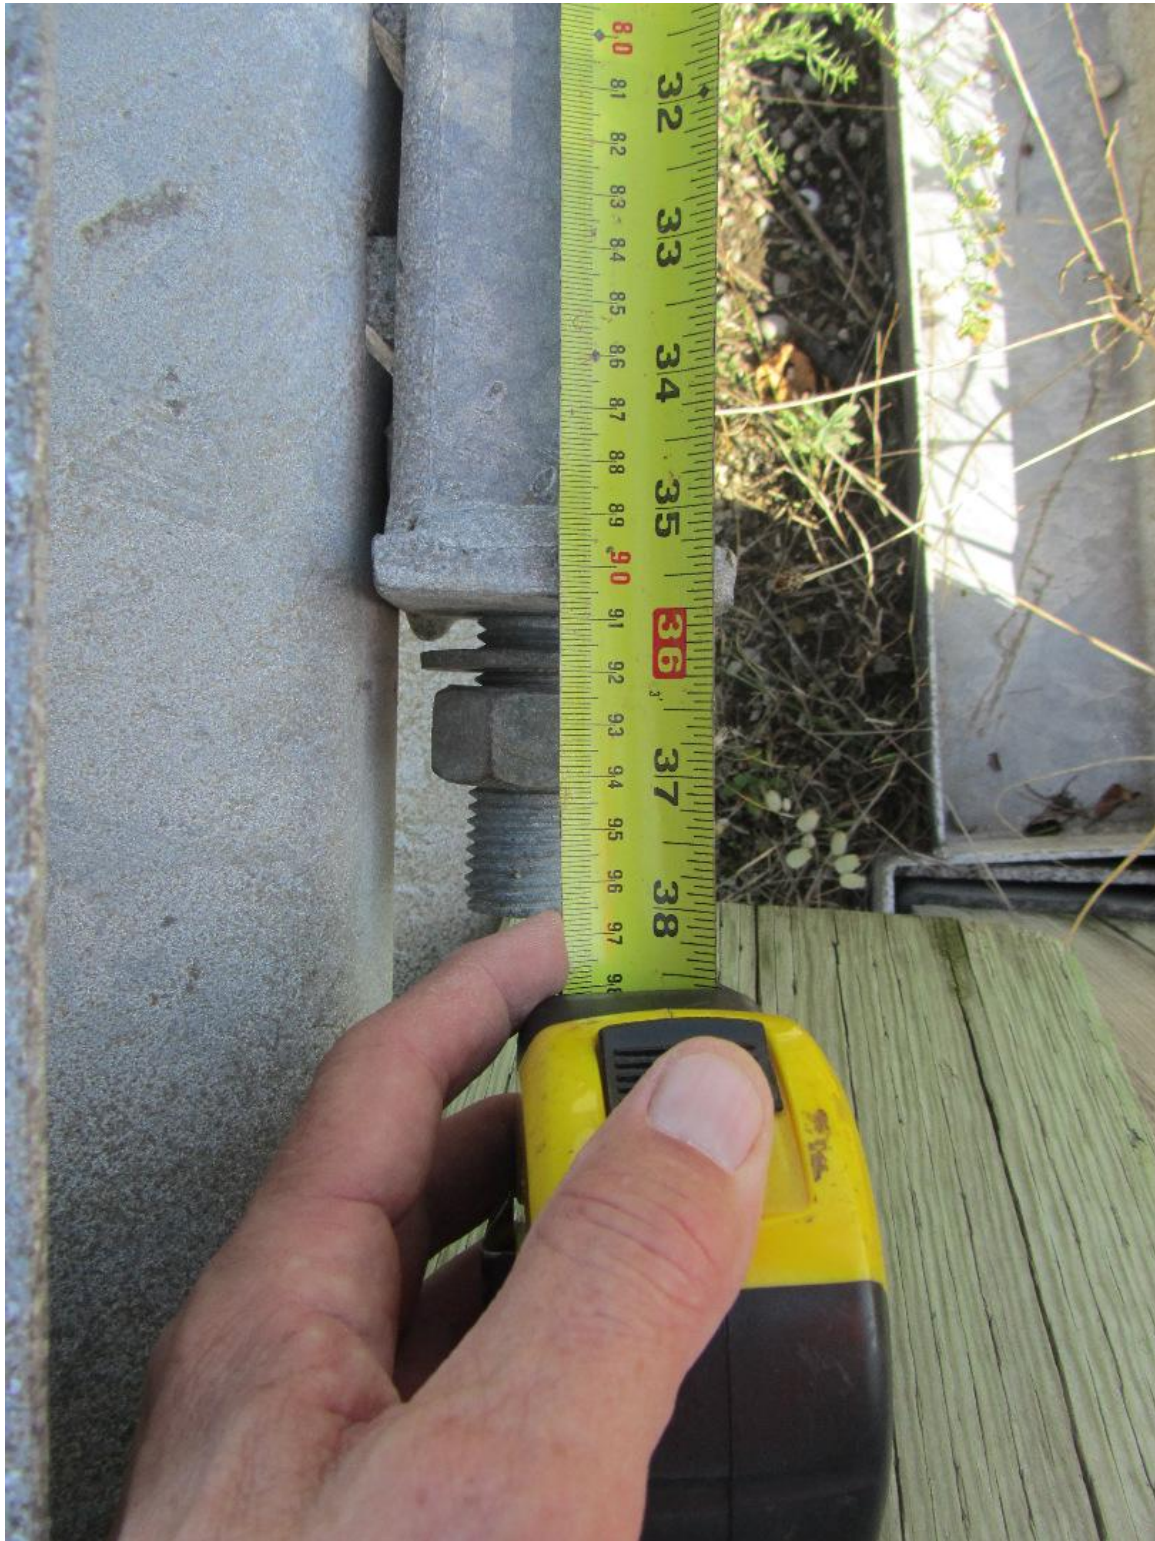
Figure 10: Result of standard measurement indicating a distance of 35.5 inches.

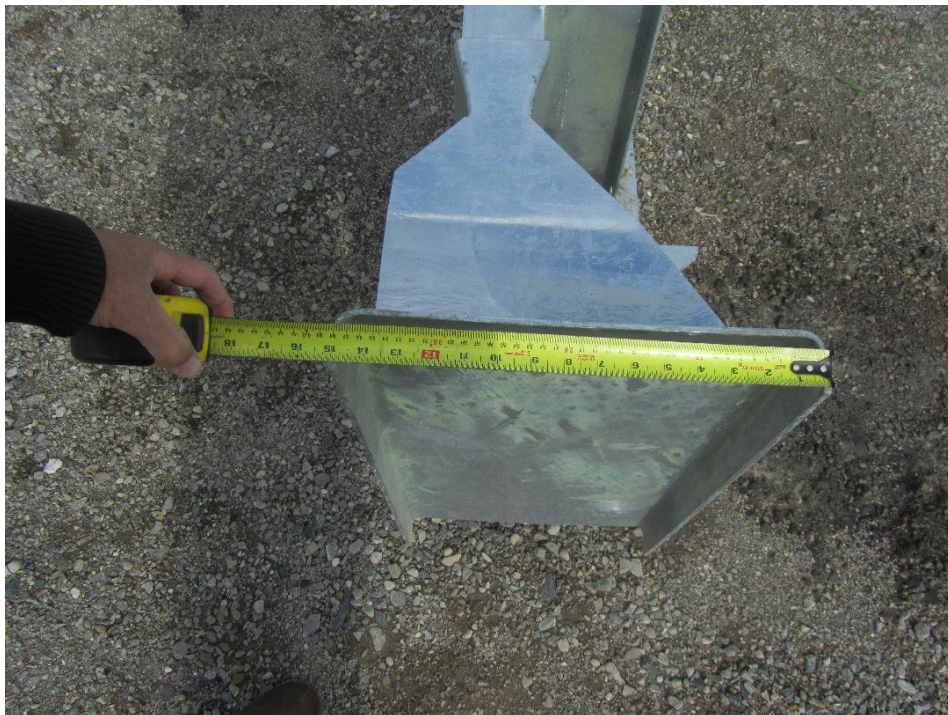
Figure 12: Measurement of front plate indicating a width of 15 inches.

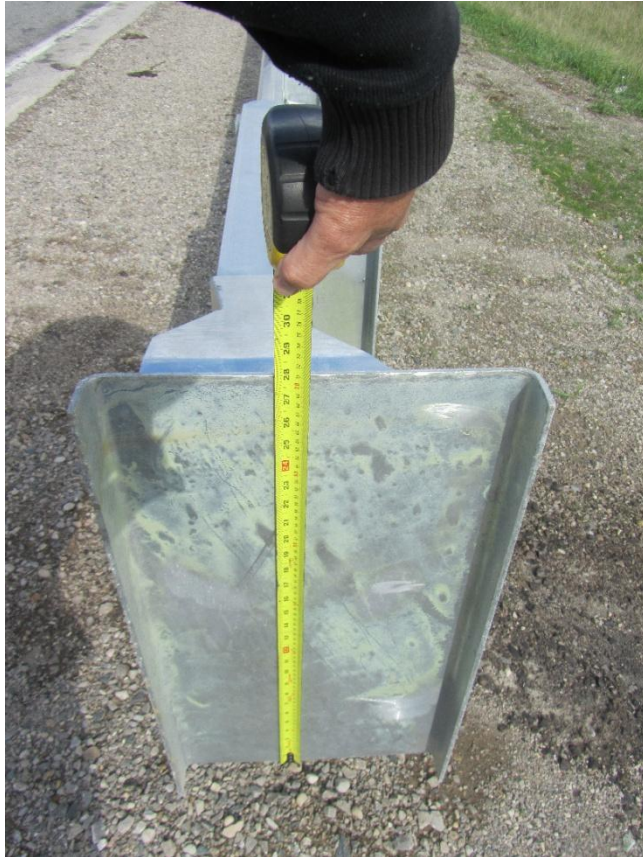
Figure 13: Measurement indicating the end plate height of 28 inches.

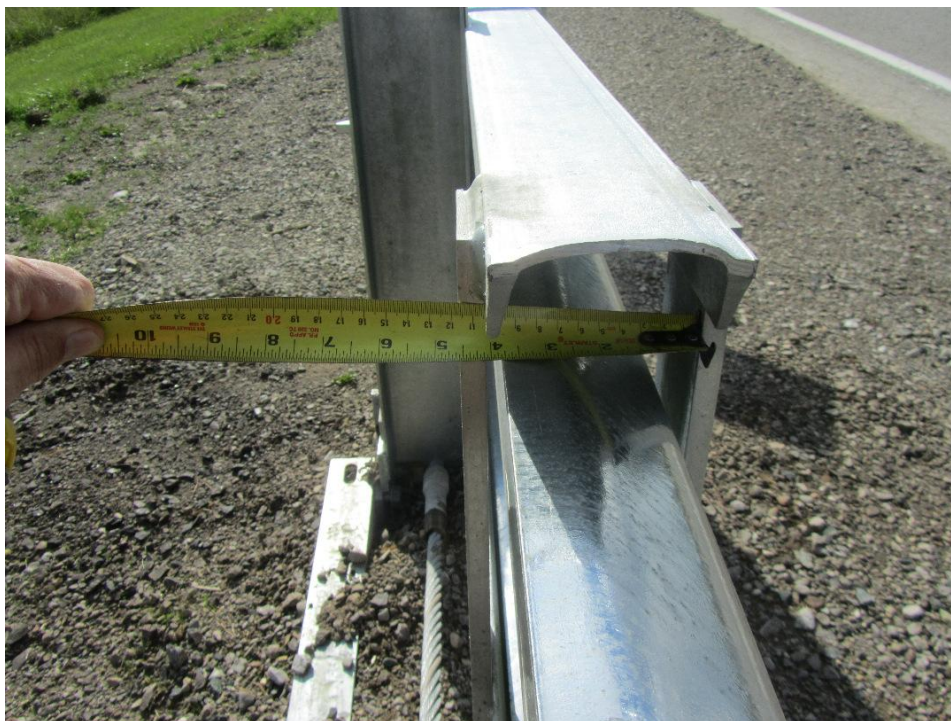
Figure 14: Measurement of channel indicating a width of 4 inches.

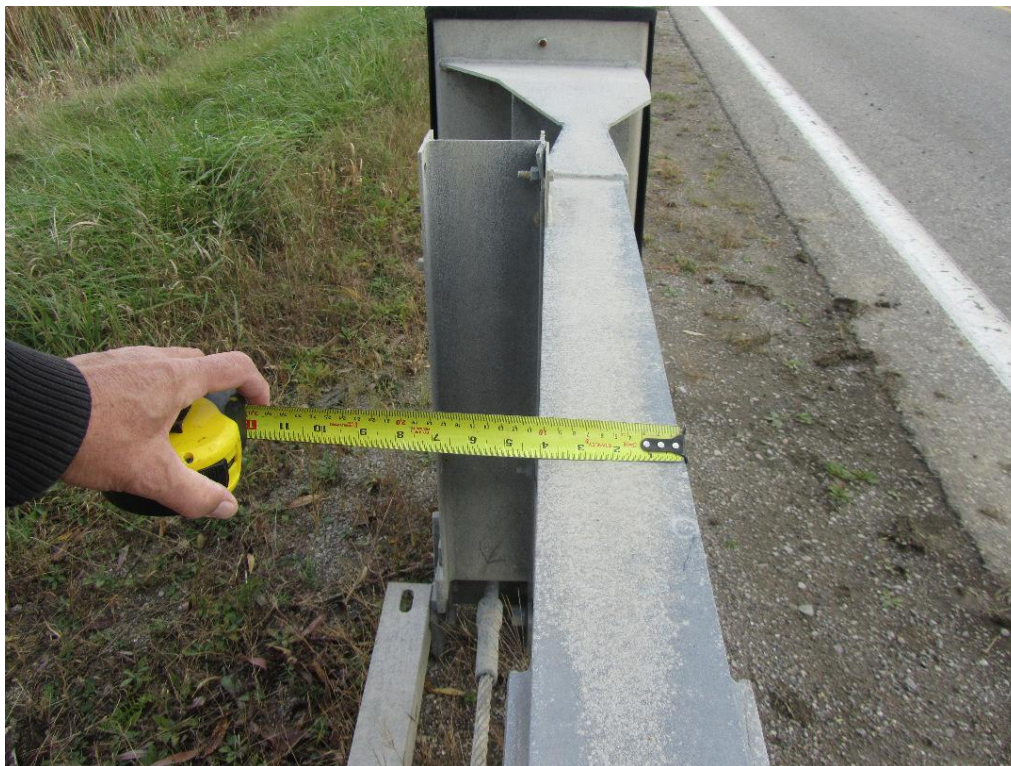
Figure 18: Measurement indicates the width of the channel is 4 inches.

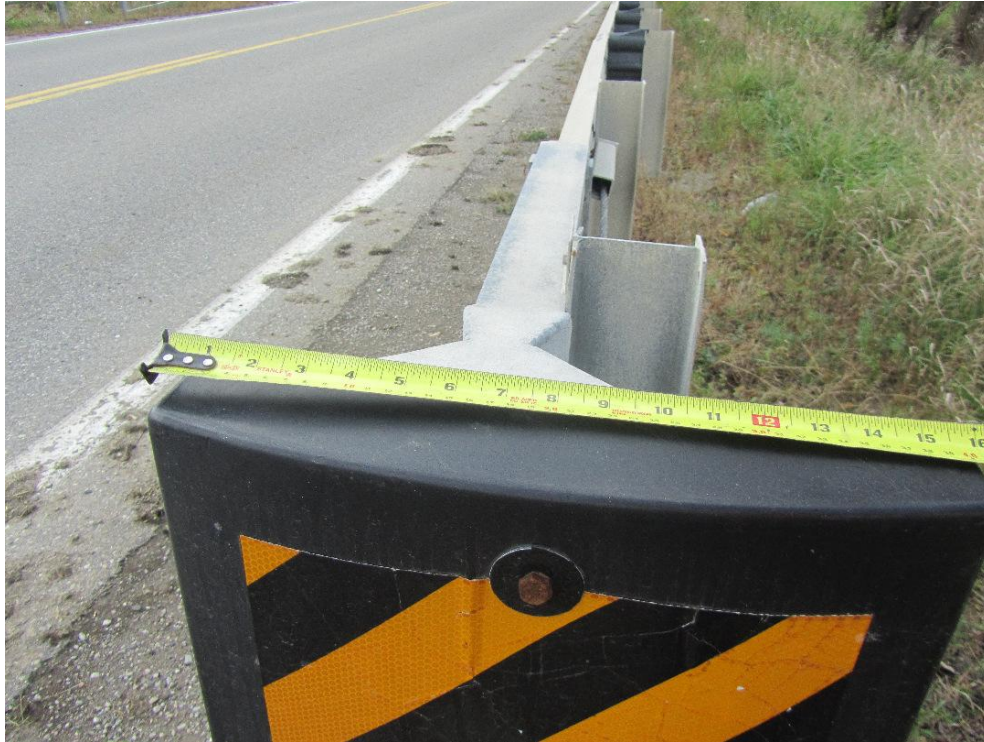
Figure 19: With the black cover attached the end plate is about 16 inches wide.

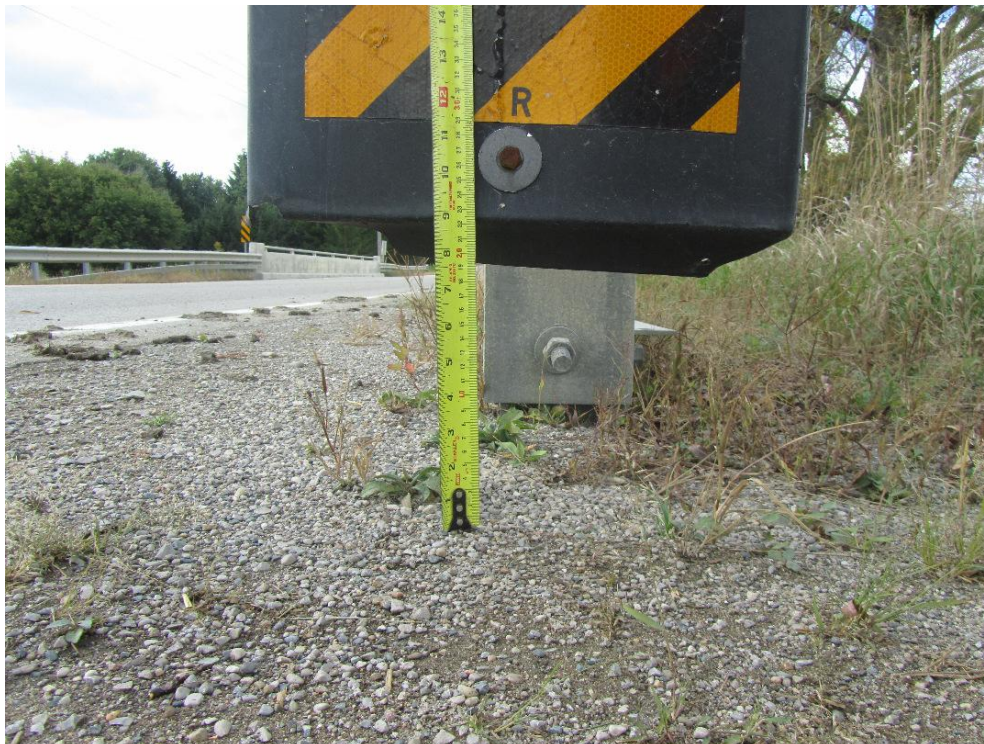
Figure 20: With the front cover attached the bottom of the end plate is about 9 inches above the ground.

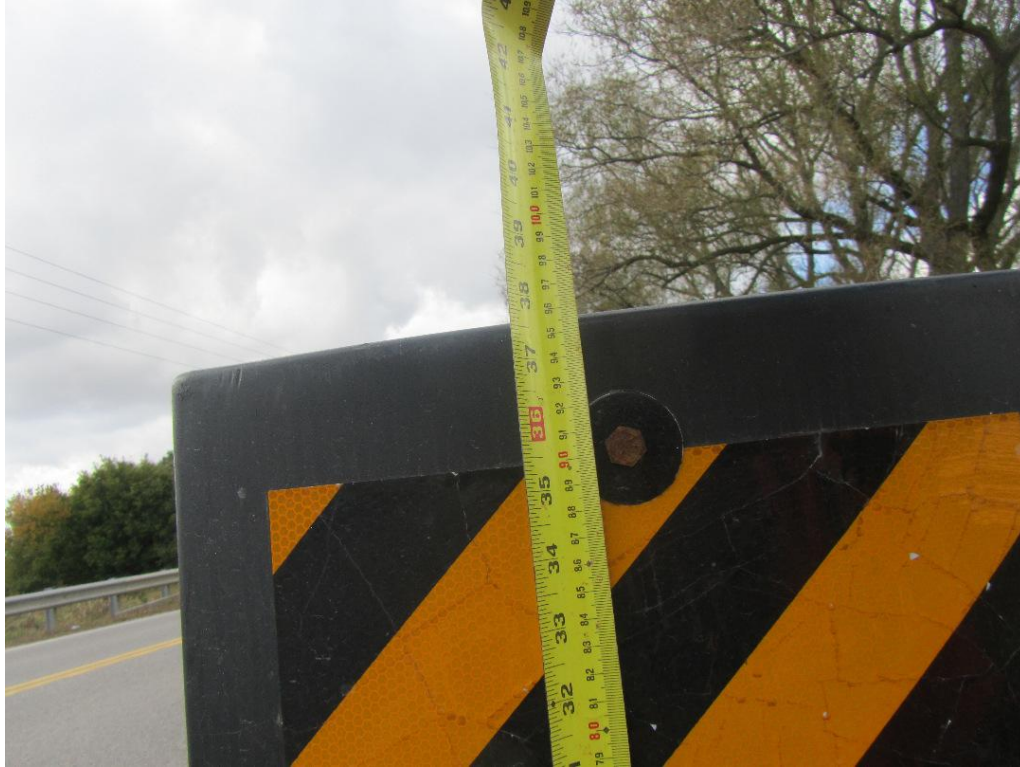
Figure 21: With the black cover attached the end plate is about 37.5 inches above the ground, thus the height of the black cover is about 28.5 inches tall.

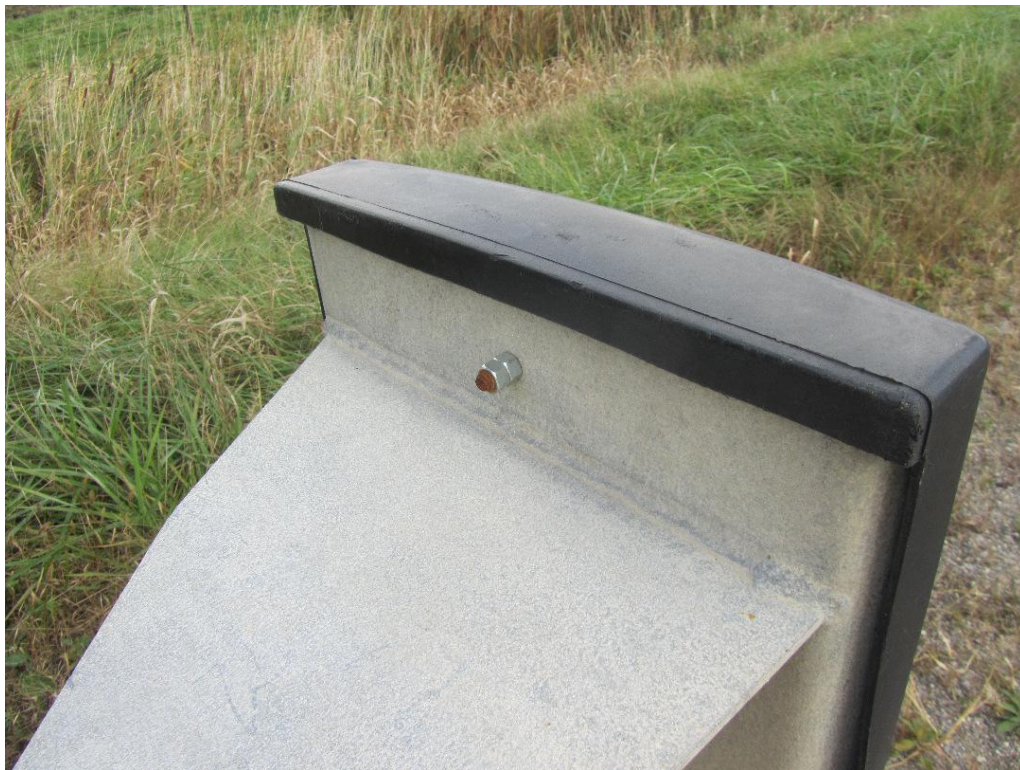
Figure 22: Efforts to secure the black cover to the end plate are evident here as a bolt holds the cover to the plate.

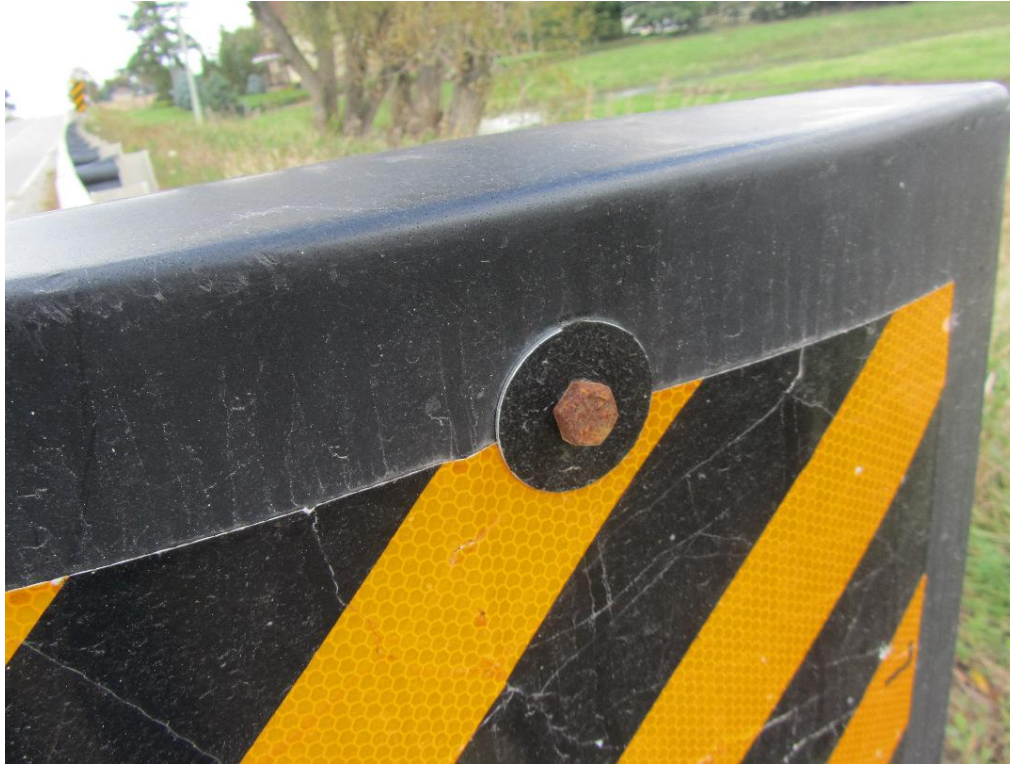
Figure 23: A bolt is used to fasten the black cover to the end plate.

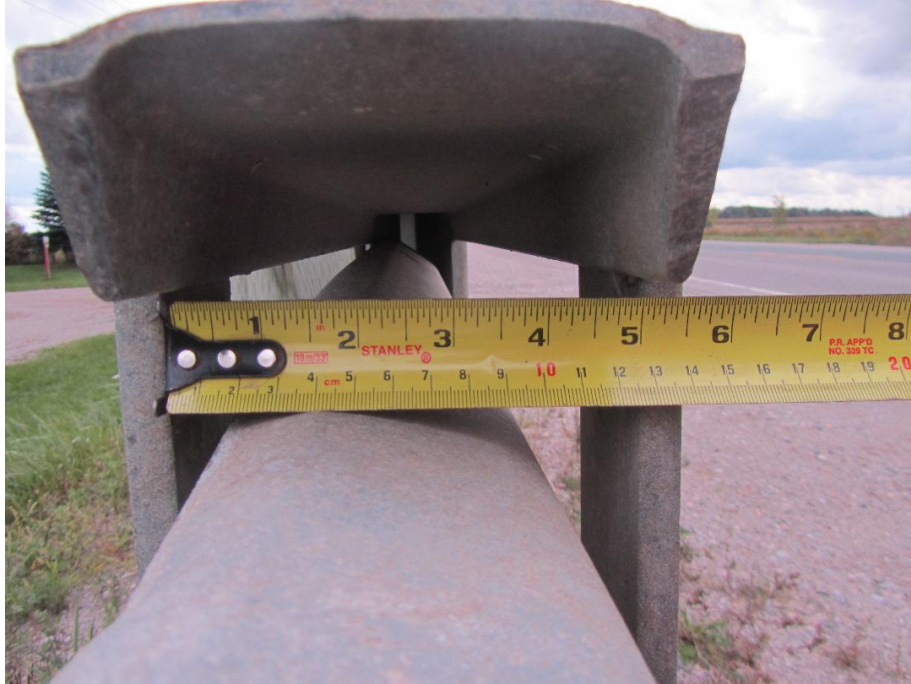
Figure 27: Measurement indicates the channel is 5 inches wide.

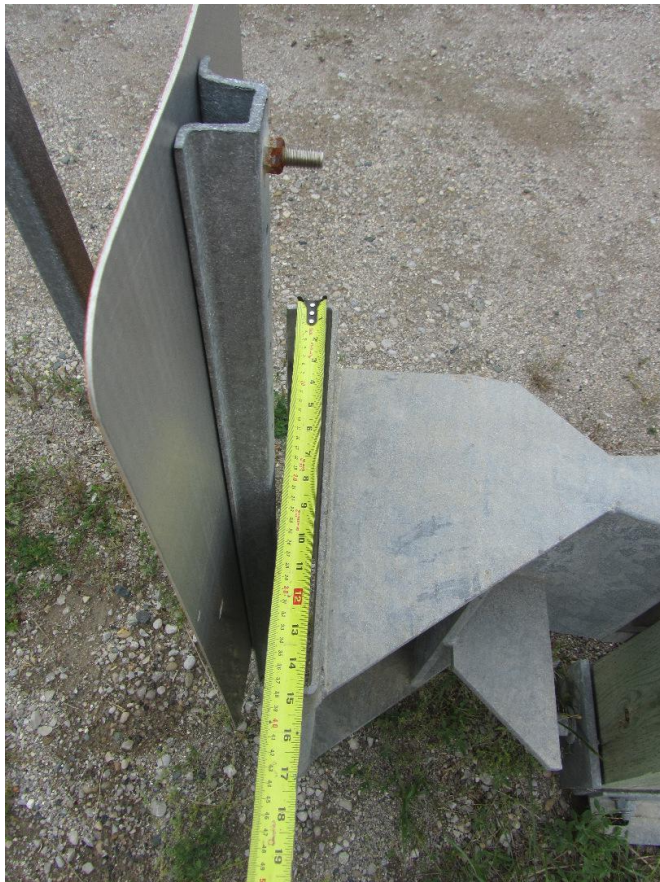
Figure 28: Without the black cover the end plate is about 15 inches wide.

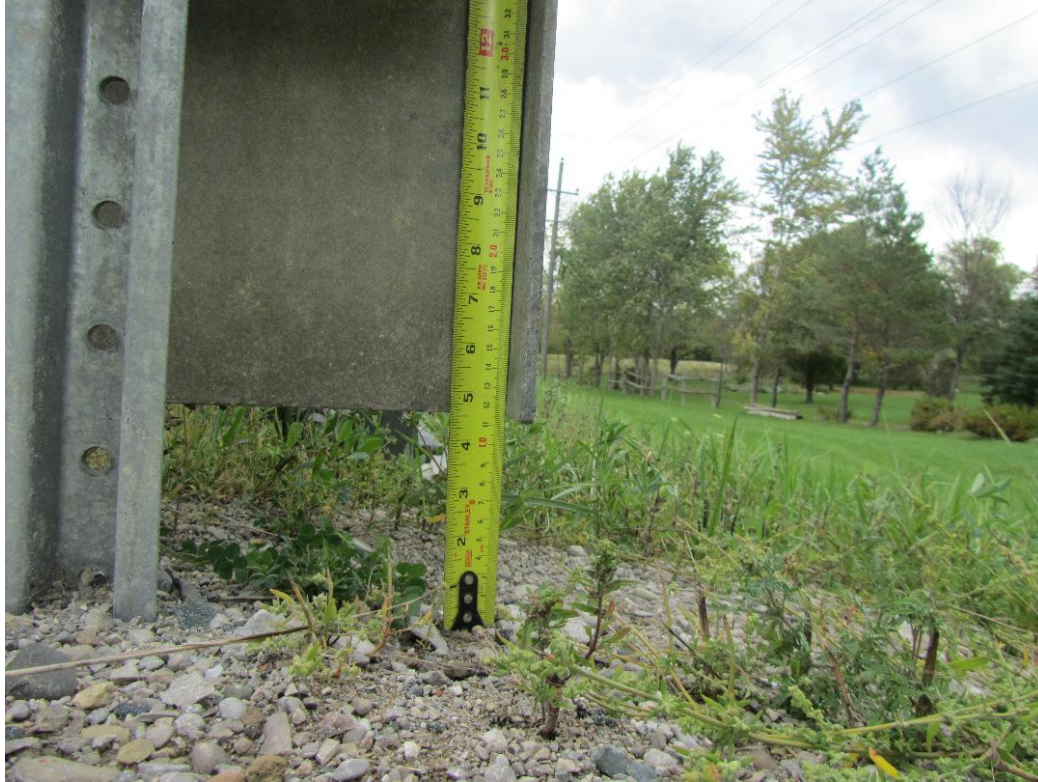
Figure 29: The base of the end plate is just slightly less than 5 inches above the ground.

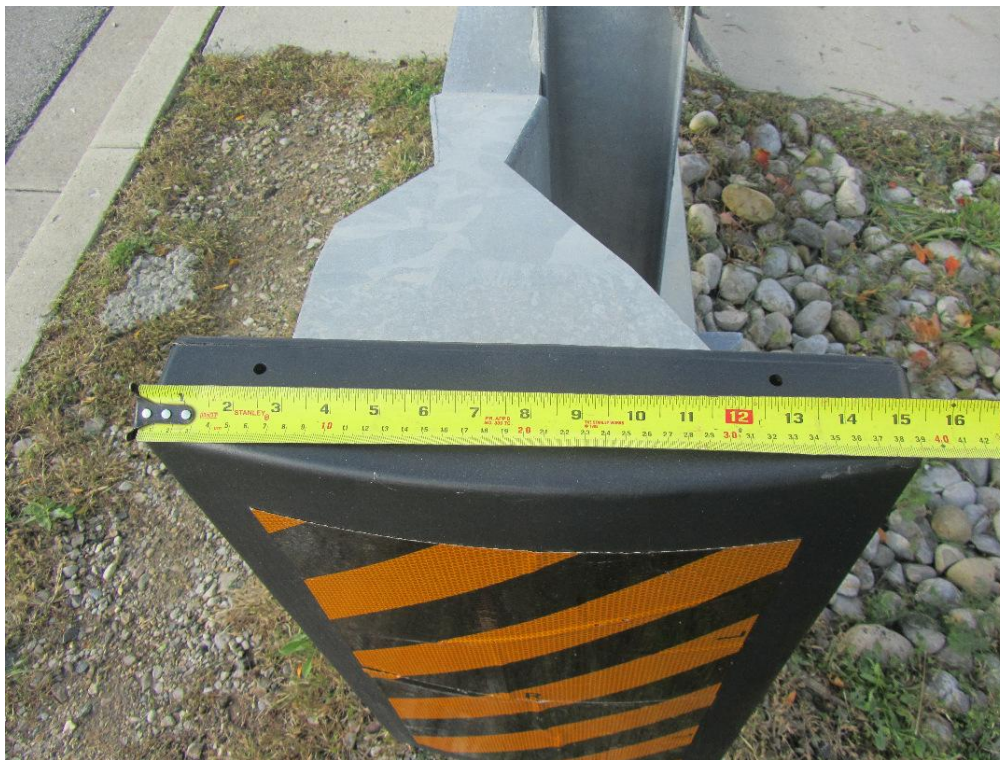
Figure 34: The black cover of the end plate is just over 15 inches wide.

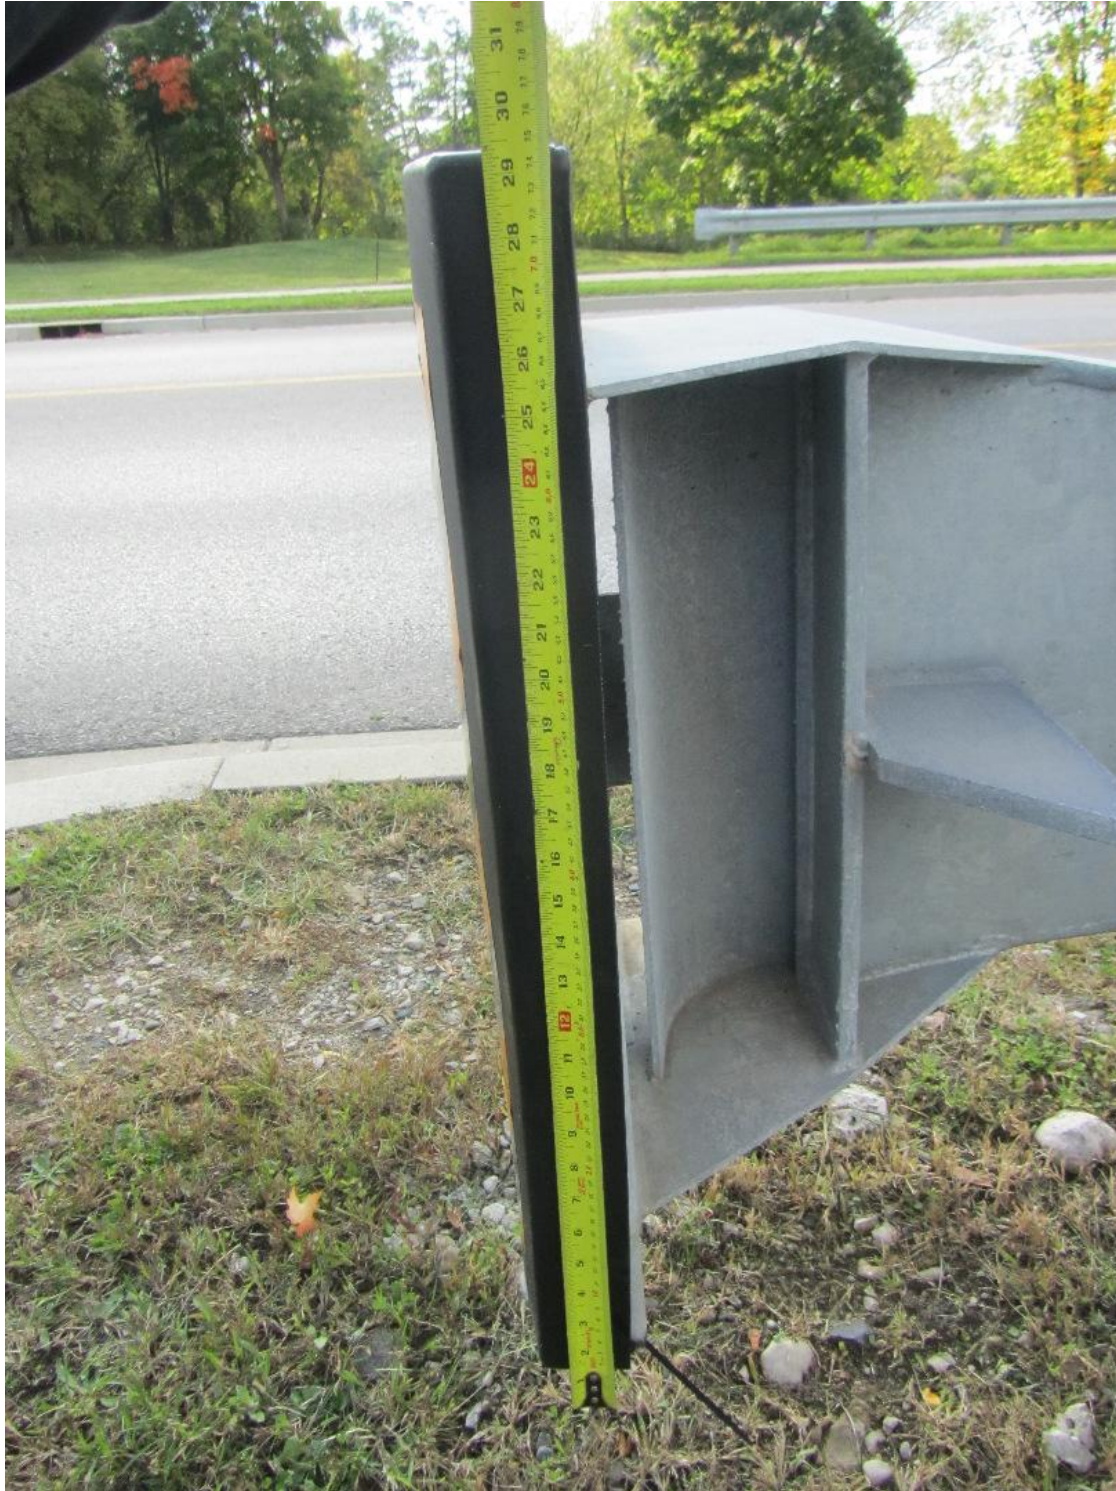
Figure 35: The black cover is slightly taller than 28 inches.

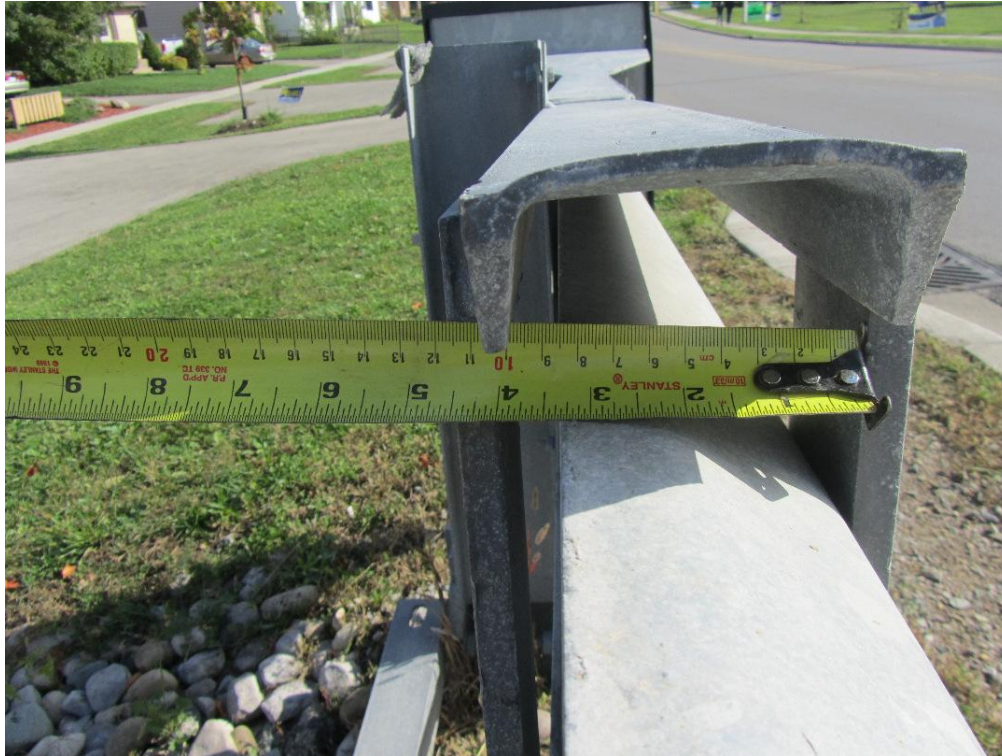
Figure 36: The channel is 4 inches wide.

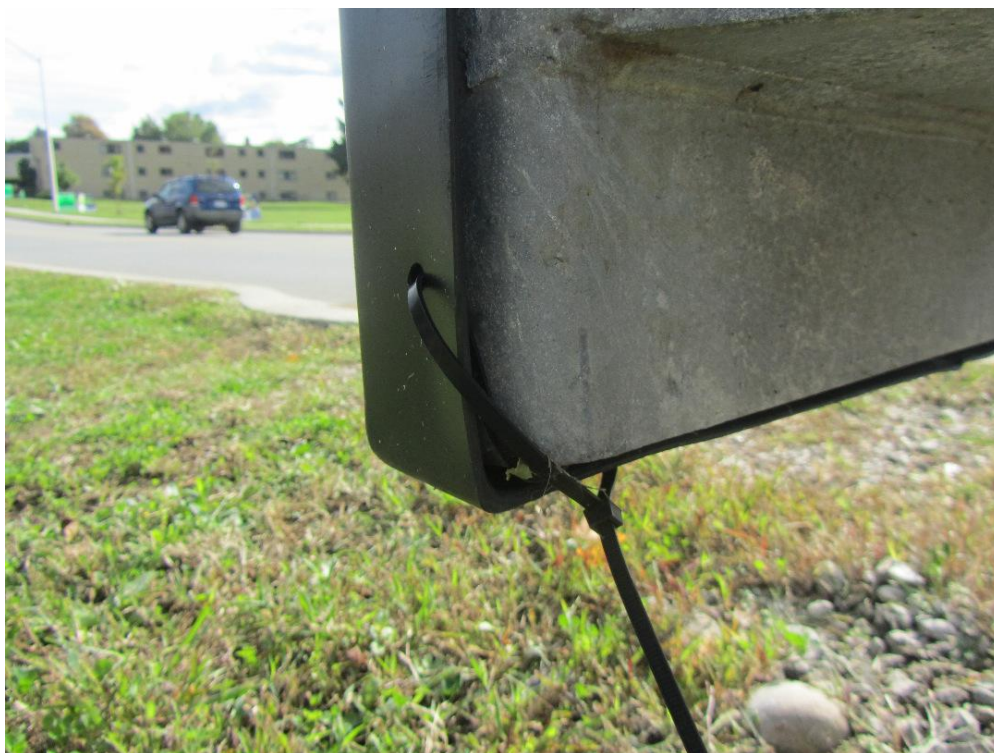
Figure 37: View of plastic tie used to secure the black plastic cover to the end plate.

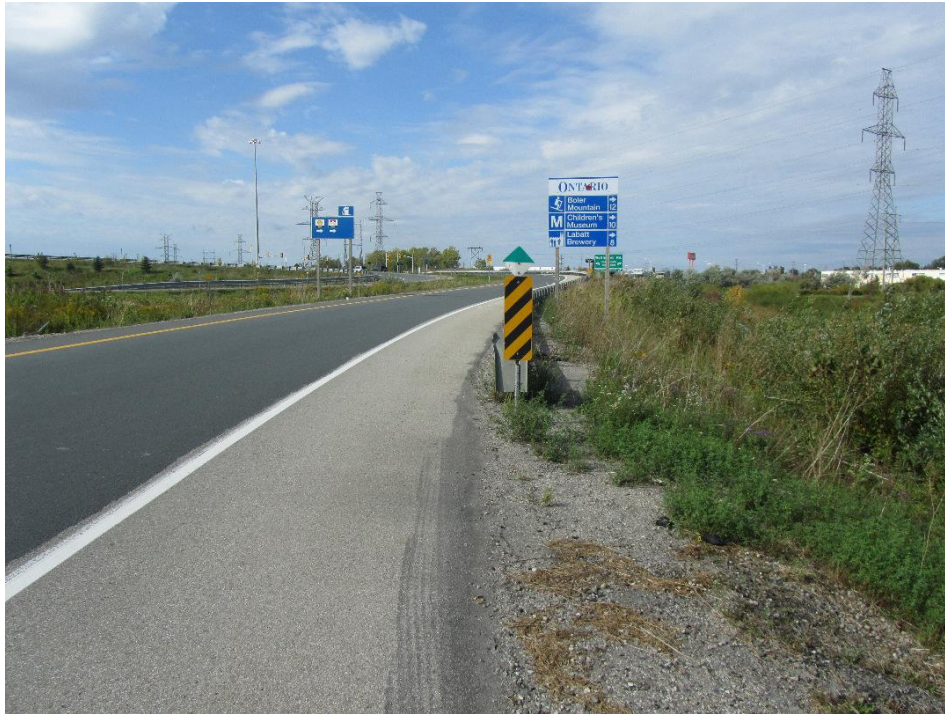
Figure 38: Overall view of hazard marker in front of guardrail end cap.

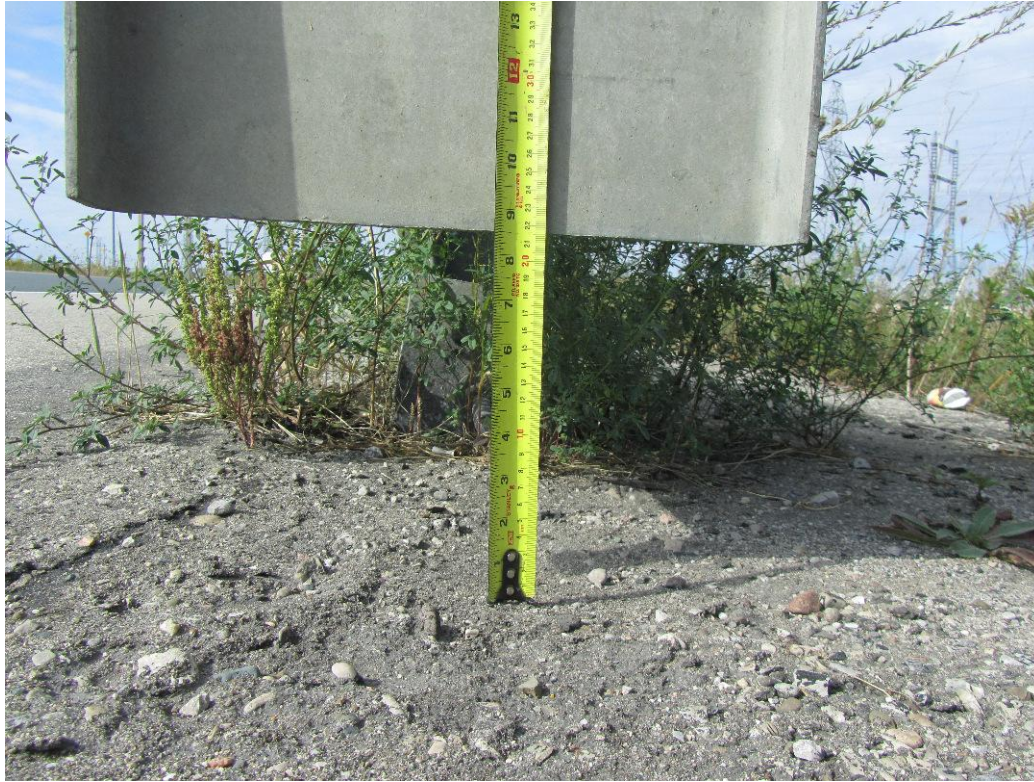
Figure 42: Base of end plate positioned about 8.5 inches above the ground.

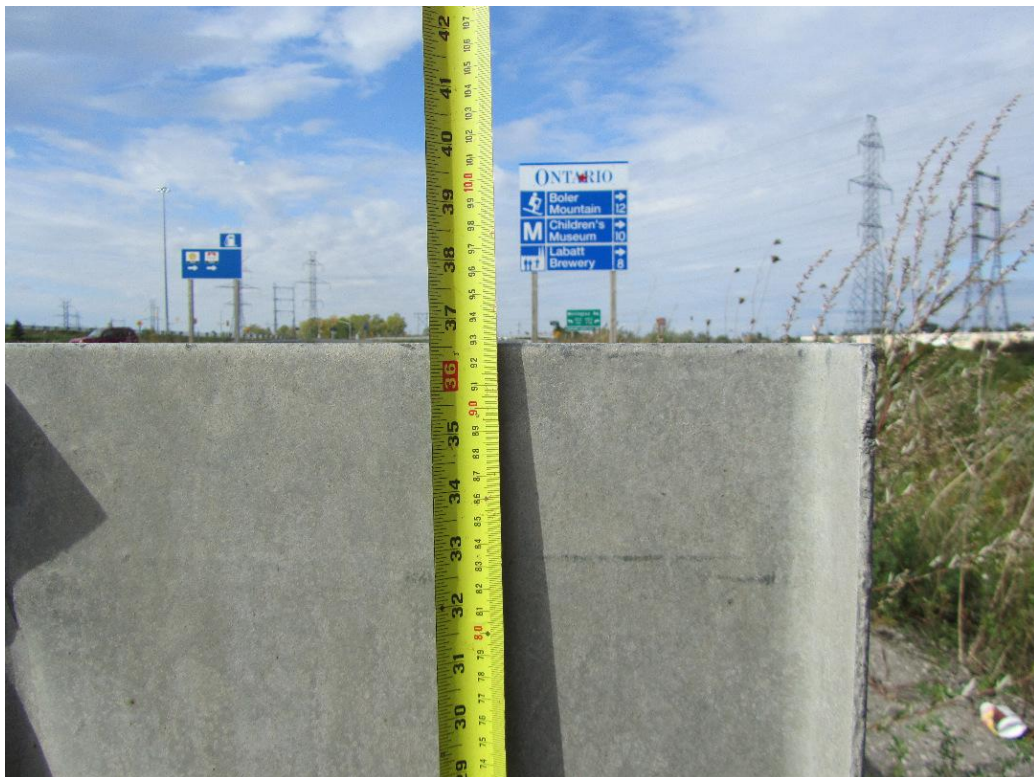
Figure 43: Top of end plate positioned 36.5 inches above the ground, thus the end plate is 28 inches tall.

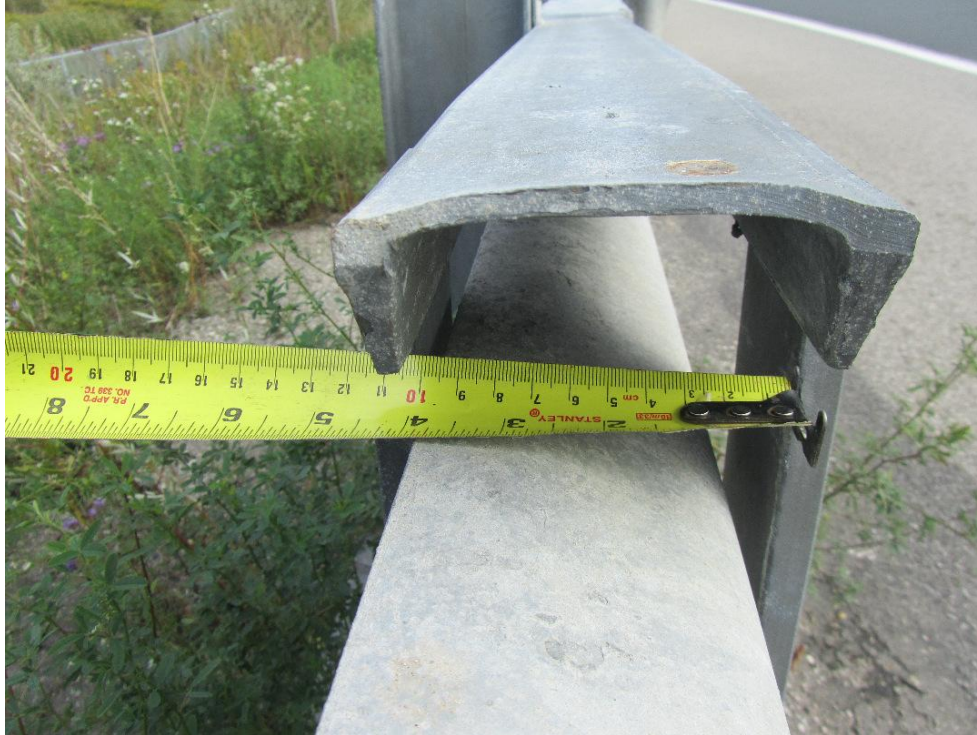
Figure 44: Measurement indicating the channel is 4 inches wide.

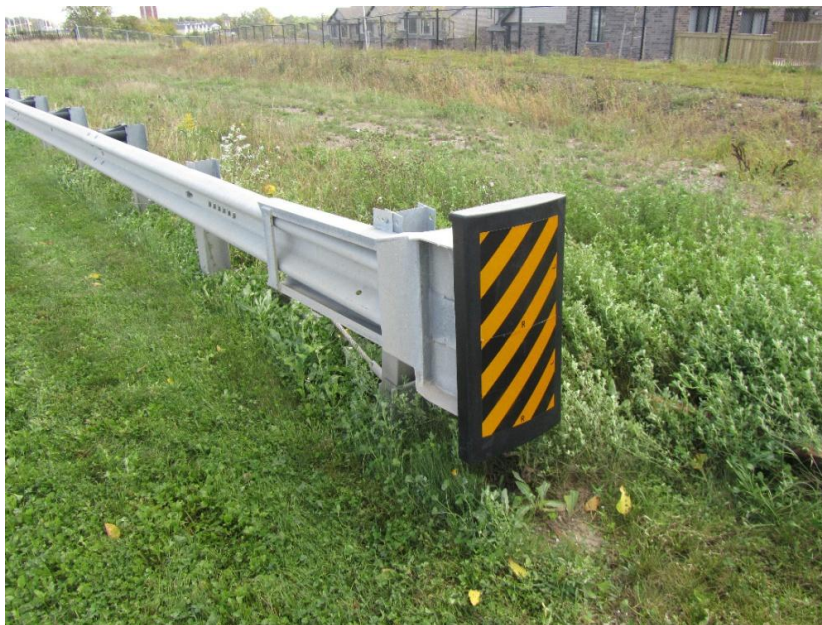
Figure 45: View of west end cap on south guardrail of Sarnia Road.
