Trinity Guardrail End Caps In & Near London Ontario - Survey of Locations & Condition

Posting Date: 09-Oct 2014

Survey of Trinity End Cap Location & Condition

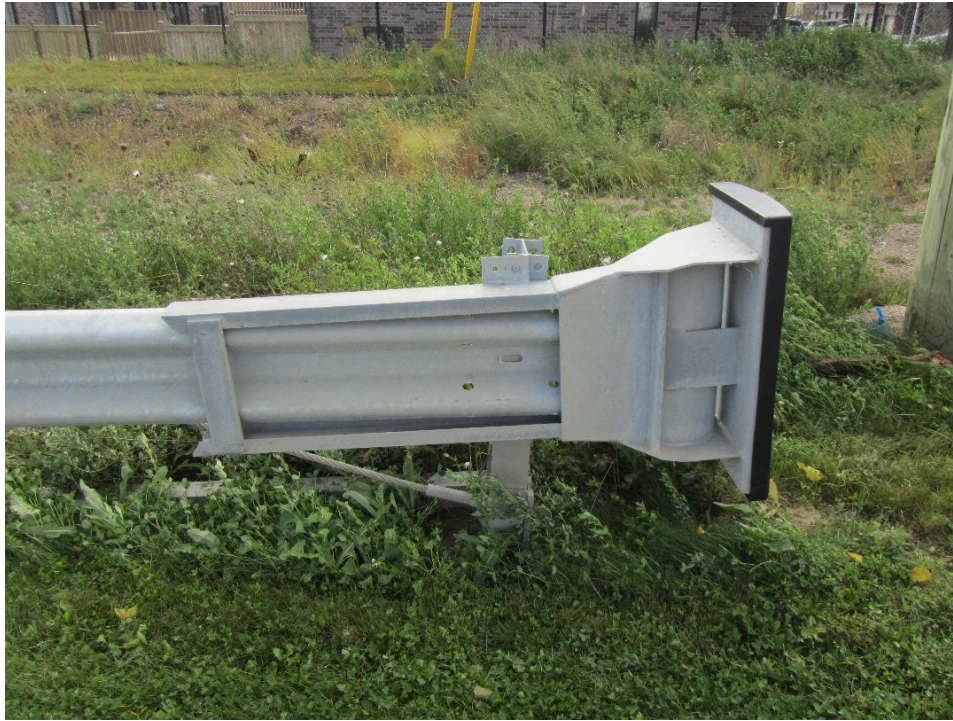
Figure 46: Street view of channel and end plate.

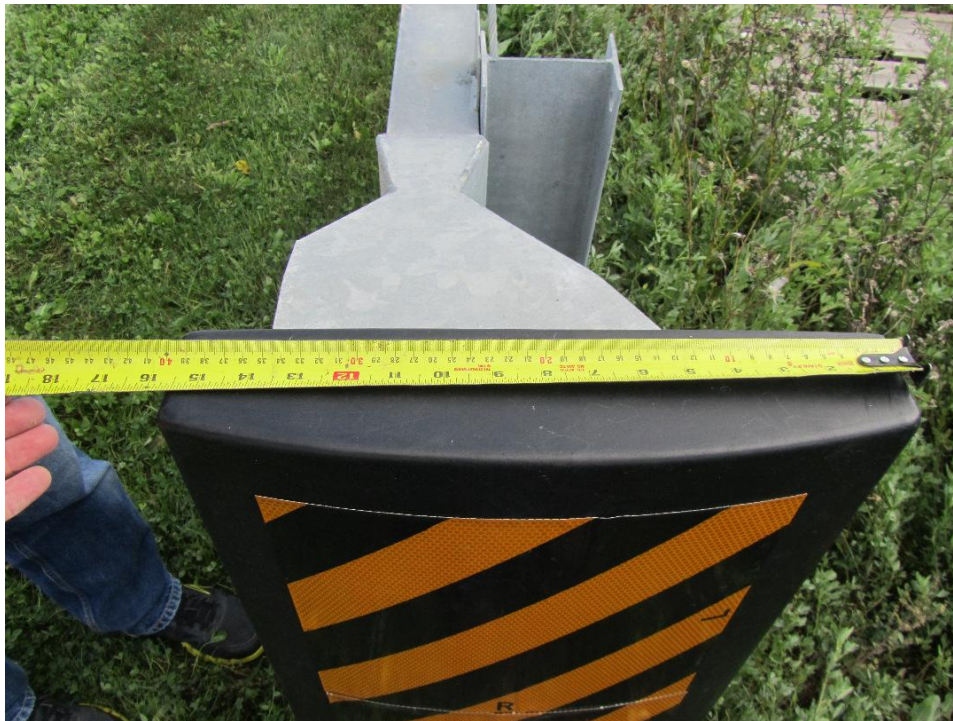
Figure 47: Width measurement (15.5 inches) of end plate cover which is consistent with measurements of other covers

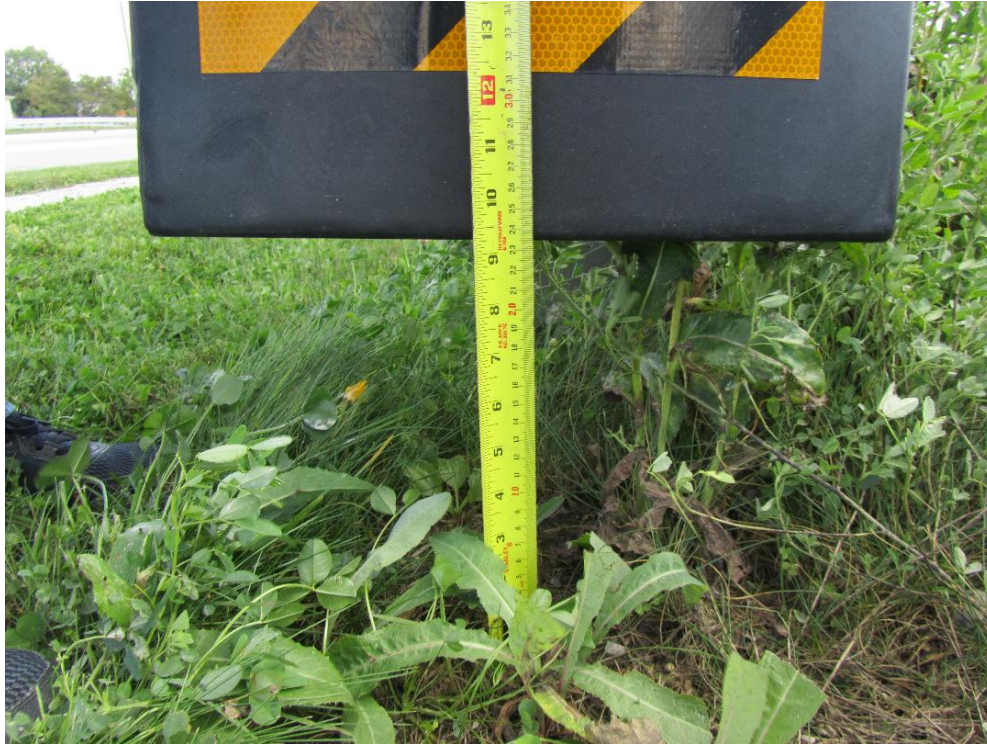
Figure 48: Measurement indicating that the base of the end plate cover is about 9.5 inches above the ground.

In a number of installations we have observed some minor differences in the installation height of the end plate and the vertical angle of the plate with respect to the length of the rail and how high the rail rests within the channel. All these minor alterations may be of little consequence to the system's performance, however, we simply do not know.

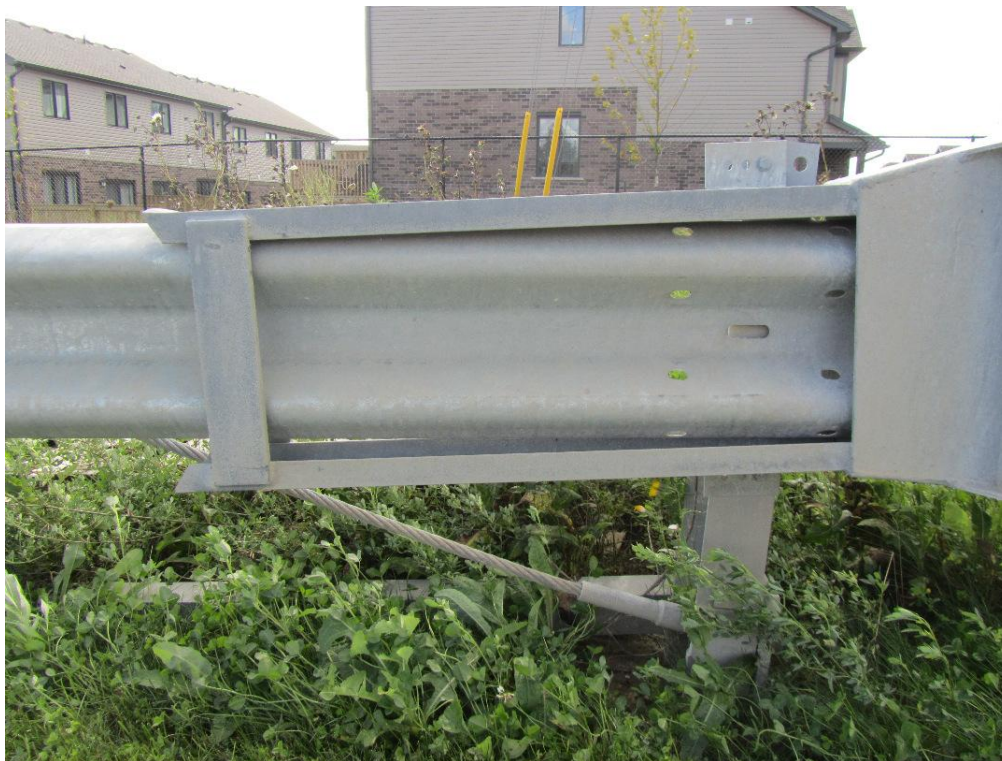
Figure 49: Closer view of channel and guardrail beam noting that they are not in vertical alignment.

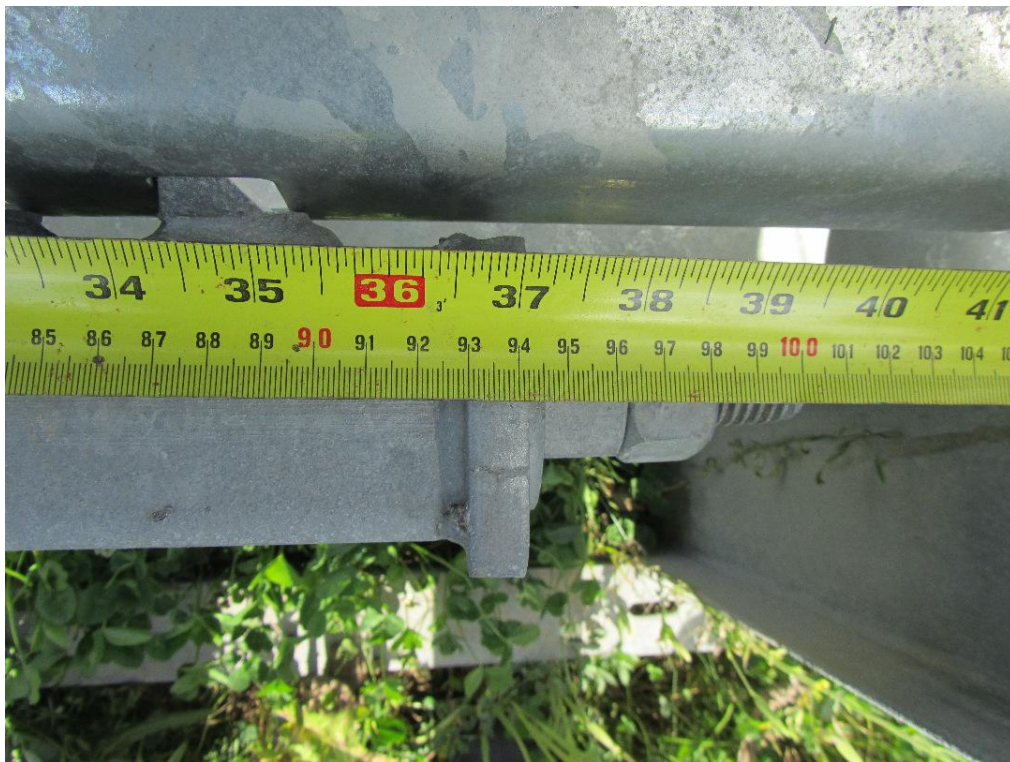
Figure 51: Close-up view showing standard measurement of just over 37 inches.

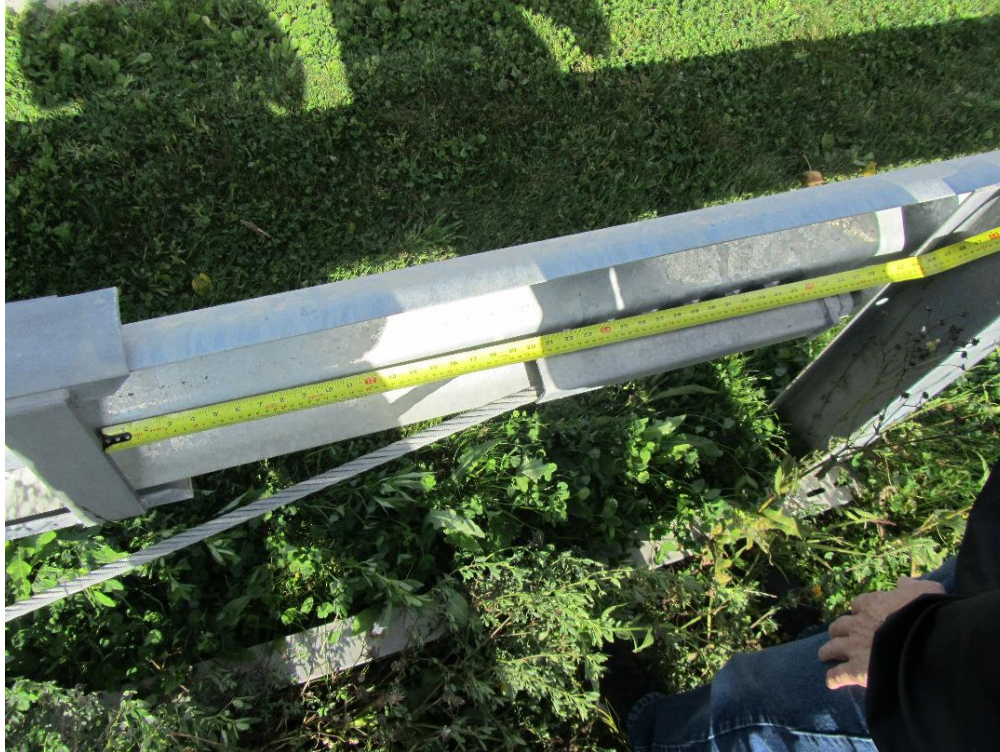
Figure 52: View of standard measurement being taken to document position of the end cap.

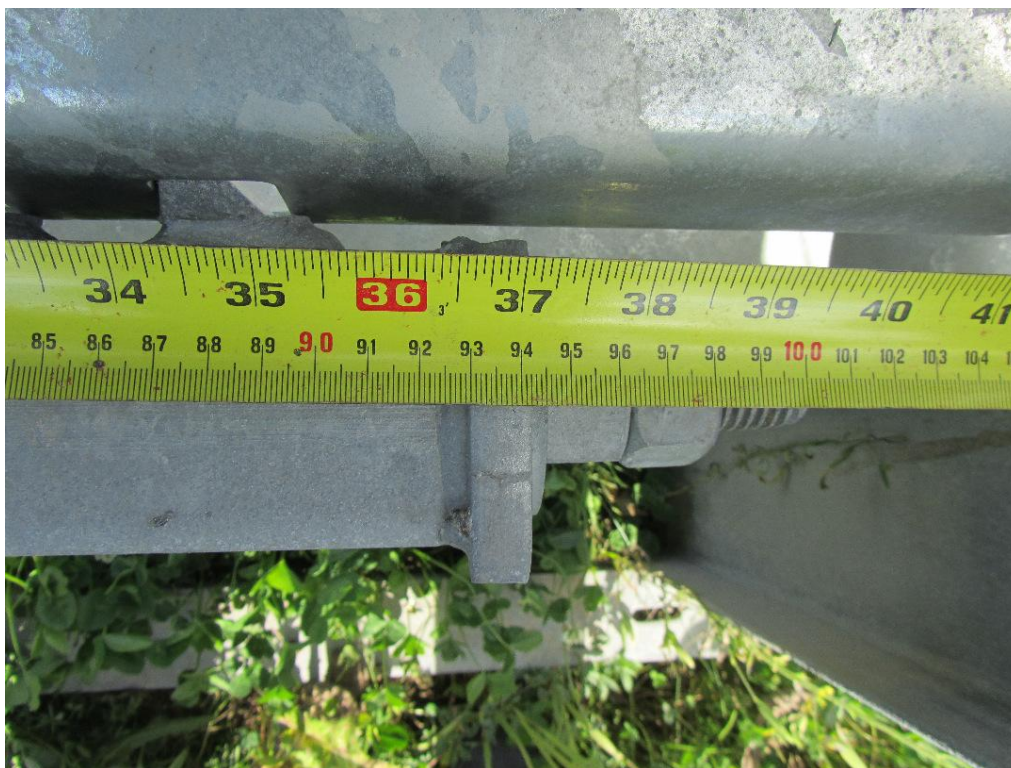
Figure 53: Result of standard measurement indicating a distance of 37.25 inches.

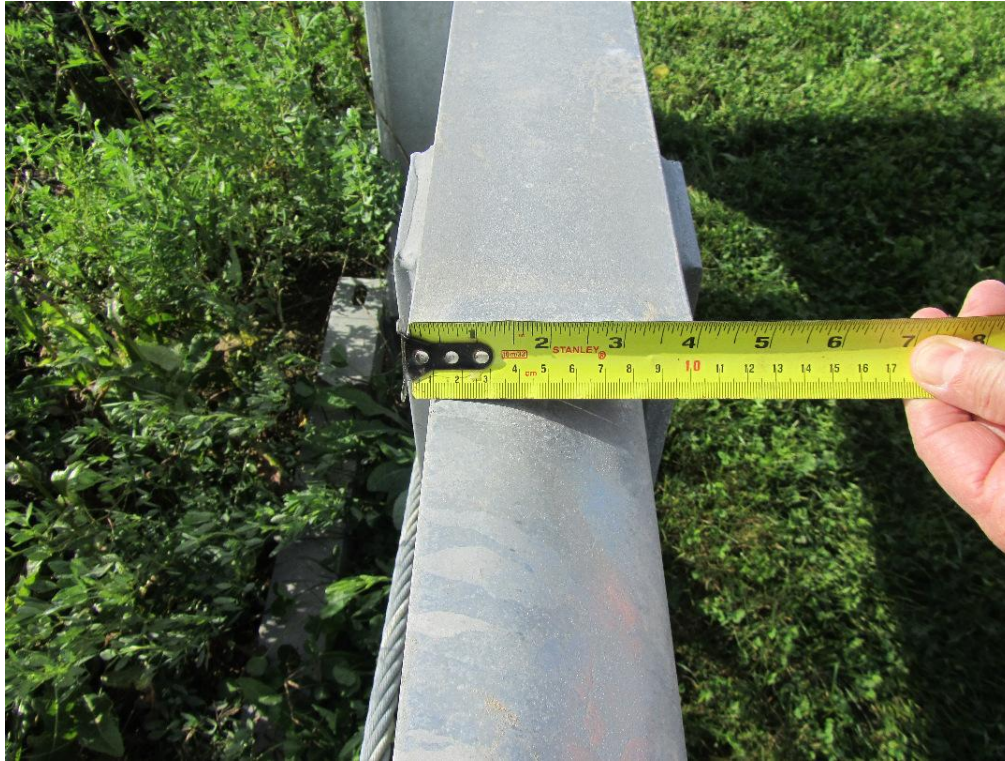
Figure 54: Measurement indicating a 4 inch wide channel.

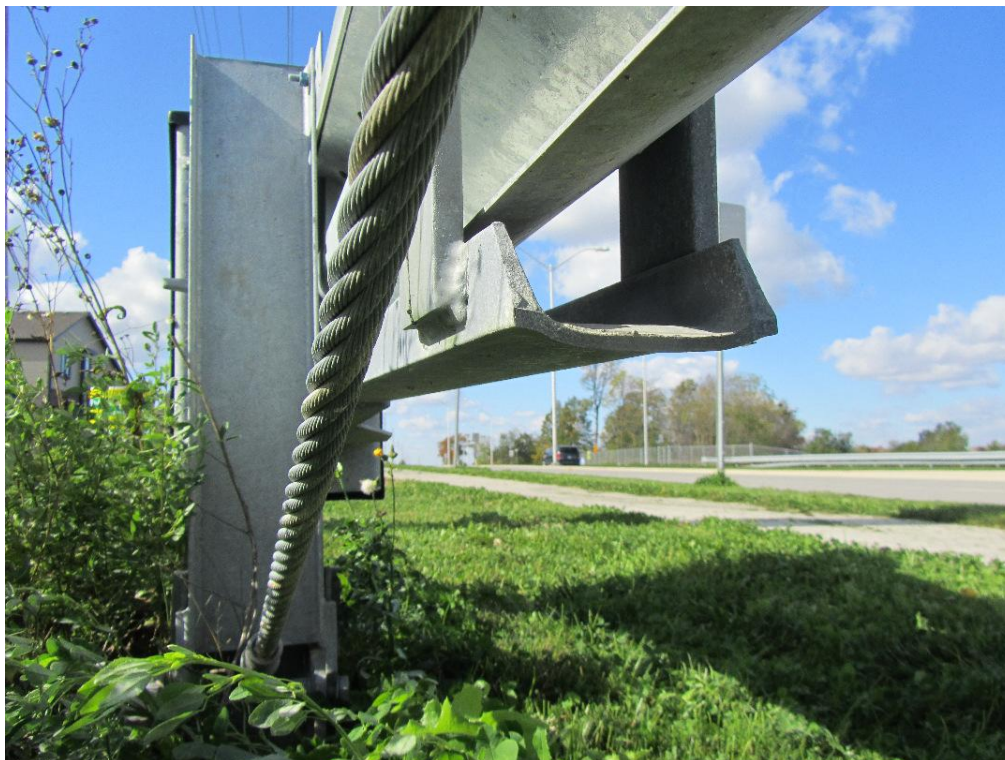
Figure 55: View showing the rail positioned high within the channel.

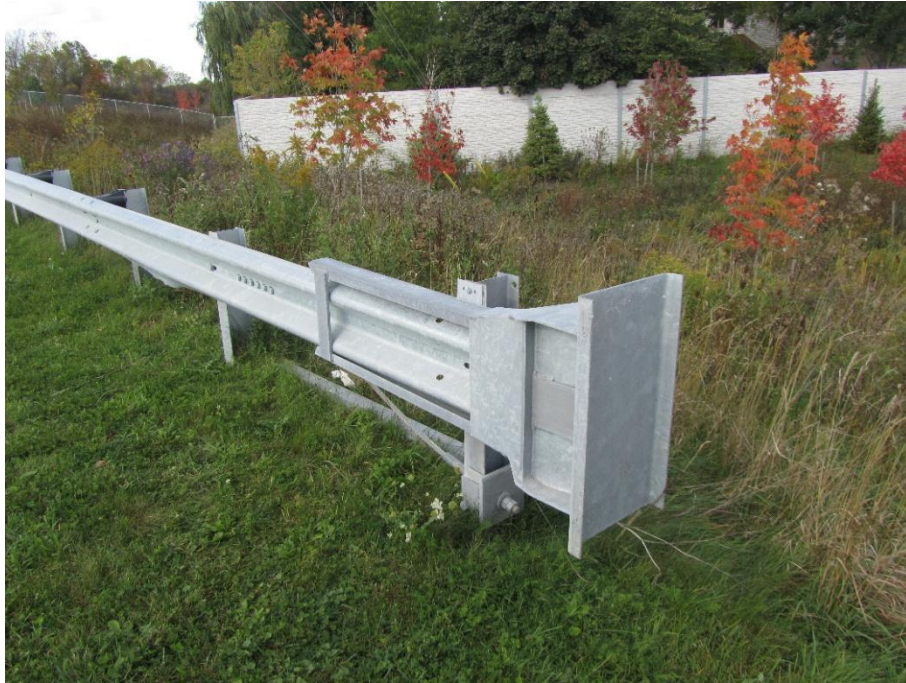
Figure 56: Overall view of north guardrail on Sarnia Road CP railway overpass.

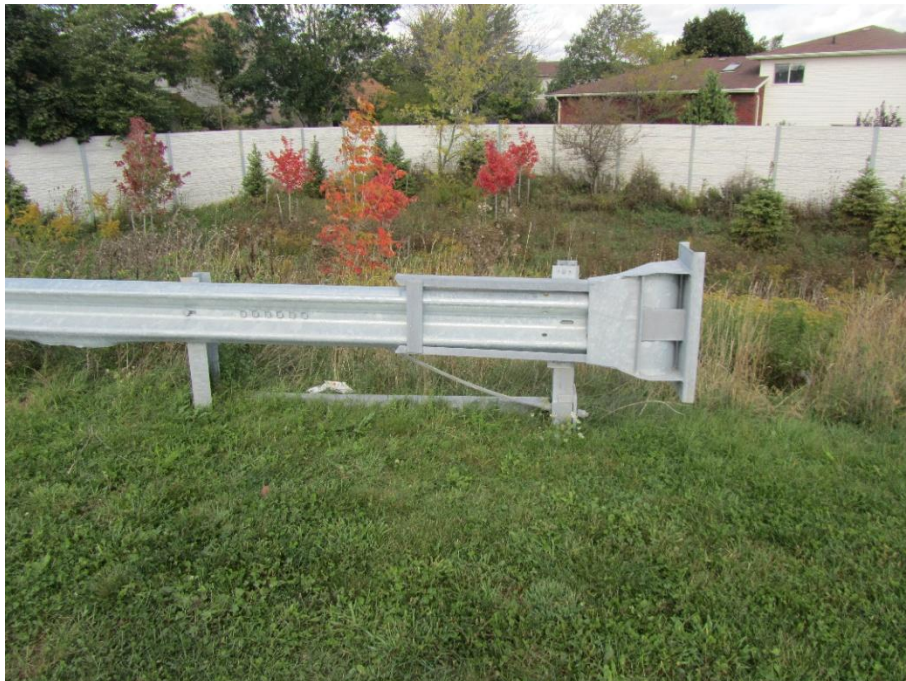
Figure 57: Street view of north guardrail.

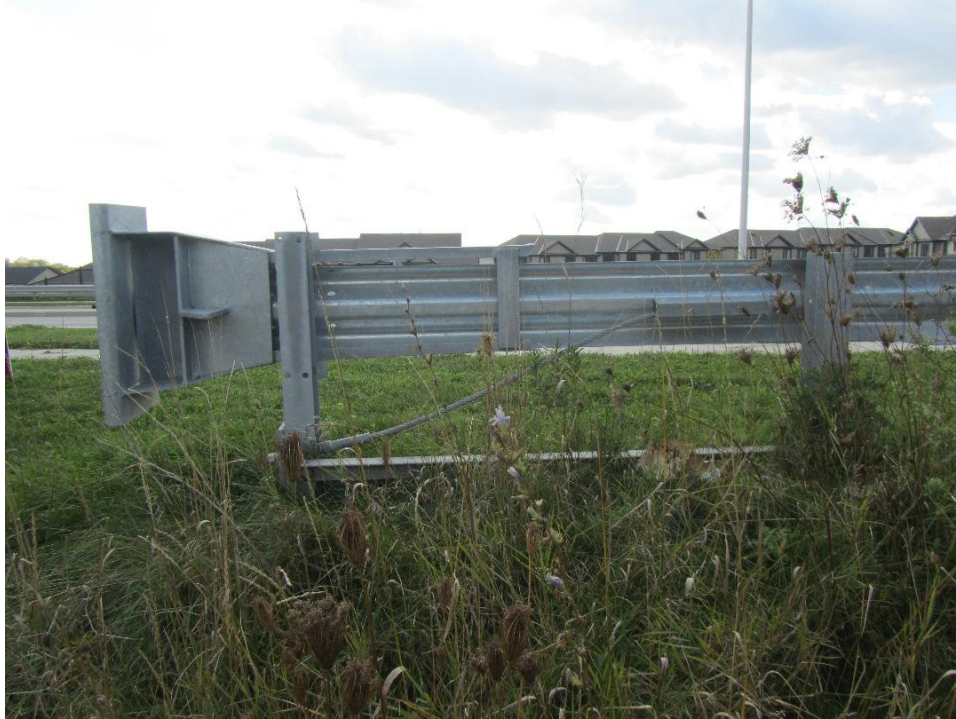
Figure 58: Ditch view of north guardrail.

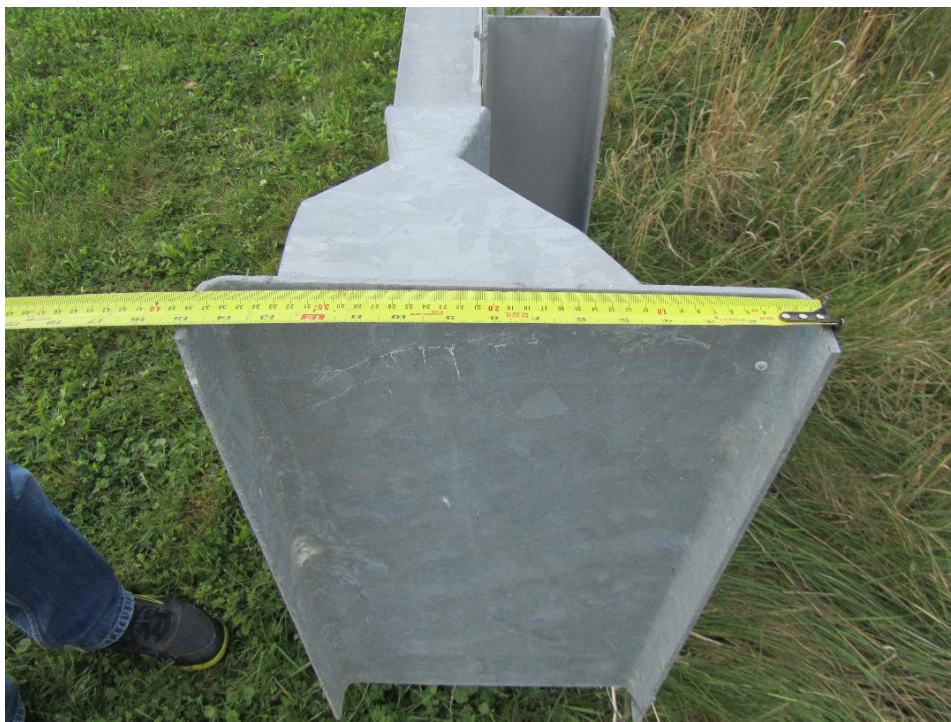
Figure 59: Measurement indicating the typical width of 15 inches for the end plate.

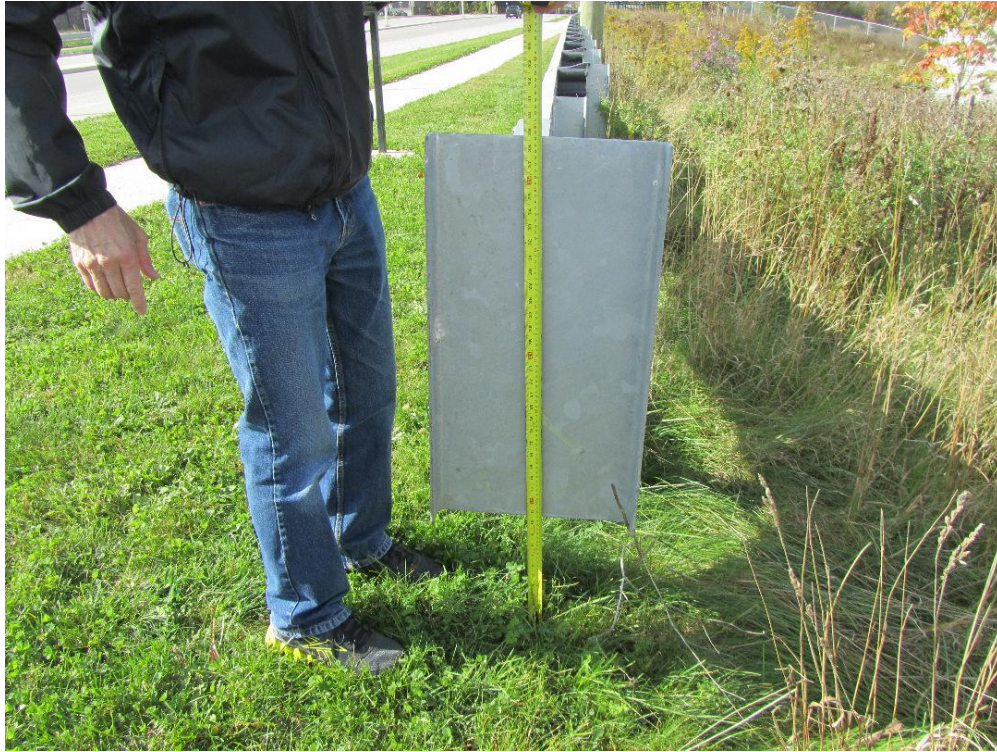
Figure 60: View showing the installed height of the end plate with the base positioned 10.5 inches above the ground.

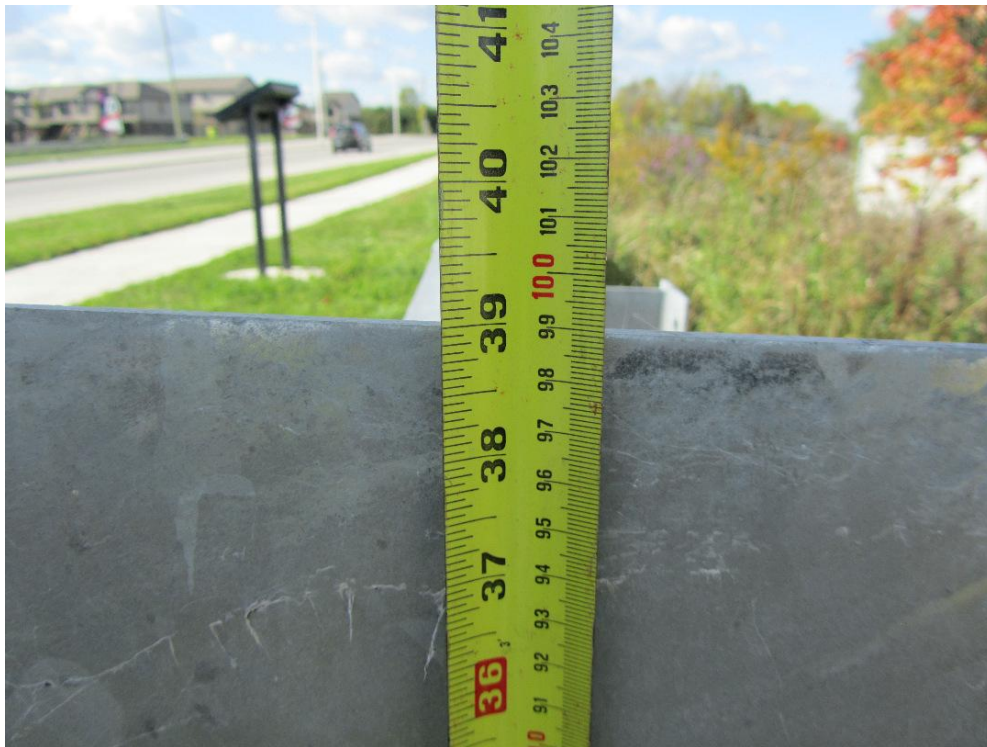
Figure 61: Measurement showing the top edge of the end plate at almost 39 inches above the ground.

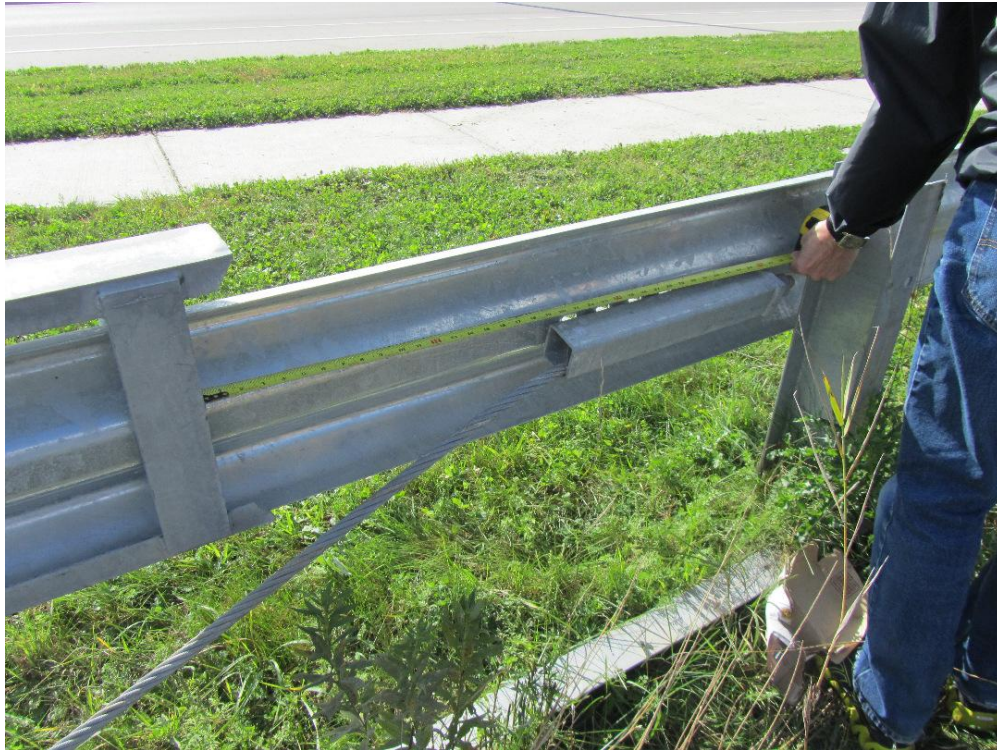
Figure 62: View of standard measurement being taken to document the end cap's position with respect to the guardrail.

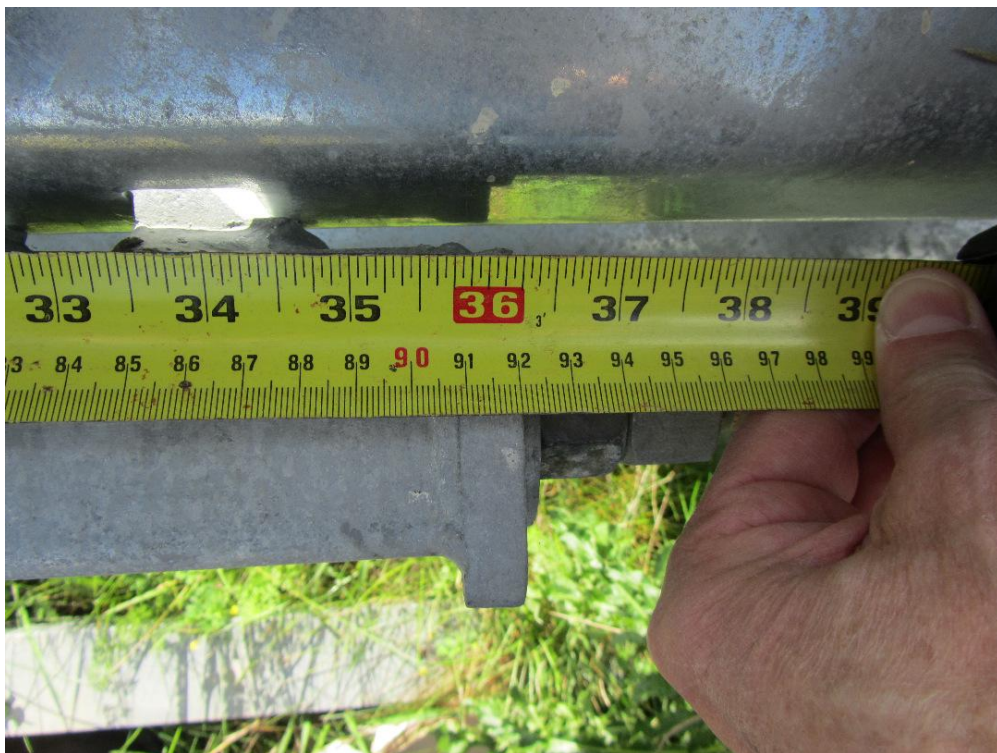
Figure 63: Result of standard measurement indicating a distance of 36.25 inches.

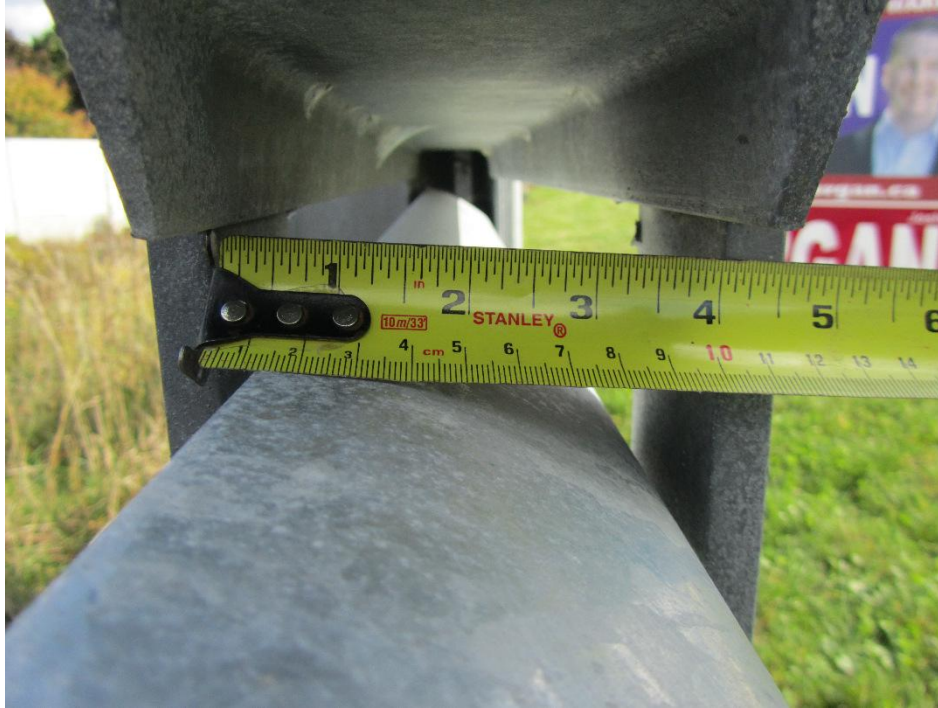
Figure 64: Measurement indicating the width of the channel is 4 inches.

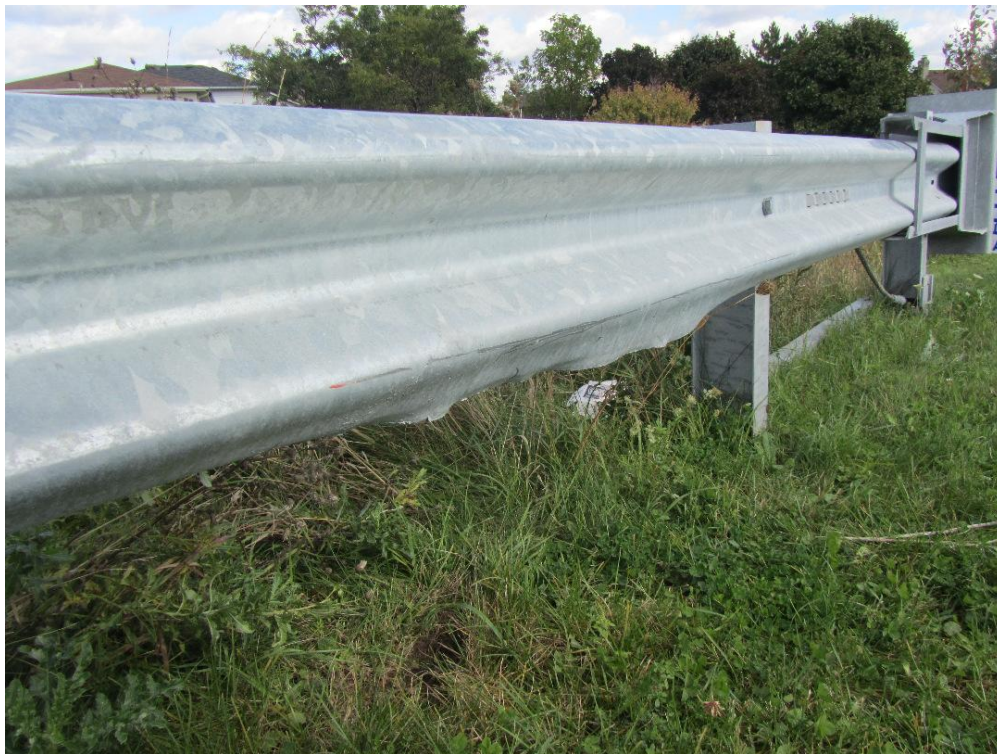
Figure 67: Photo indicating that scrapes also exist to the front face of the rail in the area of the deformation.

At several sites we have observed that the system was damaged, possibly from previous impacts, and that the system was still left in its condition, without a repair. Again, it cannot be known what level of damage could become important in changing the safe functioning of the systems.

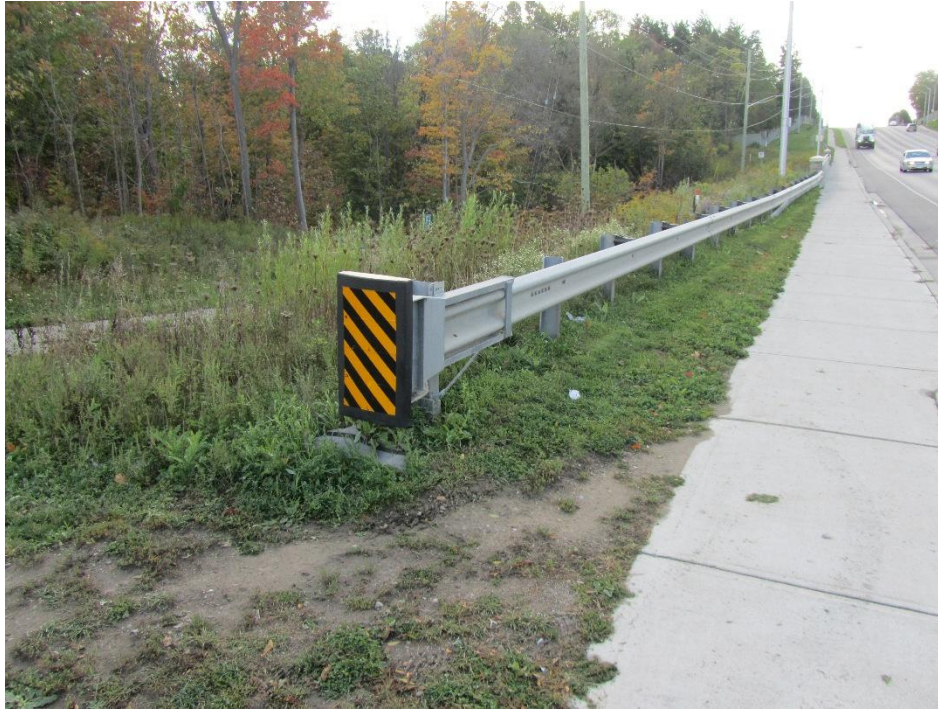
Figure 68: Overall view of north end cap of east guard rail.

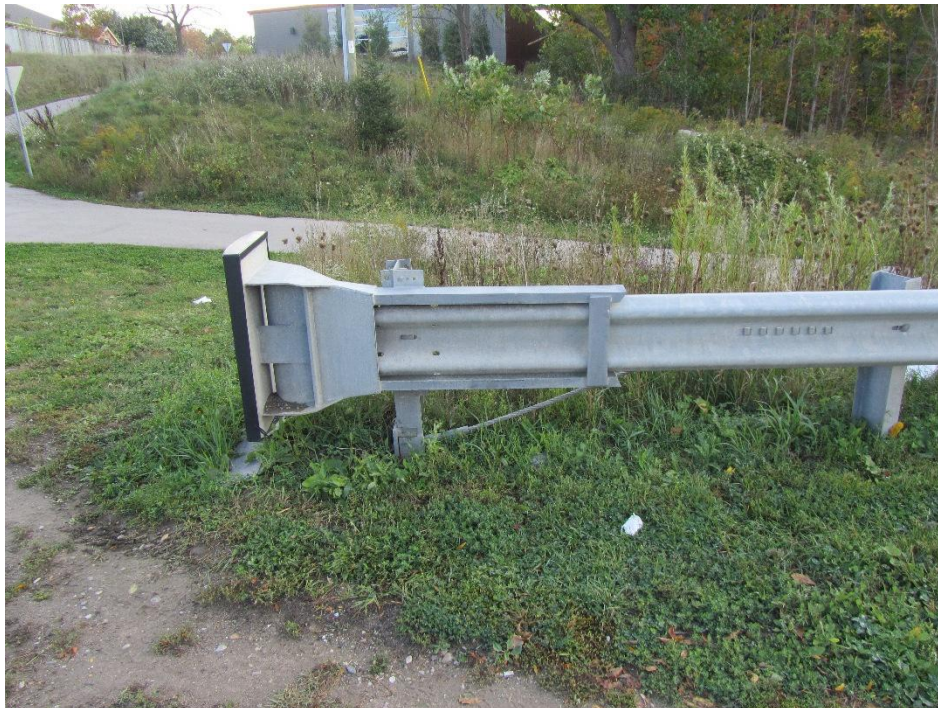
Figure 69: Street side view.

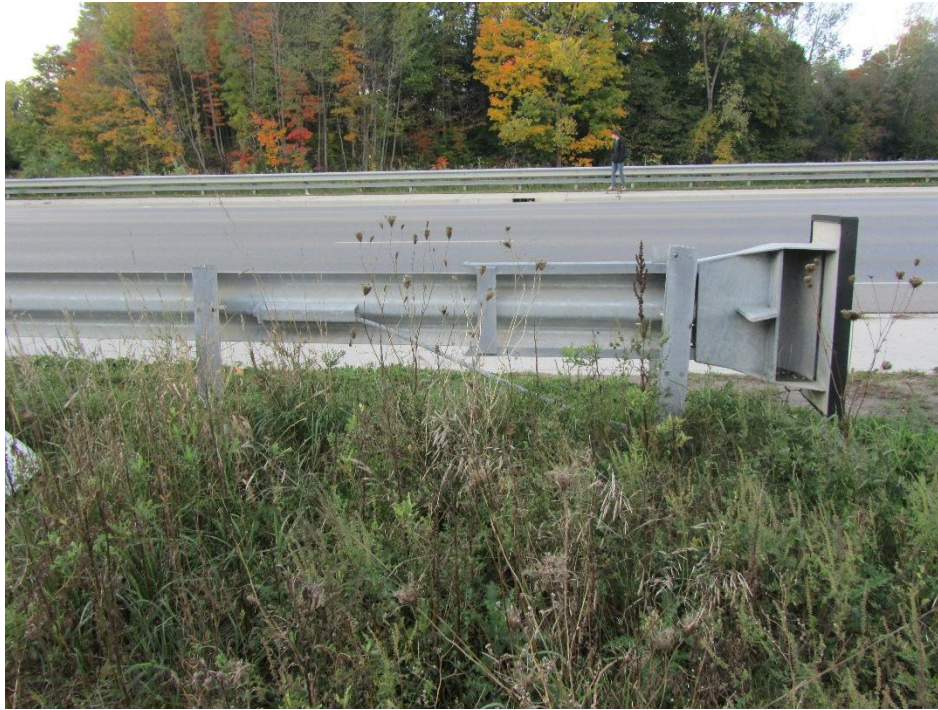
Figure 70: Ditch side view.

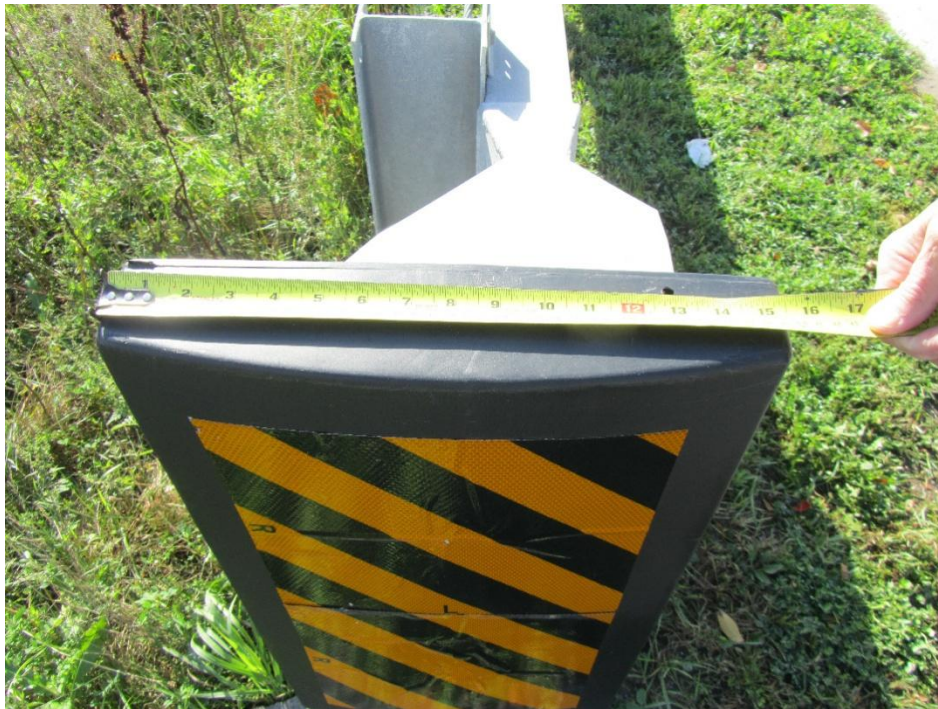
Figure 71: Measurement indicating typical width of 15.5 inches to the cover the end plate.

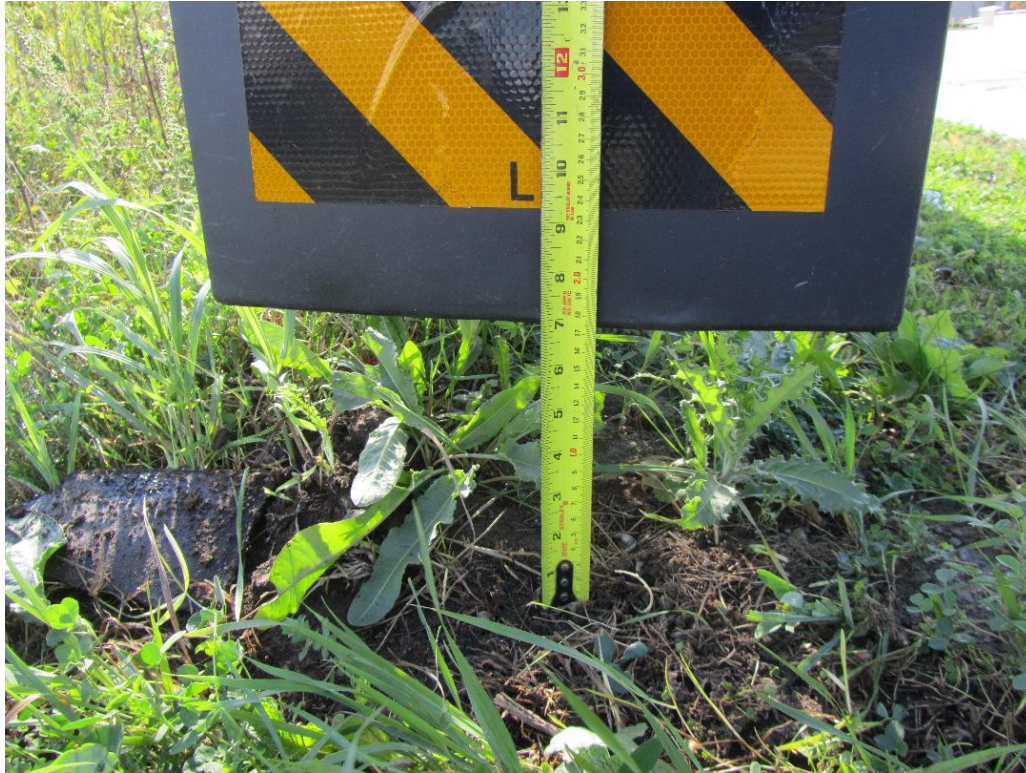
Figure 72: Measurement indicating that the base of the end plate cover is about 7 inches above the ground.

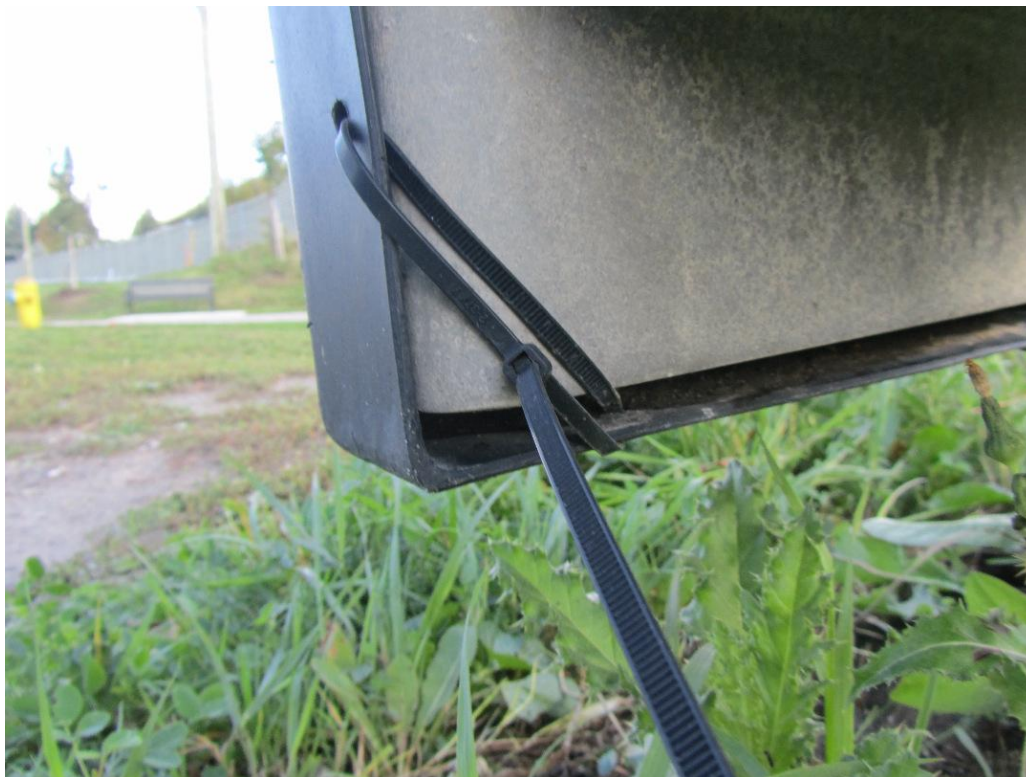
Figure 73: View of typical plastic tie used to secure the cover to the end plate.

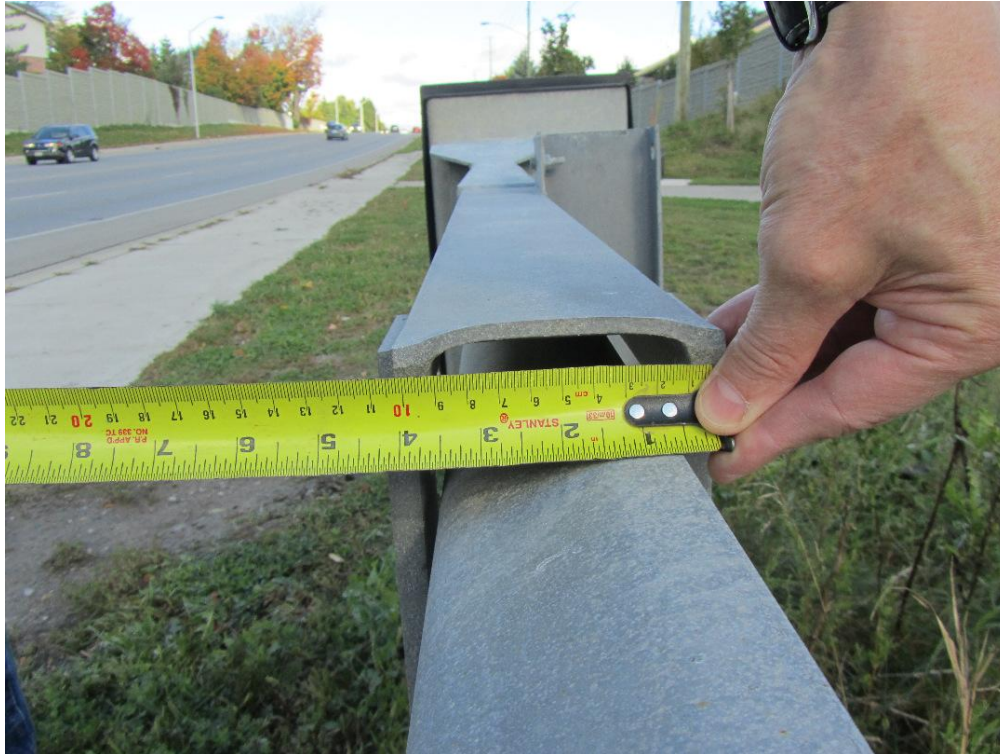
Figure 74: Measurement showing that the channel is the typical 4 inch width.

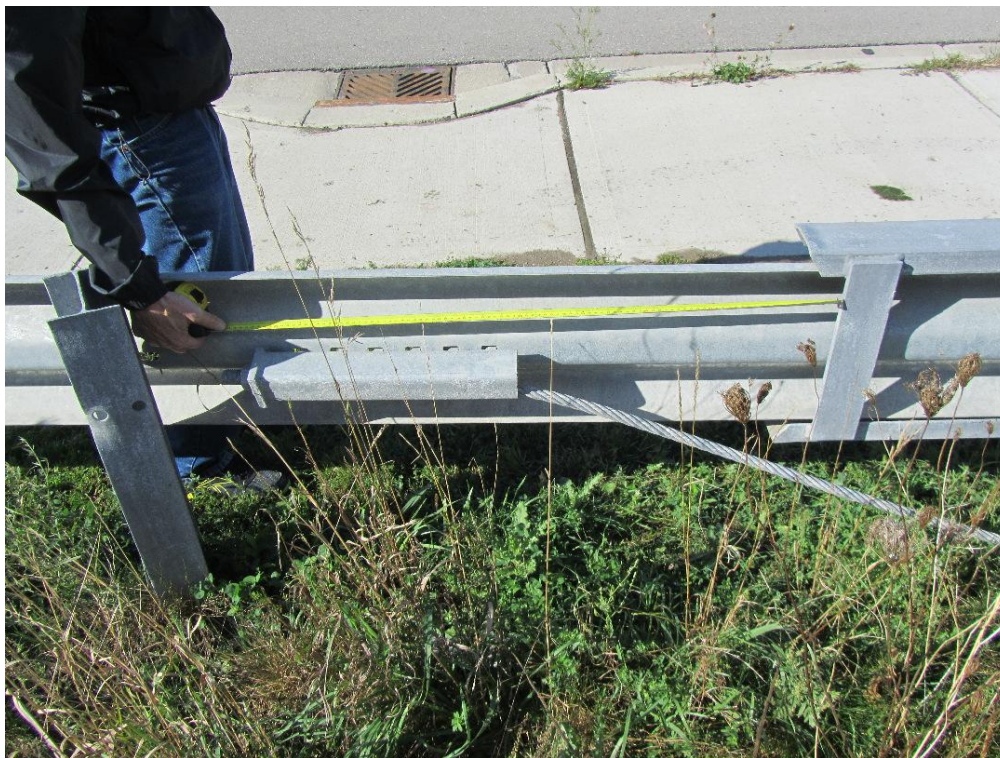
Figure 75: View of standard measurement being taken to document the position of the end cap with respect to the guardrail.

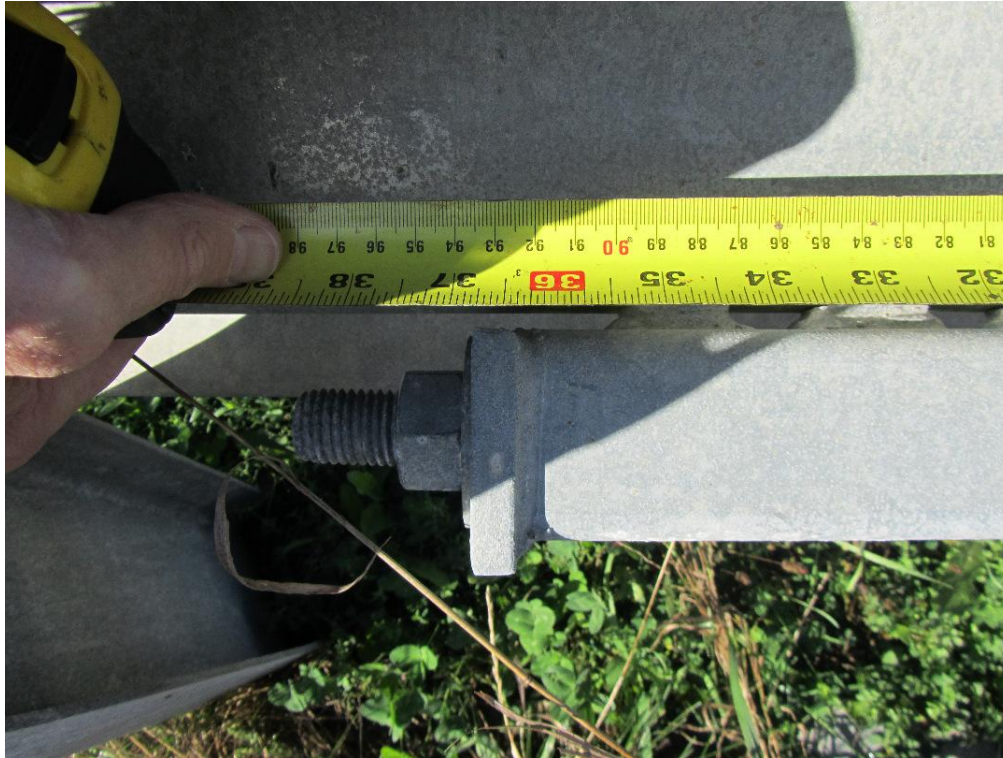
Figure 76: Result of standard measurement indicates a distance of 36.75 inches.

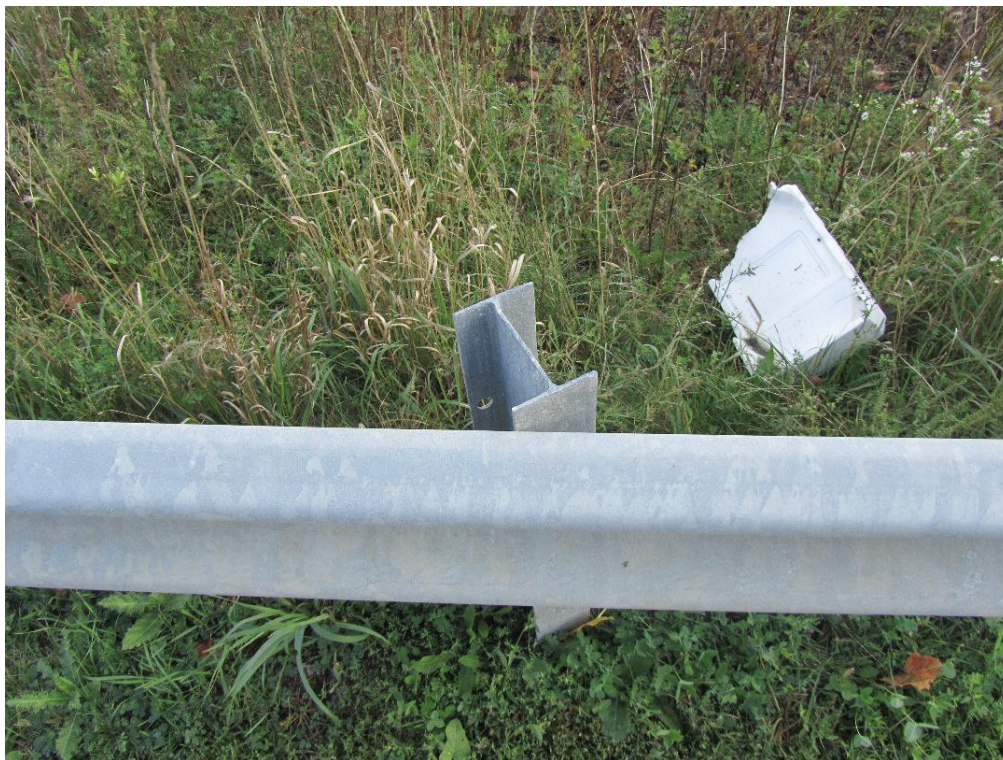
Figure 77: View of peculiar position of the rail anchorage post near the end cap.

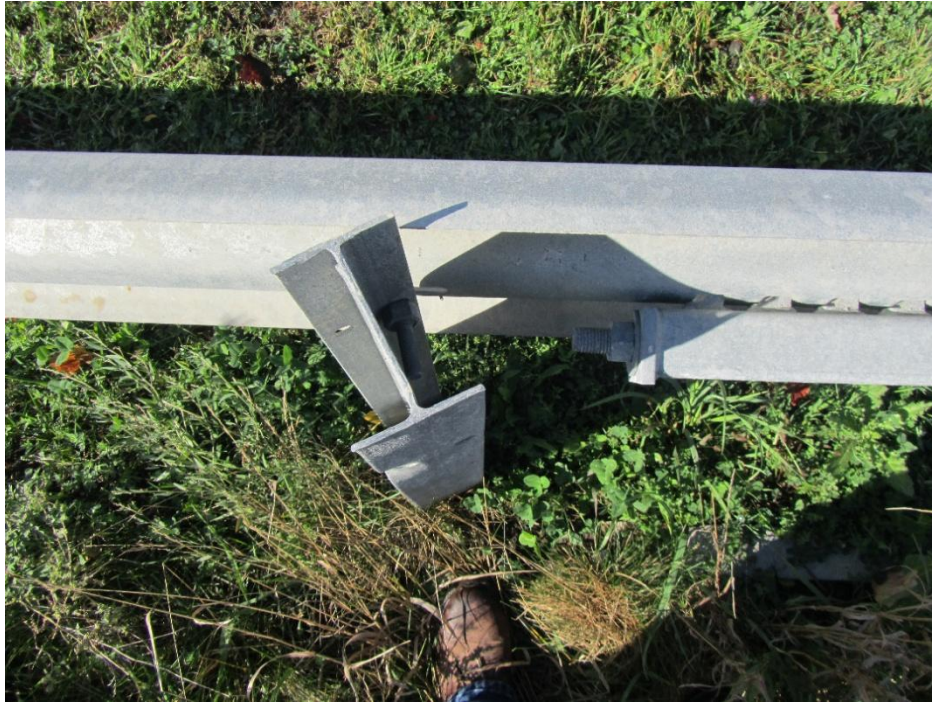
Figure 78: View of peculiar position of the rail anchorage post near the end cap.

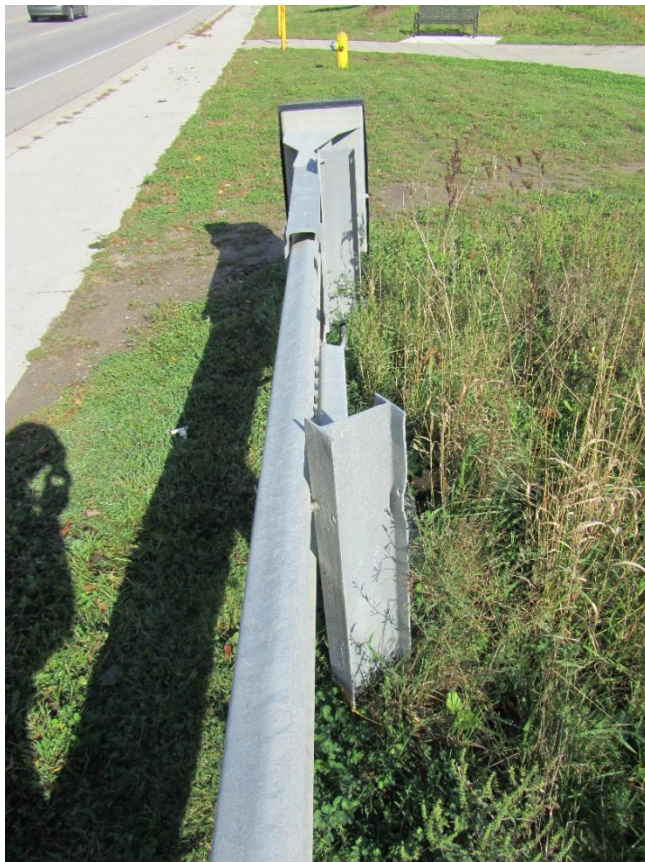
Figure 79: View of peculiar position of anchorage post.
